REPORT NO.: 214-MGA-97-09
SAFETY COMPLIANCE TESTING FOR
FMVSS 214 "SIDE IMPACT PROTECTION -
PASSENGER CARS"

FORD MOTOR COMPANY
1997 FORD PROBE 3 DOOR HATCHBACK
NHTSA NO: CV0208

MGA PROVING GROUNDS
5000 WARREN ROAD
BURLINGTON, WI 53105

FINAL REPORT

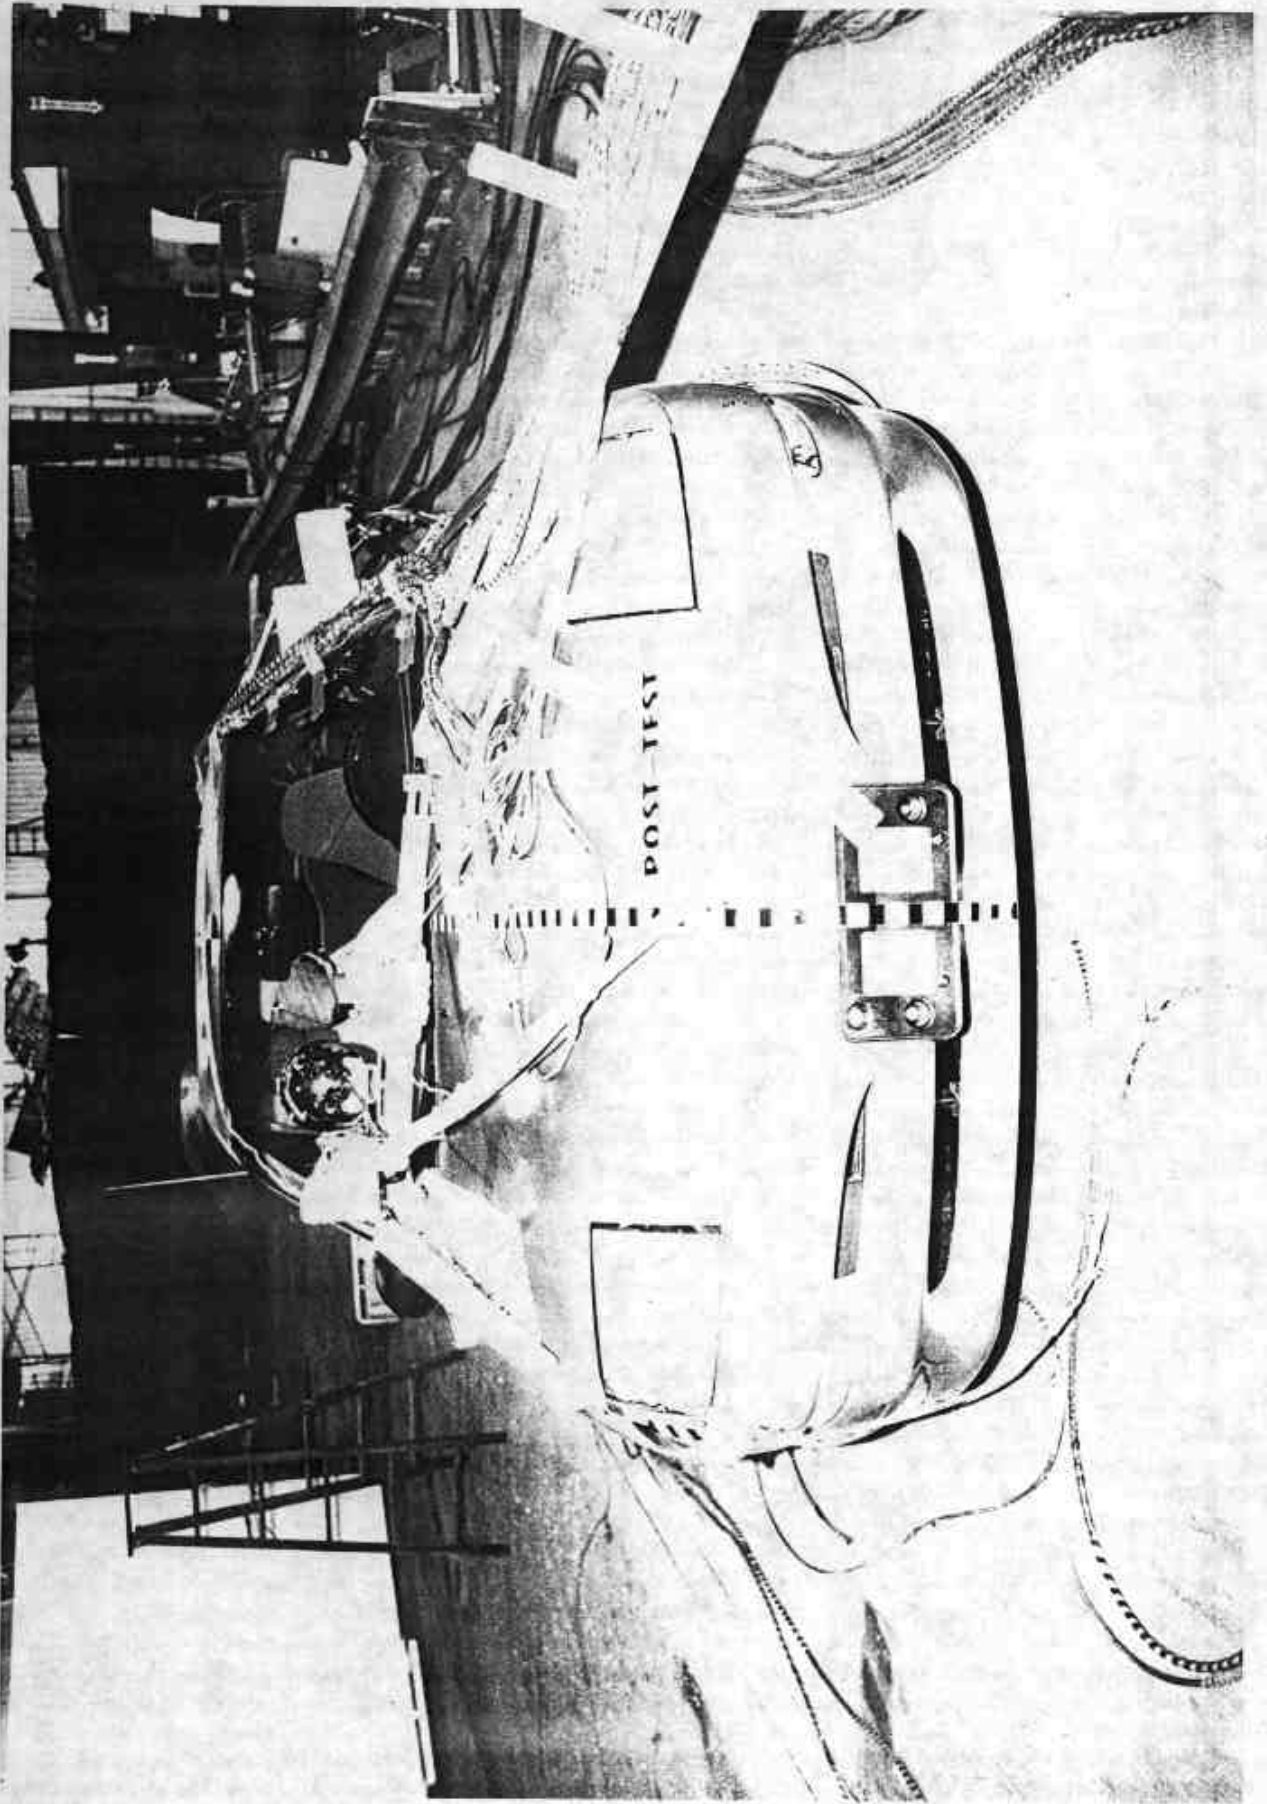
Photo No. A-2 - Post-Test Front View of Test Vehicle

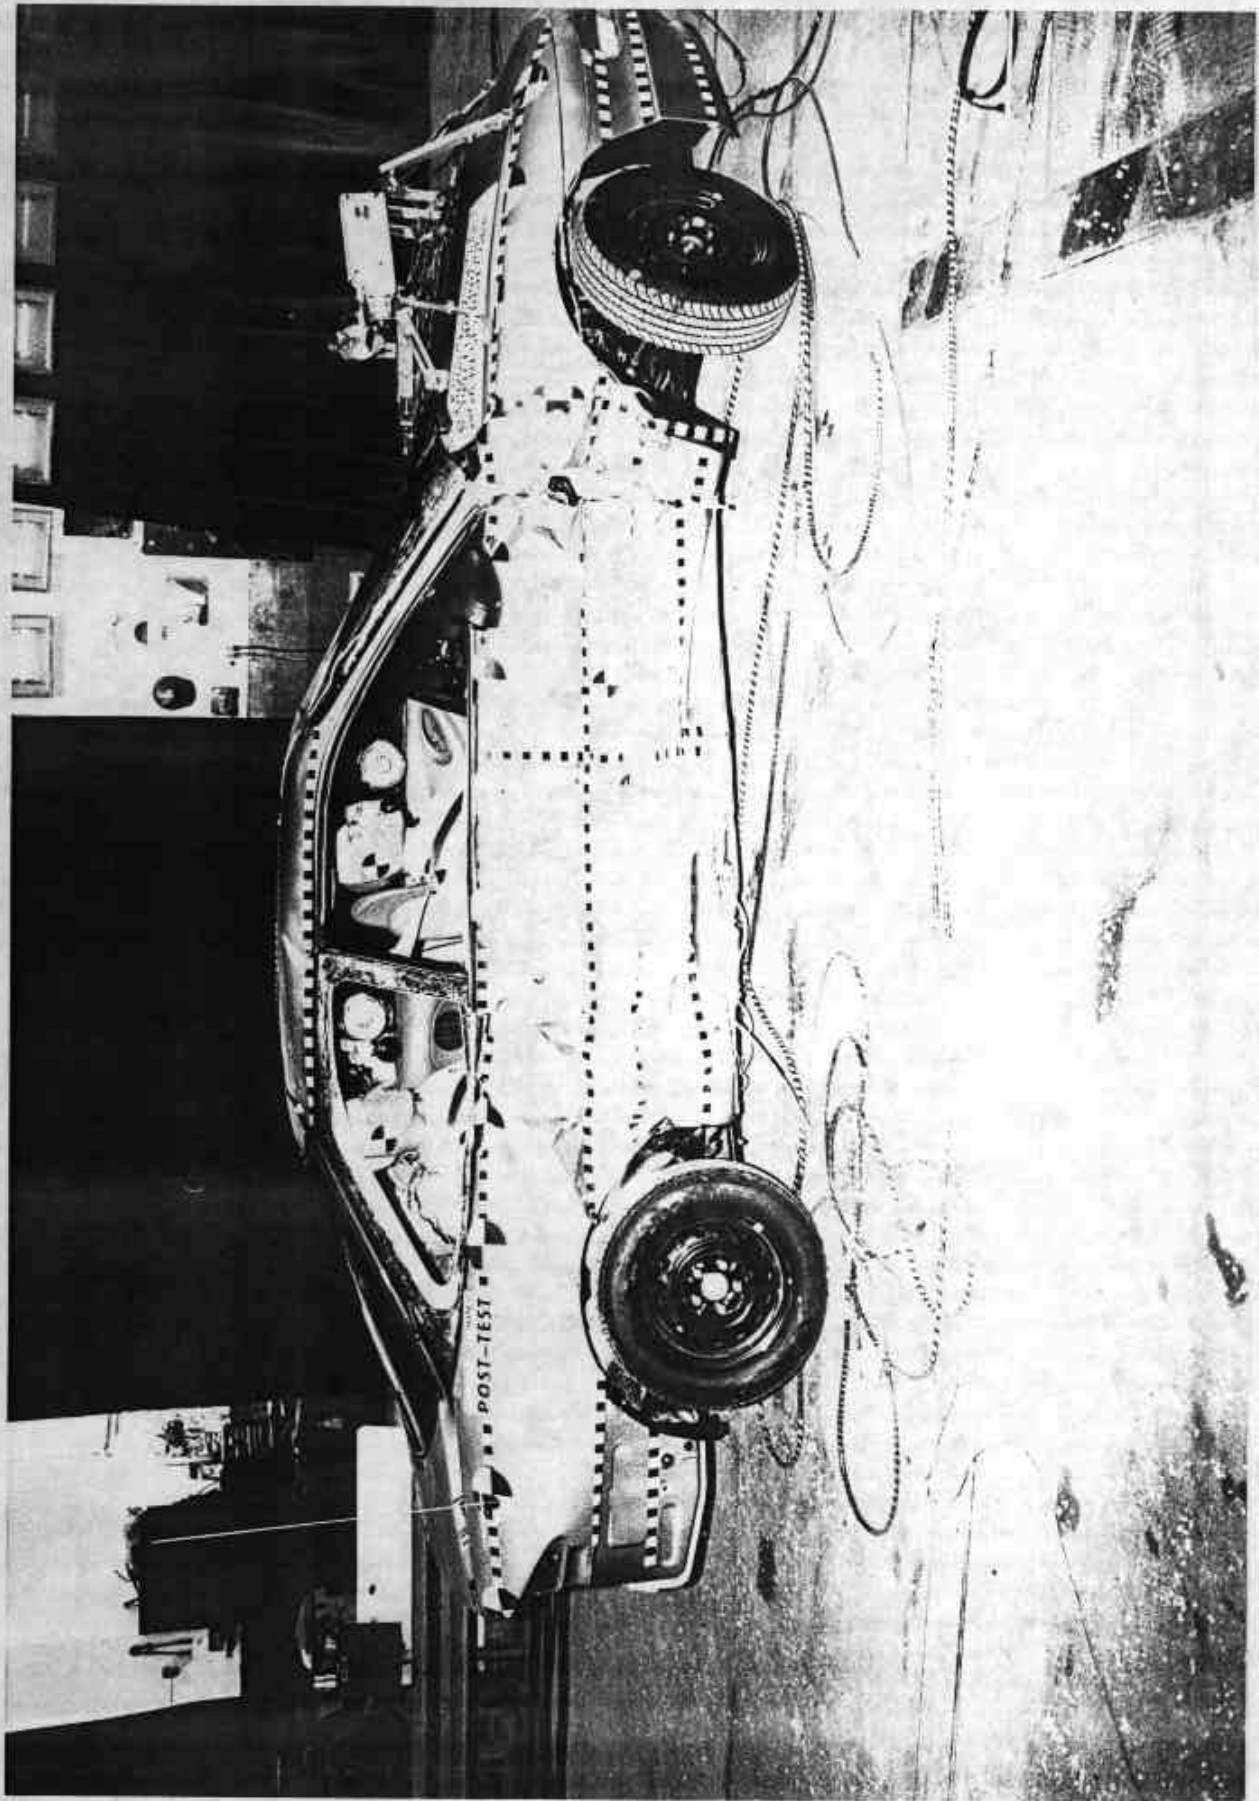
Photo No. A-6 - Post-Test Right Side View of Test Vehicle

1. LEVEL 1 (236 mm above ground) = 196 mm
2. LEVEL 2 (422 mm above ground) = 357 mm
3. LEVEL 3 (572 mm above ground) = 378 mm
4. LEVEL 4 (831 mm above ground) = 224 mm
5. LEVEL 5 (1202 mm above ground) = 66 mm
Maximum Post-Test Intrusion = 378 mm

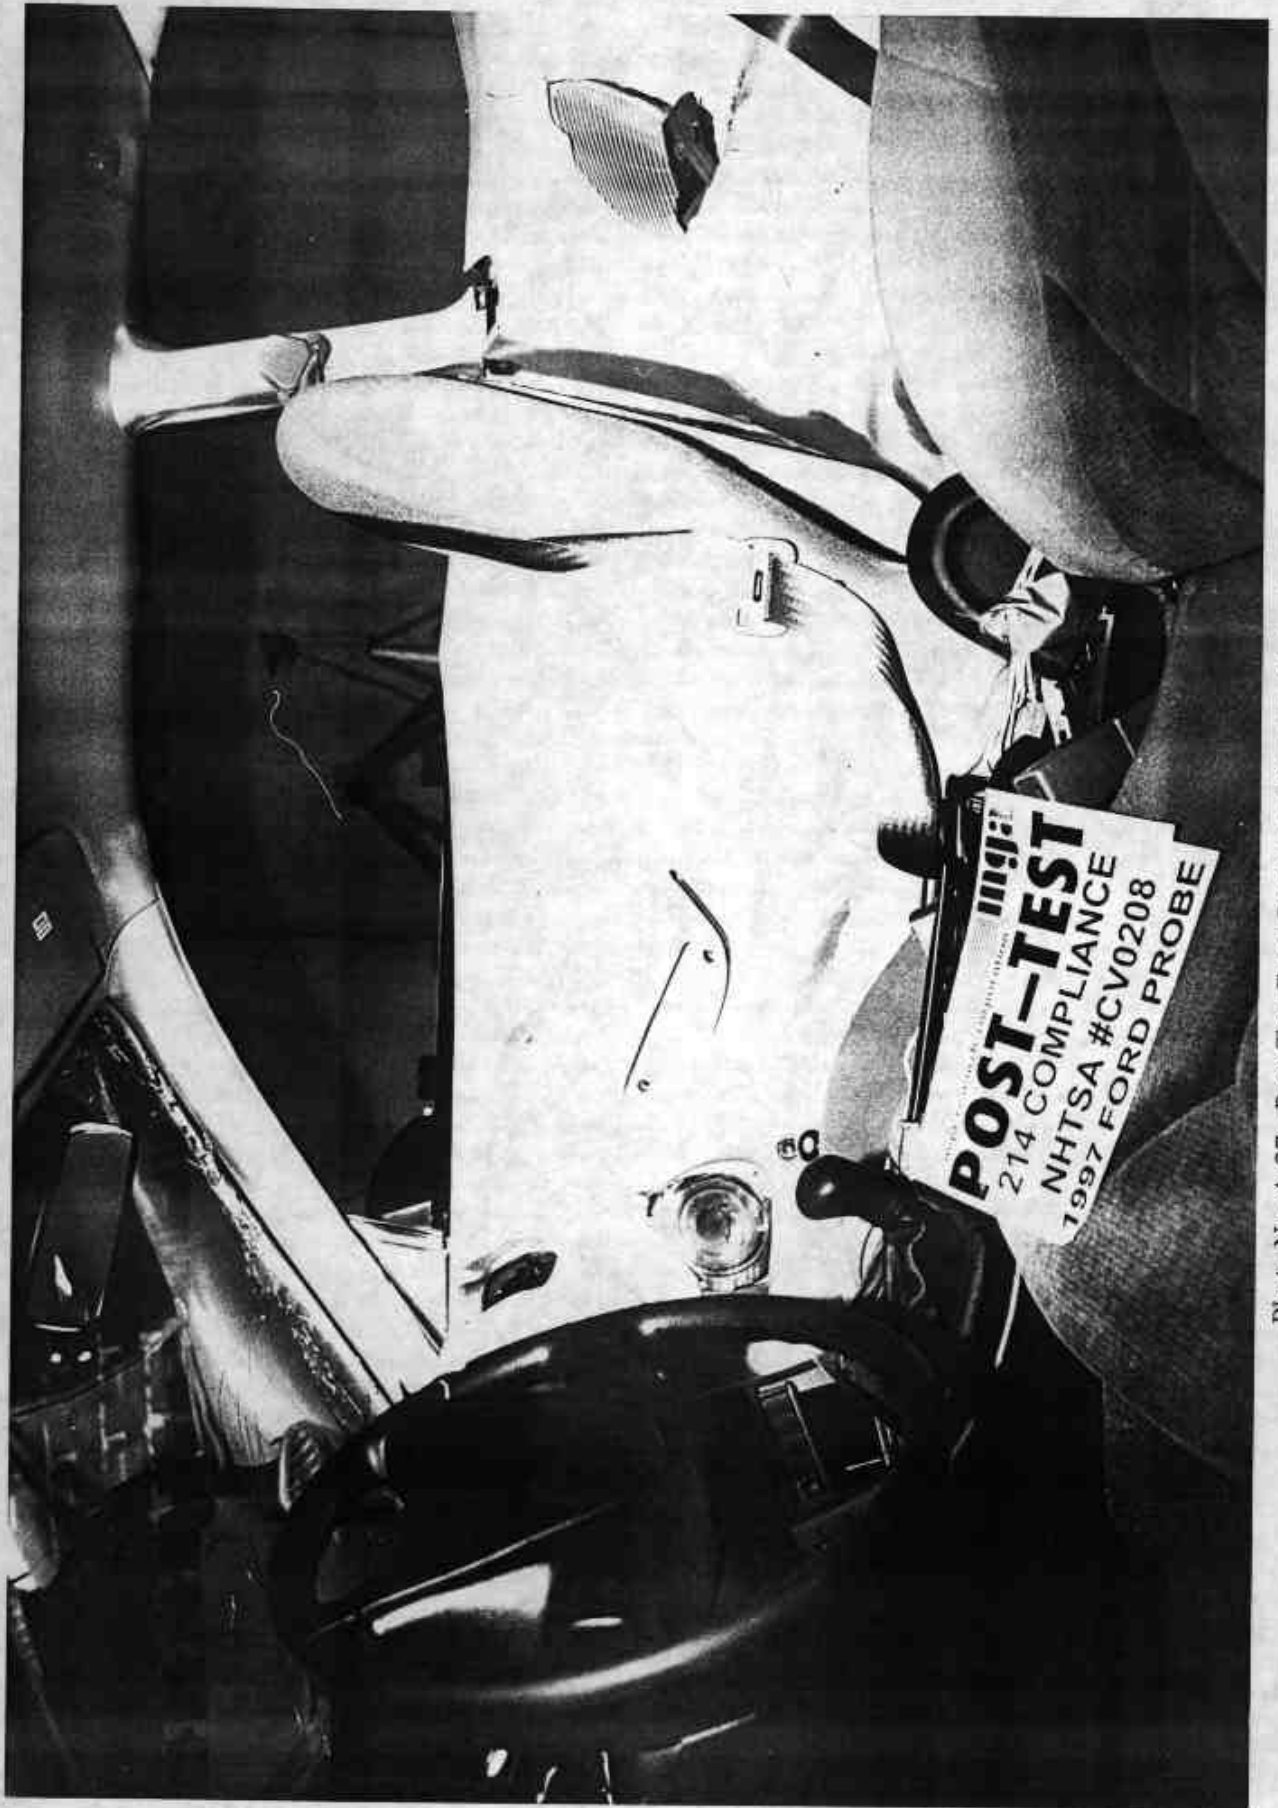
Photo No. A-27 - Post-Test Front Passenger Dummy Contact

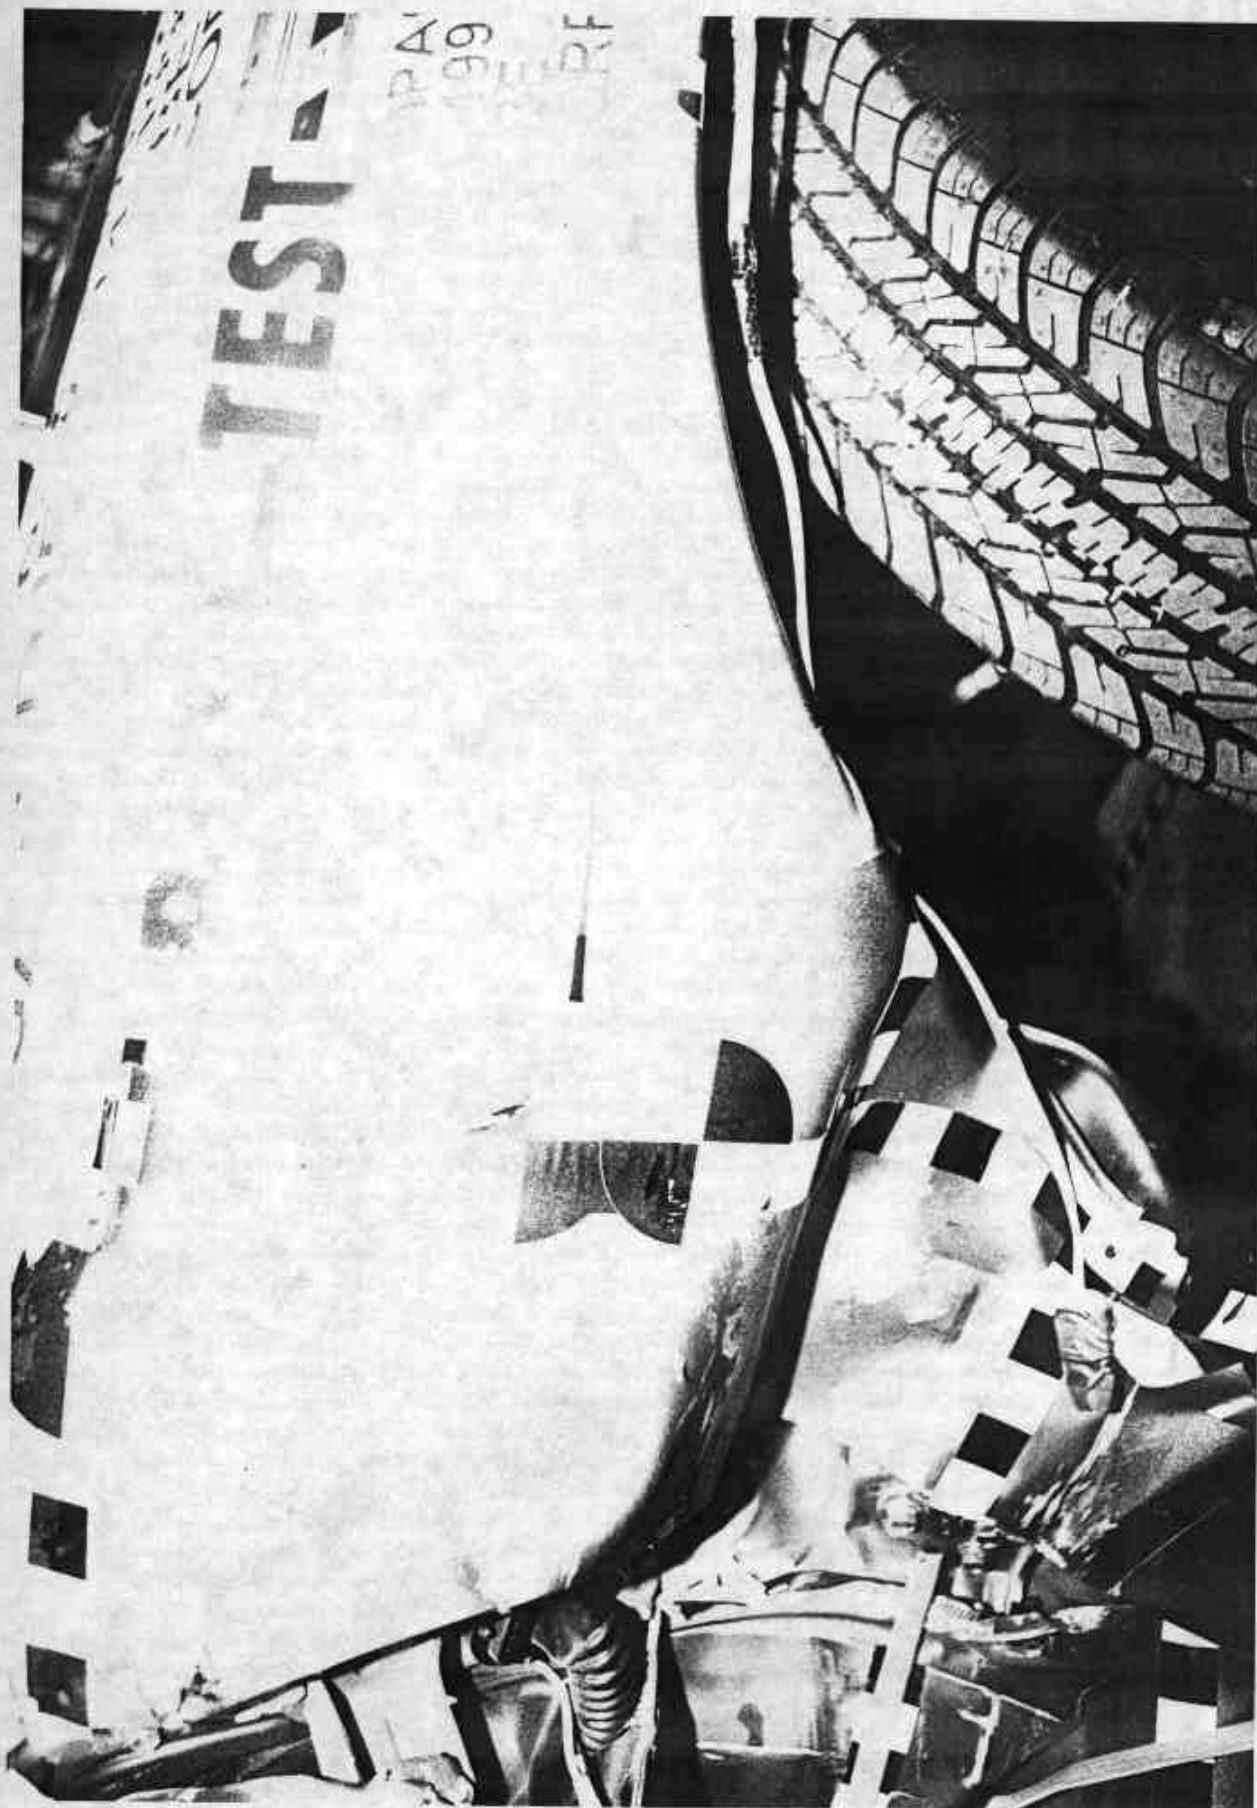
Photo No. A-37 - Post-Test Right Front Impact Point on Vehicle

Impact Point is 366 mm rearward of front axle centerline
