REPORT NO.: 214-MGA-97-18  
SAFETY COMPLIANCE TESTING FOR  
FMVSS 214 "SIDE IMPACT PROTECTION -  
PASSENGER CARS"

MAZDA MOTOR COMPANY  
1997 MAZDA MIATA 2 DOOR  
NHTSA NO: CV5400

MGA PROVING GROUNDS  
5000 WARREN ROAD  
BURLINGTON, WI 53105

FINAL REPORT

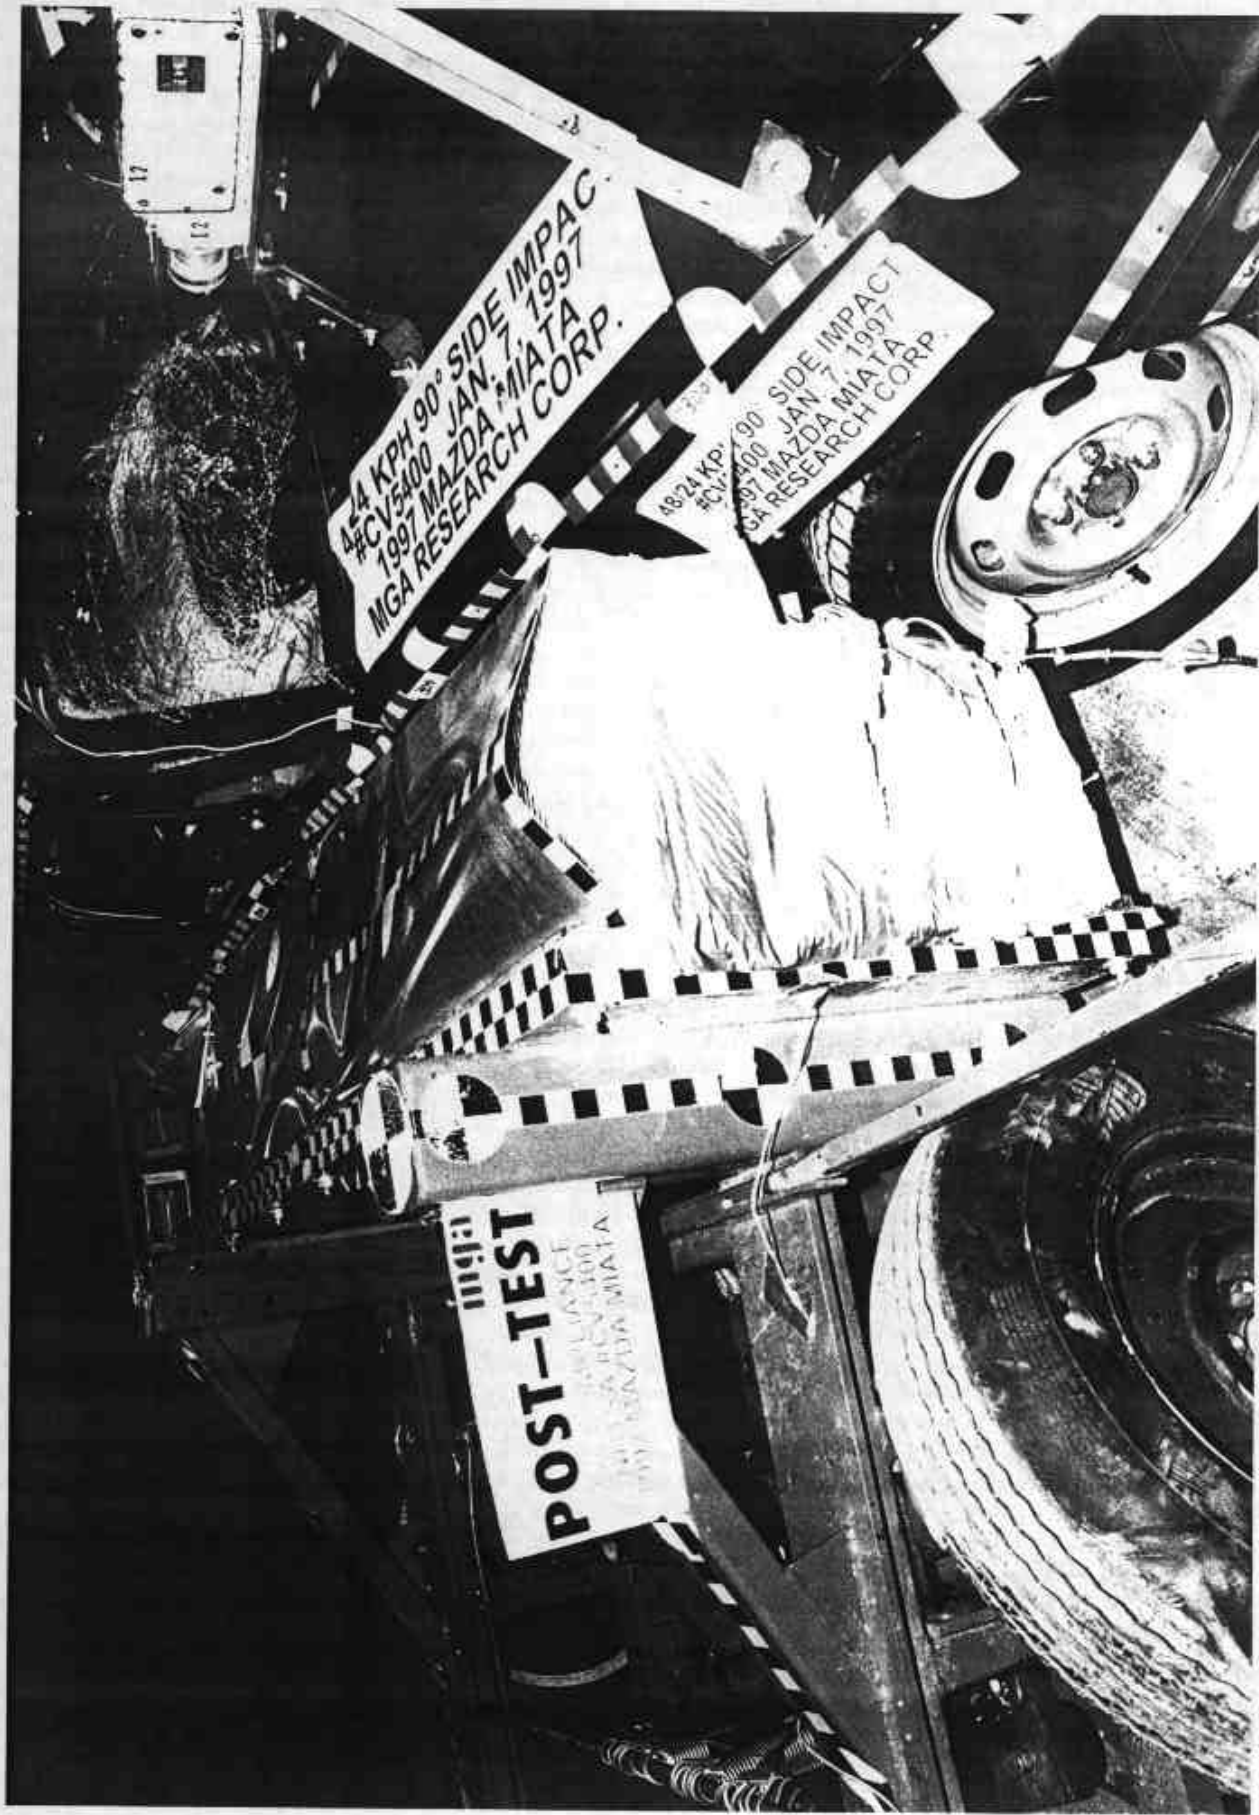
Photo No. A-10 - Post-Test MDB Positioned Against Vehicle (right side)

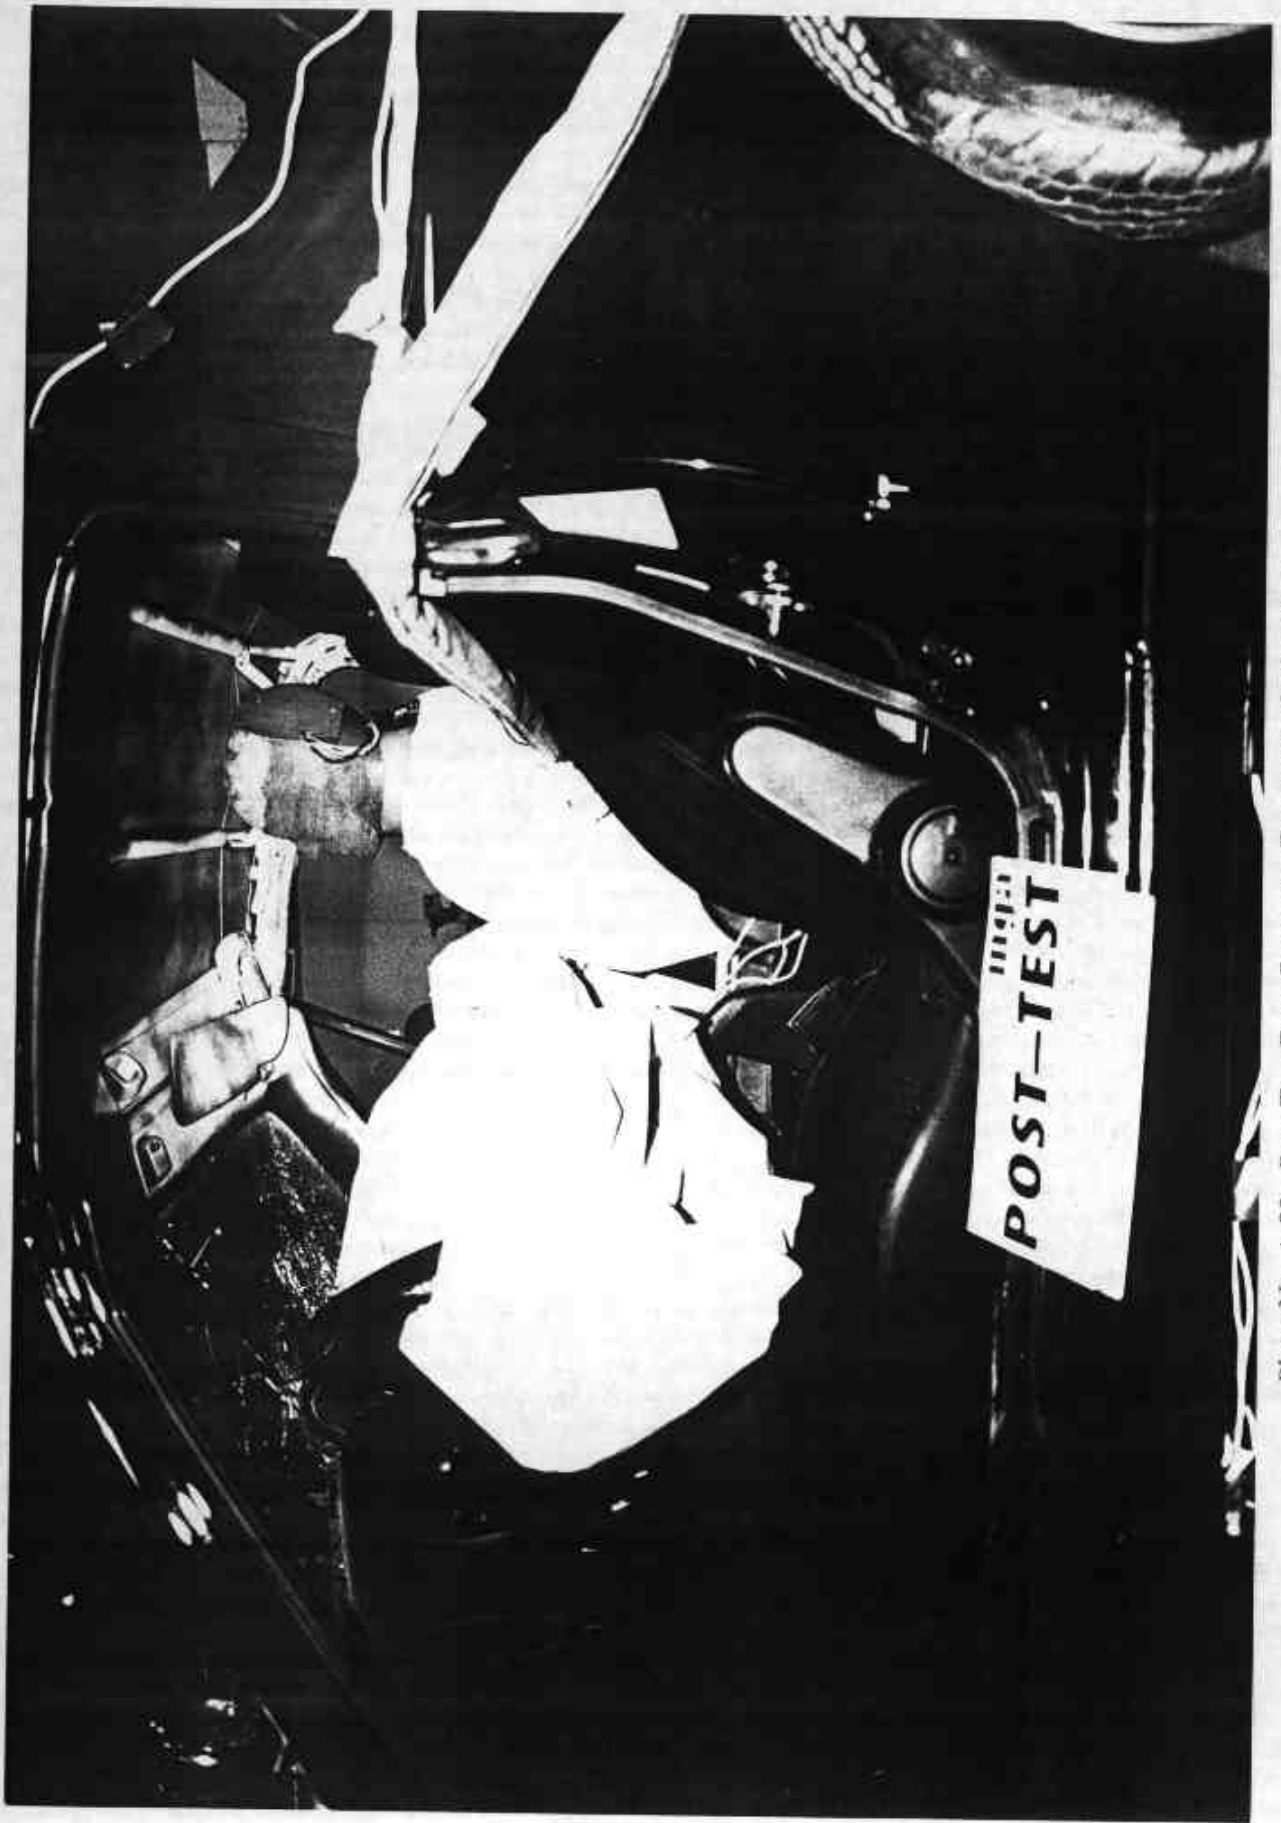
Photo No. A-23 - Post-Test Front Passenger Dummy Left Side View

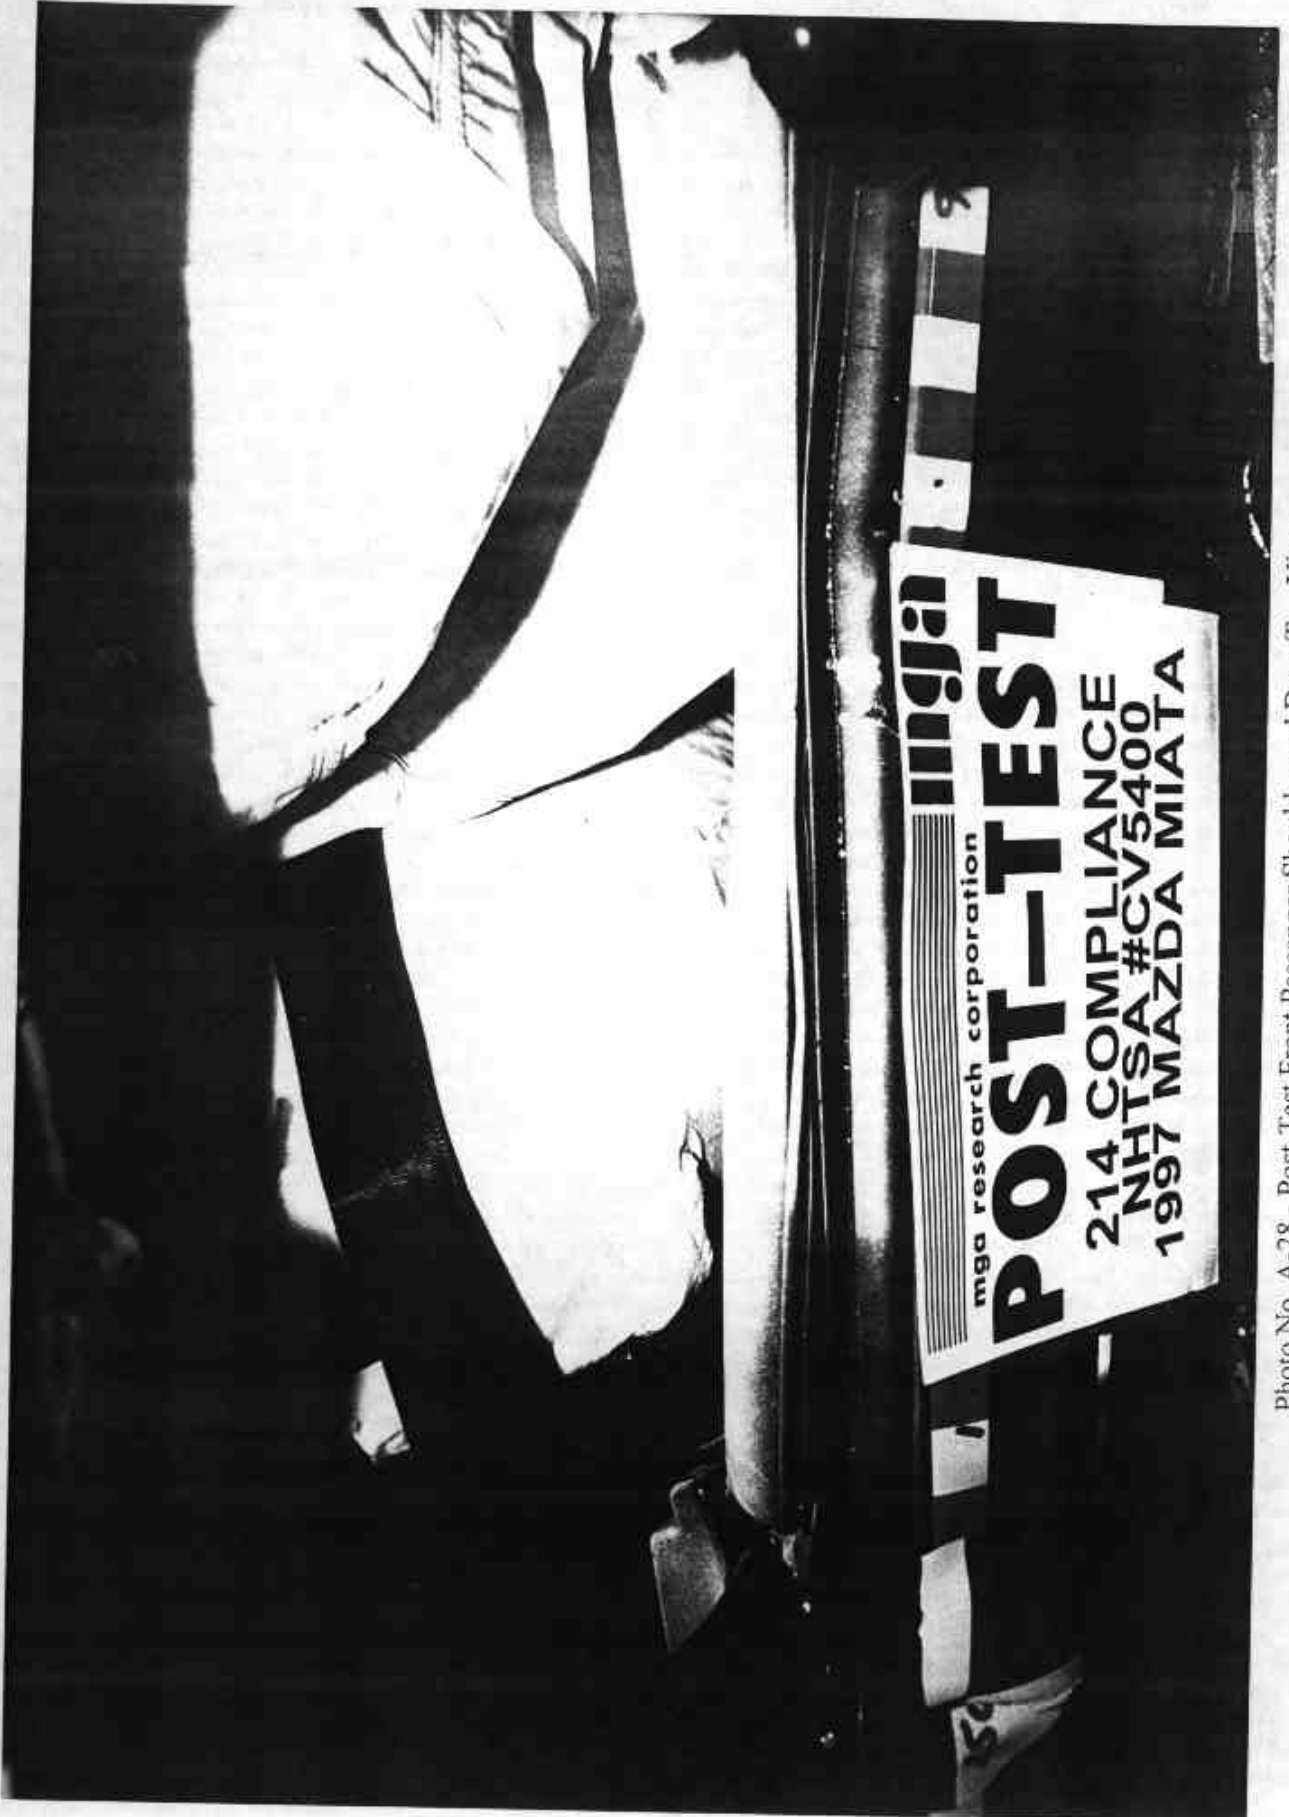
Photo No. A-28 - Post-Test Front Passenger Shoulder and Door Top View

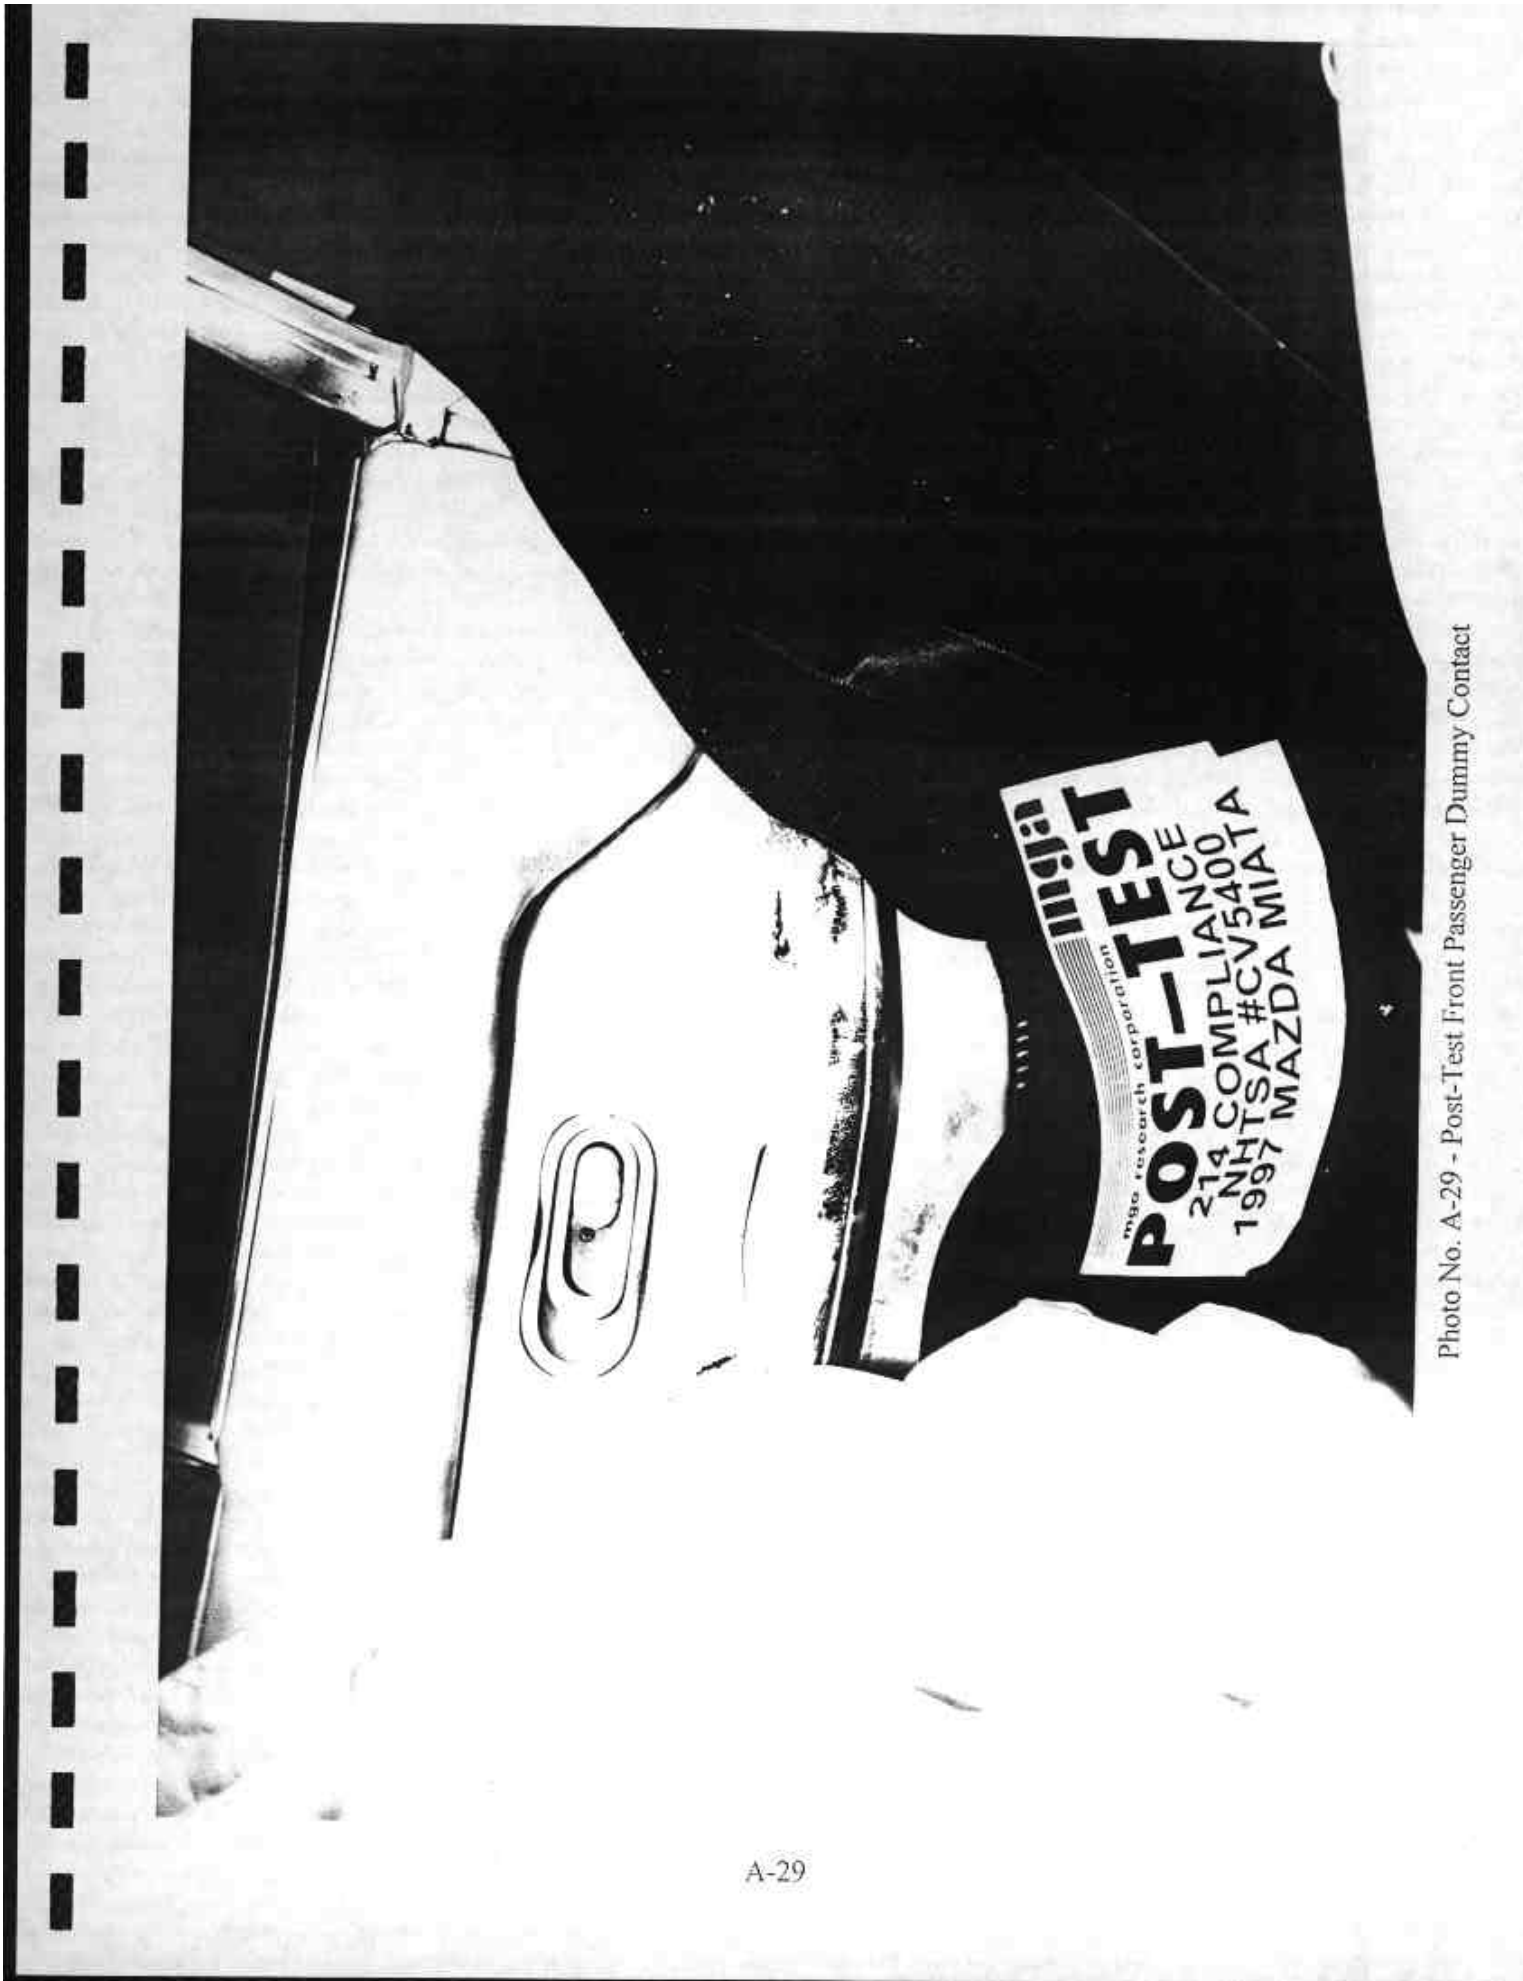
Photo No. A-29 - Post-Test Front Passenger Dummy Contact
