REPORT NO.: 214-MGA-97-19  
SAFETY COMPLIANCE TESTING FOR  
FMVSS 214 "SIDE IMPACT PROTECTION -  
PASSENGER CARS"

HYUNDAI MOTOR COMPANY  
1997 HYUNDAI ELANTRA 4 DOOR  
NHTSA NO: CV0500

MGA PROVING GROUNDS  
5000 WARREN ROAD  
BURLINGTON, WI 53105

FINAL REPORT

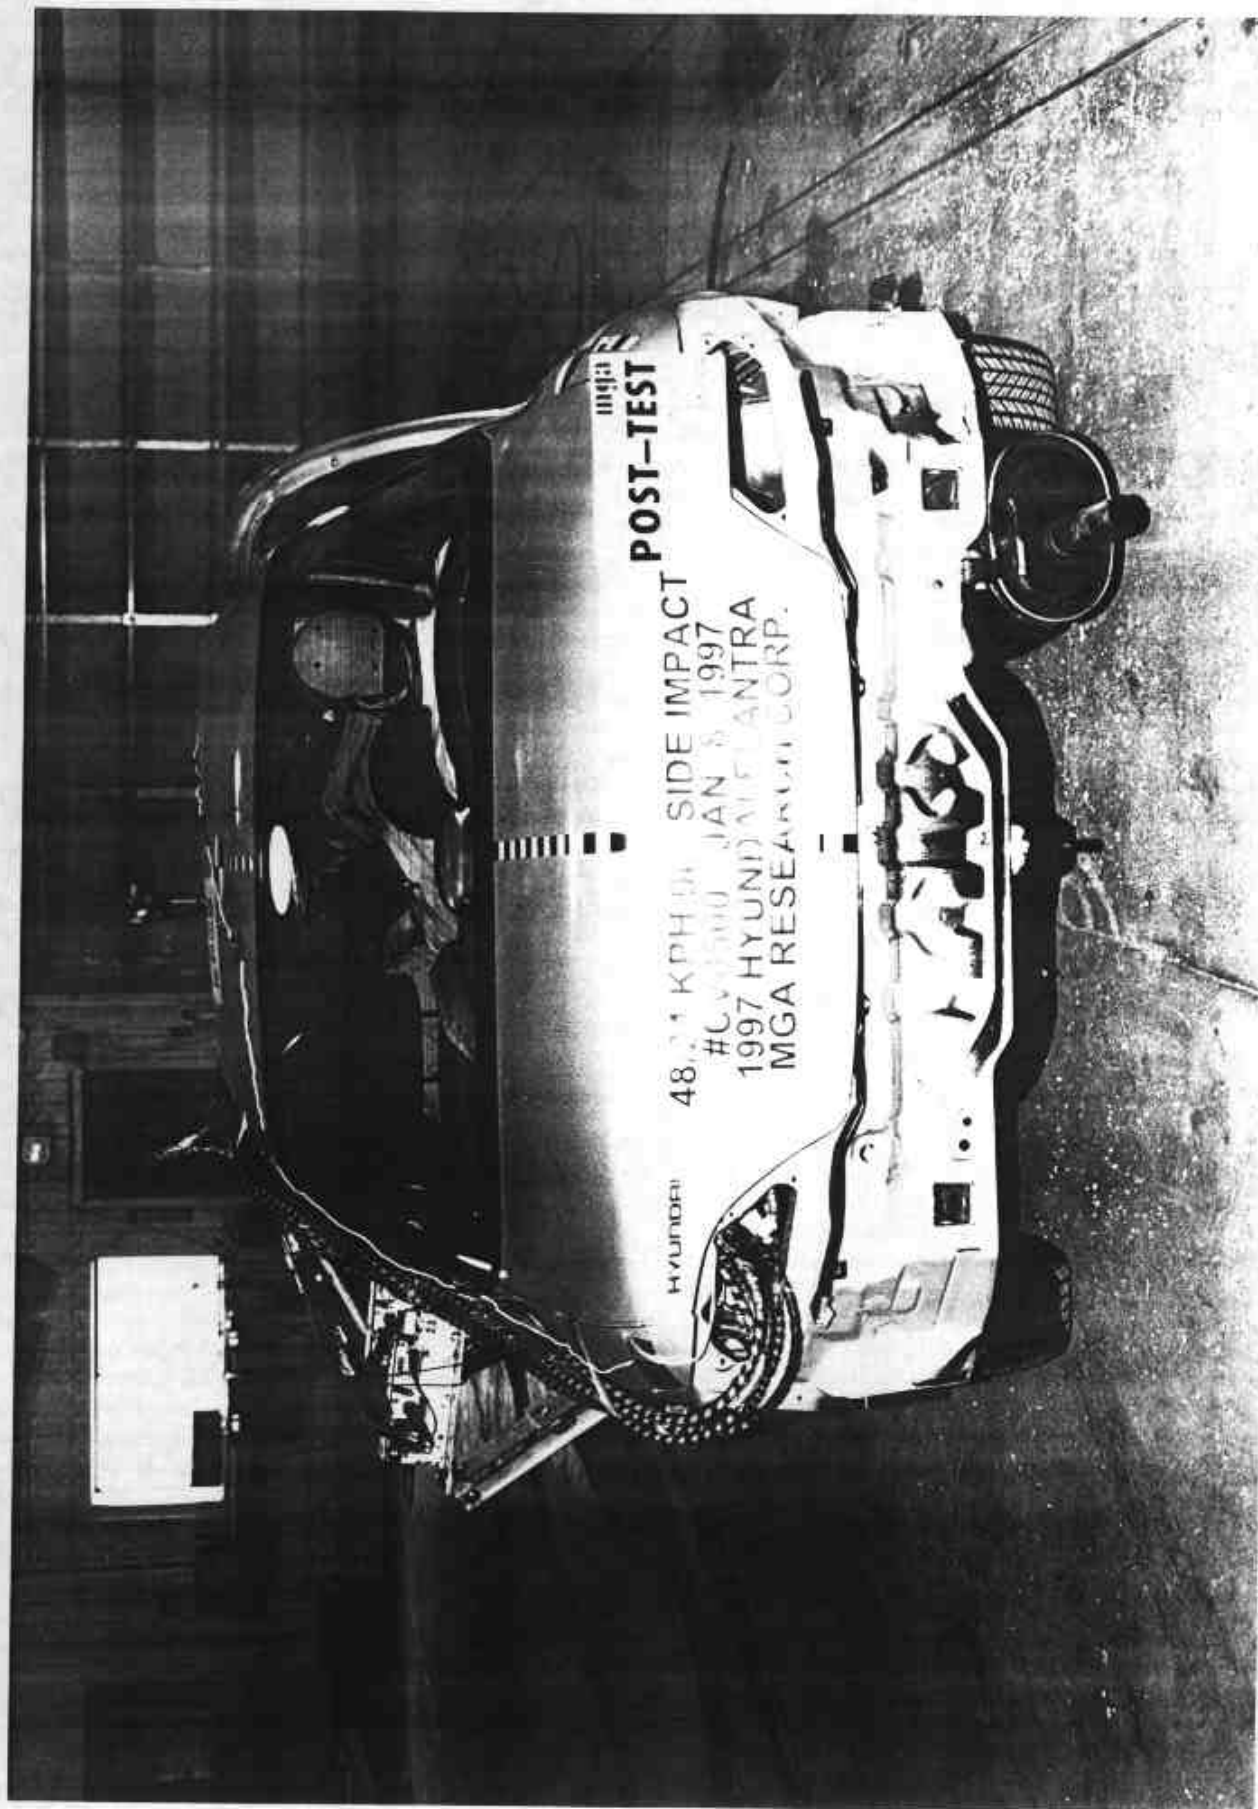
Photo No. A-4 - Post-Test Rear View of Test Vehicle

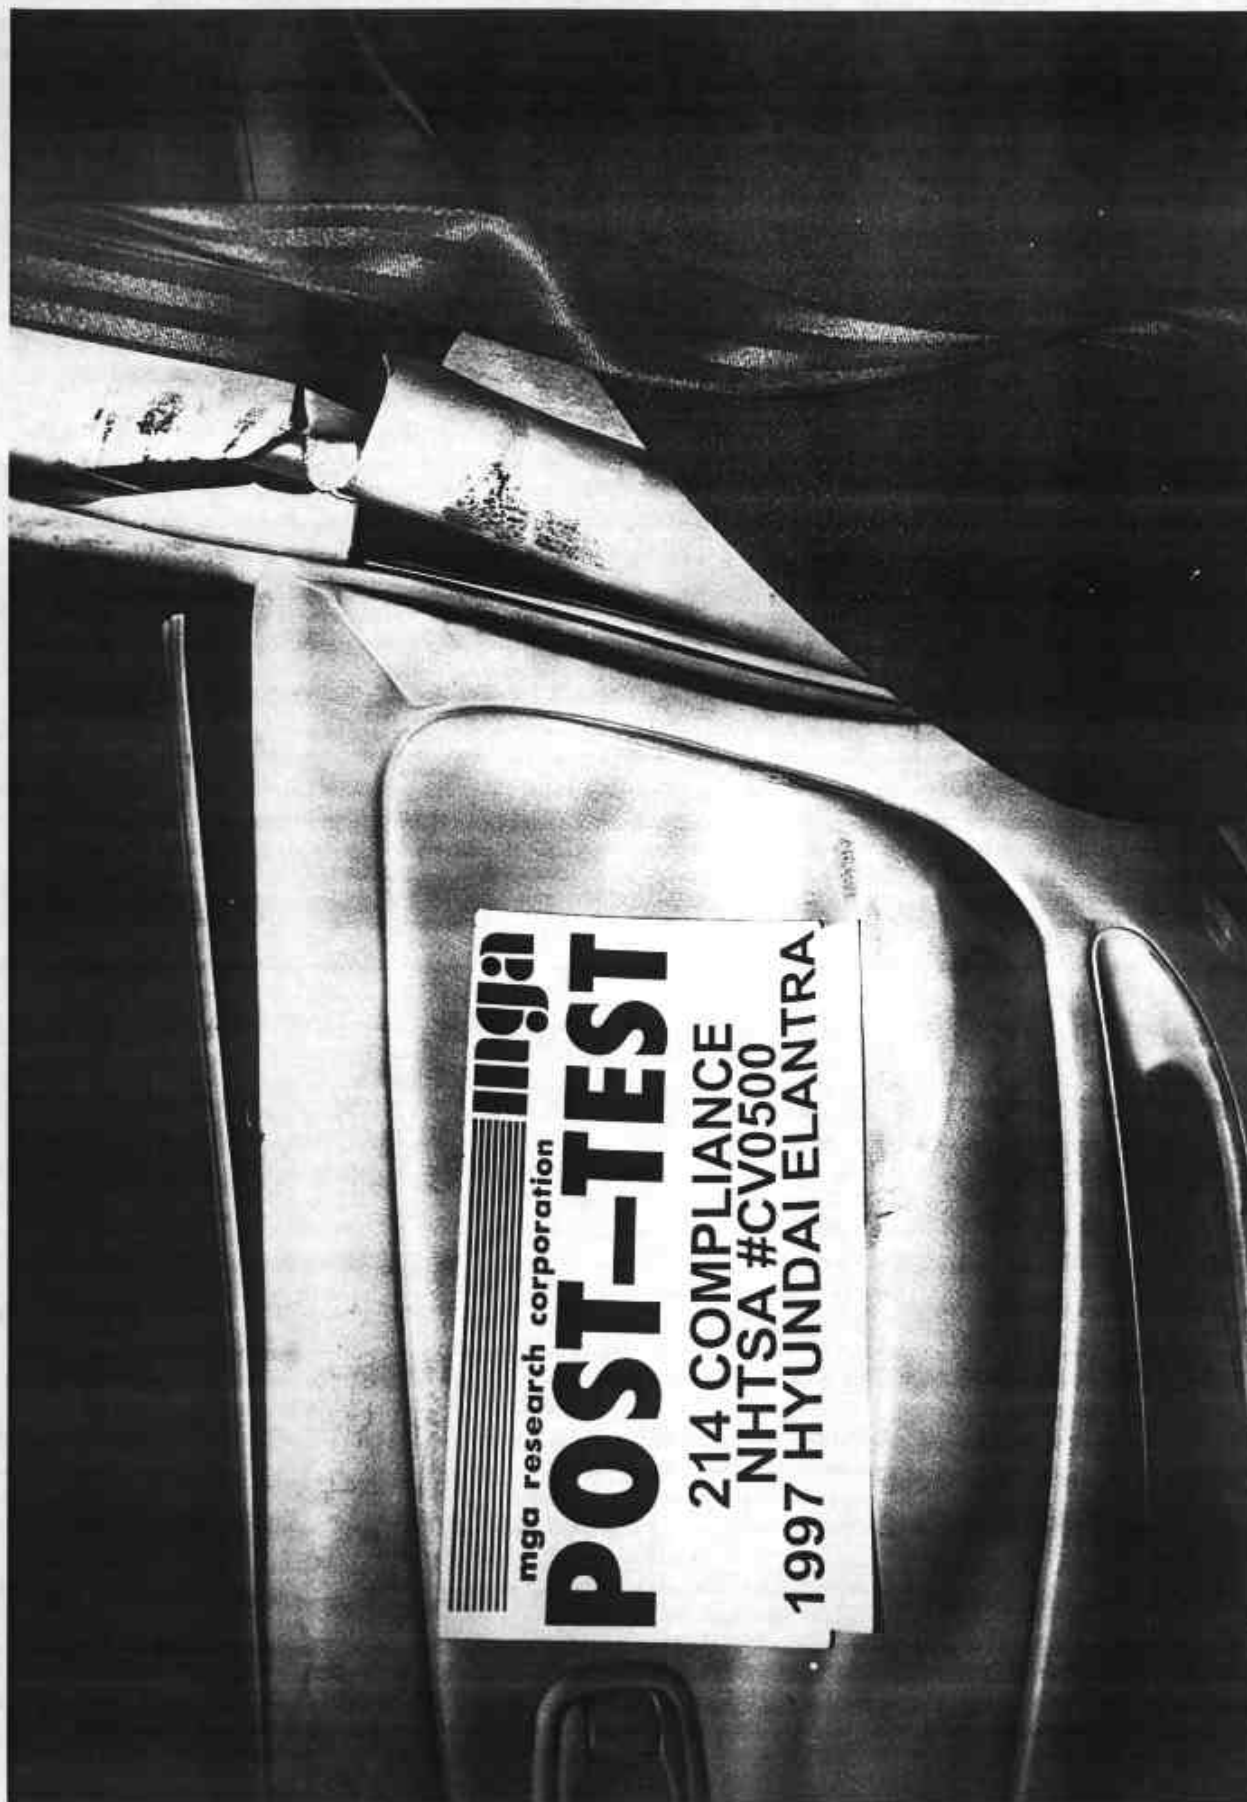
Photo No. A-29 - Post-Test Front Passenger Dummy Contact

| | <u>RIGHT FRONT SID</u> | <u>RIGHT REAR SID</u> |
| Head | <u>to D Ring</u> | <u>to C Post</u> |
| Arm | <u>to door</u> | <u>to door</u> |
| Pelvis | <u>to armrest</u> | <u>to armrest</u> |

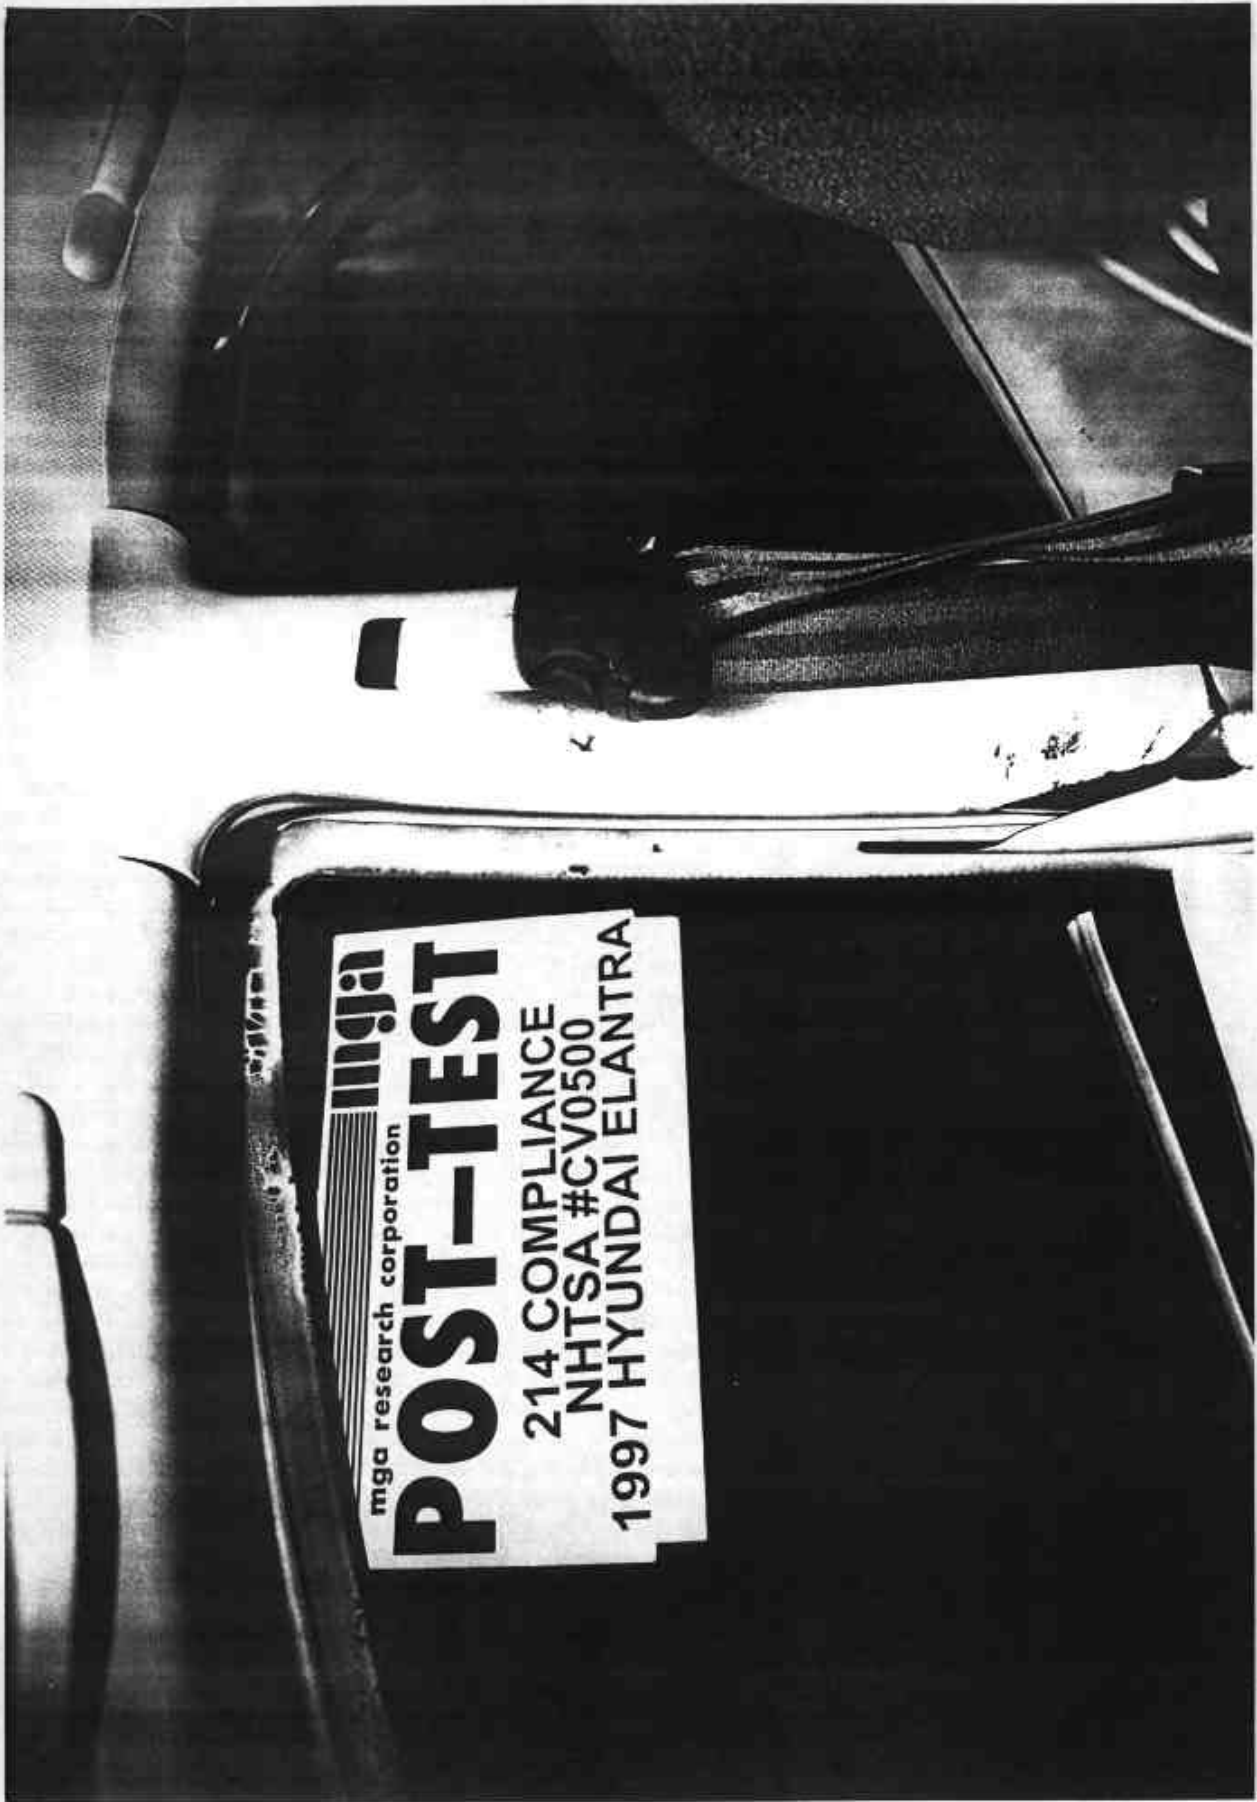
Photo No. A-31 - Post-Test Front Passenger Head Contact

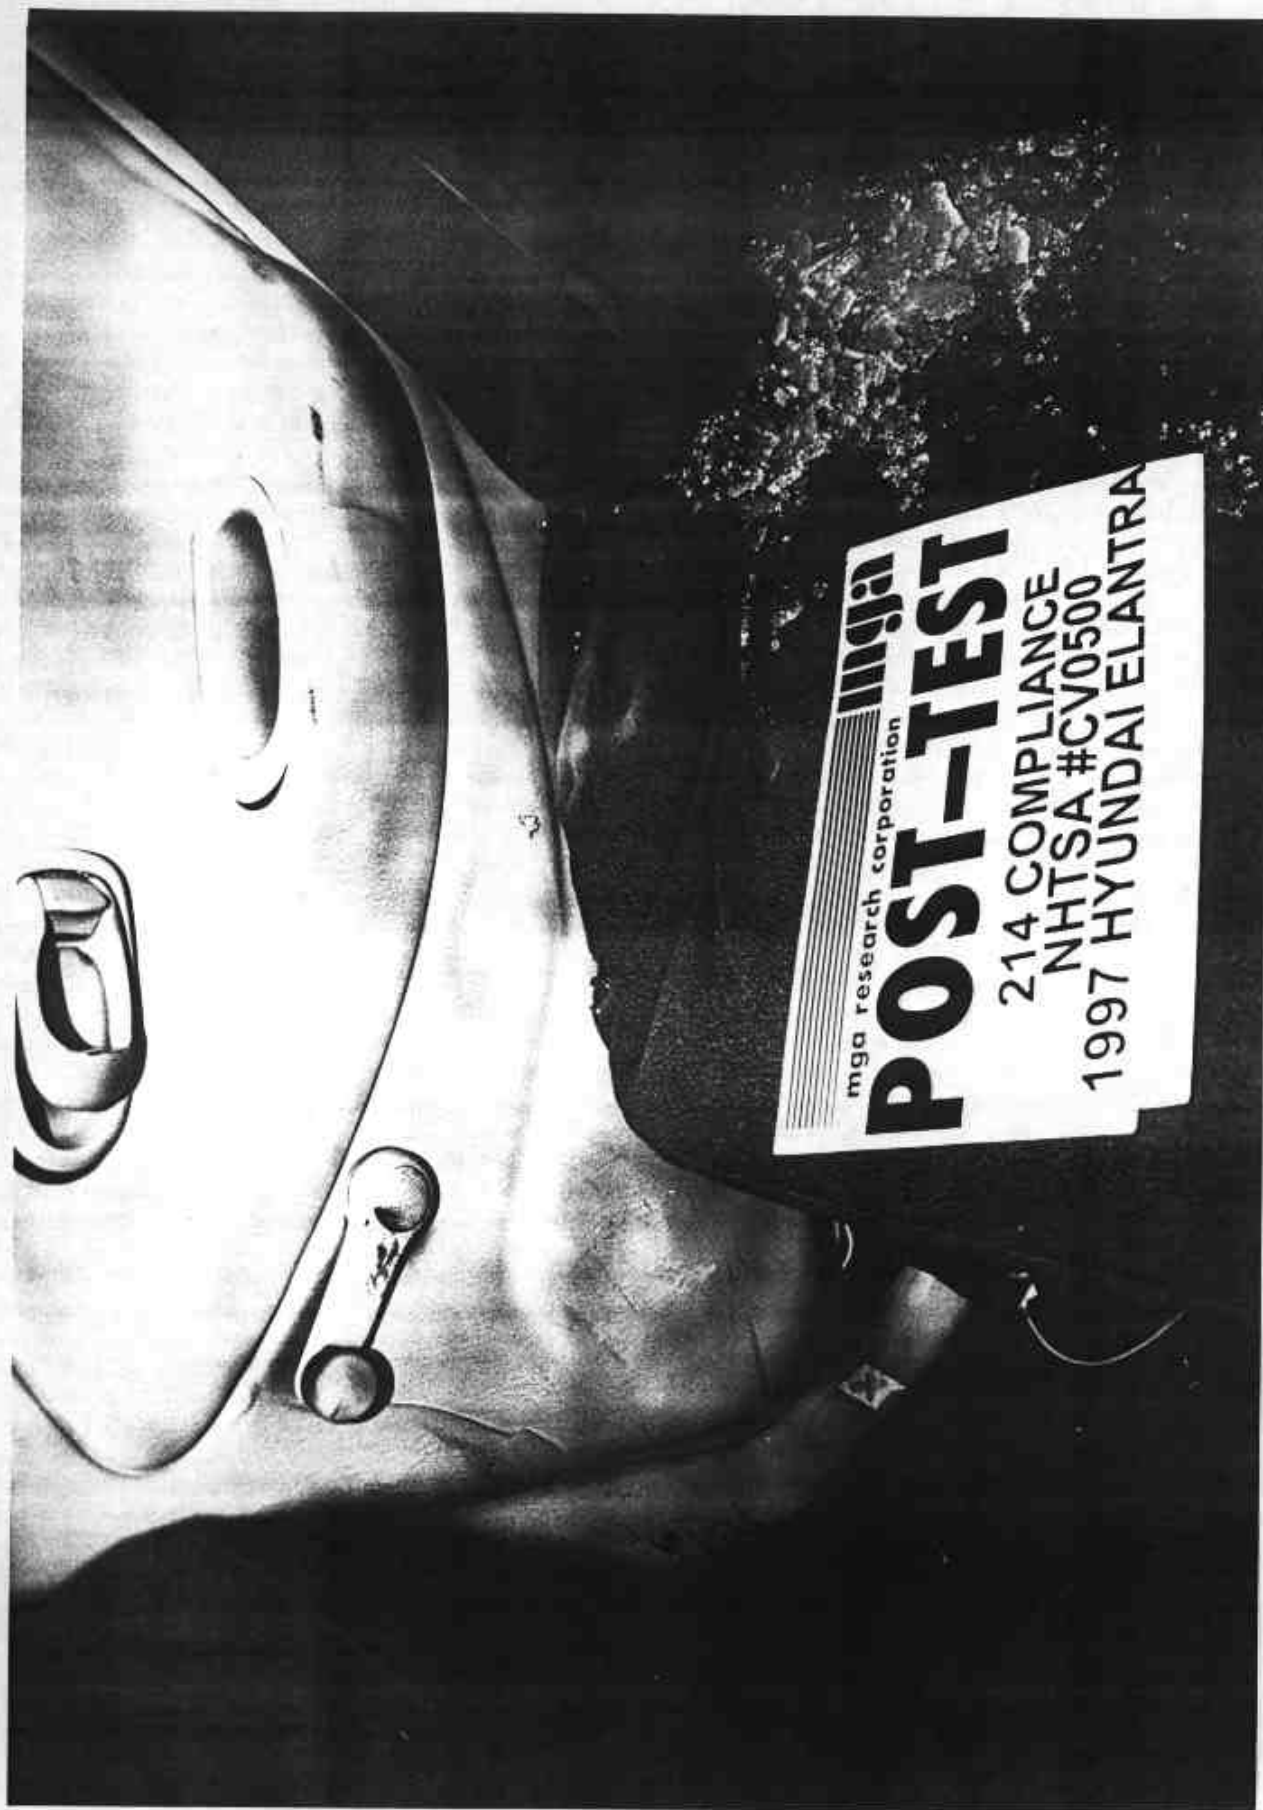
Photo No. A-39 - Post-Test Rear Passenger Dummy Contact

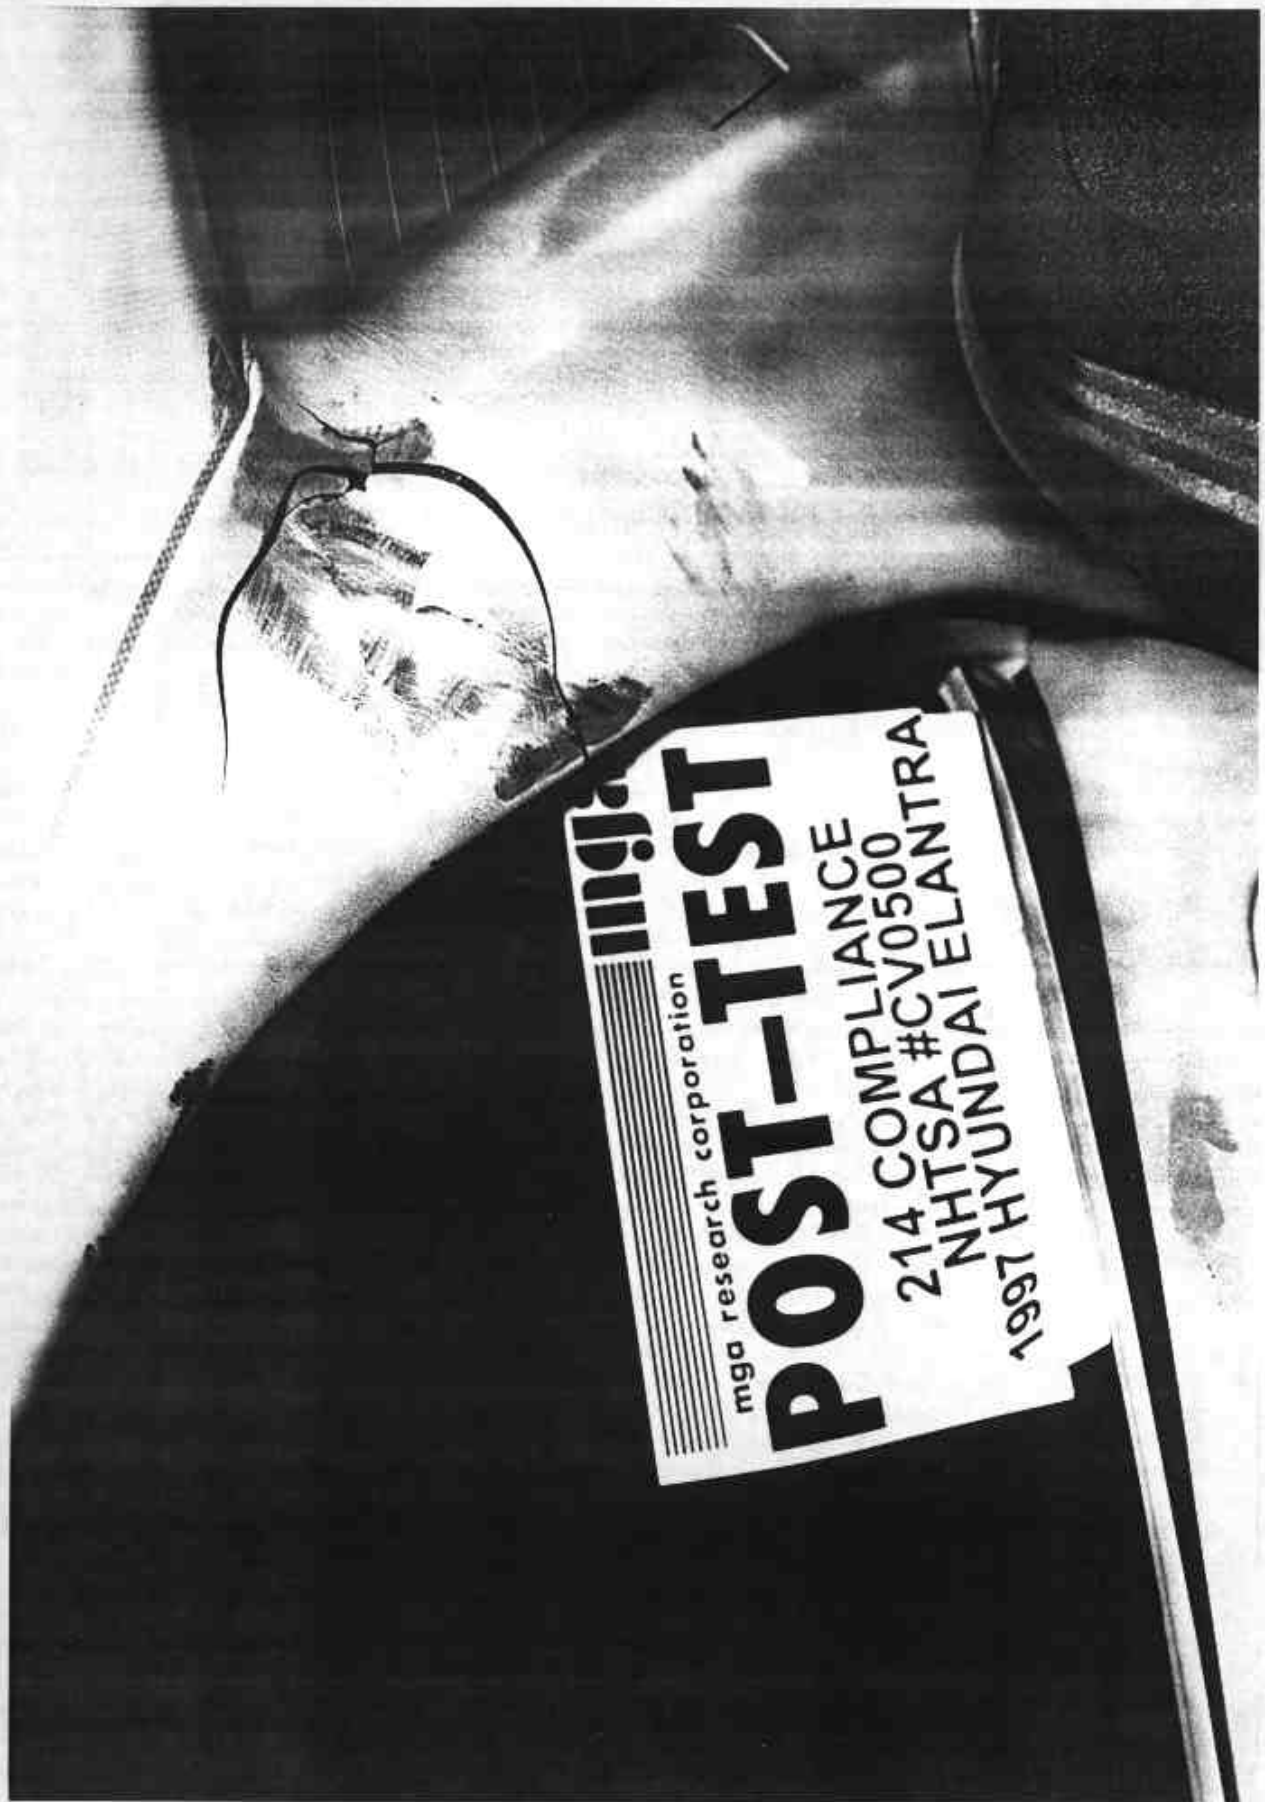
Photo No. A-40 - Post-Test Rear Passenger Dummy Head Contact
