REPORT NO.: 214-MGA-97-17  
SAFETY COMPLIANCE TESTING FOR  
FMVSS 214 "SIDE IMPACT PROTECTION -  
PASSENGER CARS"

HONDA MOTOR CO., LTD.  
1997 HONDA CIVIC 4 DOOR  
NHTSA NO: CV5300

MGA PROVING GROUNDS  
5000 WARREN ROAD  
BURLINGTON, WI 53105

FINAL REPORT

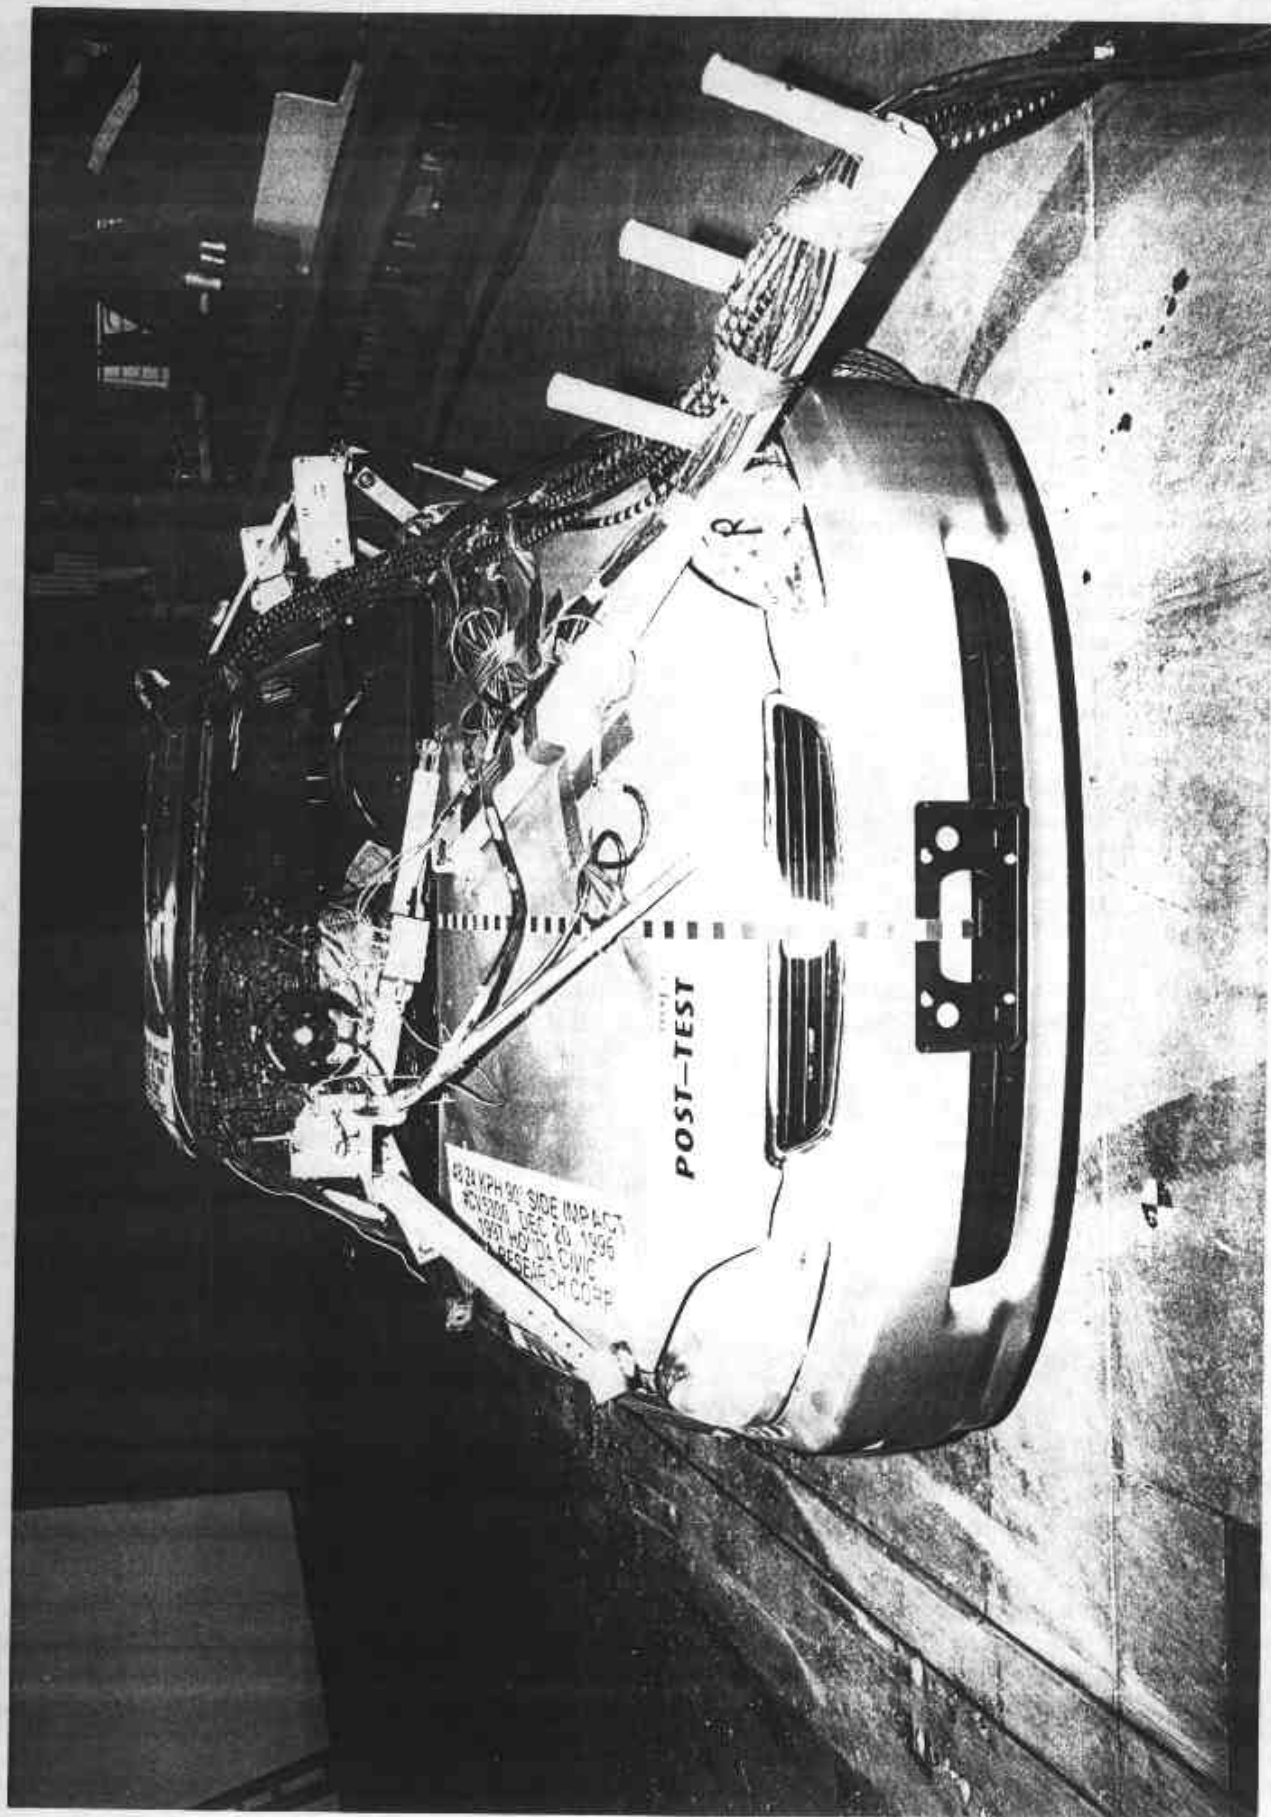
Photo No. A-2 - Post-Test Front View of Test Vehicle

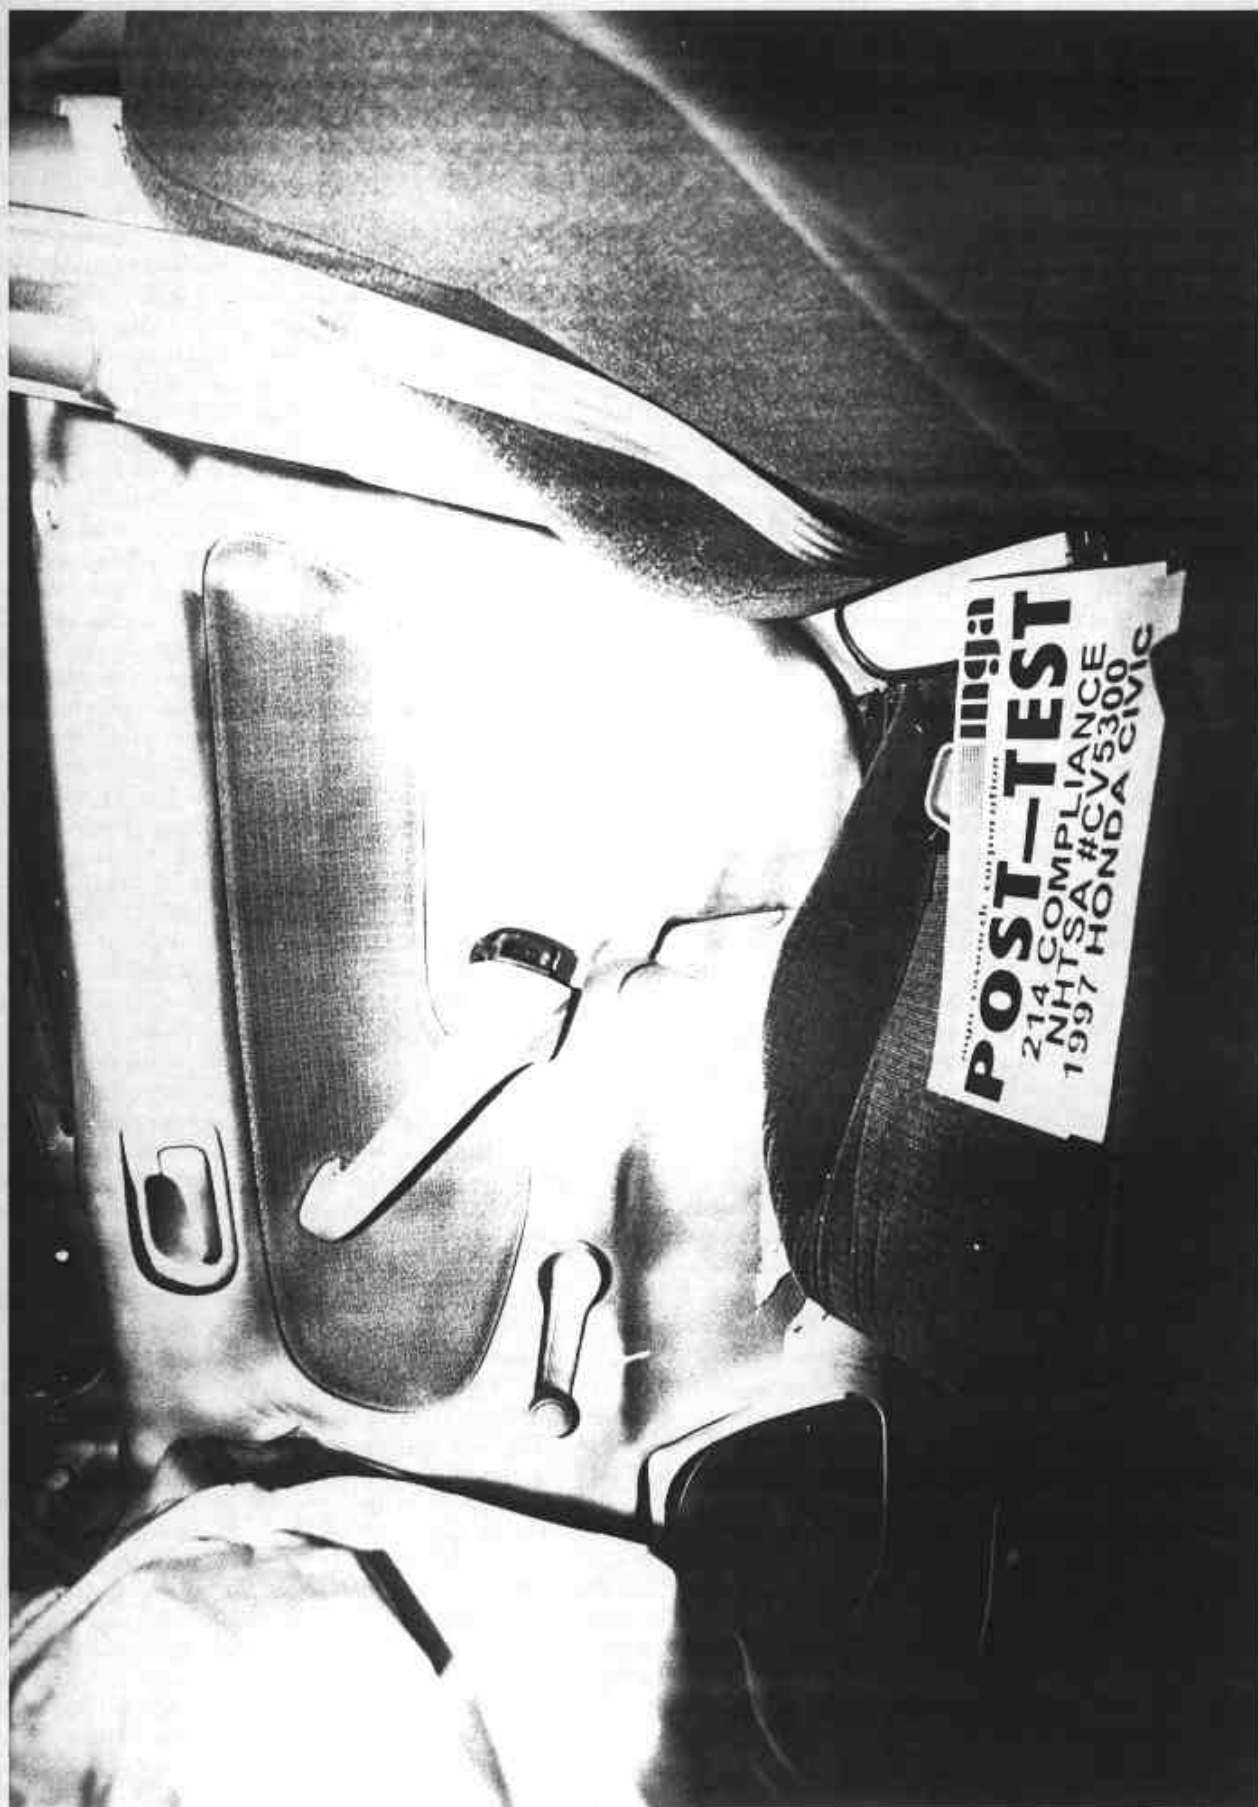
Photo No. A-29 - Post-Test Front Passenger Dummy Contact

VISIBLE DUMMY CONTACT POINTS:

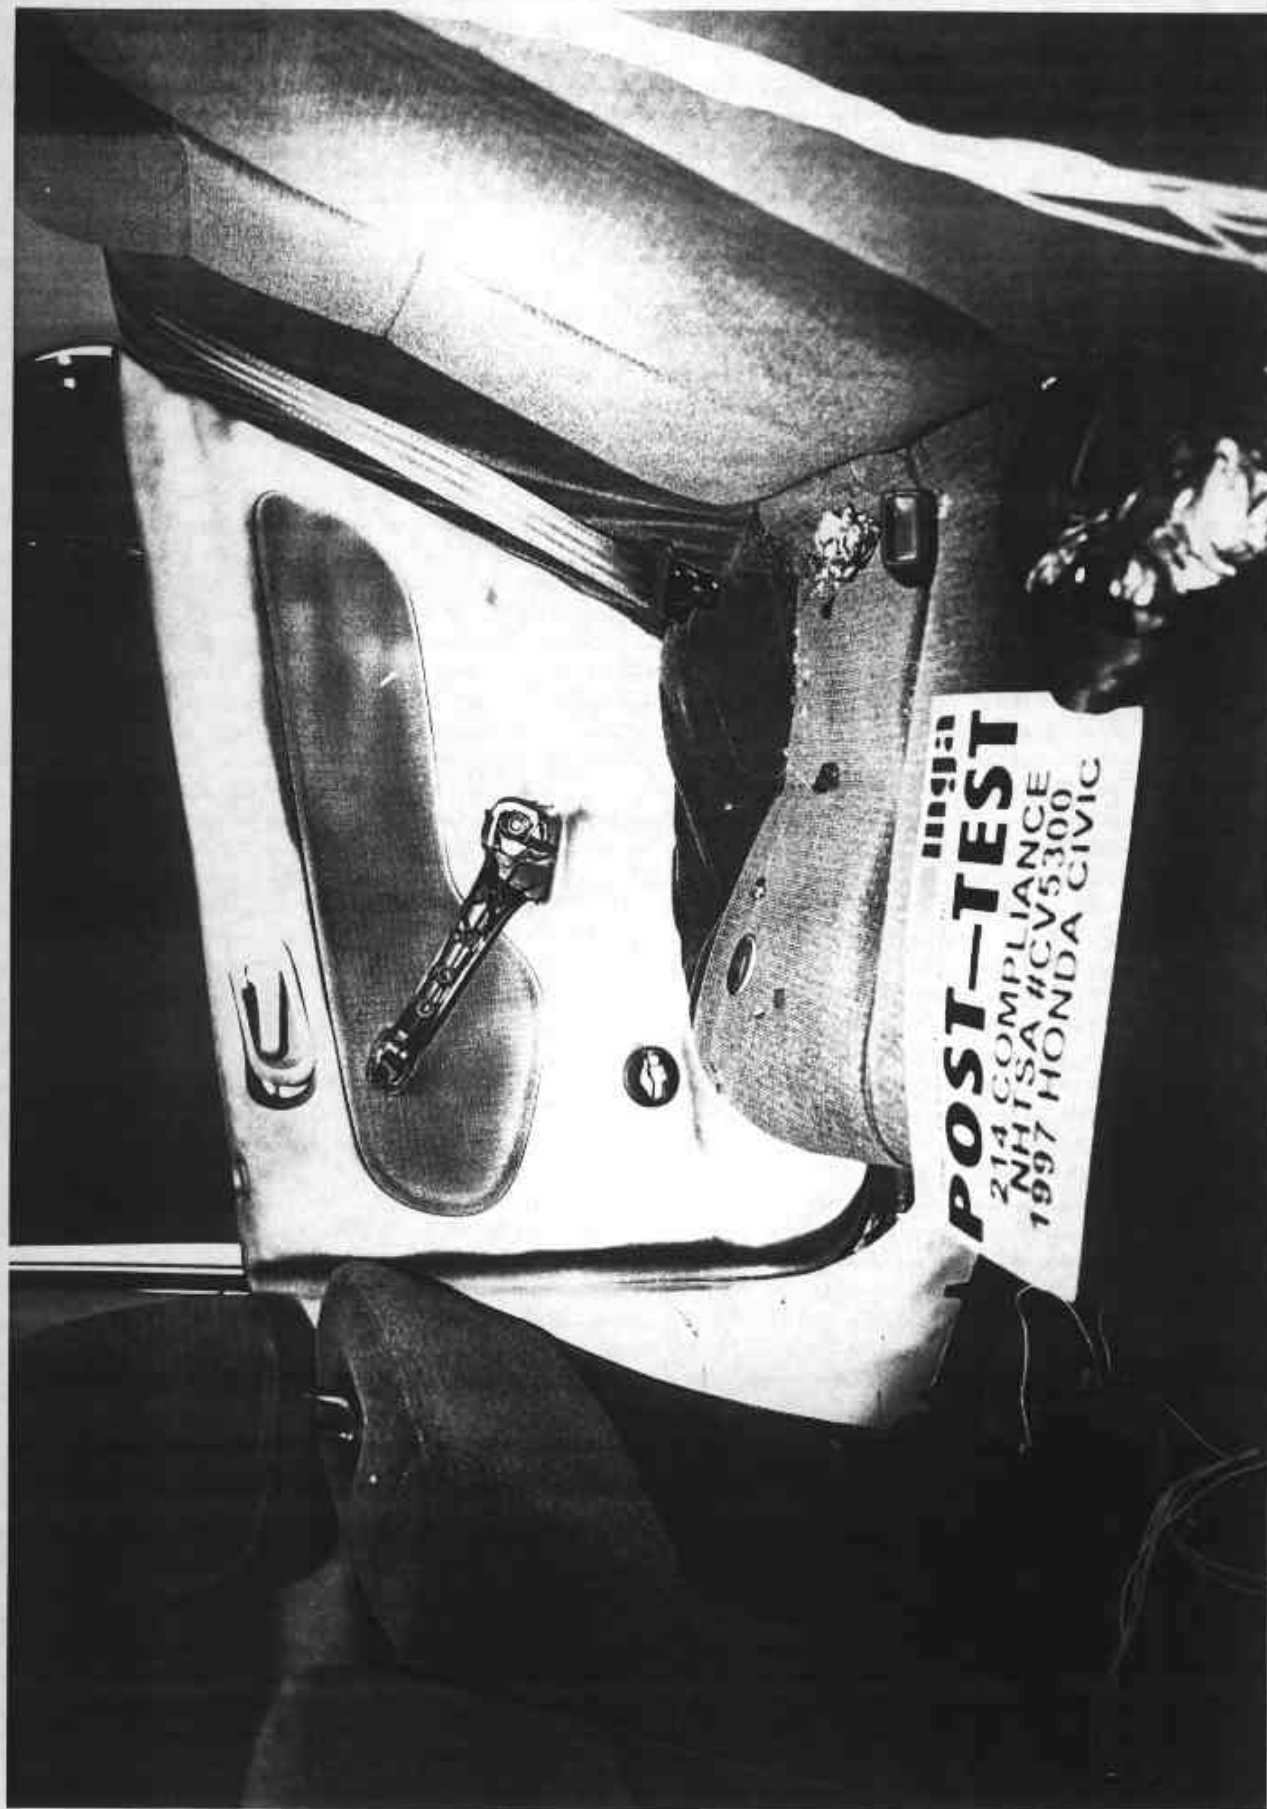
Photo No. A-38 - Post-Test Rear Passenger Dummy Contact
