Vehicle Safety Compliance Testing  
for Occupant Crash Protection,  
Windshield Retention and, Windshield Zone Intrusion.

General Motors Corporation  
1997 Chevrolet S-10 Extended Cab  
Fleetside Pickup  
NHTSA Number: CV0115  
TRC Test Number: 970502

Final Report

| 4. Title and Subtitle<br>Final Report of FMVSS Nos. 208, 212, and 219 (partial)<br>Compliance Testing of a 1997 Chevrolet S-10<br>Extended Cab Fleetside Pickup, NHTSA No. CV0115 | | 5. Report Date<br>May 30, 1997 | |

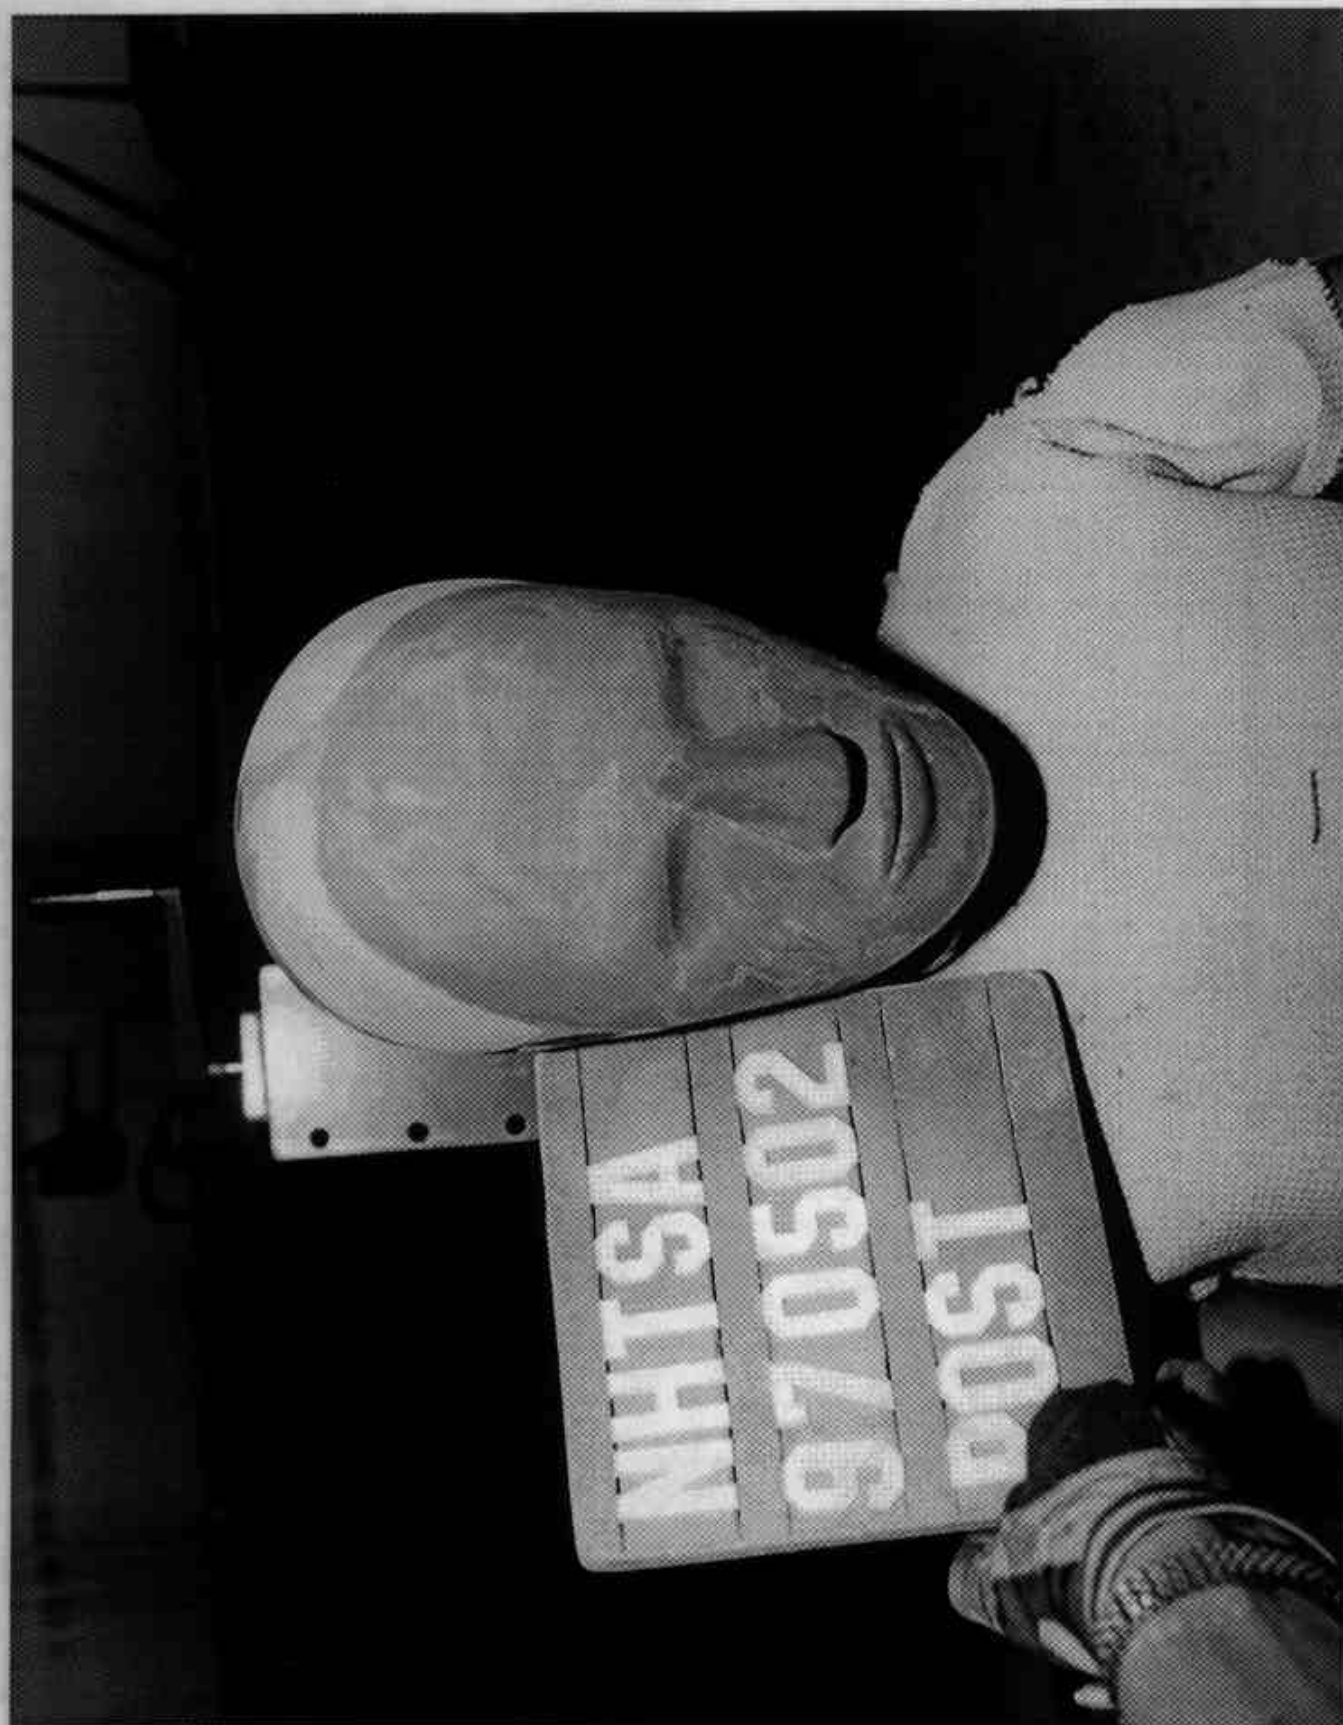
Figure A-39 Post-Test Driver Dummy Head Contact - View 1  
A-40

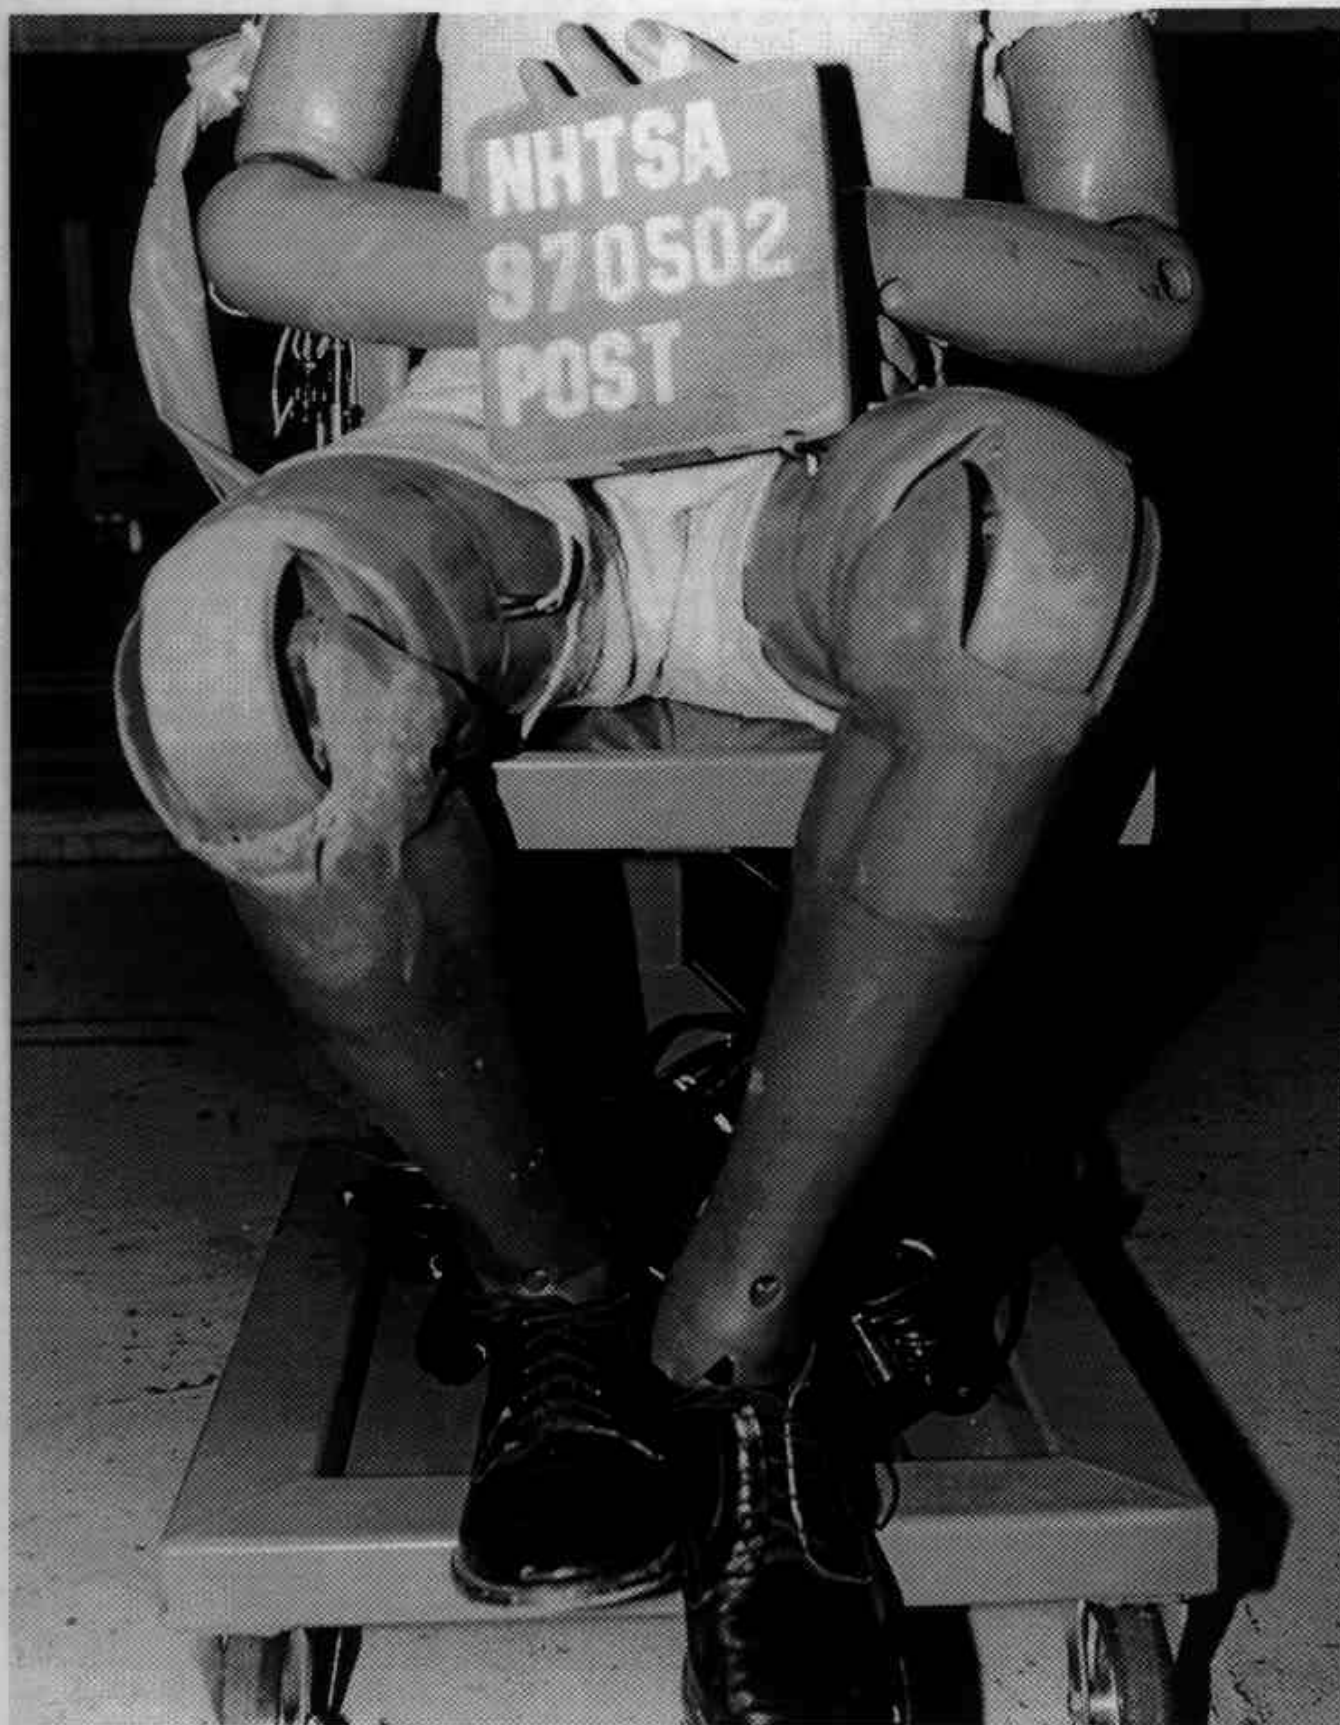
Figure A-41 Post-Test Driver Dummy Knee Contact - View 1  
A-42

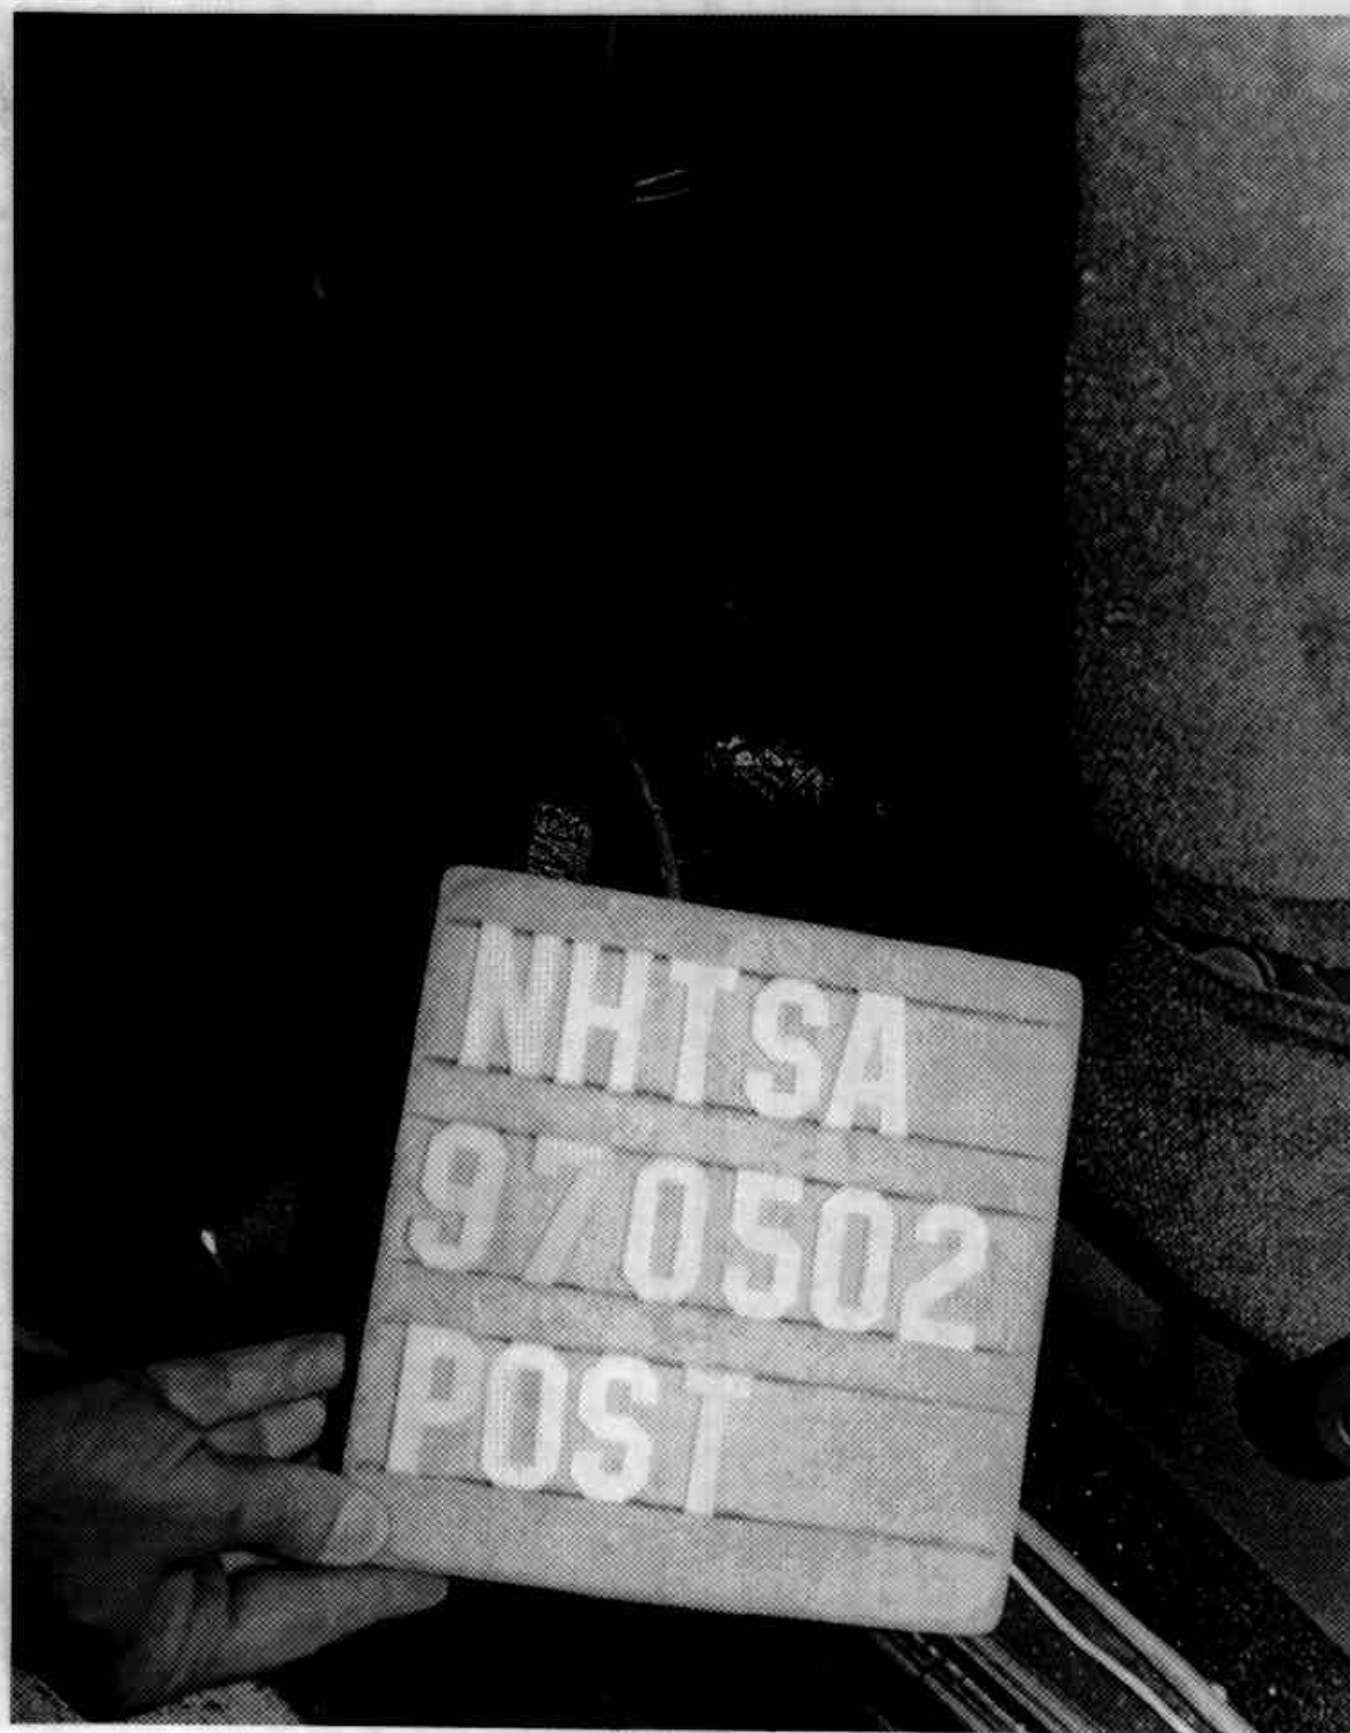
Figure A-48 Post-Test Seat Belt Damage View
