**NHTSA  
VEHICLE DATABASE  
REPORT  
TEST# 2644**

**Test Title:** IIHS OFFSET CRASHWORTHINESS EVALUATION

**Test Performer:** INSURANCE INSTITUTE FO **Test Reference Number:** CF95030

**Test Objectives:** IIHS 40% OVERLAP - 1996 FORD EXPLORER

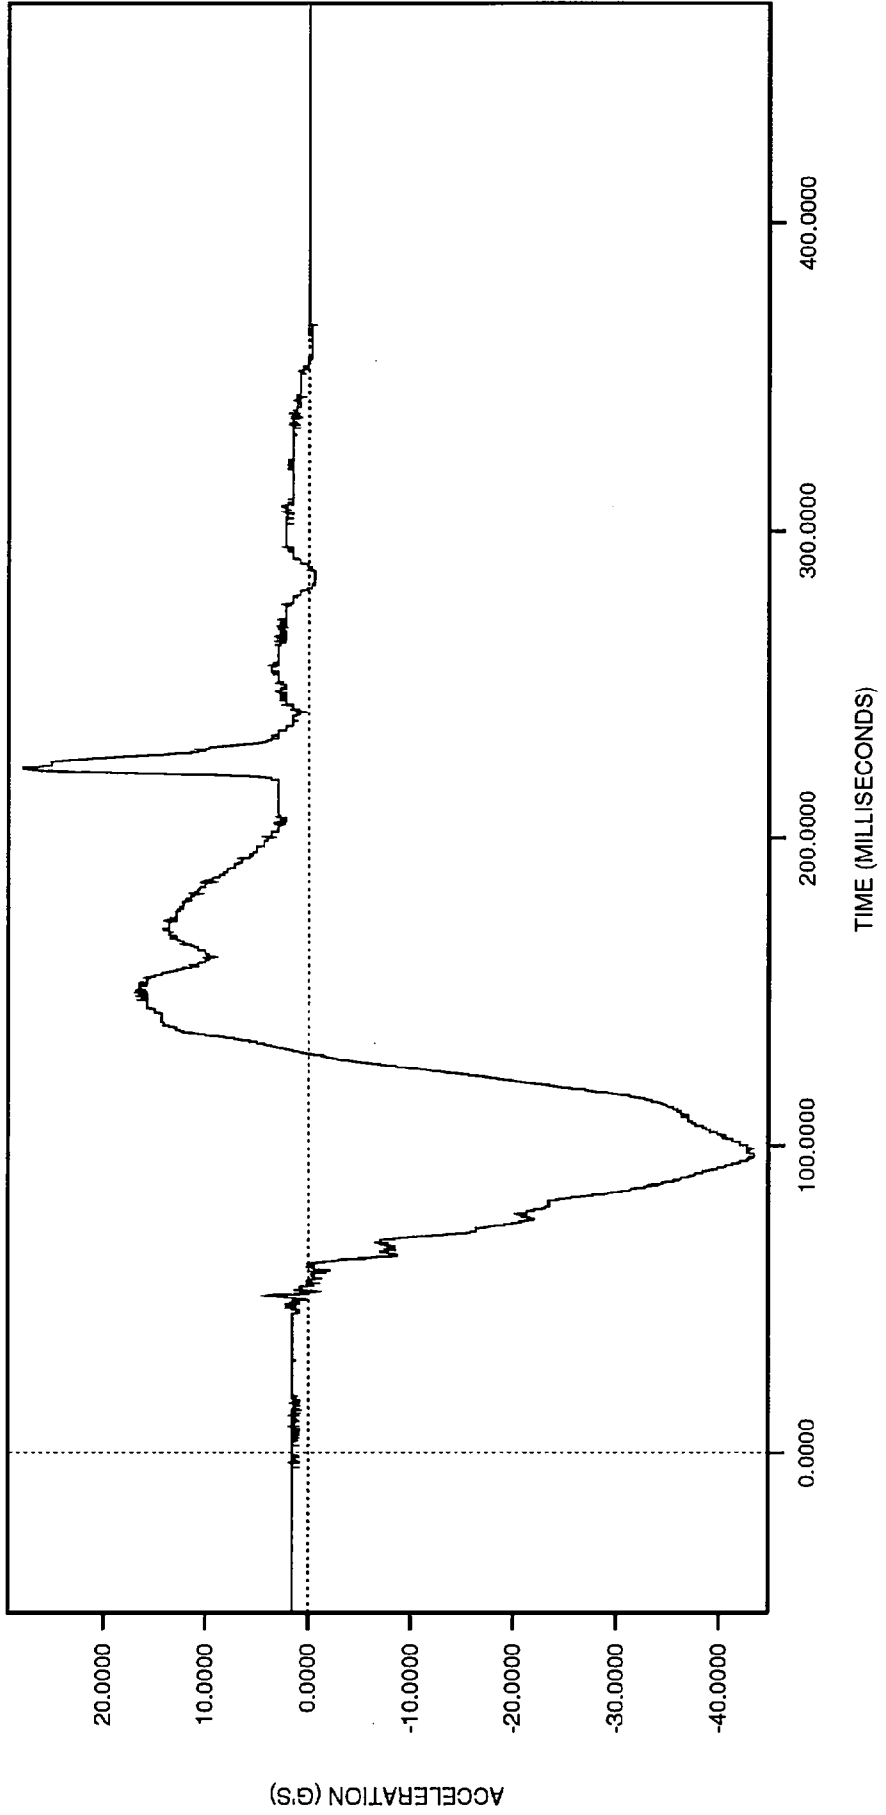
File : v2644aa0.001

Test Performer : INSURANCE INSTITUTE FOR H  
Year : 1996 Make : FORD  
Occupant Location : OTHER  
Restraint [1] : AIR BAG  
Sensor Attachment : HEAD CG  
Status : AS MEASURED  
Filter CutOff : 2500 HZ  
Comments :

Reference : CF95030  
Model : EXPLORER  
Occupant Type : H3  
Restraint [2] : 3 POINT BELT  
YMIN = -43.3875  
YMAX = 27.8844

Config : VTB  
Vehicle # : 1  
CSI = 0.00  
Axis : XL

Sensor Type : ACCELERATION  
AT 96.4000 MILLISECONDS  
AT 222.9000 MILLISECONDS

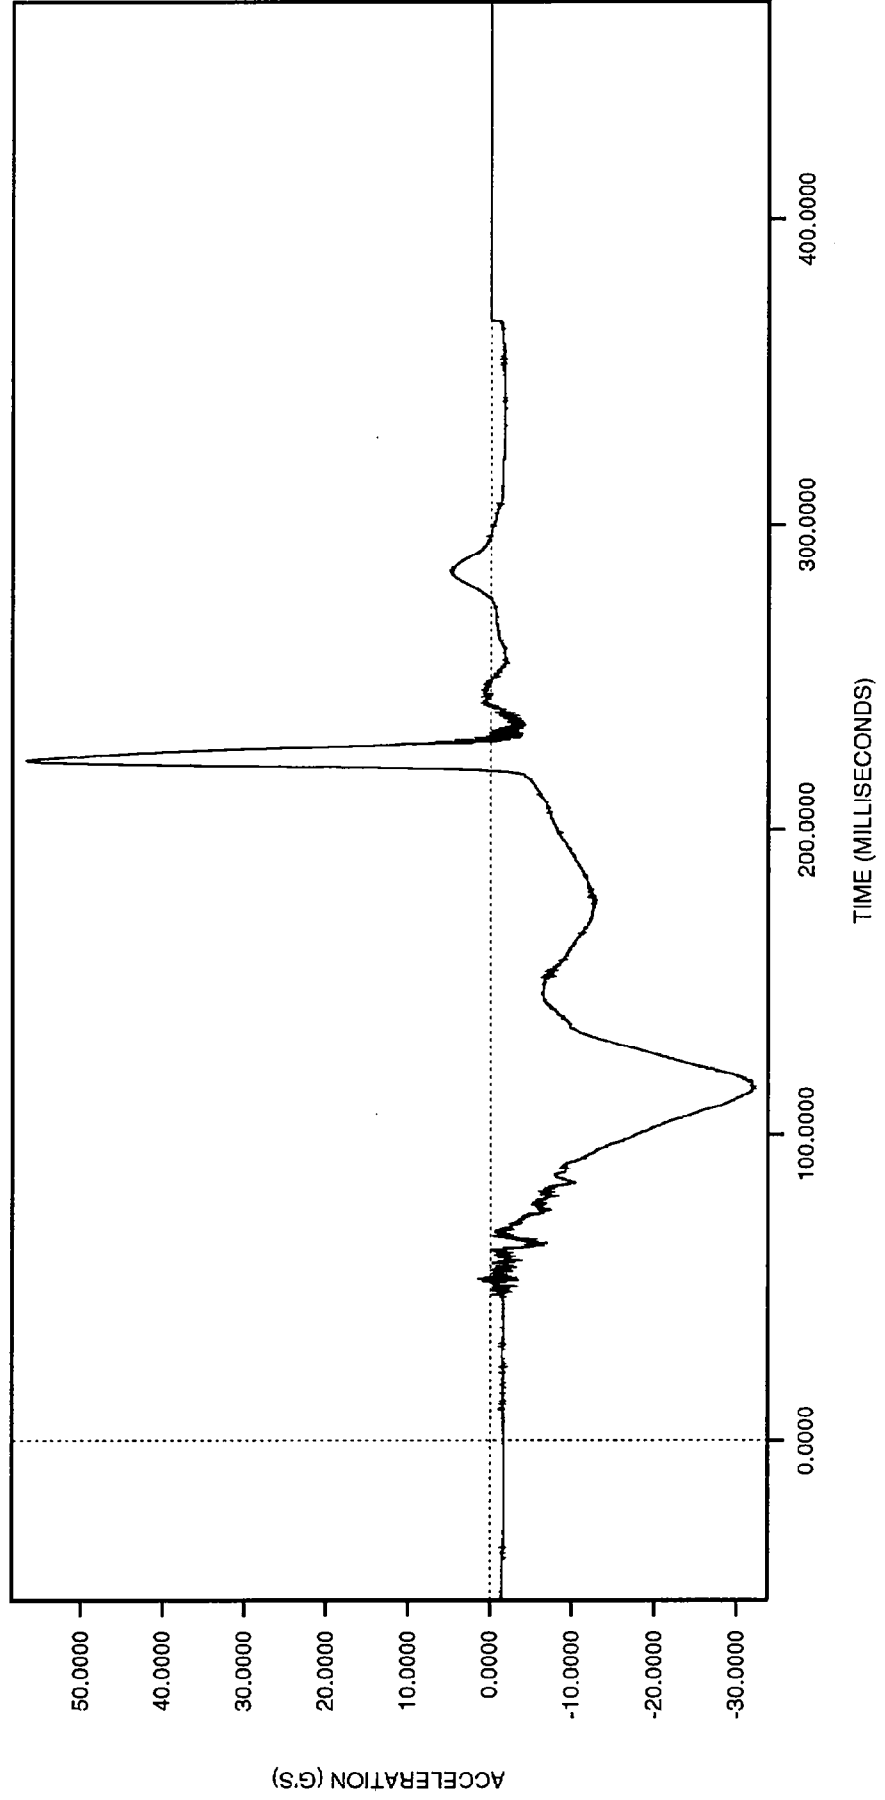
File : v2644aa0.002

Sensor Attachment : HEAD CG

YMIN = -32.0199

YMAX = 56.6140

Sensor Type : ACCELERATION

Axis : YL

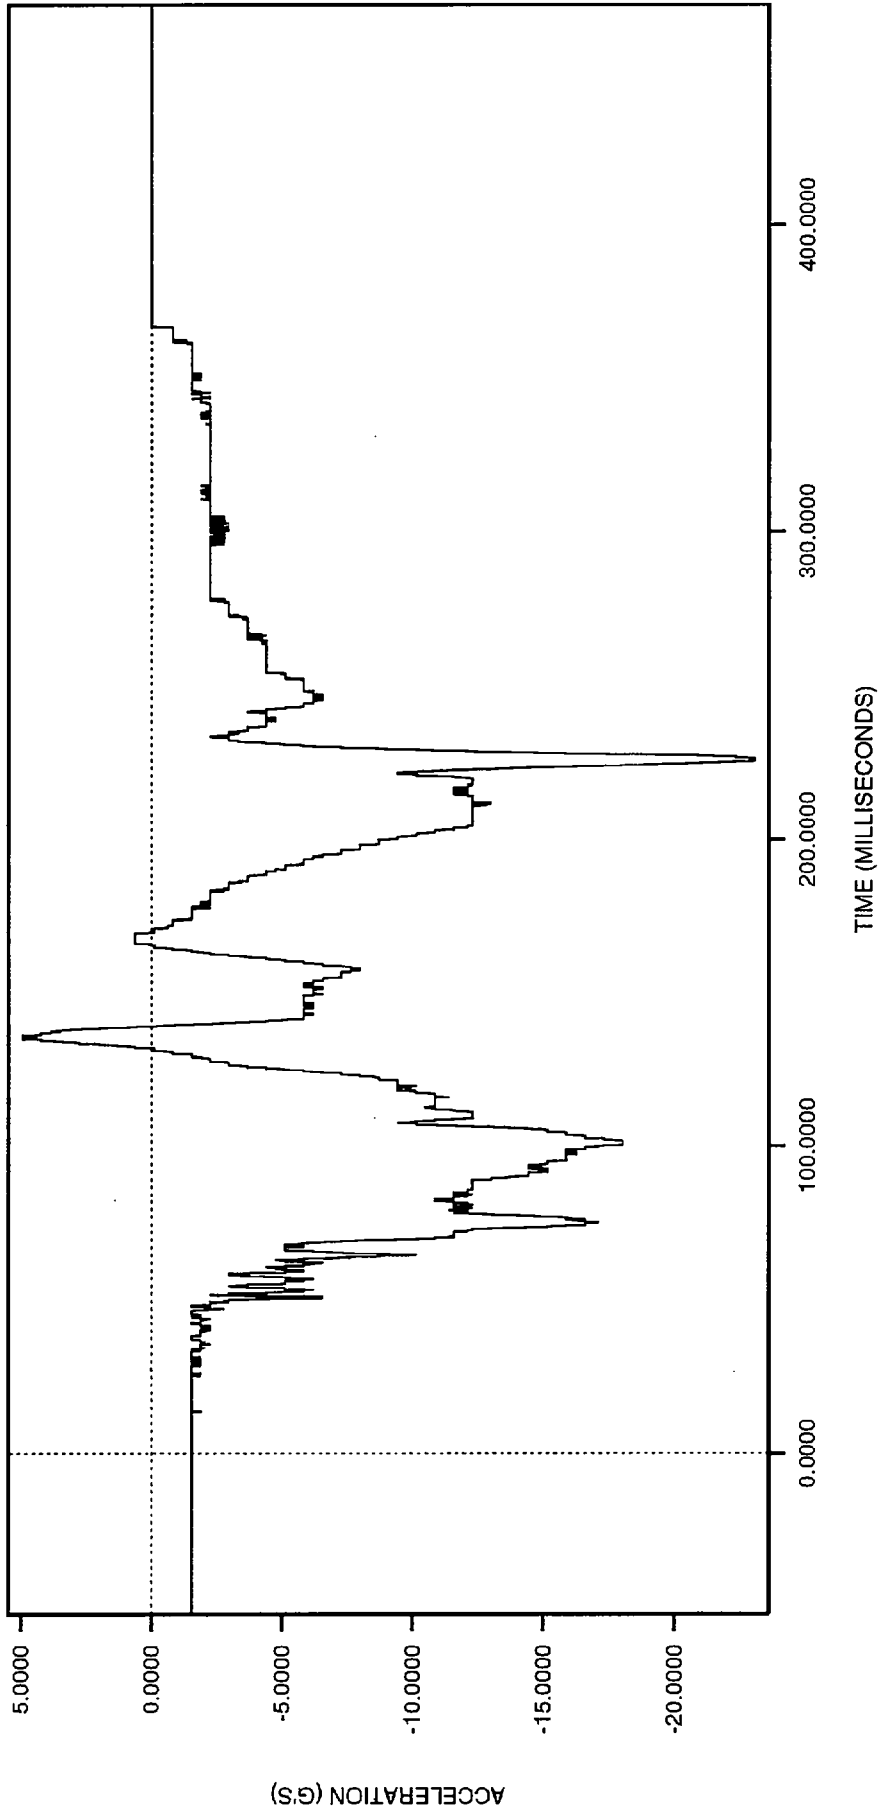
File : v2644aa0.003

Sensor Attachment : HEAD CG

YMIN = -23.0538

YMAX = 4.9352

Sensor Type : ACCELERATION

Axis : ZL

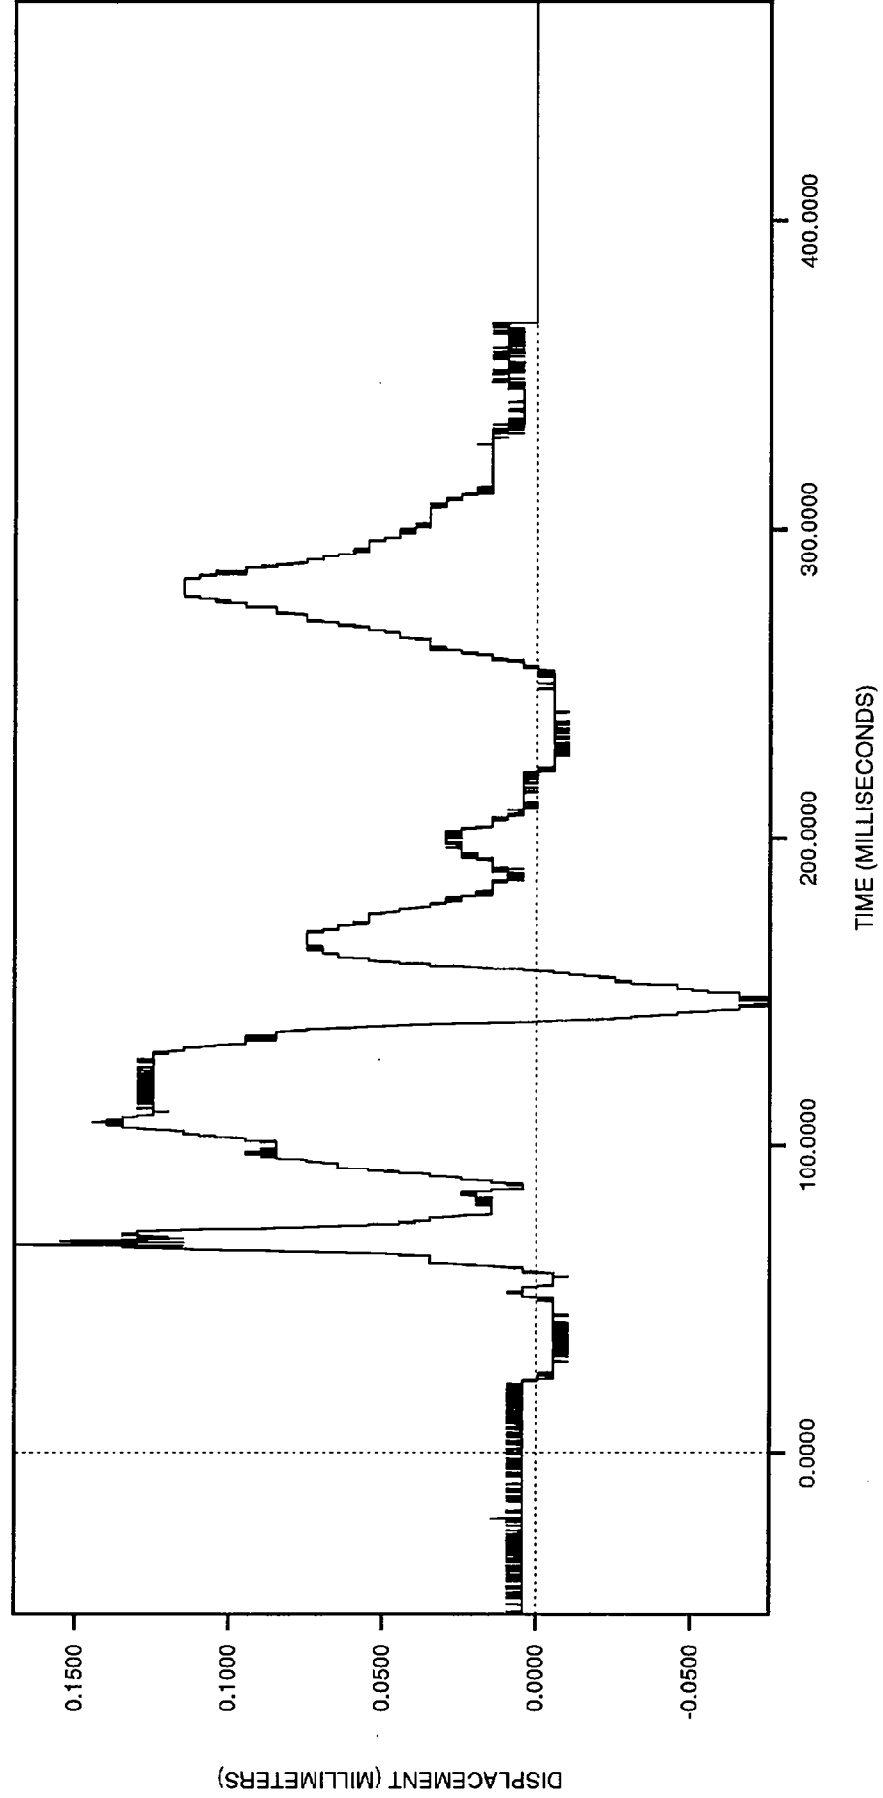
File : v2644da0.004

Sensor Attachment : KNEE - RIGHT

YMIN = -0.0756

YMAX = 0.1696

Sensor Type : DISPLACEMENT

Axis : XL

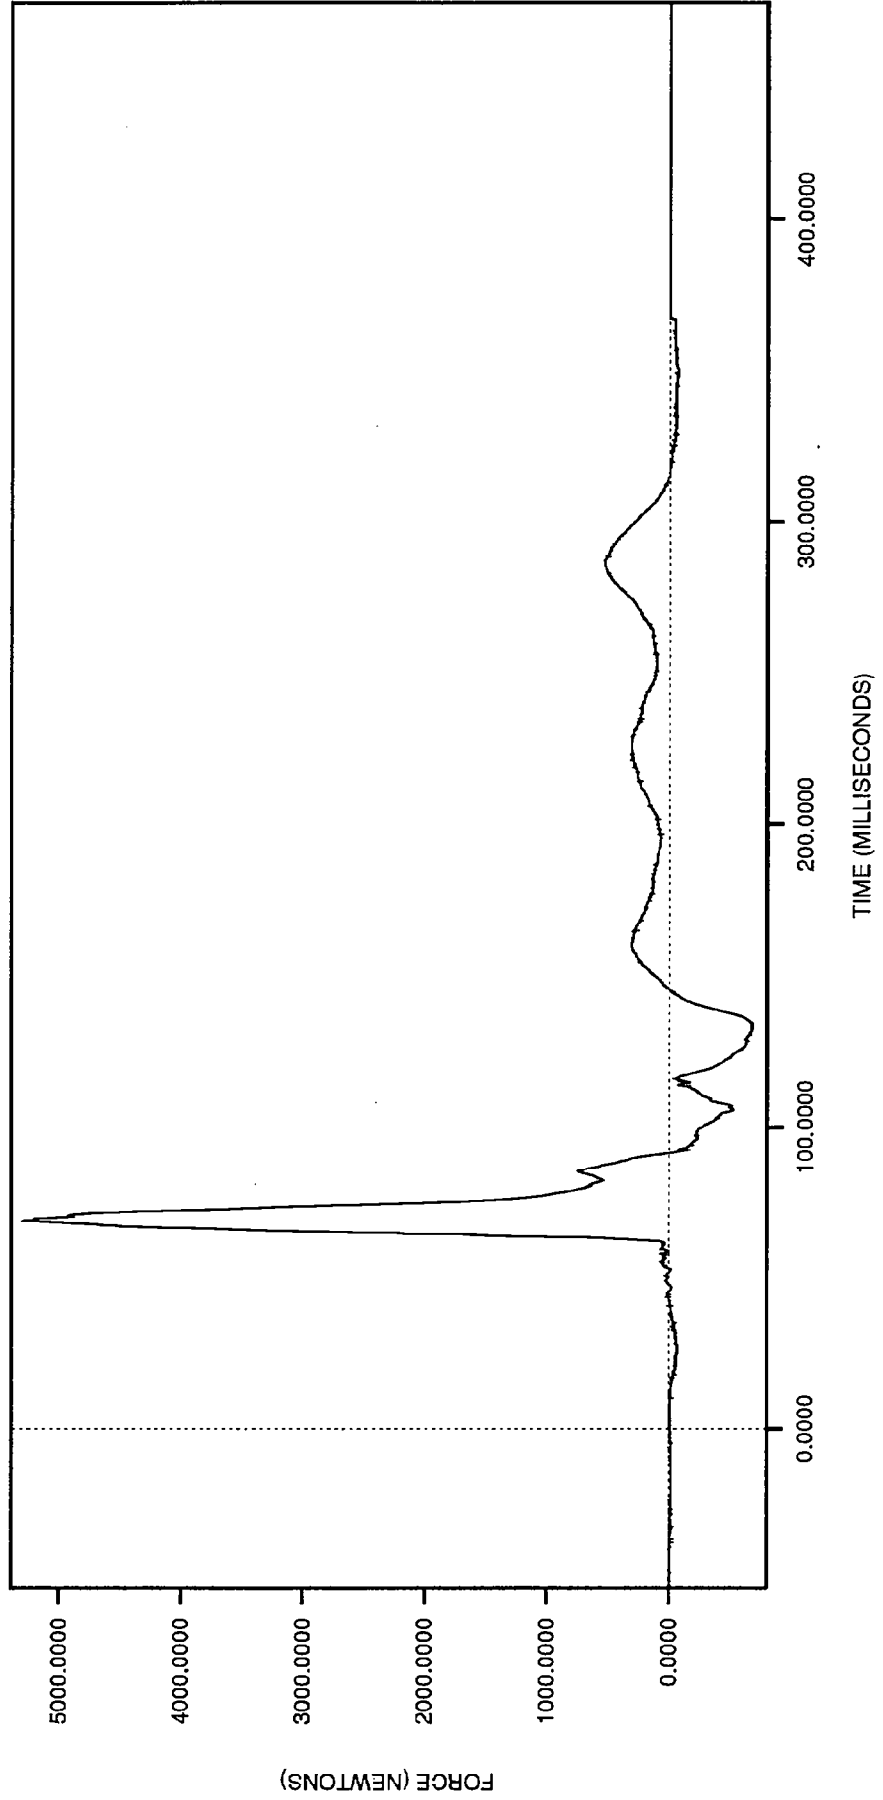
File : v2644fa0.005

Sensor Attachment : FEMUR - RIGHT

YMIN = -677.6540

YMAX = 5273.3301

Sensor Type : FORCE

Axis : ZL

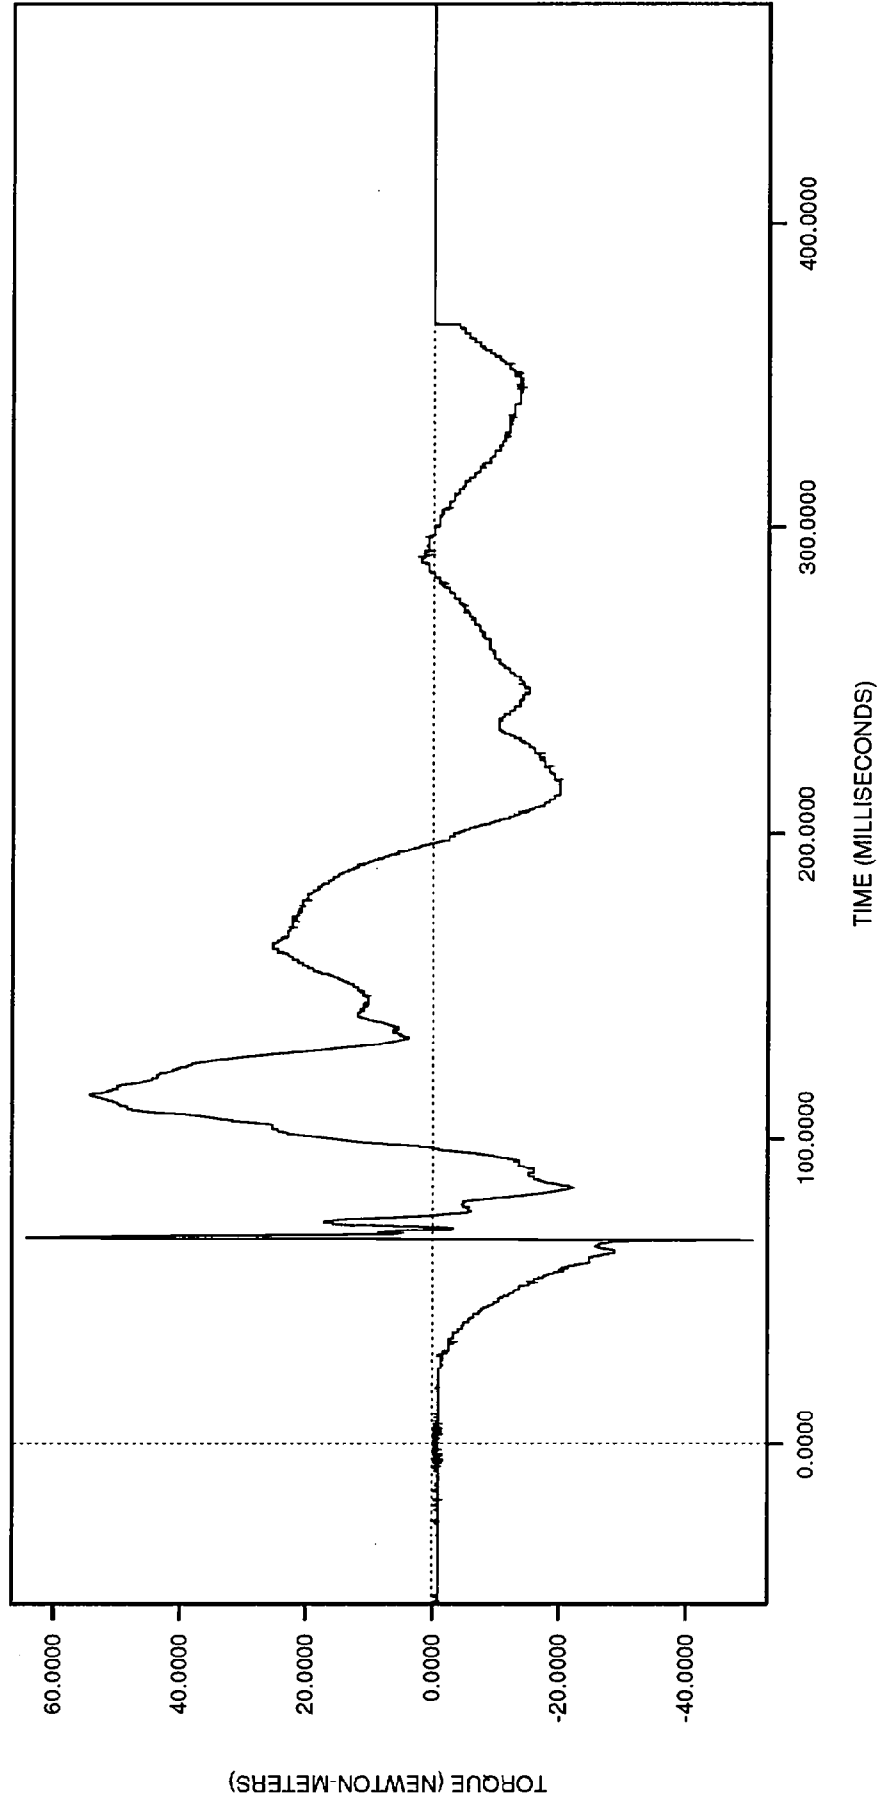
File : v2644ta0.006

Test Performer : INSURANCE INSTITUTE FOR H  
Year : 1996 Make : FORD  
Occupant Location : OTHER  
Restraint [1] : AIR BAG  
Sensor Attachment : TIBIA - RIGHT UPPER  
Status : AS MEASURED  
Filter CutOff : 2500 HZ  
Comments :

Reference : CF95030  
Model : EXPLORER  
Occupant Type : H3  
Restraint [2] : 3 POINT BELT  
YMIN = -50.5693  
YMAX = 64.2806

Speed : 64.40 KMPH  
Body : UTILITY VEHICLE  
HIC = 475.00  
Sensor Type : TORQUE  
AT 66.8000 MILLISECONDS  
AT 67.6000 MILLISECONDS

Config : VTB  
Vehicle # : 1  
CSI = 0.00  
Axis : XL

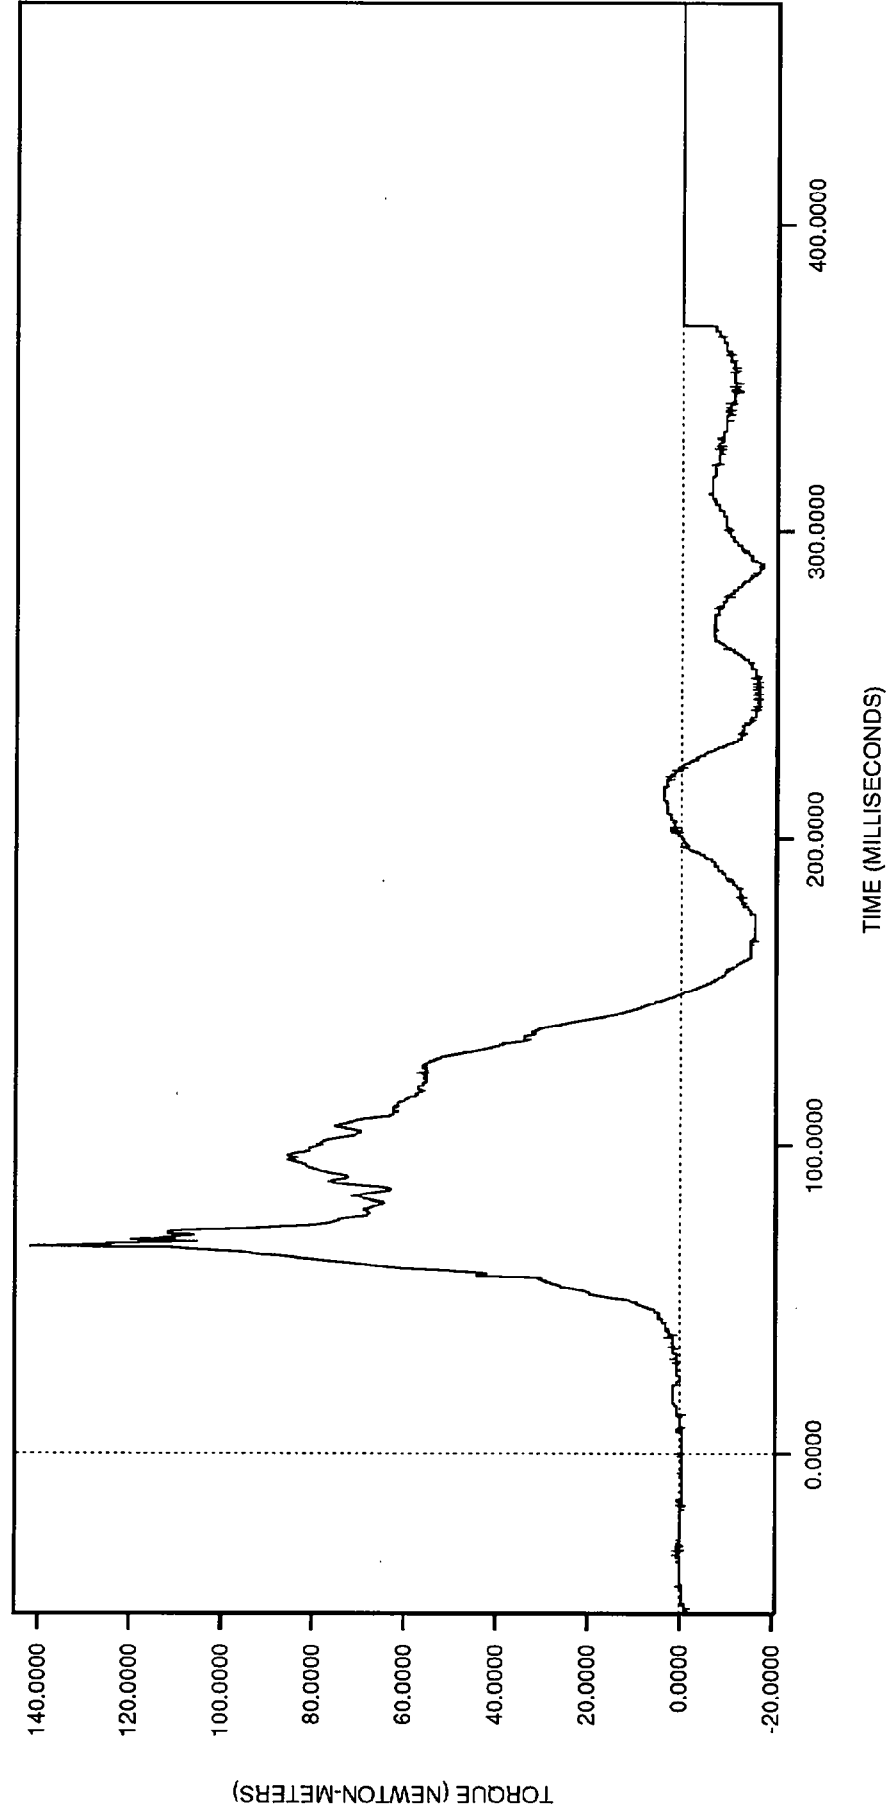
File : v2644ta0.007

Sensor Attachment : TIBIA - RIGHT UPPER

YMIN = -17.5215

YMAX = 141.8810

Sensor Type : TORQUE

Axis : YL

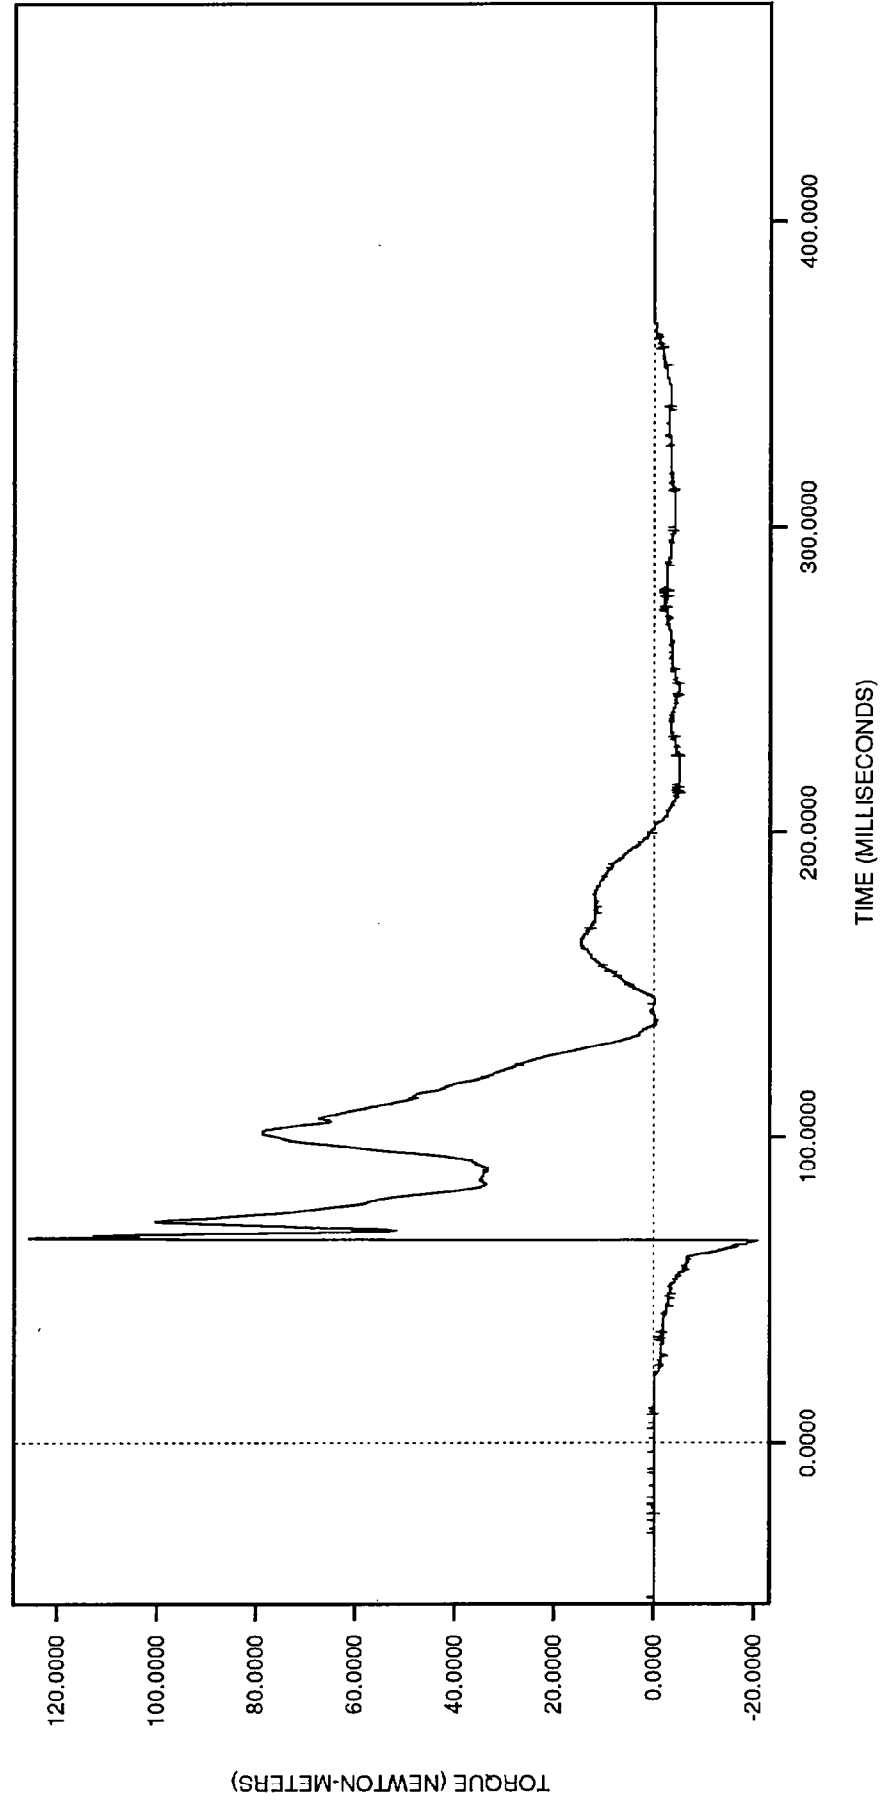
File : v2644ta0.008

Test Performer : INSURANCE INSTITUTE FOR H  
Year : 1996 Make : FORD  
Occupant Location : OTHER  
Restraint [1] : AIR BAG  
Sensor Attachment : TIBIA - RIGHT LOWER  
Status : AS MEASURED  
Filter CutOff : 2500 HZ  
Comments :

Reference : CF95030  
Model : EXPLORER  
Occupant Type : H3  
Restraint [2] : 3 POINT BELT  
YMIN = -20.3374  
YMAX = 125.8160

Speed : 64.40 KMPH  
Body : UTILITY VEHICLE  
HIC = 475.00  
Sensor Type : TORQUE  
AT 66.2000 MILLISECONDS  
AT 67.2000 MILLISECONDS

Config : VTB  
Vehicle # : 1  
CSI = 0.00  
Axis : XL

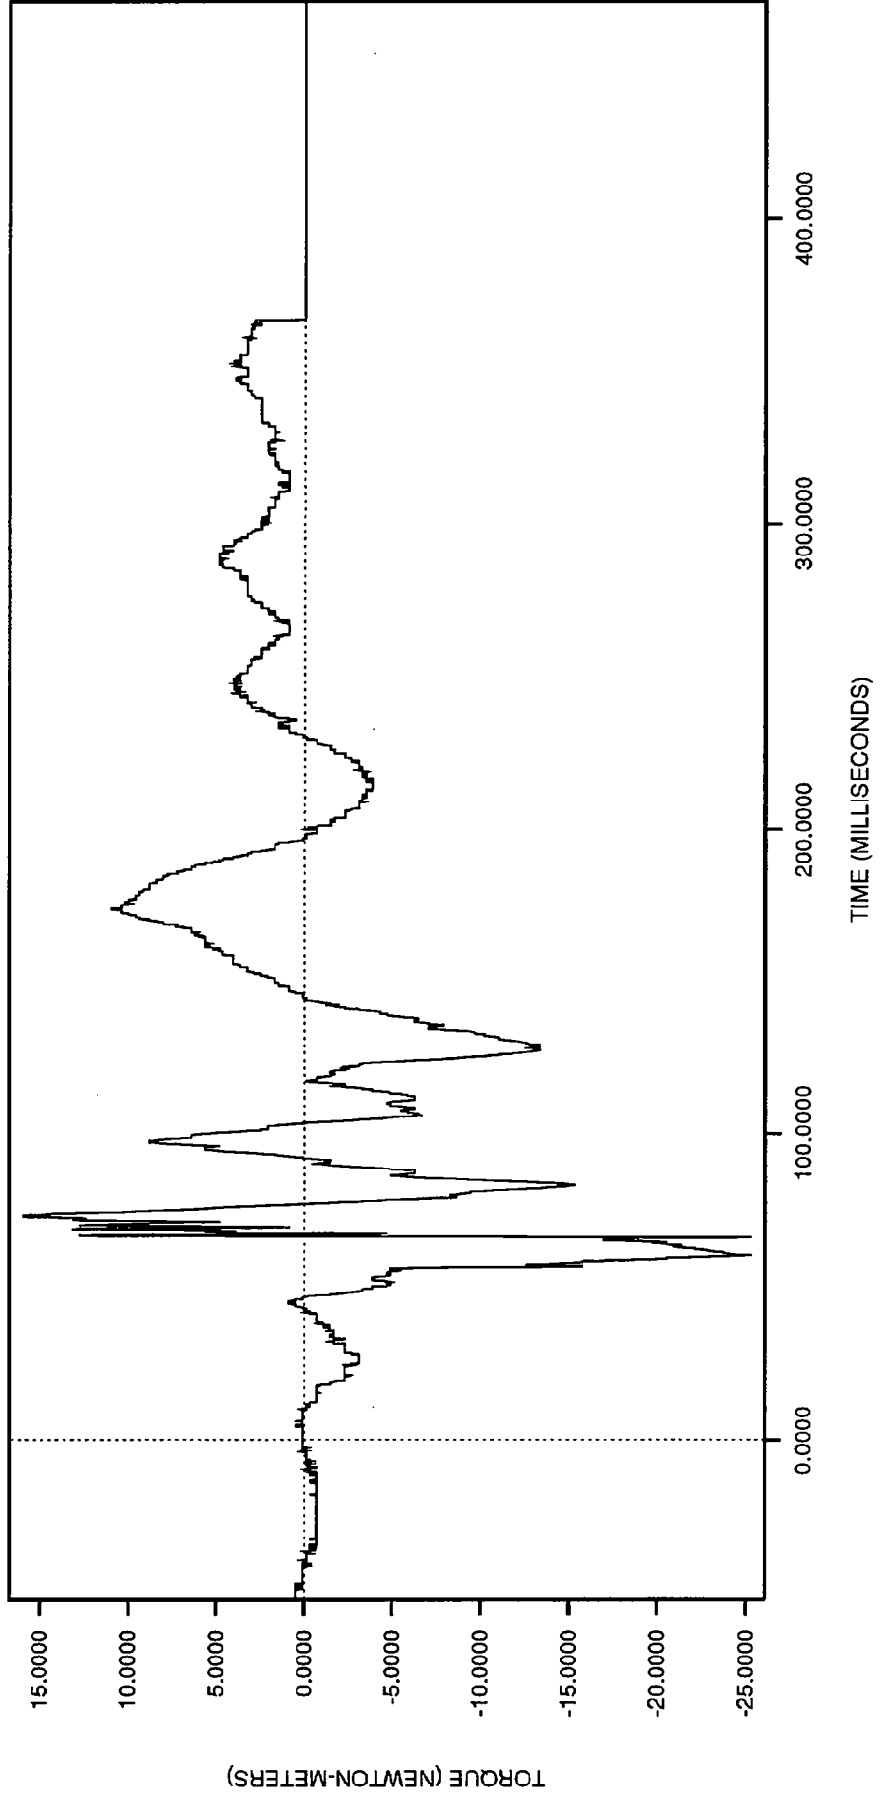
File : v2644ta0.009

Test Performer : INSURANCE INSTITUTE FOR H  
Year : 1996 Make : FORD  
Occupant Location : OTHER  
Restraint [1] : AIR BAG  
Sensor Attachment : TIBIA - RIGHT LOWER  
Status : AS MEASURED  
Filter CutOff : 2500 HZ

Reference : CF95030  
Model : EXPLORER  
Occupant Type : H3  
Restraint [2] : 3 POINT BELT  
YMIN = -25.2768  
YMAX = 15.9385

Sensor Type : TORQUE  
Axis : YL  
AT 60.6000 MILLISECONDS  
AT 73.3000 MILLISECONDS

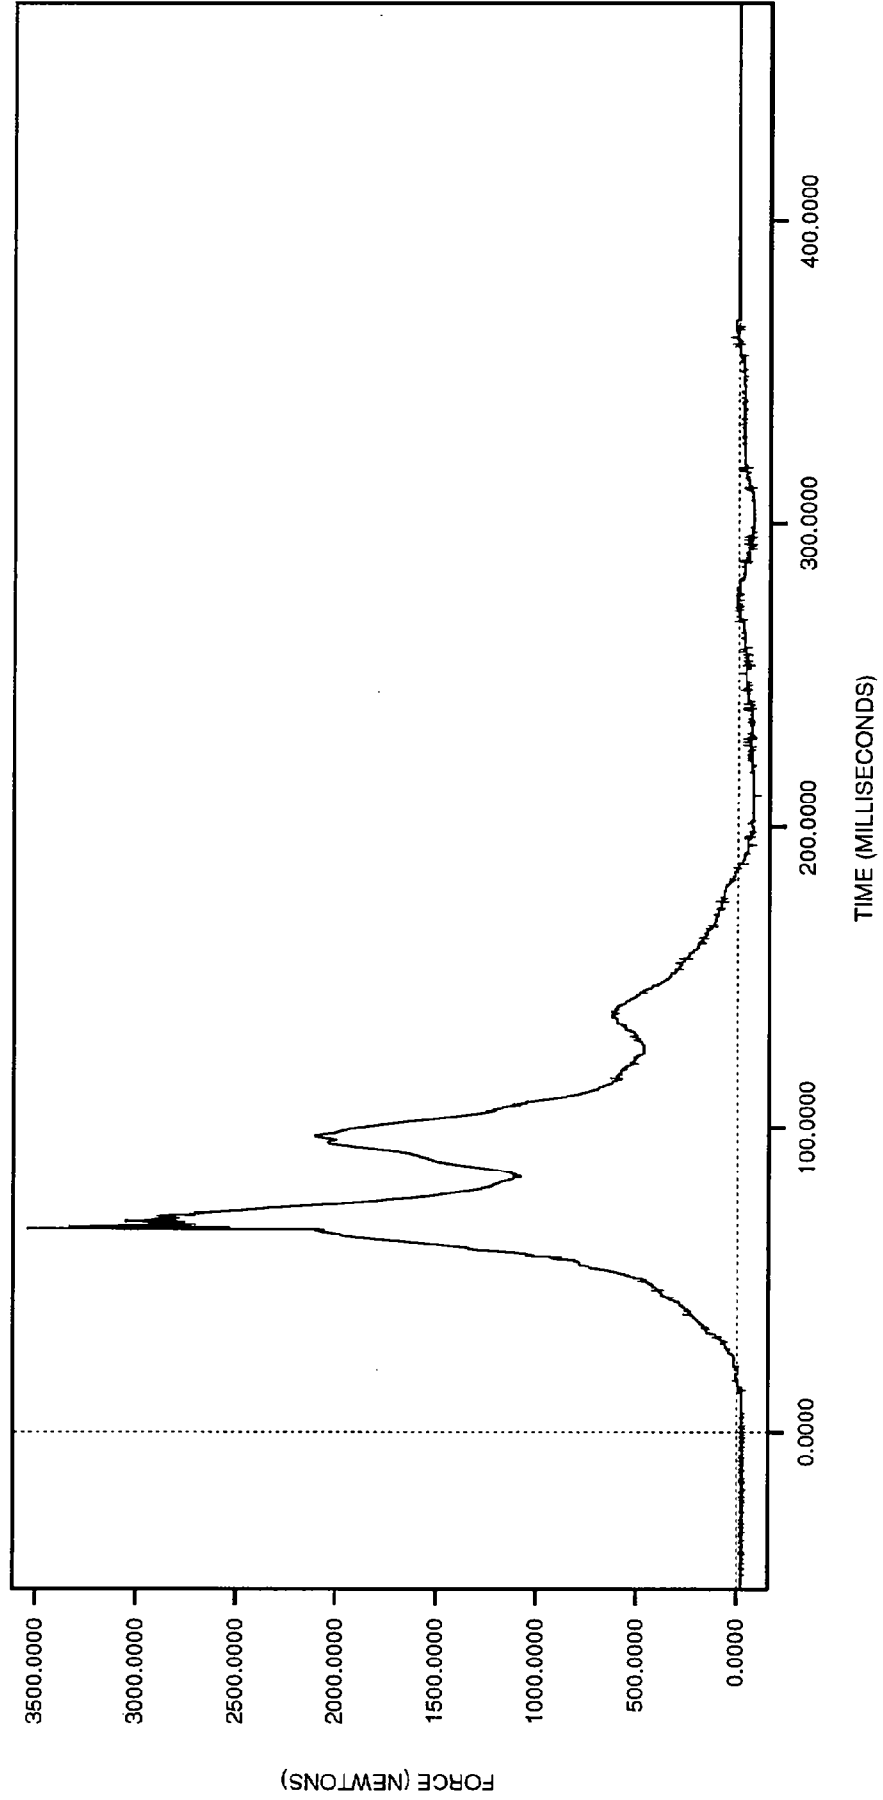
File : v2644ta0.010

Test Performer : INSURANCE INSTITUTE FOR H  
Year : 1996 Make : FORD  
Occupant Location : OTHER  
Restraint [1] : AIR BAG  
Sensor Attachment : TIBIA - RIGHT LOWER  
Status : AS MEASURED  
Filter CutOff : 2500 HZ  
Comments :

Reference : CF95030  
Model : EXPLORER  
Occupant Type : H3  
Restraint [2] : 3 POINT BELT  
YMIN = -83.3023  
YMAX = 3541.4399

Speed : 64.40 KMPH  
Body : UTILITY VEHICLE  
HIC = 475.00  
Sensor Type : FORCE  
AT 210.3000 MILLISECONDS  
AT 66.7000 MILLISECONDS

Config : VTB  
Vehicle # : 1  
CSI = 0.00  
Axis : ZL

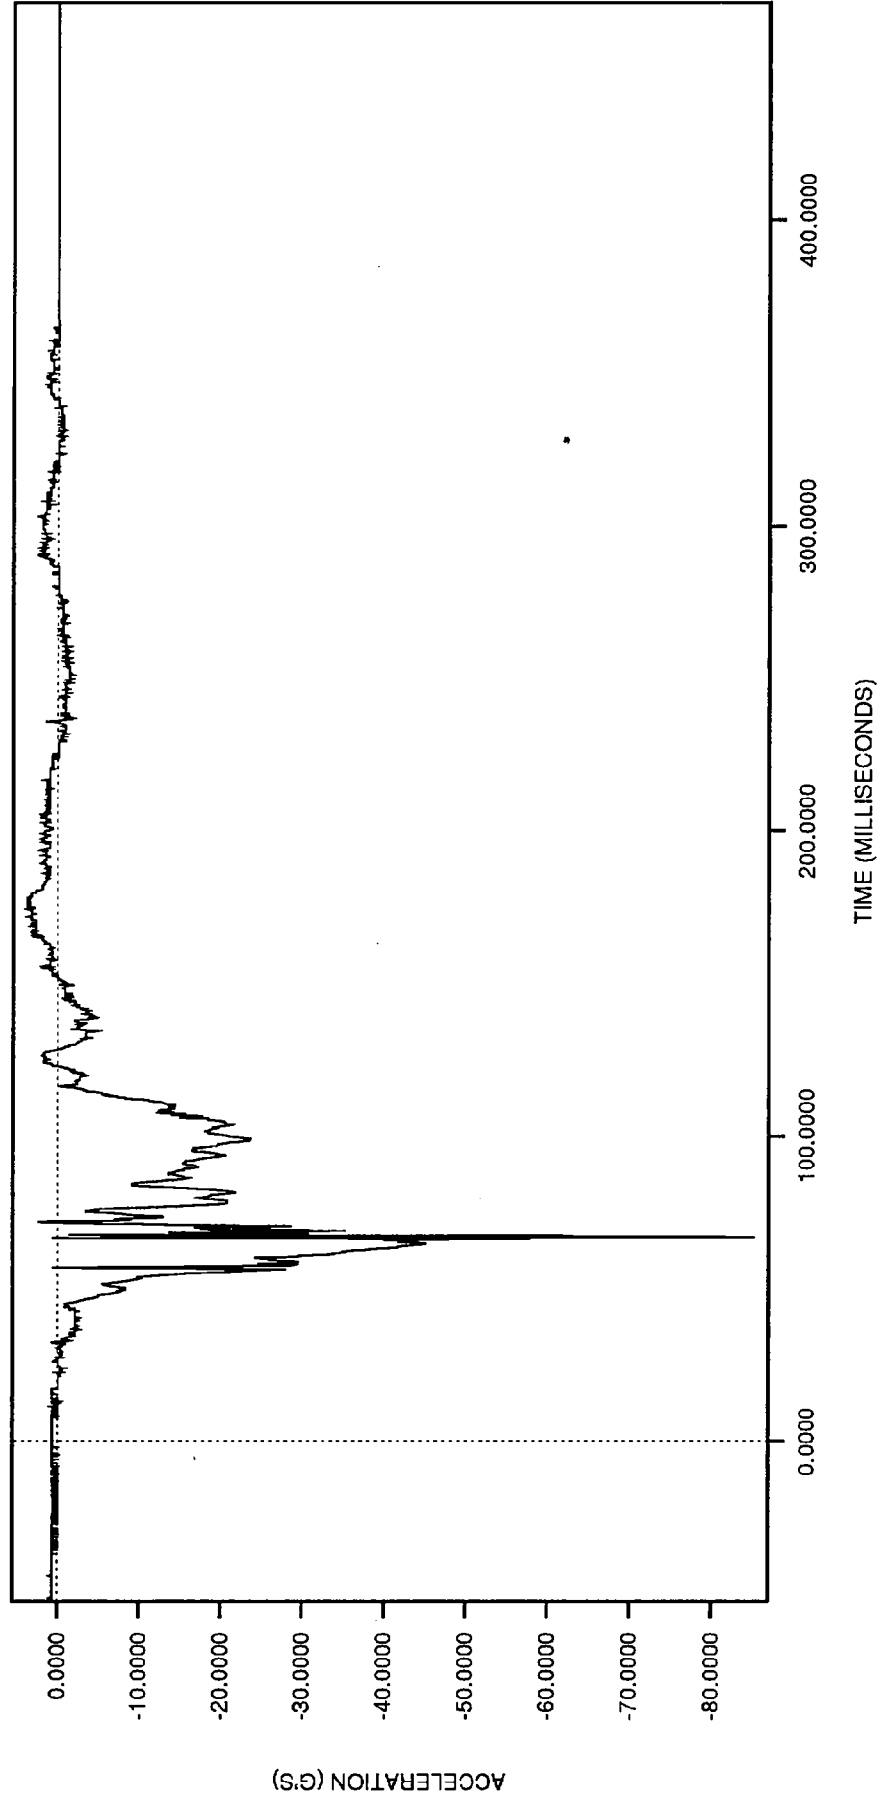
File : v2644aa0.011

Sensor Attachment : FOOT - RIGHT

YMIN = -86.2321

YMAX = 3.7071

Sensor Type : ACCELERATION

Axis : XL

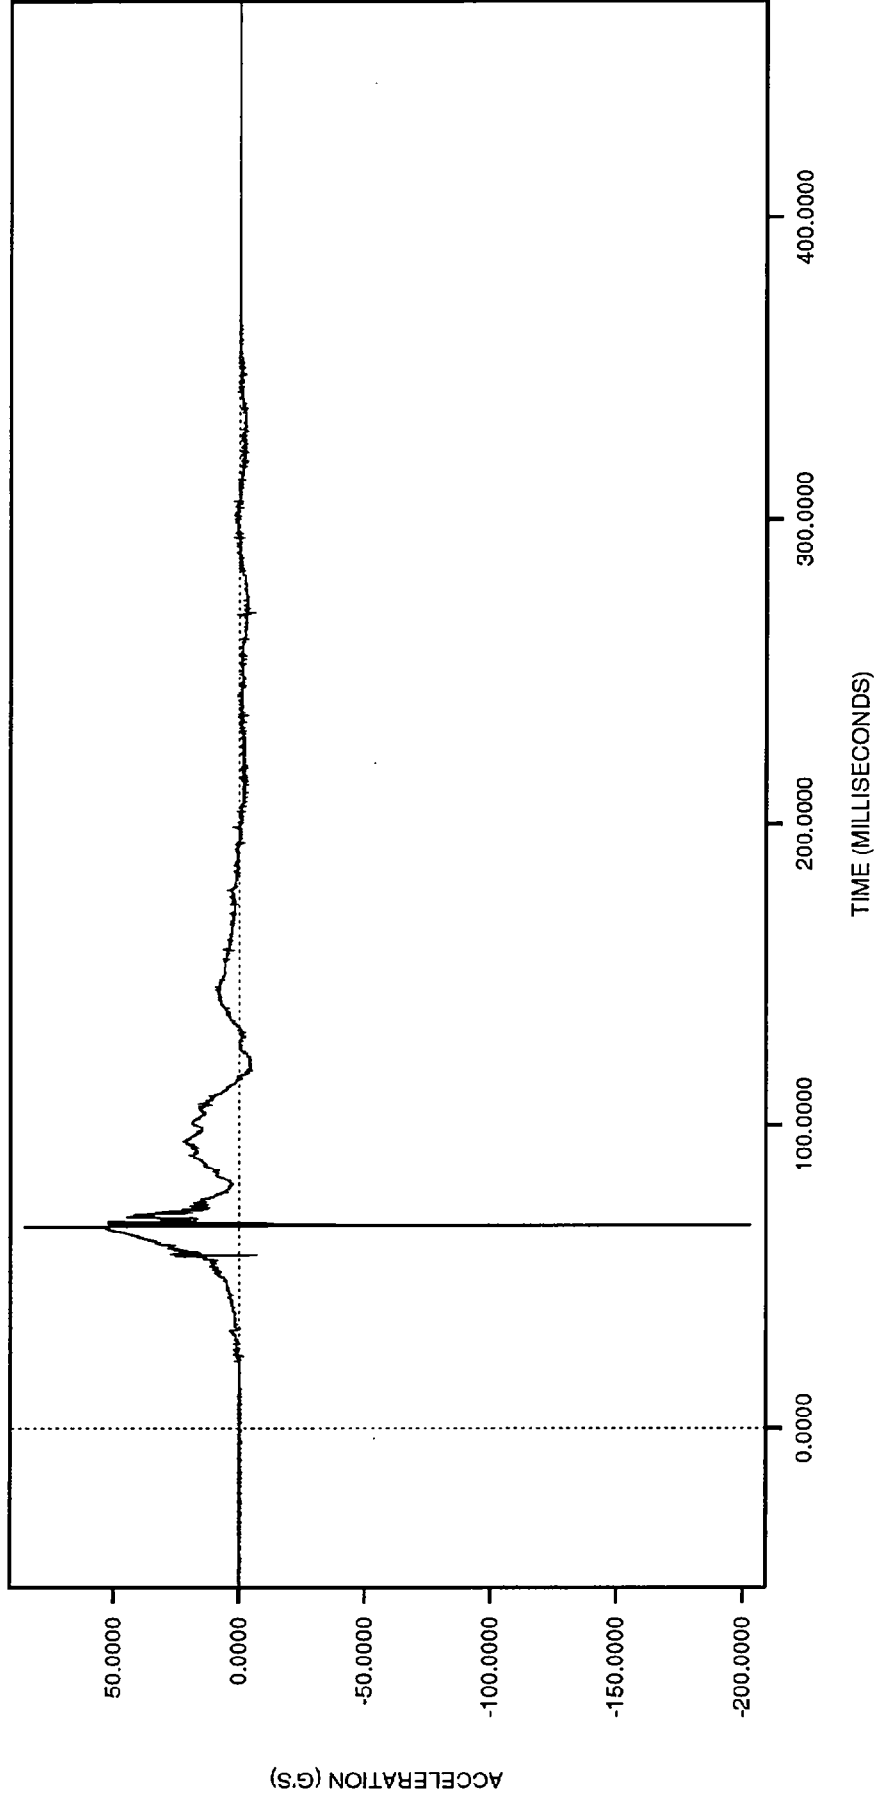
File : v2644aa0.012

Sensor Attachment : FOOT - RIGHT

YMIN = -203.5280

YMAX = 85.4869

Sensor Type : ACCELERATION

Axis : ZL

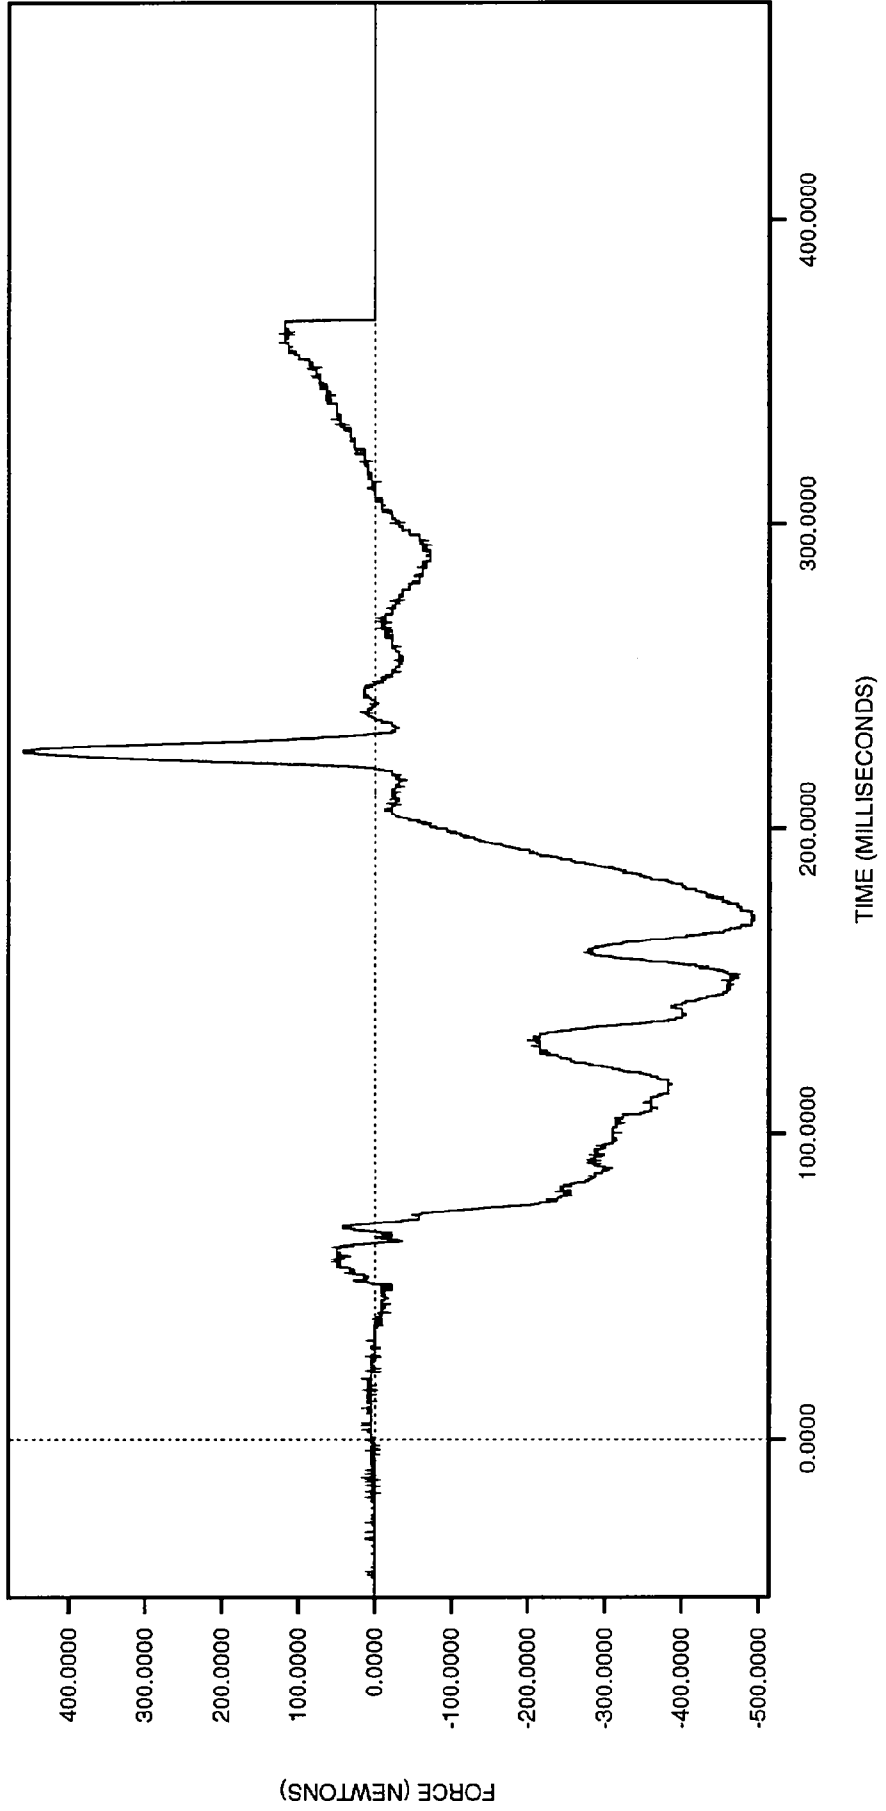
File : v2644fa0.013

Test Performer : INSURANCE INSTITUTE FOR H  
Year : 1996 Make : FORD  
Occupant Location : OTHER  
Restraint [1] : AIR BAG  
Sensor Attachment : NECK - UPPER  
Status : AS MEASURED  
Filter CutOff : 2500 HZ

Reference : CF95030  
Model : EXPLORER  
Occupant Type : H3  
Restraint [2] : 3 POINT BELT  
YMIN = -494.7450  
YMAX = 459.2890

Axis : XL
