**NHTSA  
VEHICLE DATABASE  
REPORT  
TEST# 2644**

**Test Title:** IIHS OFFSET CRASHWORTHINESS EVALUATION

**Test Performer:** INSURANCE INSTITUTE FO **Test Reference Number:** CF95030

**Test Objectives:** IIHS 40% OVERLAP - 1996 FORD EXPLORER

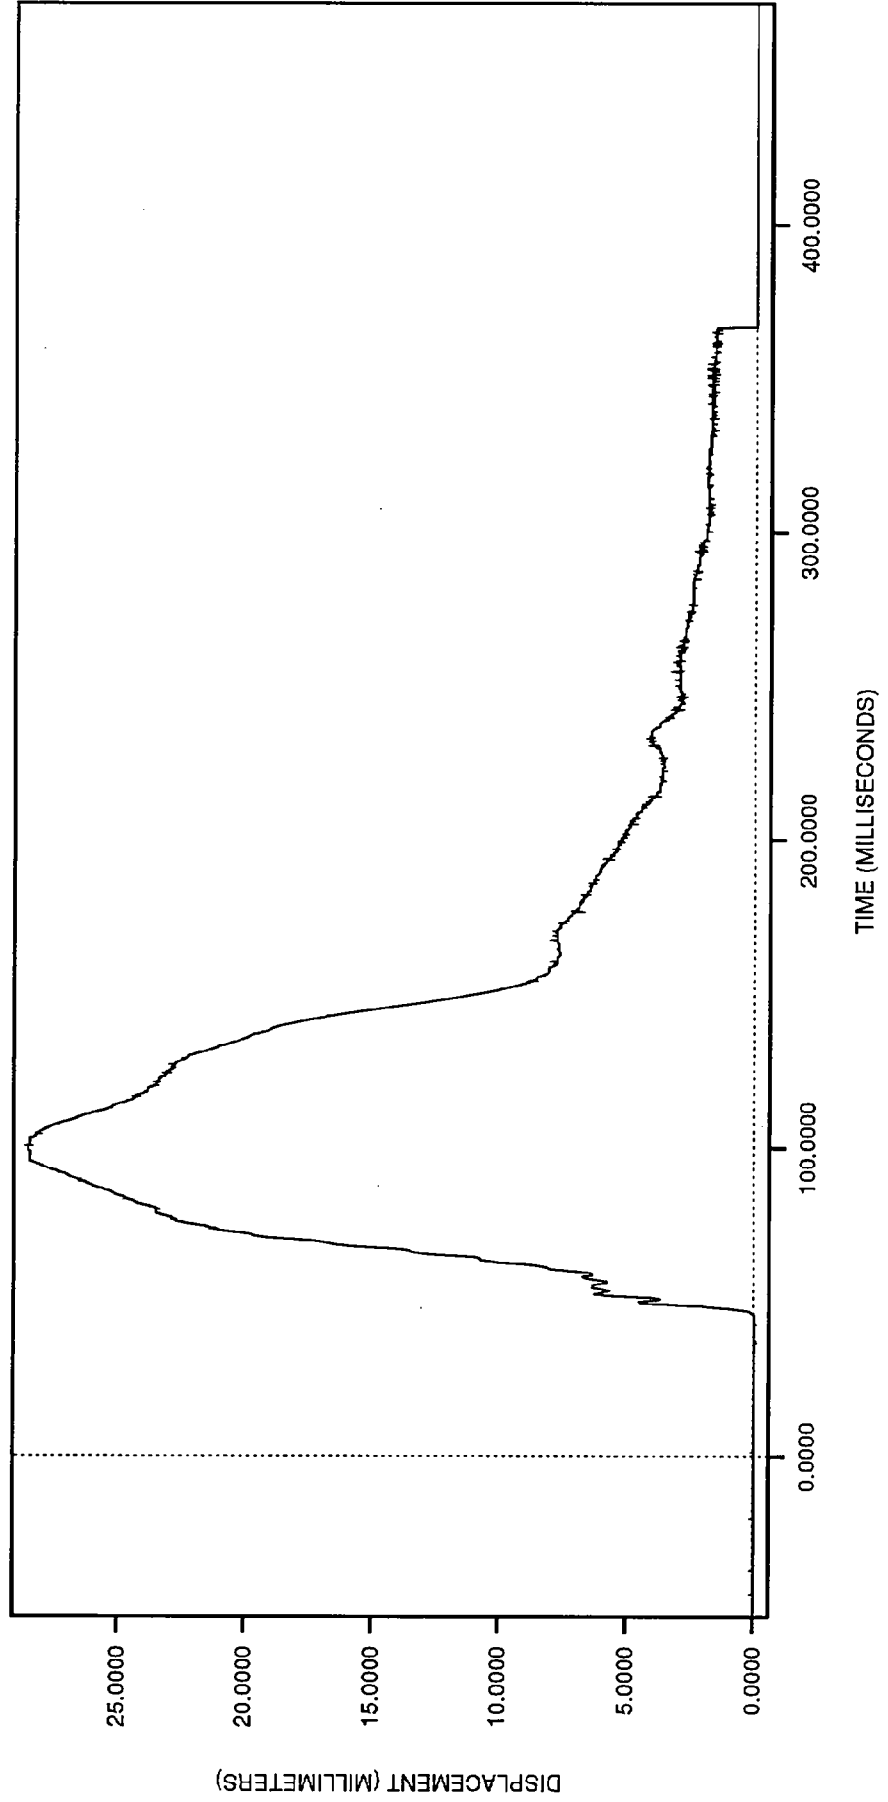
File : v2644da0.021

Test Performer : INSURANCE INSTITUTE FOR H  
Year : 1996 Make : FORD  
Occupant Location : OTHER  
Restraint [1] : AIR BAG  
Sensor Attachment : CHEST  
Status : AS MEASURED  
Filter CutOff : 2500 HZ  
Comments :

Speed : 64.40 KMPH  
Body : UTILITY VEHICLE  
HIC = 475.00  
Sensor Type : DISPLACEMENT  
AT 36.9000 MILLISECONDS  
AT 99.0000 MILLISECONDS

Config : VTB  
Vehicle # : 1  
CSI = 0.00  
Axis : XL

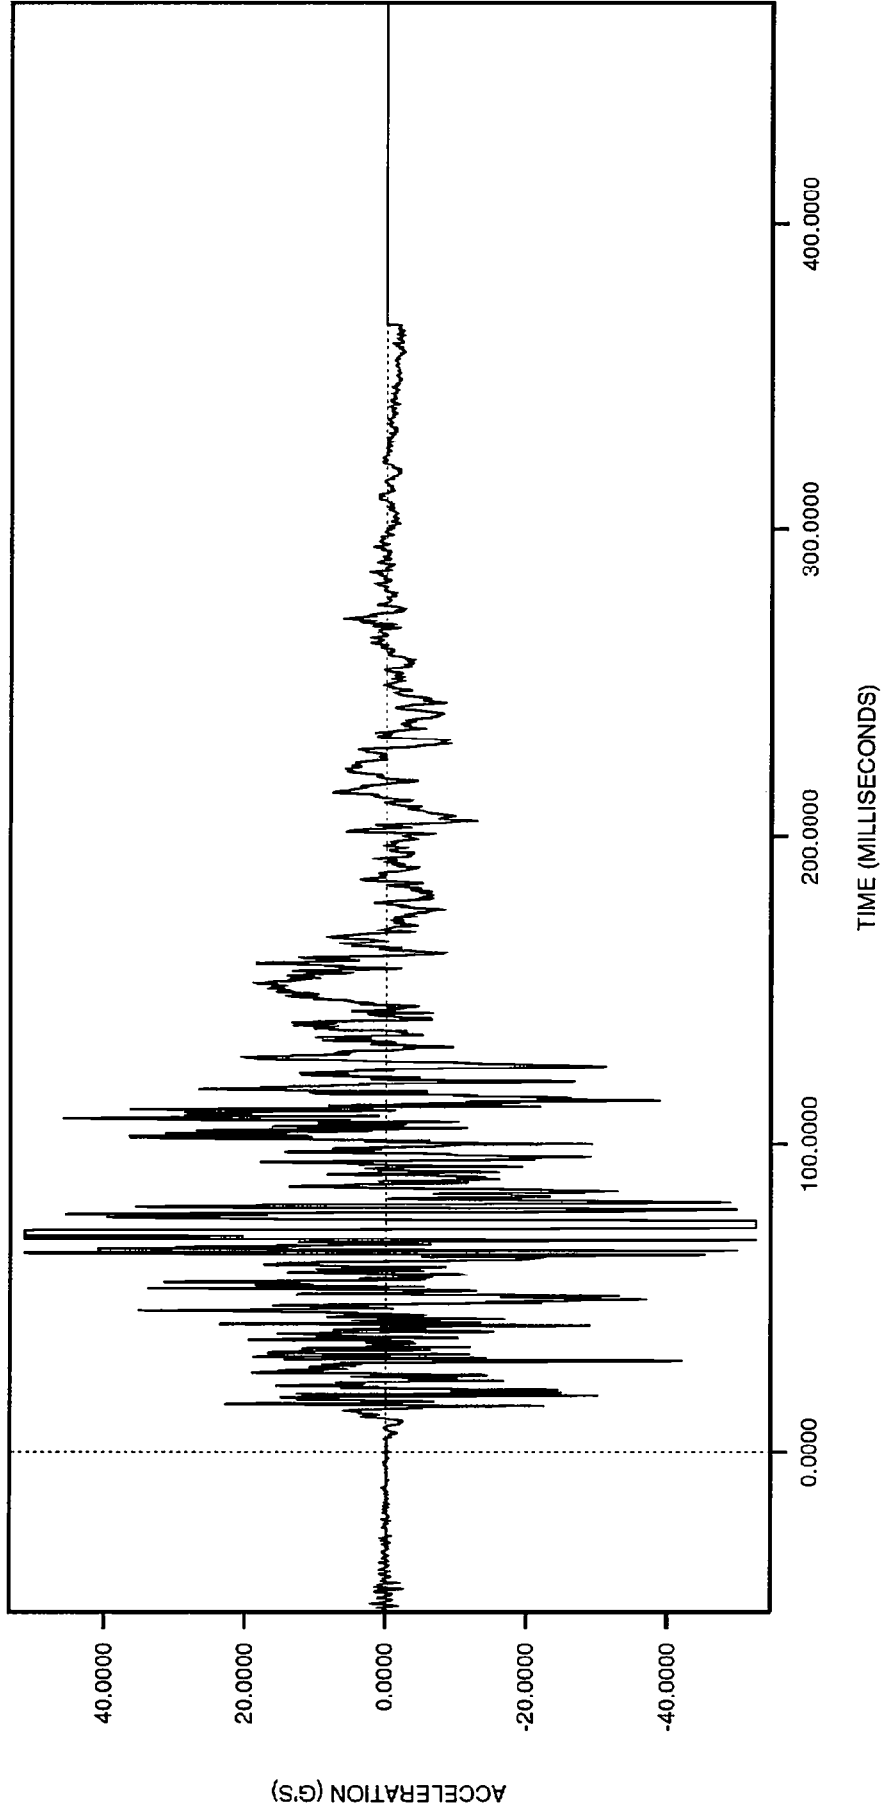
File : v2644aa0.027

Test Performer : INSURANCE INSTITUTE FOR H  
Year : 1996 Make : FORD  
Occupant Location : OTHER  
Restraint [1] : AIR BAG  
Sensor Attachment : VEHICLE CG  
Status : AS MEASURED  
Filter CutOff : 2500 HZ  
Comments :

Sensor Type : ACCELERATION  
AT 68.7000 MILLISECONDS  
AT 64.5000 MILLISECONDS

Axis : ZG

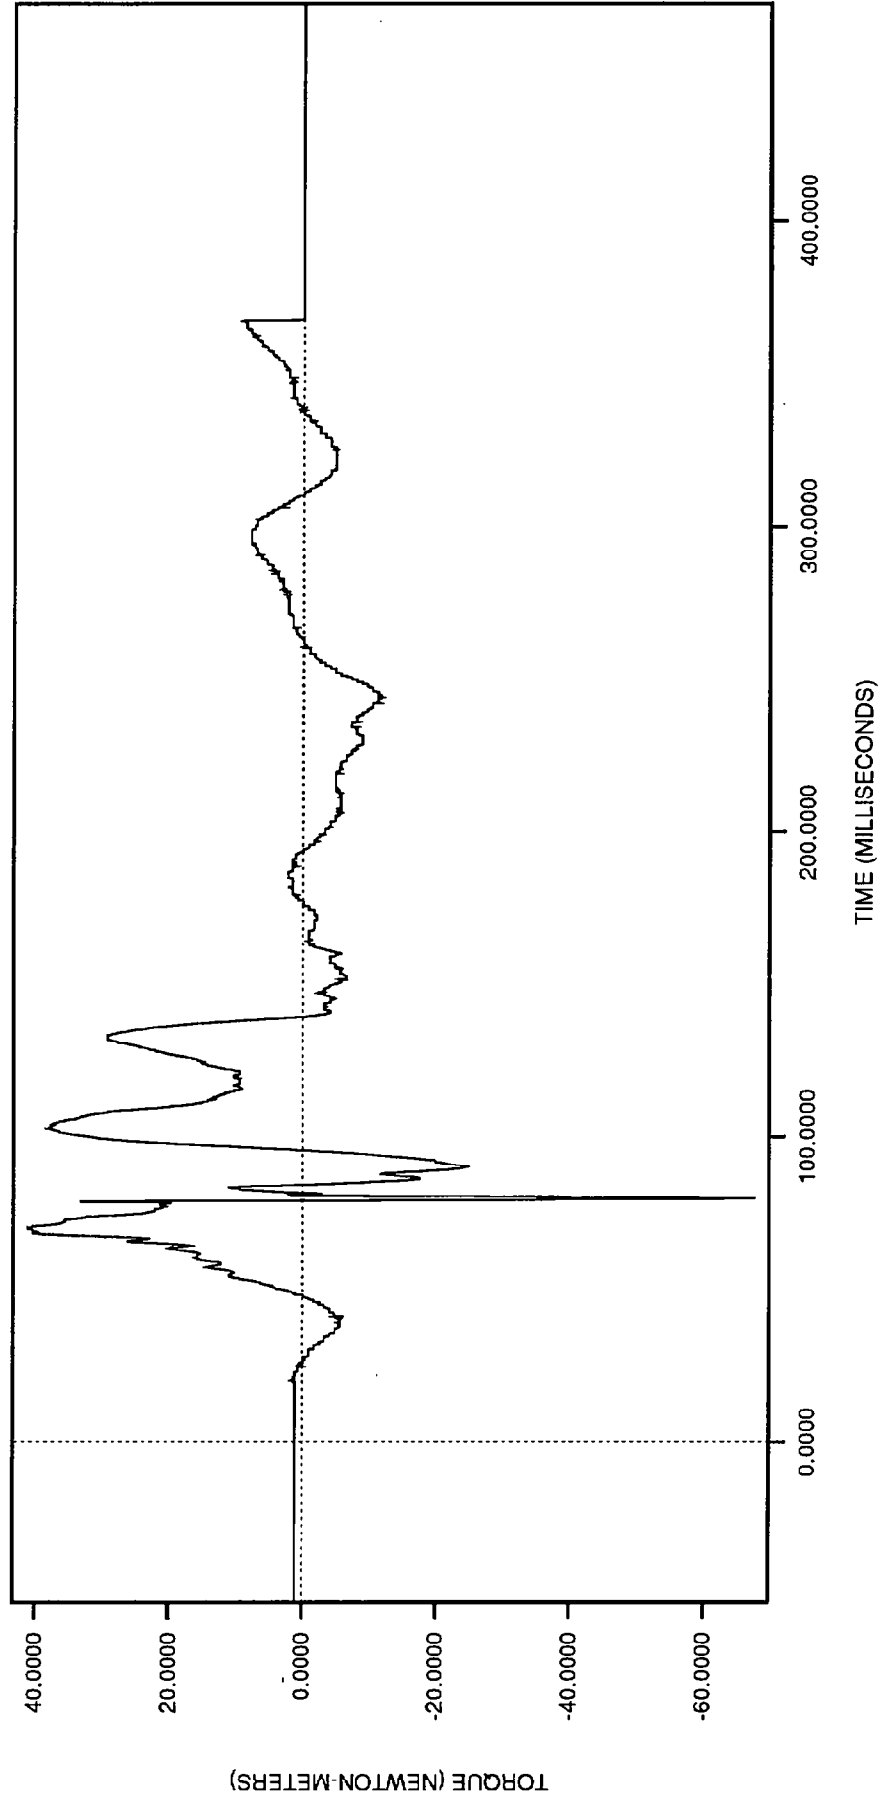
File : v2644ta0.030

Test Performer : INSURANCE INSTITUTE FOR H  
Year : 1996 Make : FORD  
Occupant Location : OTHER  
Restraint [1] : AIR BAG  
Sensor Attachment : TIBIA - LEFT UPPER  
Status : AS MEASURED  
Filter CutOff : 2500 HZ  
Comments :

Speed : 64.40 KMPH  
Body : UTILITY VEHICLE  
HIC = 475.00  
Sensor Type : TORQUE  
AT 79.9000 MILLISECONDS  
AT 70.1000 MILLISECONDS

Config : VTB  
Vehicle # : 1  
CSI = 0.00  
Axis : XL

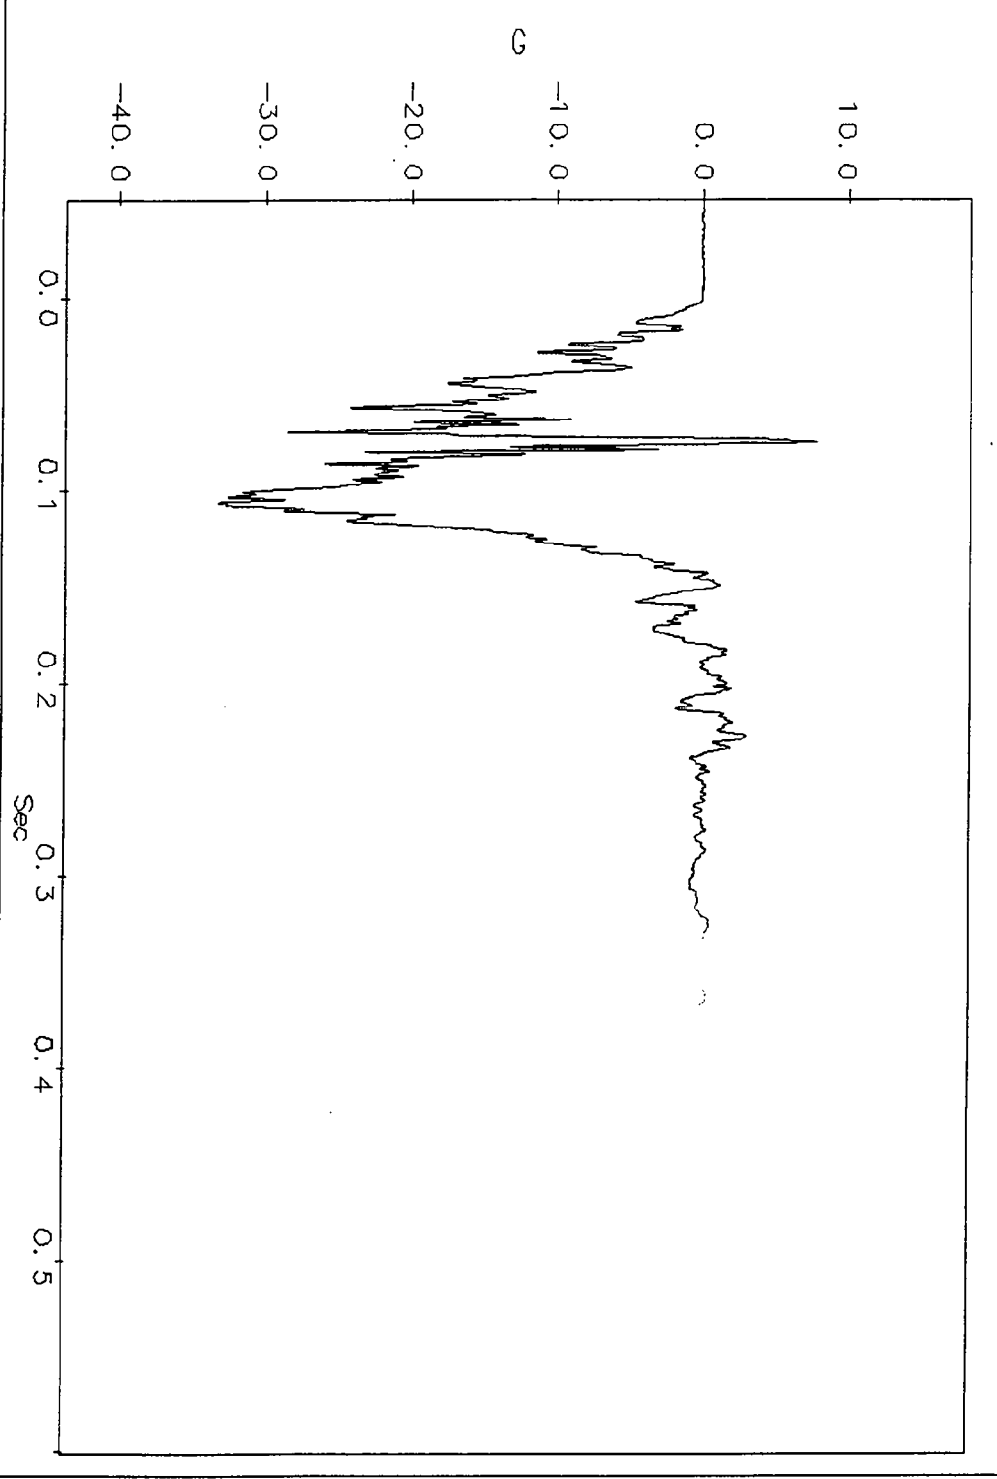
R-1 950330 Ford Explorer XLT 1996 Vehicle Longitudinal Accel

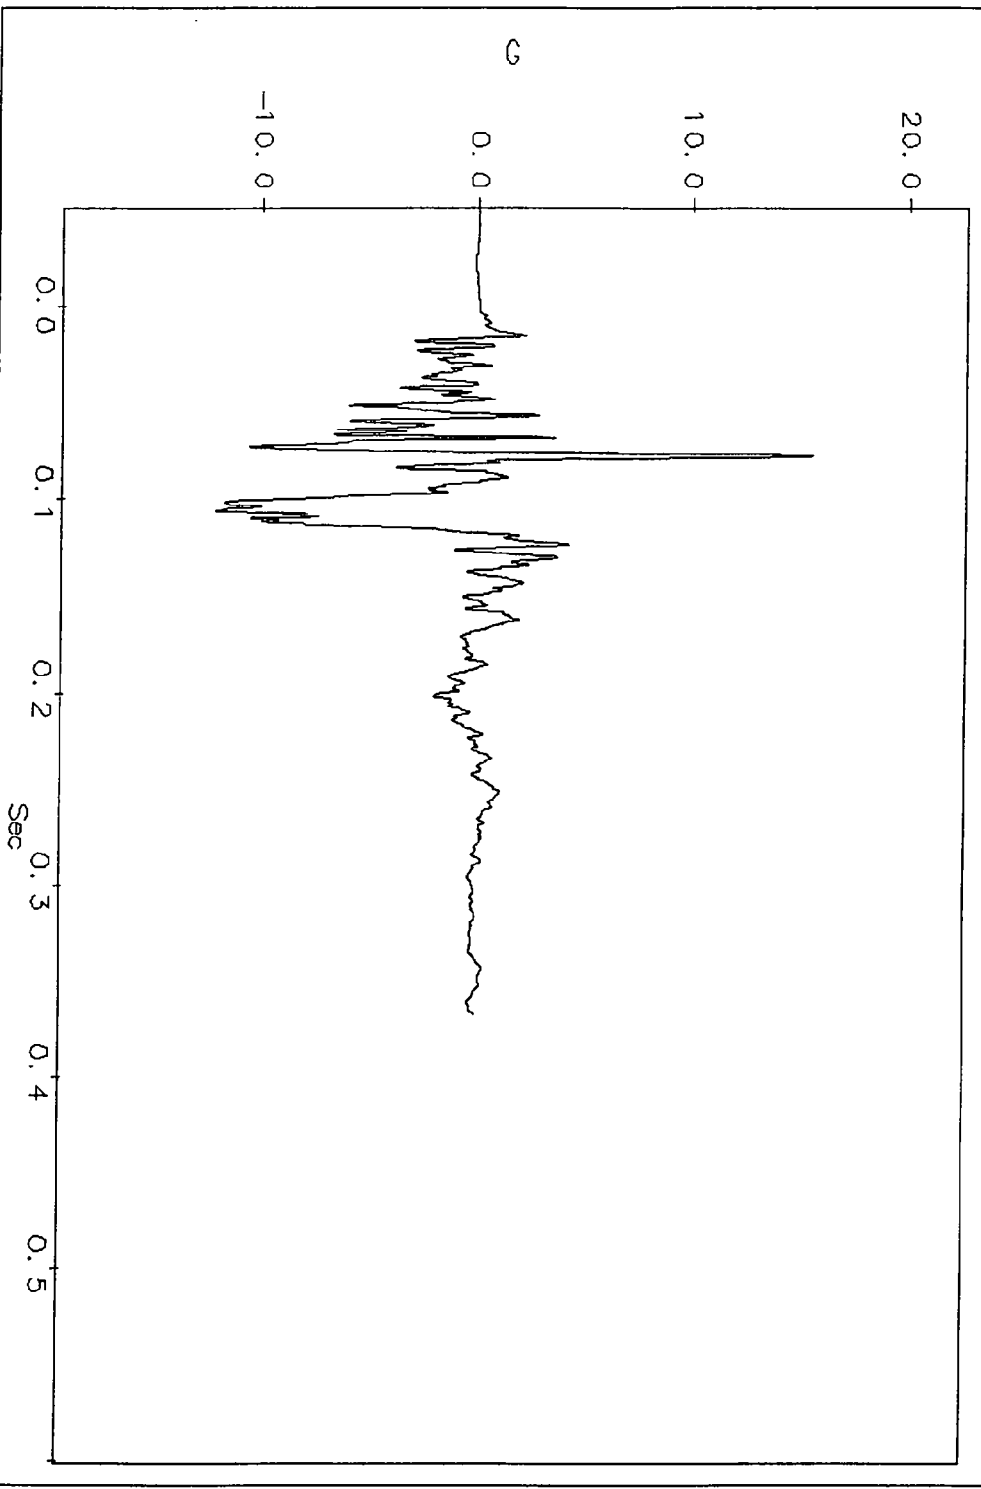
A-2 95030 Ford Explorer XLT 1996 Vehicle Lateral Accel.

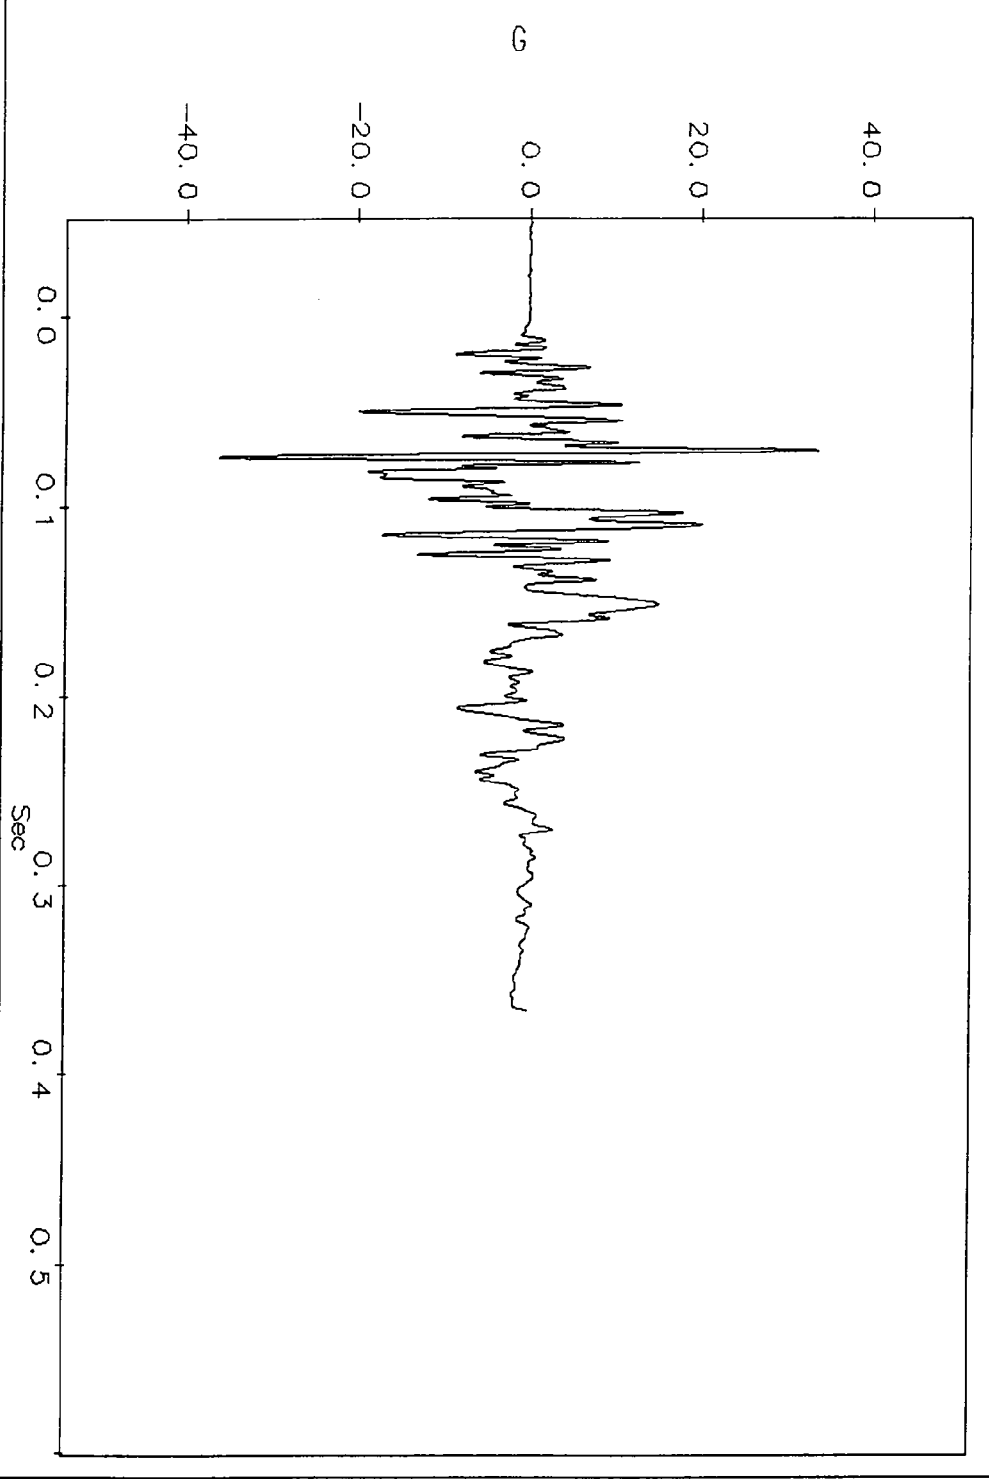
A-3 95030 Ford Explorer XLT 1996 Vehicle Vertical Accel.

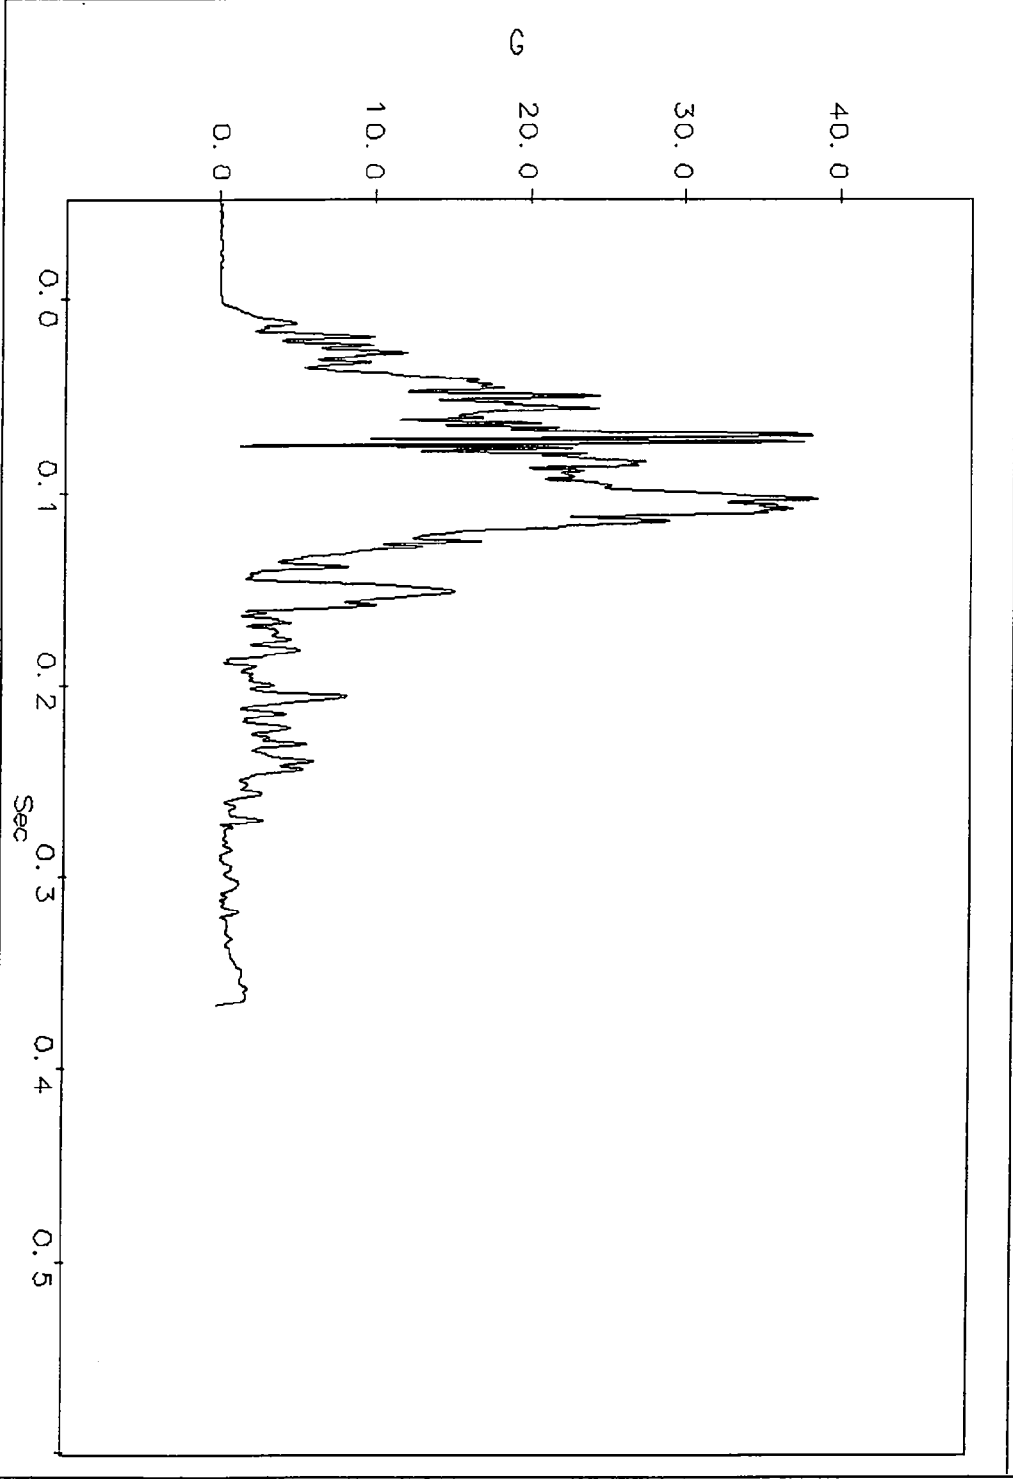
R-4 95030 Ford Explorer XLT 1996 Vehicle Vector Accel.

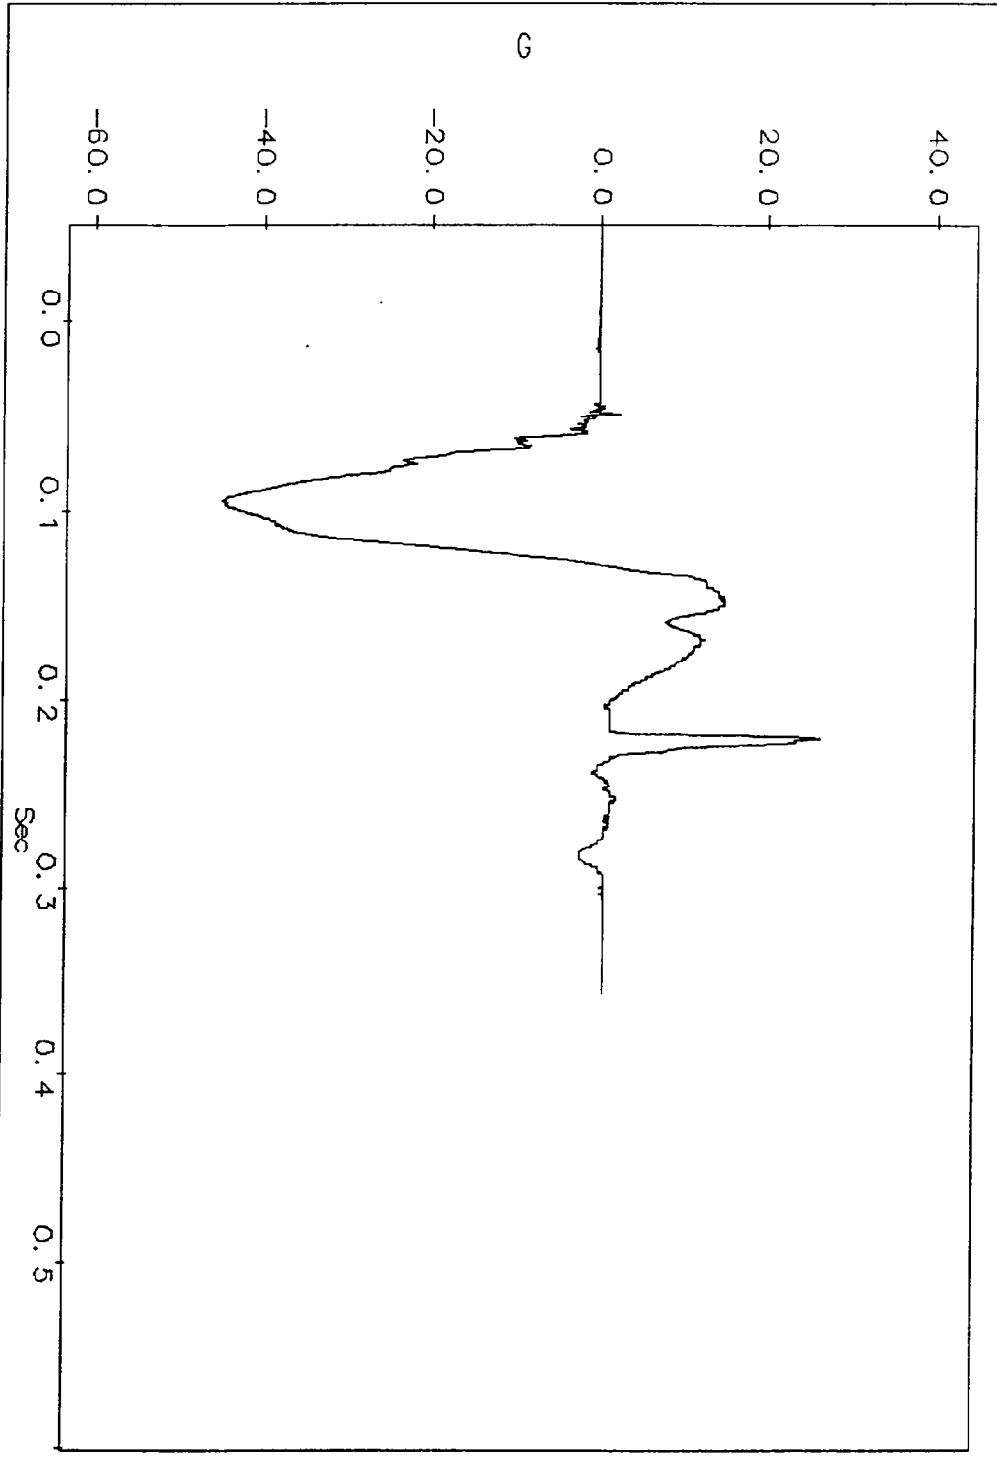
A-5 95030 Ford Explorer Head A-P Accel.

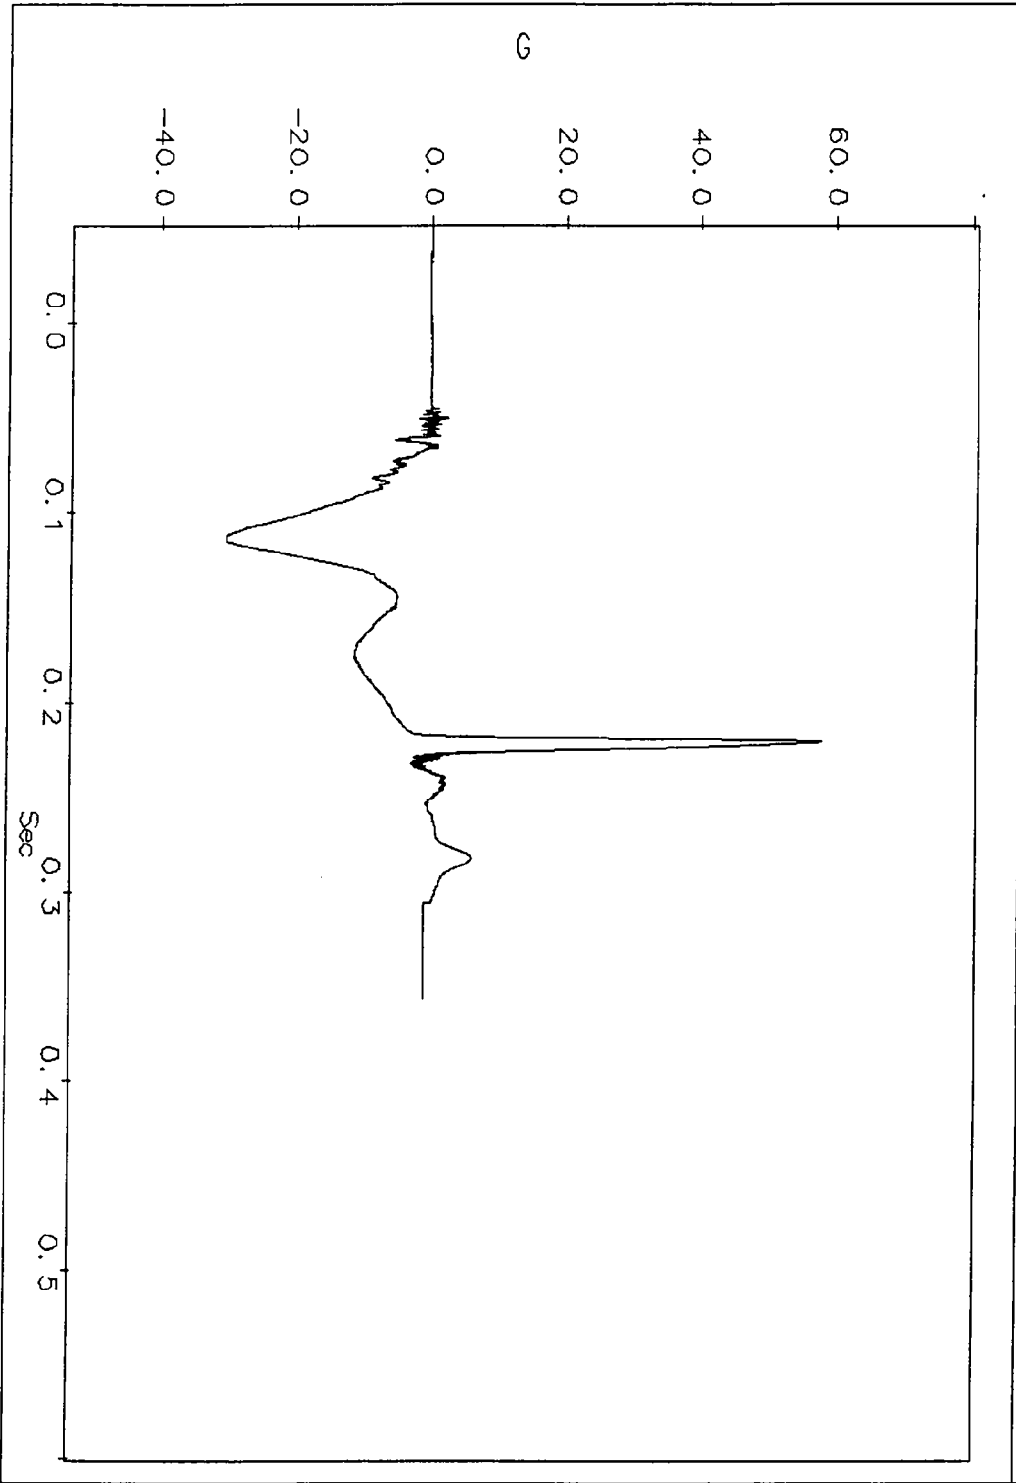
A-6 95030 Ford Explorer XLT 1996 Head Lateral Accel.

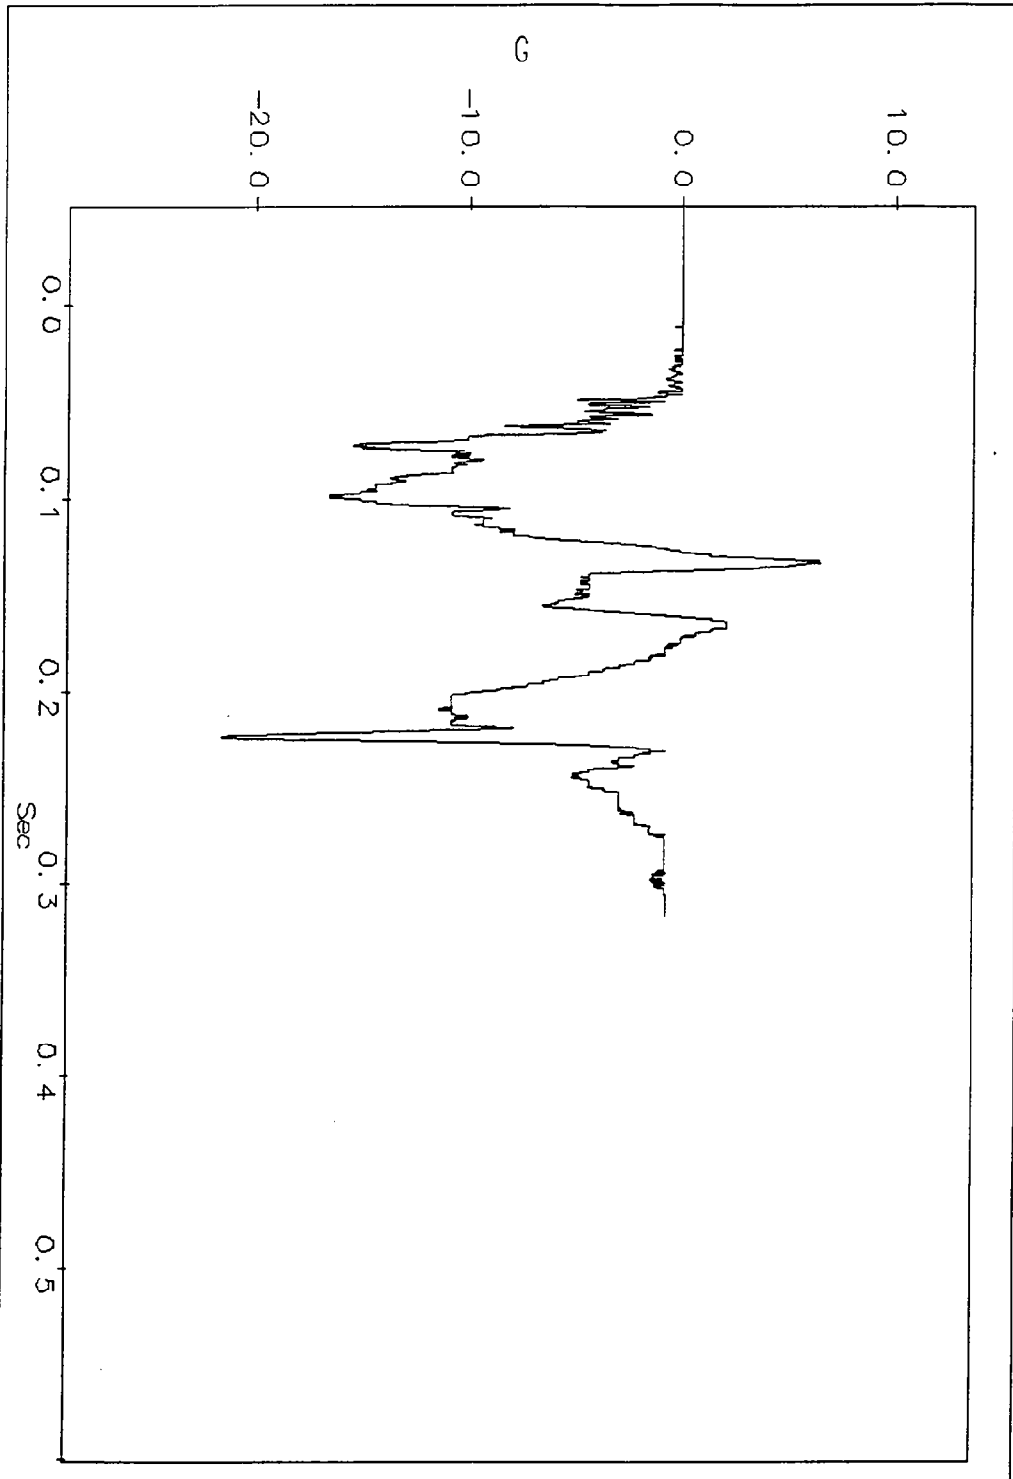
A-7 95030 Ford Explorer XLT 1996 Head I-5 Accel.

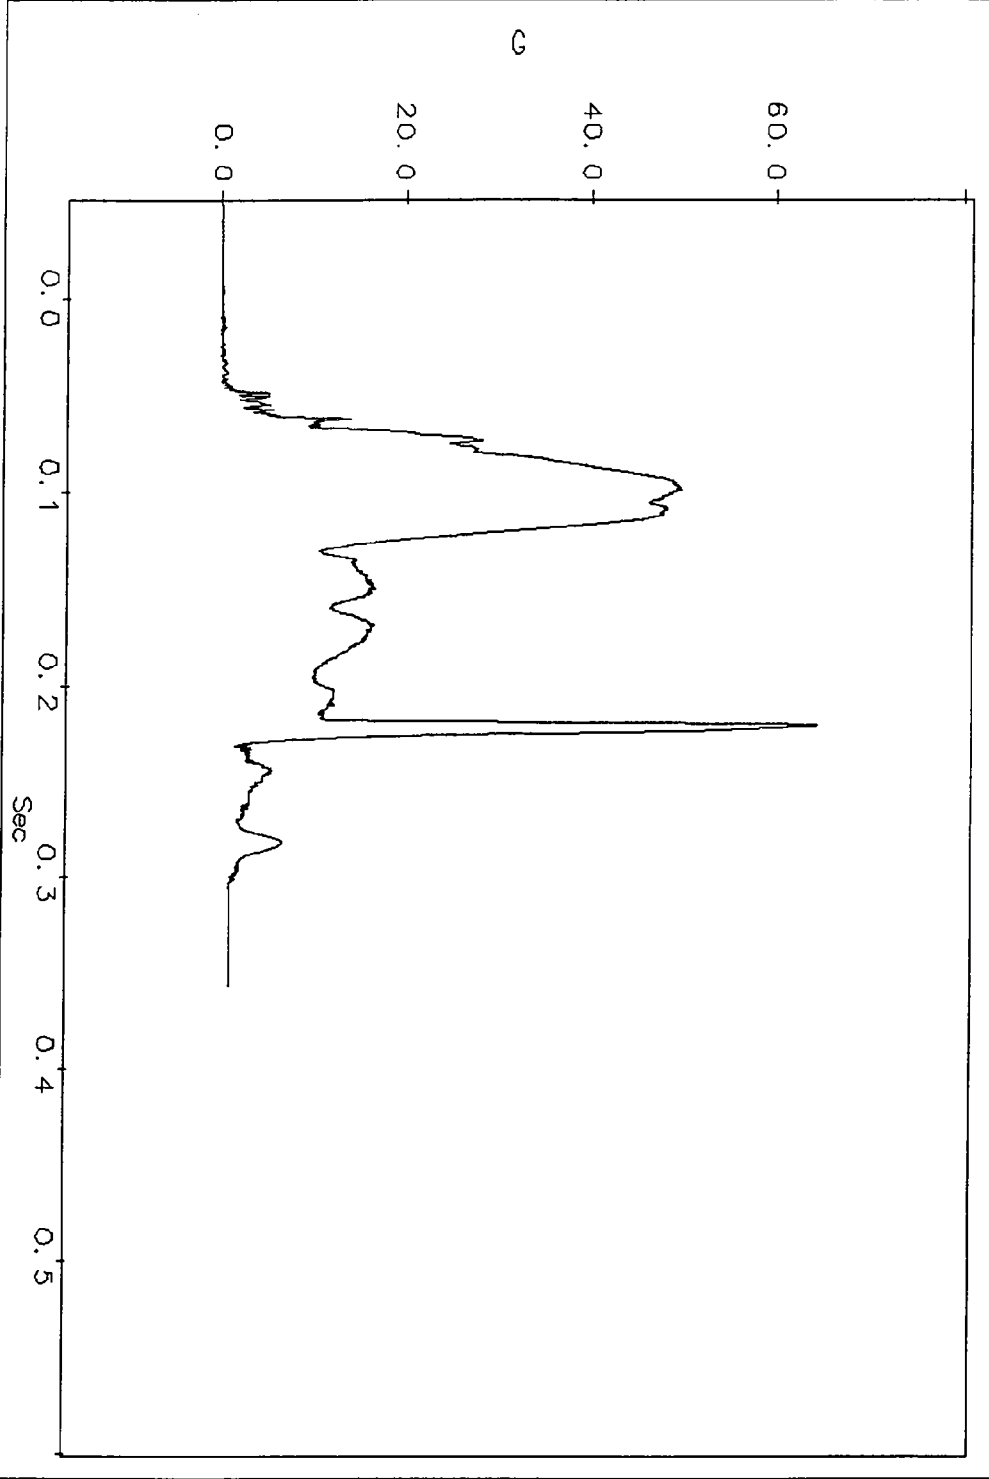
A-B 95030 Ford Explorer XLT 1996 Head Vector Accel.

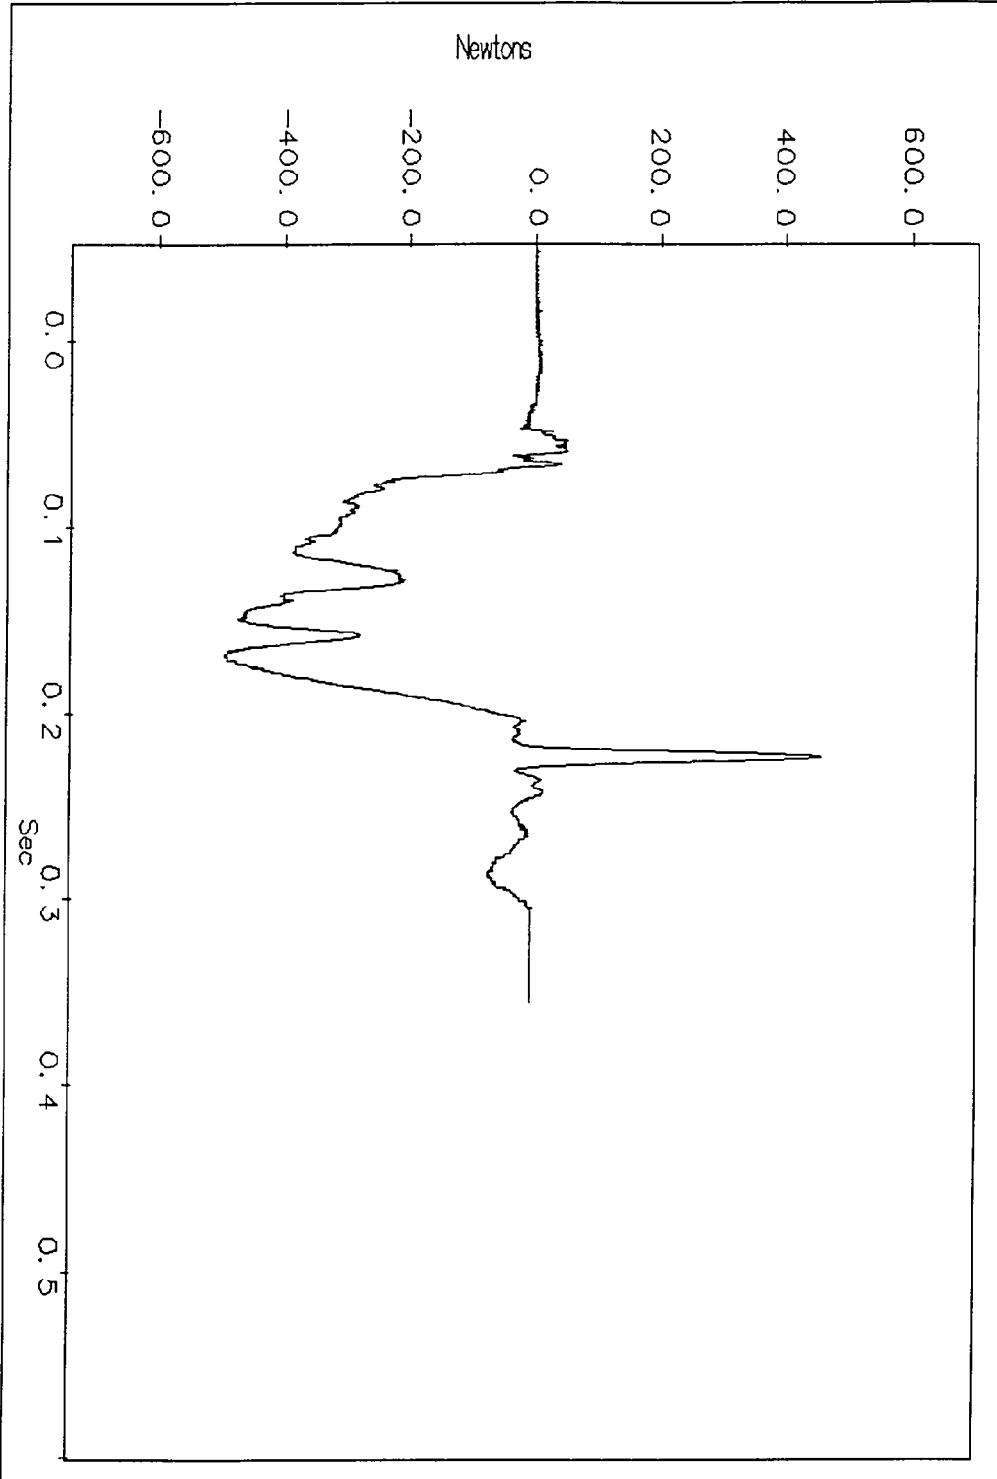
A-9 95030 Ford Explorer XLT 1996 Neck A-P Force

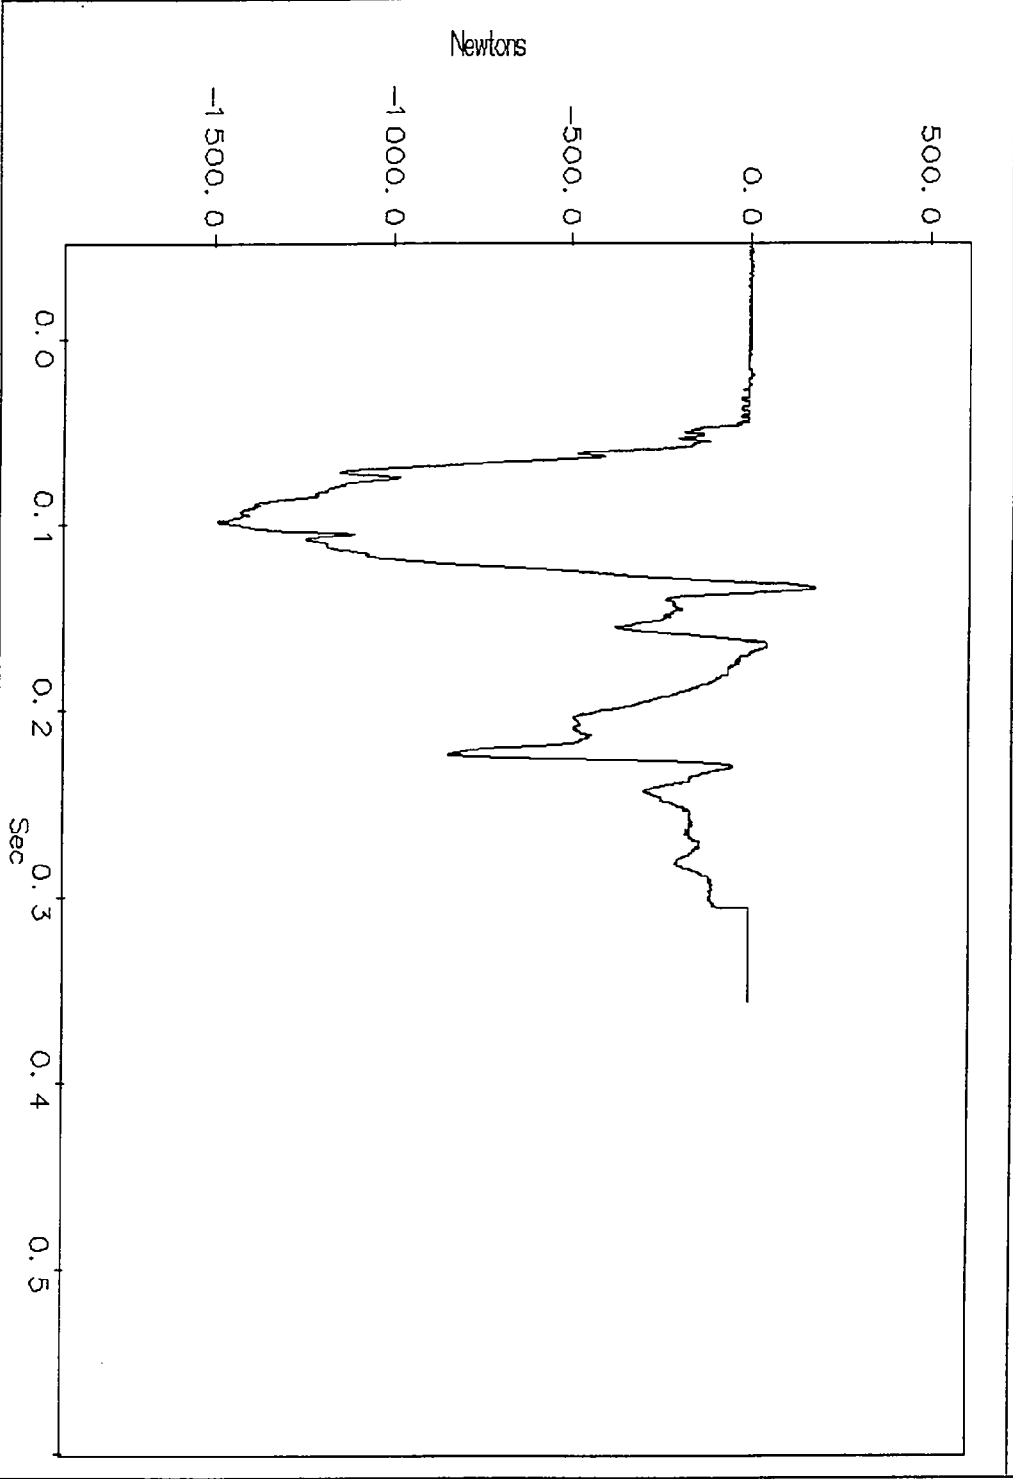
R-10 95030 Ford Explorer XLT 1996 Neck Axial Force

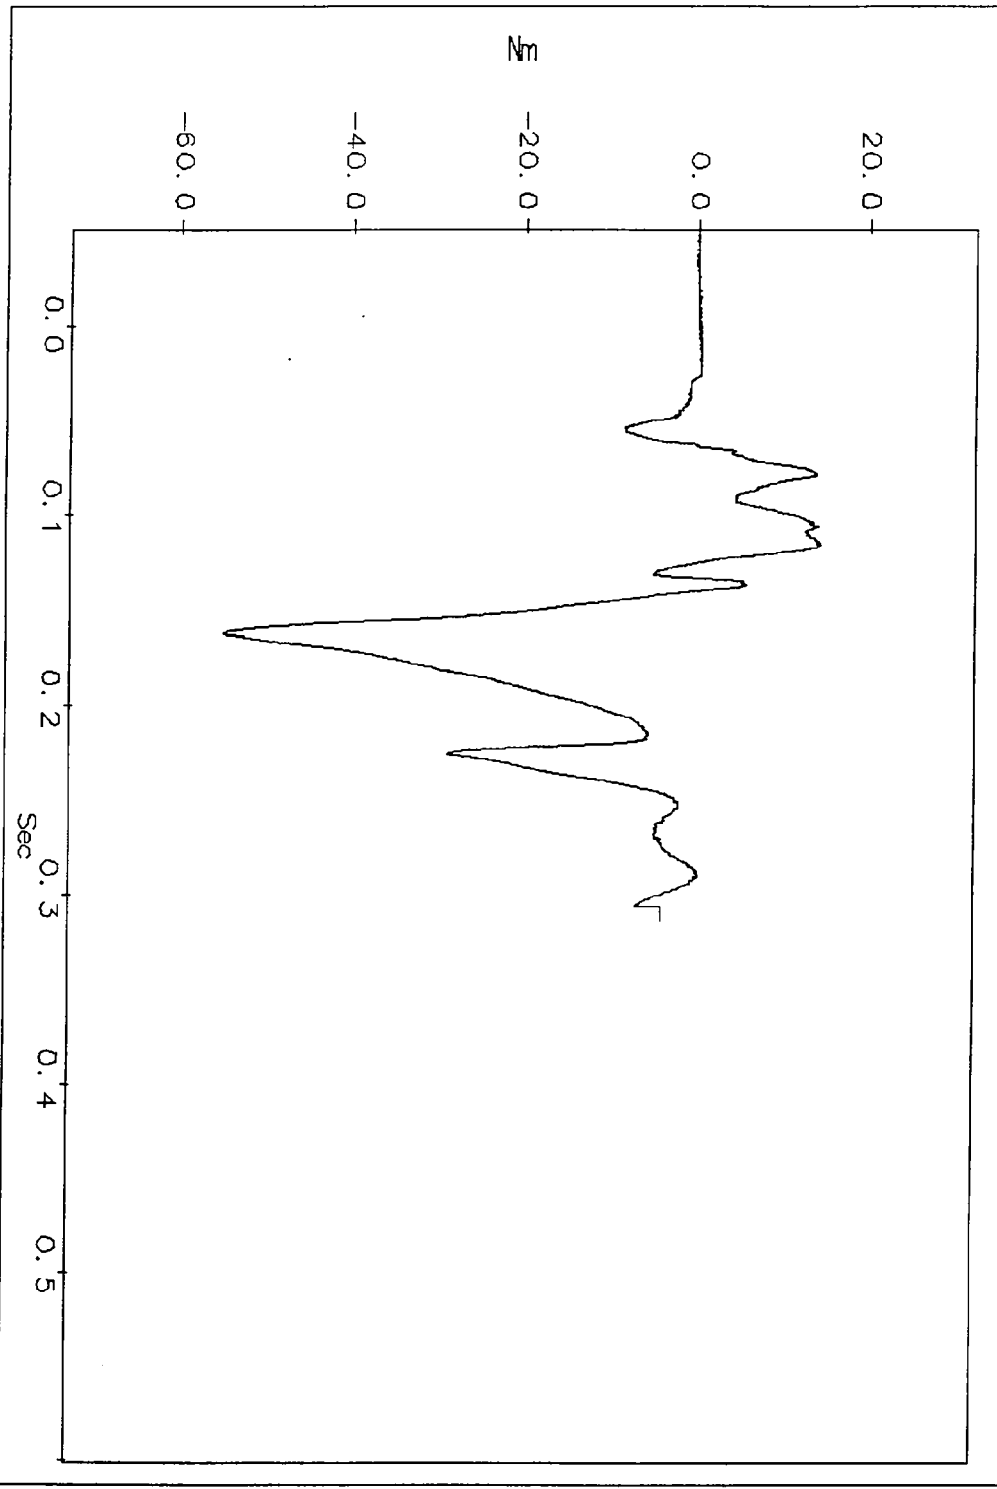
R-11 95030 Ford Explorer XLT 1996 Neck Occipital A-P Moment

\*\* These published thresholds are recommended injury assessment reference values from Bakaitis and Mertz (1994), but significant neck injury may occur at lower bending moments. Mertz and Patrick (1971) report that bending moments of 47 Nm in extension and 88 Nm in flexion would be non-injurious for occupants represented by the Hybrid III 50th percentile adult male dummy.

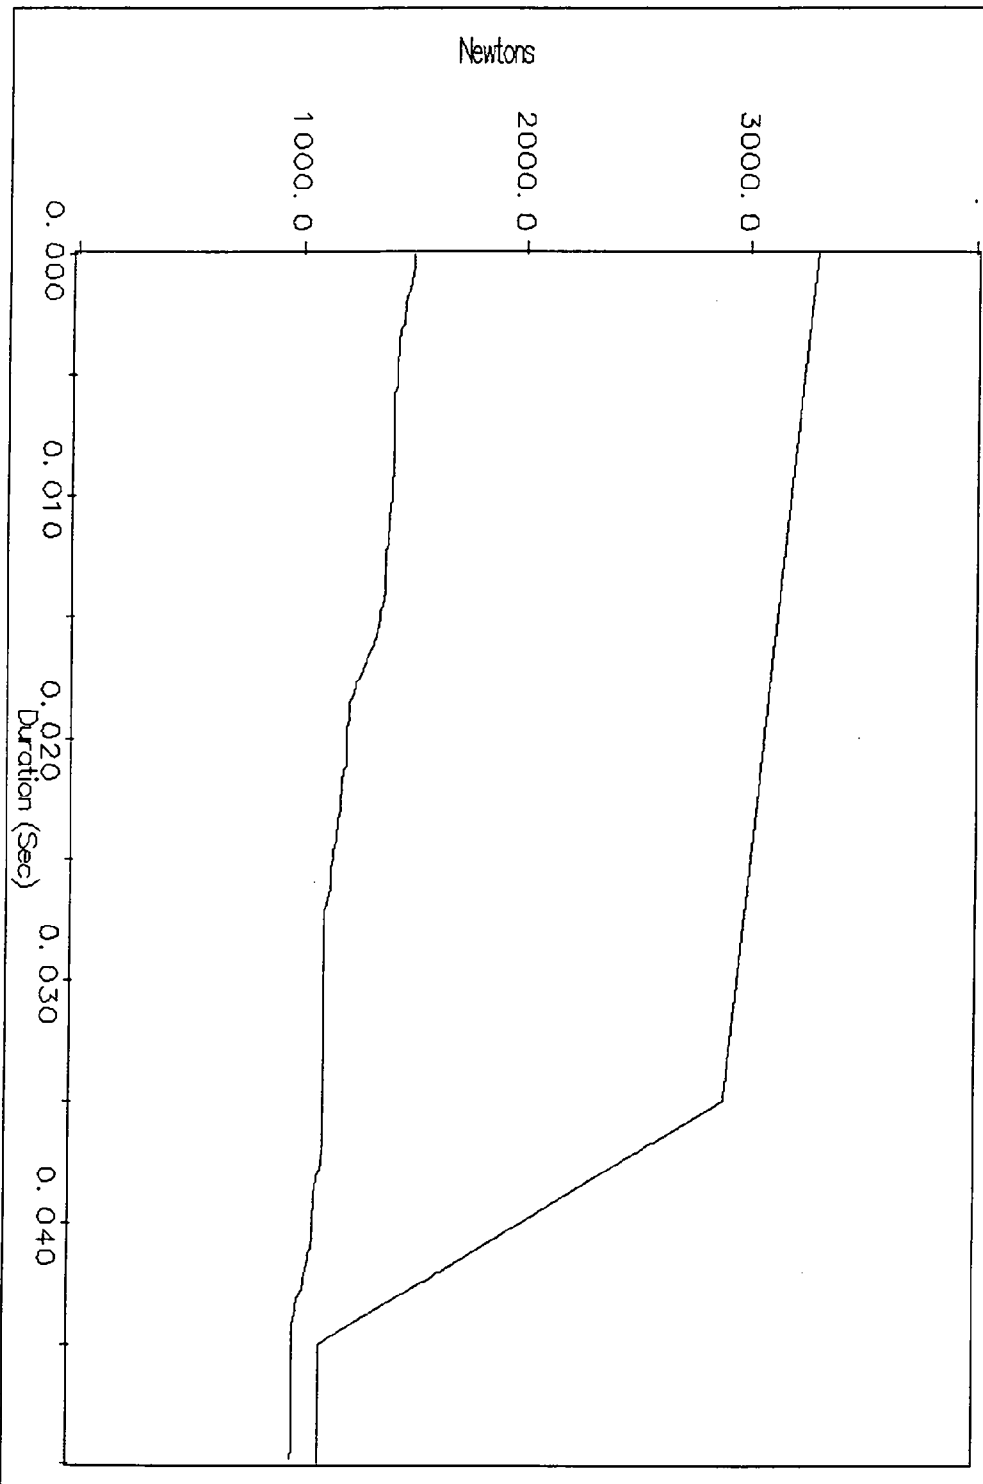
A-12 95030 Ford Explorer XLT 1996 Neck Tension Analysis
