**NHTSA  
VEHICLE DATABASE  
REPORT  
TEST# 2644**

**Test Title:** IIHS OFFSET CRASHWORTHINESS EVALUATION

**Test Performer:** INSURANCE INSTITUTE FO **Test Reference Number:** CF95030

**Test Objectives:** IIHS 40% OVERLAP - 1996 FORD EXPLORER

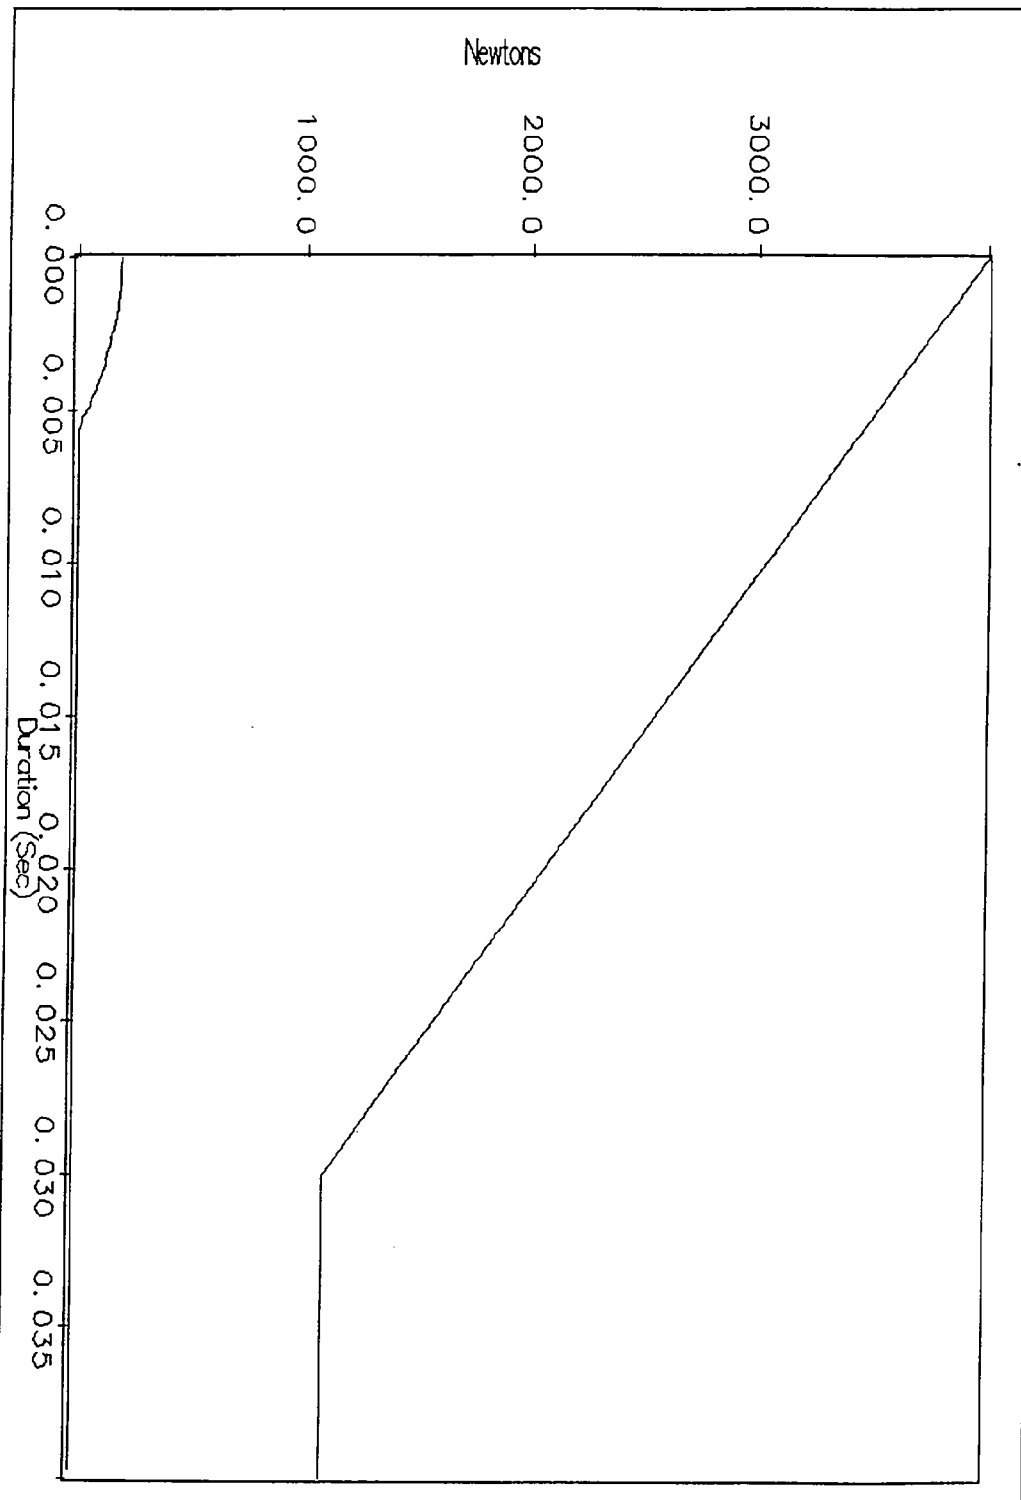
A-13 95030 Ford Explorer XLT 1996 Neck Compression Analysis

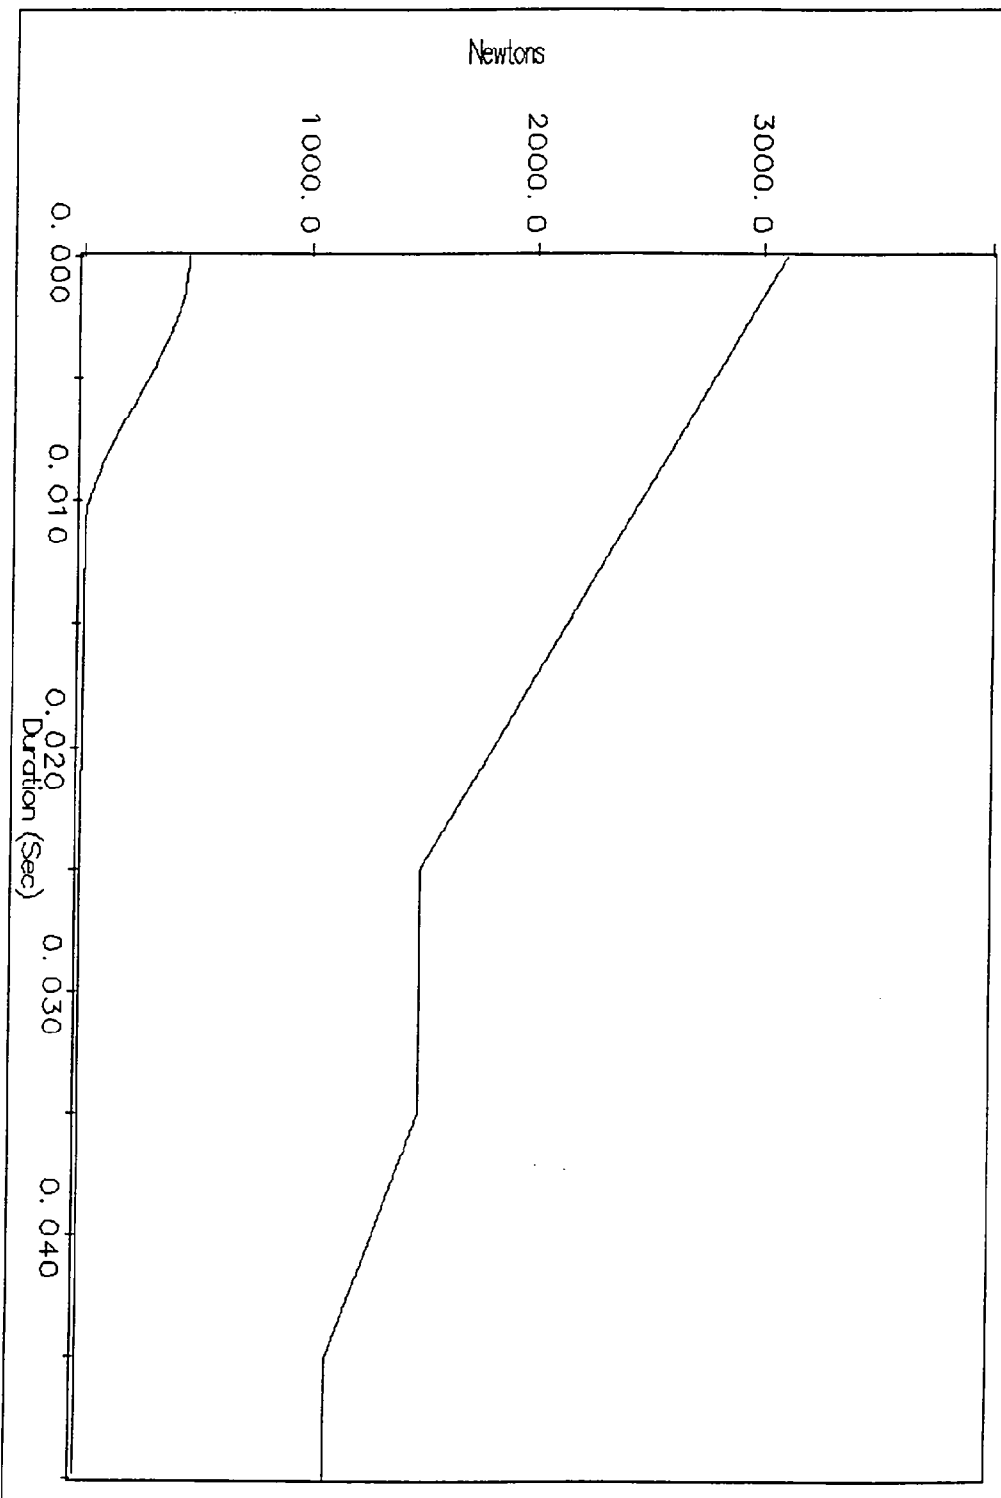
A-14 95030 Ford Explorer XLT 1996 Neck Shear (Pos.) Analysis

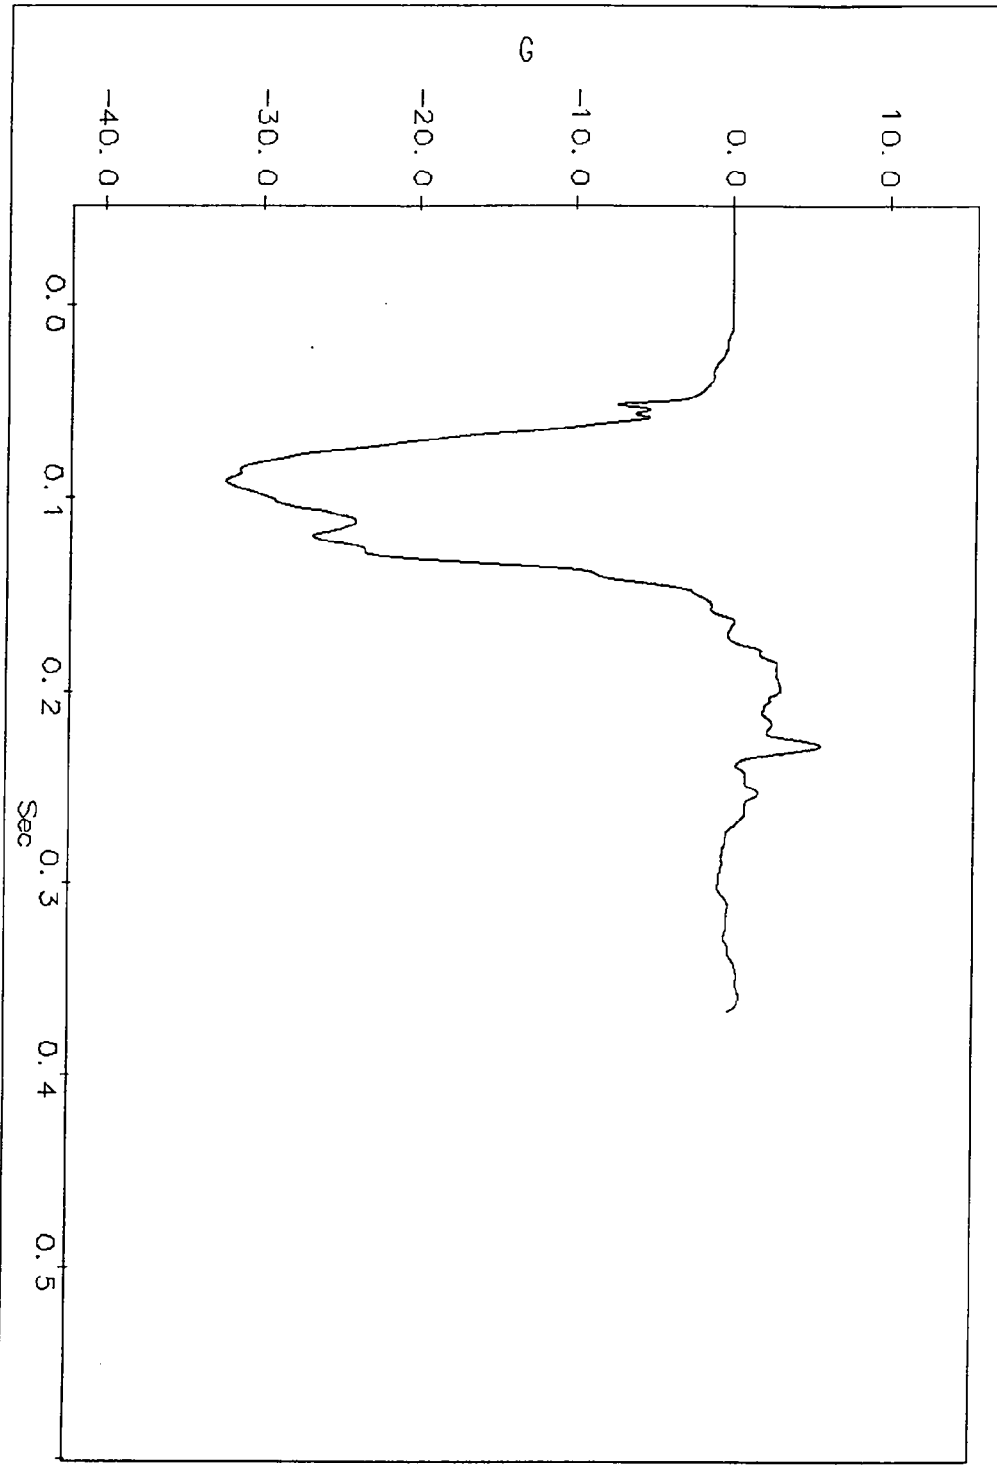
A-17 95030 Ford Explorer XLT 1996 Chest A-P Accel.

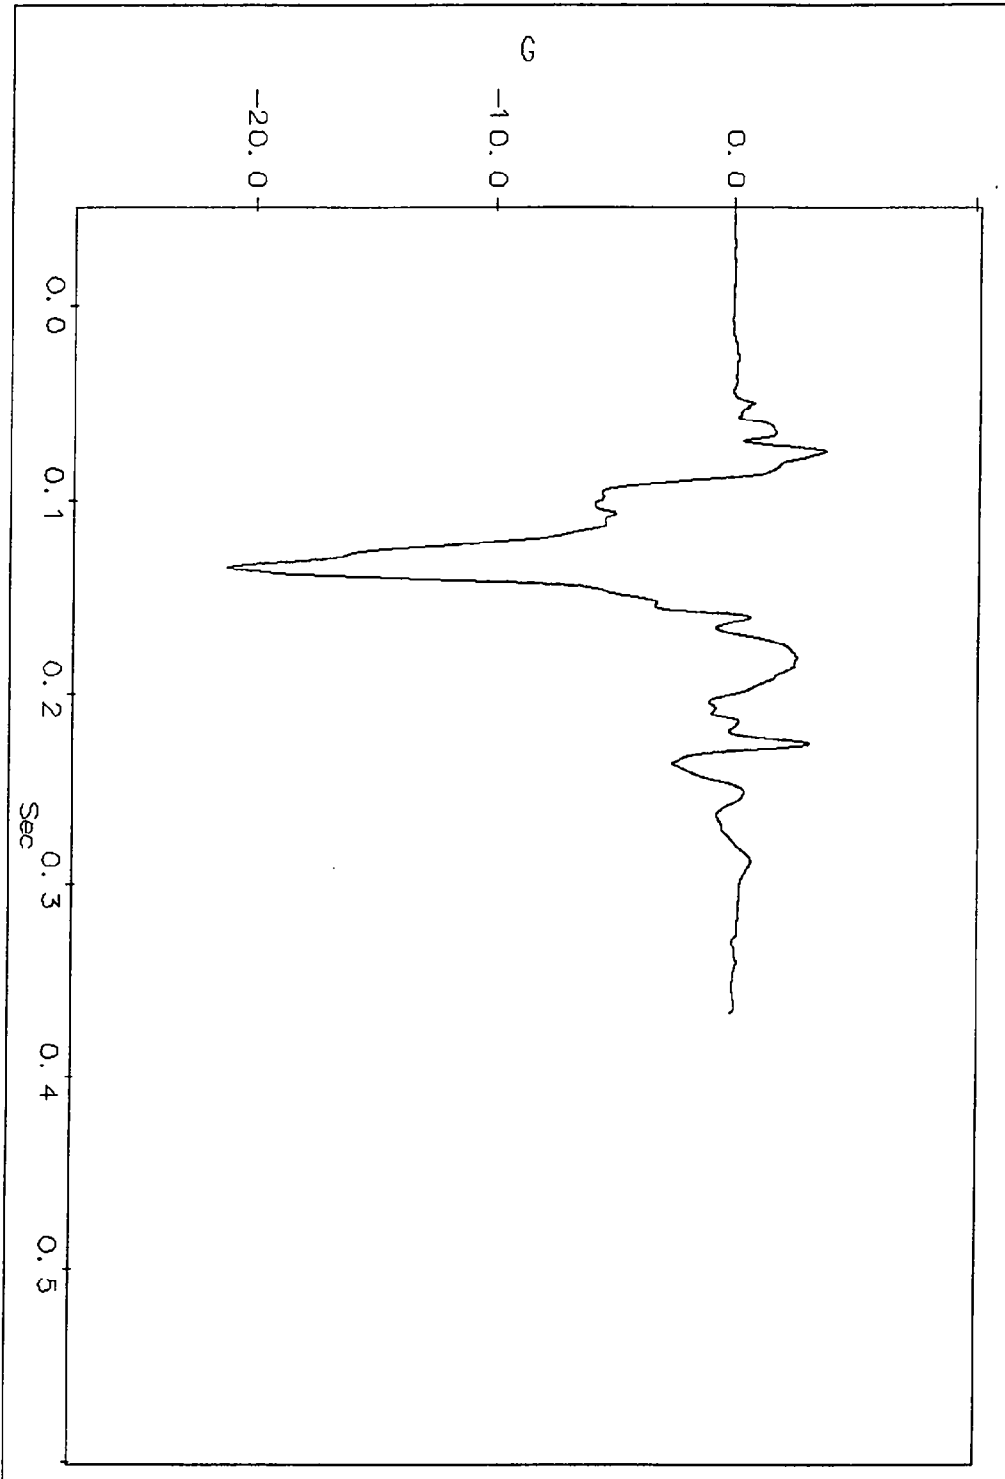
A-18 95030 Ford Explorer XLT 1996 Chest Lateral Accel.

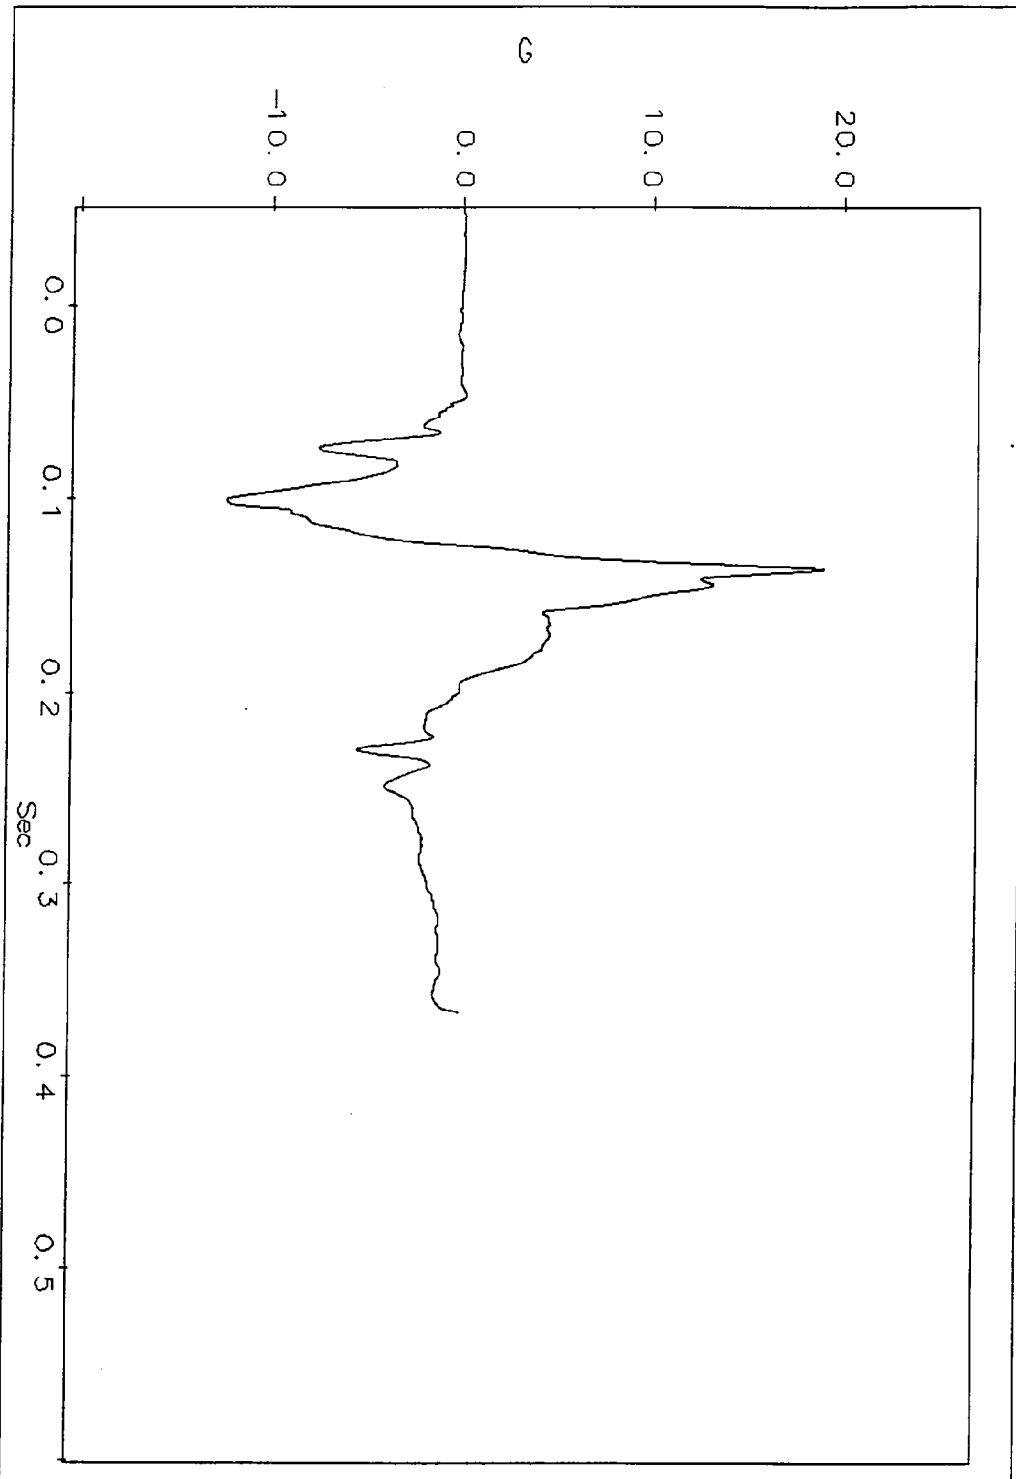
R-19 95030 Ford Explorer XLT 1996 Chest I-5 Accel.

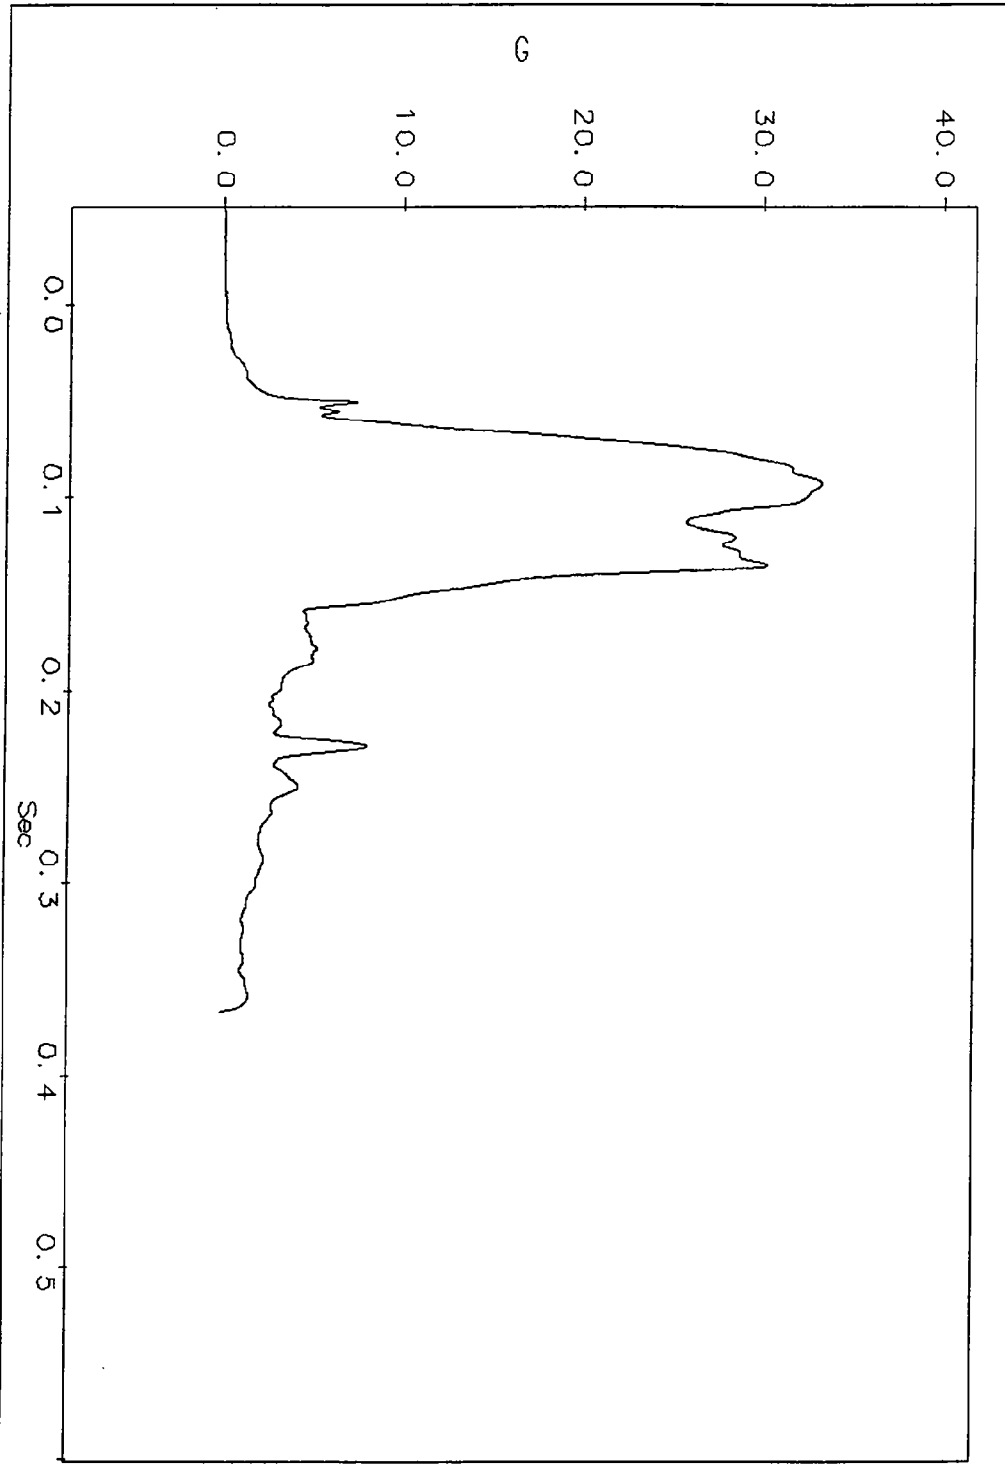
A-20 950330 Ford Explorer XLT 1996 Chest Vector Accel.

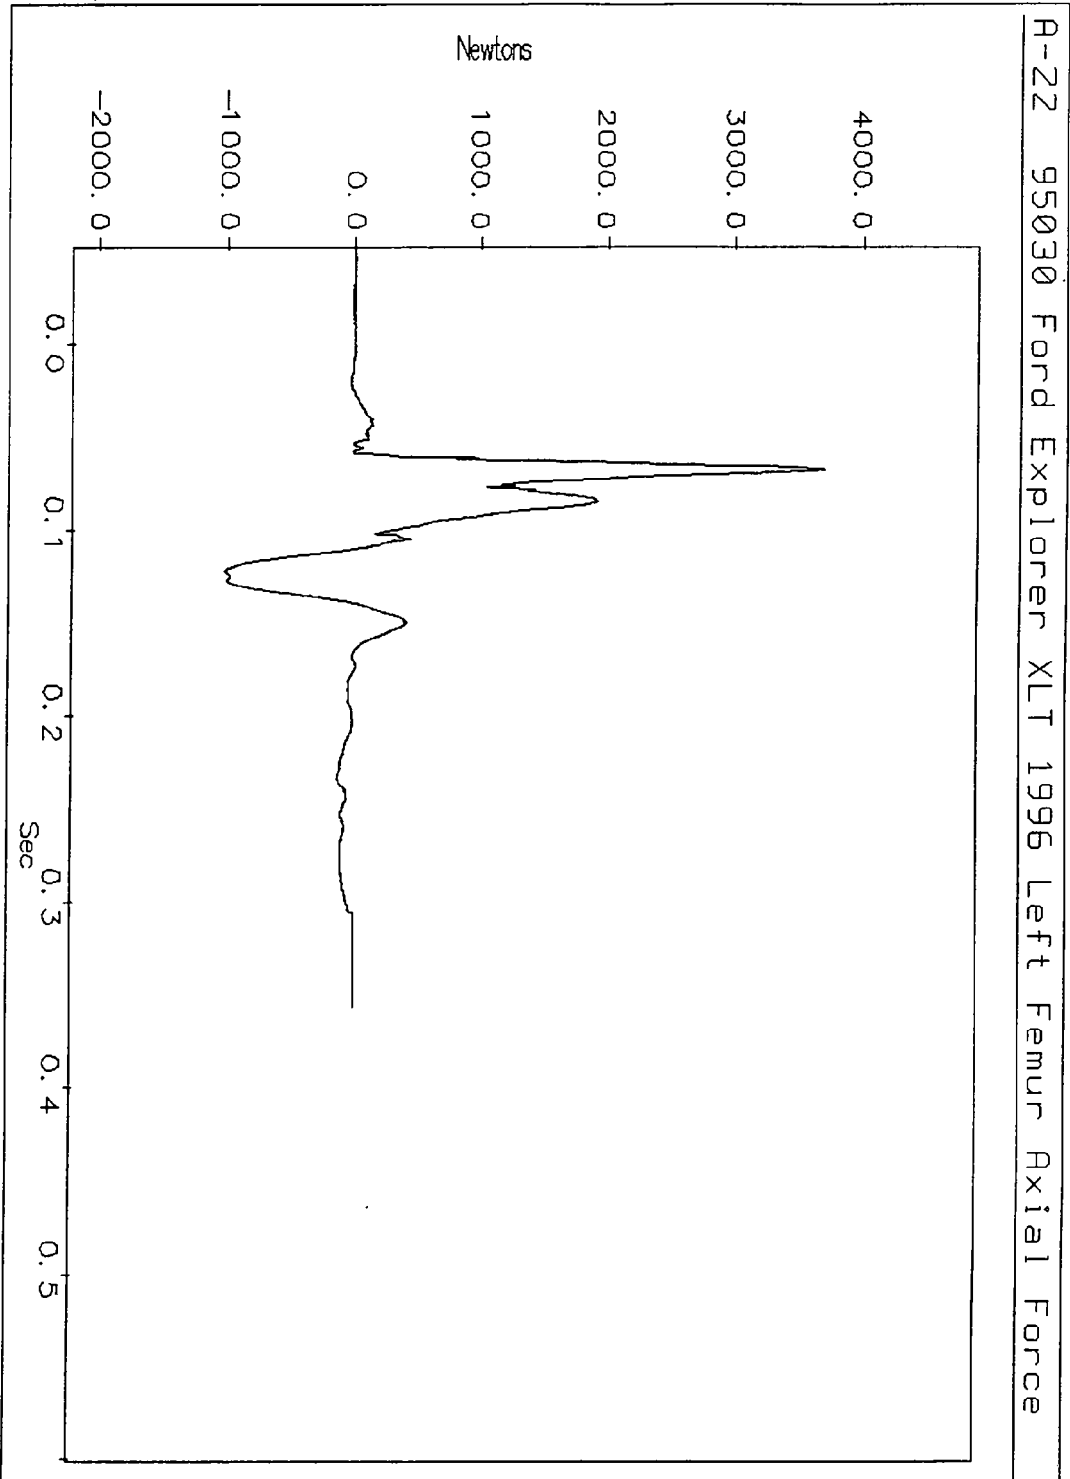
A-22 95030 Ford Explorer XLT 1996 Left Femur Axial Force

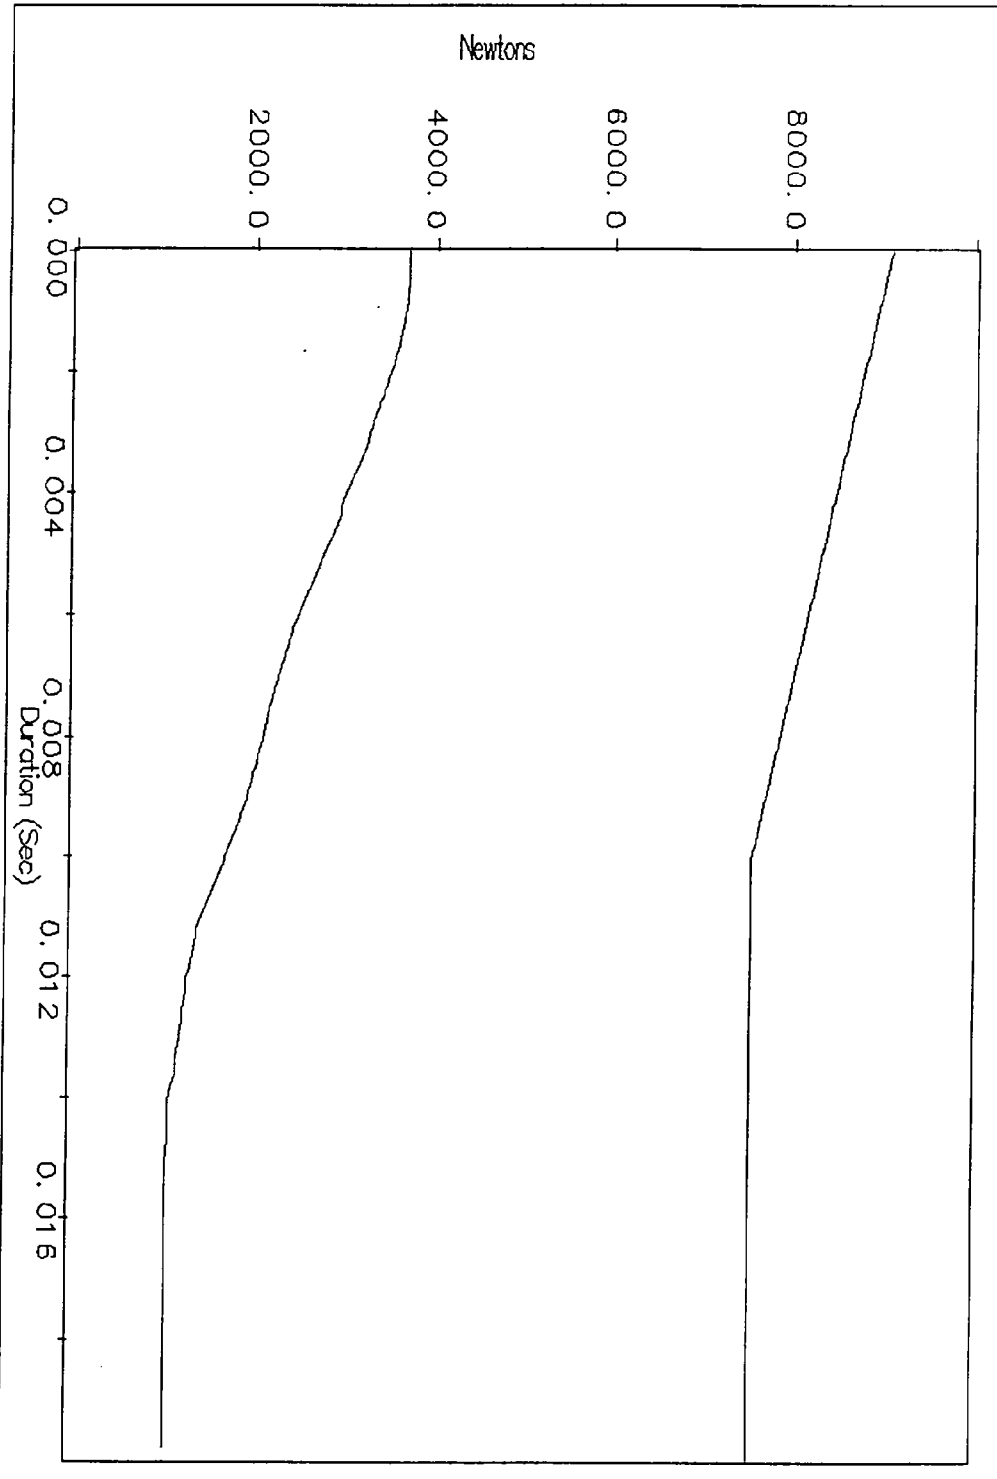
H-23 95030 Ford Explorer XLT 1996 Left Femur Analysis

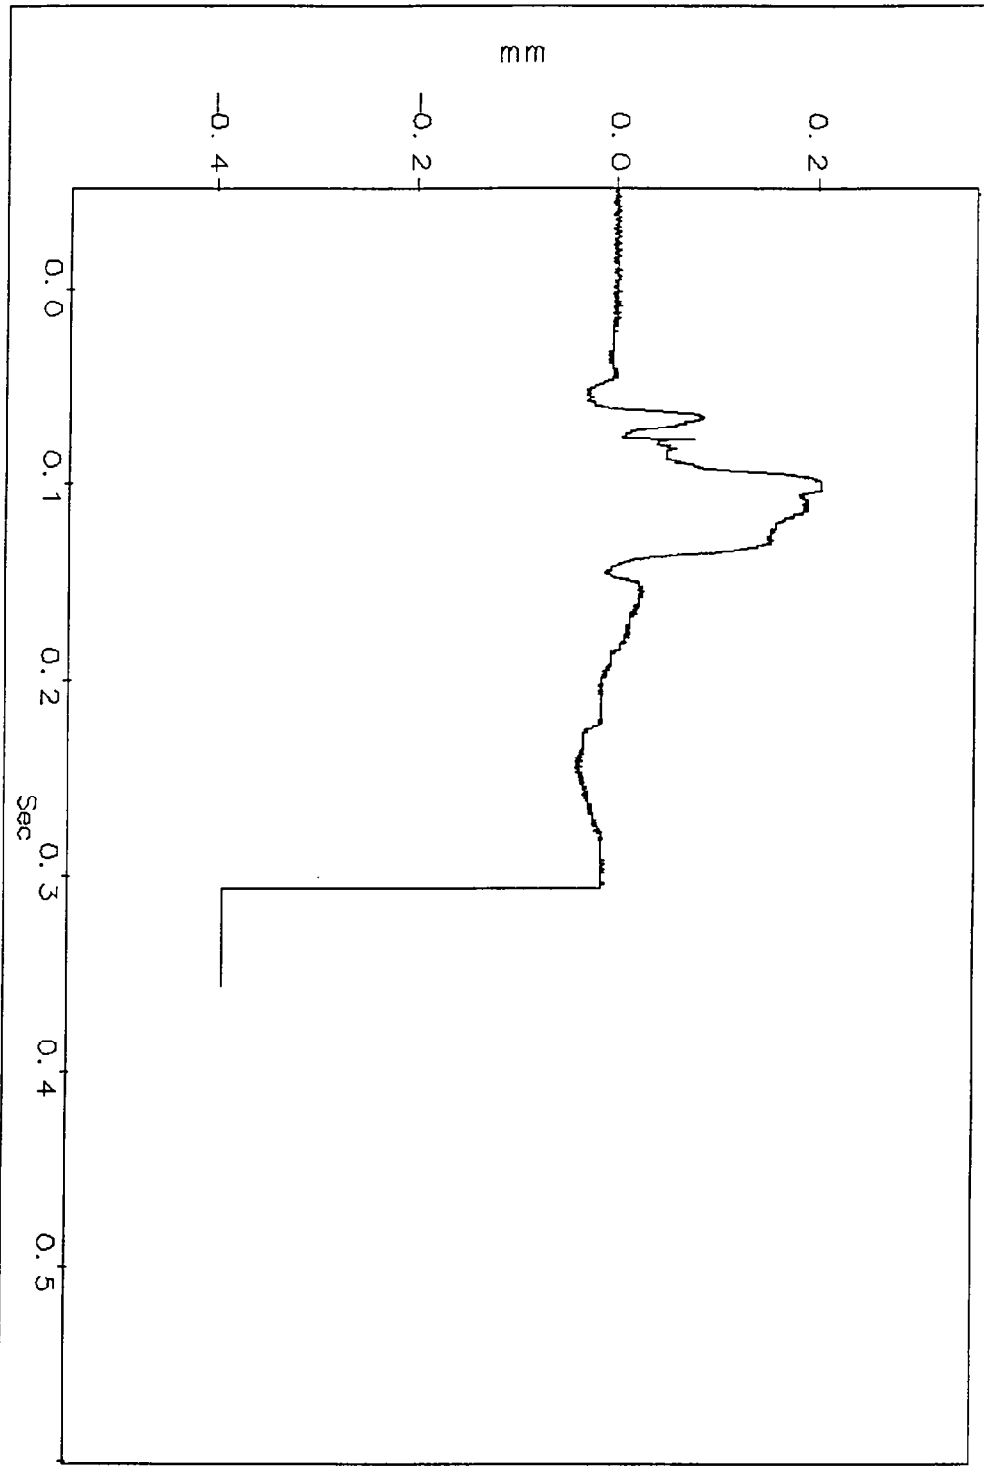
A-24 95030 Ford Explorer XLT 1996 Left Tibia-Femur Disp.

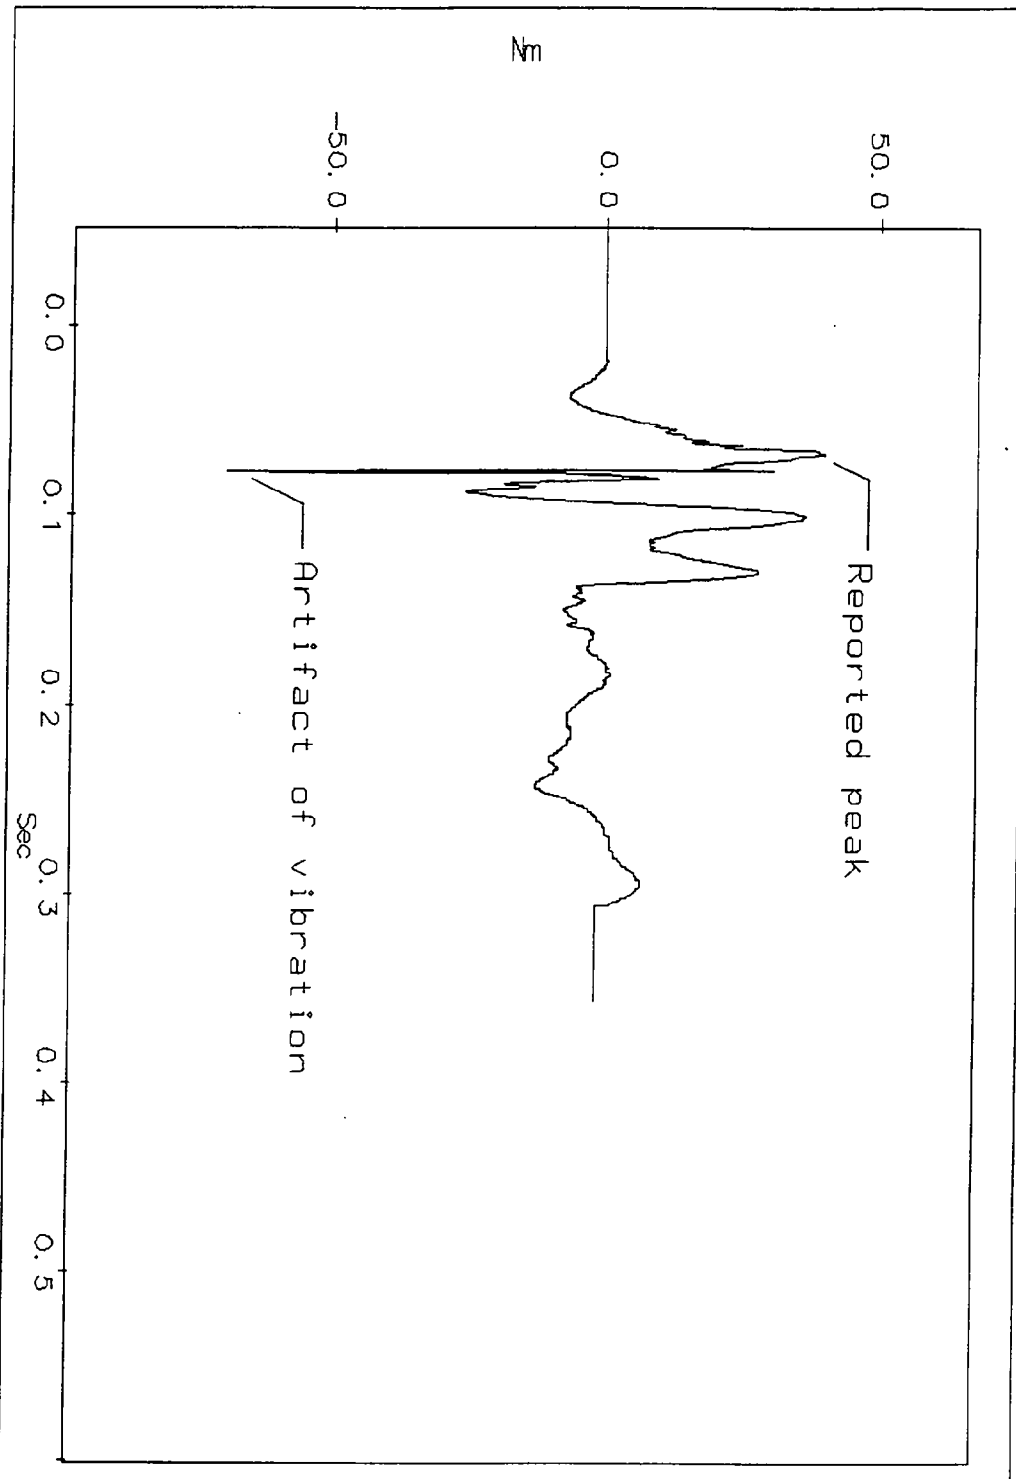
A-25 95030 Ford Explorer XLT 1996 L Upper Tibia L-M Moment

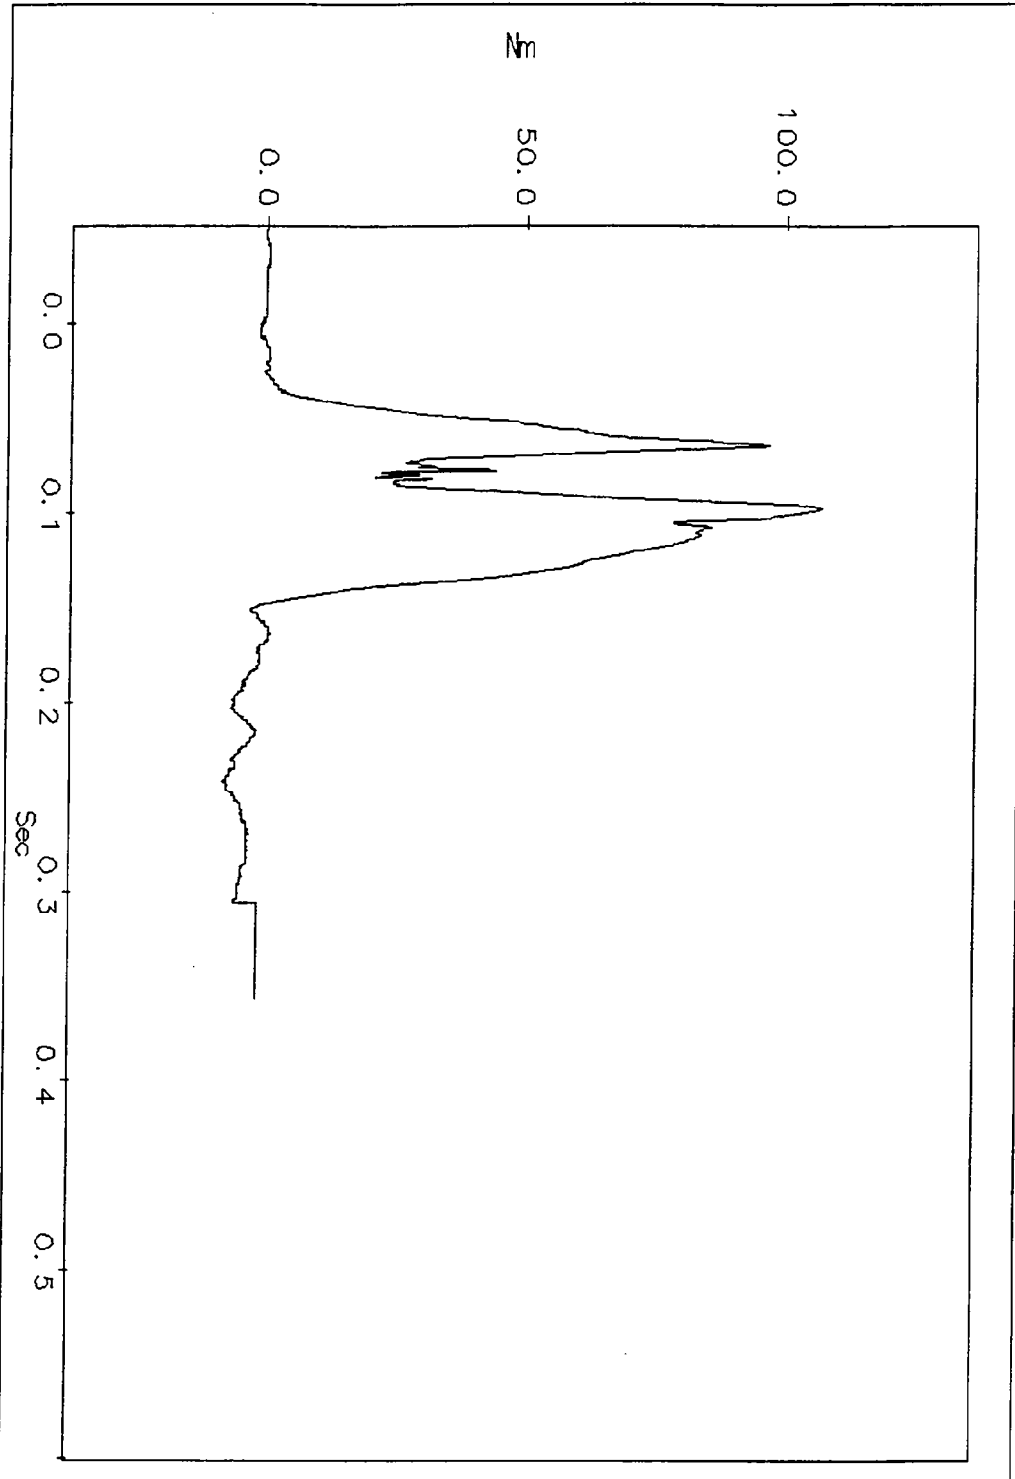
A-26 95030 Ford Explorer XLT 1996 L Upper Tibia A-P Moment

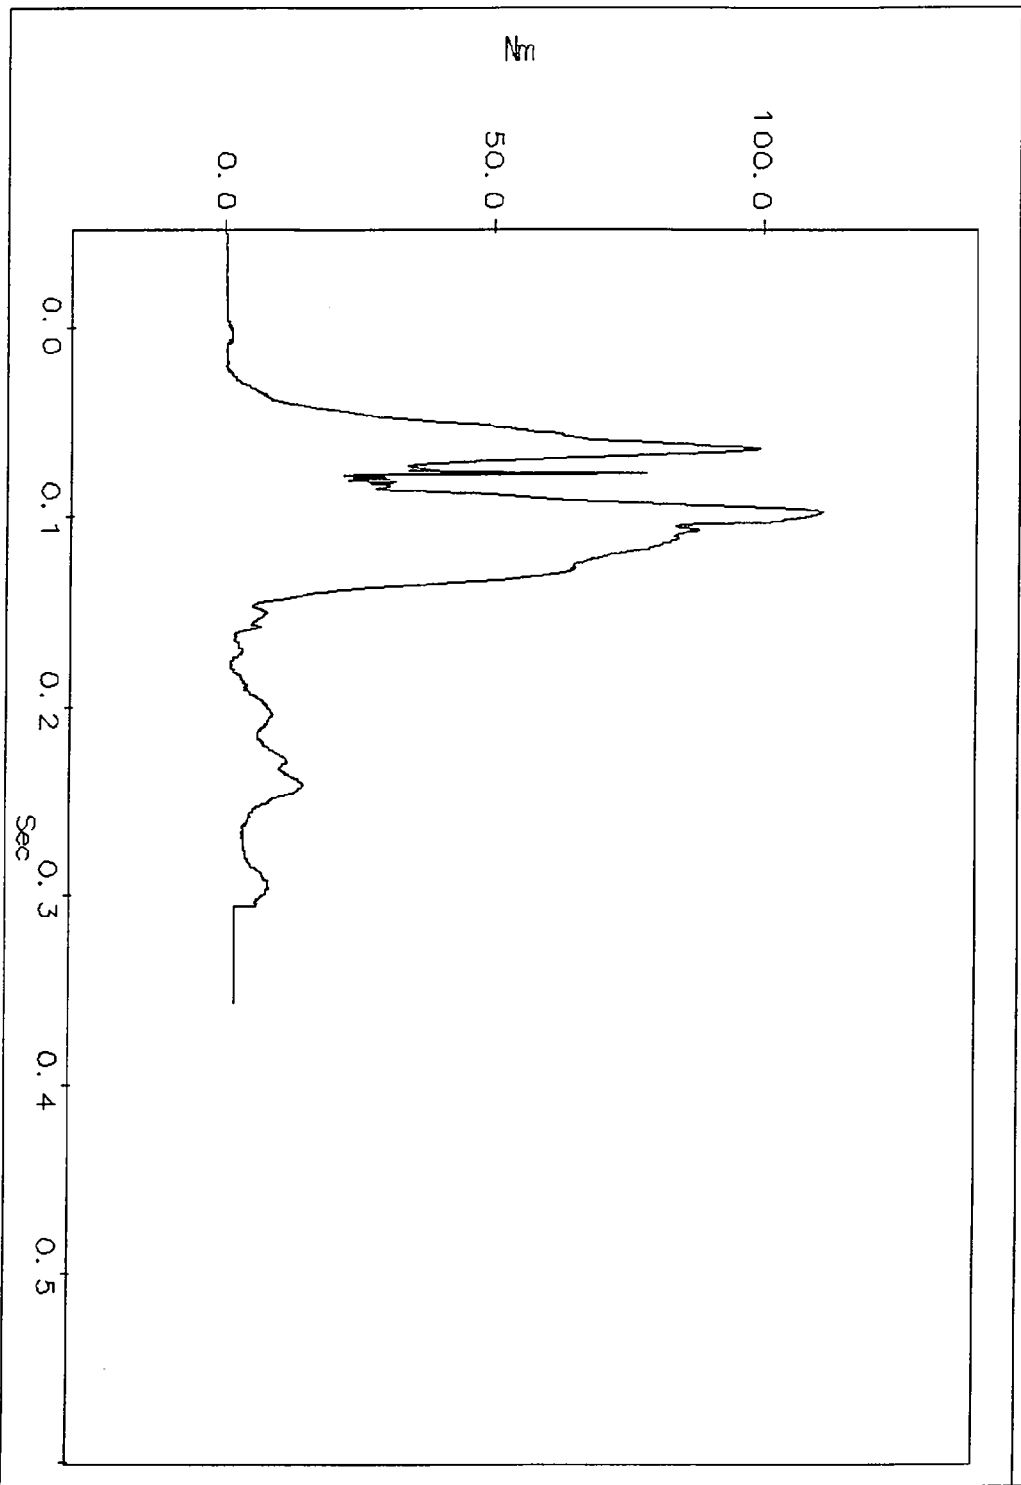
R-27 95030 Ford Explorer XLT 1996 L Upper Vector Moment

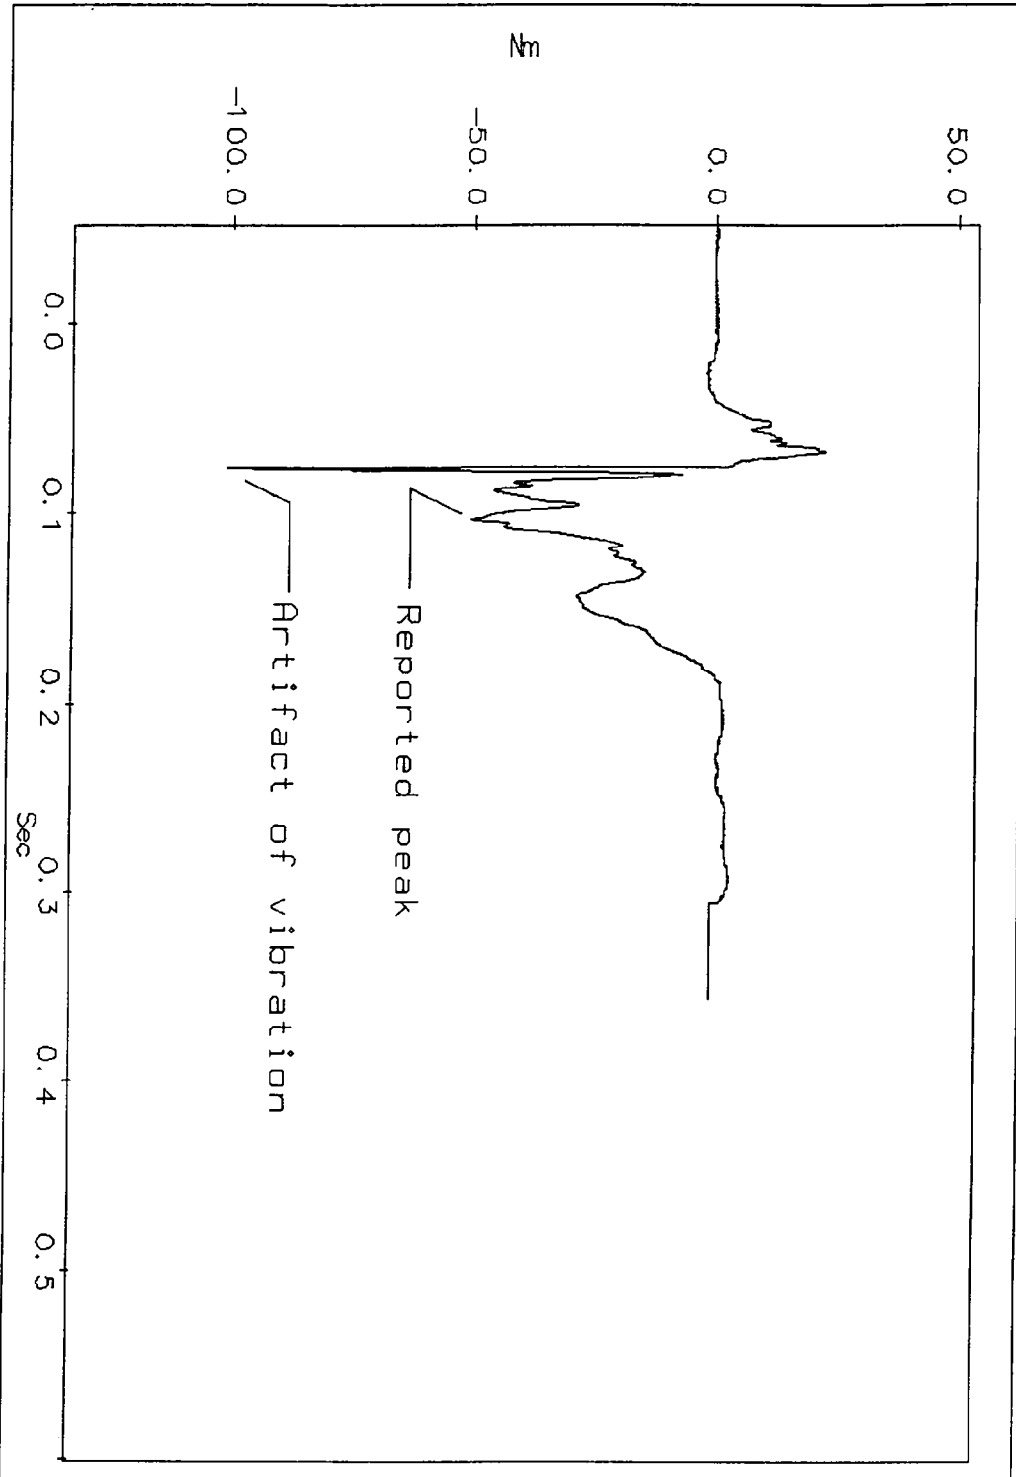
A-28 95030 Ford Explorer XLT 1996 L Lower Tibia L-M Moment

\*\* These published thresholds are for fractures of the tibia. Ankle and foot injuries could be produced by bending moments as low as 50-100 Nm, and heel fractures have been associated with axial forces as low as 6.0 kN.

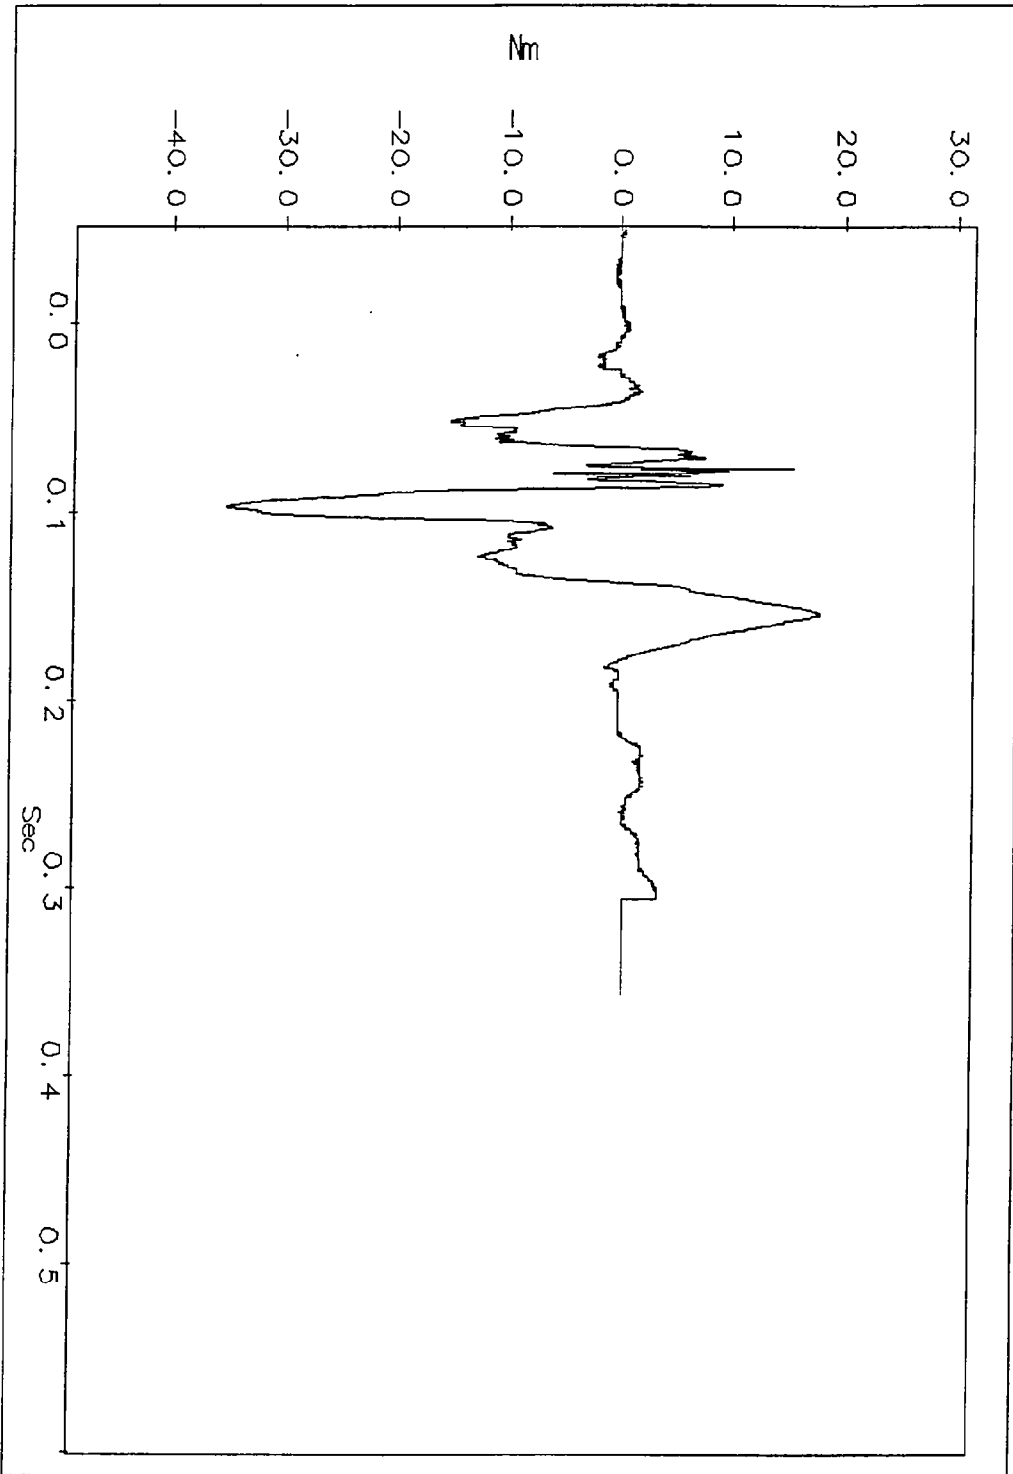
R-29 95030 Ford Explorer XLT 1996 L Lower Tibia A-P Moment

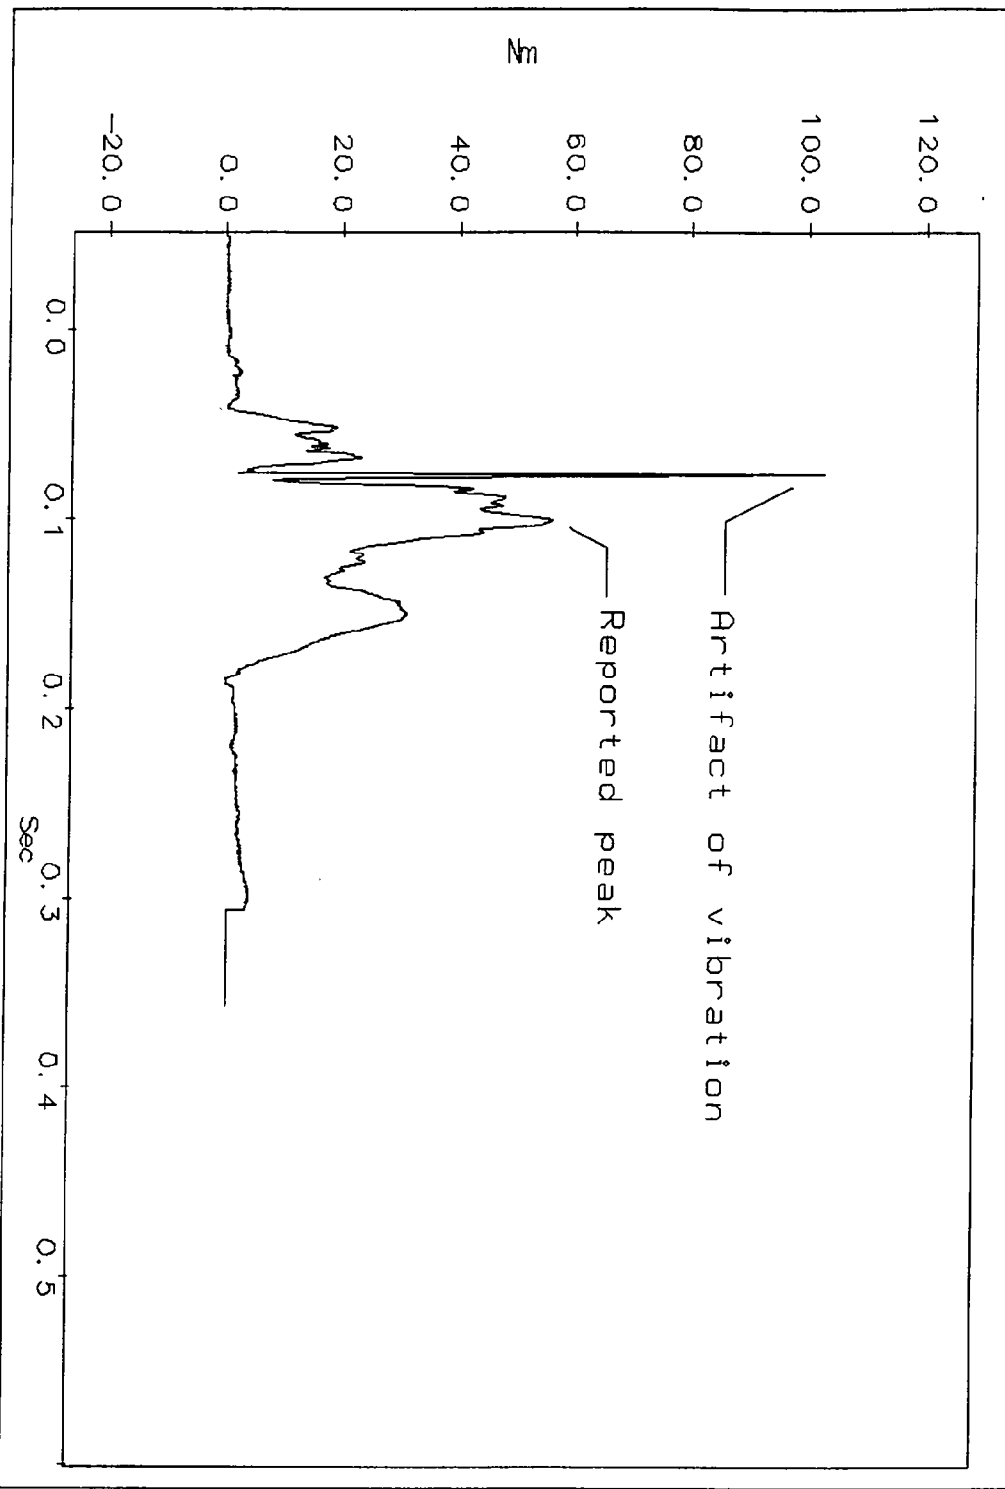
A-30 95030 Ford Explorer XLT 1996 L Lower Vector Moment

*Left Leg and Foot.* The recorded foot accelerations showed a period of relatively high frequency vibrations (75-83 ms) that were observed in other data channels on the same leg. These vibrations, which are characteristic of metal to metal contact, probably occurred as the ankle shaft reached its rotation limit and may not be indicative of the forces that would have been experienced by a human occupant. Consequently, measurements made during this period of vibration in the foot accelerometers were excluded from the left leg injury results reported in Table 6. The upper and lower tibia L-M moments and the lower tibia vector moment and tibia index were affected by this adjustment.
