**NHTSA  
VEHICLE DATABASE  
REPORT  
TEST# 2644**

**Test Title:** IIHS OFFSET CRASHWORTHINESS EVALUATION

**Test Performer:** INSURANCE INSTITUTE FO **Test Reference Number:** CF95030

**Test Objectives:** IIHS 40% OVERLAP - 1996 FORD EXPLORER

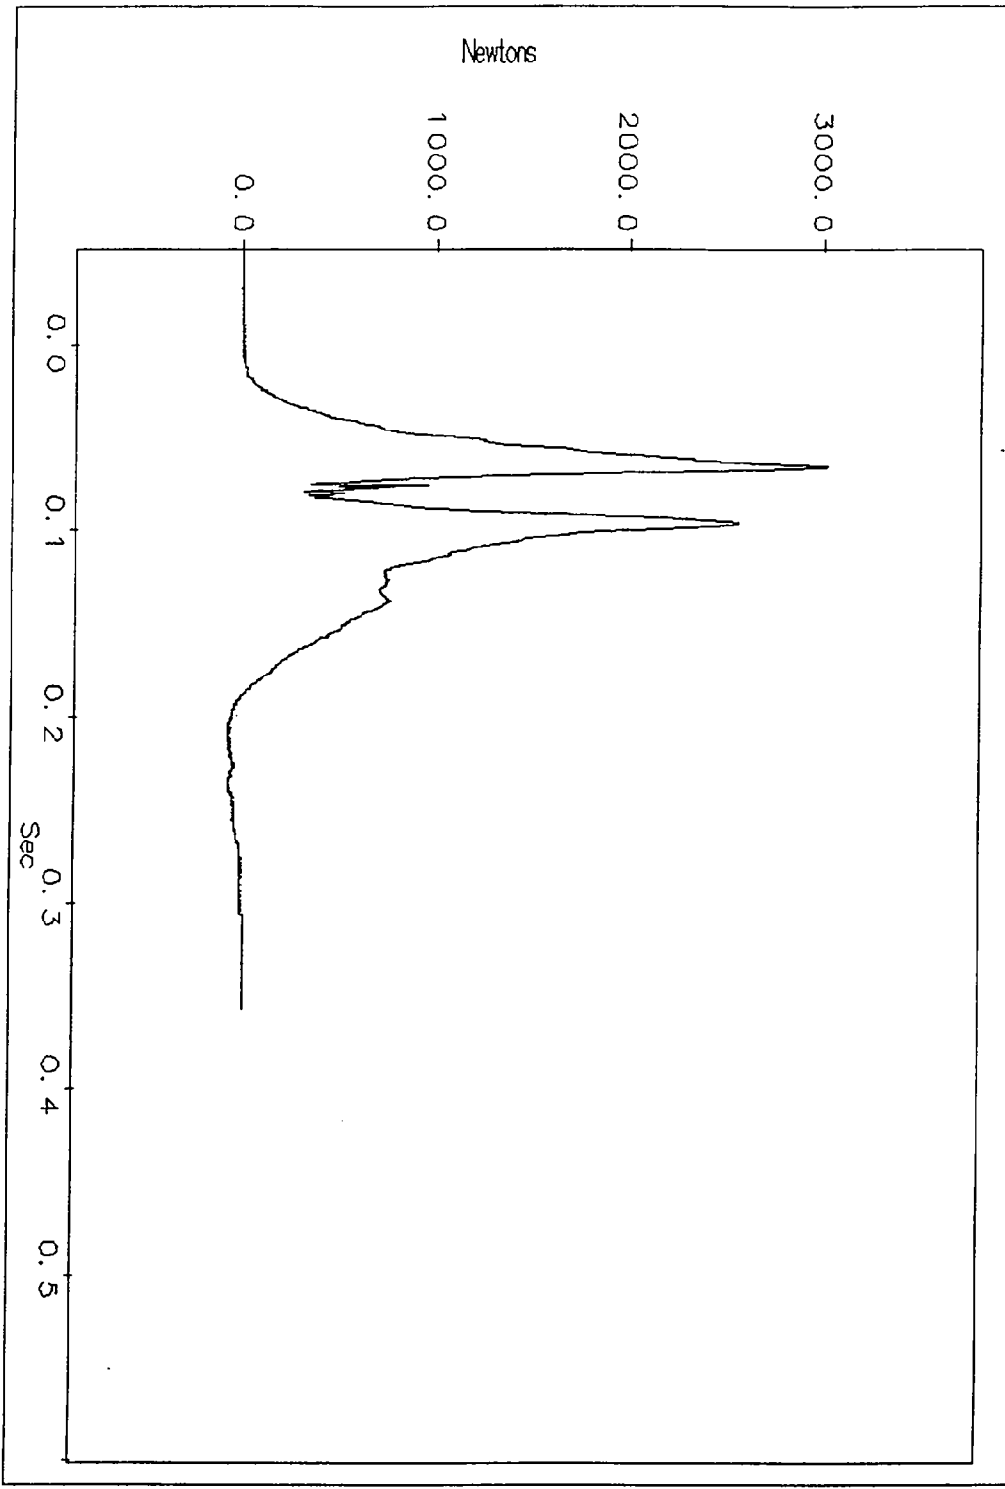
A-31 95030 Ford Explorer XLT 1996 L Lower Tibia Axial Force

\*\* These published thresholds are for fractures of the tibia. Ankle and foot injuries could be produced by bending moments as low as 50-100 Nm, and heel fractures have been associated with axial forces as low as 6.0 kN.

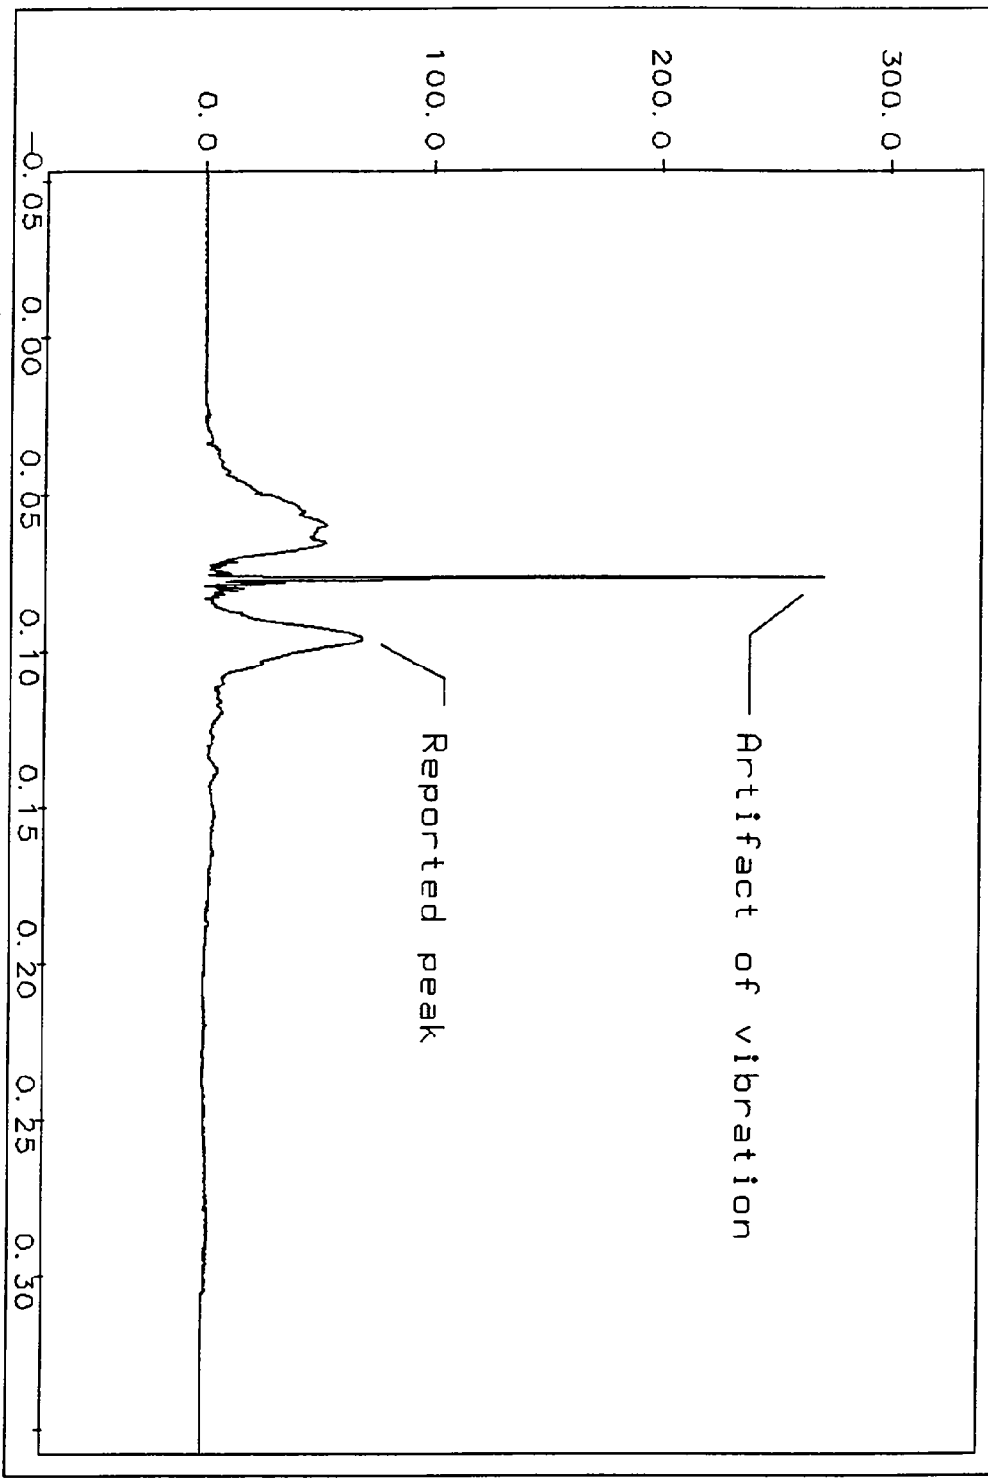
A-32 Ford Explorer XLT 1996 Left Foot Vector Accel.

*Left Leg and Foot.* The recorded foot accelerations showed a period of relatively high frequency vibrations (75-83 ms) that were observed in other data channels on the same leg. These vibrations, which are characteristic of metal to metal contact, probably occurred as the ankle shaft reached its rotation limit and may not be indicative of the forces that would have been experienced by a human occupant. Consequently, measurements made during this period of vibration in the foot accelerometers were excluded from the left leg injury results reported in Table 6. The upper and lower tibia L-M moments and the lower tibia vector moment and tibia index were affected by this adjustment.

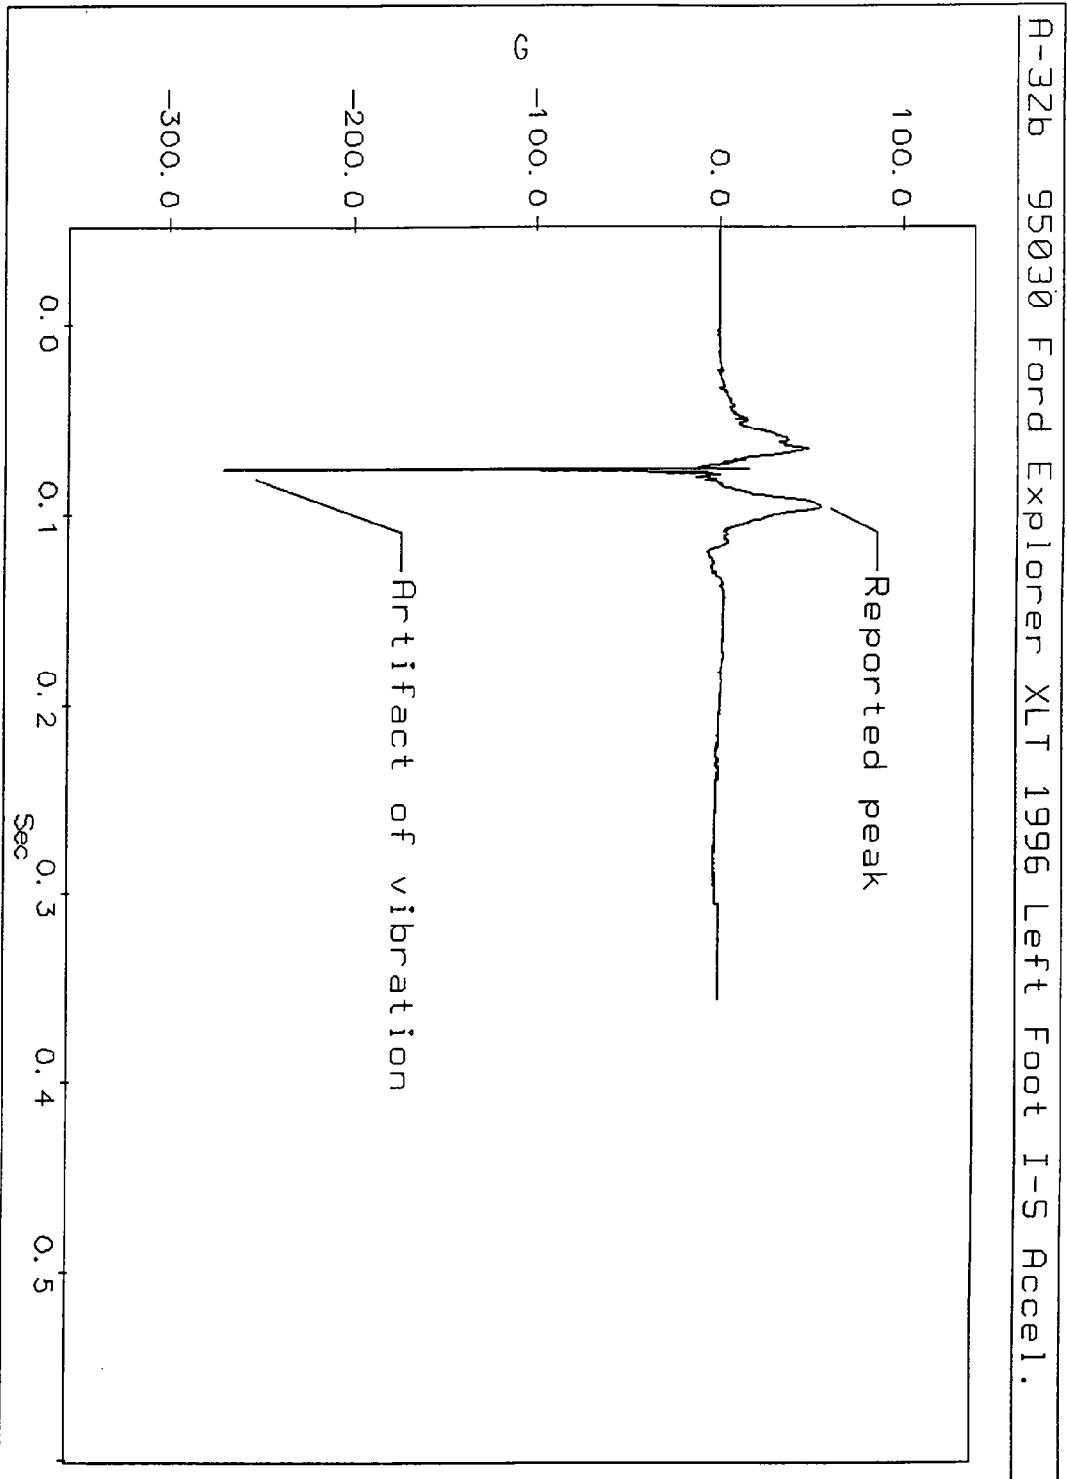
R-32b 95030 Ford Explorer XLT 1996 Left Foot I-S Accel.

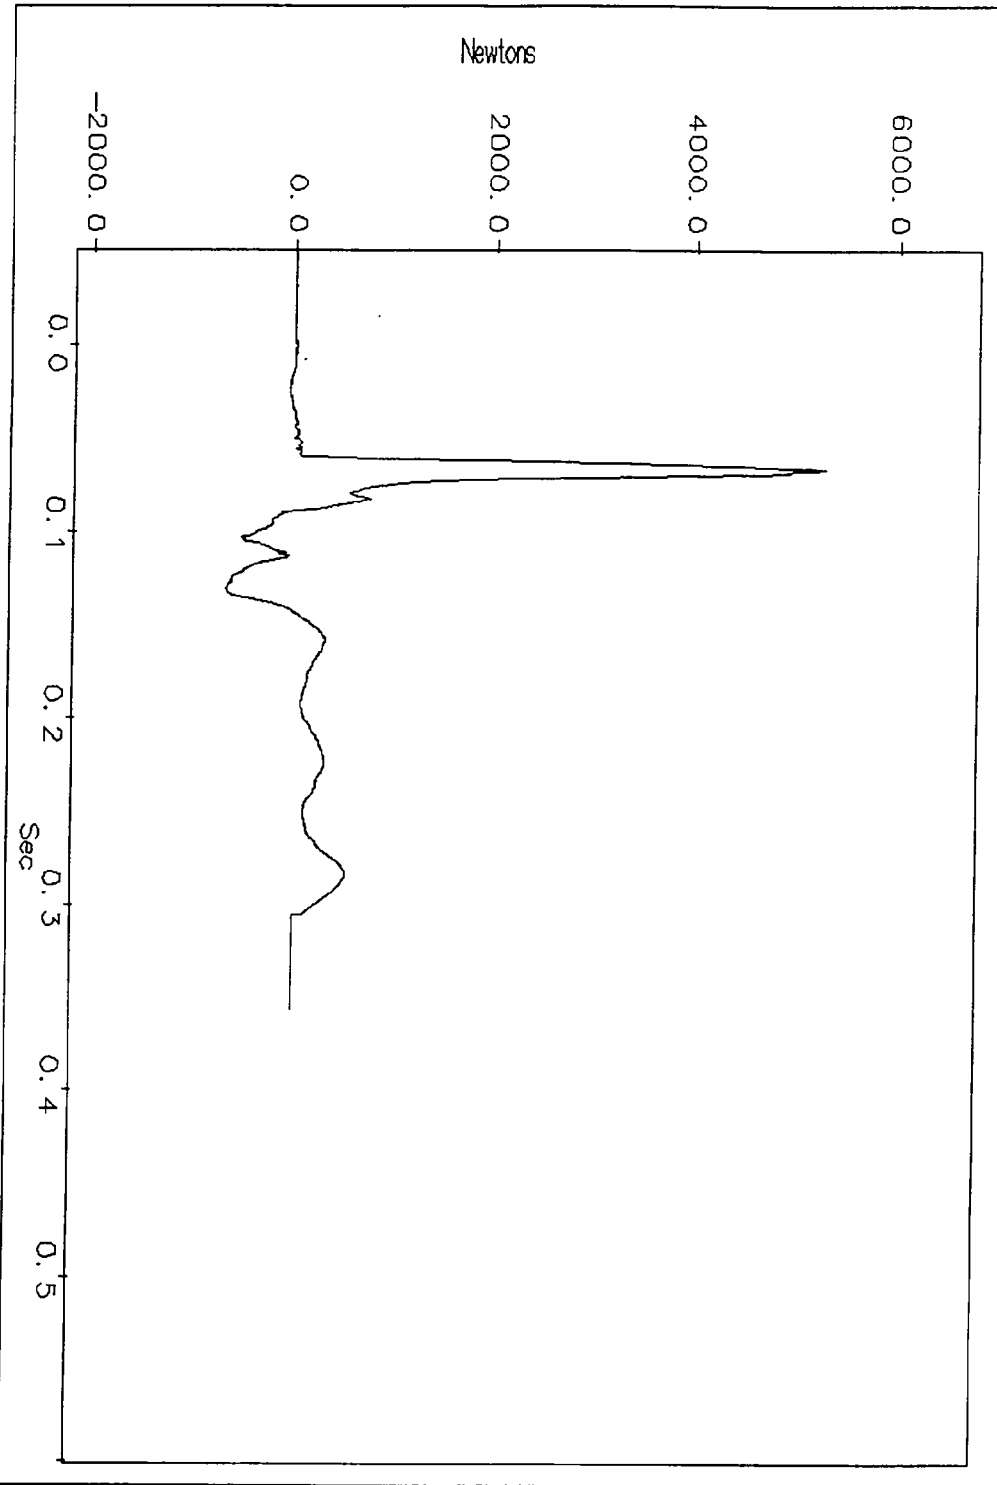
A-33 95030 Ford Explorer XLT 1996 Right Femur Axial Force

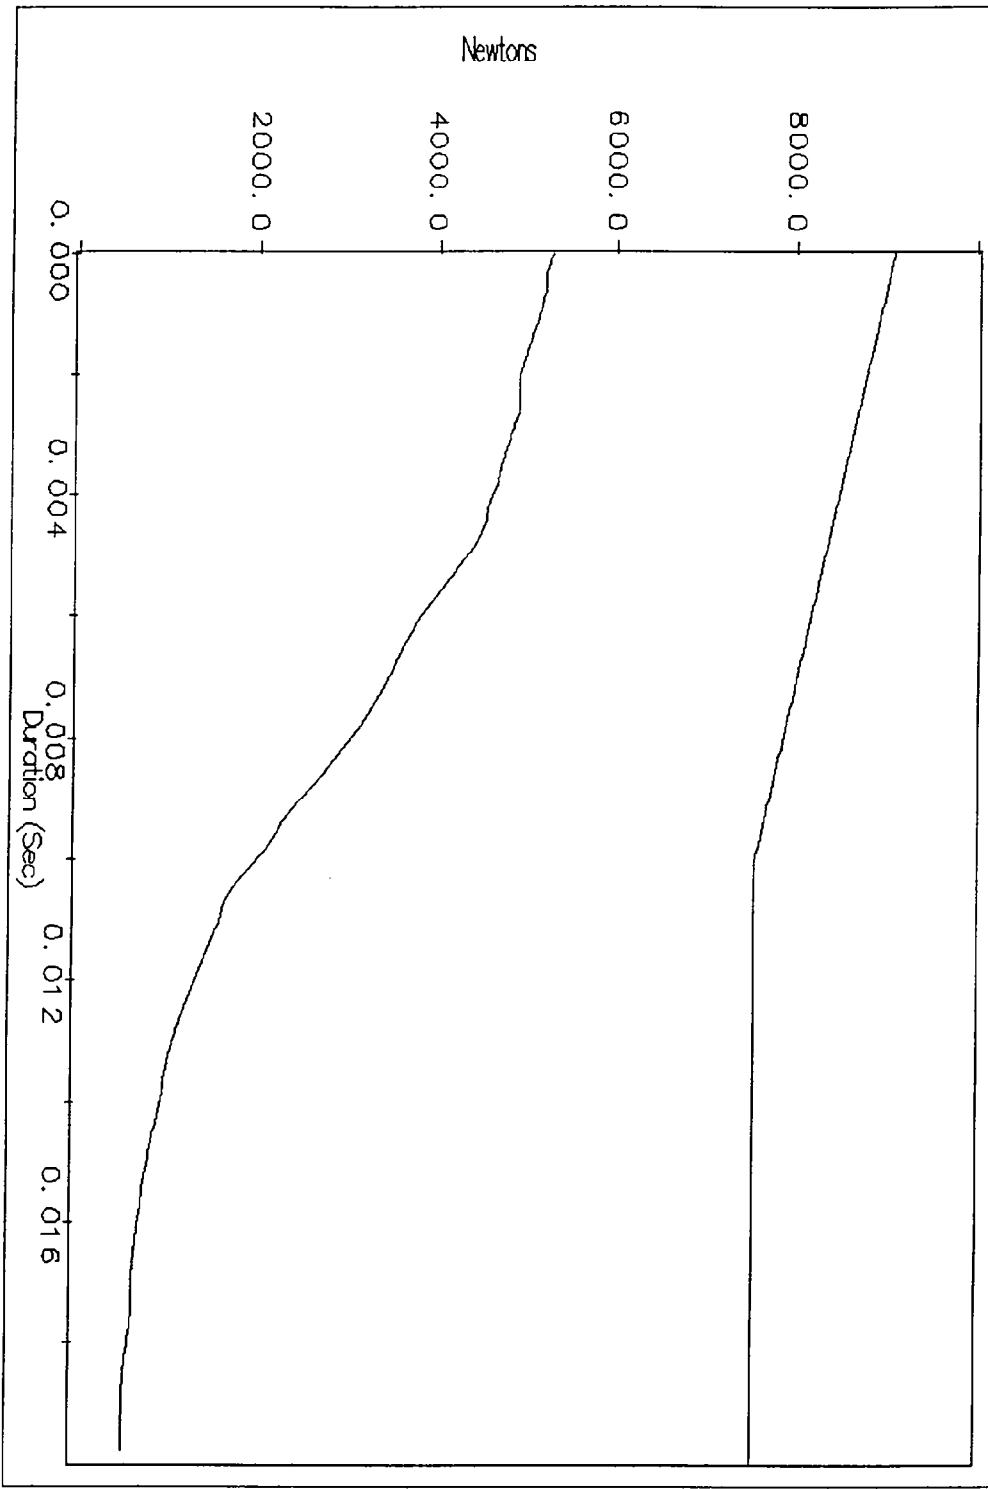
A-34 95030 Ford Explorer XLT 1996 Right Femur Analysis

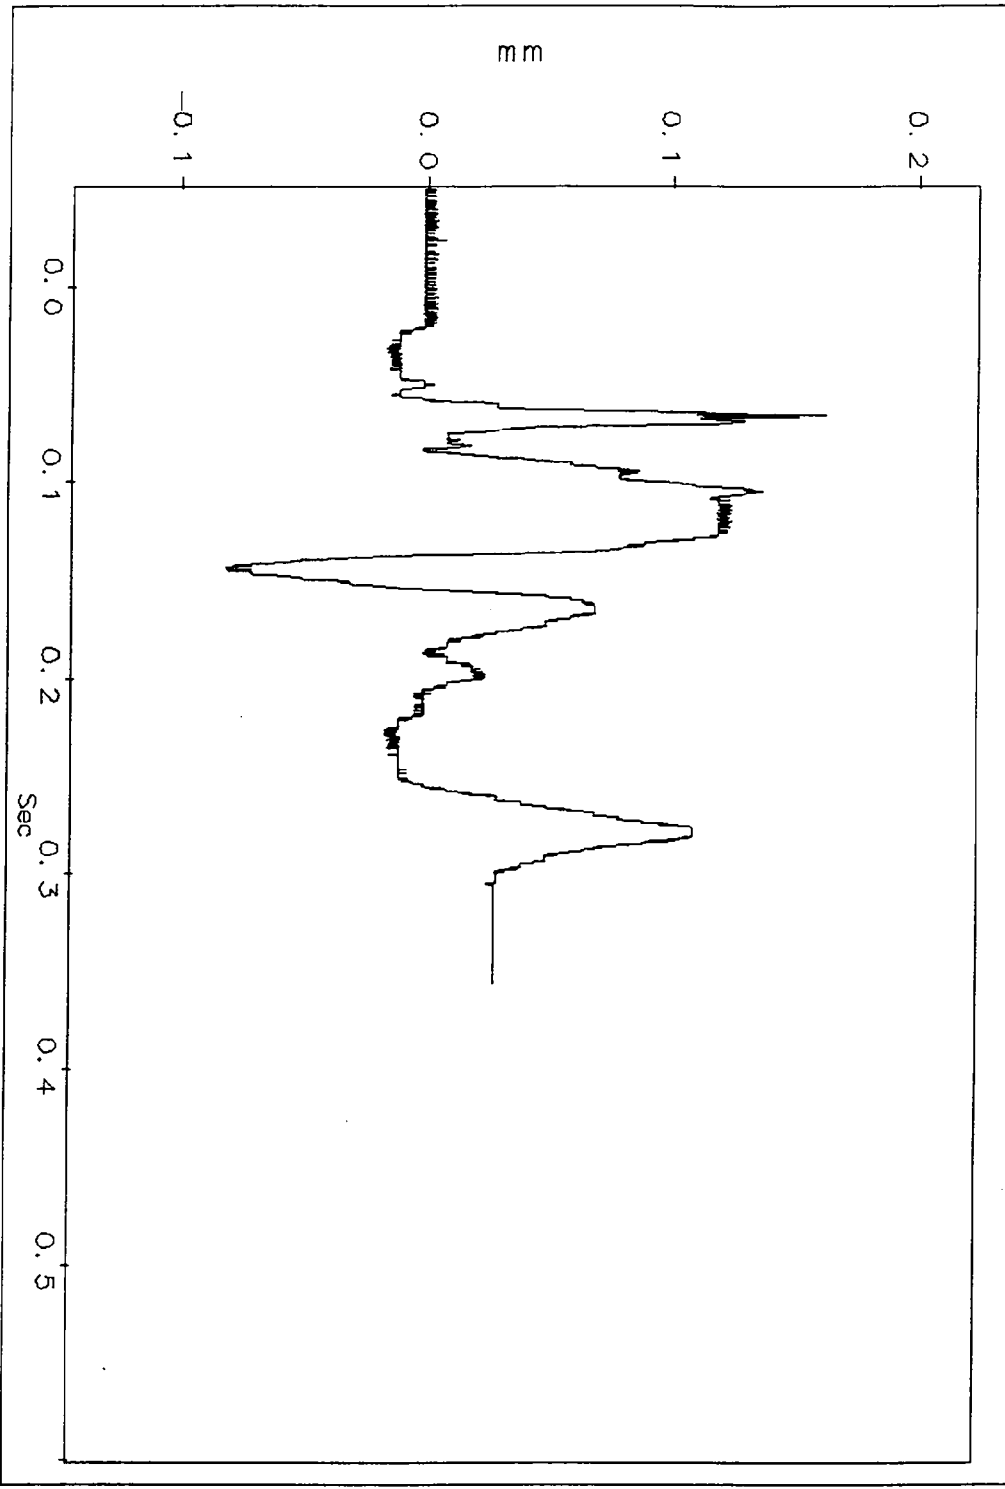
A-35 95030 Ford Explorer XLT 1996 Right Tibia-Femur Disp.

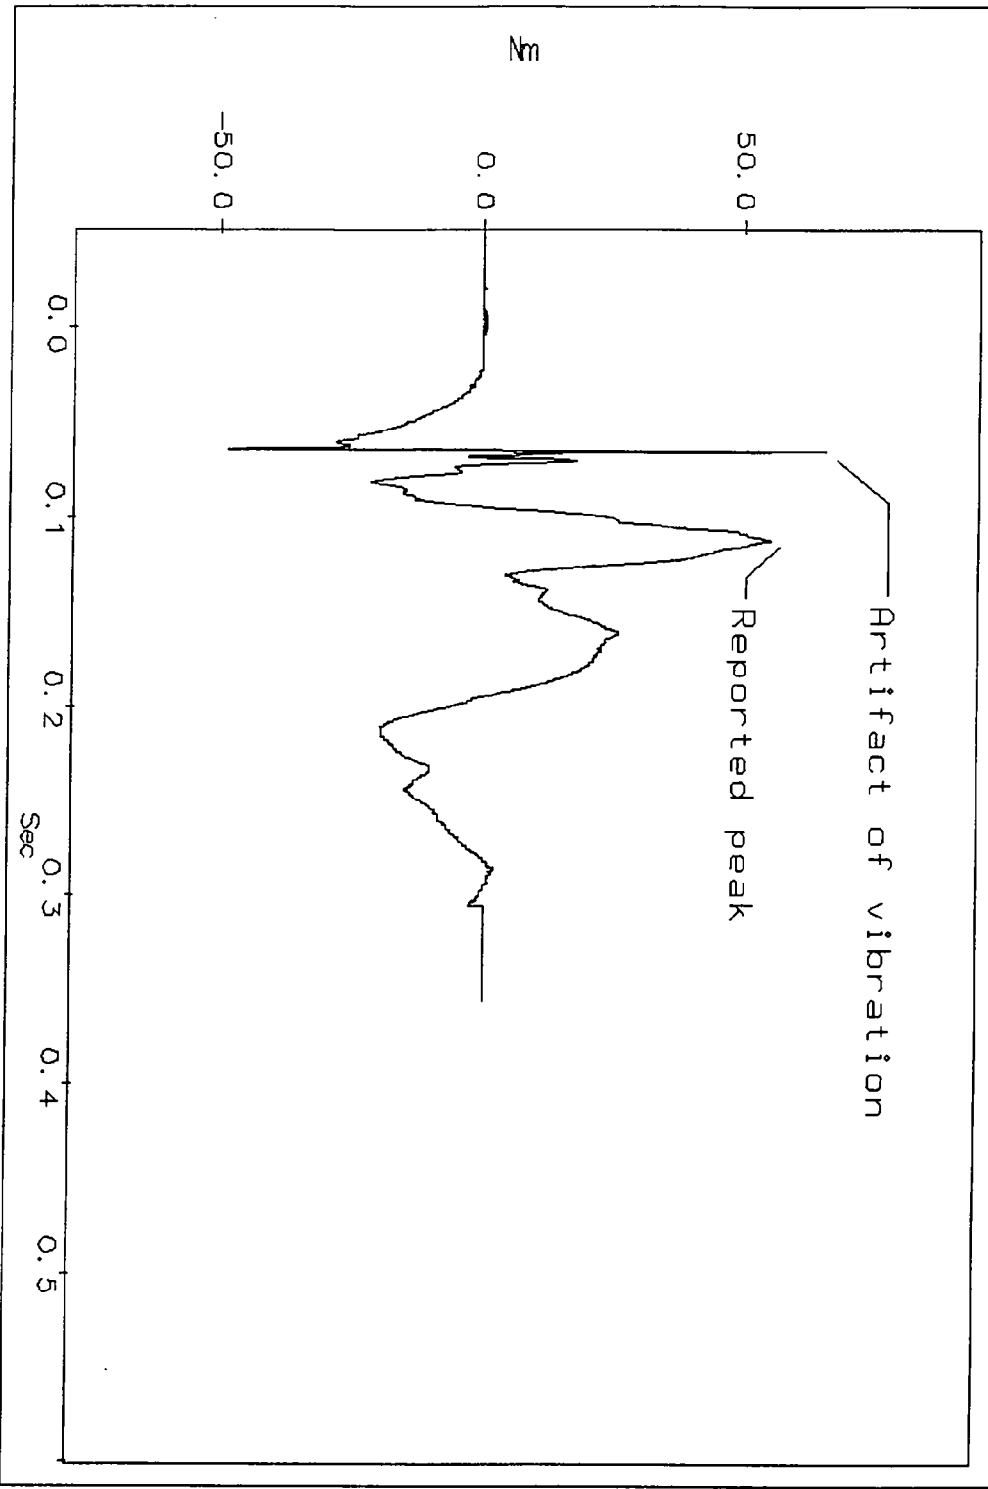
A-36 95030 Ford Explorer XLT 1996 R Upper Tibia L-M Moment

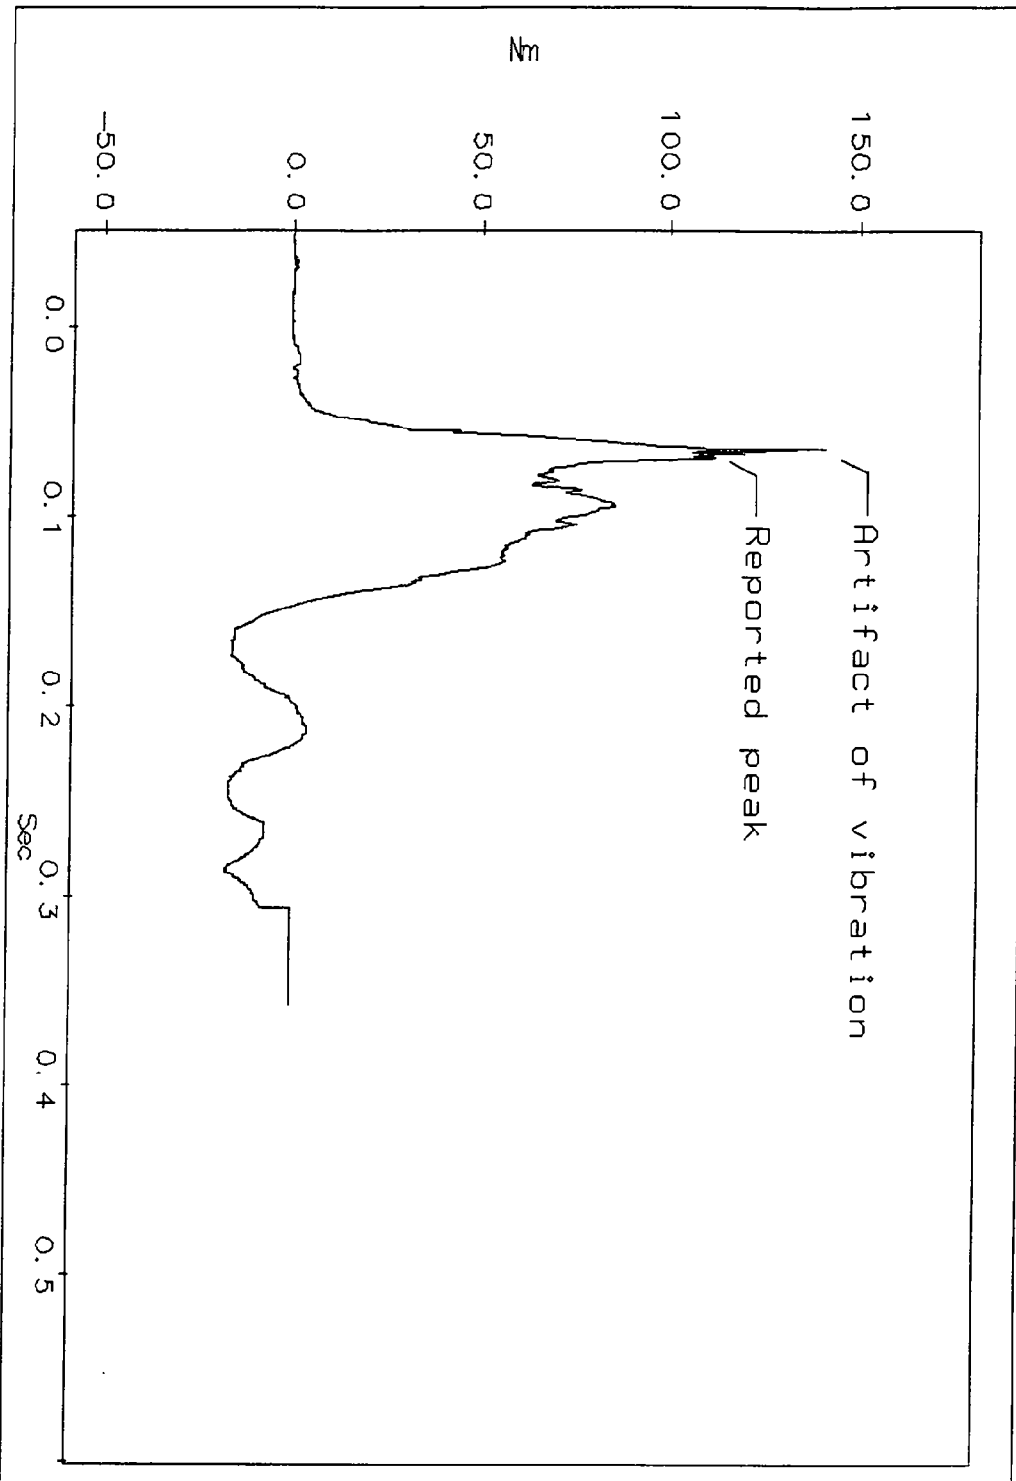
A-37 95030 Ford Explorer XLT 1996 R Upper Tibia A-P Moment

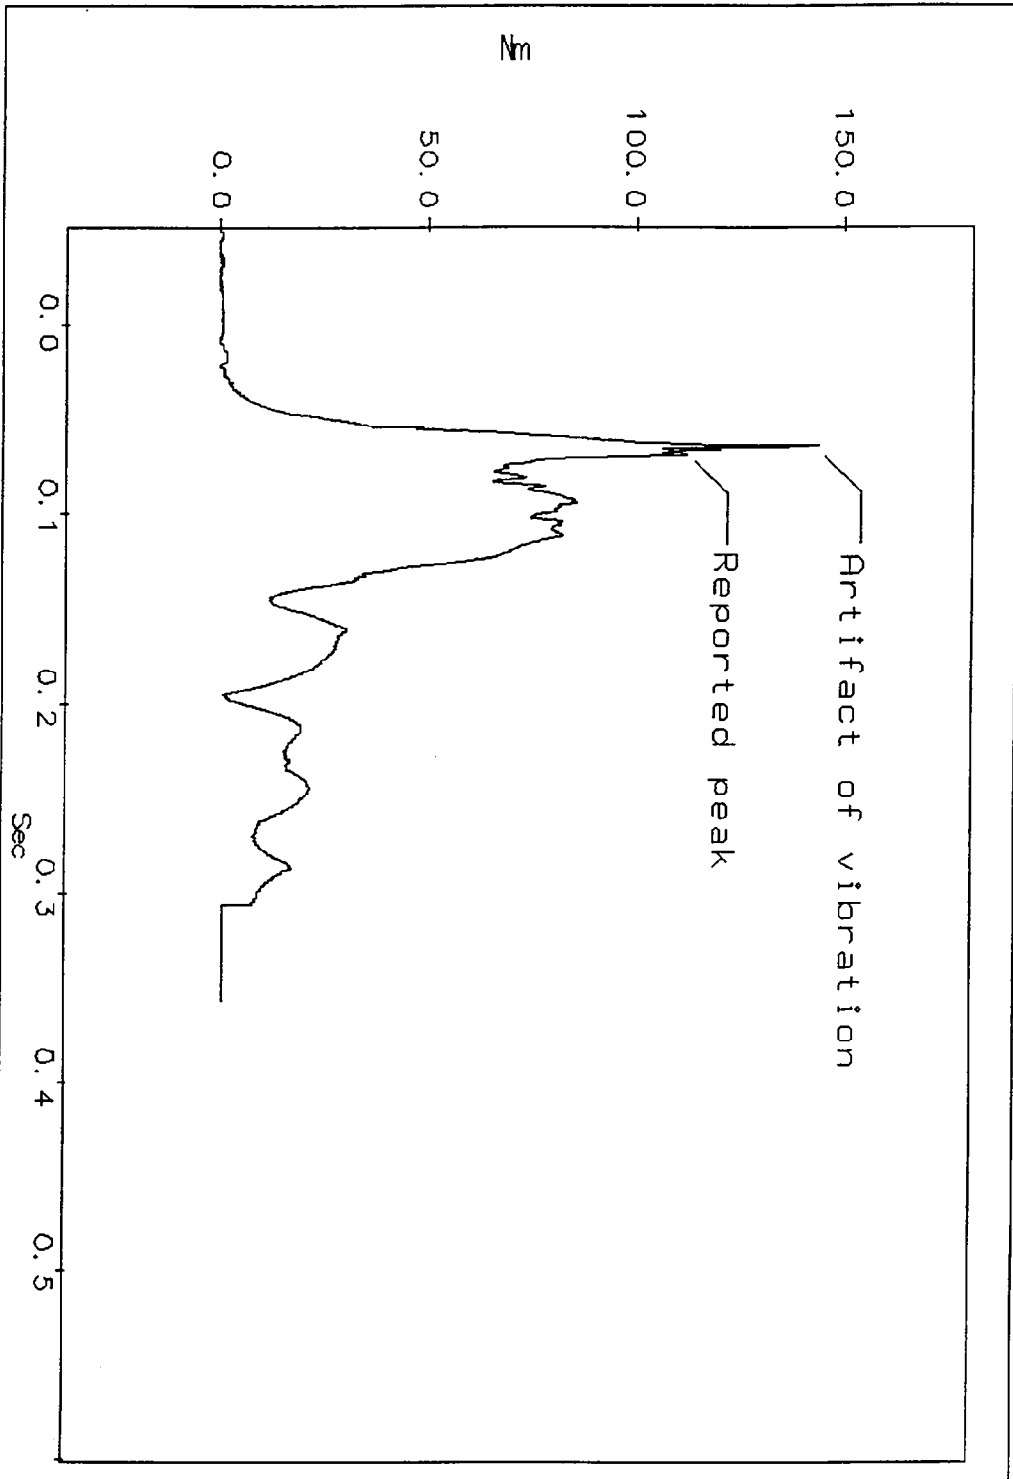
A-38 95030 Ford Explorer XLT 1996 R Upper Vector Moment

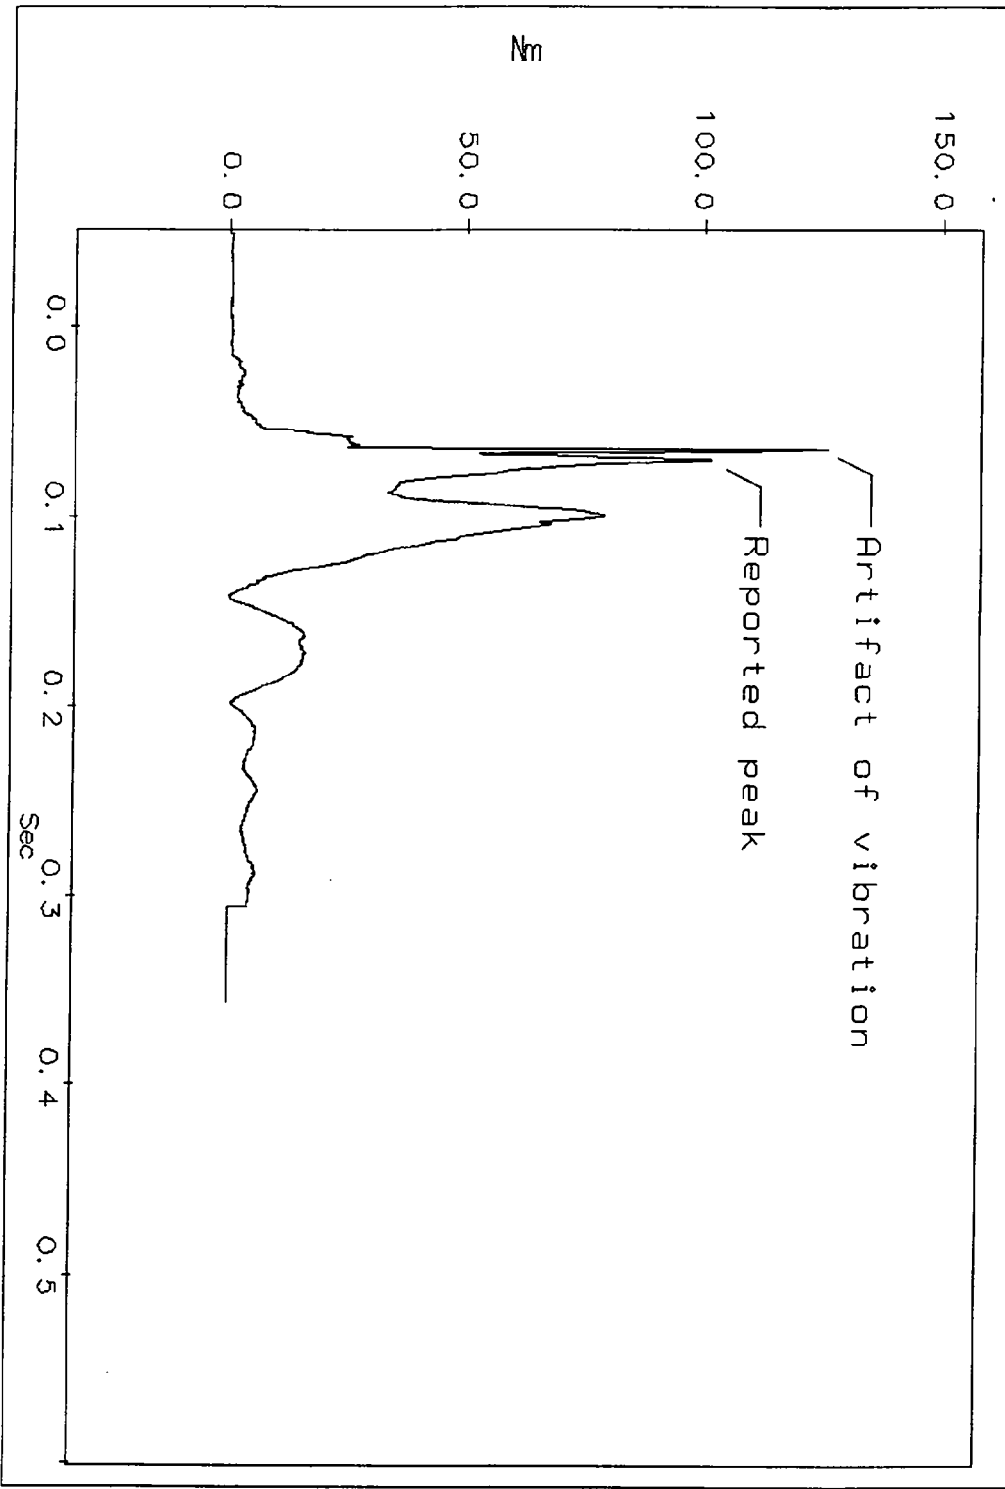
R-41 95030 Ford Explorer XLT 1996 R Lower Vector Moment

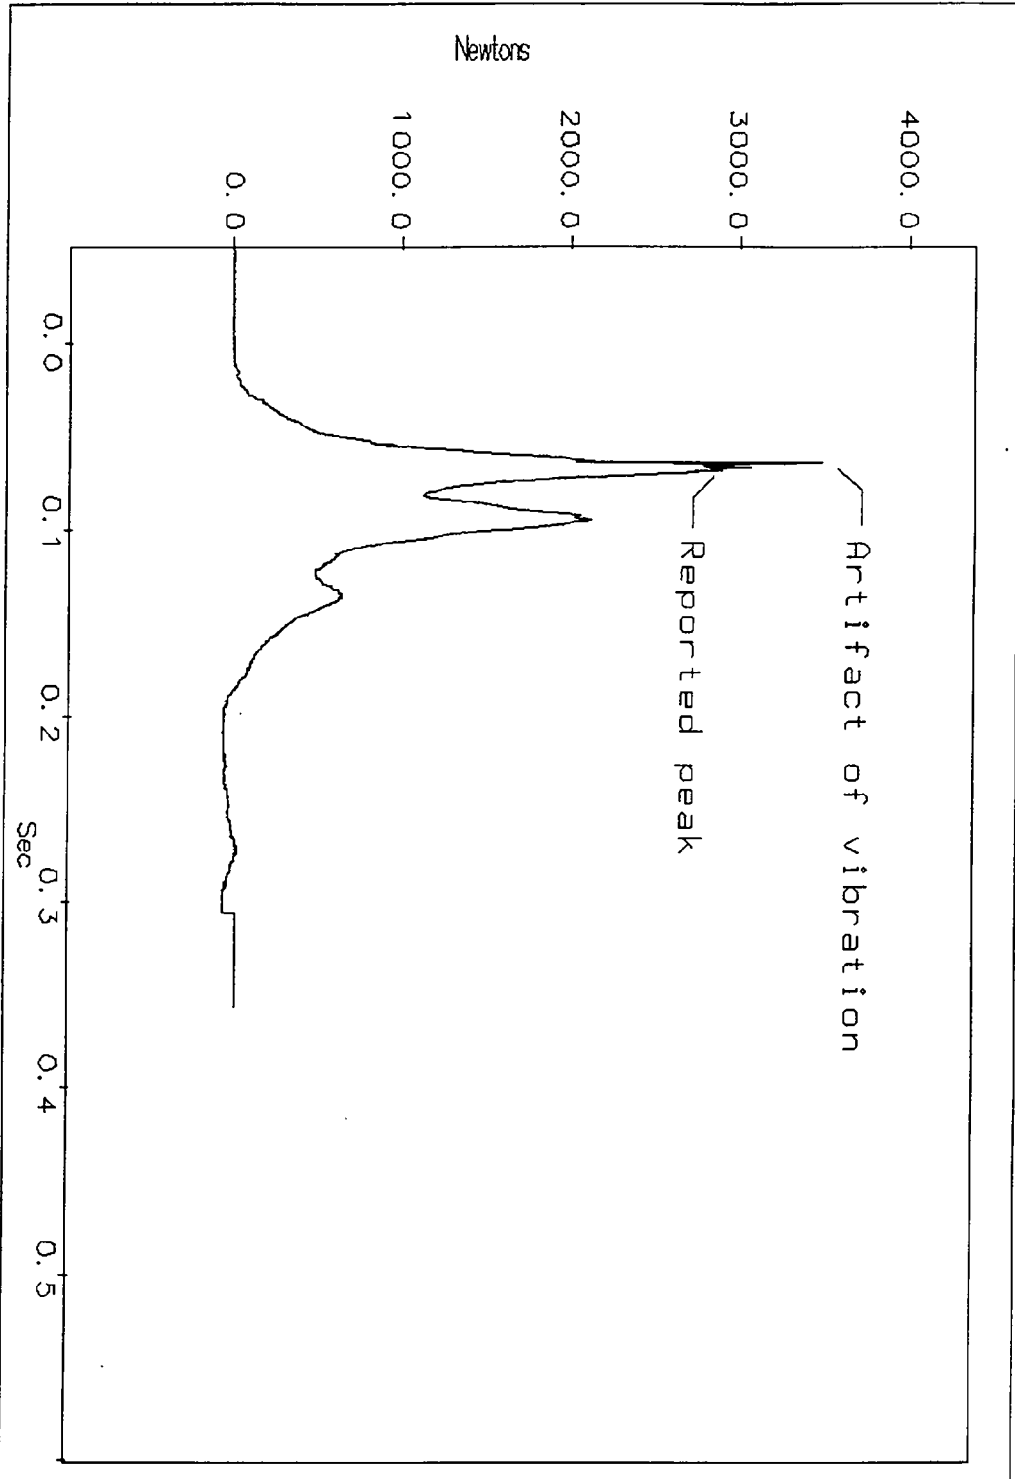
A-42 95030 Ford Explorer XLT 1996 R Lower Tibia Axial Force

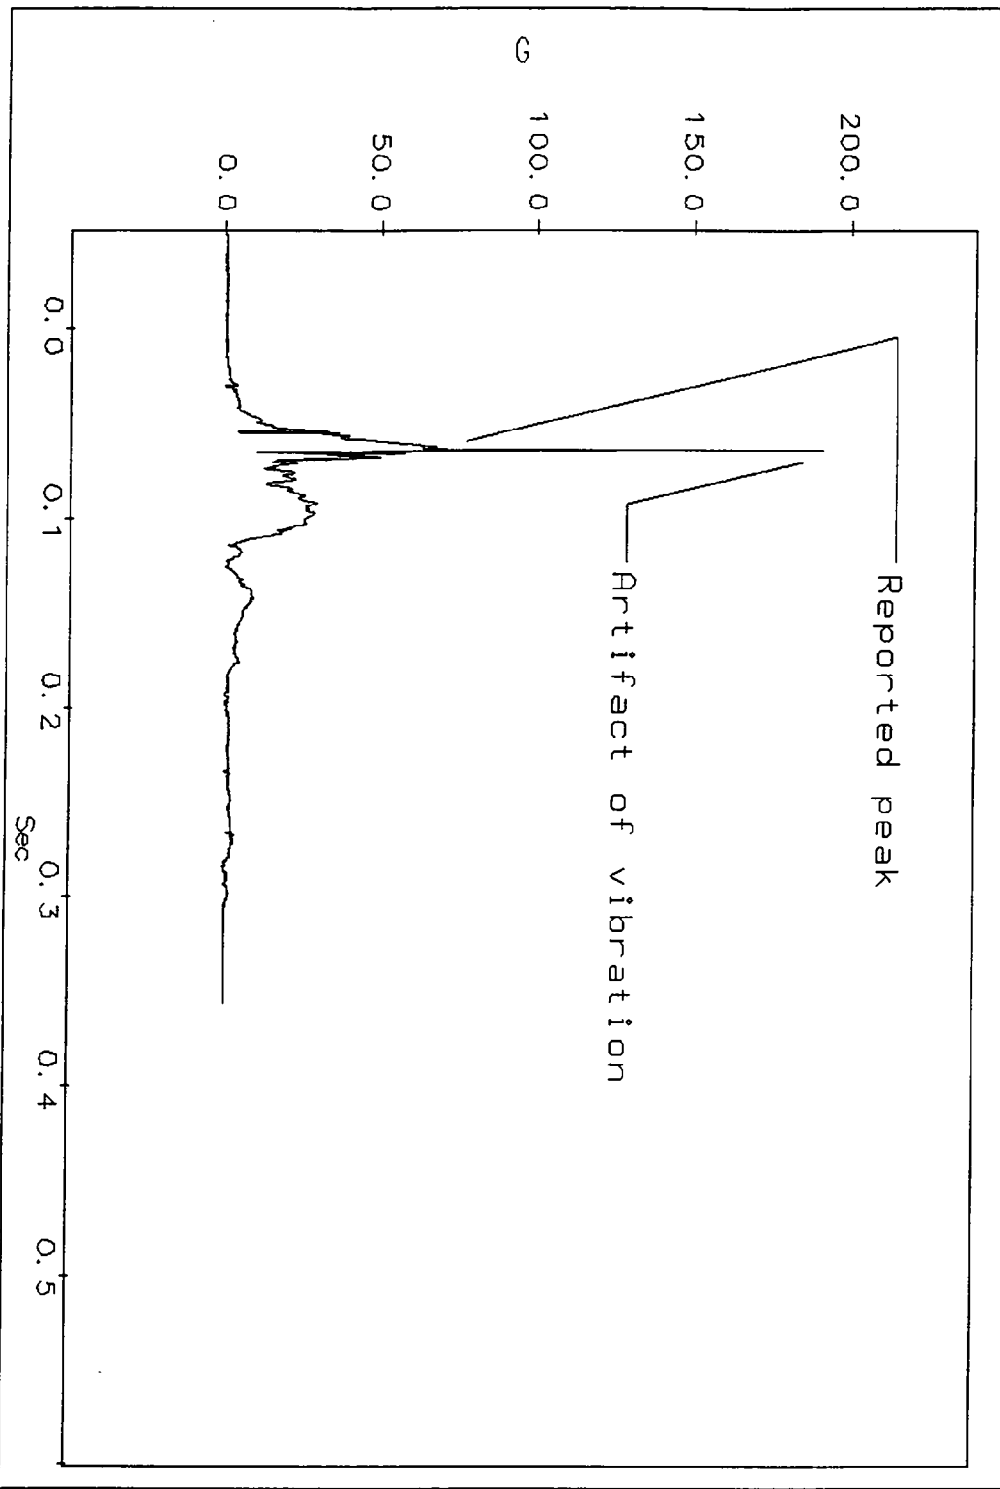
A-43 95030 Ford Explorer XLT 1996 Right Foot Vector Accel.
