REPORT NO.: 214-MGA-97-21  
SAFETY COMPLIANCE TESTING FOR  
FMVSS 214 "SIDE IMPACT PROTECTION -  
PASSENGER CARS"

FUJI HEAVY INDUSTRIES  
1997 SUBARU IMPREZA OUTBACK  
NHTSA NO: CV5501

MGA PROVING GROUNDS  
5000 WARREN ROAD  
BURLINGTON, WI 53105

FINAL REPORT

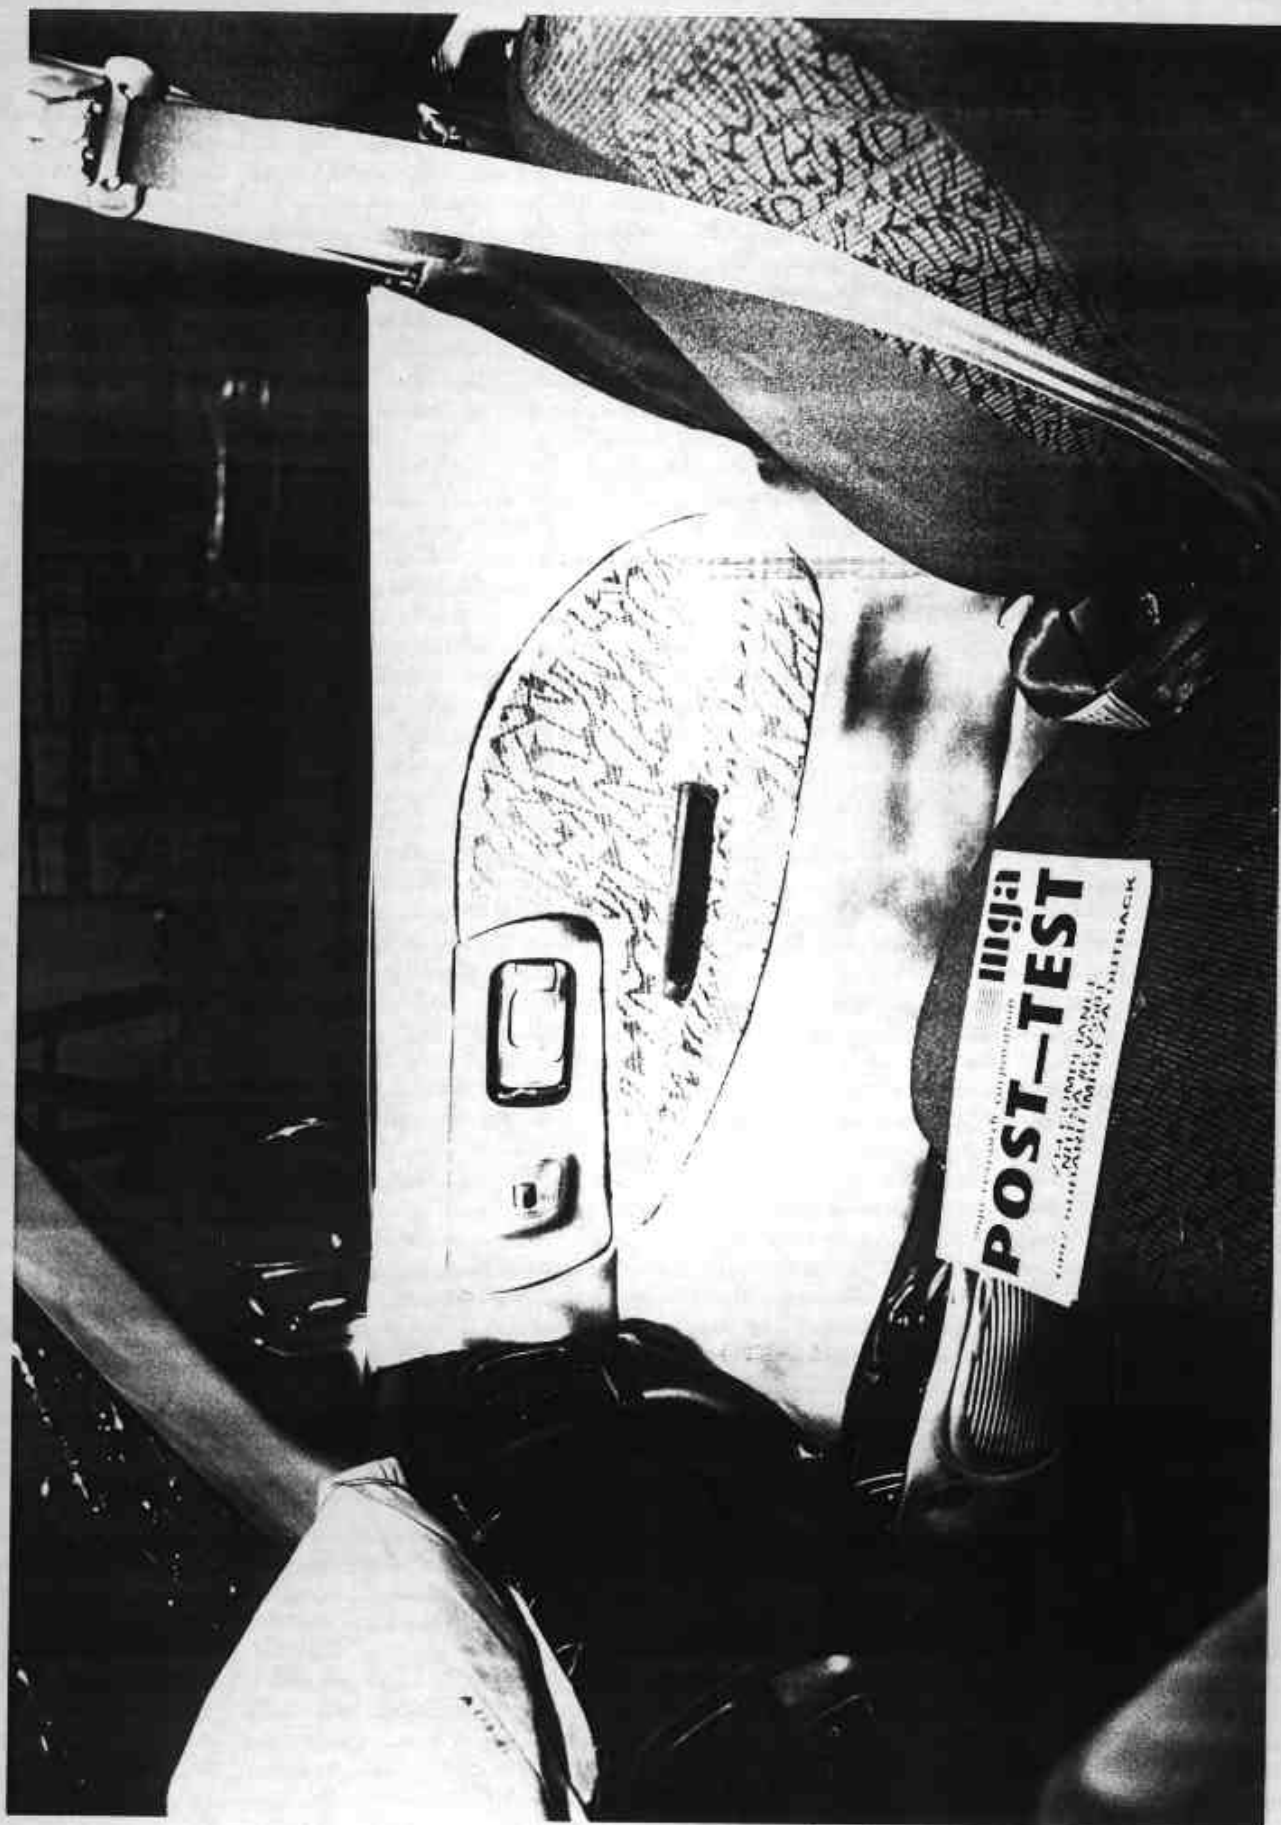
Photo No. A-28 - Post-Test Front Passenger Dummy Contact

| | <u>RIGHT FRONT SID</u> | <u>RIGHT REAR SID</u> |
|---|---|---|
| Head | <u>back of head to D-ring, face to</u><br><u>airbag and seat belt</u> | <u>Top of head to C Pillar</u> |
| Arm | <u>to door trim</u> | <u>to rear of door</u> |
| Pelvis | <u>to door trim</u> | <u>to arm rest</u> |

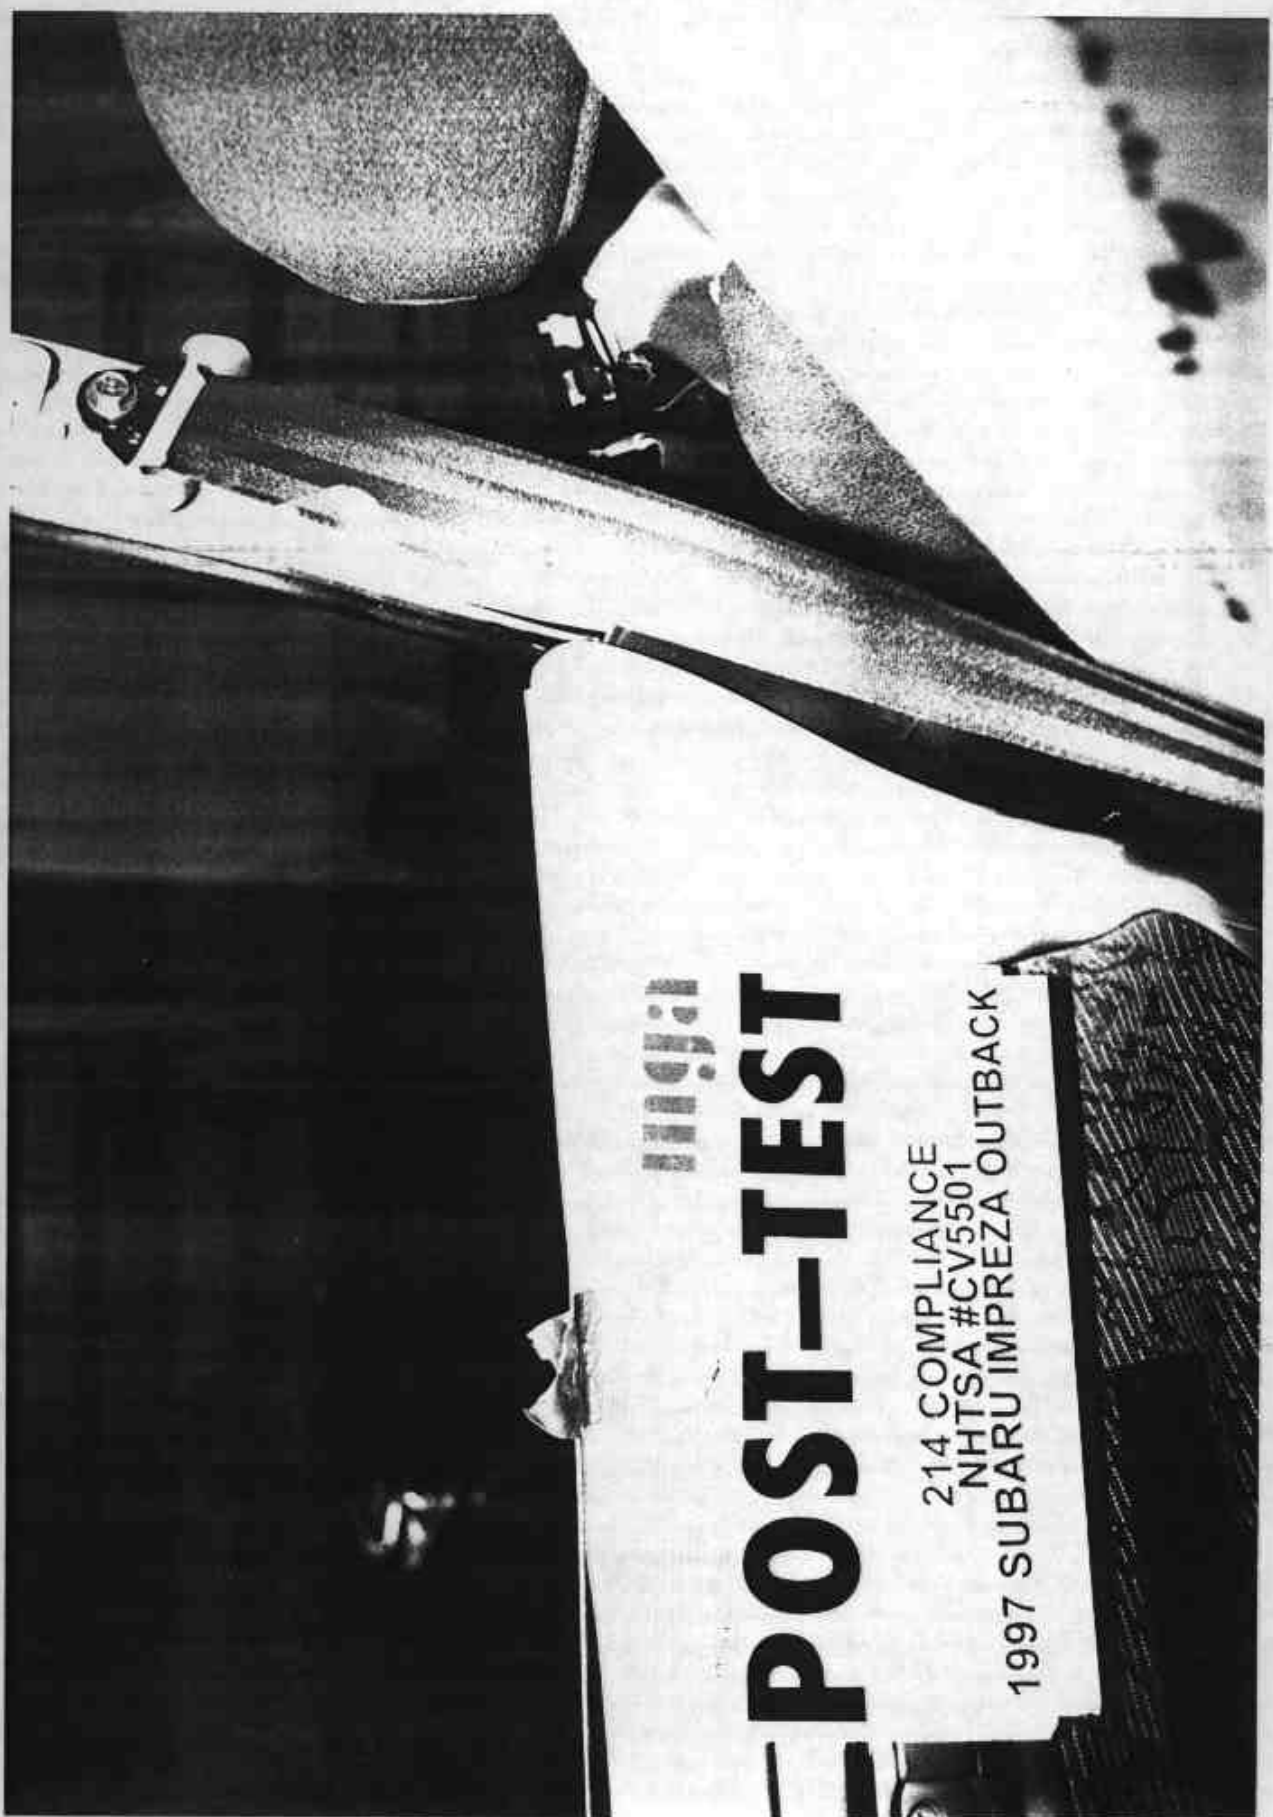
Photo No. A-29 - Post-Test Front Passenger Head Contact

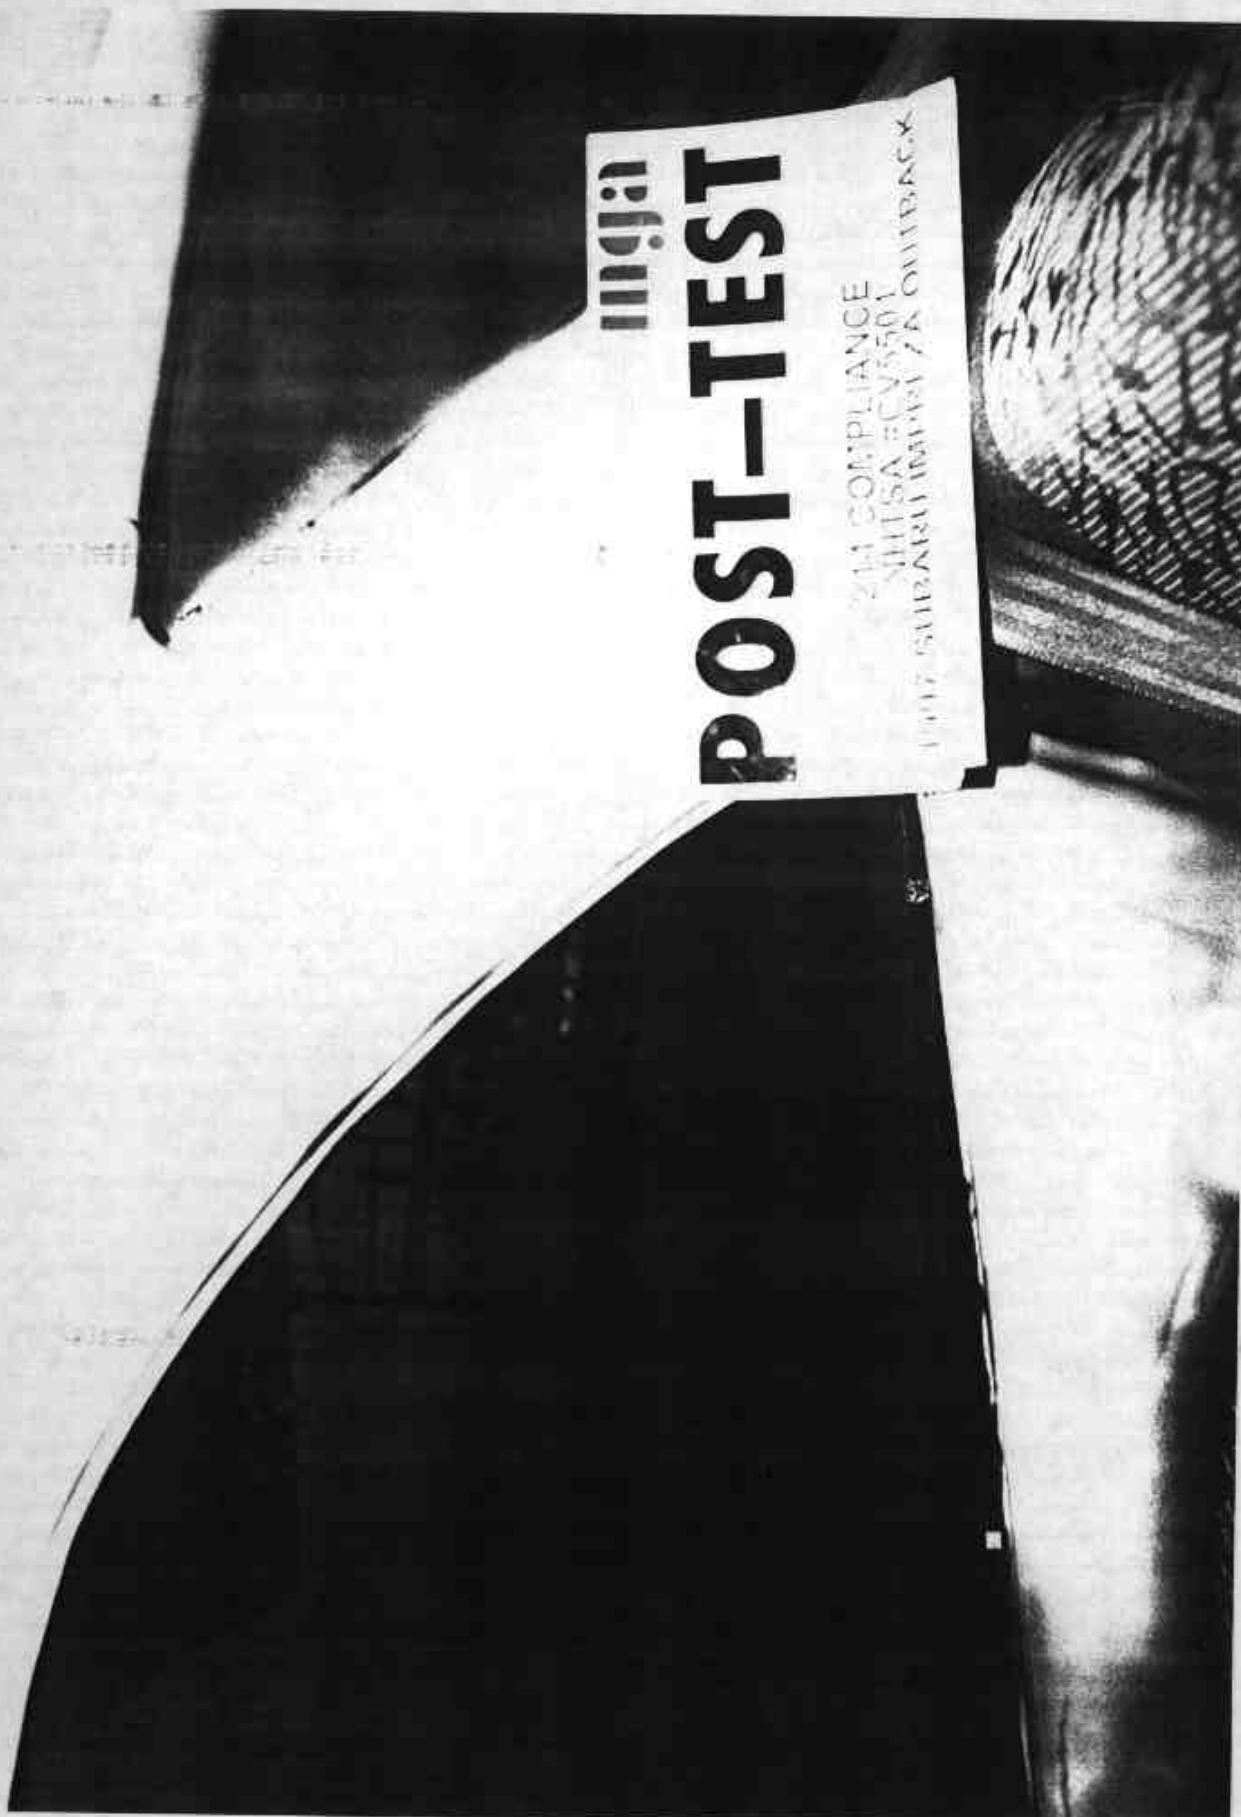
Photo No. A-38 - Post-Test Rear Passenger Dummy Head Contact

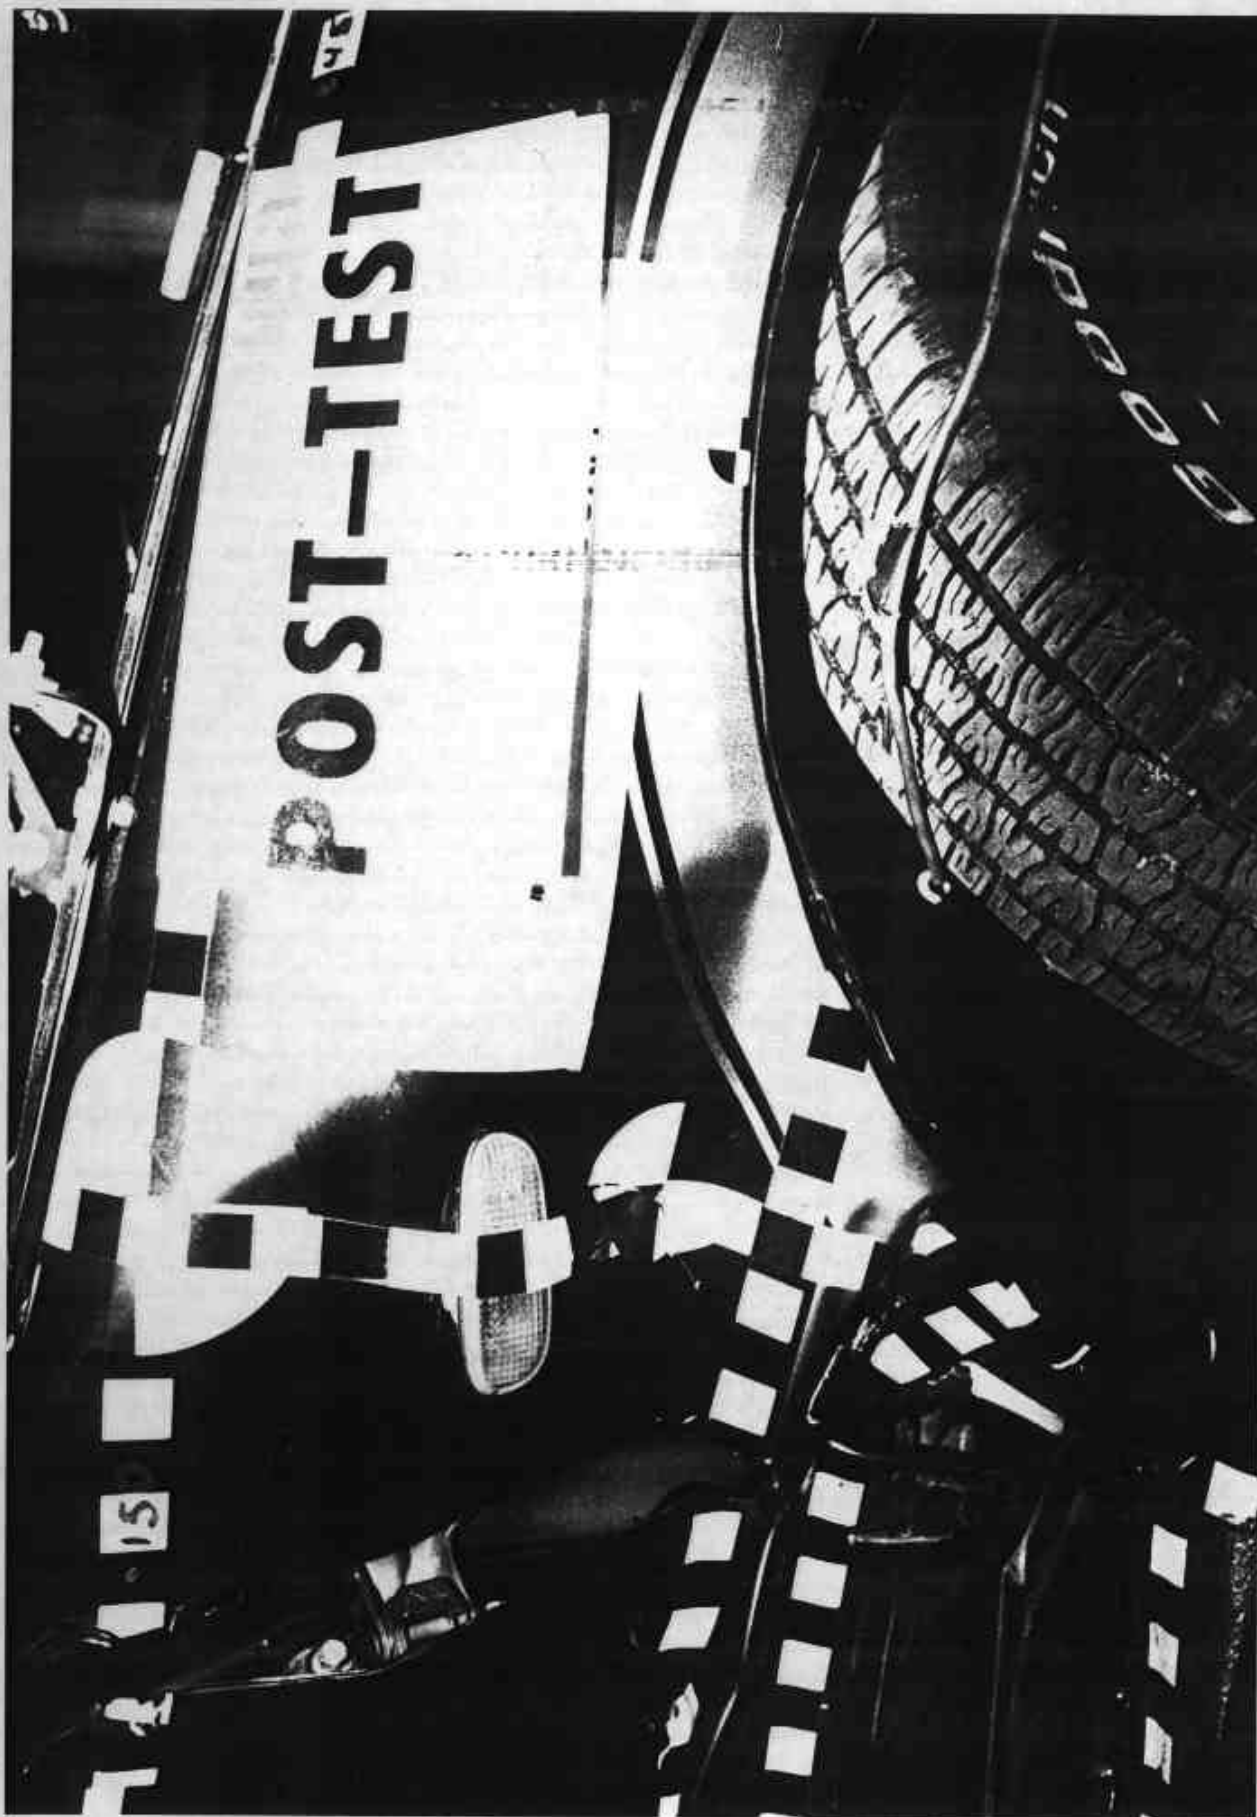
Photo No. A-40 - Post-Test Right Front Impact Point on Vehicle

Horizontal: 5 mm rearward      Vertical: 1 mm low
