NEW CAR ASSESSMENT PROGRAM  
SIDE IMPACT TESTING  
PASSENGER CARS

1998 BUICK LESABRE  
4-DOOR SEDAN  
NHTSA NO: MW0113

MGA PROVING GROUNDS  
5000 WARREN ROAD  
BURLINGTON, WI 53105

FINAL REPORT

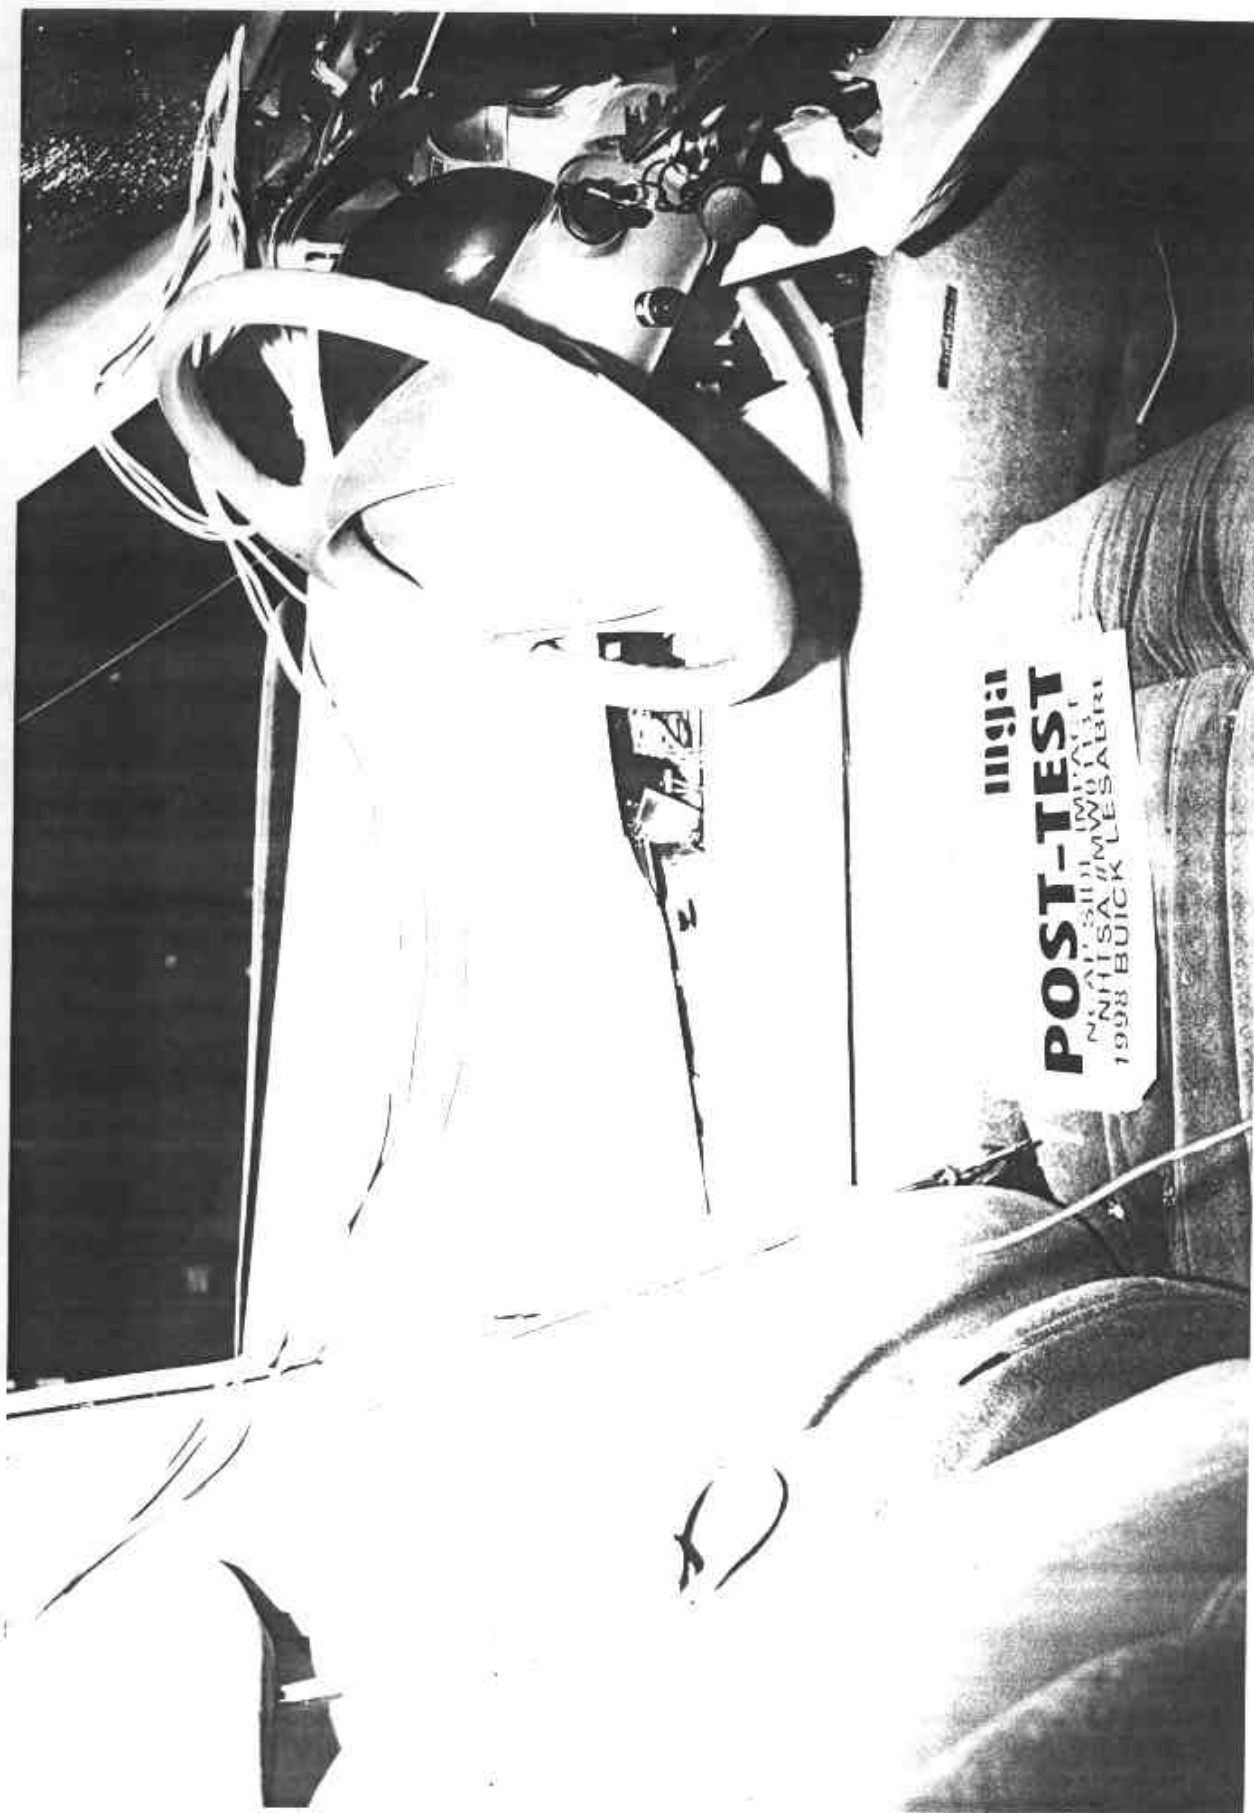
Photo No. A-25 - Post-Test Driver Dummy Contact

| | <u>LEFT FRONT SID</u> | <u>LEFT REAR SID</u> |
|---|---|---|
| Head | <u>to B post and passenger seat</u> | <u>to C post</u> |
| Arm | <u>to door trim panel</u> | <u>to door trim panel</u> |
| Pelvis | <u>to door trim panel</u> | <u>to door trim panel</u> |

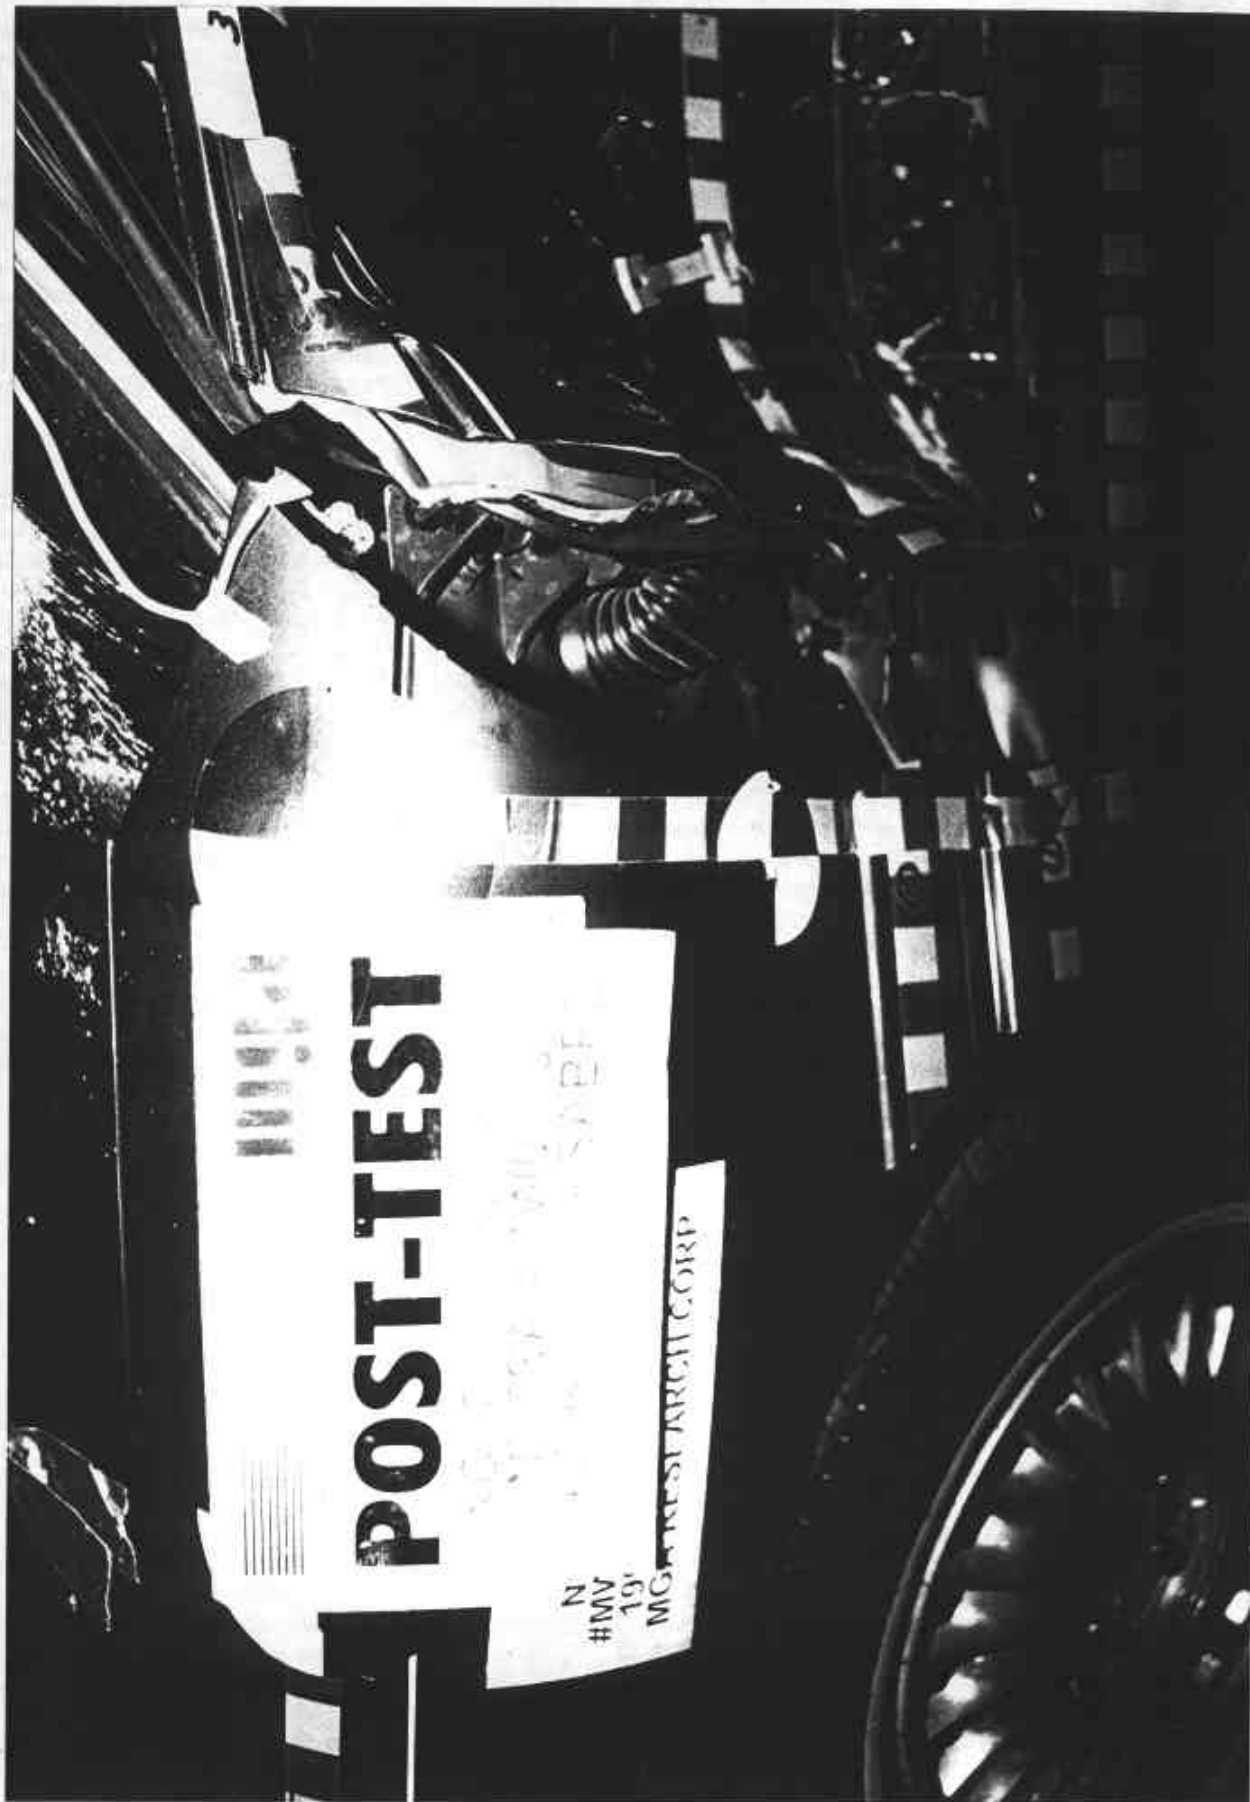
Photo No. A-38 - Post-Test Left Front Impact Point on Vehicle

Impact Point is 466 mm rearward of front axle centerline
