NEW CAR ASSESSMENT PROGRAM  
SIDE IMPACT TESTING  
PASSENGER CARS

1998 BUICK CENTURY  
4-DOOR SEDAN  
NHTSA NO: MW0112

MGA PROVING GROUNDS  
5000 WARREN ROAD  
BURLINGTON, WI 53105

FINAL REPORT

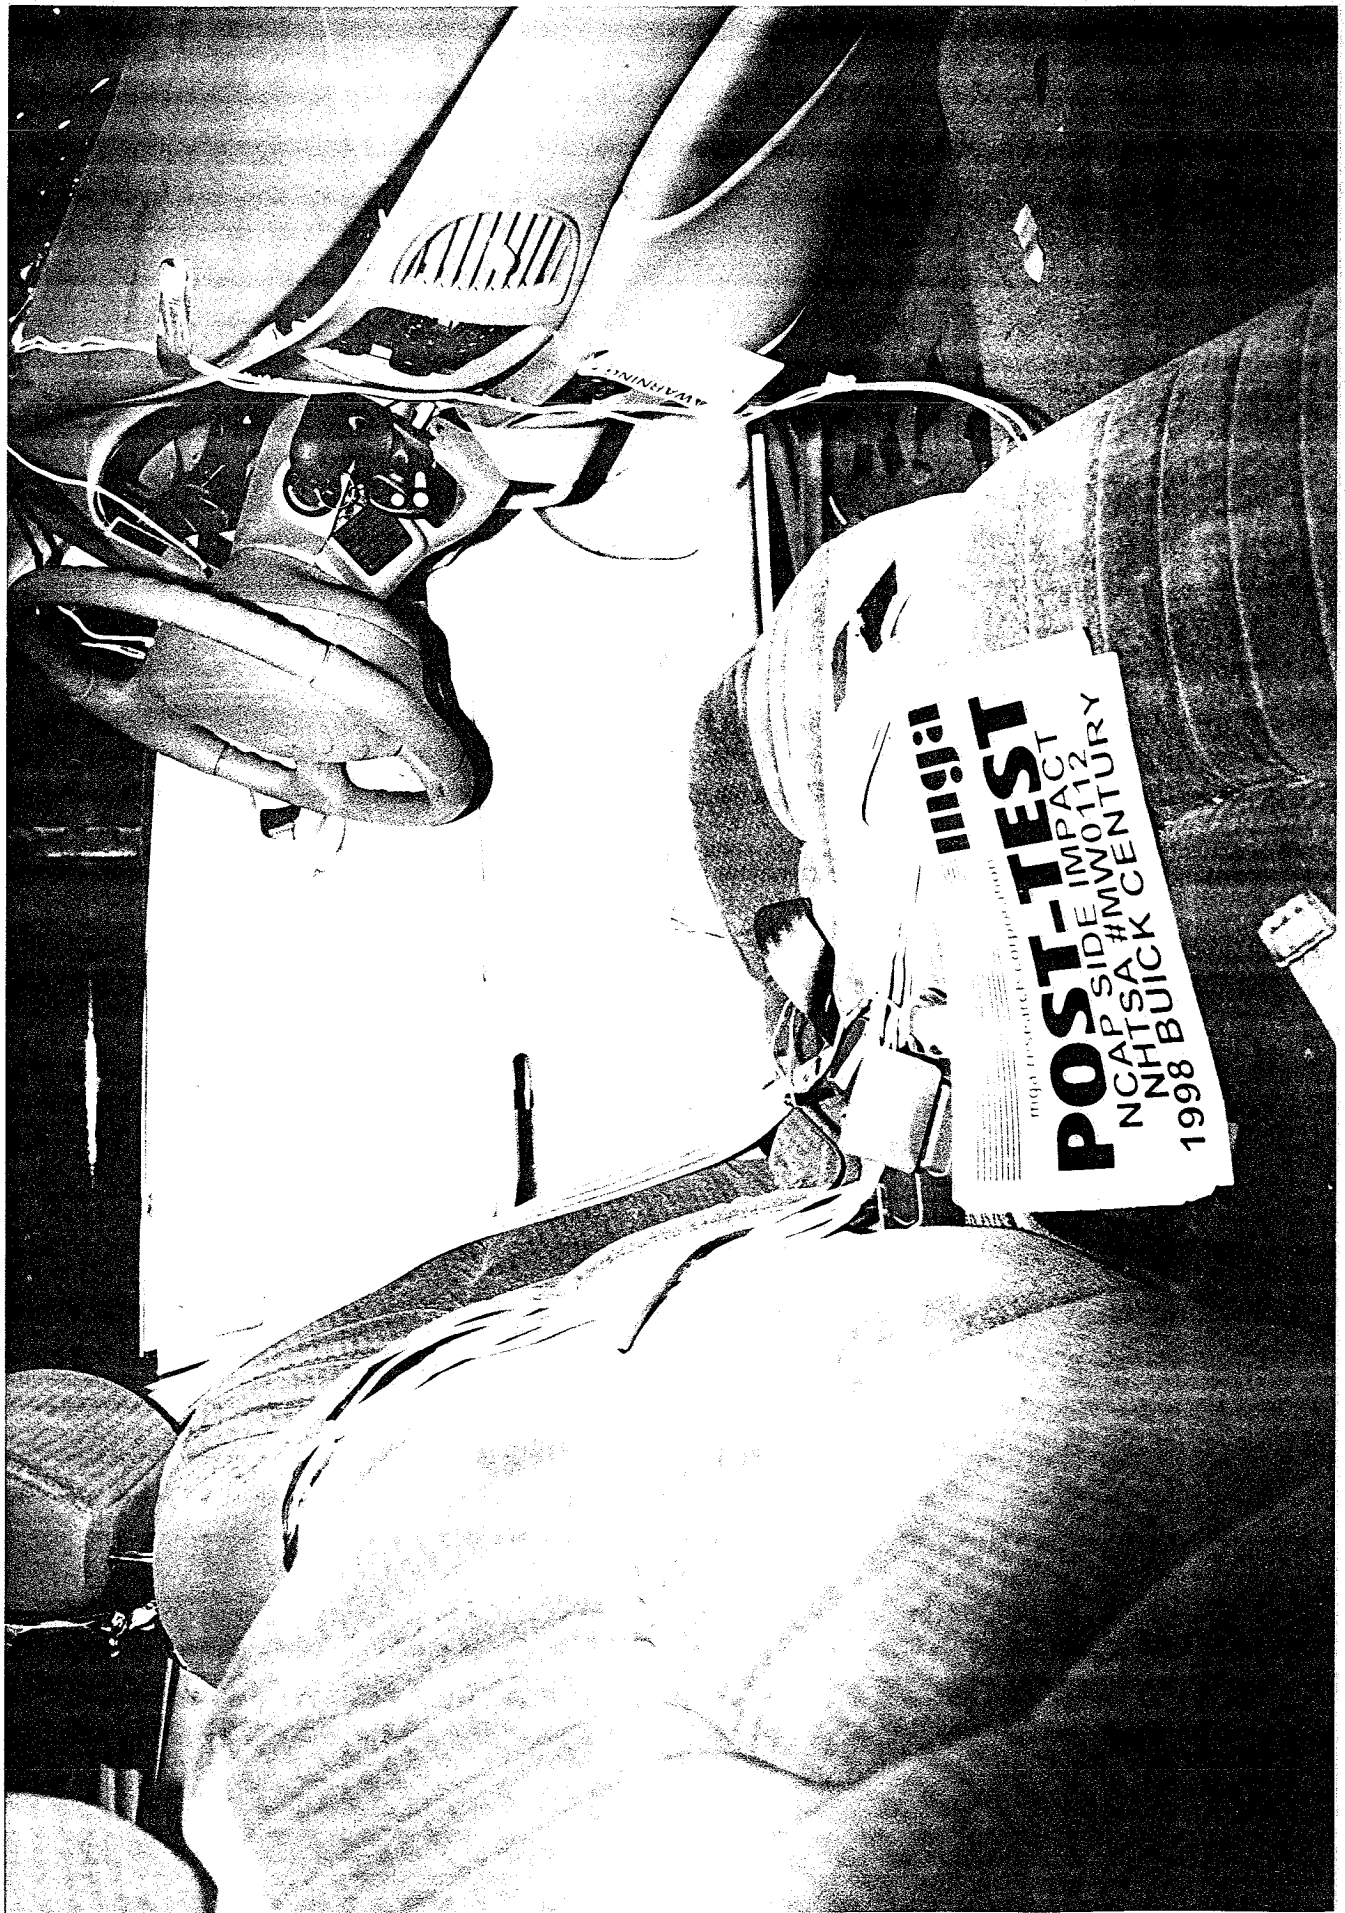
Photo No. A-28 - Post-Test Driver Dummy Contact

| | <u>LEFT FRONT SID</u> | <u>LEFT REAR SID</u> |
| Head | <u>to door panel, headrest, and</u><br><u>front passenger seat back</u> | <u>to C-pillar</u><br><u>to C-pillar</u> |
| Arm | <u>to door panel</u> | <u>to door panel</u> |
| Pelvis | <u>to door panel and armrest</u> | <u>to door panel and armrest</u> |
| Left Knee | <u>to door panel and armrest</u> | <u>to door panel and armrest</u> |

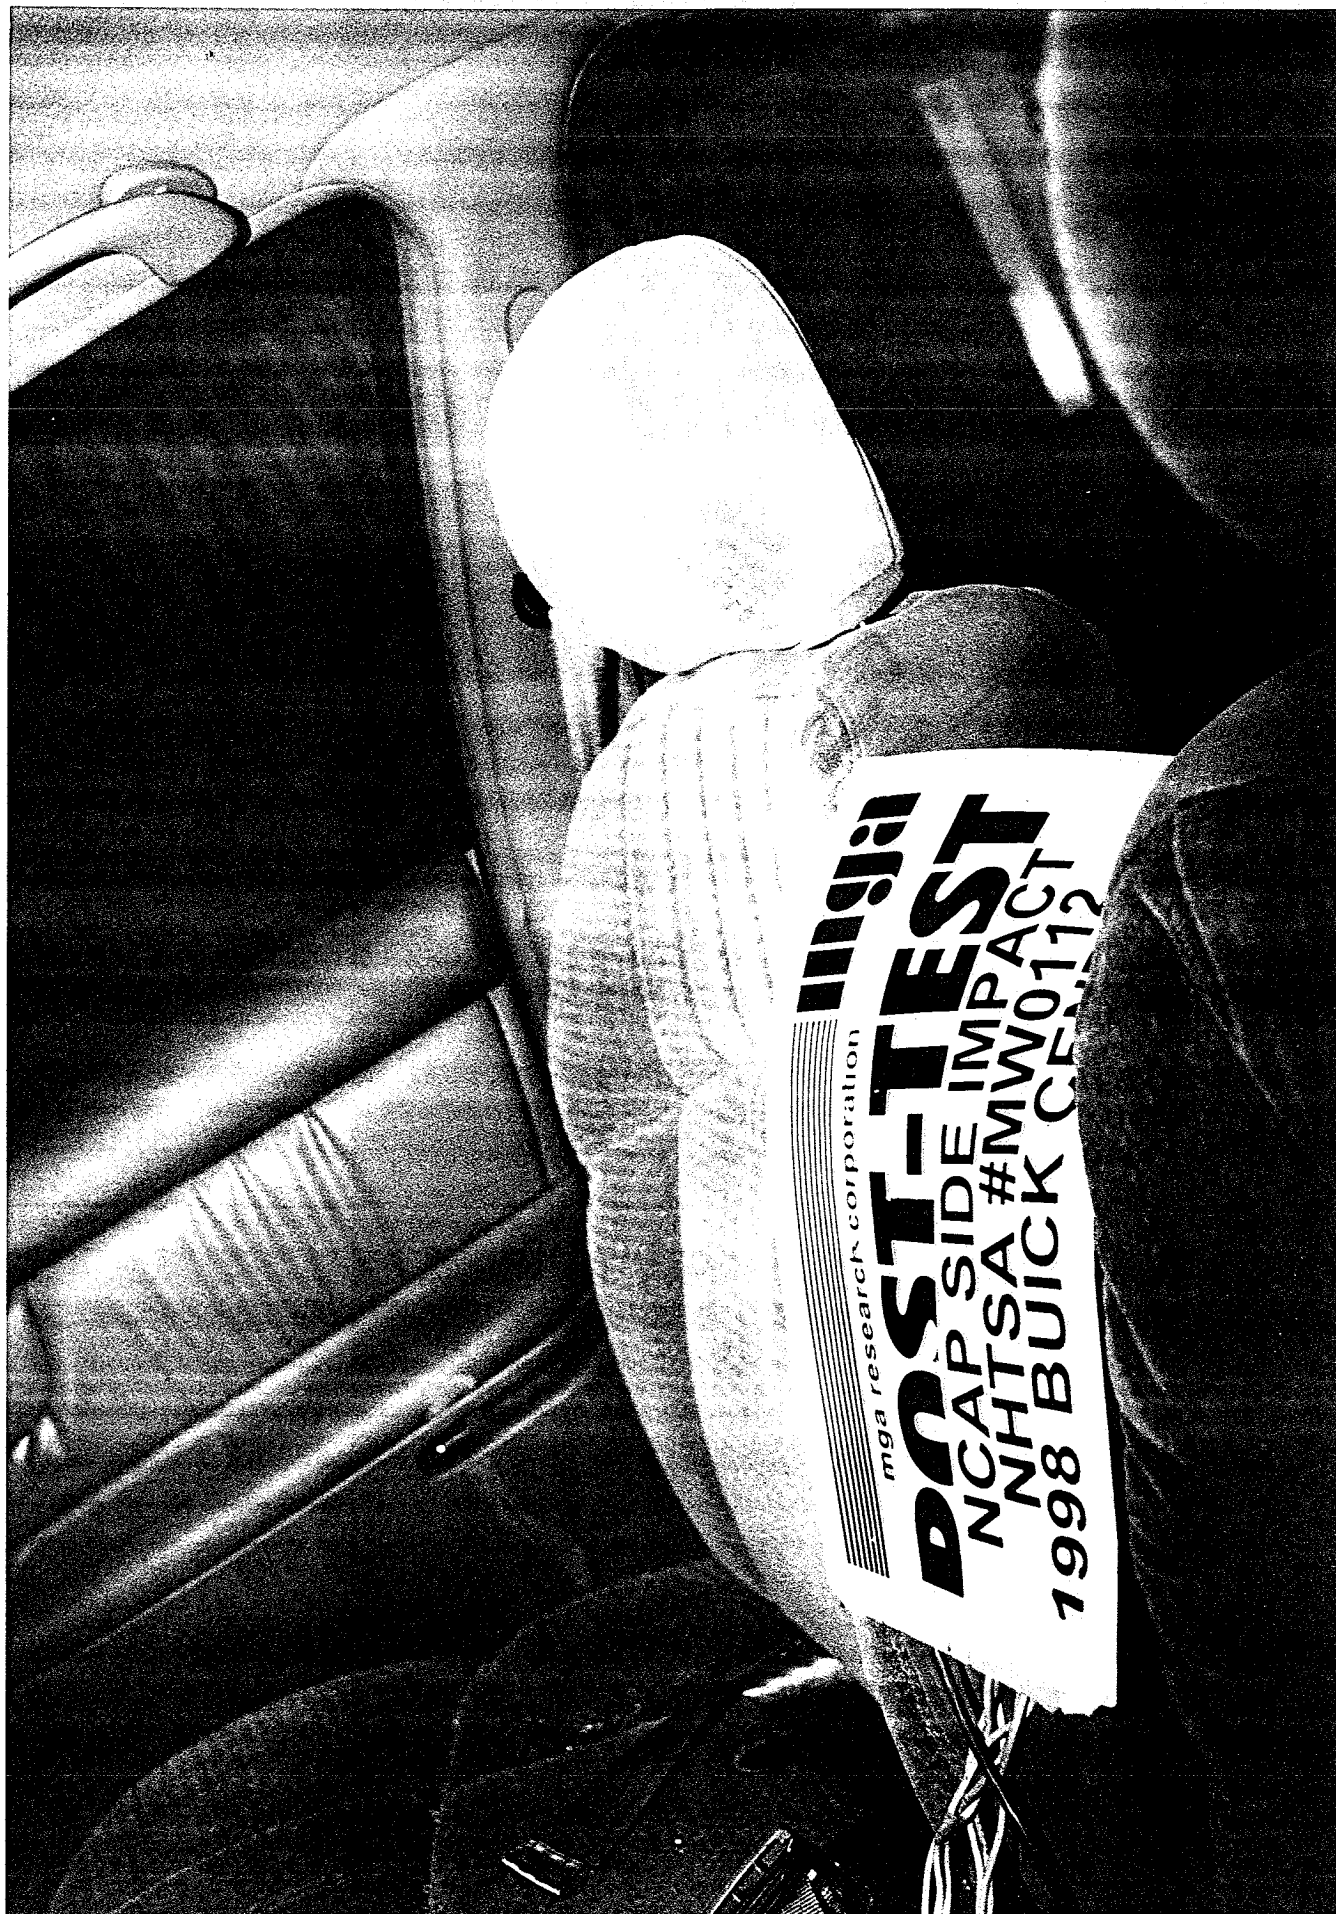
Photo No. A-29 - Post-Test Driver Dummy Head Contact

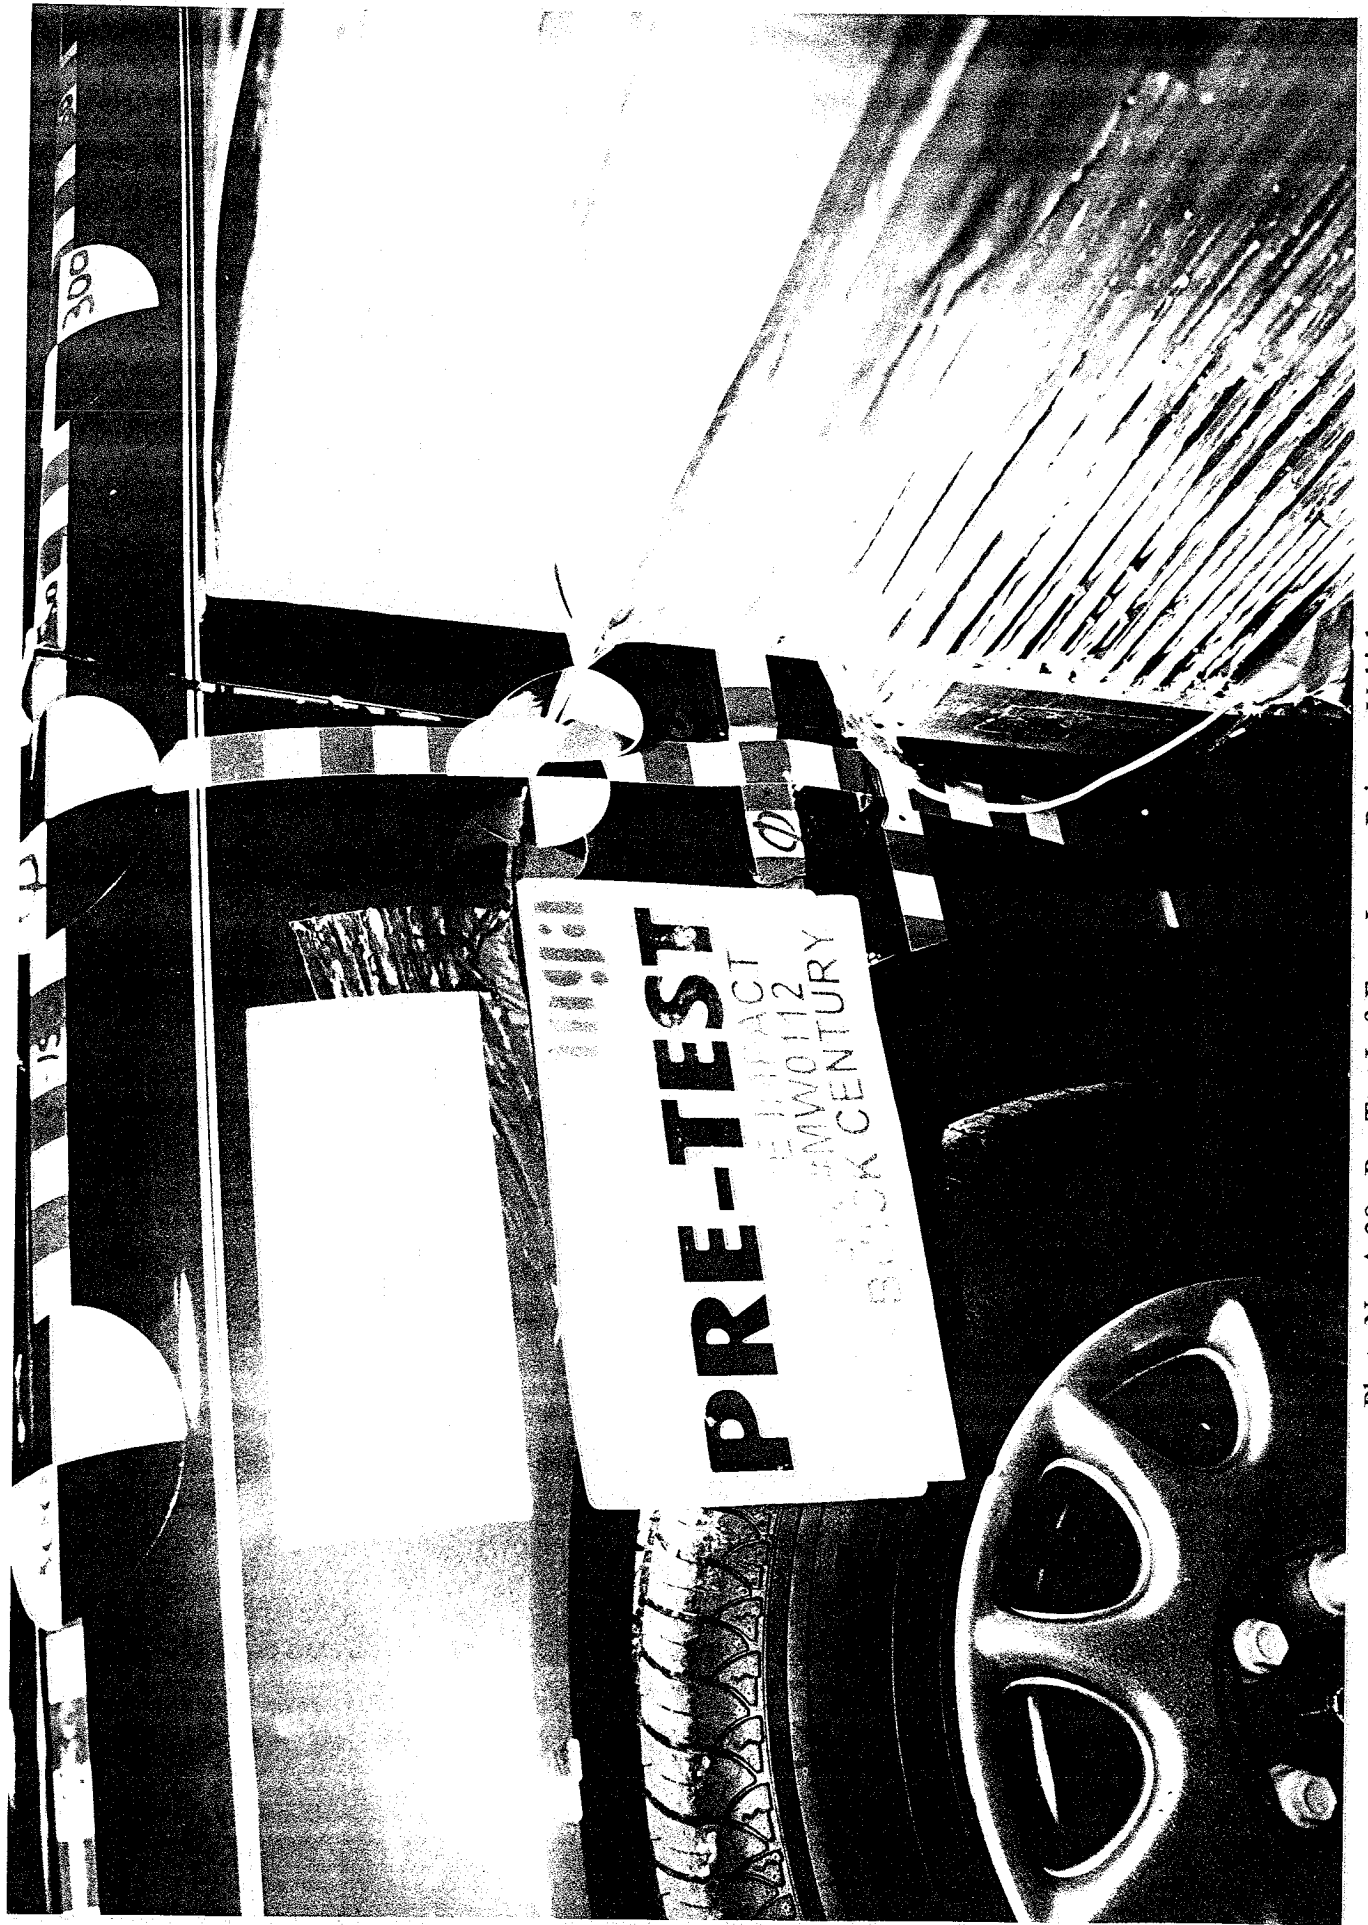
Photo No. A-39 - Pre-Test Left Front Impact Point on Vehicle

Impact Point is 445 mm rearward of front axle centerline

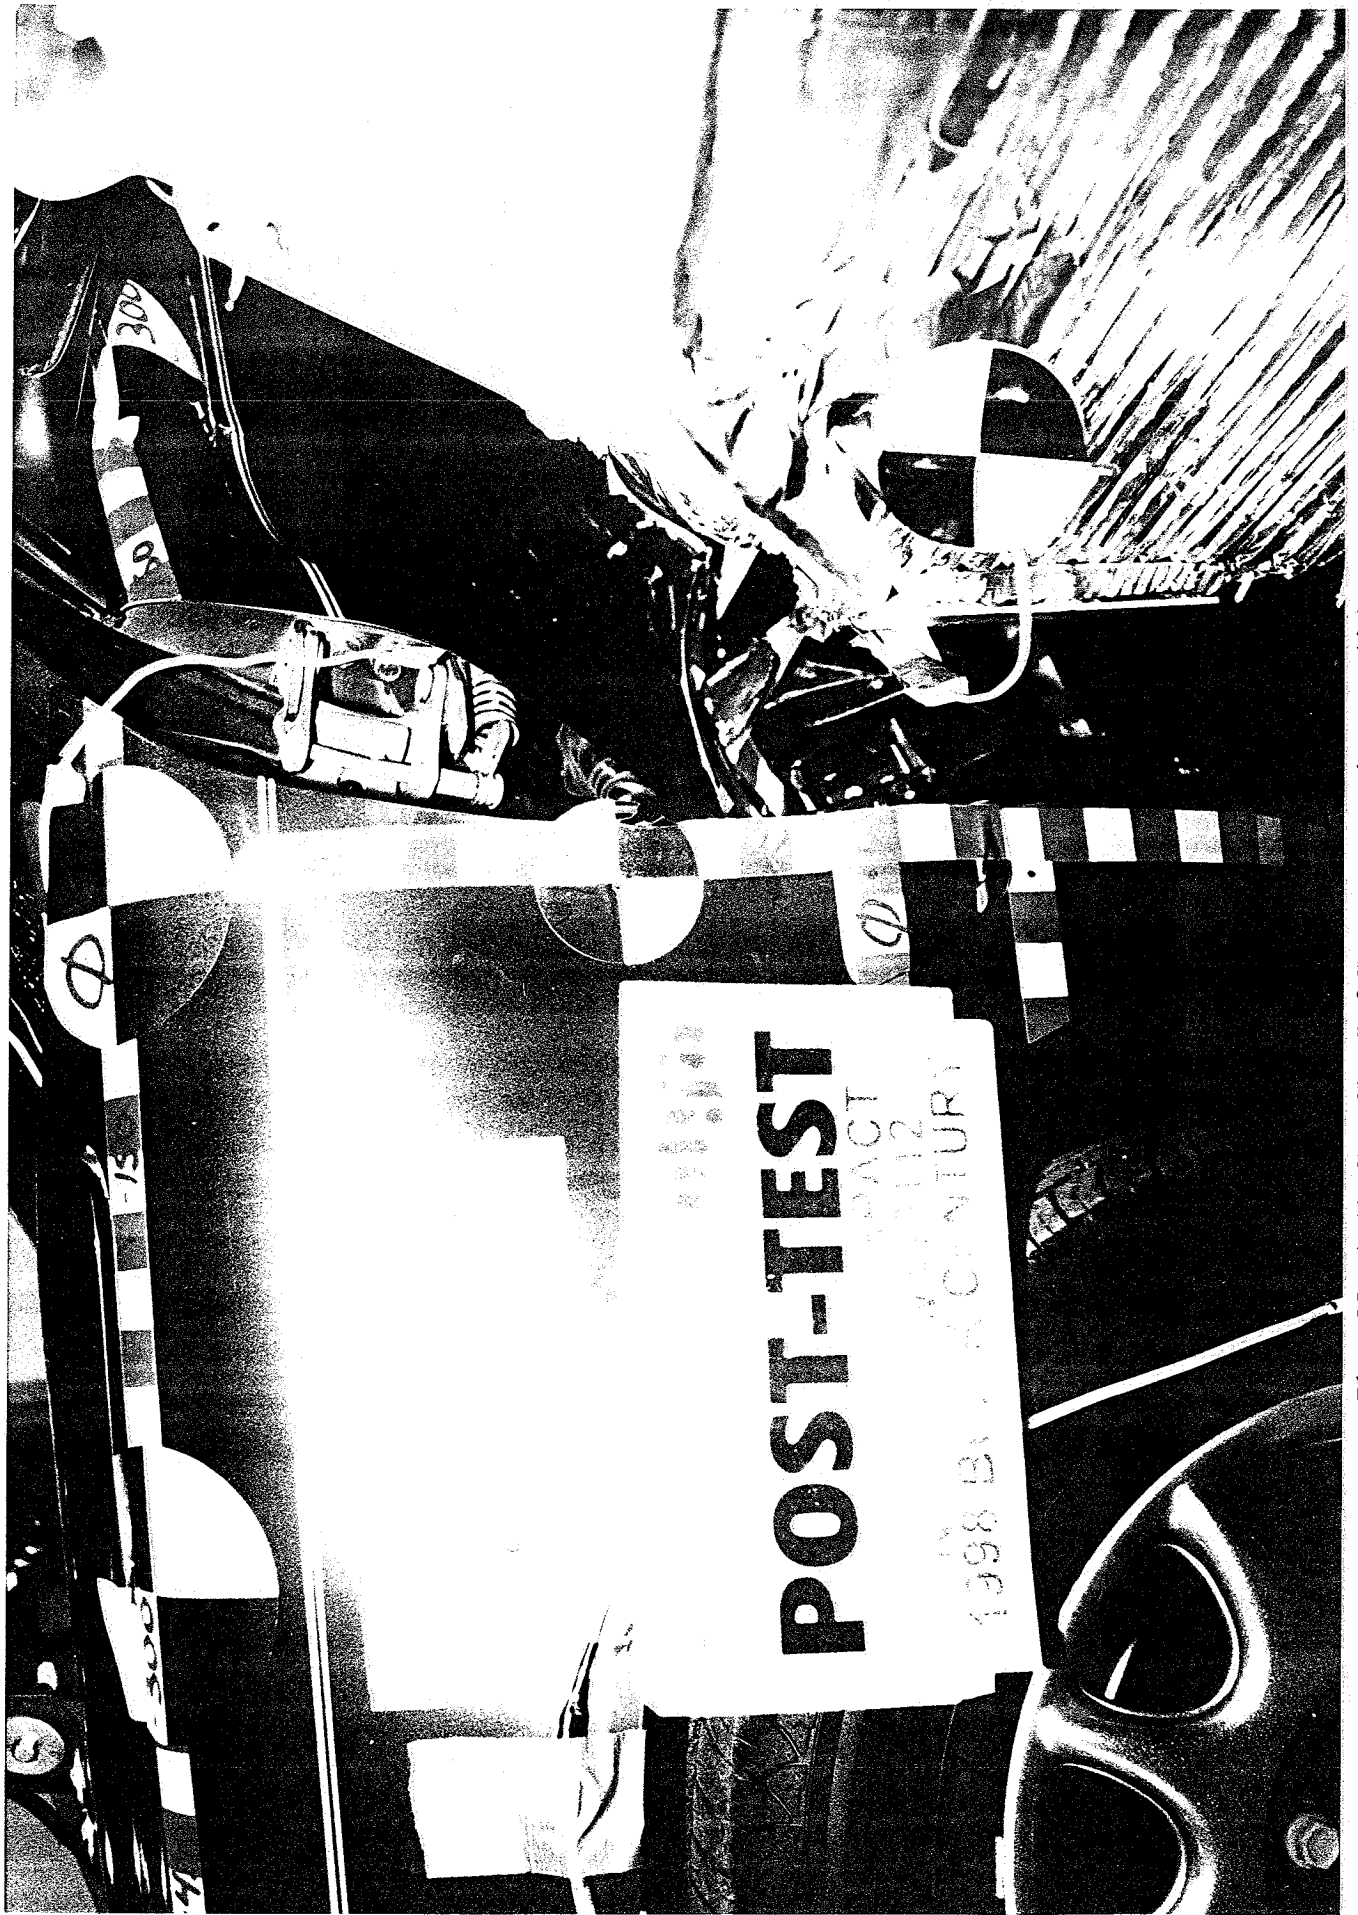
Photo No. A-40 - Post-Test Left Front Impact Point on Vehicle

Horizontal: 2 mm forward      Vertical: 1 mm high
