NEW CAR ASSESSMENT PROGRAM  
SIDE IMPACT TESTING  
PASSENGER CARS

1998 MERCEDES-BENZ C230  
4-DOOR SEDAN  
NHTSA NO: MW0500

FINAL REPORT

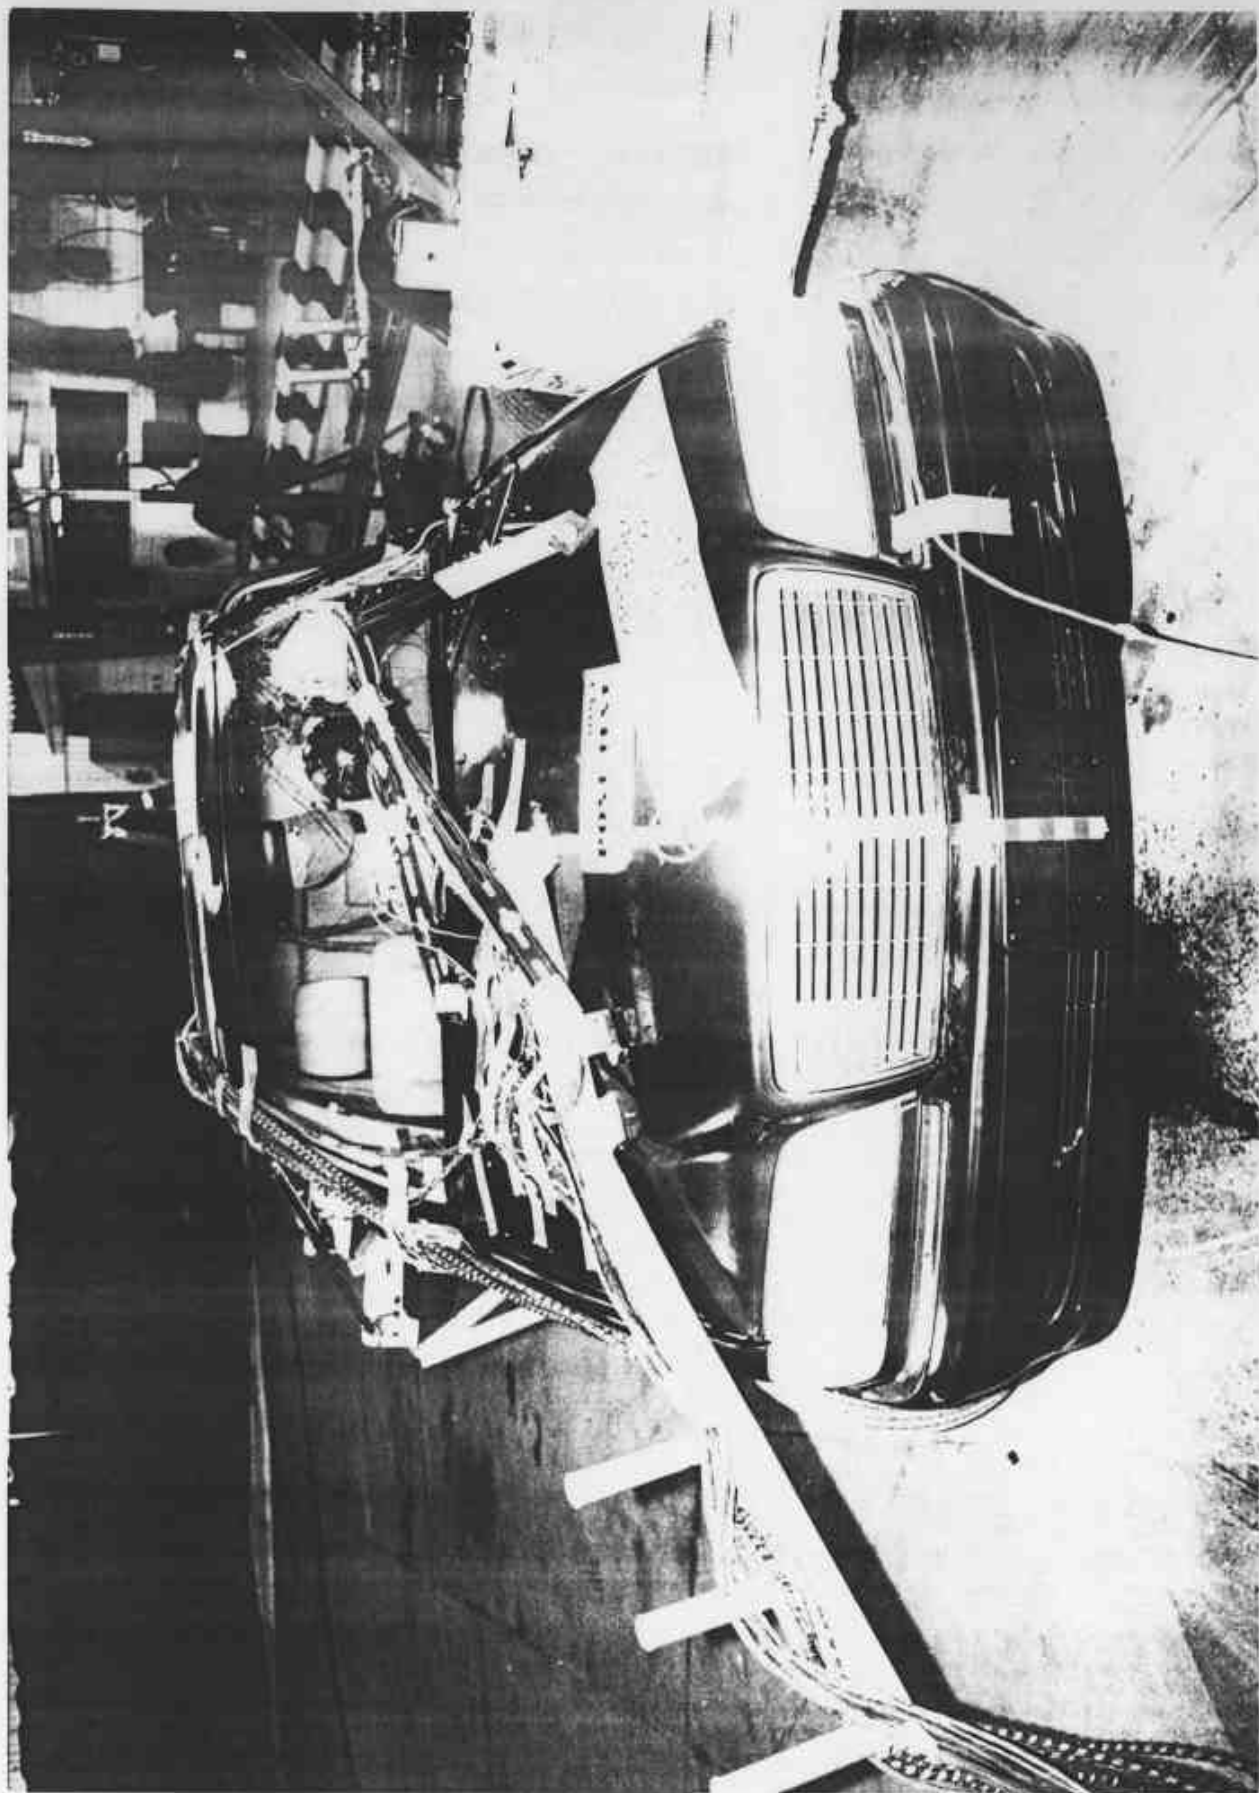
Photo No. A-2 - Post-Test Front View of Test Vehicle

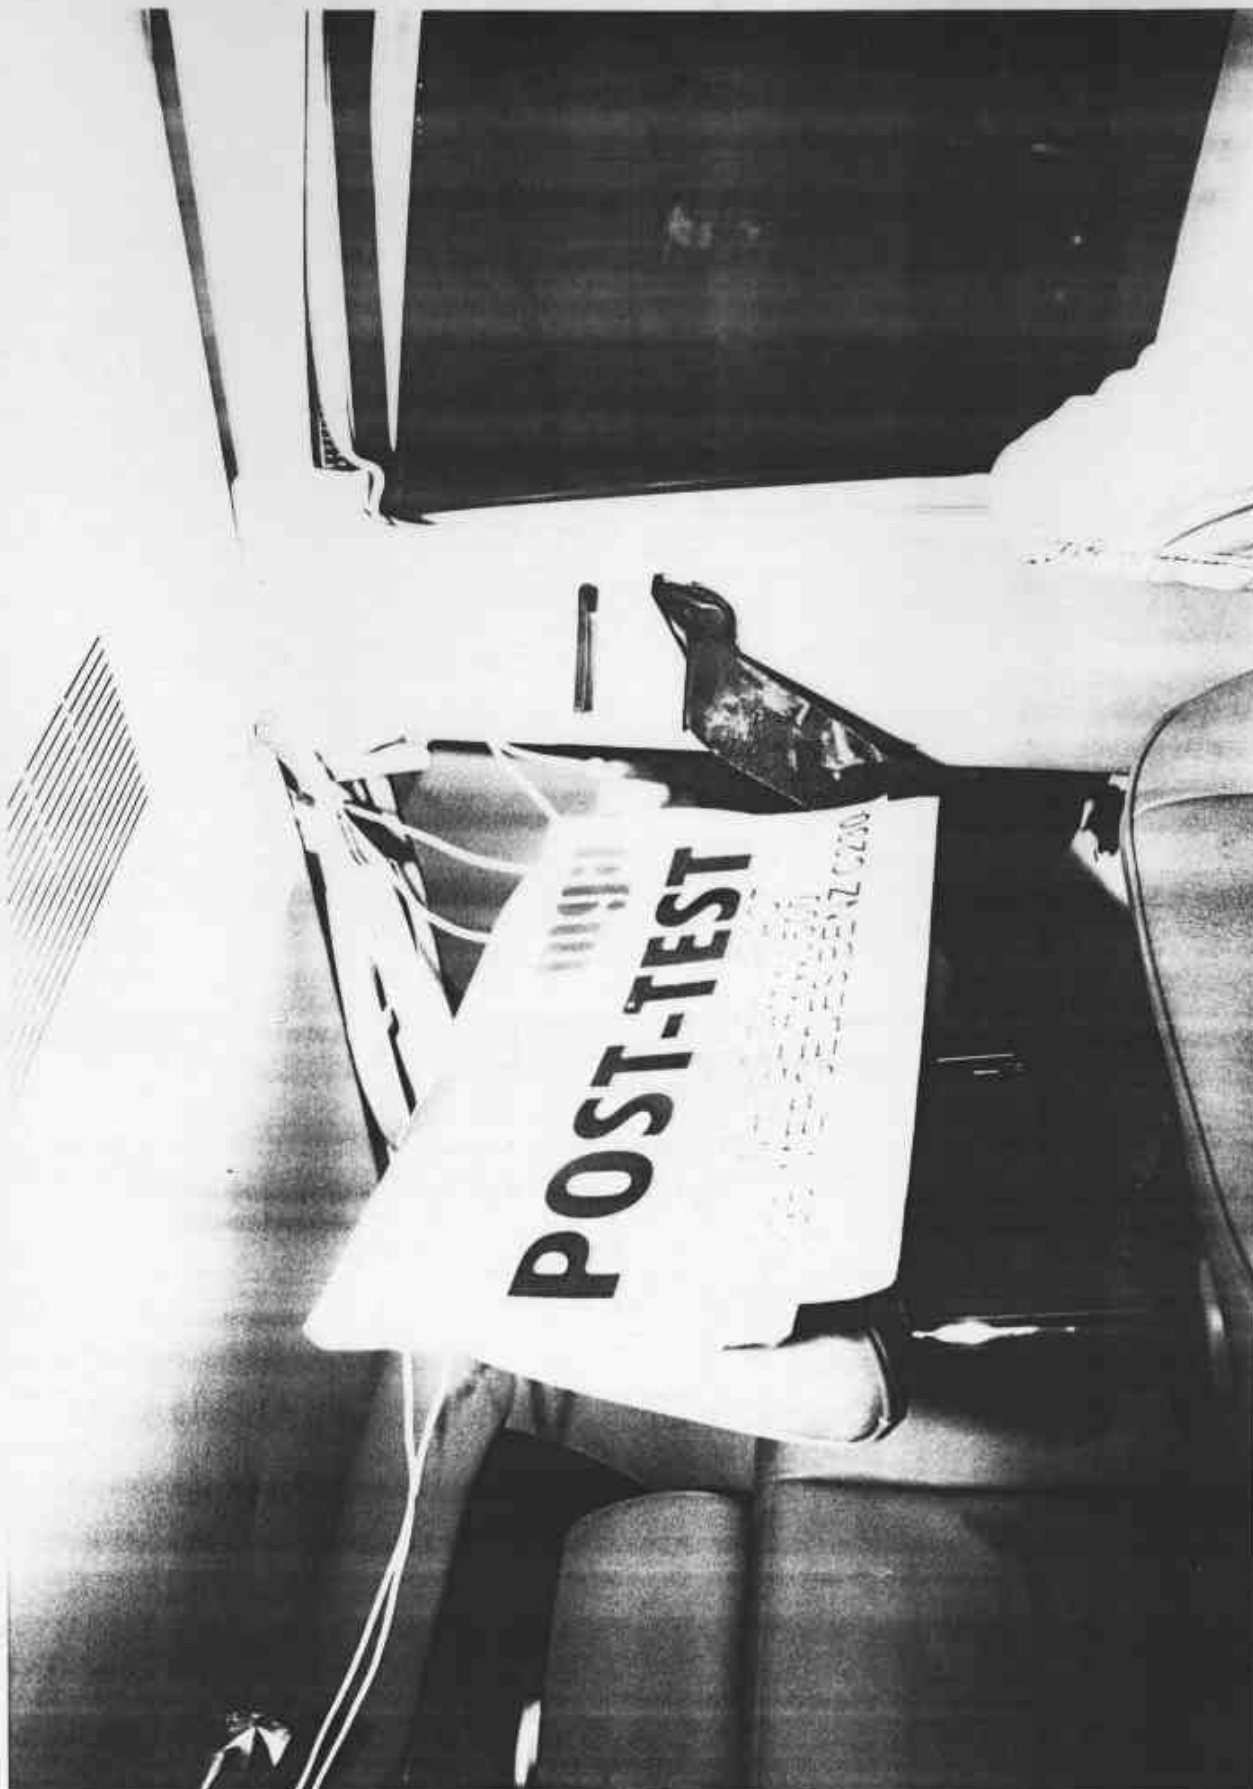
Photo No. A-29 - Post-Test Driver Dummy Head Contact

| | <u>LEFT FRONT SID</u> | <u>LEFT REAR SID</u> |
|---|---|---|
| Head | <u>B-post and side airbag</u> | <u>C-post and roof</u> |

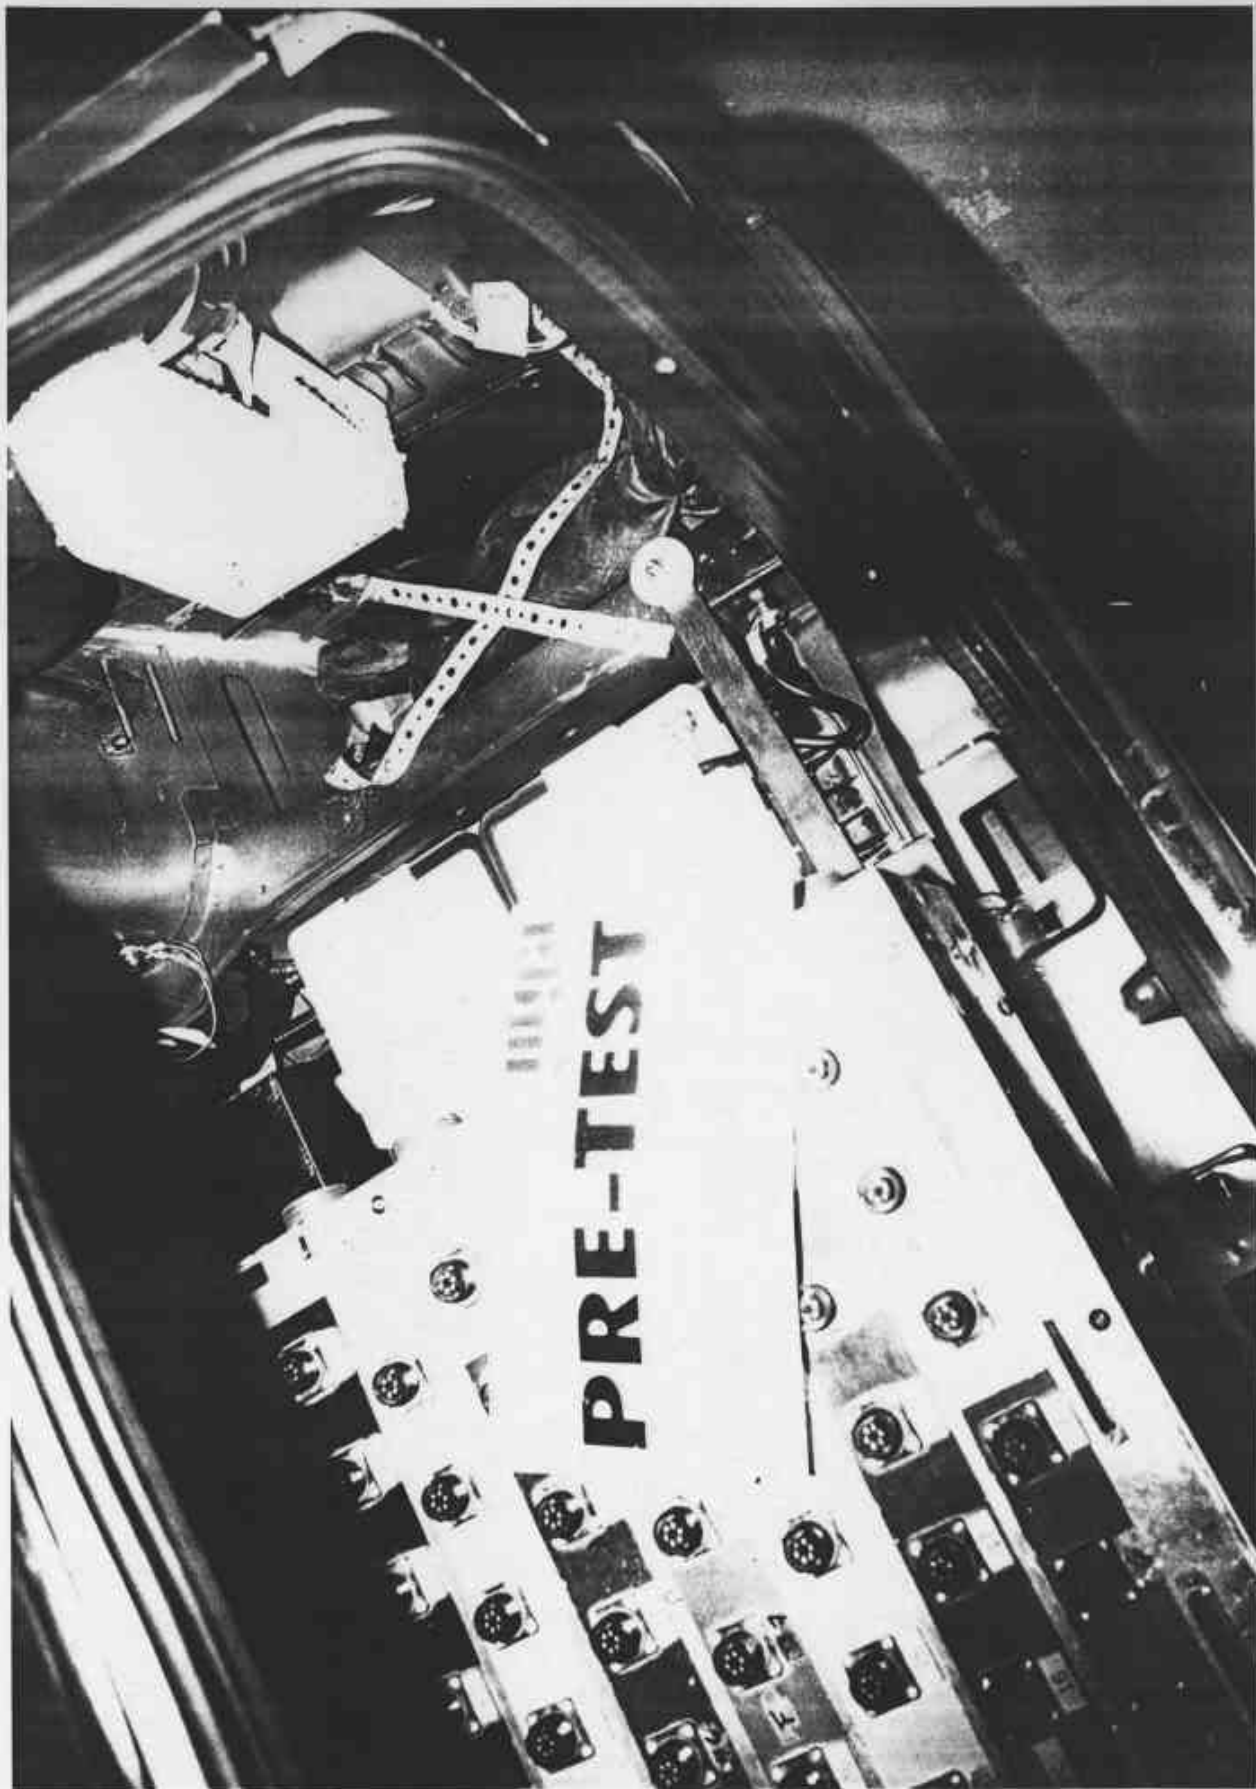
Photo No. A-41 - Added Vehicle Ballast
