REPORT NO. MGA-98-N03

NEW CAR ASSESSMENT PROGRAM (NCAP)

FRONTAL BARRIER IMPACT TEST

1998 TOYOTA CAMRY 4 DOOR
NHTSA NO. MW5100

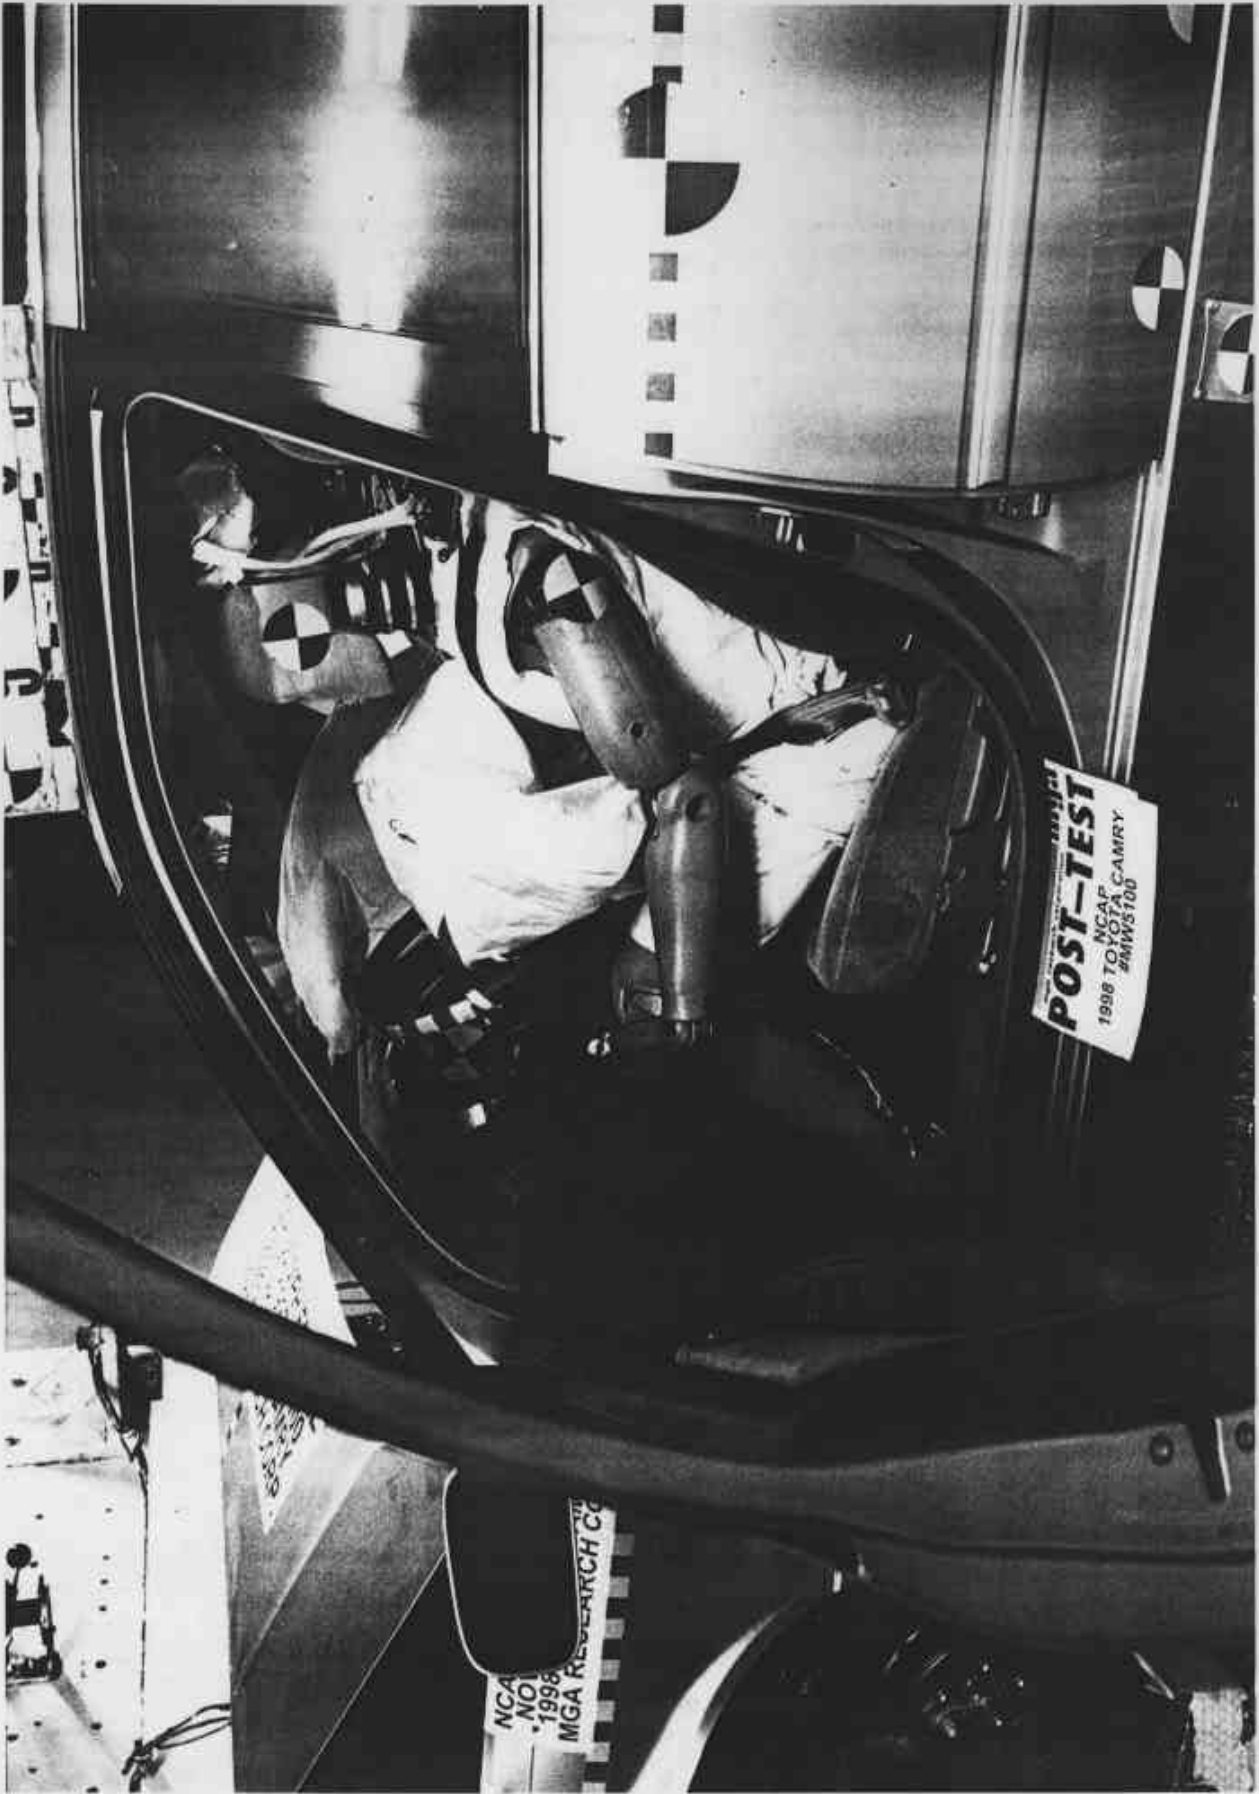
Photo No. A-29 - Post-Test Driver Dummy Position Left Side View (Door Open)

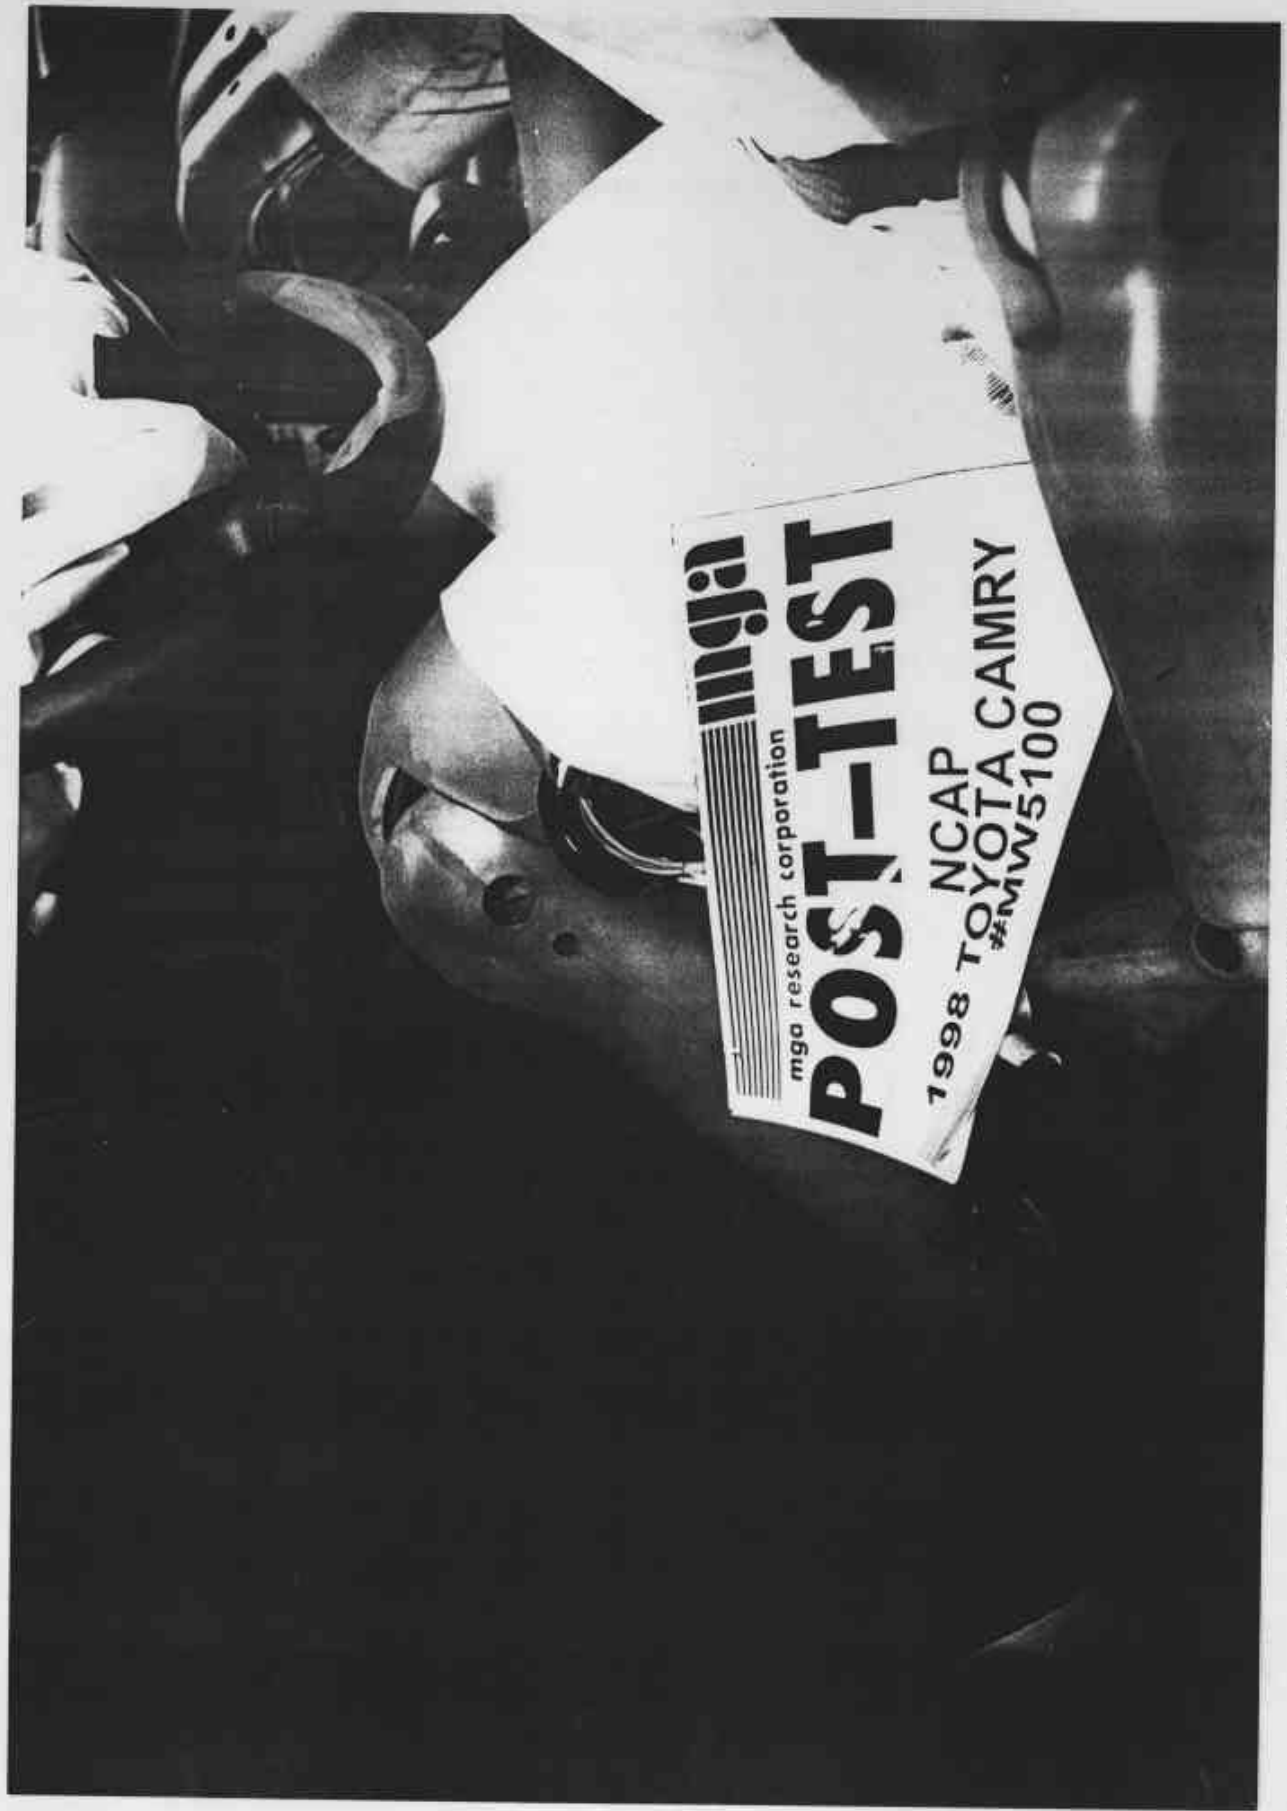
Photo No. A-33 - Post-Test Driver Dummy Knee Position

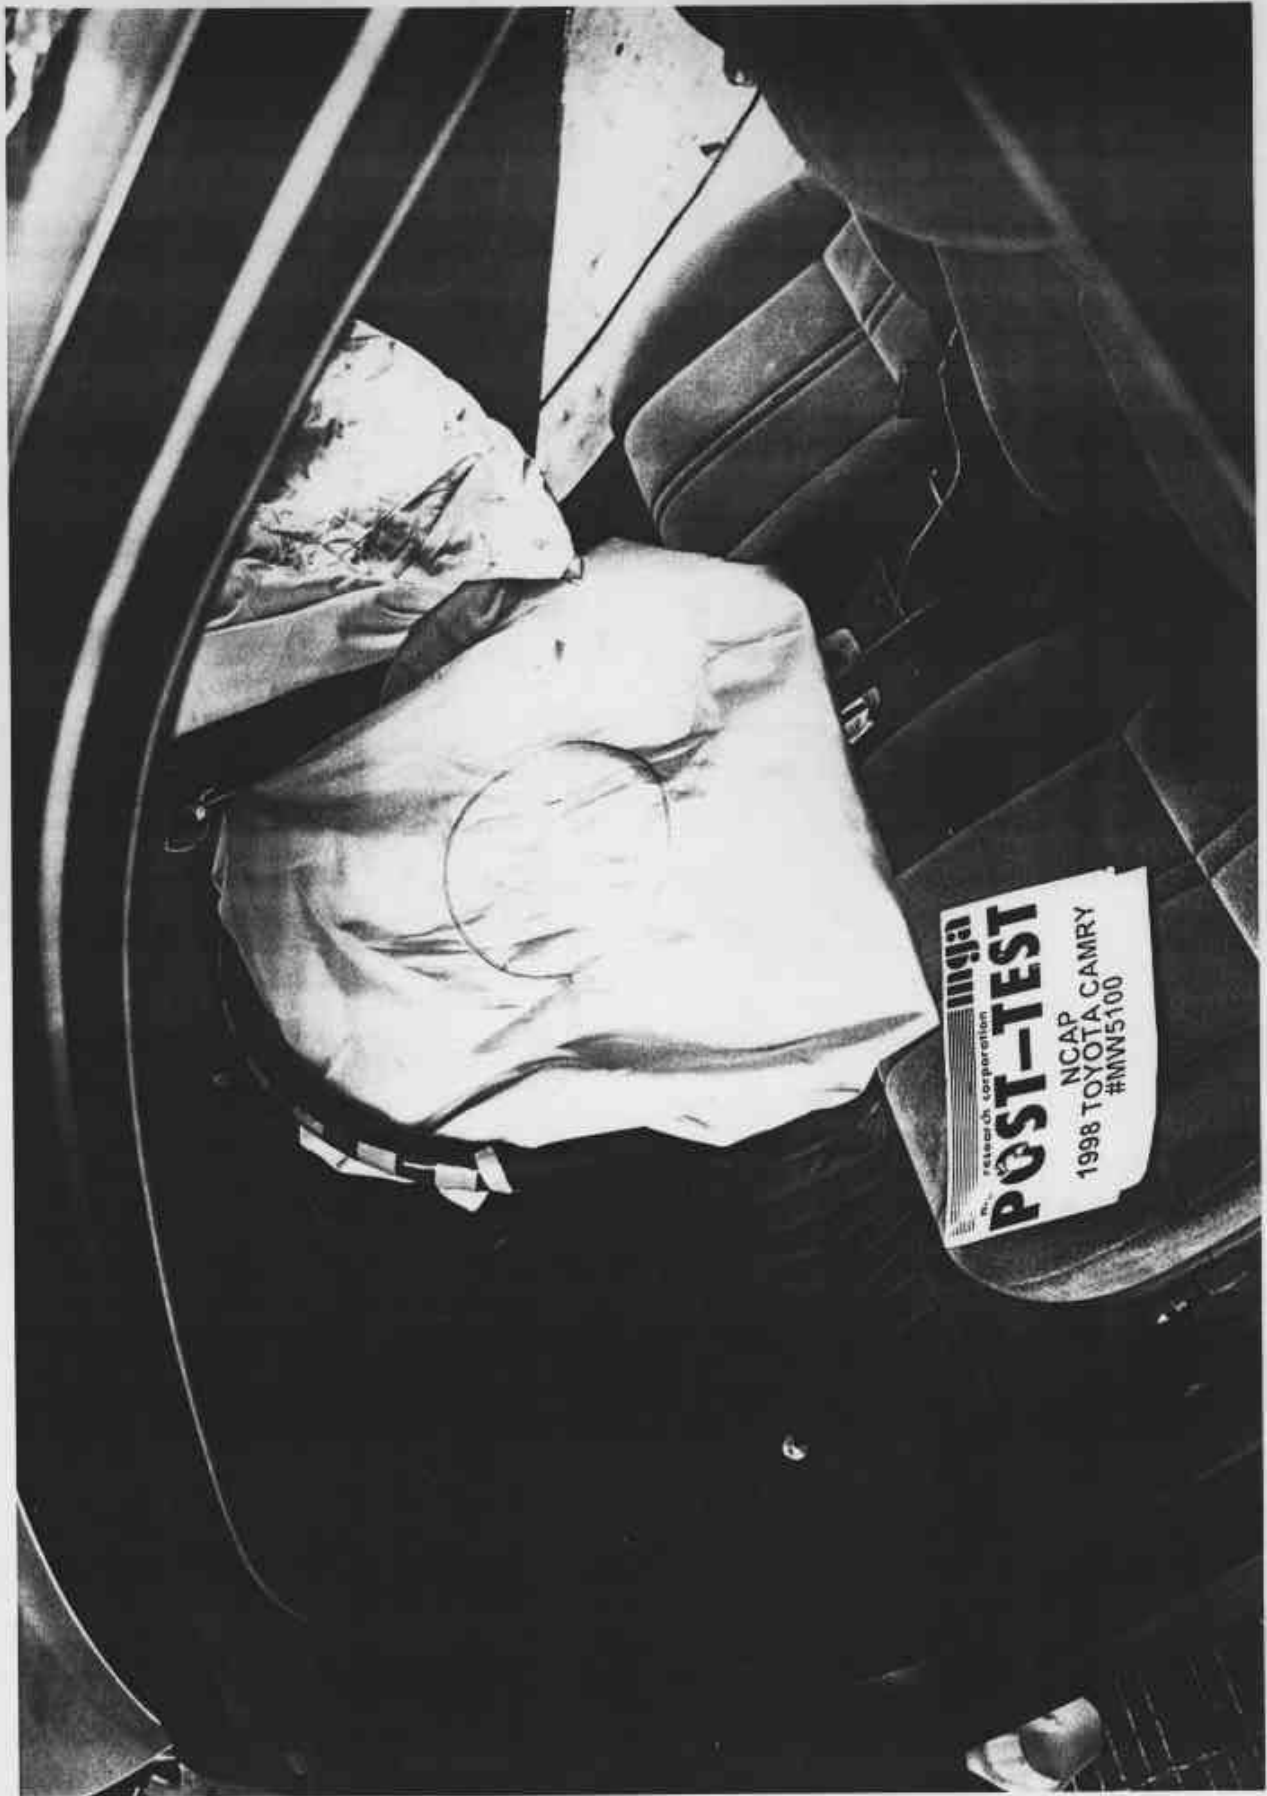
Photo No. A-34 - Post-Test Driver Airbag Contact

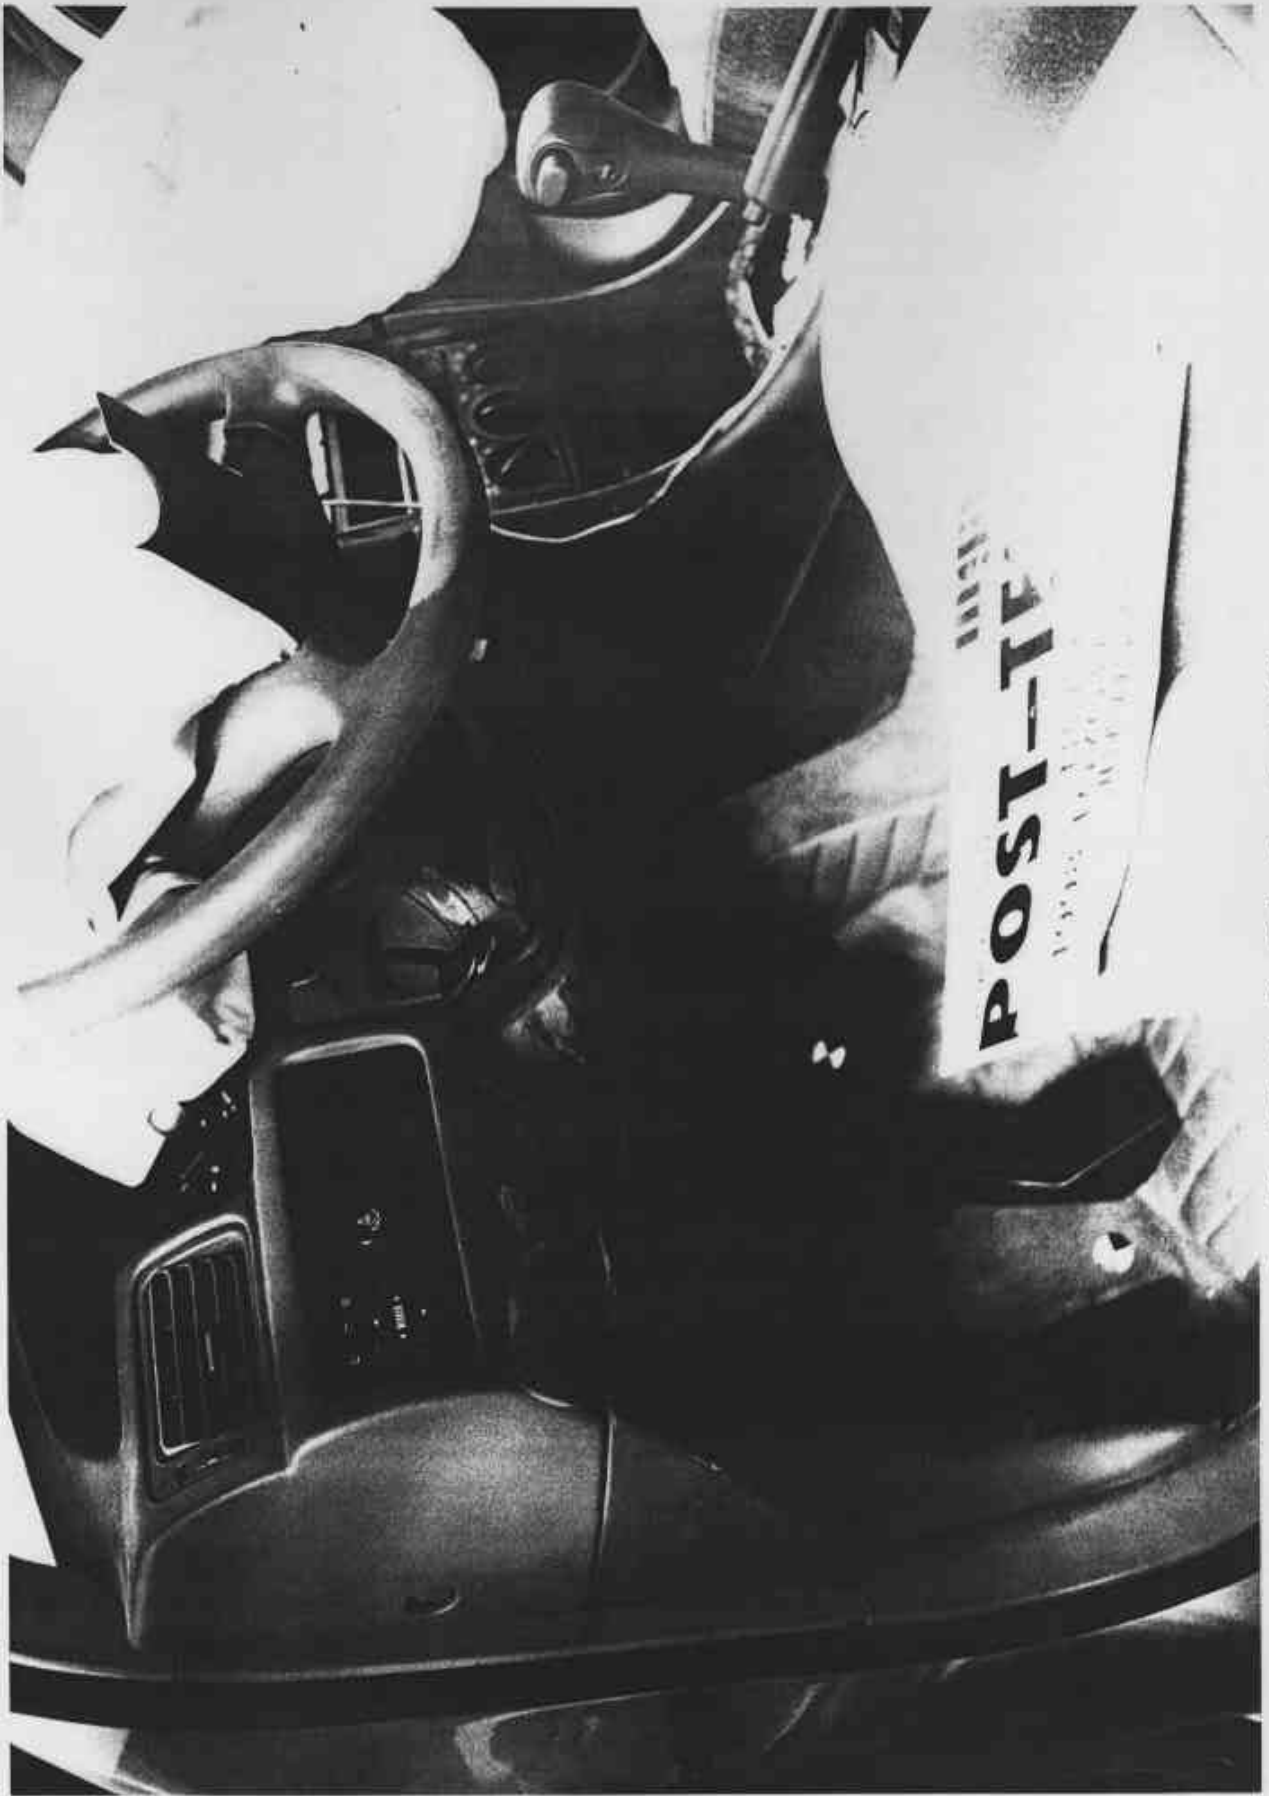
Photo No. A-35 - Post-Test Driver Knee Contact View

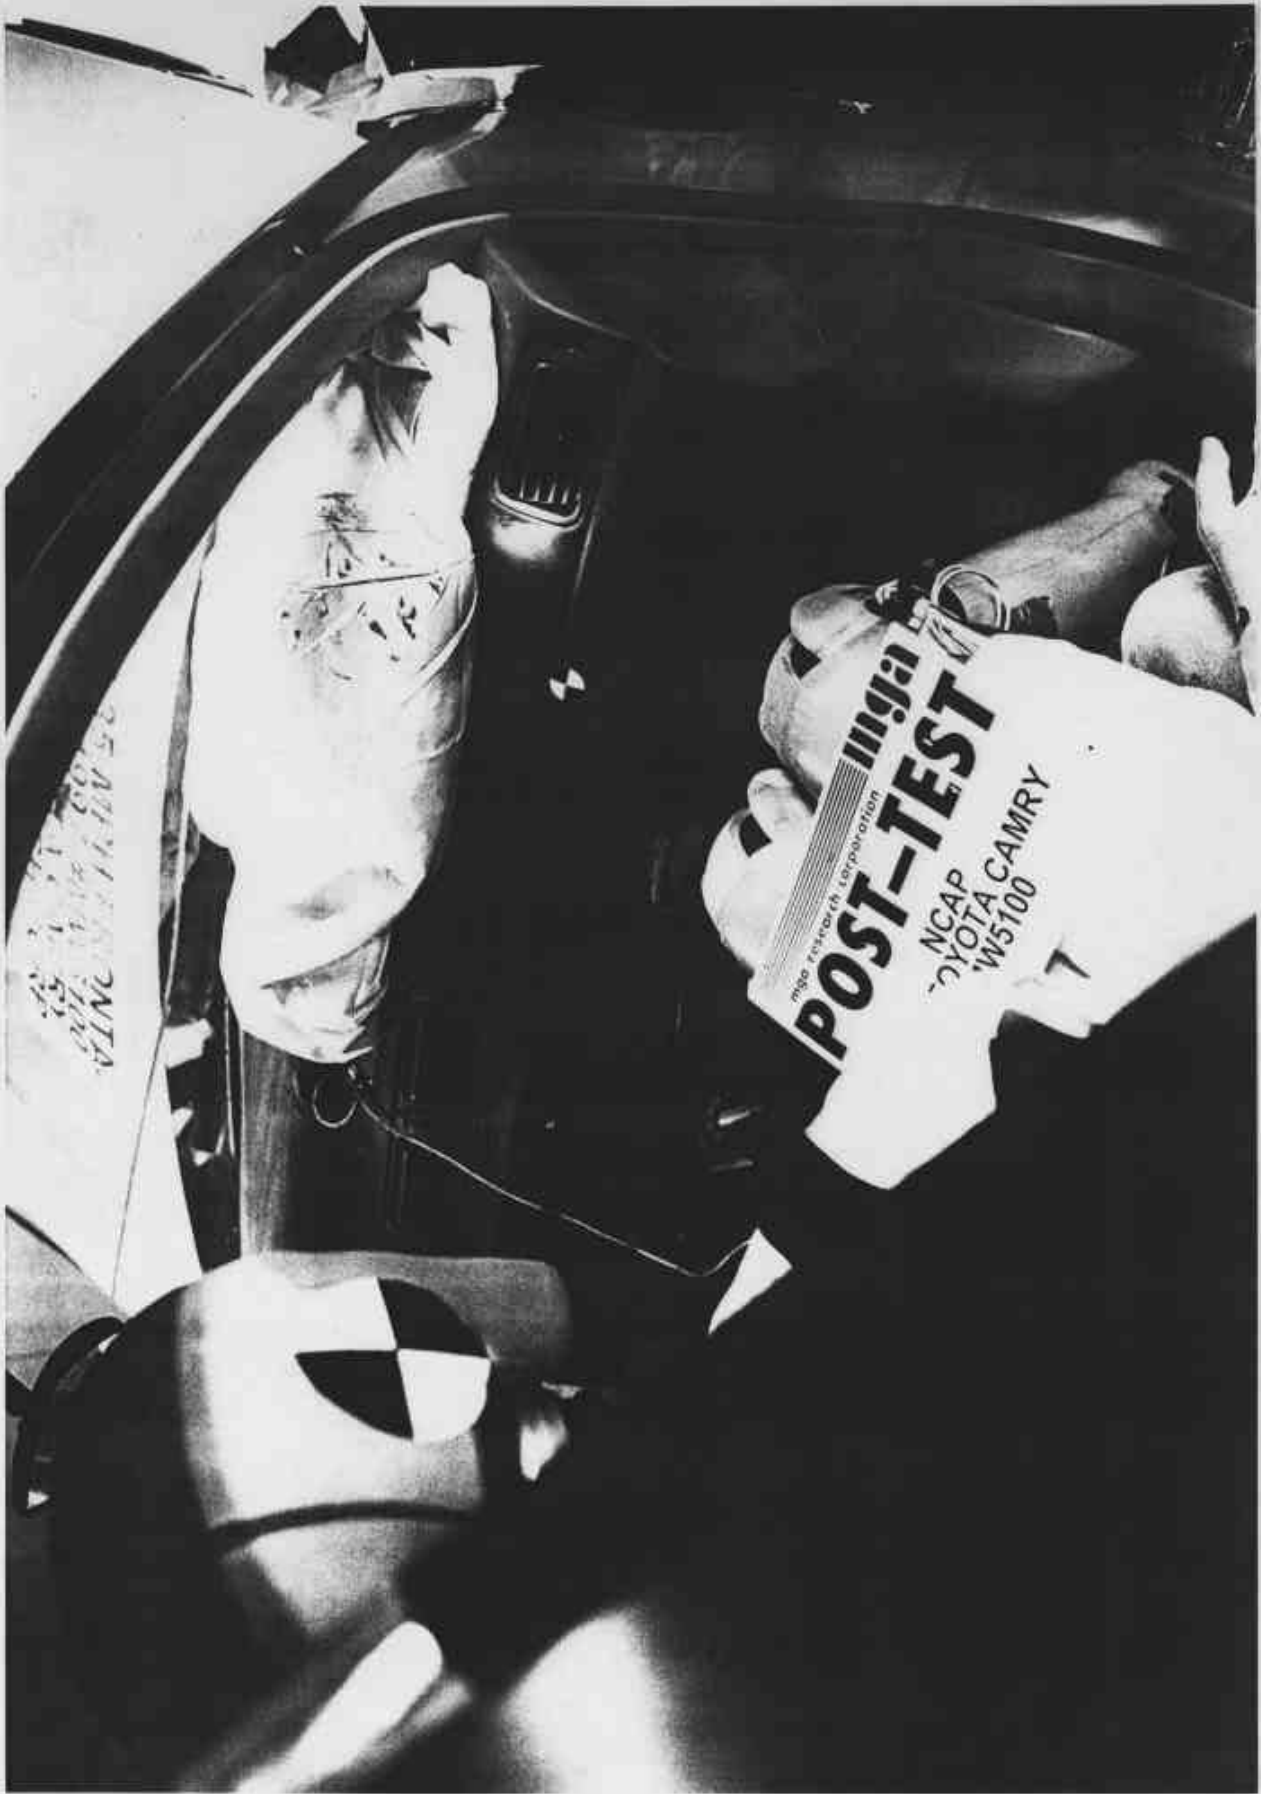
Photo No. A-43 - Post-Test Passenger Dummy Knee Position

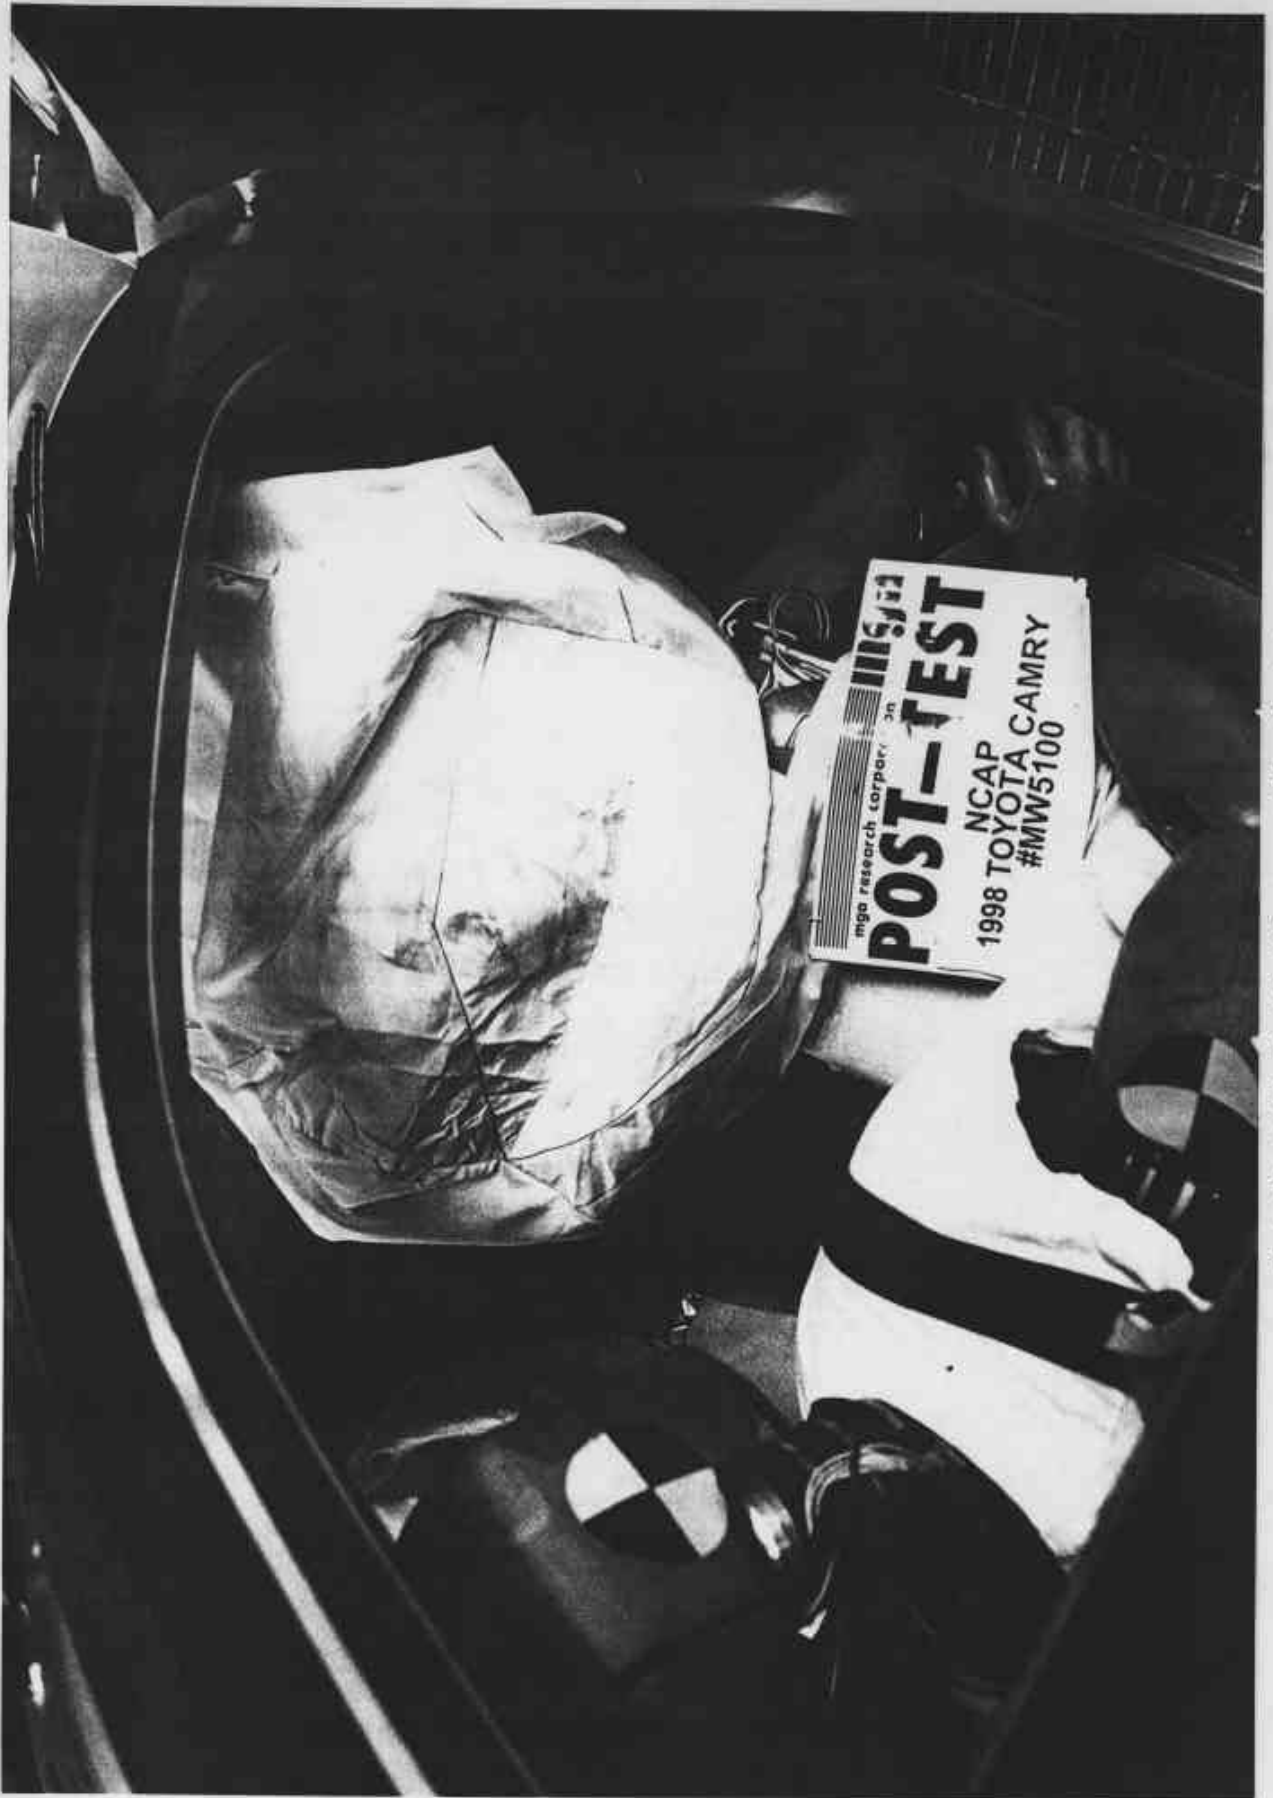
Photo No. A-44 - Post-Test Passenger Airbag Contact
