REPORT NO. KAR-98-1

NATIONAL HIGHWAY TRAFFIC SAFETY ADMINISTRATION
NEW CAR ASSESSMENT PROGRAM
FRONTAL BARRIER IMPACT TEST

GENERAL MOTORS CORPORATION
1998 CHEVROLET MALIBU
4-DOOR SEDAN
NHTSA NO. MW0106

PREPARED BY:
KARCO ENGINEERING
9270 HOLLY ROAD
ADELANTO, CALIFORNIA 92301

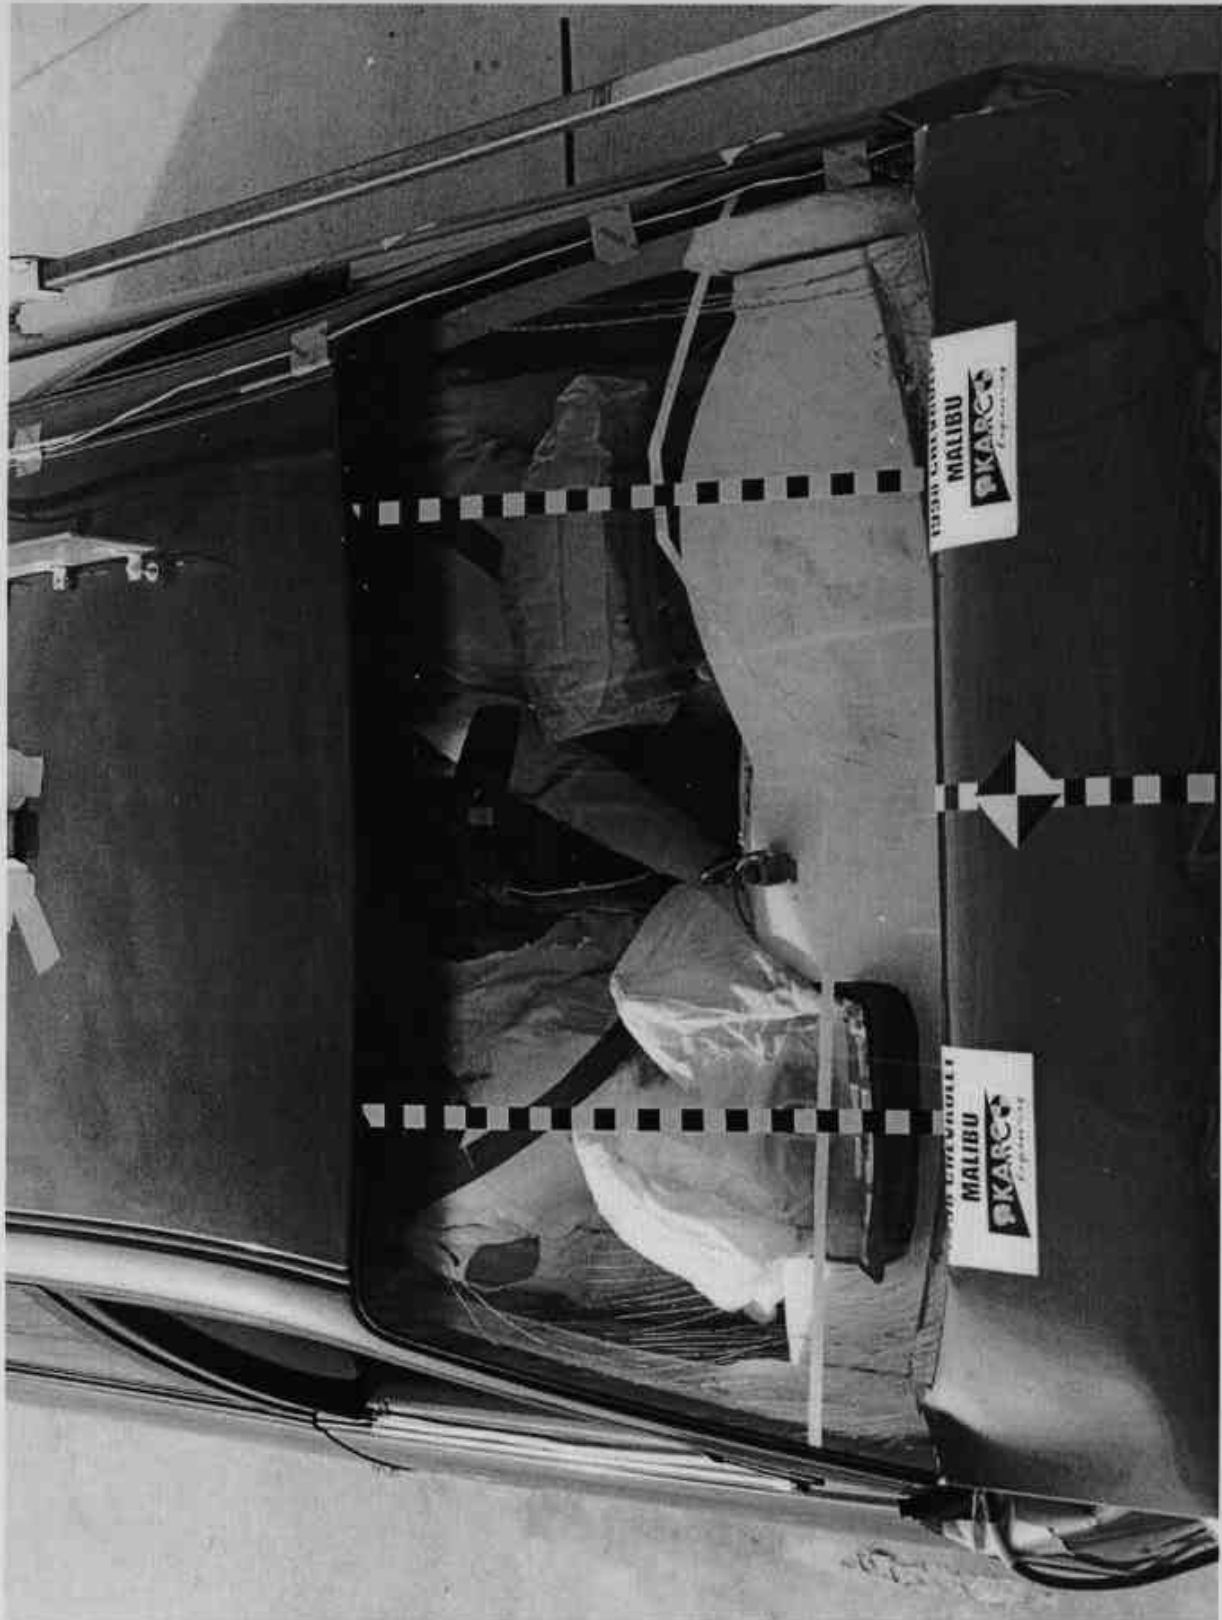
FIGURE A-16. POST TEST WINDSHIELD

There was 100 percent windshield retention, no intrusion into the protected or unprotected zone of the windshield, and no Stoddard solvent leakage occurred after impact or during any phase of the rollover.

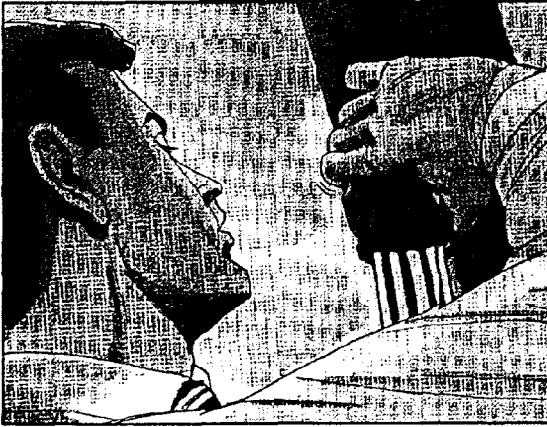
Shoulder Belt Height Adjuster

Before you begin to drive, move the shoulder belt adjuster to the height that is right for you.

To move it down, squeeze the release button and move the adjuster to the desired position. You can move the adjuster up just by pushing up on the shoulder belt guide. After you move the adjuster to where you want it, try to move it down without squeezing the release button to make sure it has locked into position.

Adjust the height so that the shoulder portion of the belt is centered on your shoulder. The belt should be away from your face and neck, but not falling off your shoulder.
