REPORT NO.: 214D-MGA-98-09

NEW CAR ASSESSMENT PROGRAM  
SIDE IMPACT TESTING  
PASSENGER CARS

1998 MAZDA 626  
4-DOOR SEDAN  
NHTSA NO: MW5401

MGA PROVING GROUNDS  
5000 WARREN ROAD  
BURLINGTON, WI 53105

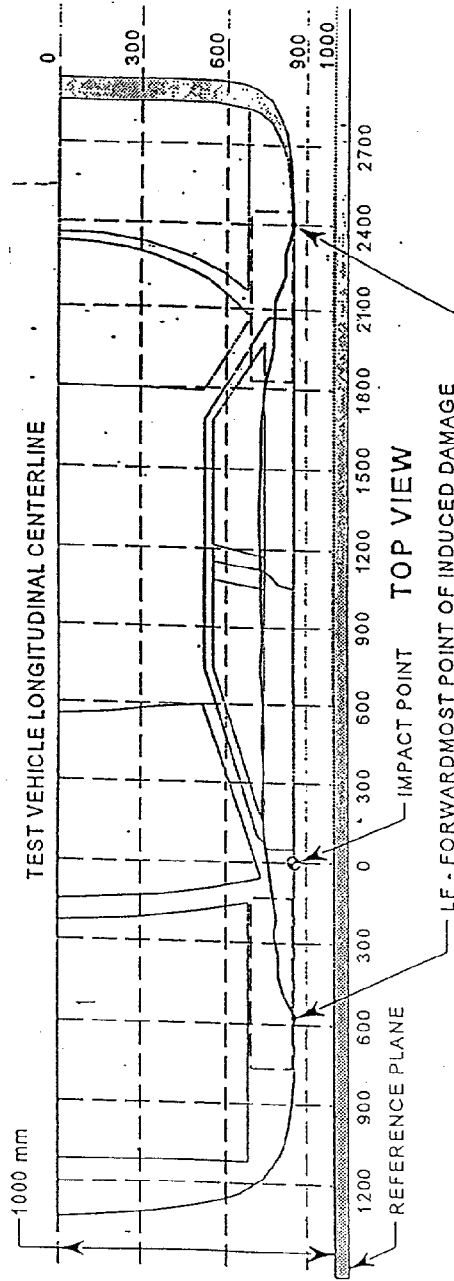
VEHICLE DAMAGE PROFILE DISTANCES

MEASUREMENT CONVENTIONS:  
 LR - REARWARDMOST POINT OF INDUCED DAMAGE  
 Forward of the impact point (towards front of vehicle) is considered negative (-).  
 Rearward of the impact point (toward rear of vehicle) is considered positive (+).

DPD MEASUREMENTS	POST-TEST (mm)	PRE-TEST (mm)	STATIC CRUSH (mm)
1. (LF = <u>-1050</u> mm)	712	705	7
2. <u>-210</u> mm	675	634	41
3. <u>630</u> mm	1045	625	420
4. <u>1470</u> mm	1082	622	460
5. <u>2310</u> mm	926	626	300
6. (LR = <u>3140</u> mm)	720	720	0

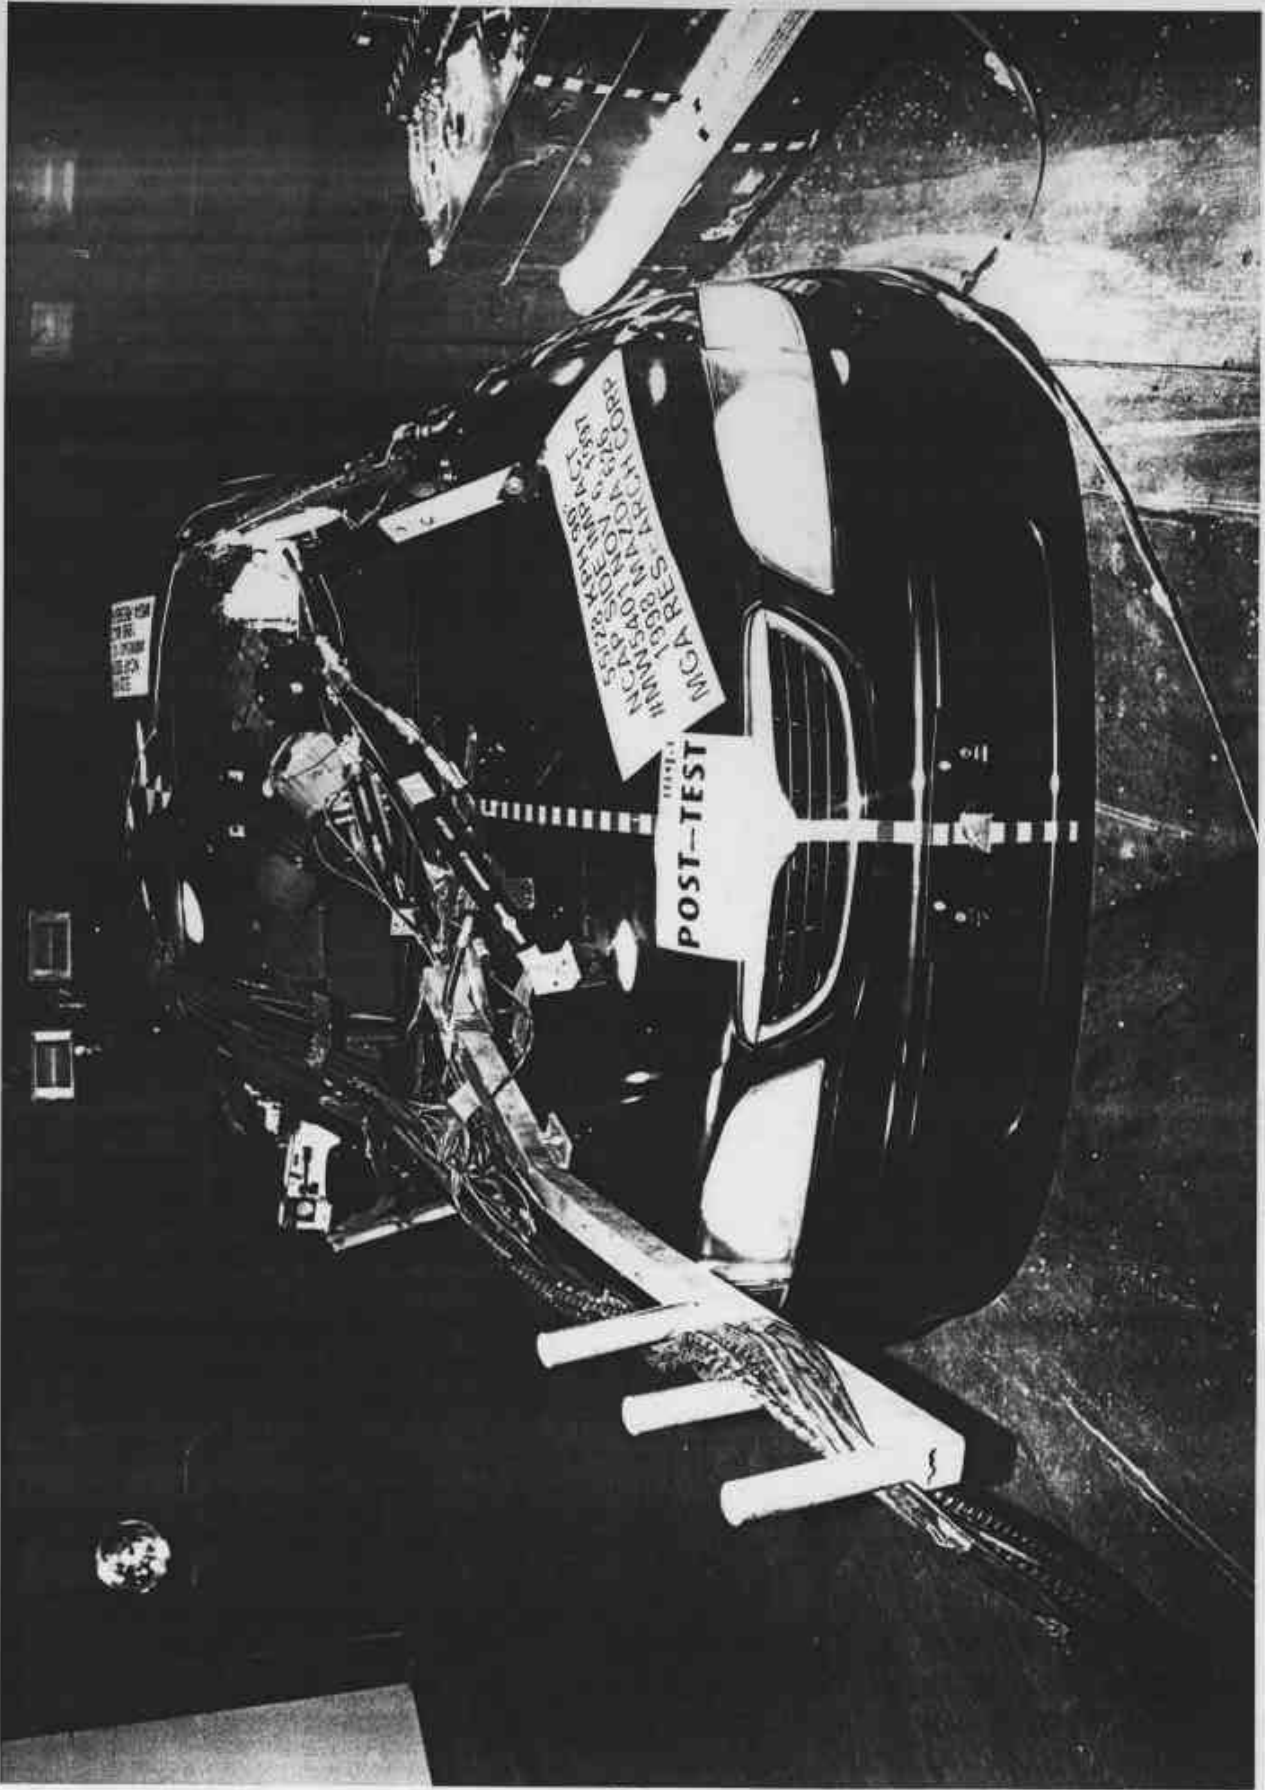
Photo No. A-2 - Post-Test Front View of Test Vehicle

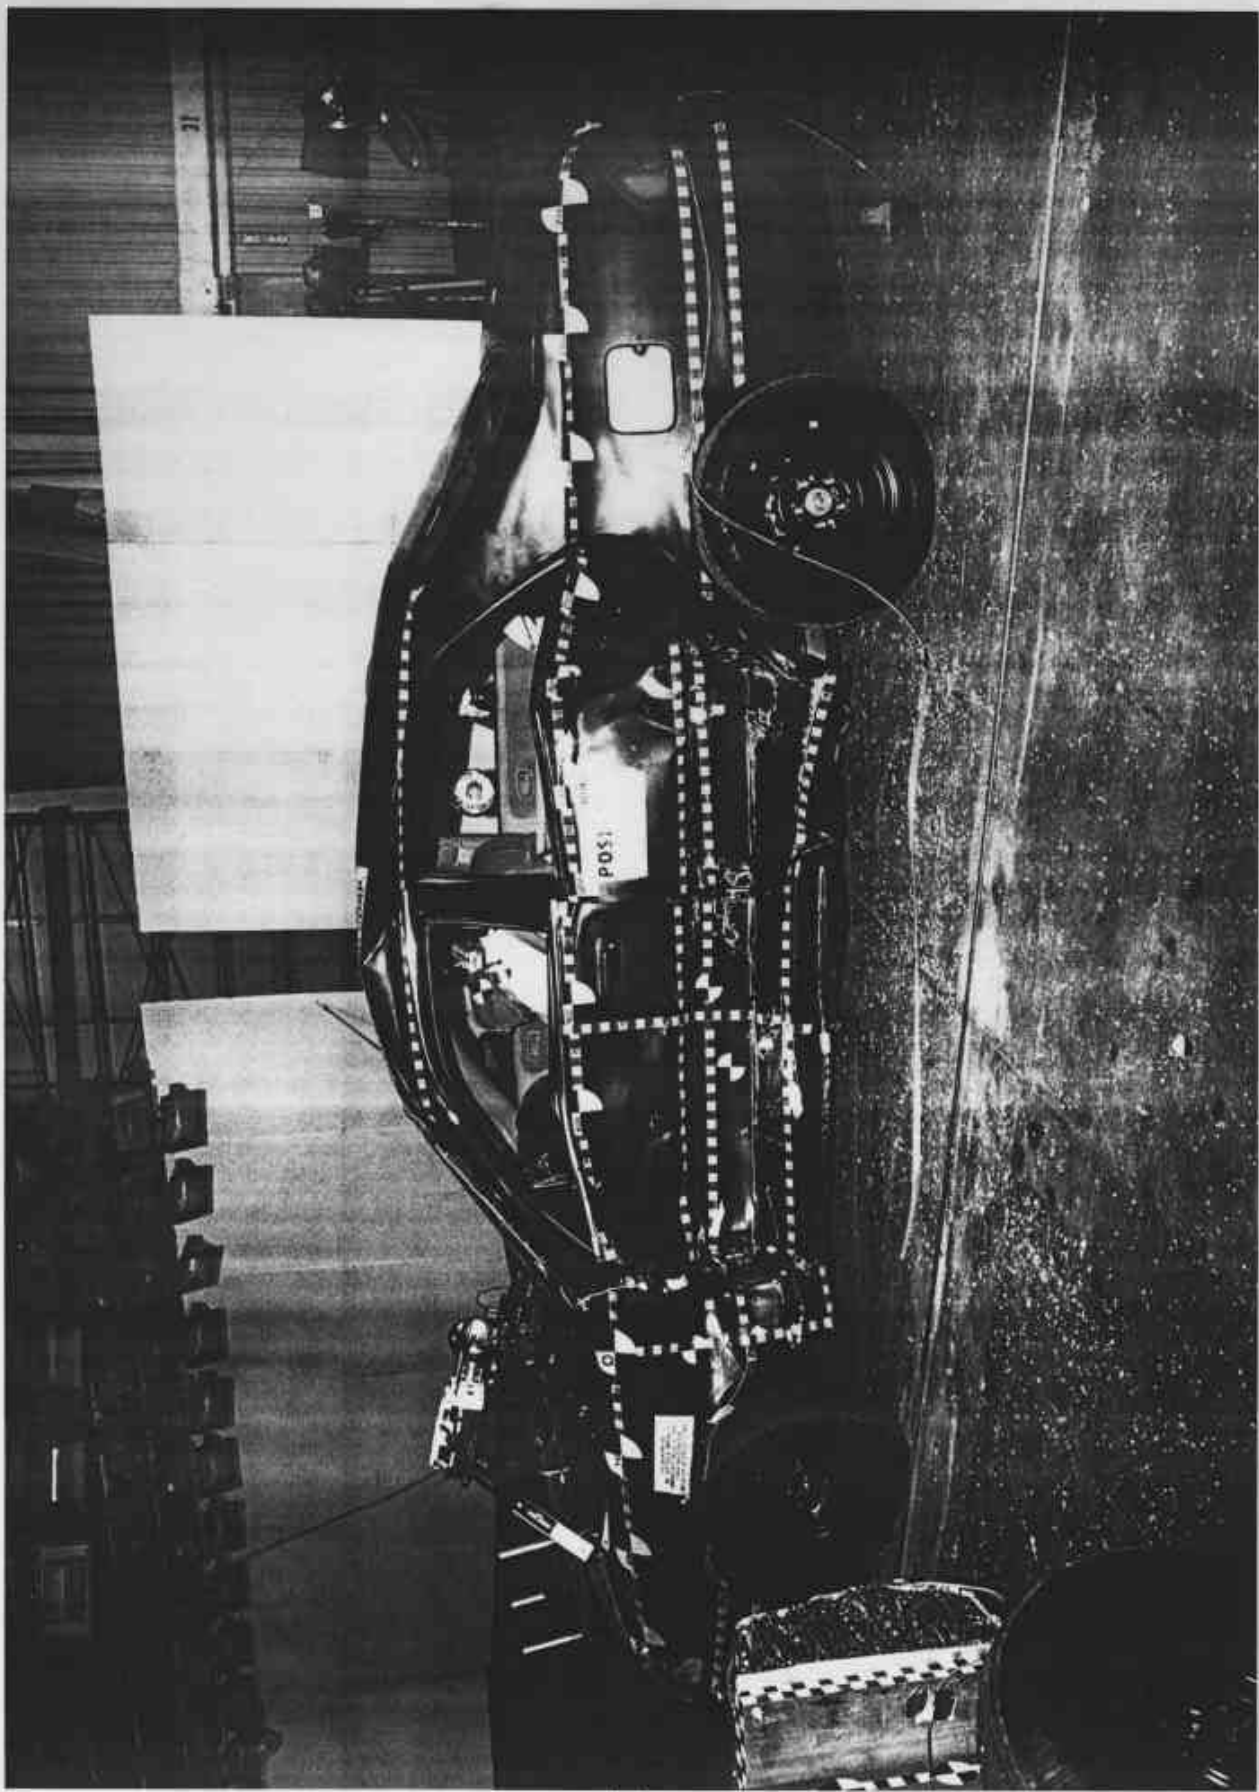
Photo No. A-6 - Post-Test Left Side View of Test Vehicle

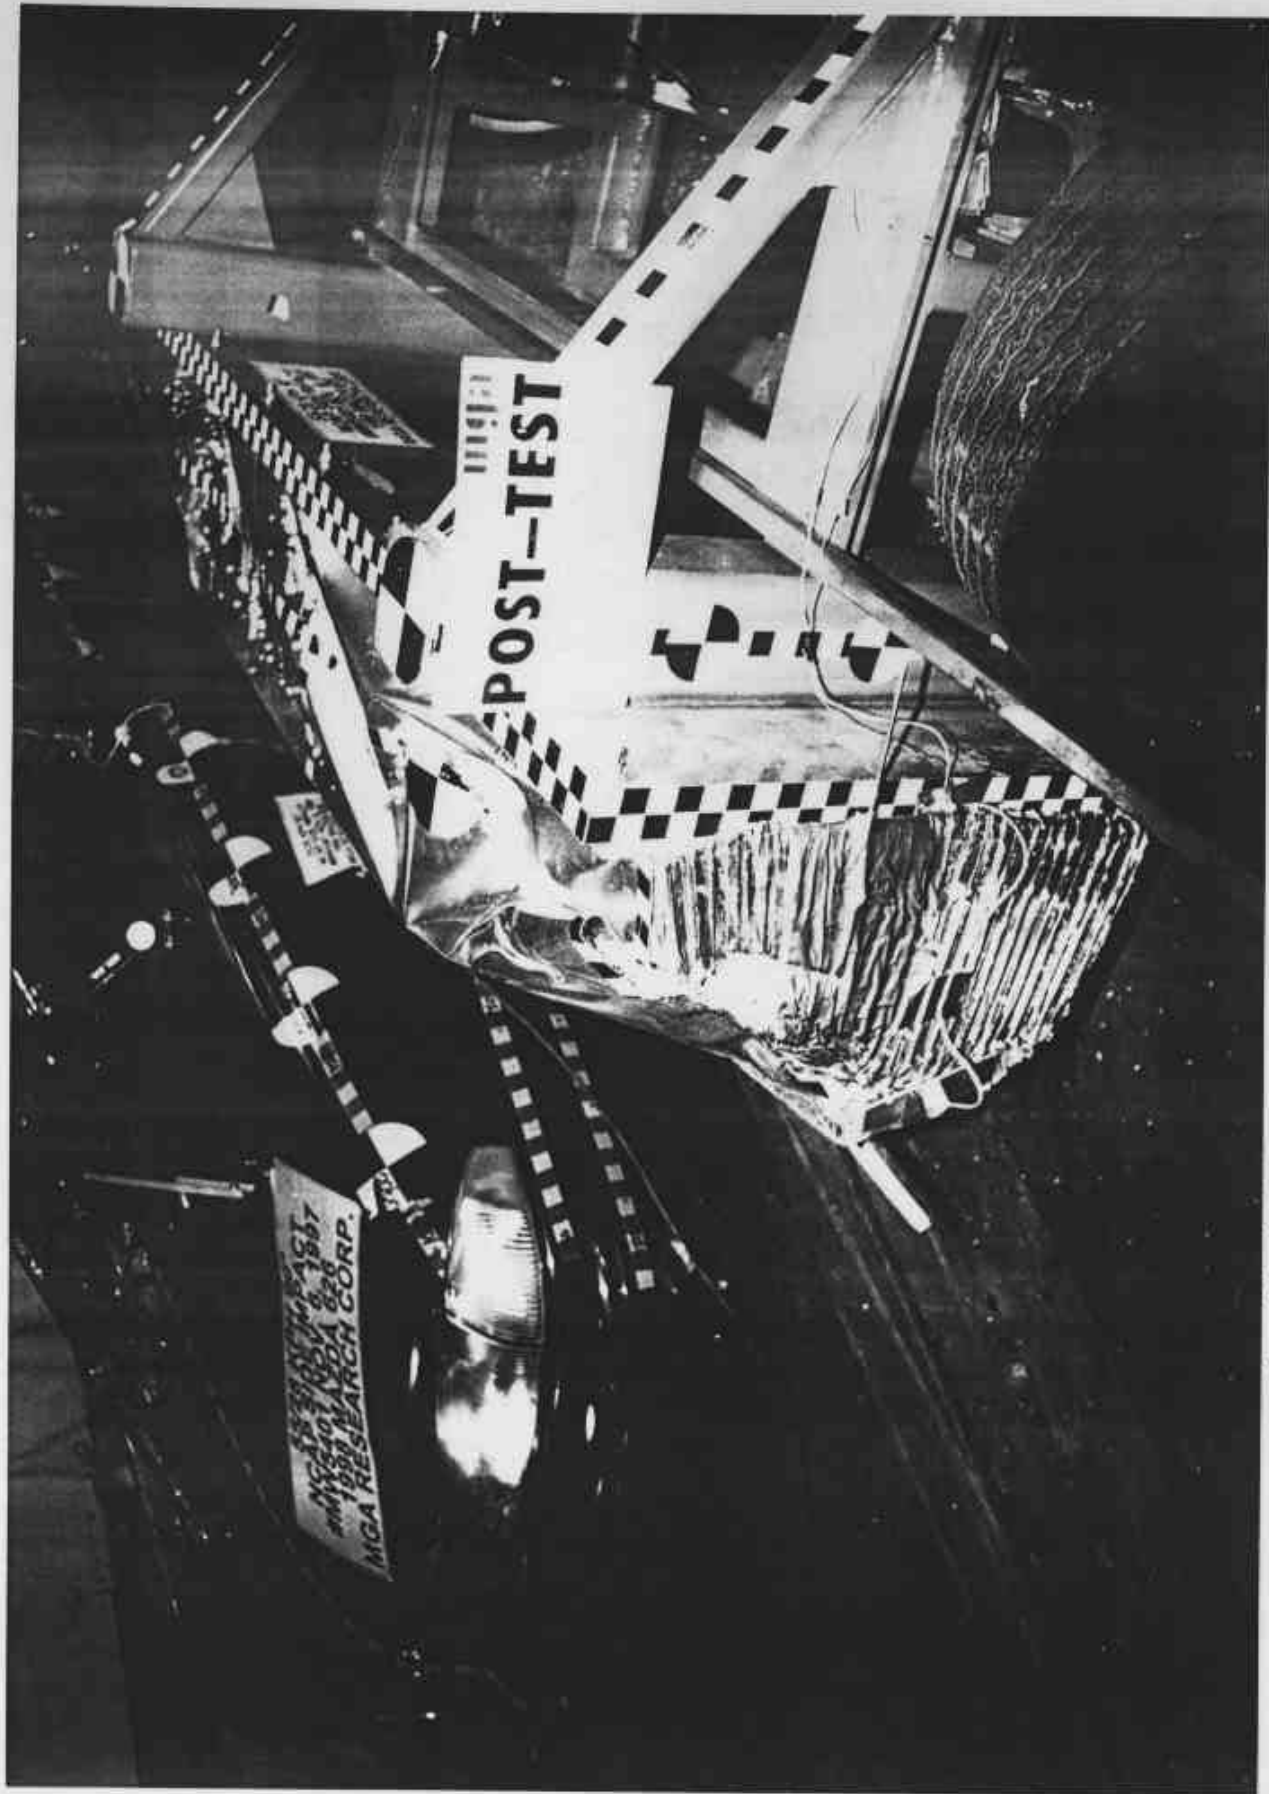
Photo No. A-10 - Post-Test MDB Positioned Against Vehicle (left side)

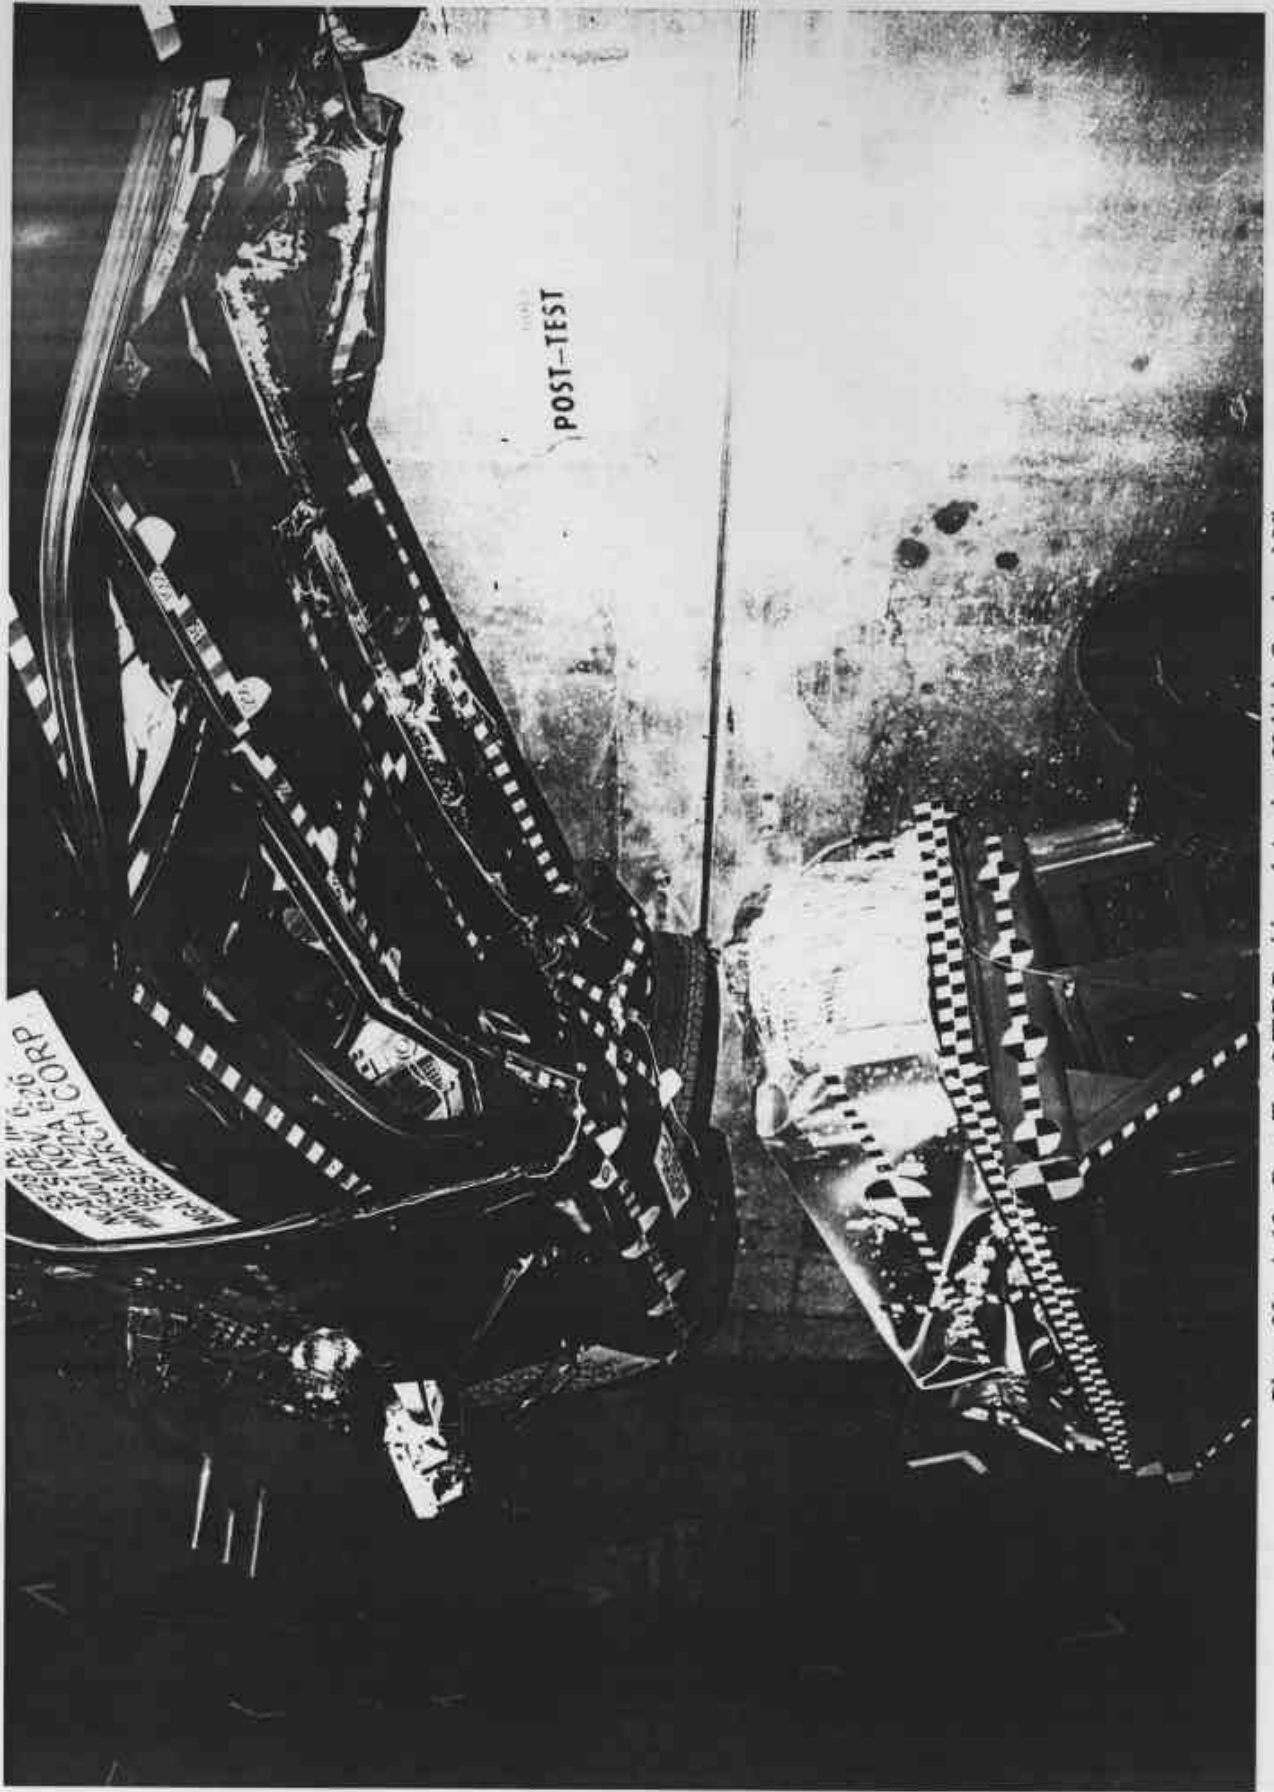
Photo No. A-12 - Post-Test MDB Positioned Against Vehicle Overhead View

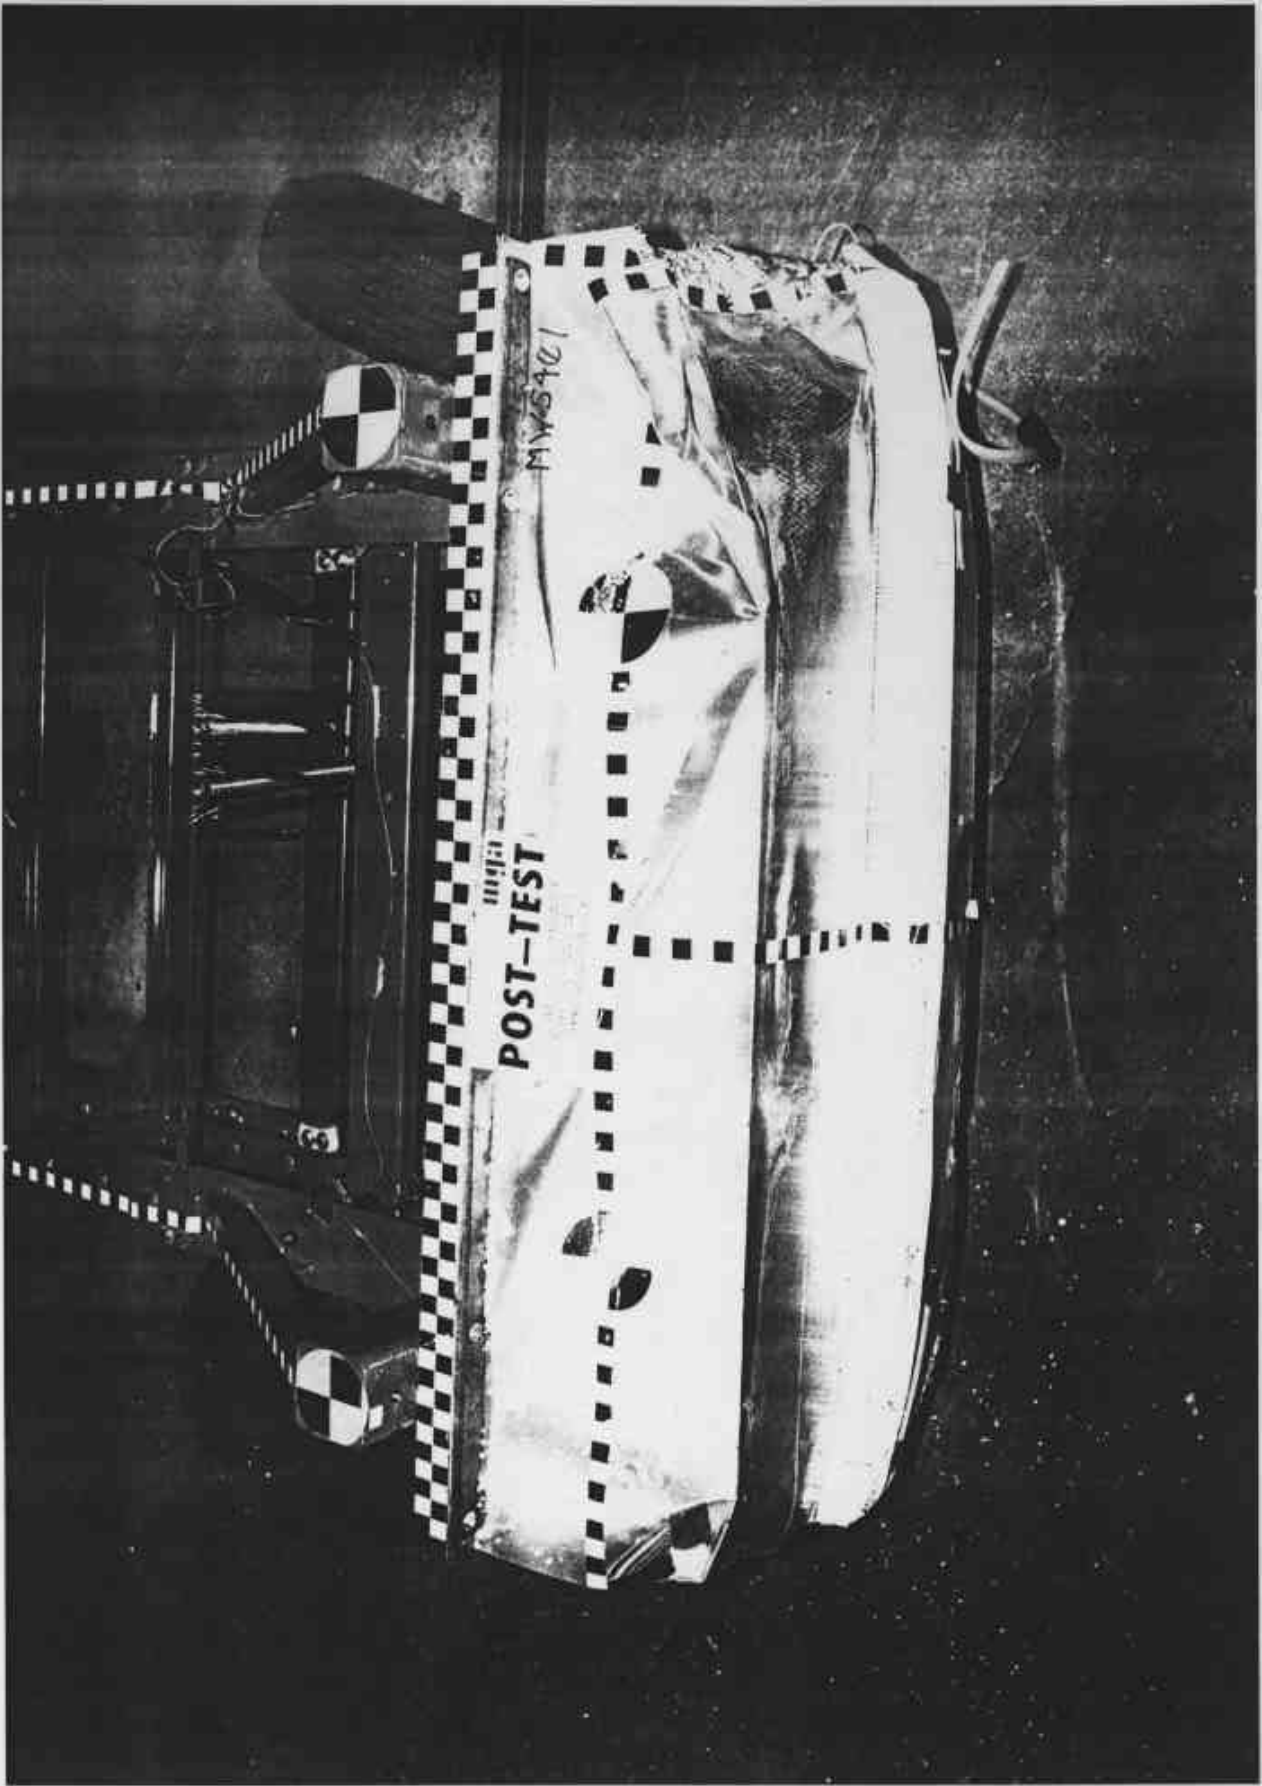
Photo No. A-14 - Post-Test MDB Top View

1. Row A Top of Stack (813 mm) = 190 mm
2. Row B Mid Stack (686 mm) = 155 mm
3. Row C Top of Bumper (533 mm) = 72 mm
4. Row D Center of Bumper (432 mm) = 116 mm

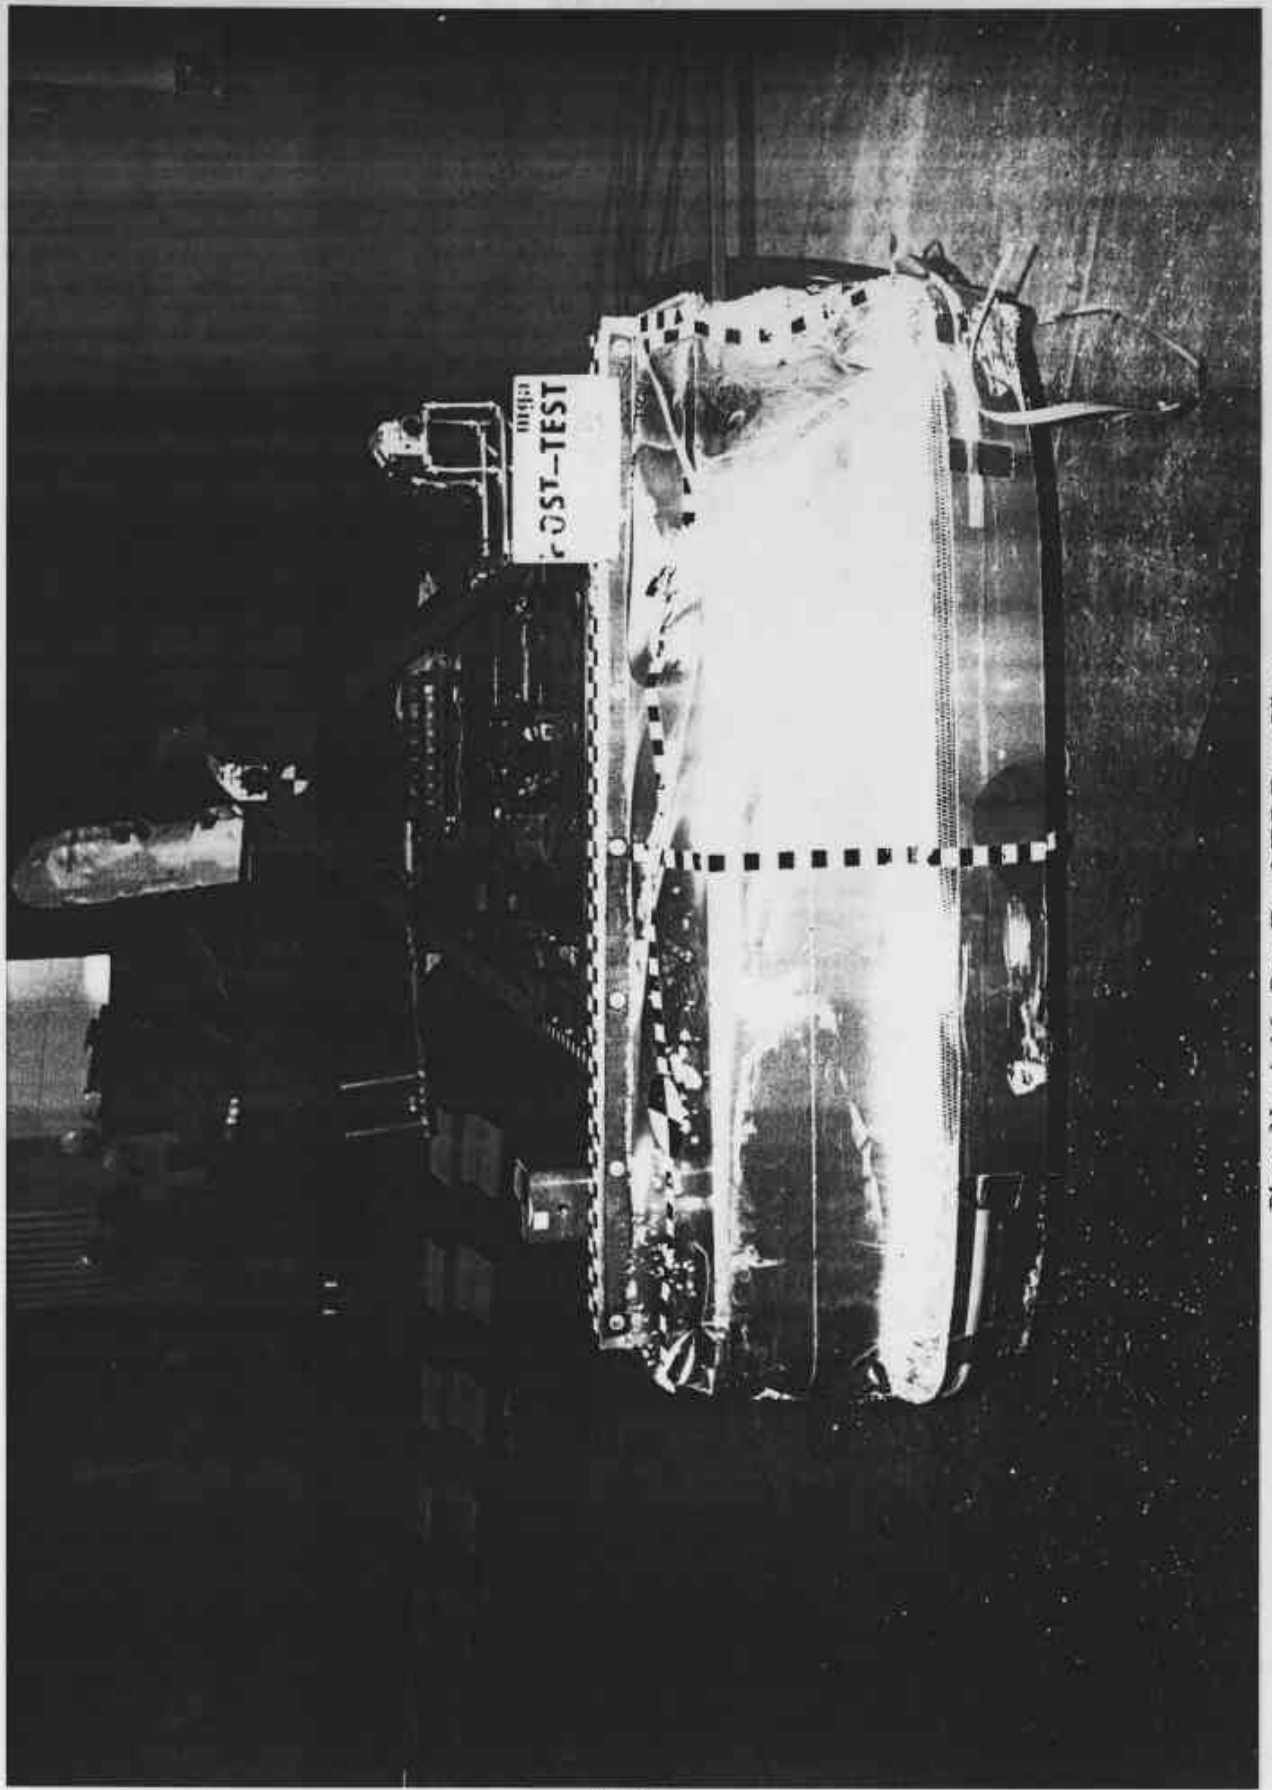
Photo No. A-16 - Post-Test MDB Front View

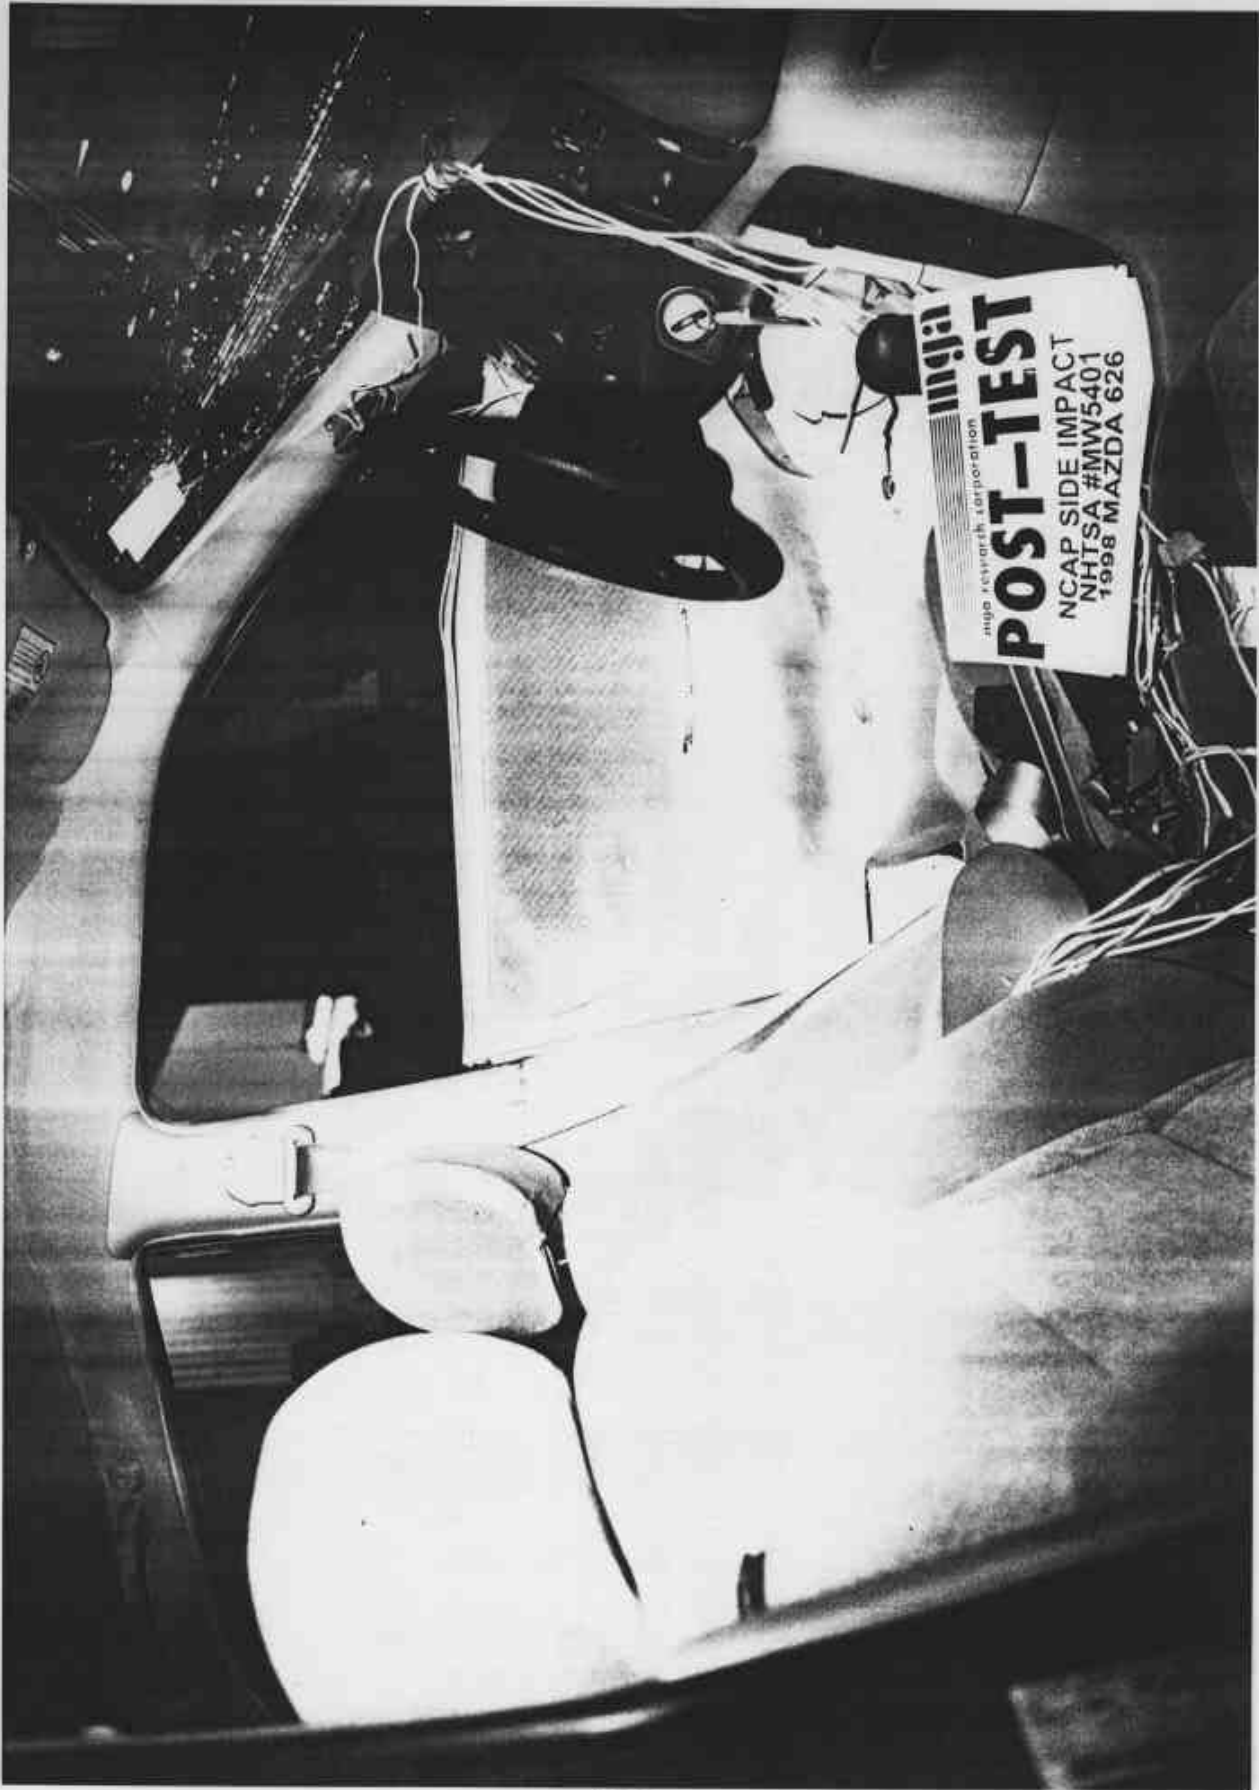
Photo No. A-28 - Post-Test Driver Dummy Contact

<u>LEFT FRONT SID</u>	<u>LEFT REAR SID</u>
Head	<u>to D-ring and left shoulder</u>	<u>to C-post and rear header</u>
Arm	<u>to upper door panel</u>	<u>to upper door panel</u>
Pelvis	<u>to lower door panel</u>	<u>to door panel</u>
Left Knee	<u>to door panel</u>	<u>to mid door panel</u>
Right Knee	<u>to left knee</u>	<u>to left knee</u>

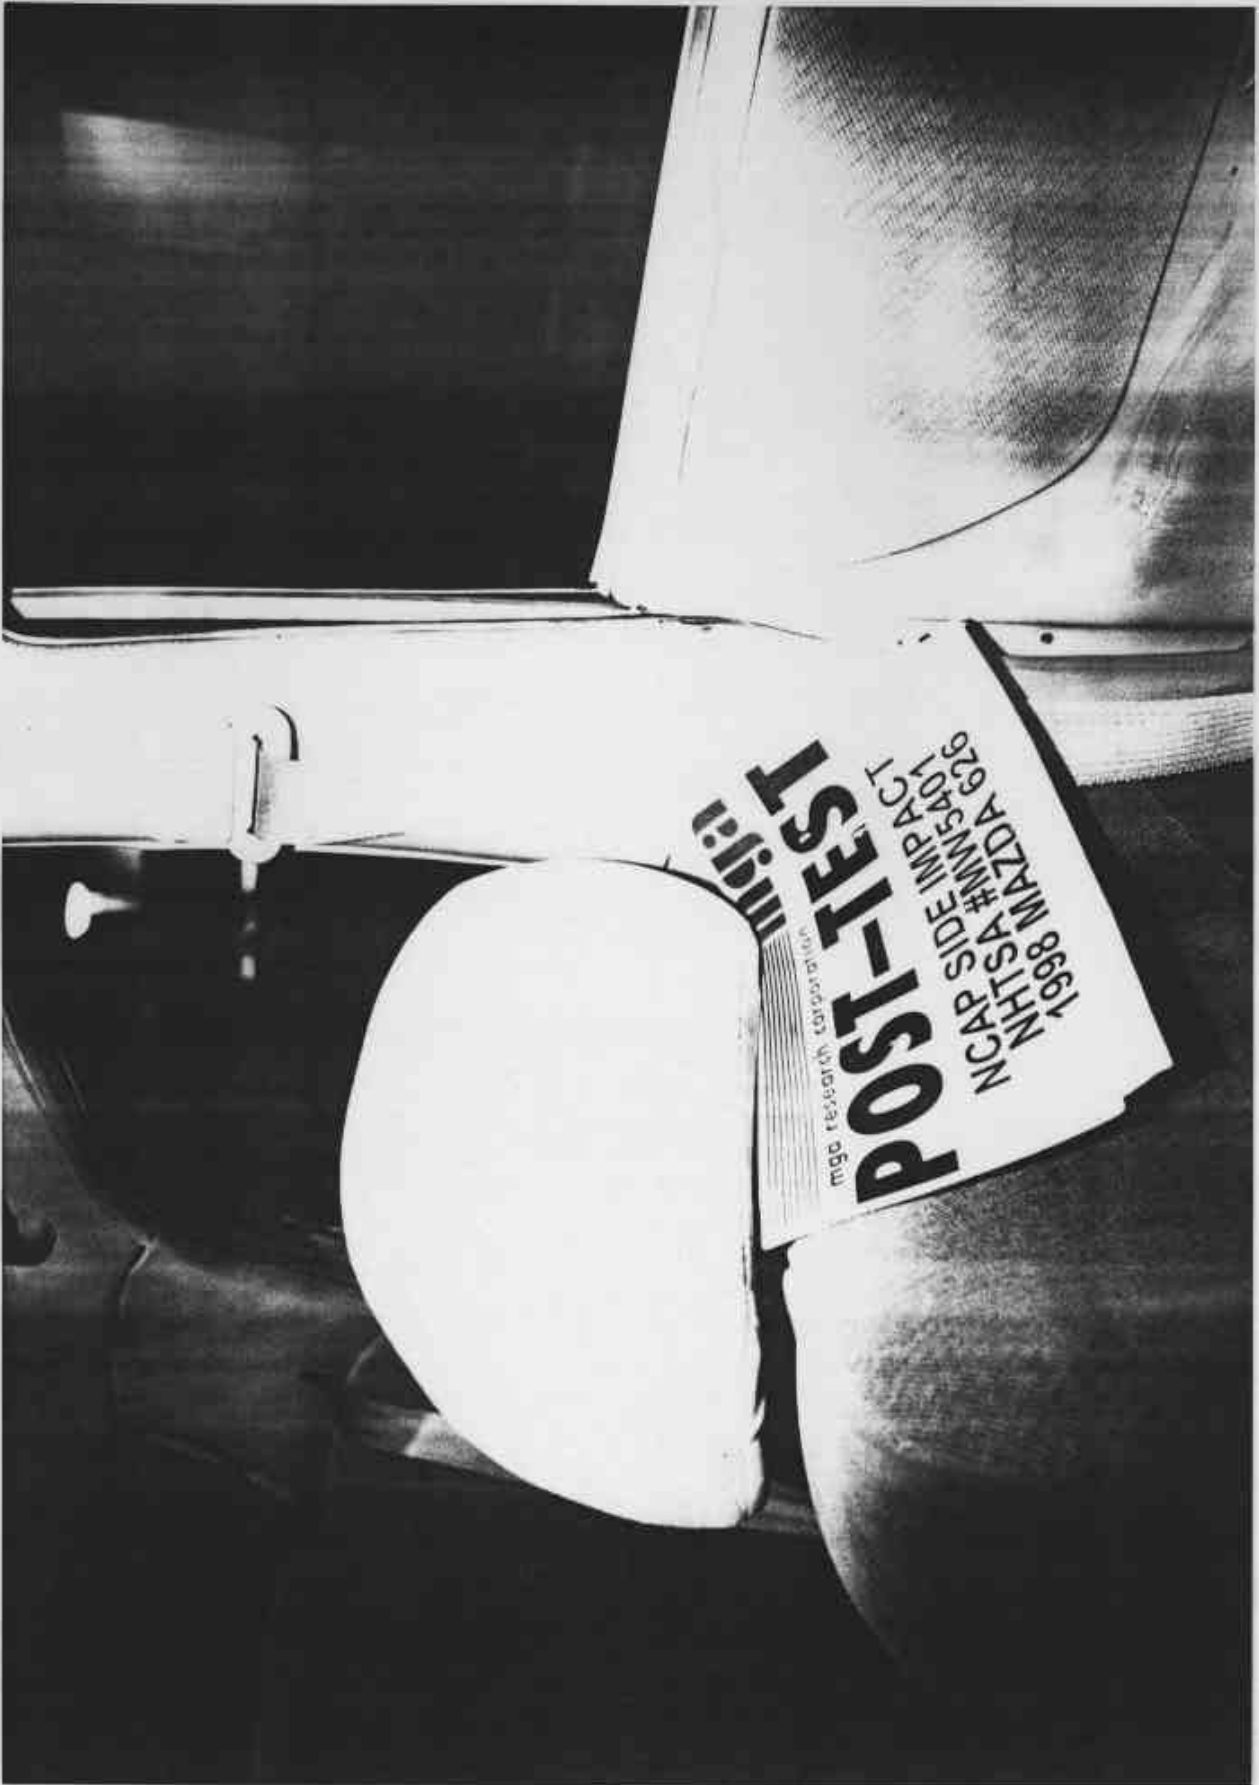
Photo No. A-30 - Post-Test Driver Dummy Head Contact

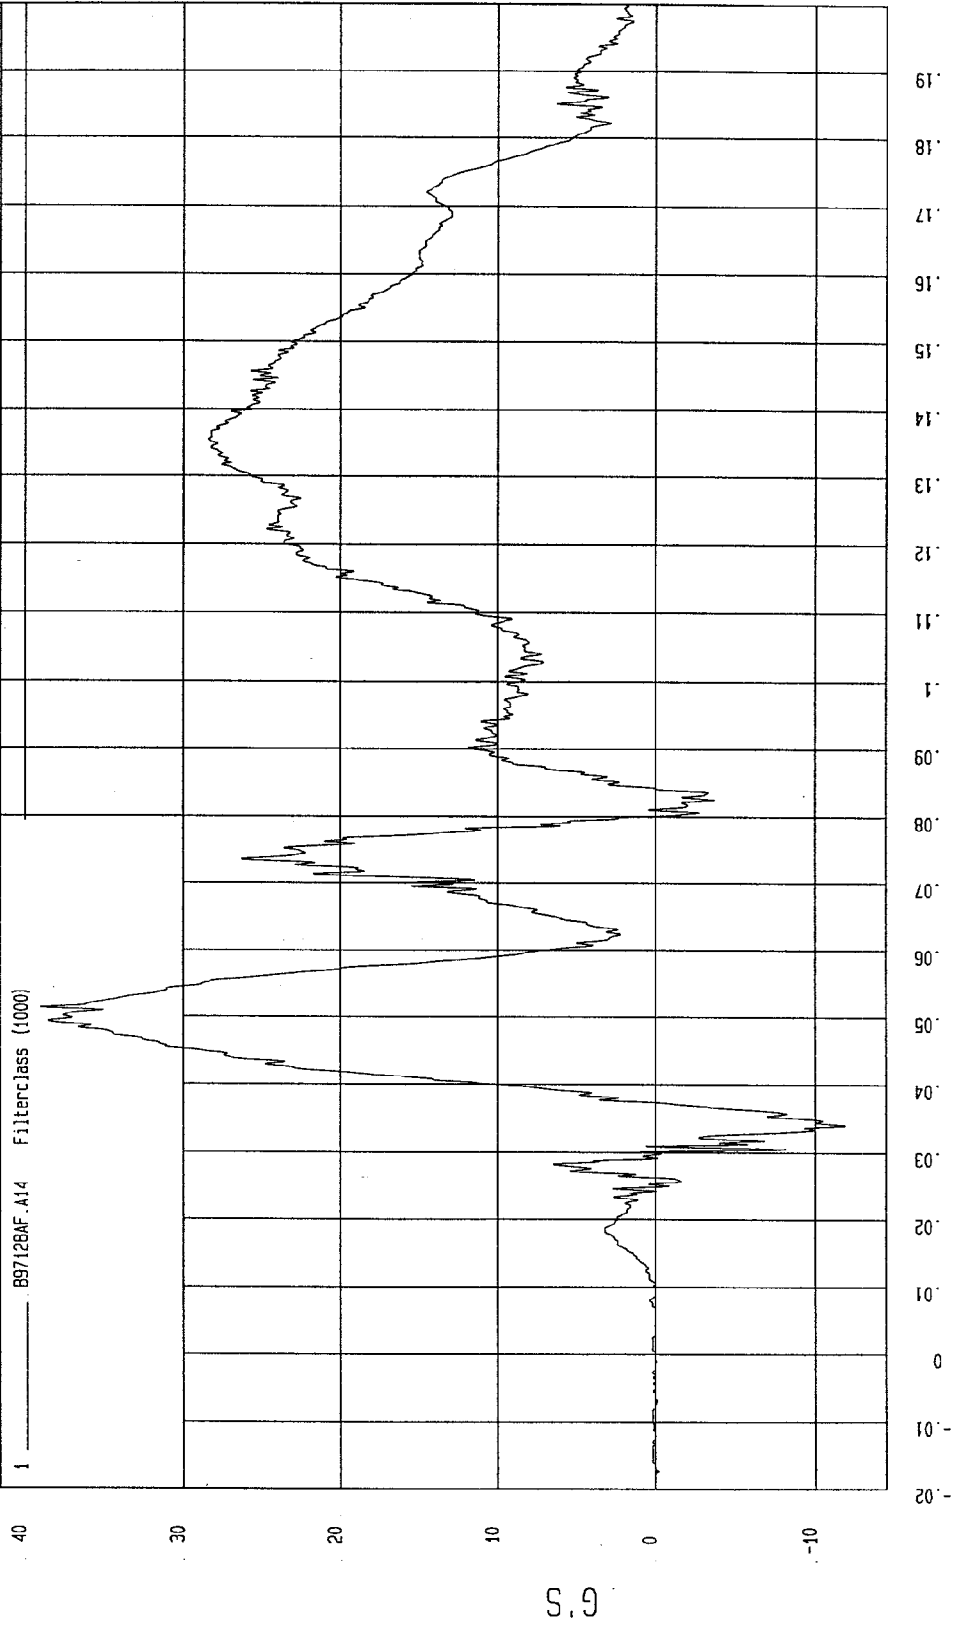
DRIVER HEAD Z ACCELERATION

1 \_\_\_\_\_ B9712BAF.A14 FilterClass (1000)

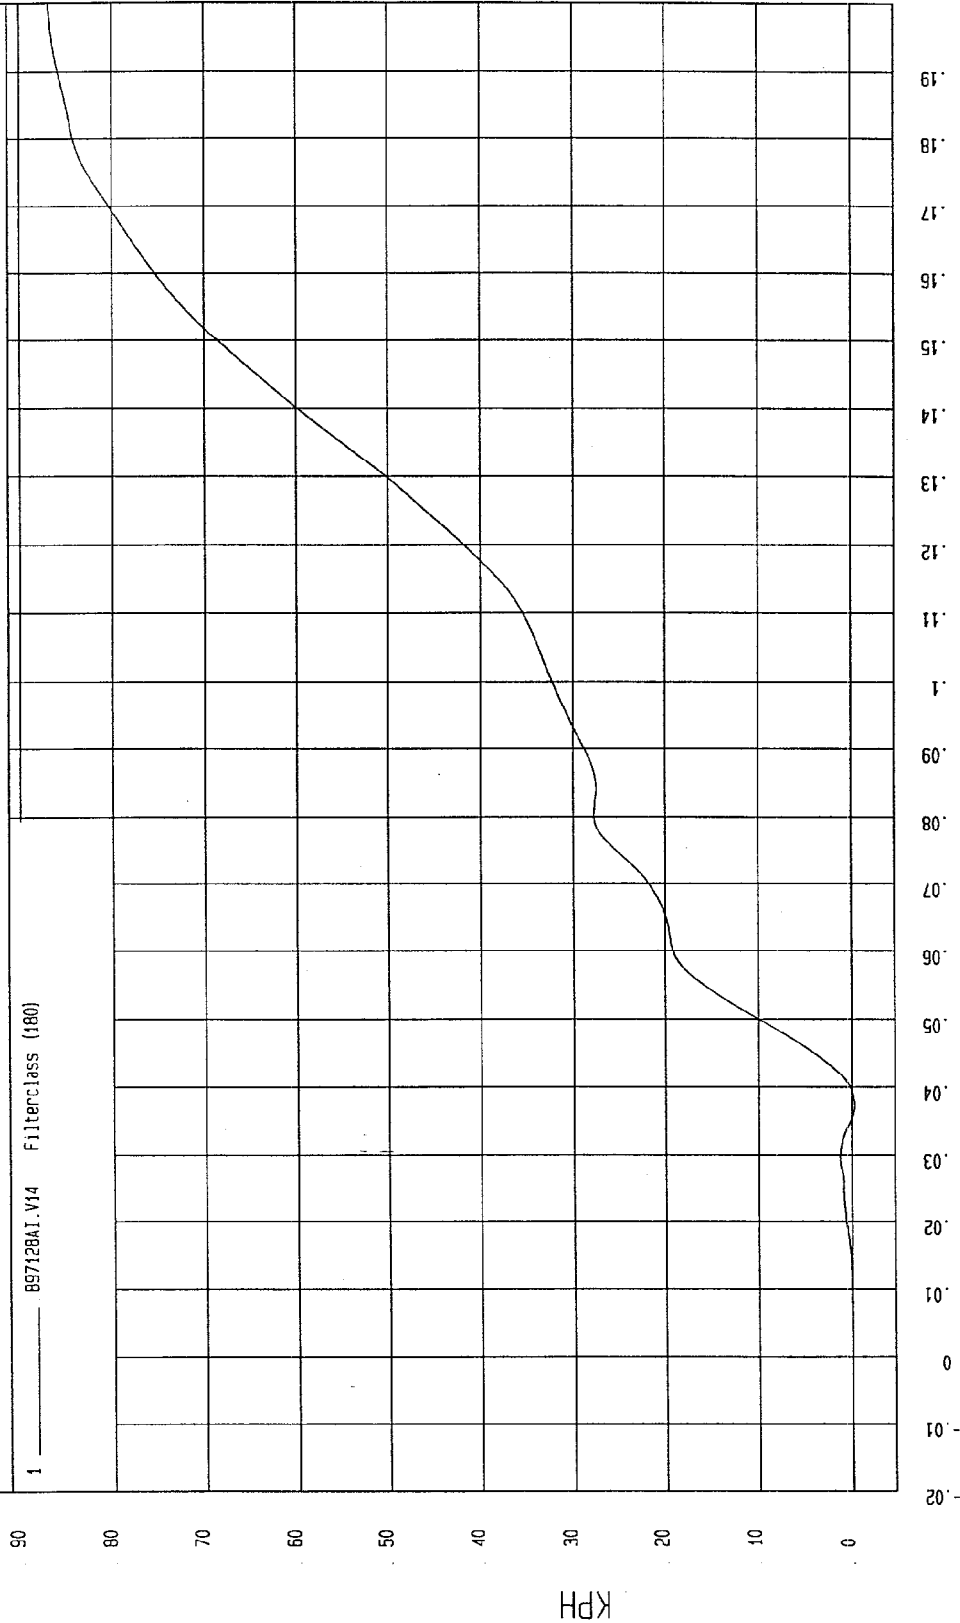
DRIVER HEAD Z VELOCITY

TEST: HIGH SPEED LATERAL IMPACT TEST DATE: 11-06-1997
