REPORT NO.: 214D-MGA-98-09

NEW CAR ASSESSMENT PROGRAM  
SIDE IMPACT TESTING  
PASSENGER CARS

1998 MAZDA 626  
4-DOOR SEDAN  
NHTSA NO: MW5401

MGA PROVING GROUNDS  
5000 WARREN ROAD  
BURLINGTON, WI 53105

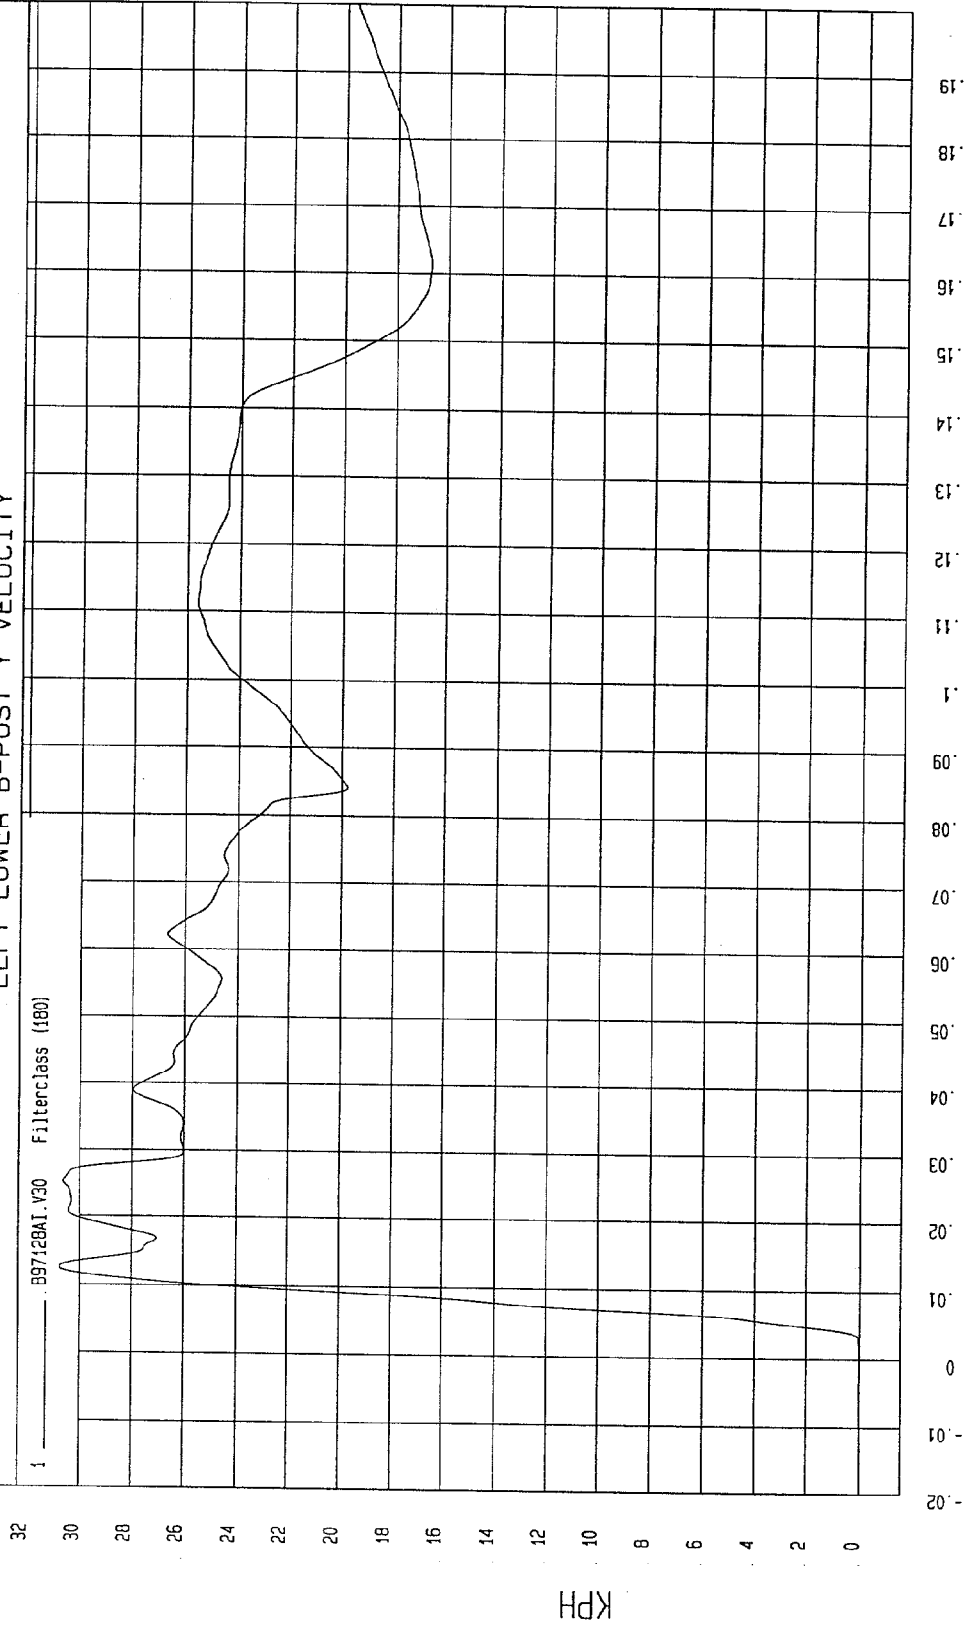
LEFT LOWER B-POST Y VELOCITY

TEST: HIGH SPEED LATERAL IMPACT TEST DATE: 11-06-1997  
COMPONENT: 1998 MAZDA 626 (MW5401) Speed: 38.2 MPH 61.5 KPH

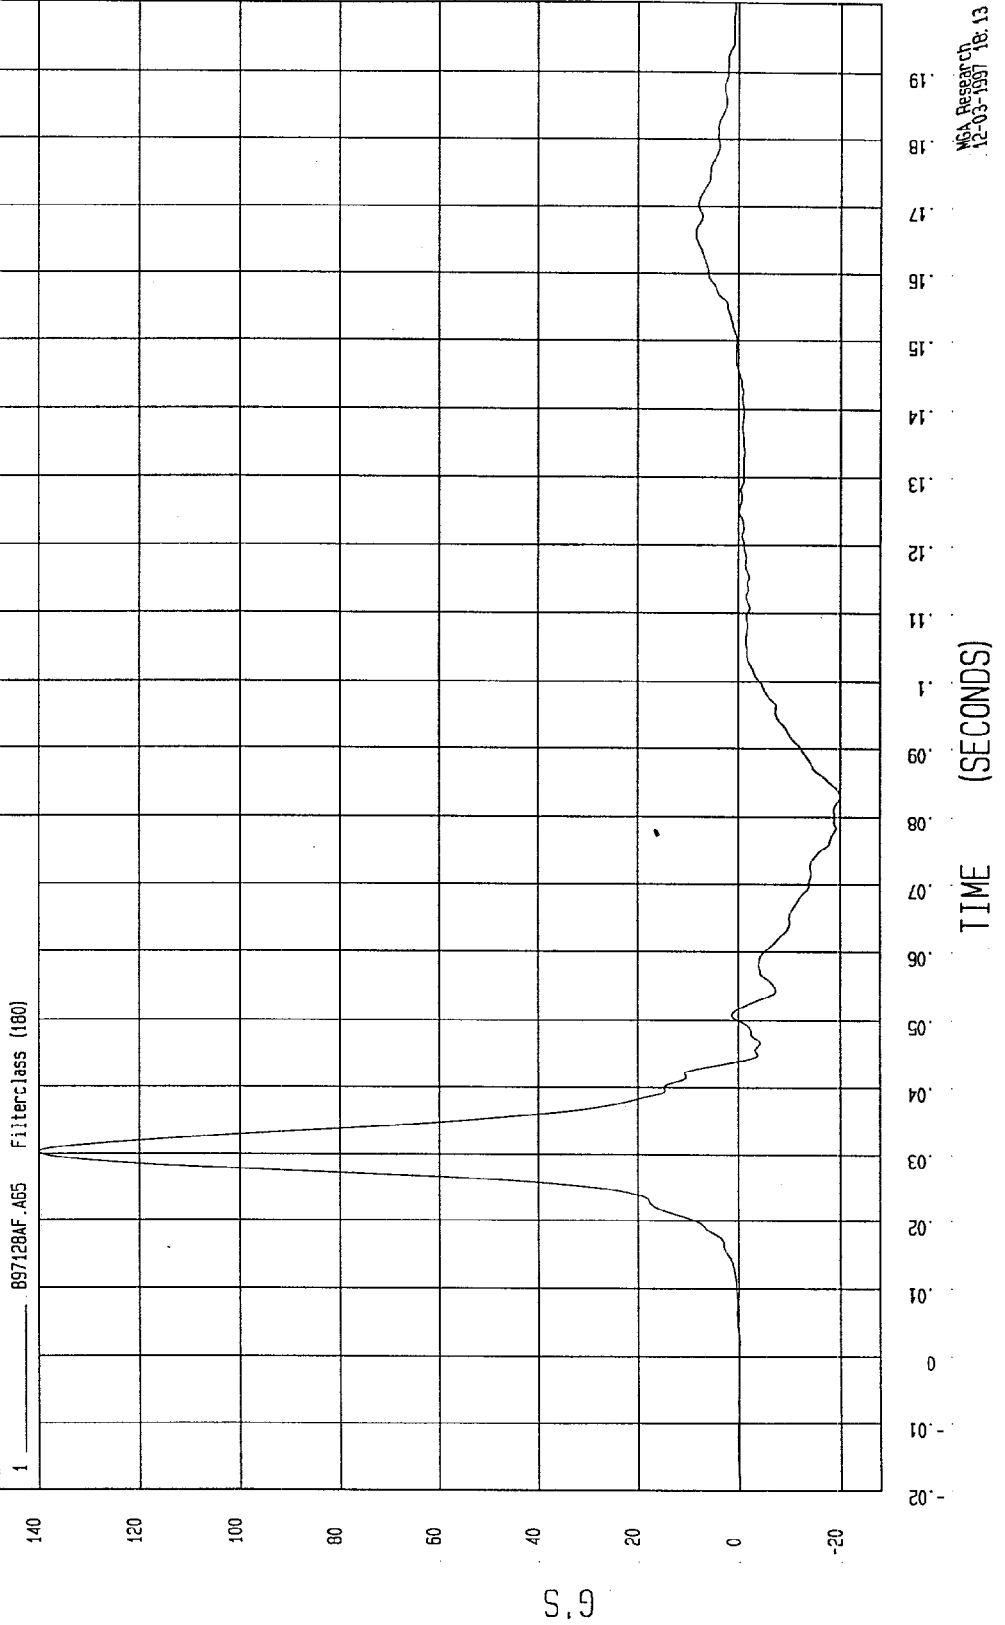
DRIVER PELVIS Y REDUNDANT ACCELERATION

COMPONENT: 1998 MAZDA 626 (MW5401) Speed: 38.2 MPH 61.5 KPH

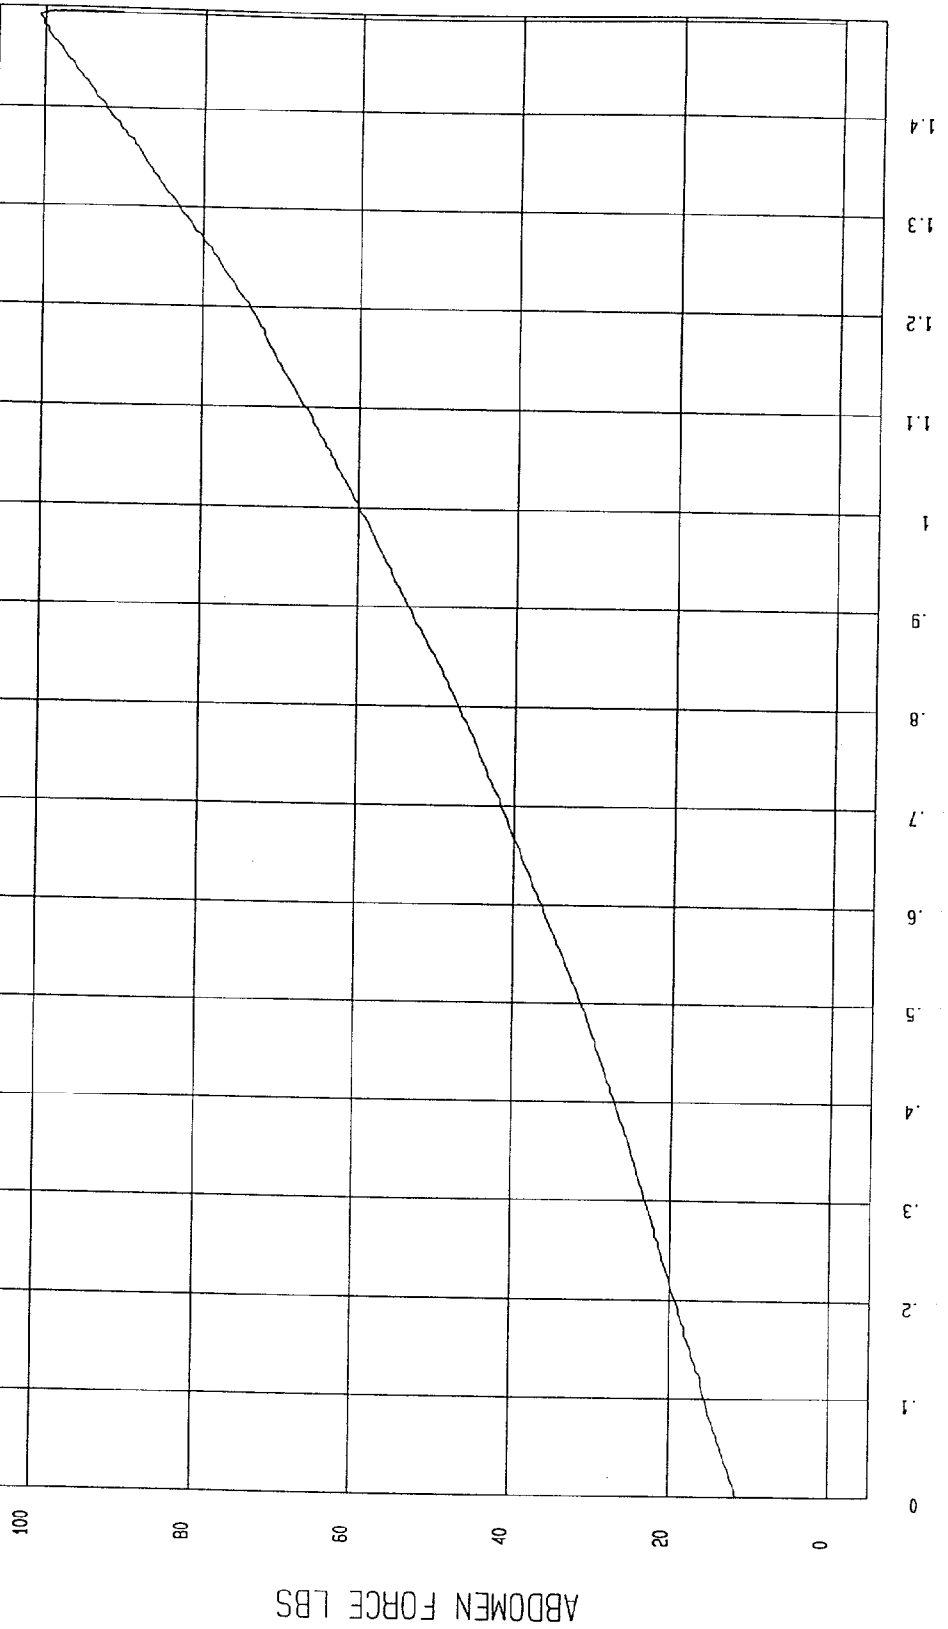
TEST PARAMETER	SPECIFICATION	TEST RESULTS
TEMPERATURE	66 - 78° F	70°
RELATIVE HUMIDITY	10 - 70%	23%
FORCE @ 0.5 in	23.3 - 36.5 lbs	31.6
FORCE @ 0.75 in	36.7 - 49.8 lbs	44.7
FORCE @ 1.0 in	50 - 63 lbs	60
FORCE @ 1.3 in	73 - 88 lbs	83

ABDOMEN FORCE as a function of ABDOMEN DISPLACEMENT

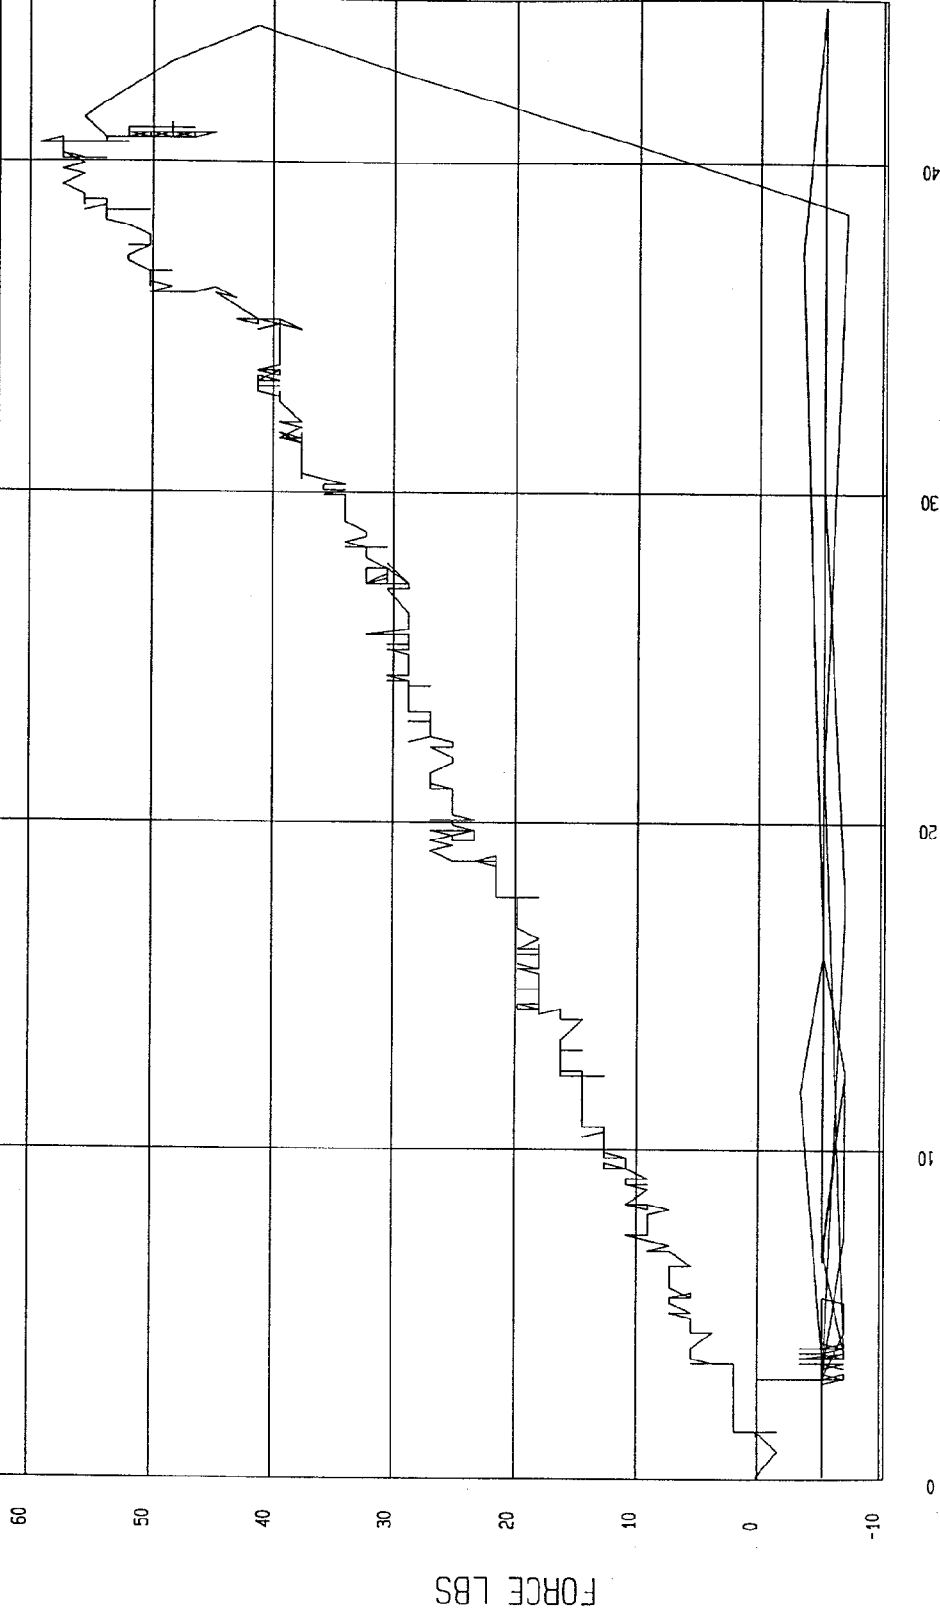
TEST PARAMETER	SPECIFICATION	TEST RESULTS
TEMPERATURE	66 - 78° F	70°
RELATIVE HUMIDITY	10 - 70%	23%
FORCE @ 0°	0 - 6 lbs	0
FORCE @ 20°	22 - 34 lbs	25
FORCE @ 30°	34 - 46 lbs	34
FORCE @ 40°	46 - 58 lbs	57
RETURN ANGLE	12° maximum	3°

FORCE as a function of TORSO ROTATION

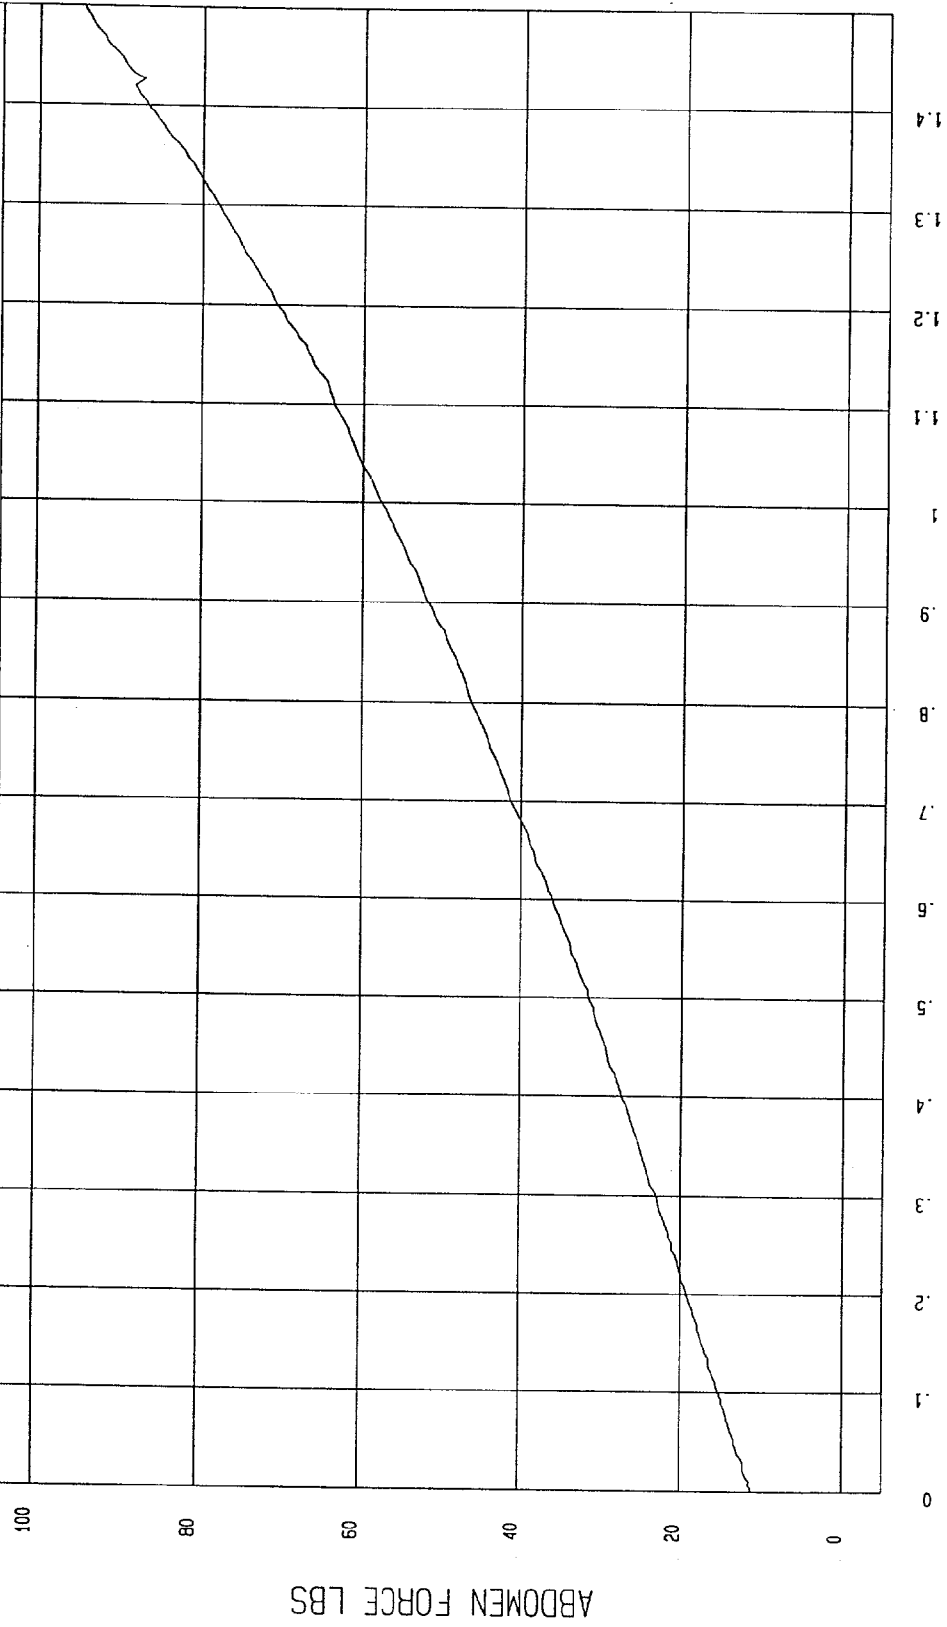
TEST PARAMETER	SPECIFICATION	TEST RESULTS
TEMPERATURE	66 - 78° F	70°
RELATIVE HUMIDITY	10 - 70%	23%
FORCE @ 0.5 in	23.3 - 36.5 lbs	31.7
FORCE @ 0.75 in	36.7 - 49.8 lbs	44.0
FORCE @ 1.0 in	50 - 63 lbs	58
FORCE @ 1.3 in	73 - 88 lbs	78

ABDOMEN FORCE as a function of ABDOMEN DISPLACEMENT

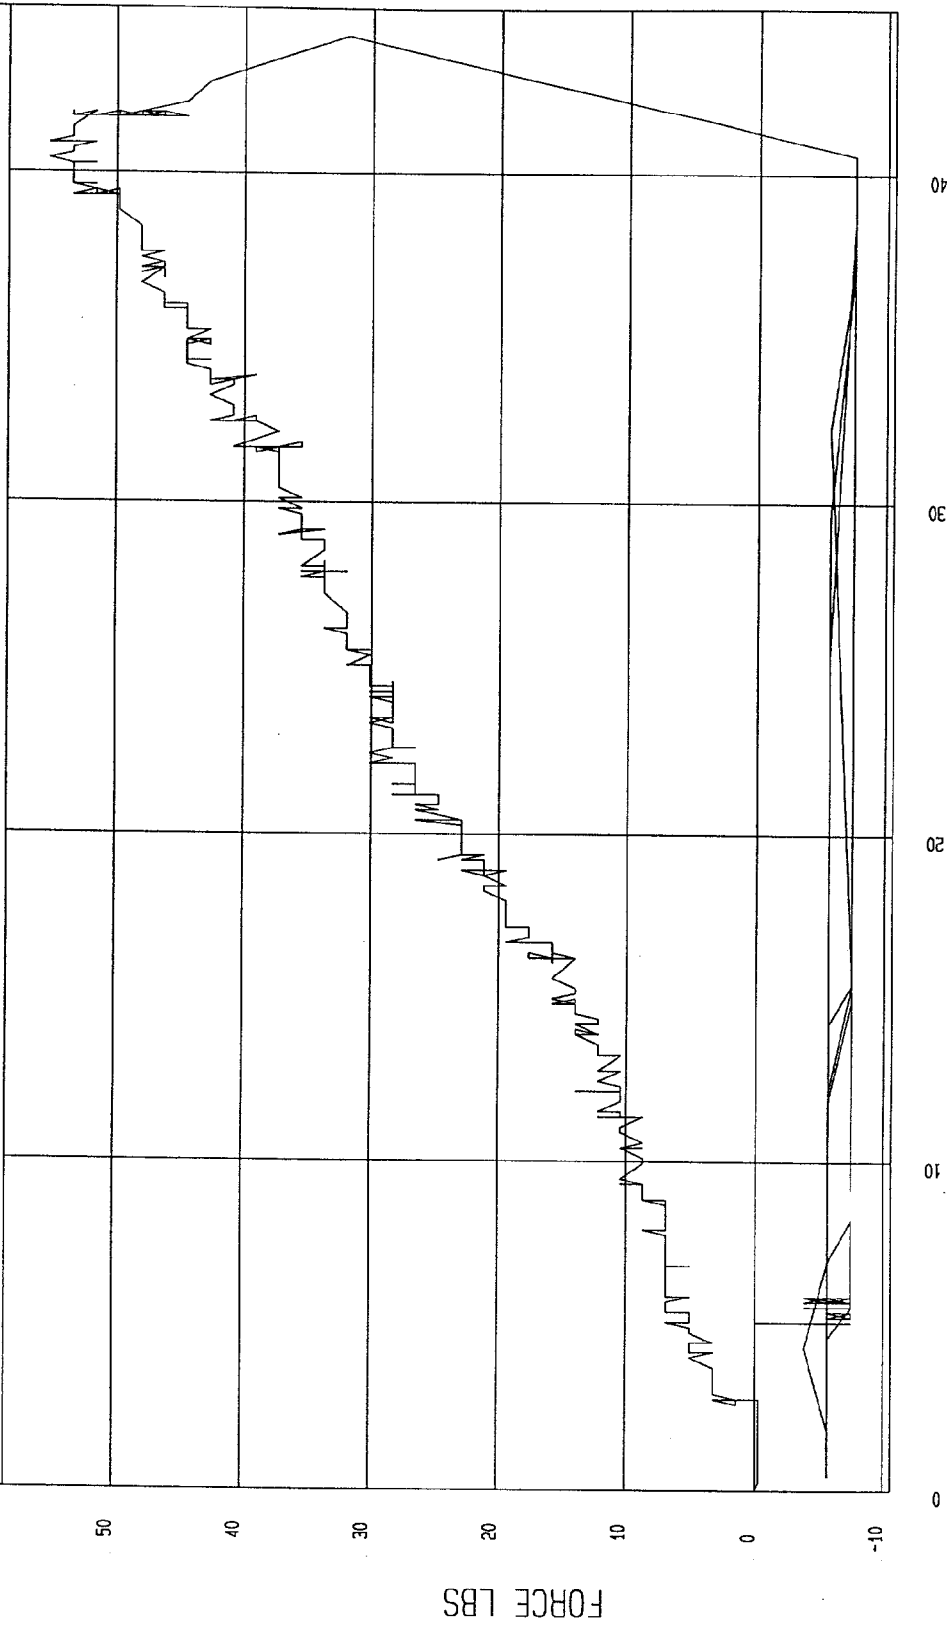
TEST PARAMETER	SPECIFICATION	TEST RESULTS
TEMPERATURE	66 - 78° F	70°
RELATIVE HUMIDITY	10 - 70%	23%
FORCE @ 0°	0 - 6 lbs	0
FORCE @ 20°	22 - 34 lbs	23
FORCE @ 30°	34 - 46 lbs	37
FORCE @ 40°	46 - 58 lbs	53
RETURN ANGLE	12° maximum	5°

FORCE as a function of TORSO ROTATION
