NEW CAR ASSESSMENT PROGRAM  
SIDE IMPACT TESTING  
PASSENGER CARS

1998 TOYOTA COROLLA  
4-DOOR SEDAN  
NHTSA NO: MW5105

MGA PROVING GROUNDS  
5000 WARREN ROAD  
BURLINGTON, WI 53105

FINAL REPORT

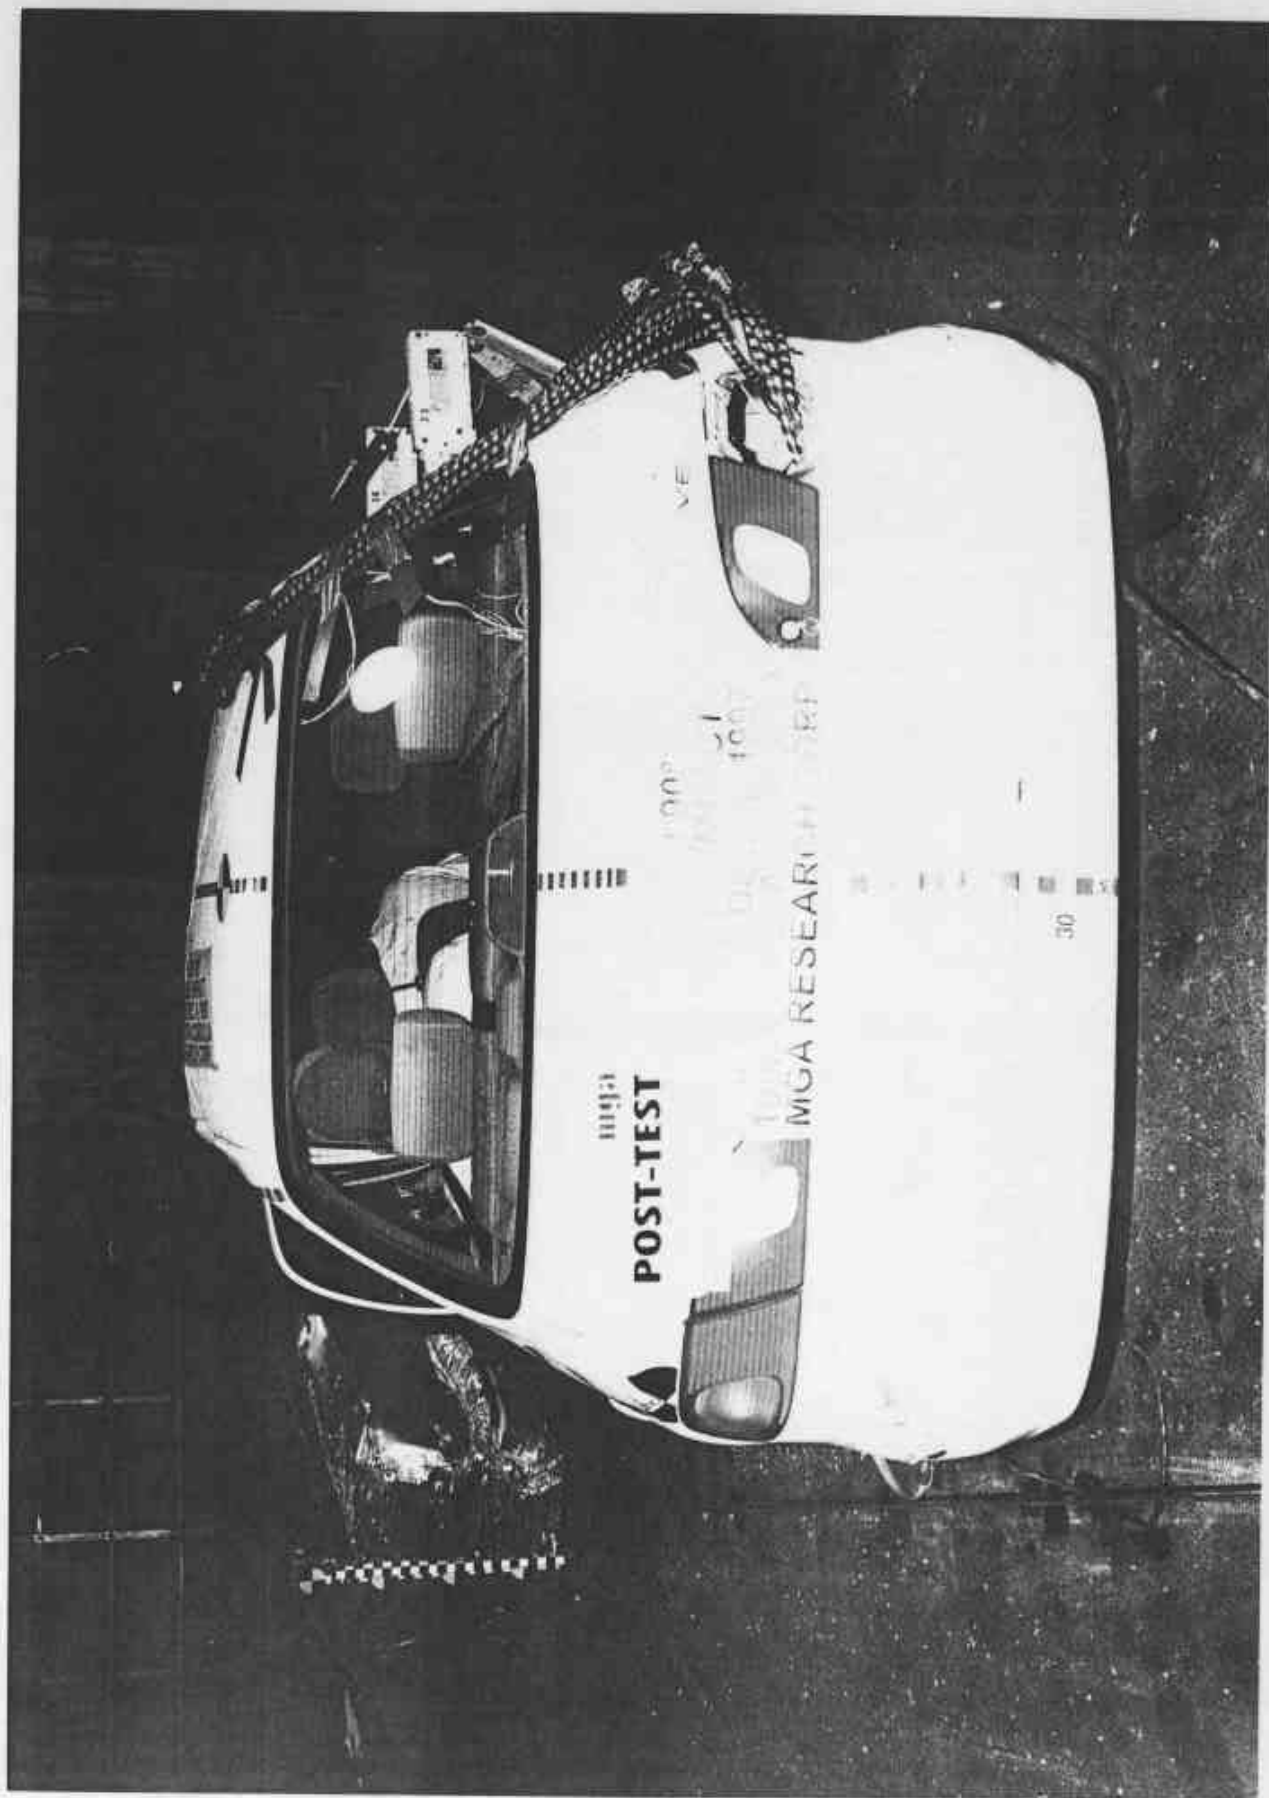
Photo No. A-4 - Post-Test Rear View of Test Vehicle

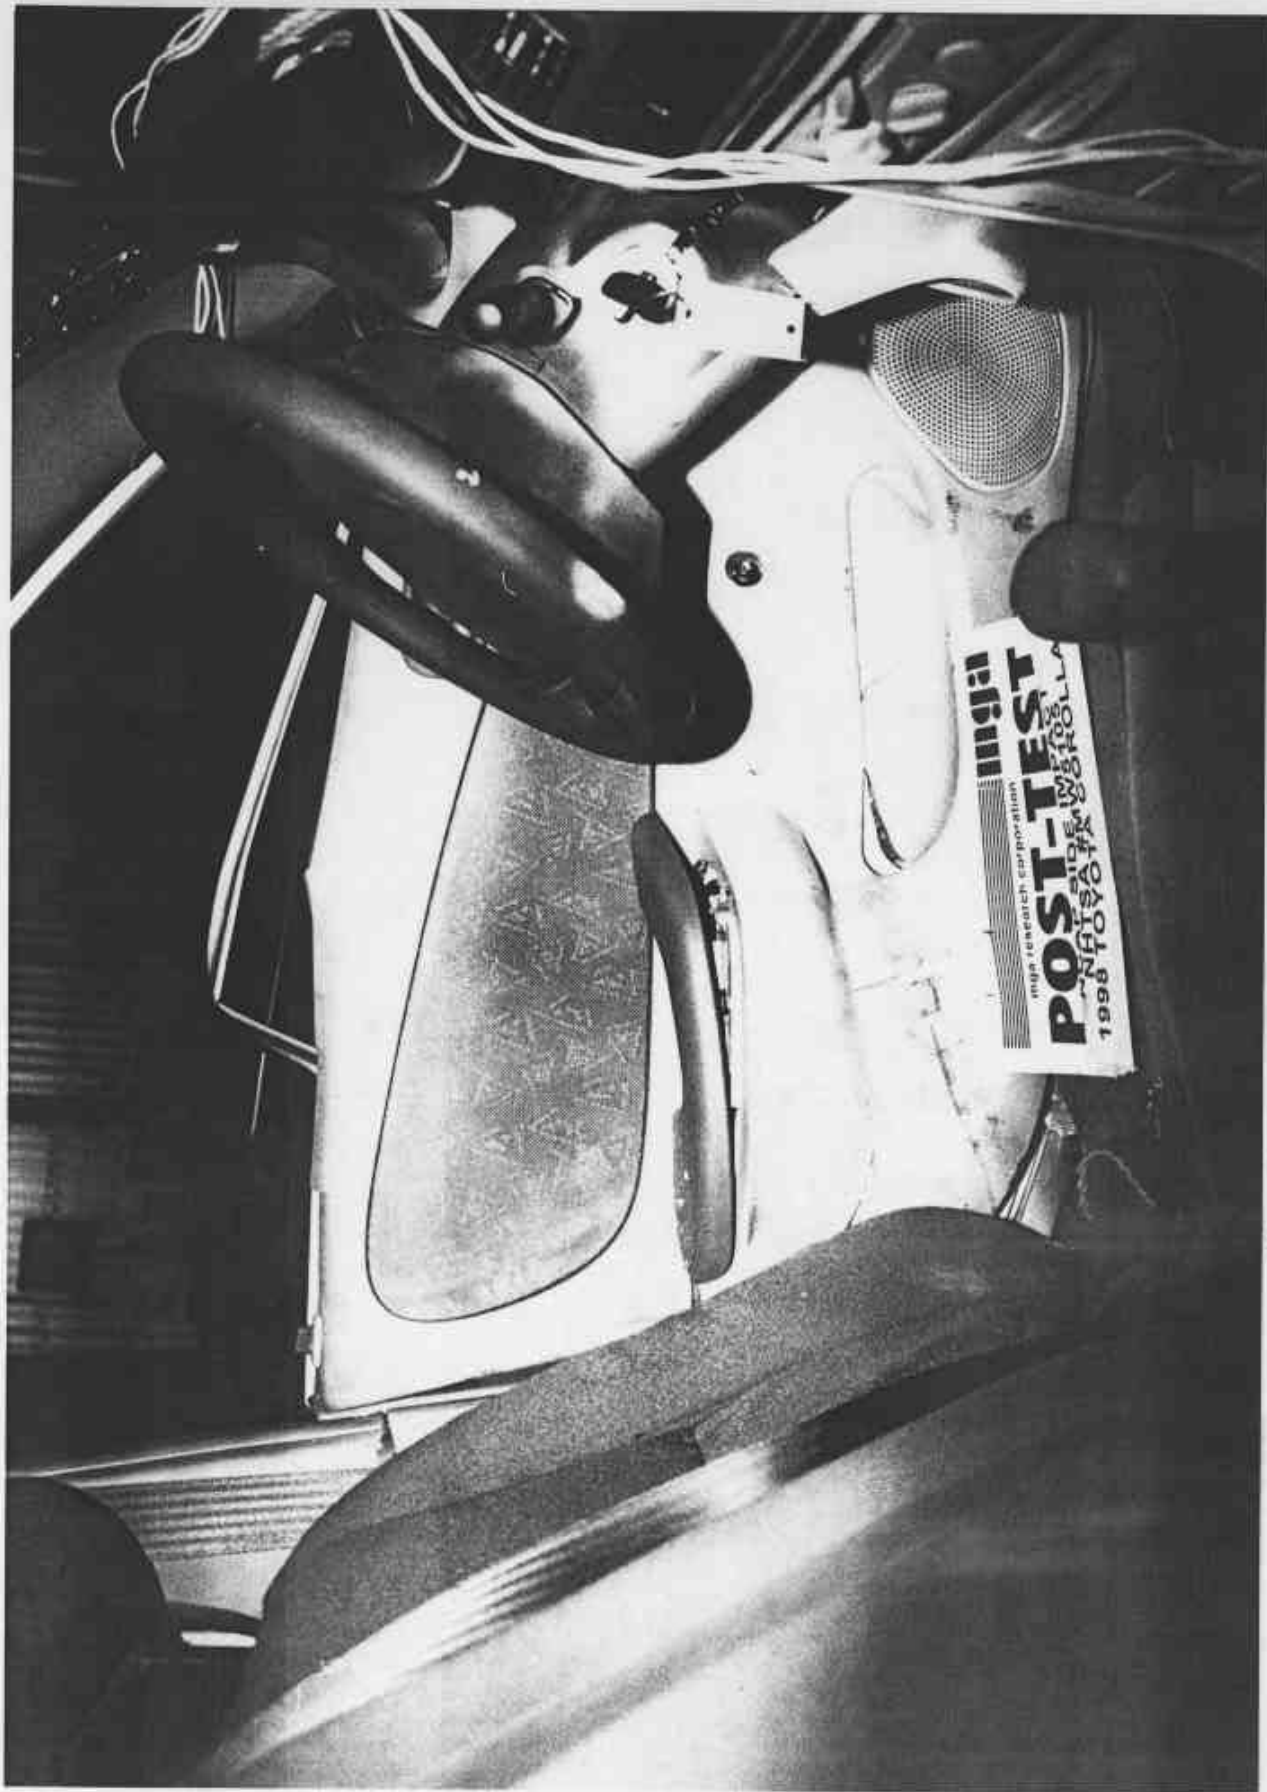
Photo No. A-27 - Post-Test Driver Dummy Contact

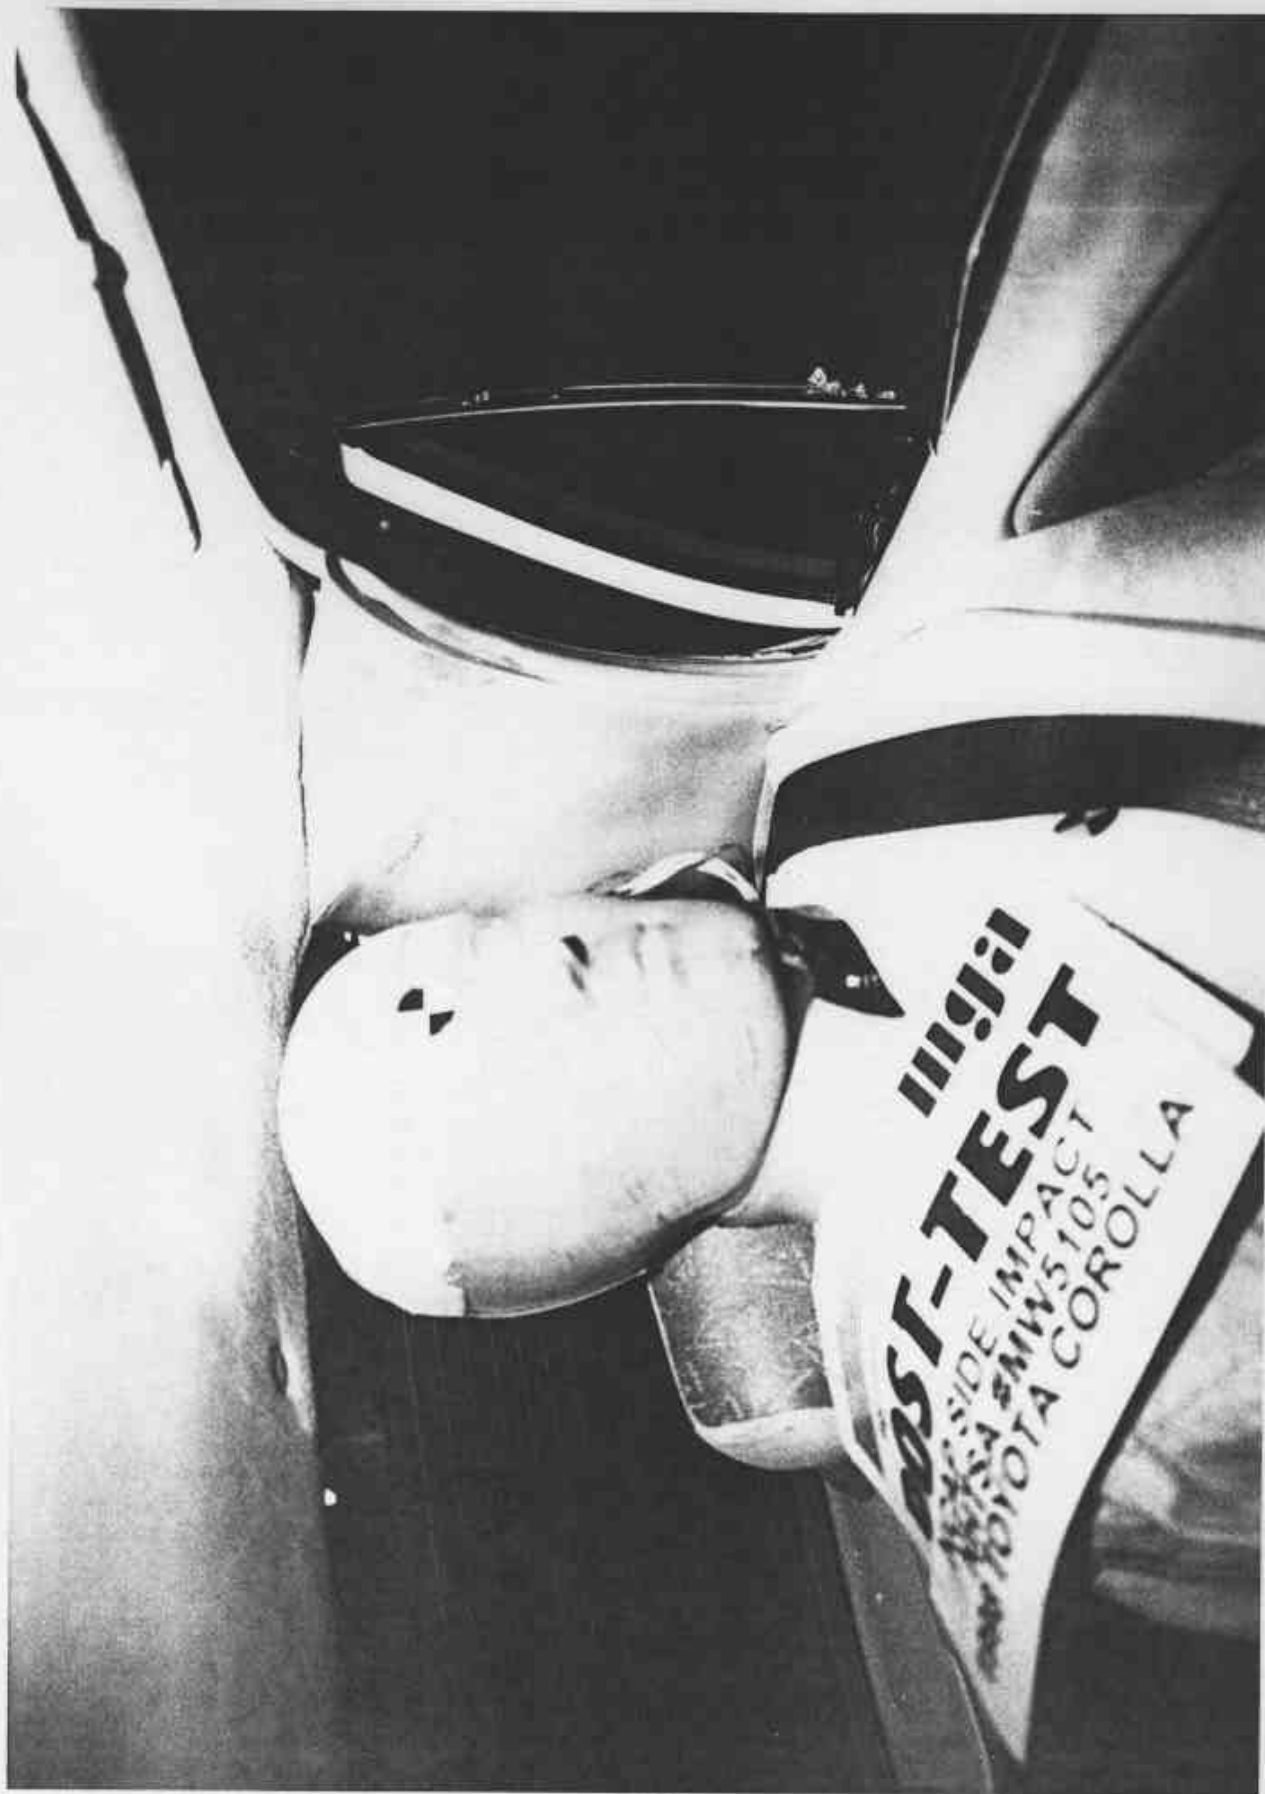
Photo No. A-37 - Post-Test Passenger Dummy Head Contact

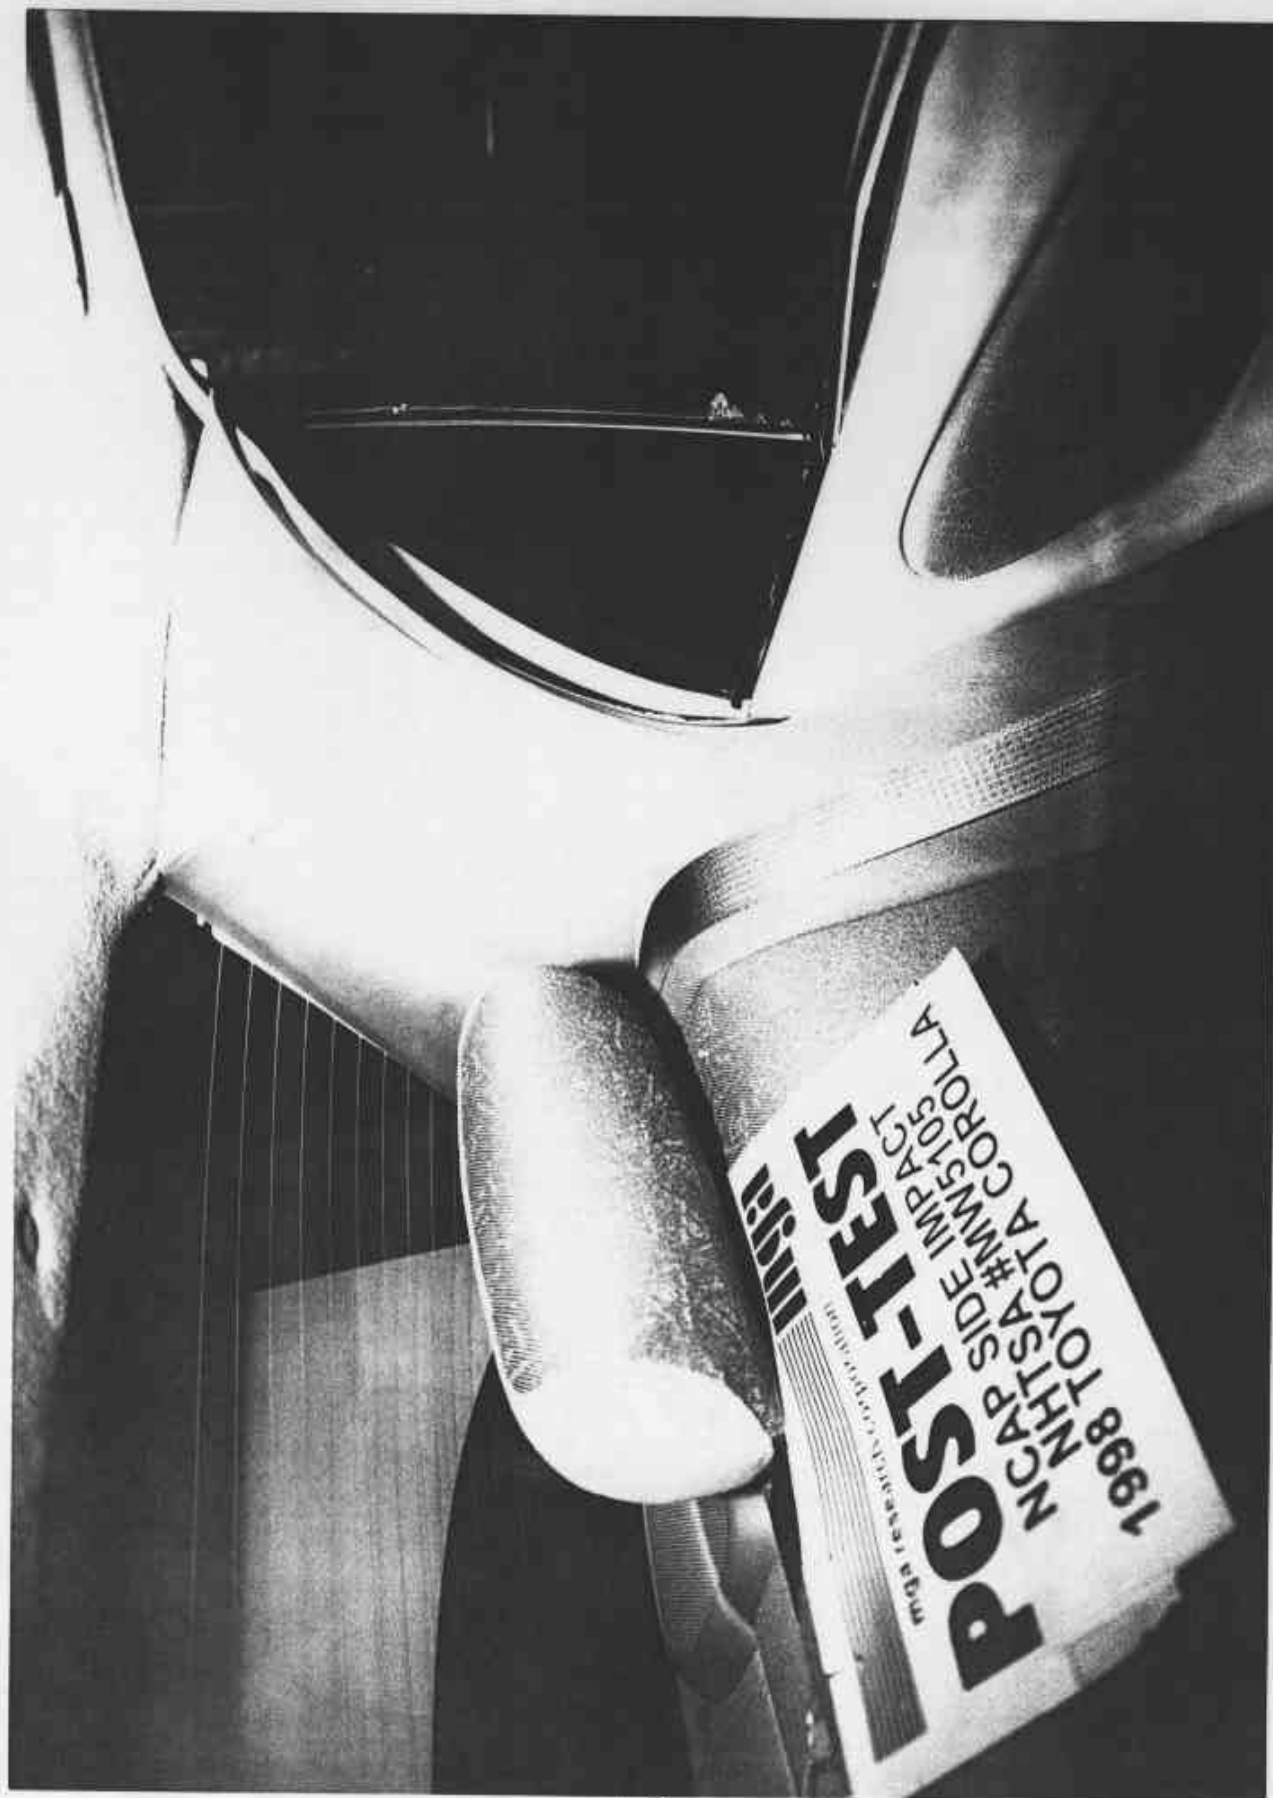
Photo No. A-38 - Post-Test Passenger Dummy Head Contact

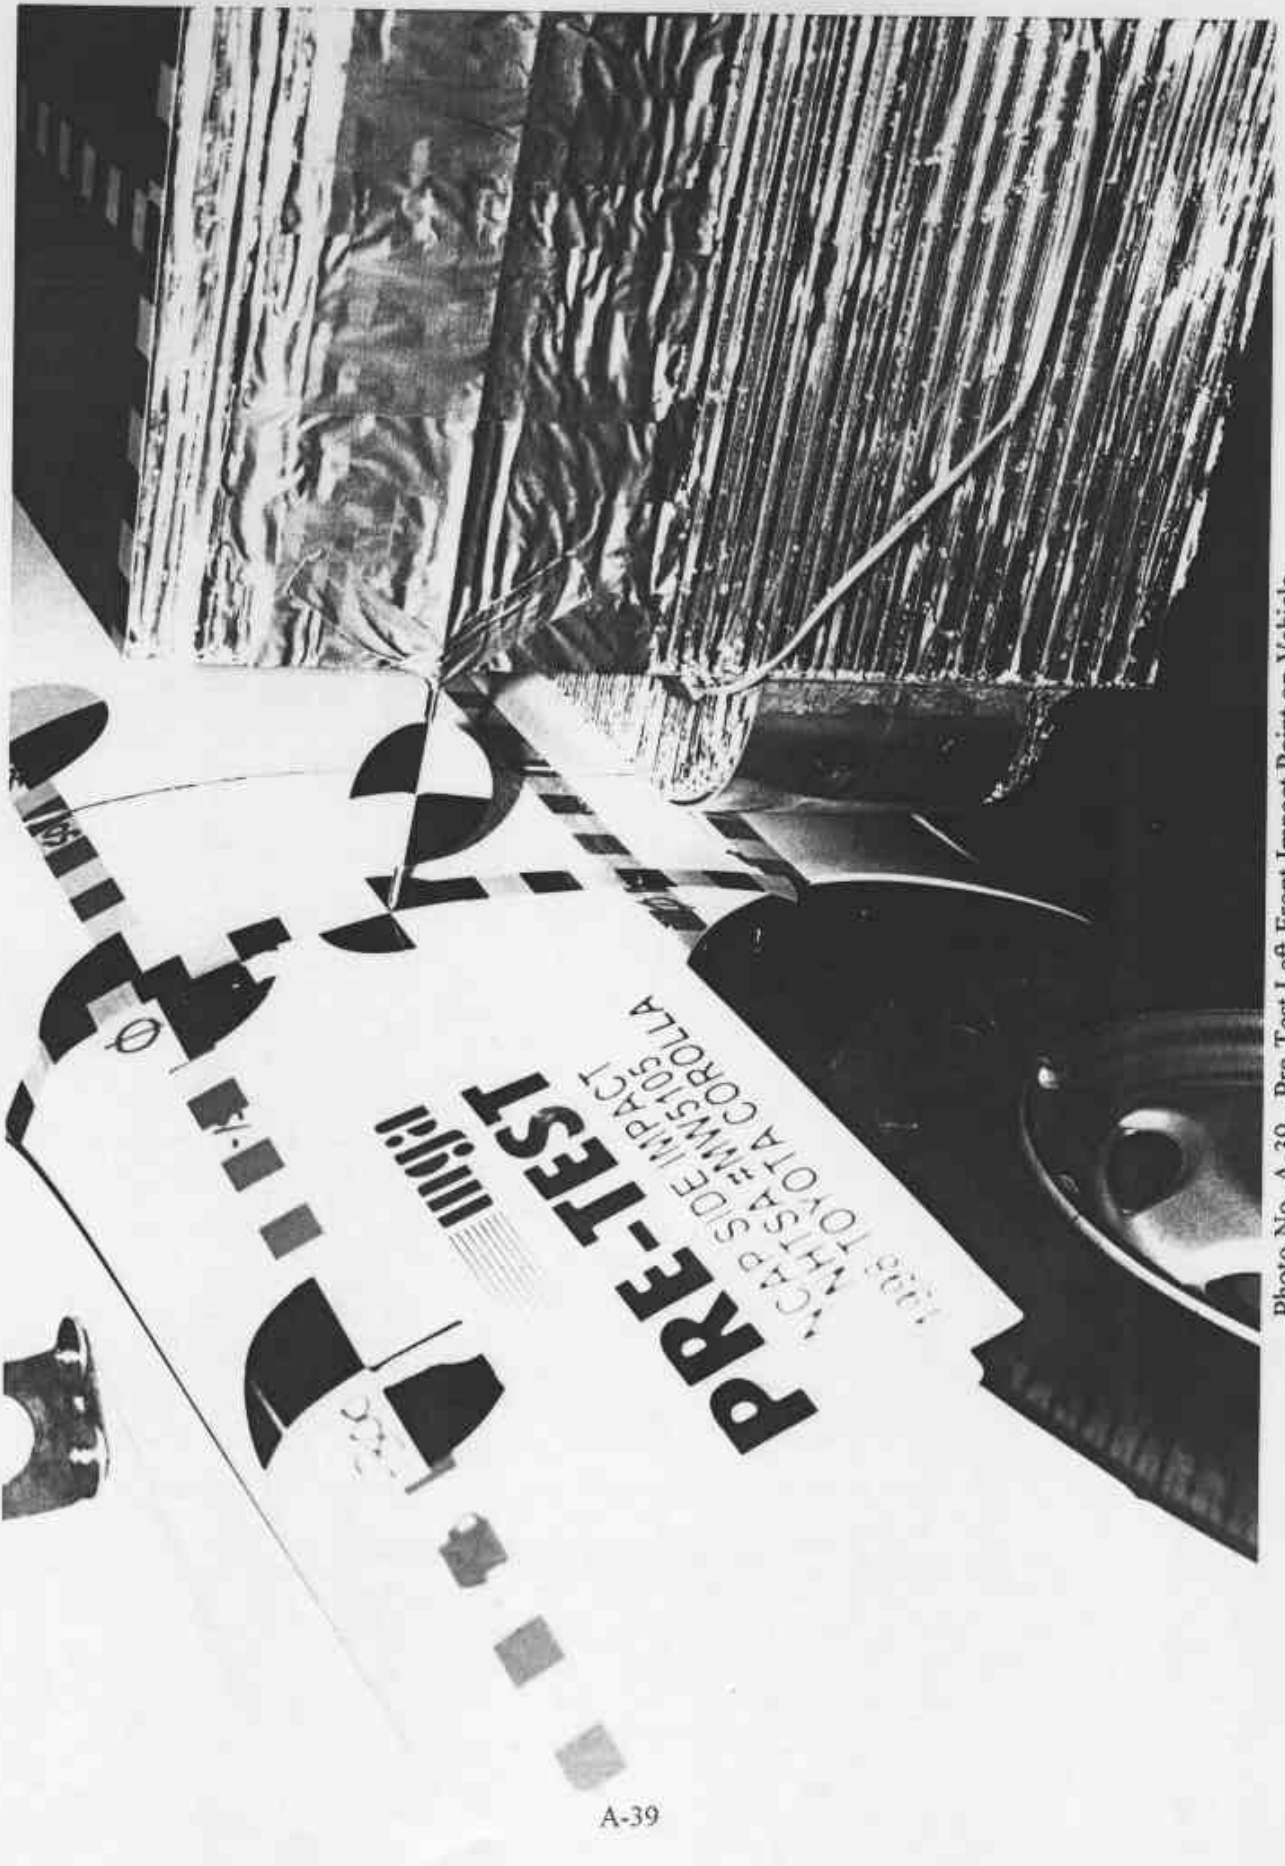
Photo No. A-39 - Pre-Test Left Front Impact Point on Vehicle

Impact Point is 293 mm rearward of front axle centerline

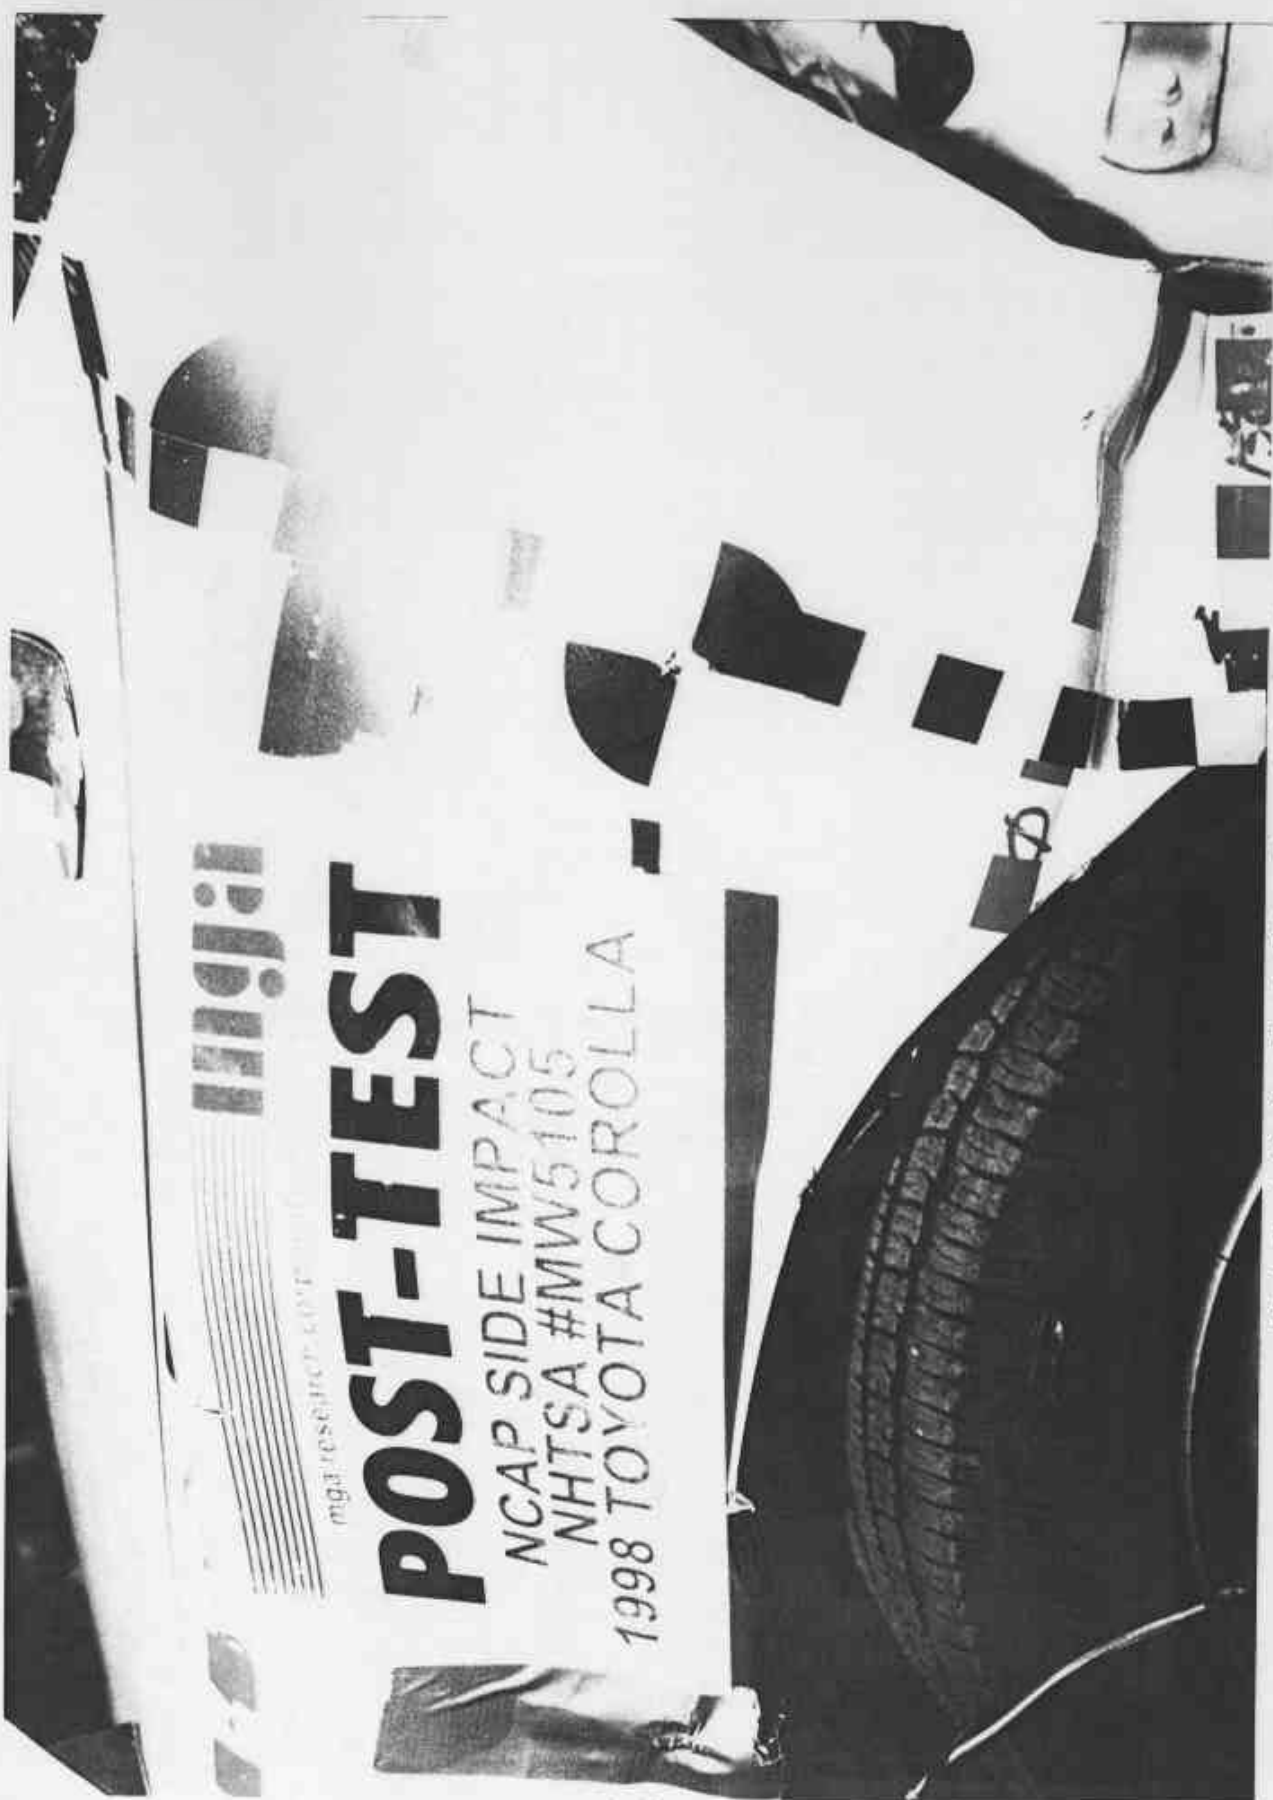
Photo No. A-40 - Post-Test Left Front Impact Point on Vehicle
