**REPORT NUMBER: 214-TRC-98-002**

**SAFETY COMPLIANCE TESTING FOR FMVSS 214  
SIDE IMPACT PROTECTION - PASSENGER CARS**

**1998 MAZDA 626  
4-DOOR SEDAN**

**NHTSA NUMBER: CW5400**

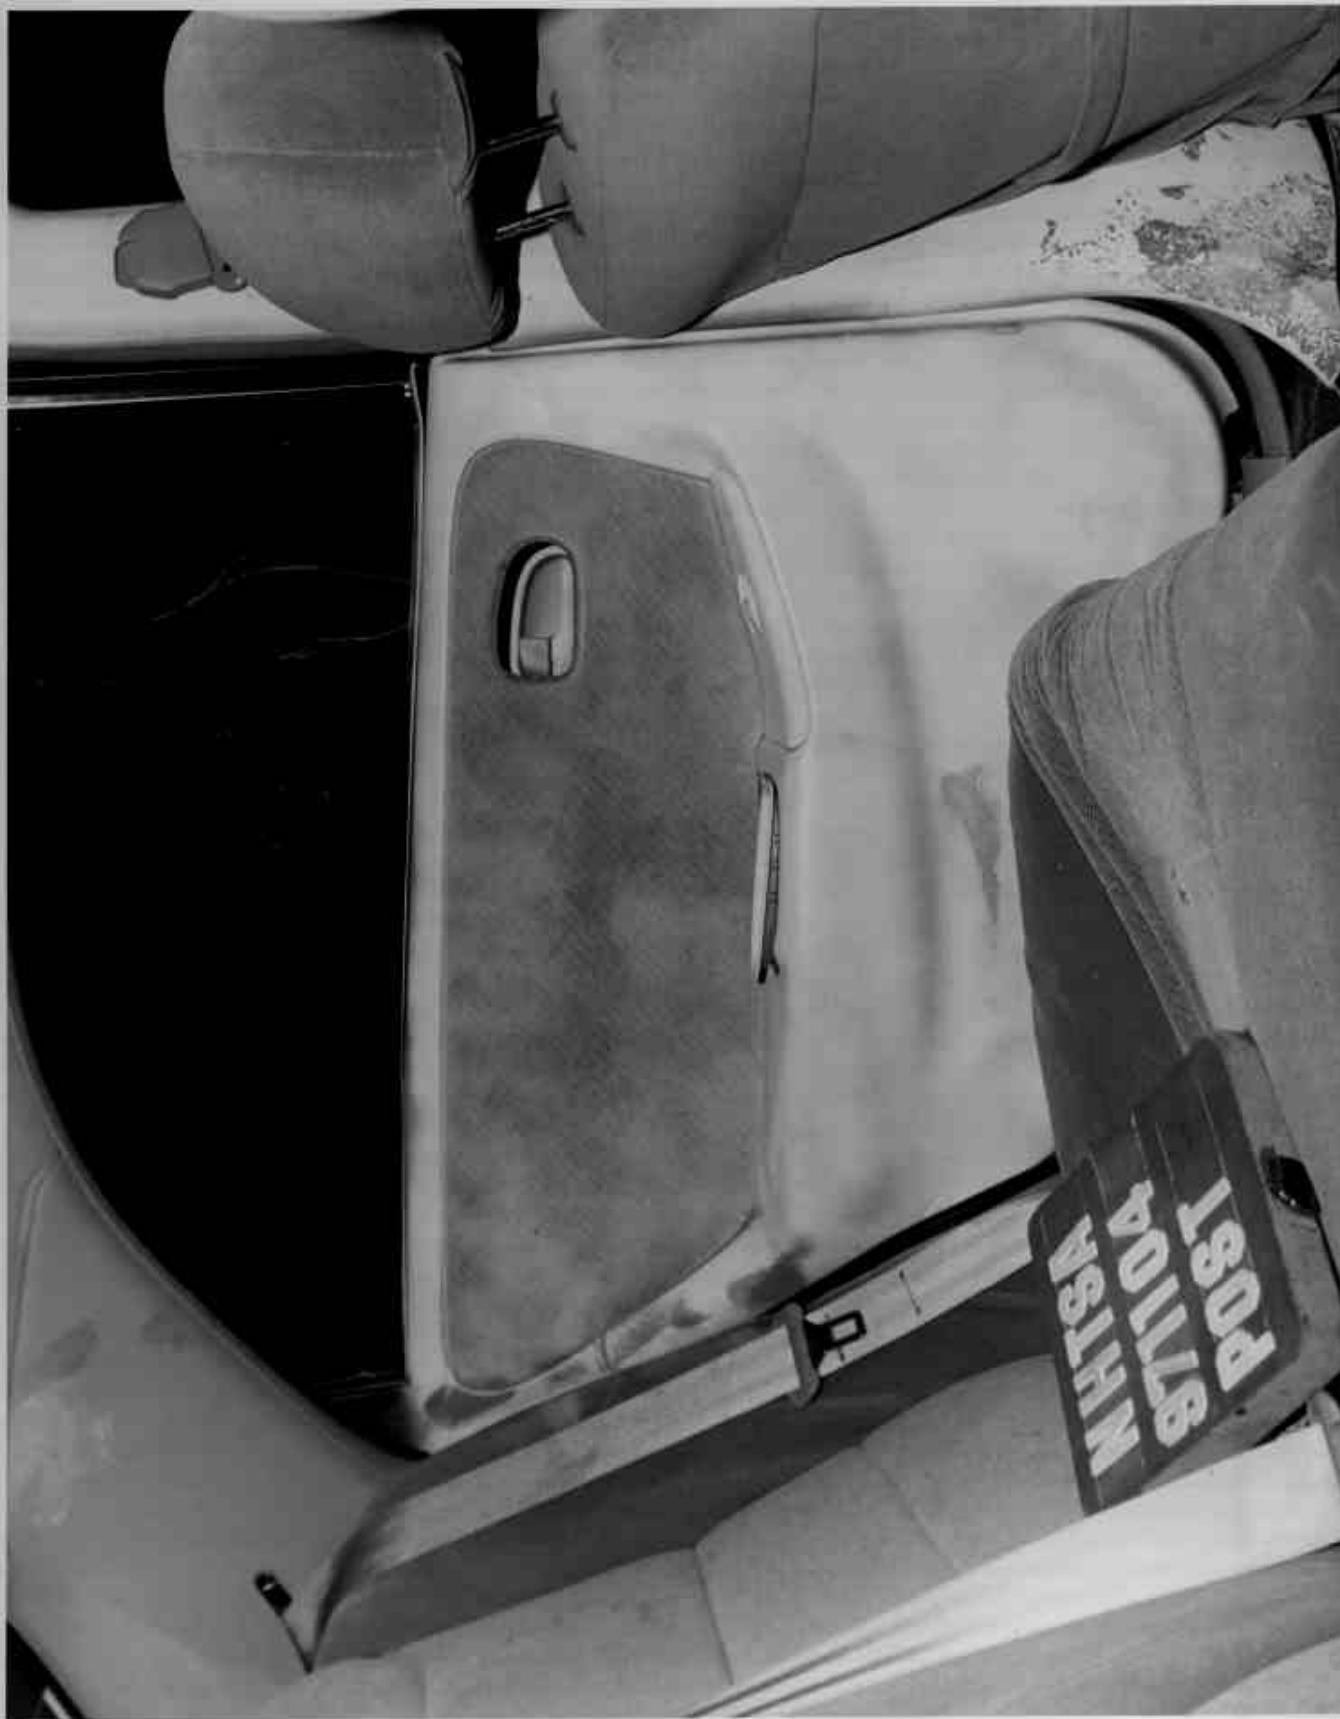
Figure A-24 Post-Test Interior Of Rear Door Showing SID Impact Locations
