REPORT NO. KAR-98-3

NATIONAL HIGHWAY TRAFFIC SAFETY ADMINISTRATION
NEW CAR ASSESSMENT PROGRAM
FRONTAL BARRIER IMPACT TEST

HONDA MOTORS CORPORATION
1998 HONDA CIVIC DX
4-DOOR SEDAN
NHTSA NO. MW5302

PREPARED BY:
KARCO ENGINEERING
9270 HOLLY ROAD
ADELANTO, CALIFORNIA 92301

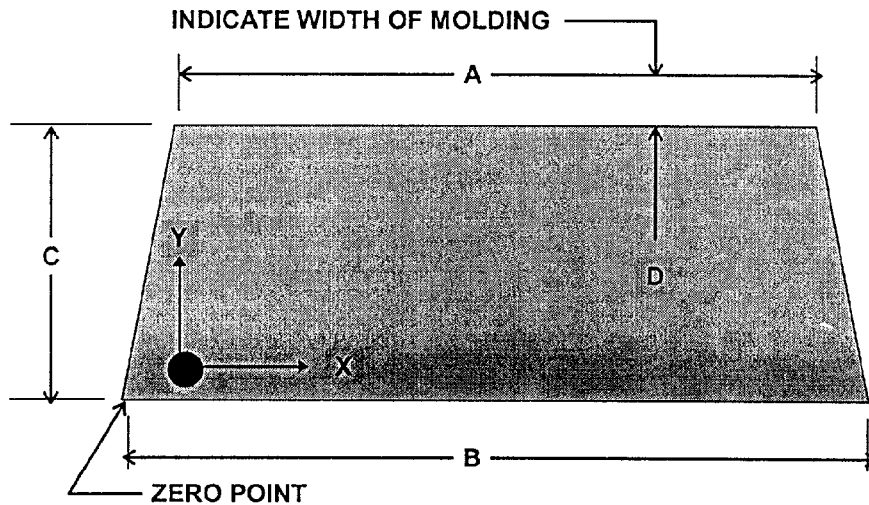
FRONT VIEW OF WINDSHIELD

Indicate area of retention failure.

Width of molding = Top & Sides 30 mm, Bottom 40 mm.

There was 71.9 percent windshield retention (minimum 50 percent required for passive restraint systems), no intrusion into the protected or unprotected zone of the windshield, and no Stoddard solvent leakage occurred after impact or during any phase of the rollover.

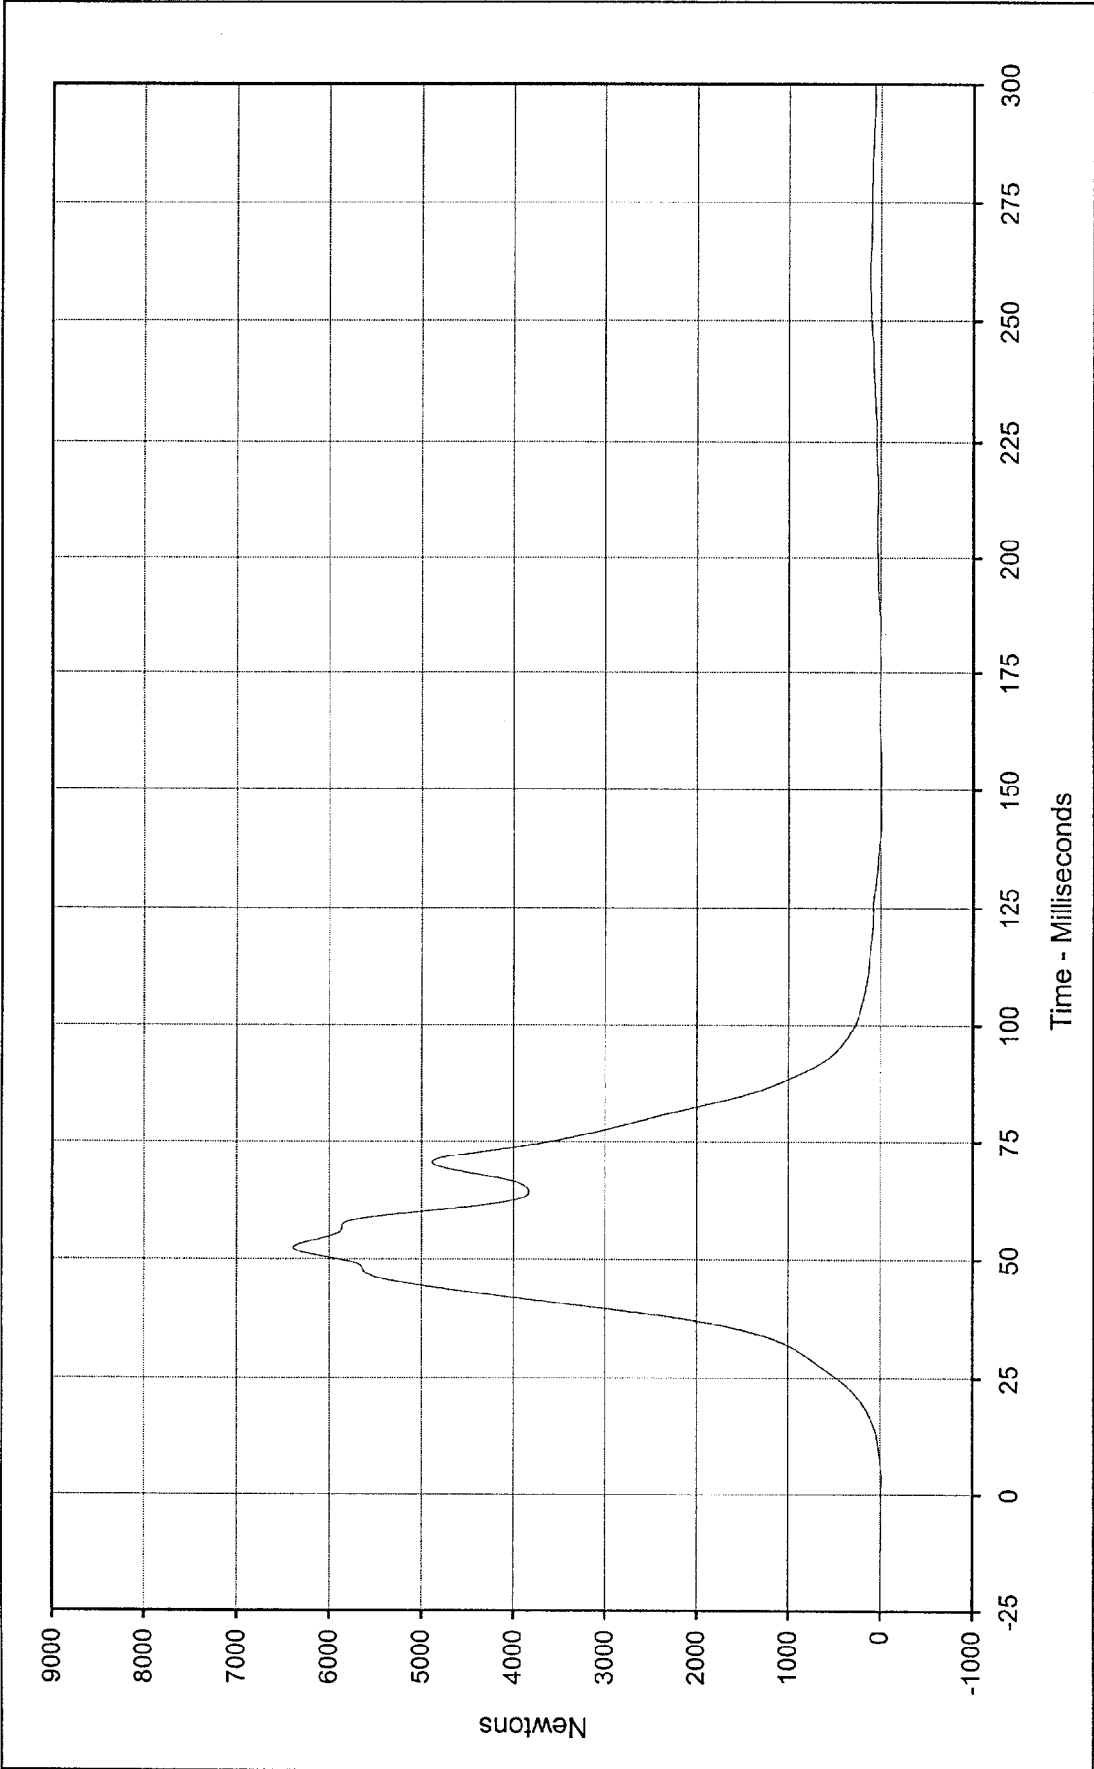
Curve Description: Driver Lap Belt Force Testing Program 1998 NHTSA 35 mph NCAP No.: MW5302
 Maximum Value: 6389.3 at 52.3 Milliseconds Test Vehicle: 1998 Honda Civic DX 4 Door Sedan
 Minimum Value: -17.9 at 3.3 Milliseconds
 SAE Filter Class: 60
 Date of Test: 12/11/97
 Curve Number: FIL-041

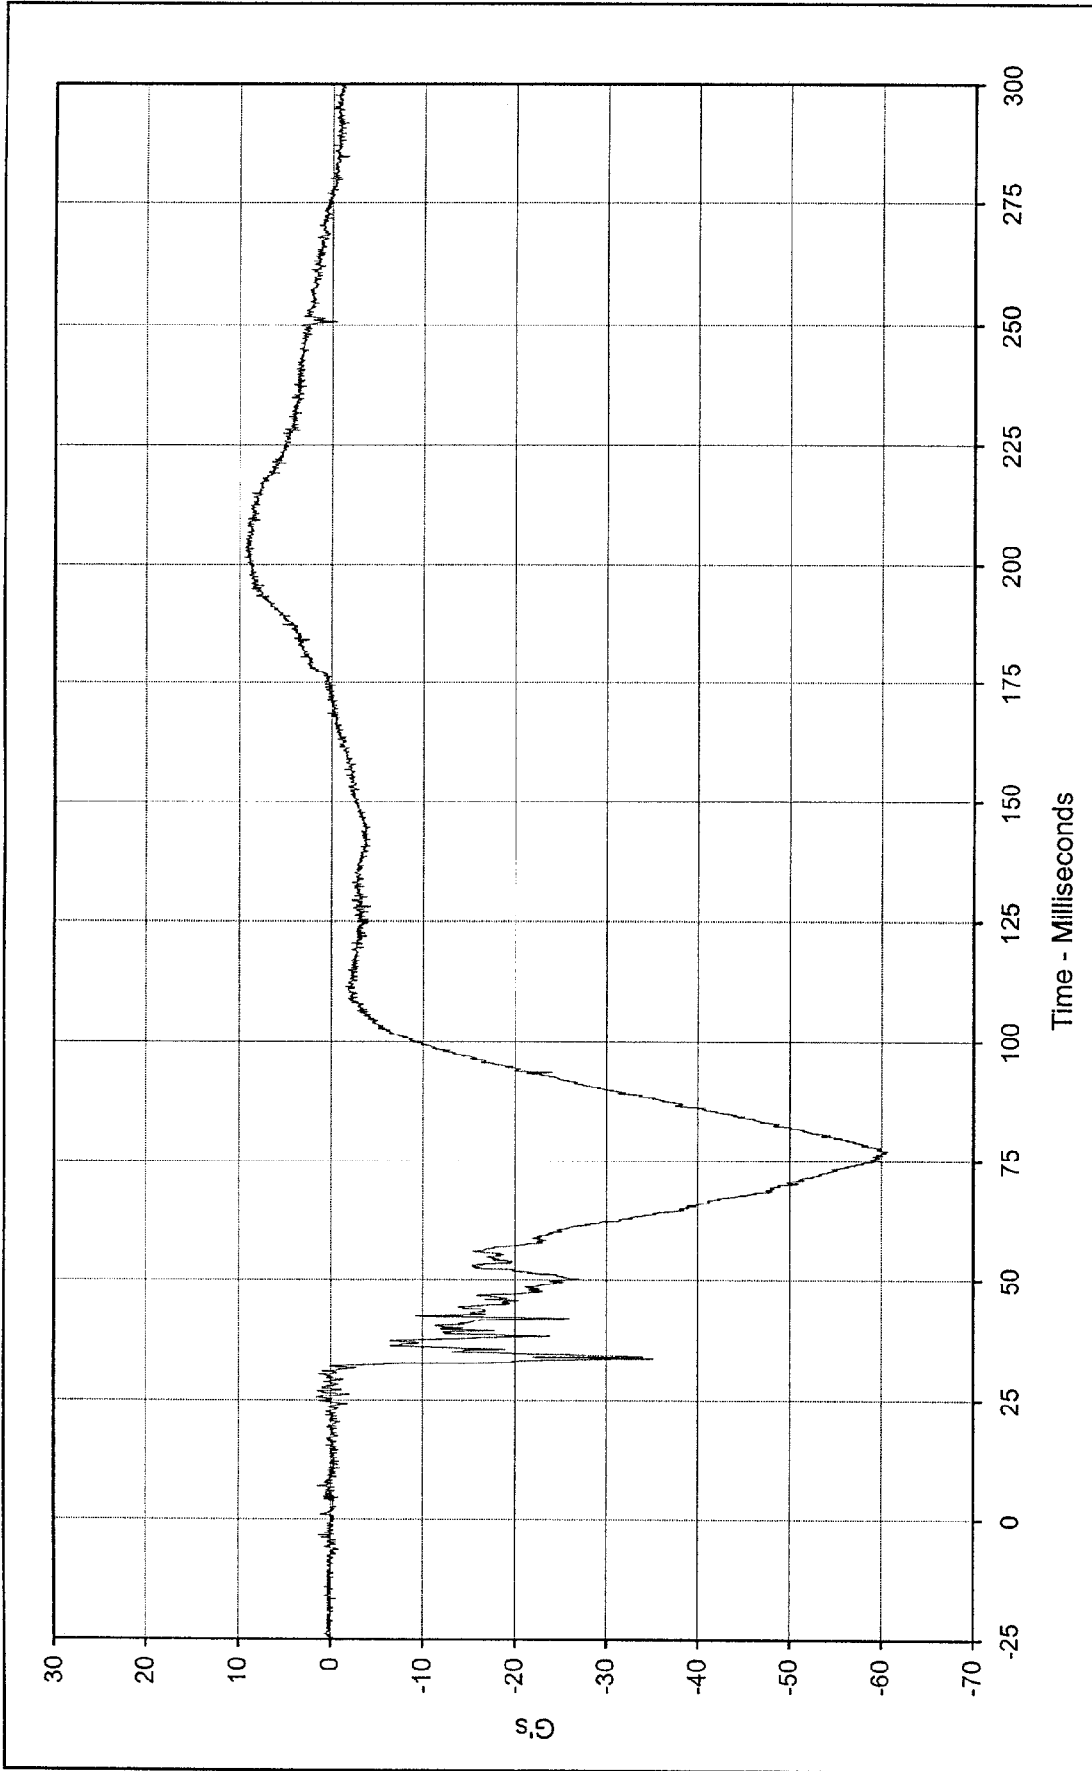
Curve Description: Passenger Head Primary X Testing Program 1998 NHTSA 35 mph NCAP No.: MW5302
 Maximum Value: 9.5 at 201.6 Milliseconds Test Vehicle: 1998 Honda Civic DX 4 Door Sedan
 Minimum Value: -60.7 at 77.1 Milliseconds
 SAE Filter Class: 1000
 Date of Test: 12/11/97
 Curve Number: FIL-045

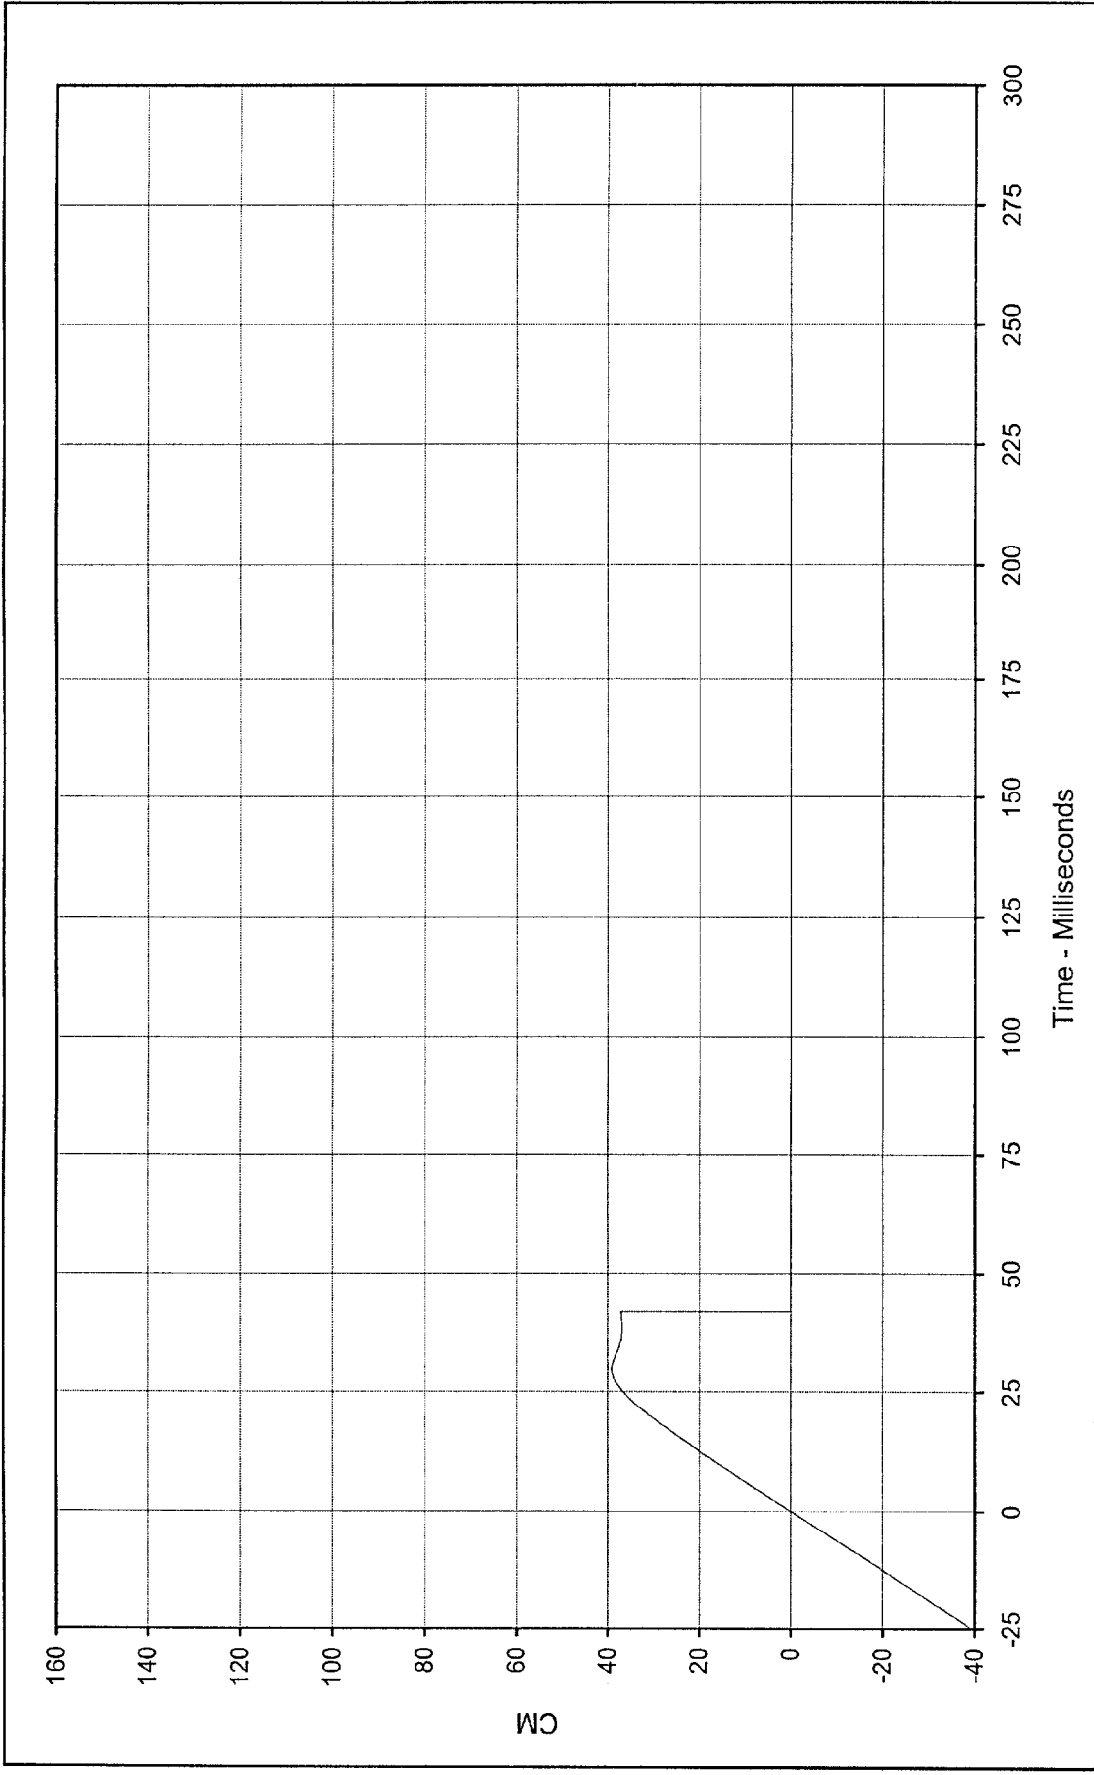
Curve Description: Vehicle Engine Bottom Displ. * Testing Program 1998 NHTSA 35 mph NCAP No.: MW5302
 Maximum Value: 39.1 at 29.8 Milliseconds Test Vehicle: 1998 Honda Civic DX 4 Door Sedan
 Minimum Value: 0.0 at 42.0 Milliseconds
 SAE Filter Class: 180
 Date of Test: 12/11/97
 Curve Number: IN2-092

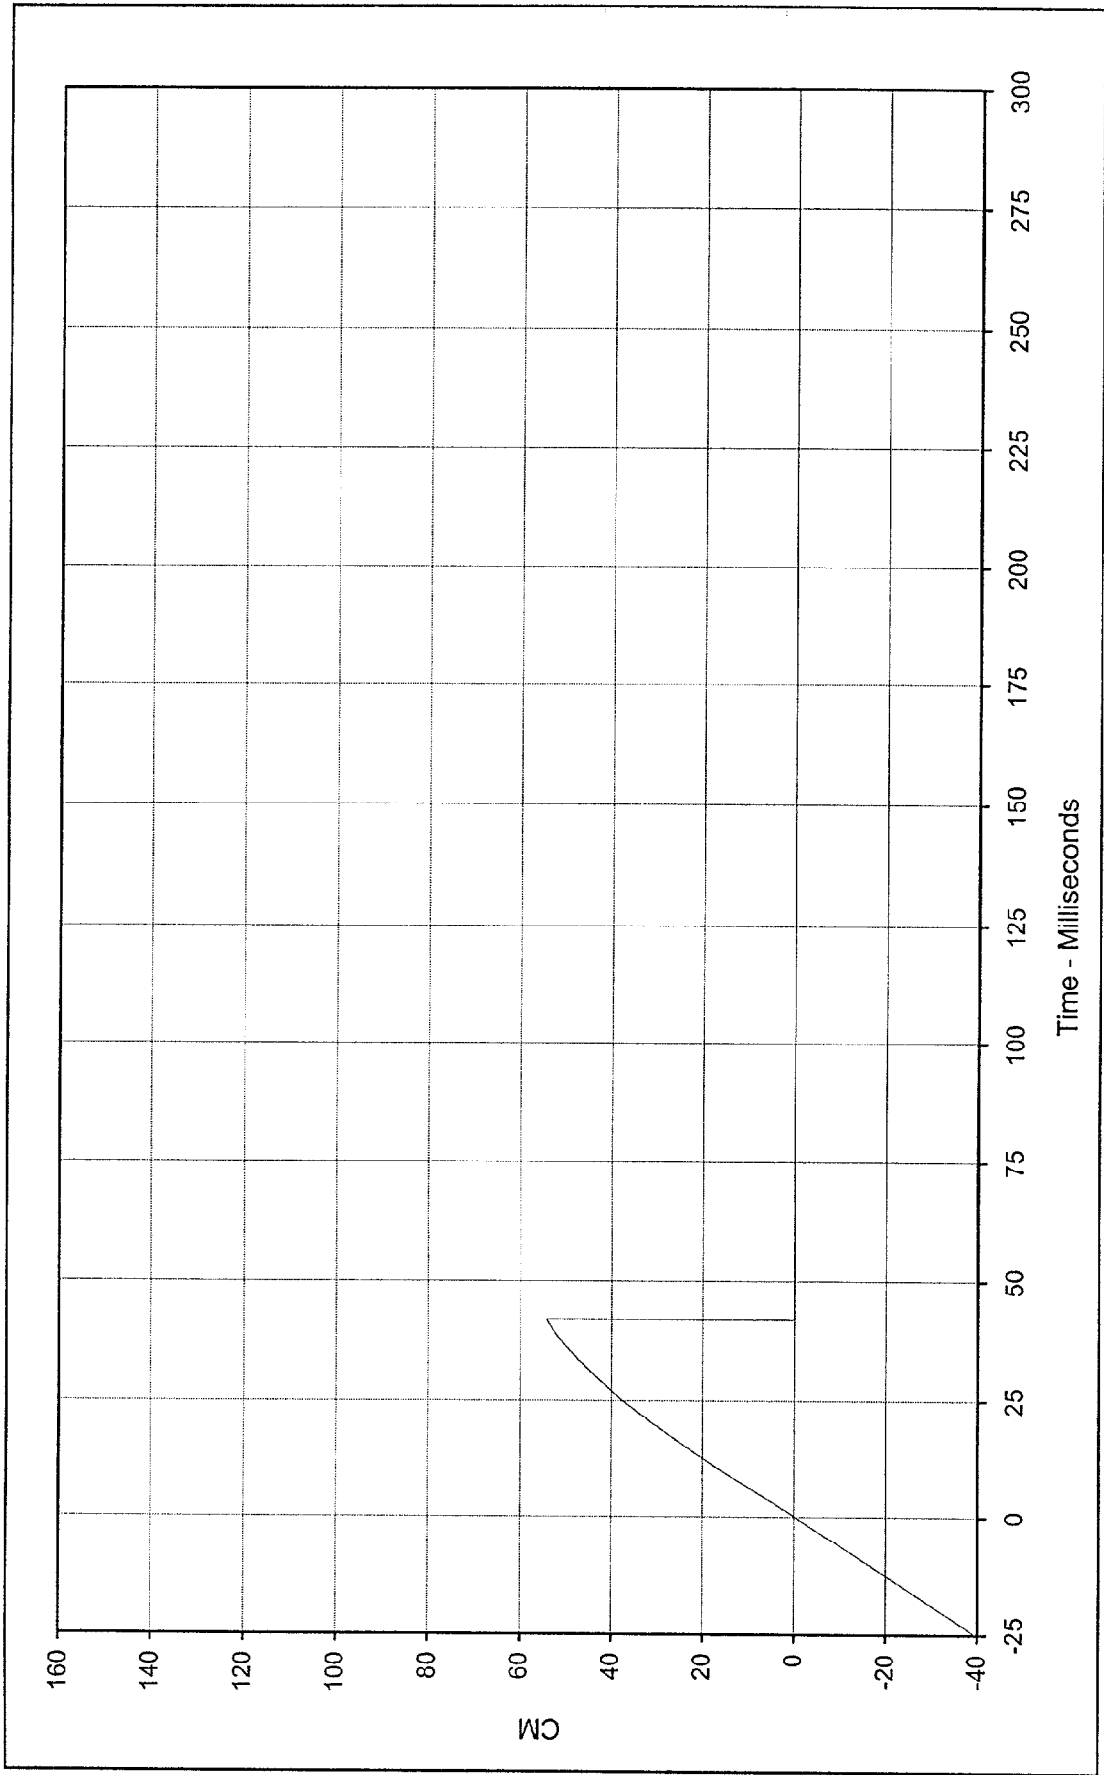
Curve Description: Vehicle Left Brake Caliper Displ. *
 Maximum Value: 54.2 at 41.9 Milliseconds
 Minimum Value: -0.2 at 0.0 Milliseconds
 SAE Filter Class: 180
 Date of Test: 12/11/97
 Curve Number: IN2-093

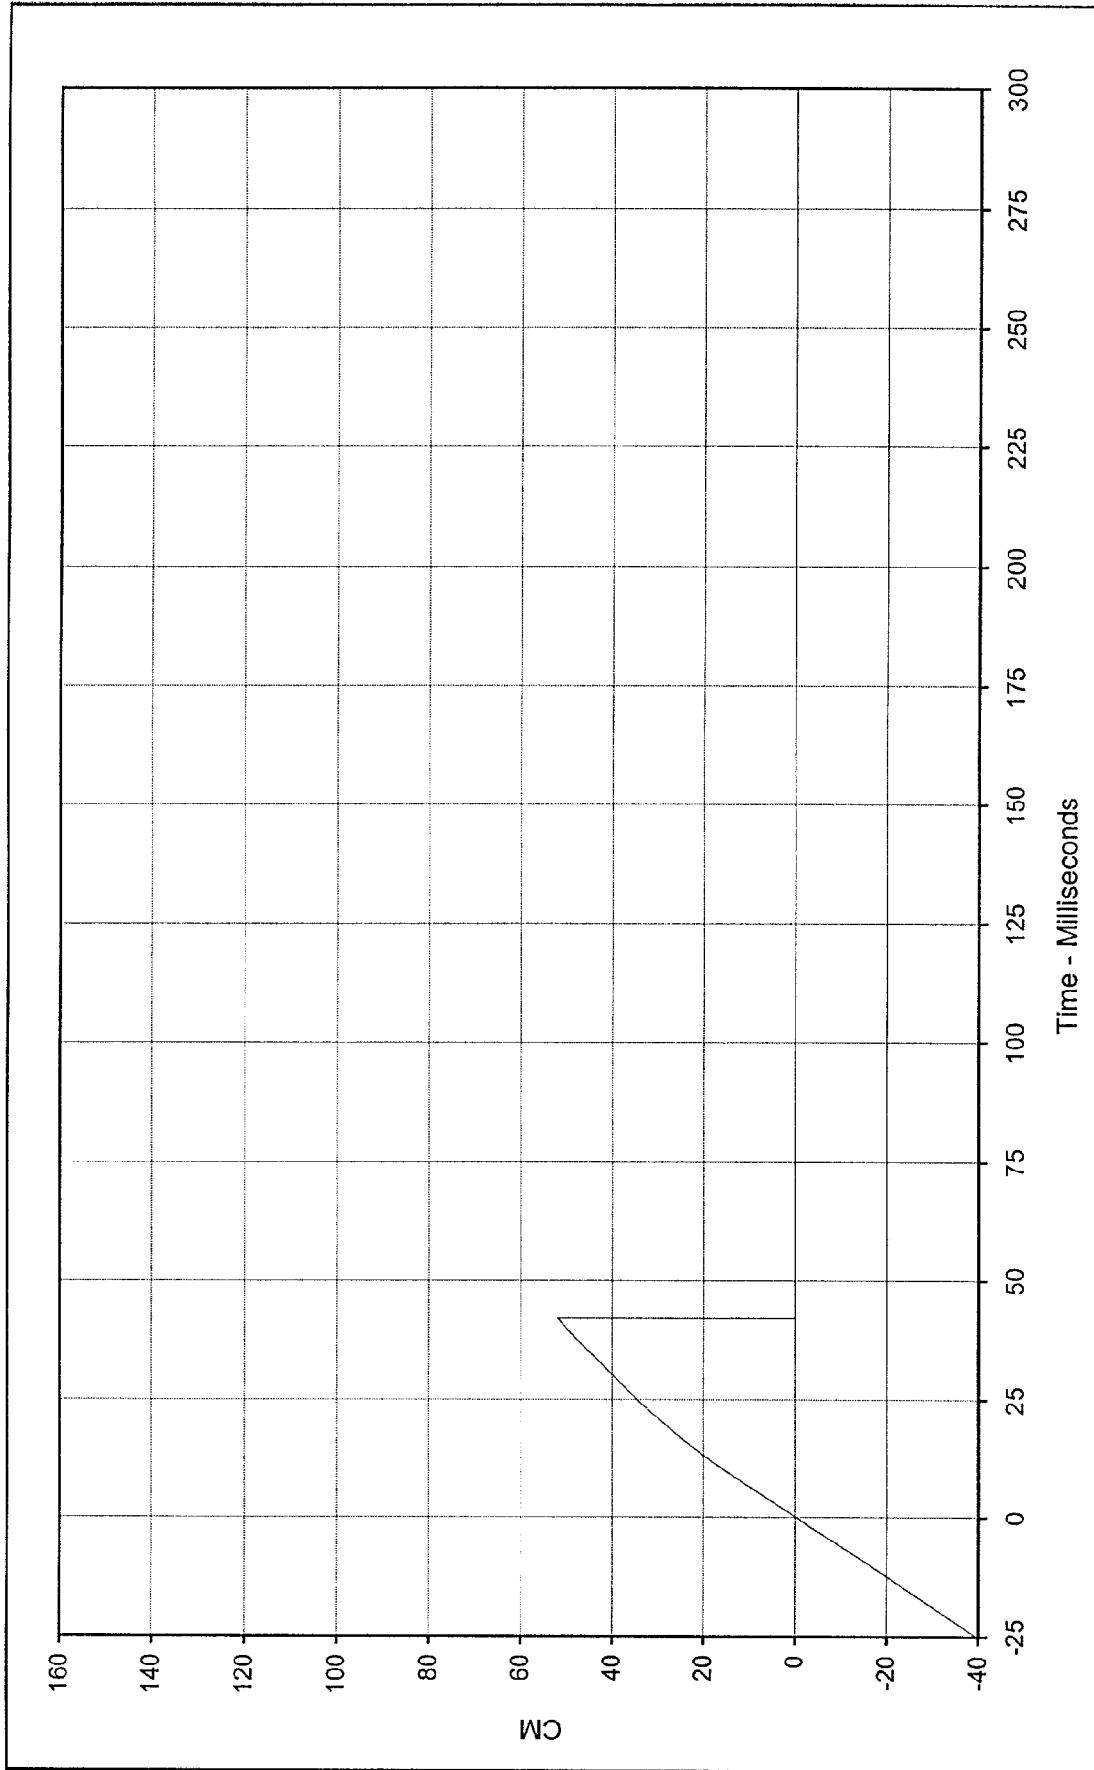
Curve Description: Vehicle Instrument Panel Displ. * Testing Program 1998 NHTSA 35 mph NCAP No.: MW5302
 Maximum Value: 51.9 at 41.9 Milliseconds Test Vehicle: 1998 Honda Civic DX 4 Door Sedan
 Minimum Value: -0.2 at 0.0 Milliseconds
 SAE Filter Class: 180
 Date of Test: 12/11/97
 Curve Number: IN2-095

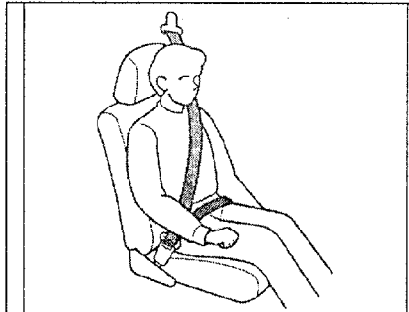
Position the lap part of the belt as low as possible across your hips, then pull up on the shoulder part of the belt so the lap part fits snugly. This lets your strong pelvic bones take the force of a crash and reduces the chance of internal injuries.

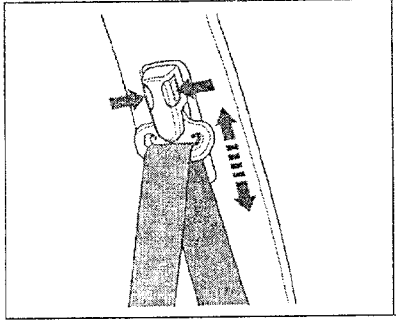
If the seat belt touches or crosses your neck, or if it crosses your arm instead of your shoulder, you need to adjust the seat belt anchor height. An improperly positioned seat belt can cause severe neck injuries if the belt is positioned too high, or serious chest or internal injuries if the belt is positioned too low.

To adjust the height of a front seat belt anchor, squeeze the two release buttons and slide the anchor up or down as needed (it has four positions).

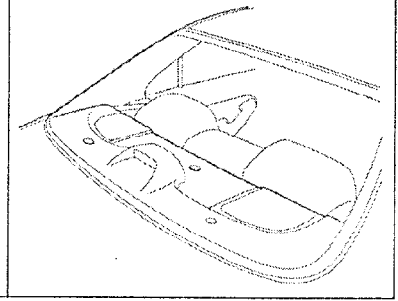
Your car has three attachment points on the rear shelf for securing a tether-style child seat to the car.
