NEW CAR ASSESSMENT PROGRAM  
SIDE IMPACT TESTING  
PASSENGER CARS

1998 Toyota Lexus ES300  
4-DOOR SEDAN  
NHTSA NO: MW5112

MGA PROVING GROUNDS  
5000 WARREN ROAD  
BURLINGTON, WI 53105

FINAL REPORT

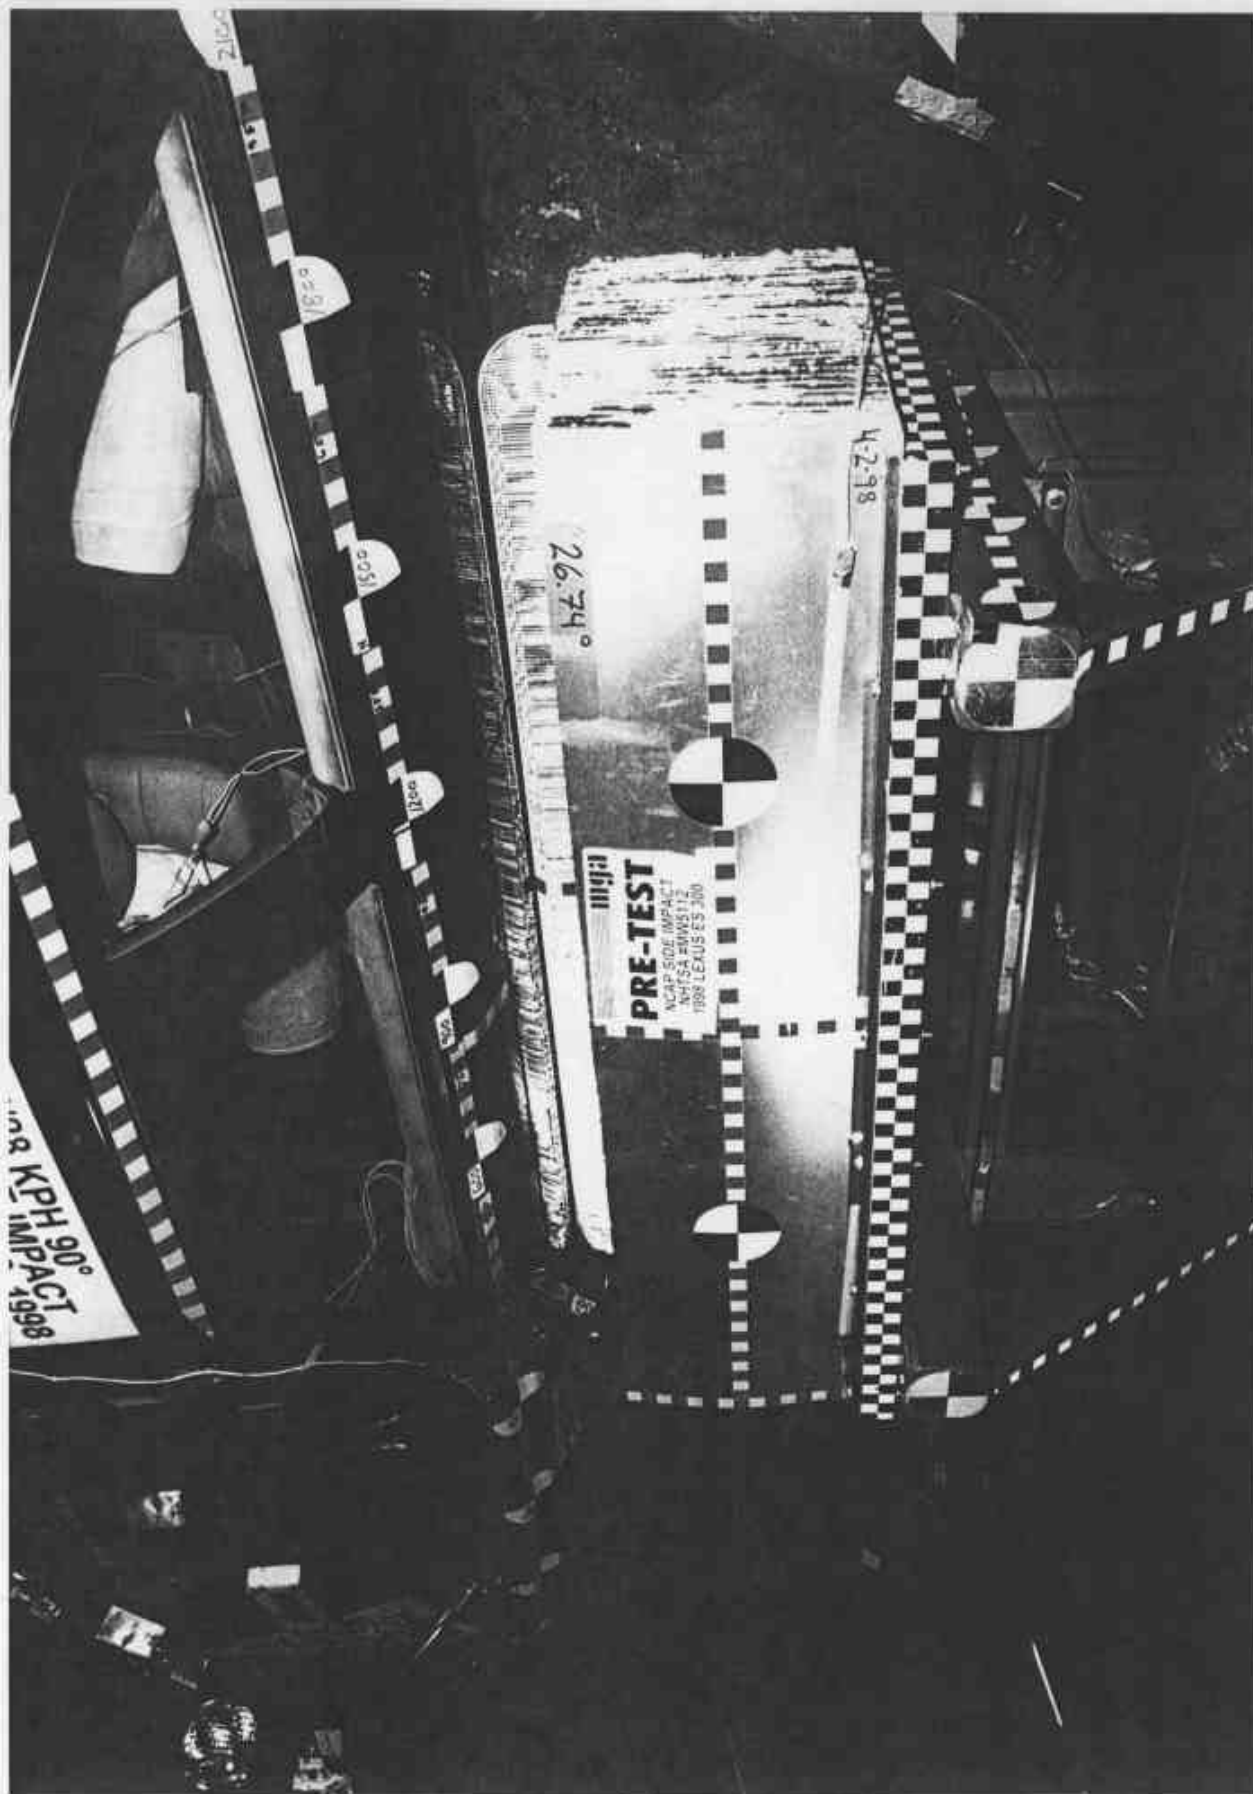
Photo No. A-9 - Pre-Test MDB Positioned Against Vehicle Overhead View

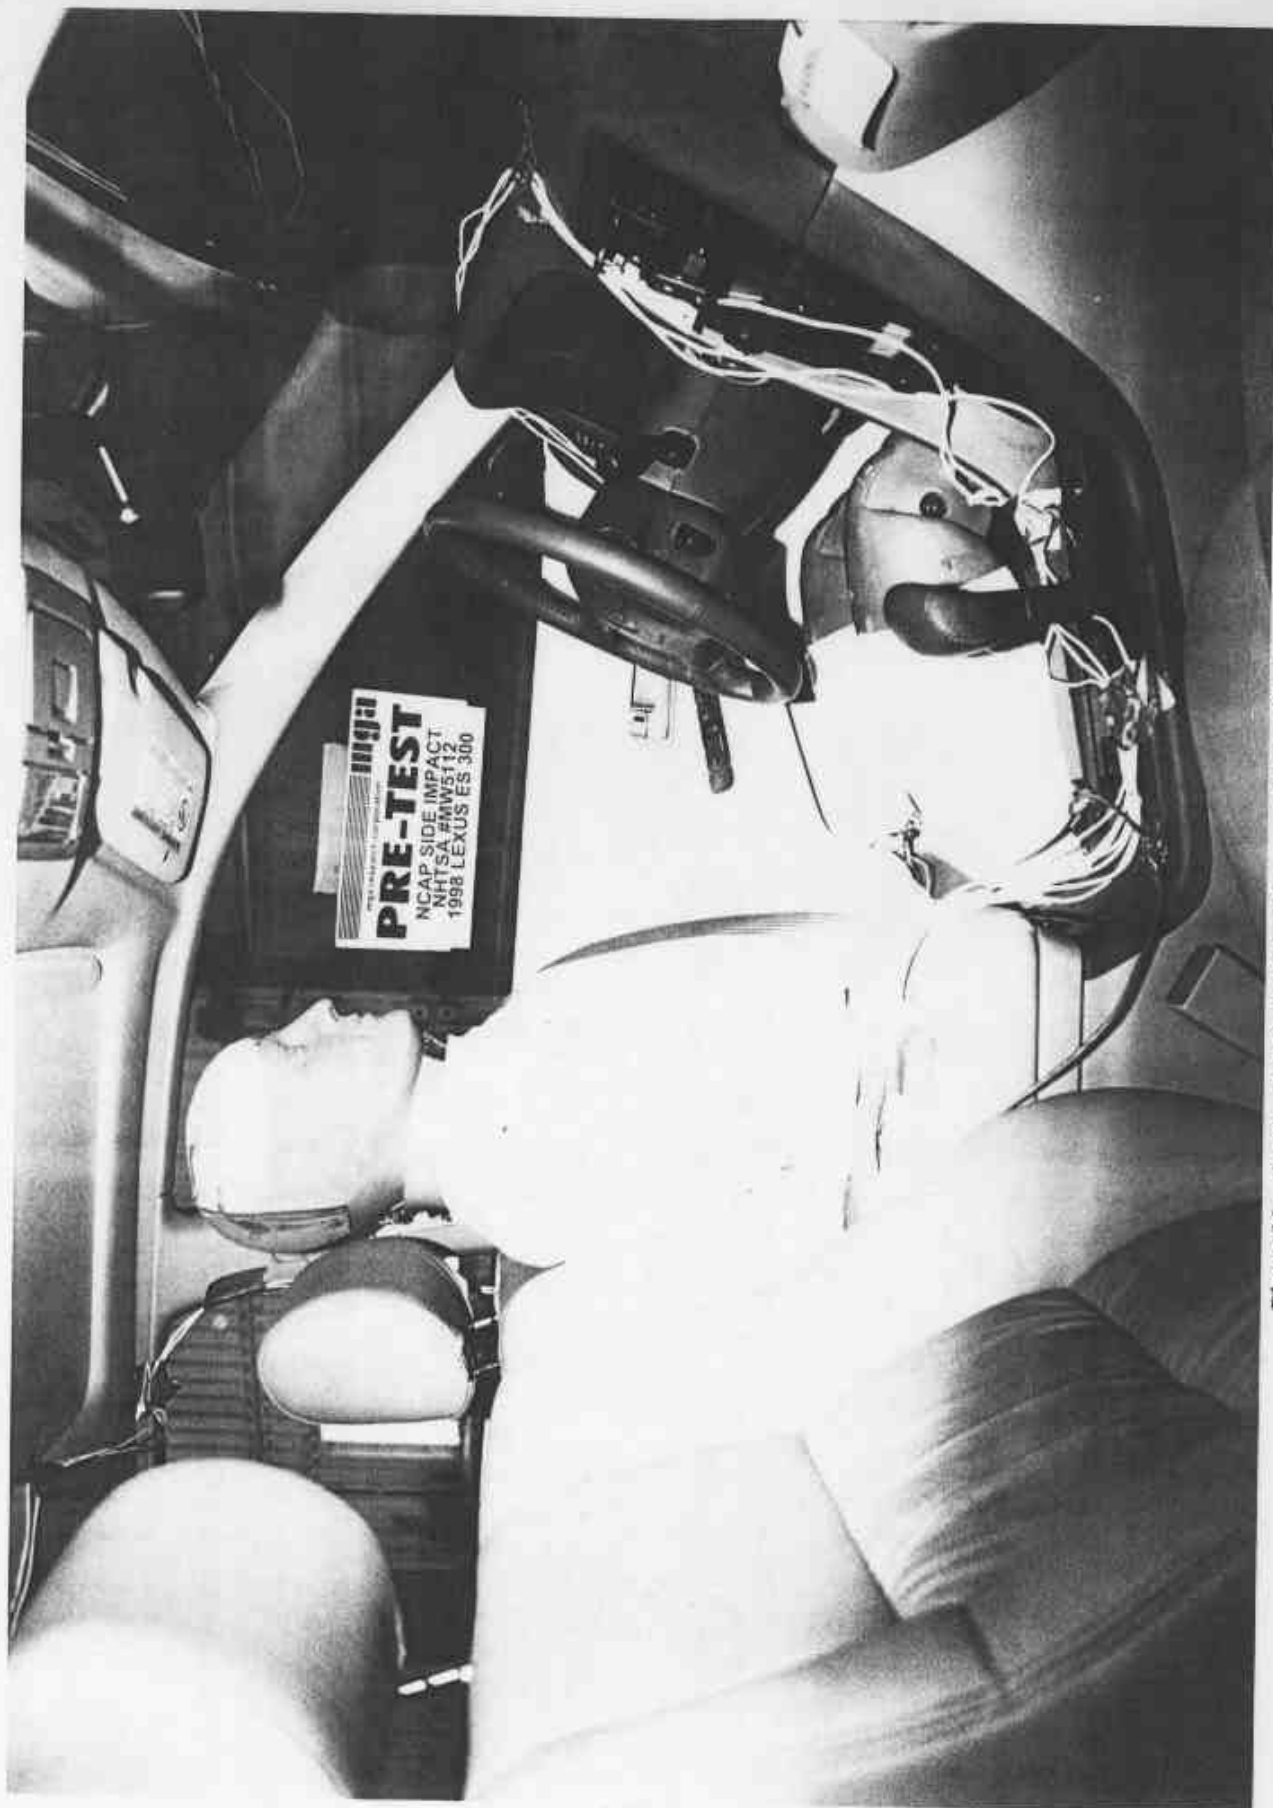
Photo No. A-21 - Pre-Test Driver Dummy Right Side View

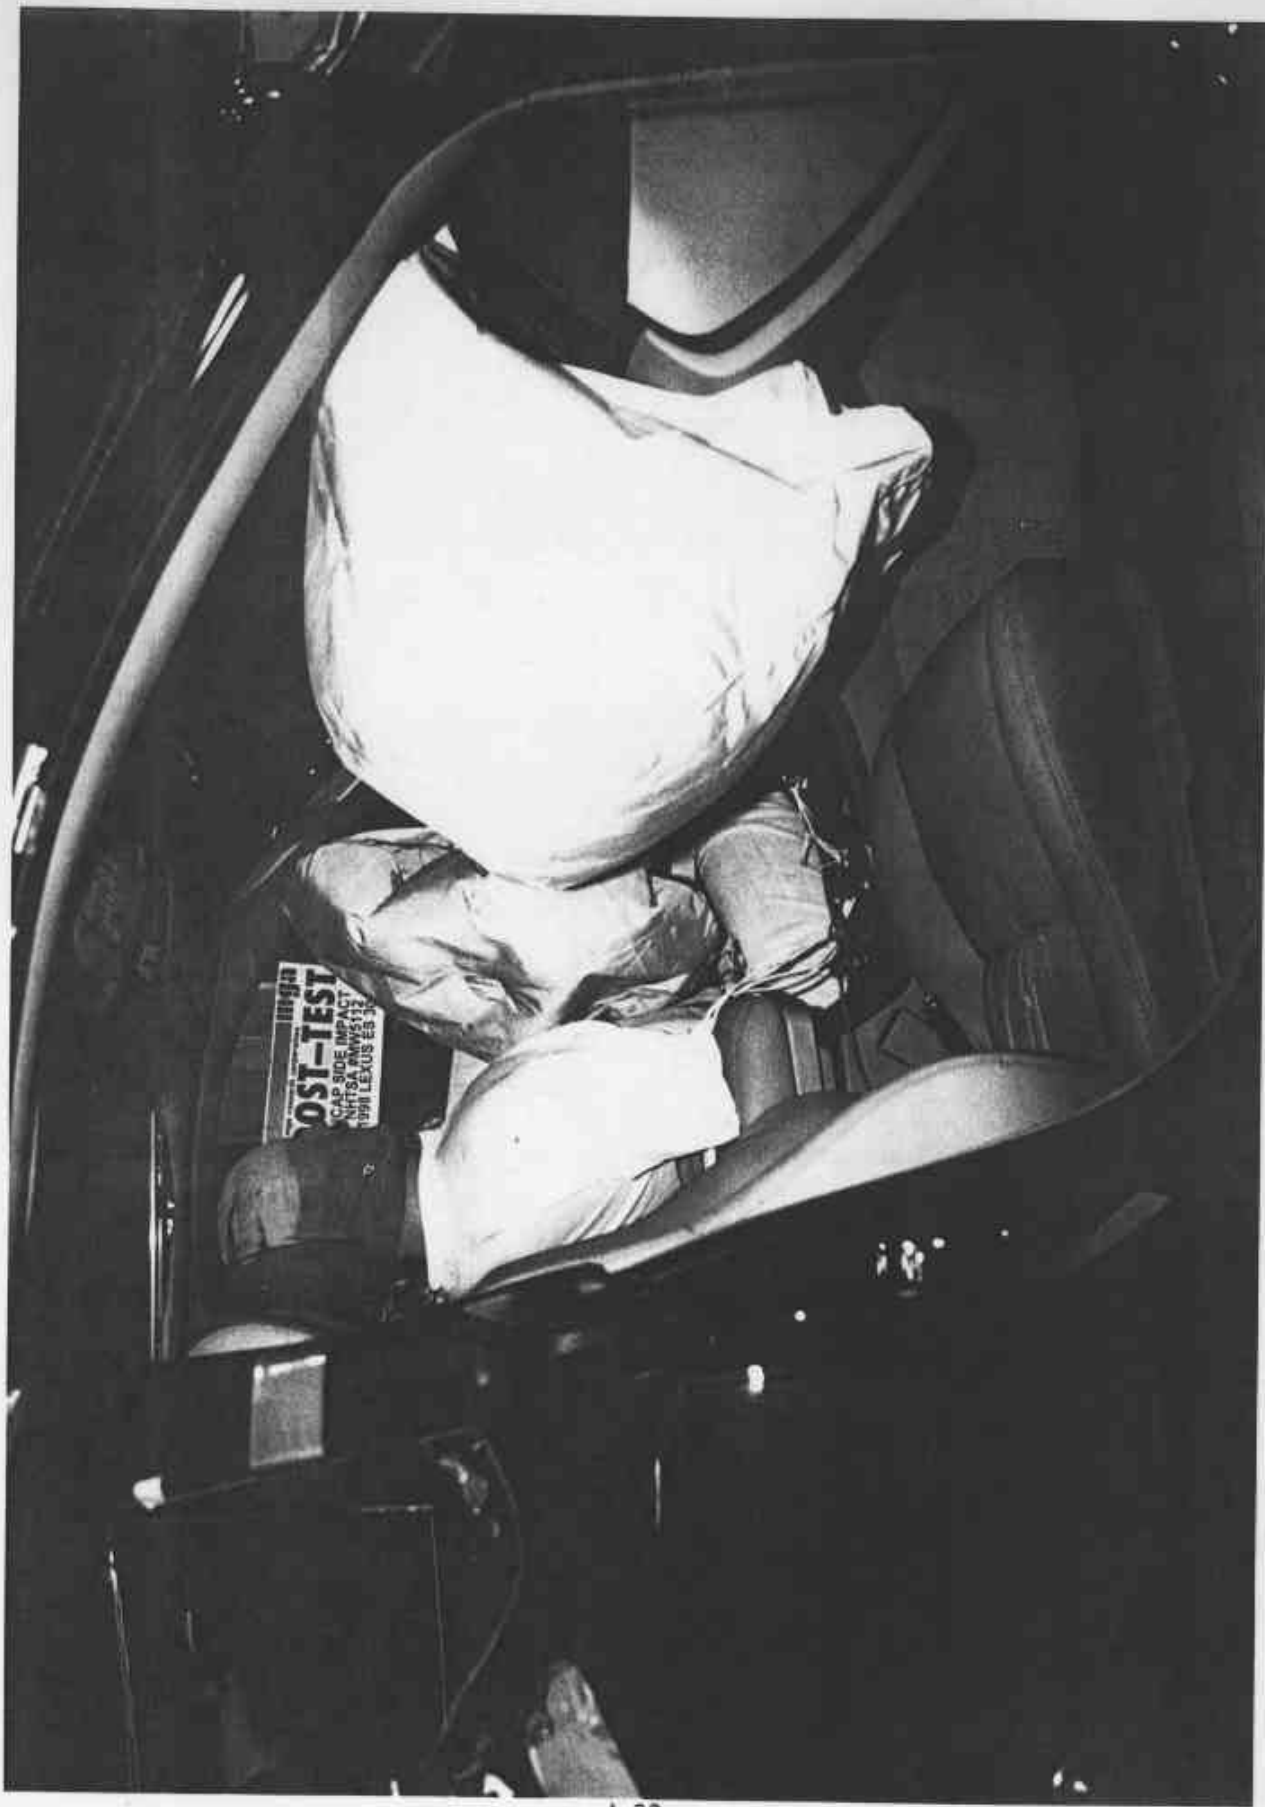
Photo No. A-22 - Post-Test Driver Dummy Right Side View

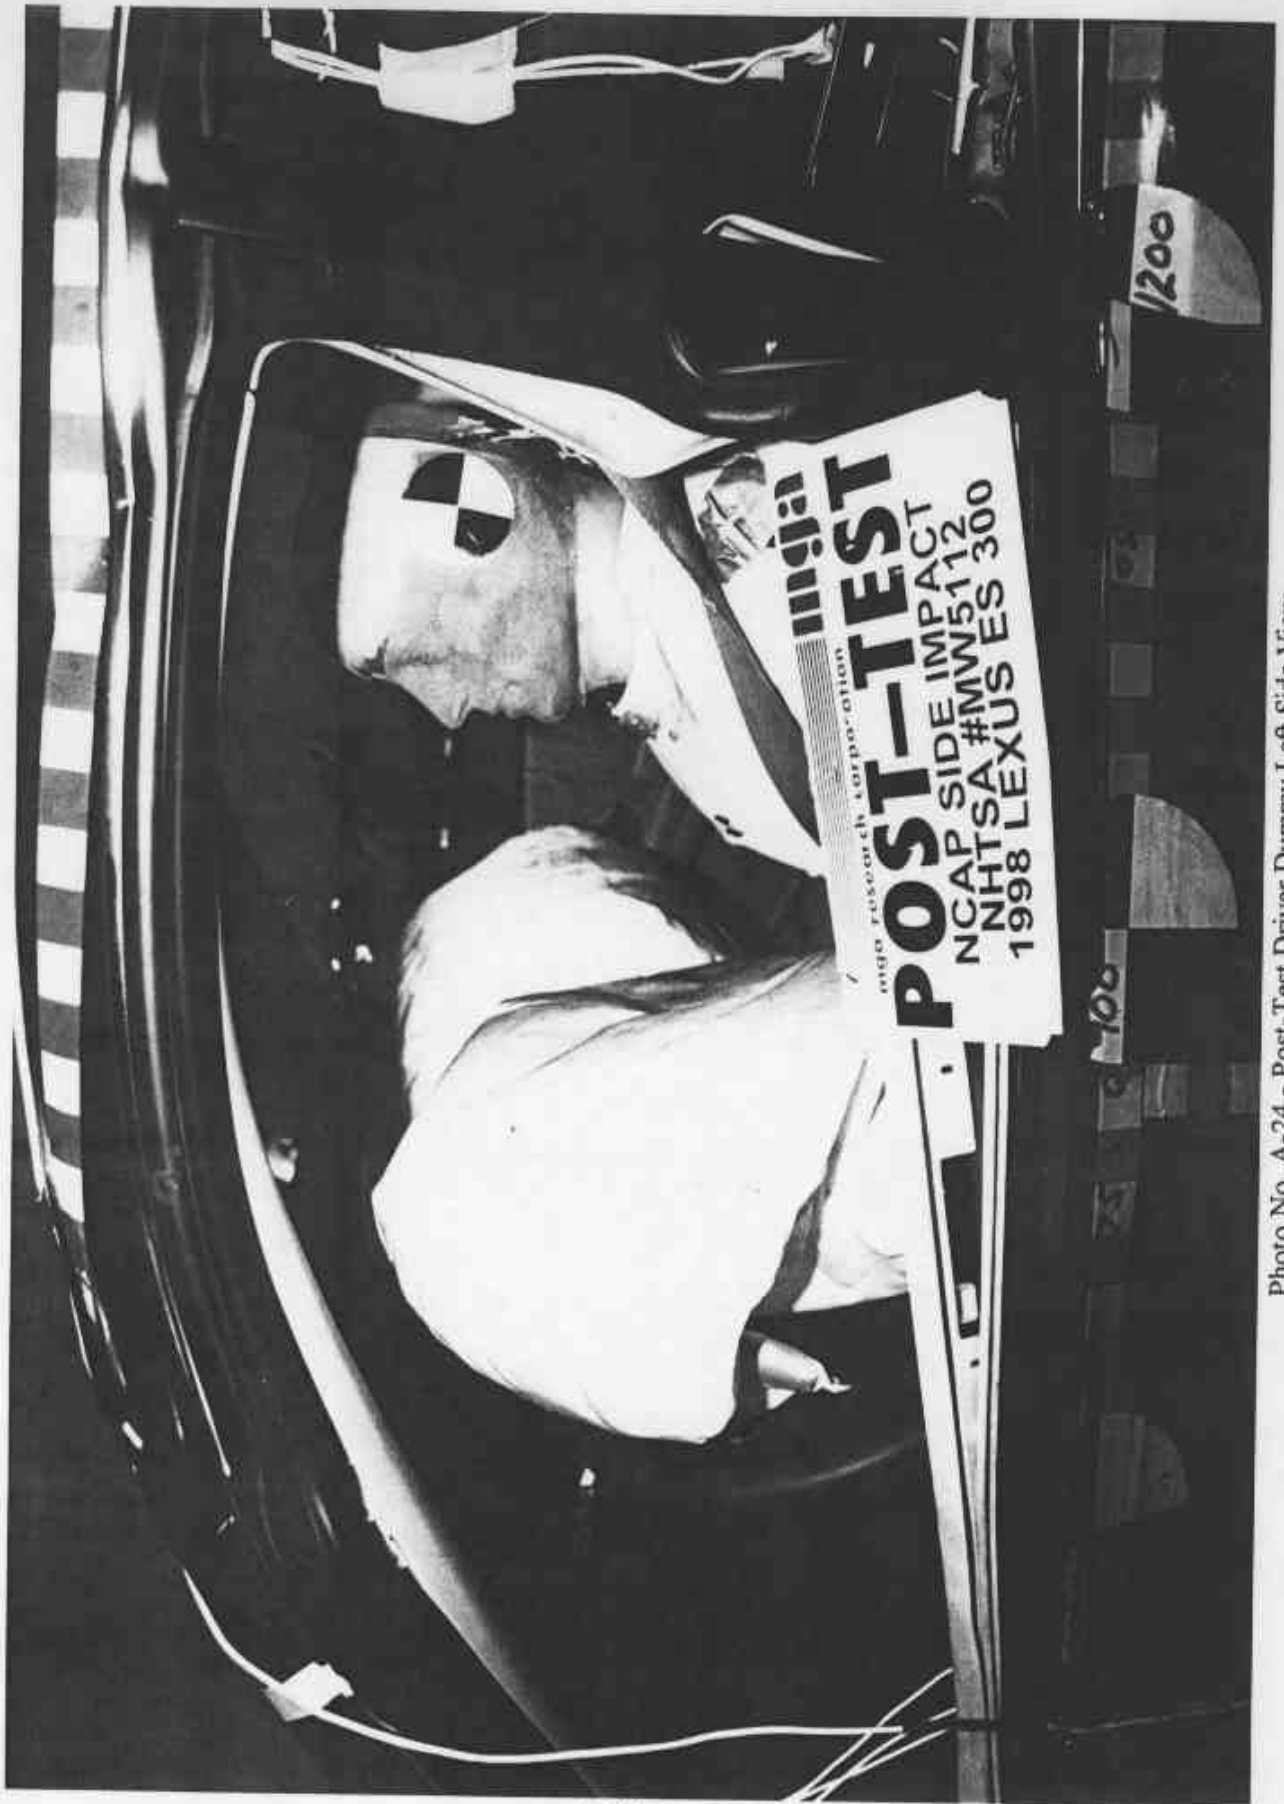
Photo No. A-24 - Post-Test Driver Dummy Left Side View

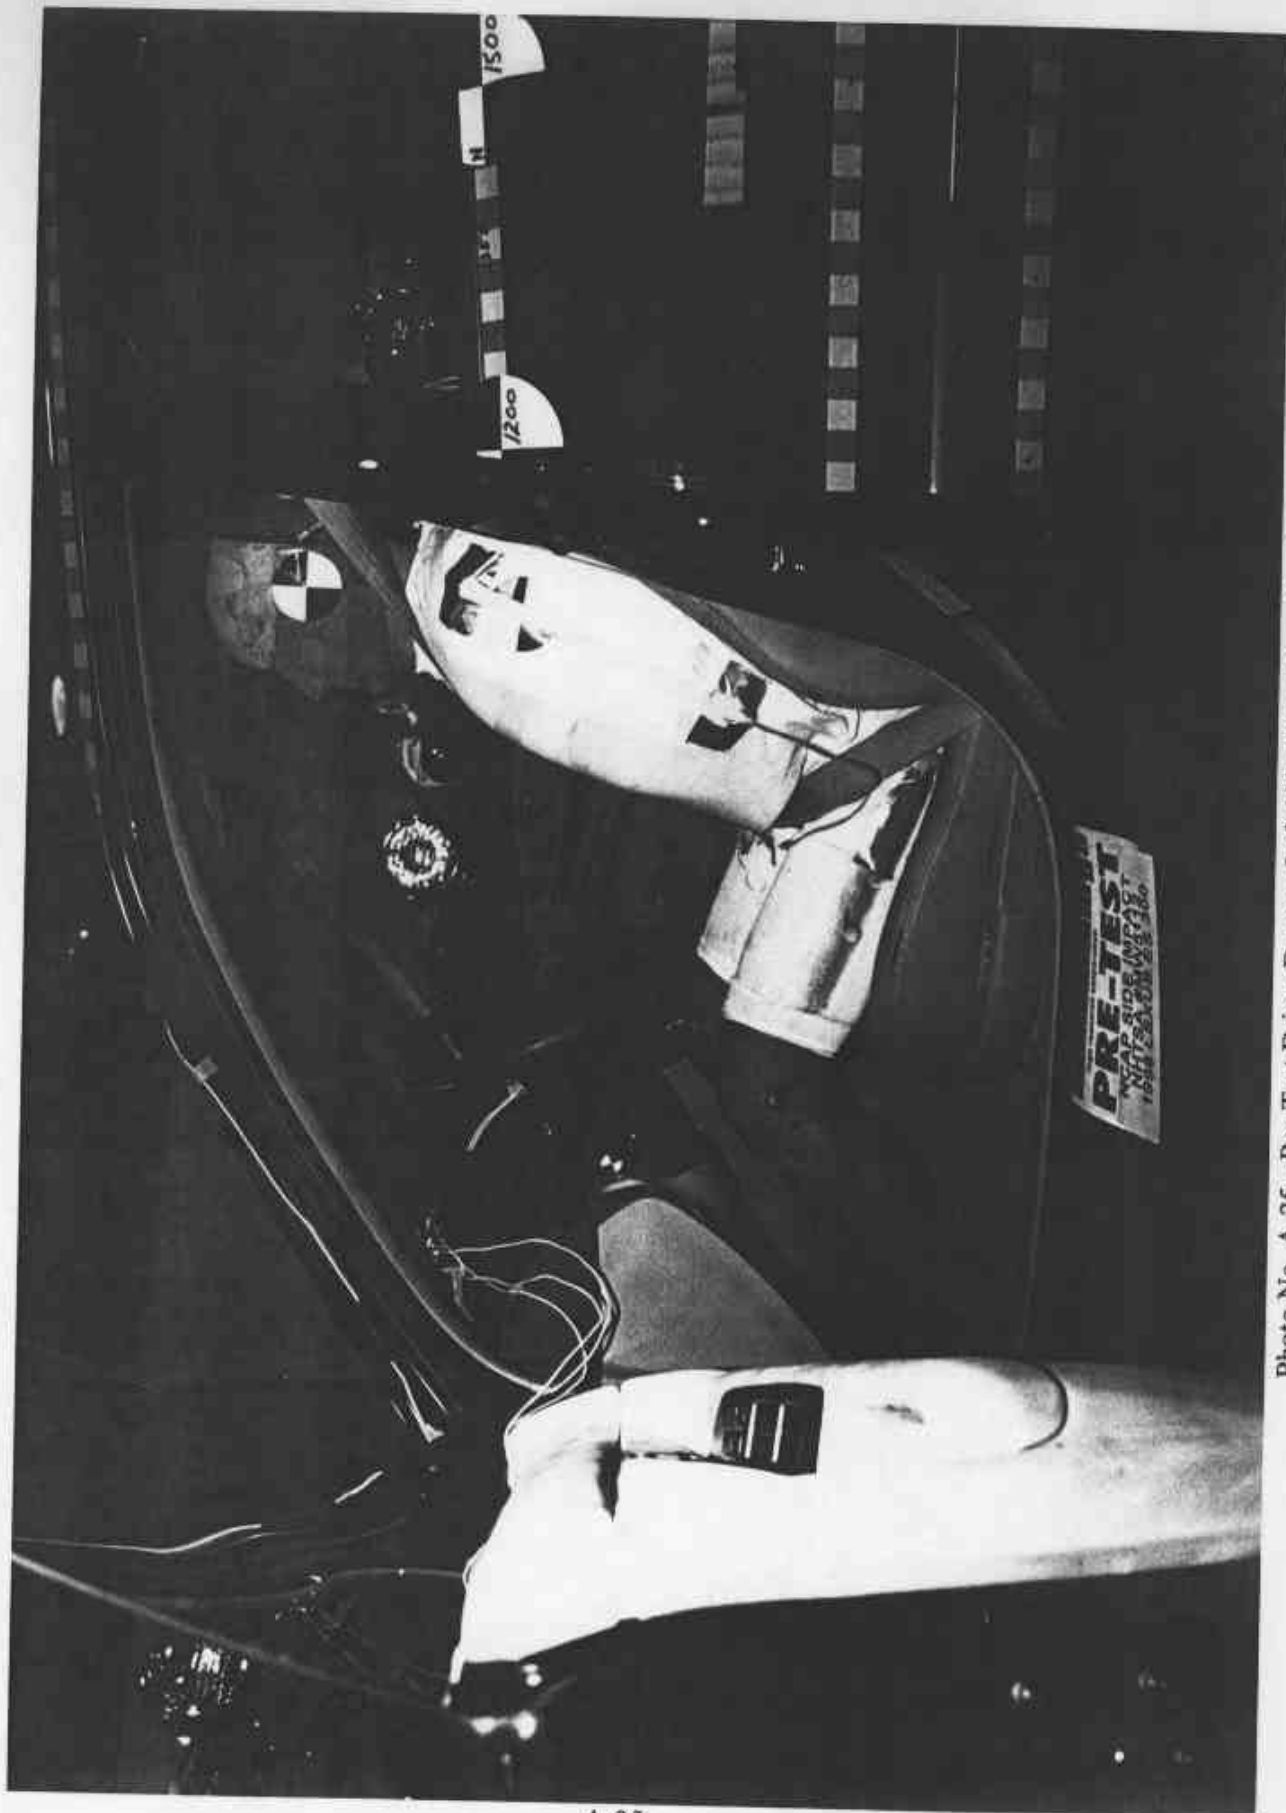
Photo No. A-25 - Pre-Test Driver Dummy Left Side View (Door Open)

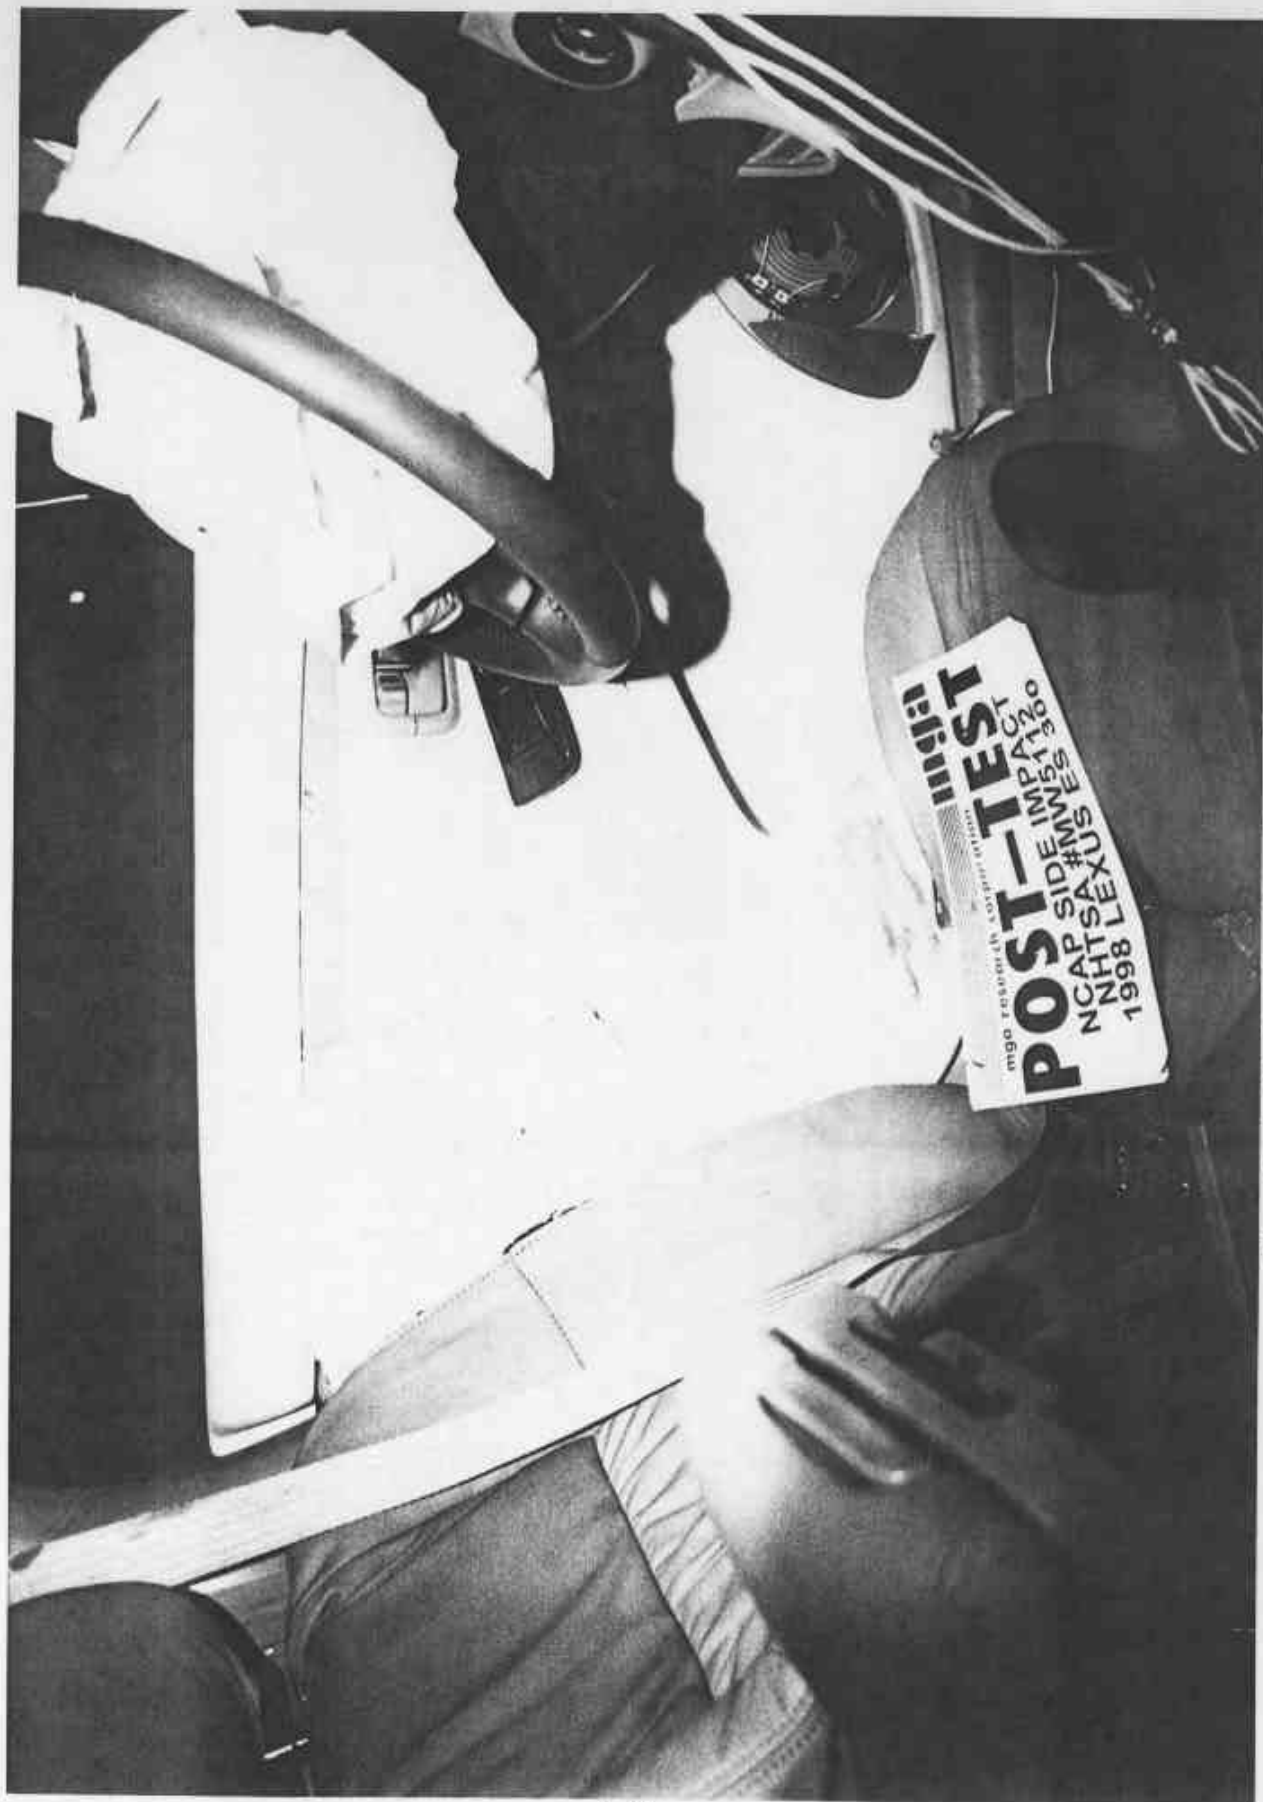
Photo No. A-28 - Post-Test Driver Dummy Contact

VISIBLE DUMMY CONTACT POINTS:

| | <u>LEFT FRONT SID</u> | <u>LEFT REAR SID</u> |
| Head | <u>to headrest</u> | <u>to C-pillar and headrest</u> |
| Arm | <u>to side airbag</u> | <u>to door (upper rear)</u> |
| Pelvis | <u>to lower rear of armrest</u> | <u>to rear of armrest</u> |
| Left Knee | <u>to door panel</u> | <u>to door panel (lower front)</u> |
| Right Knee | <u>to left knee</u> | <u>to left knee</u> |

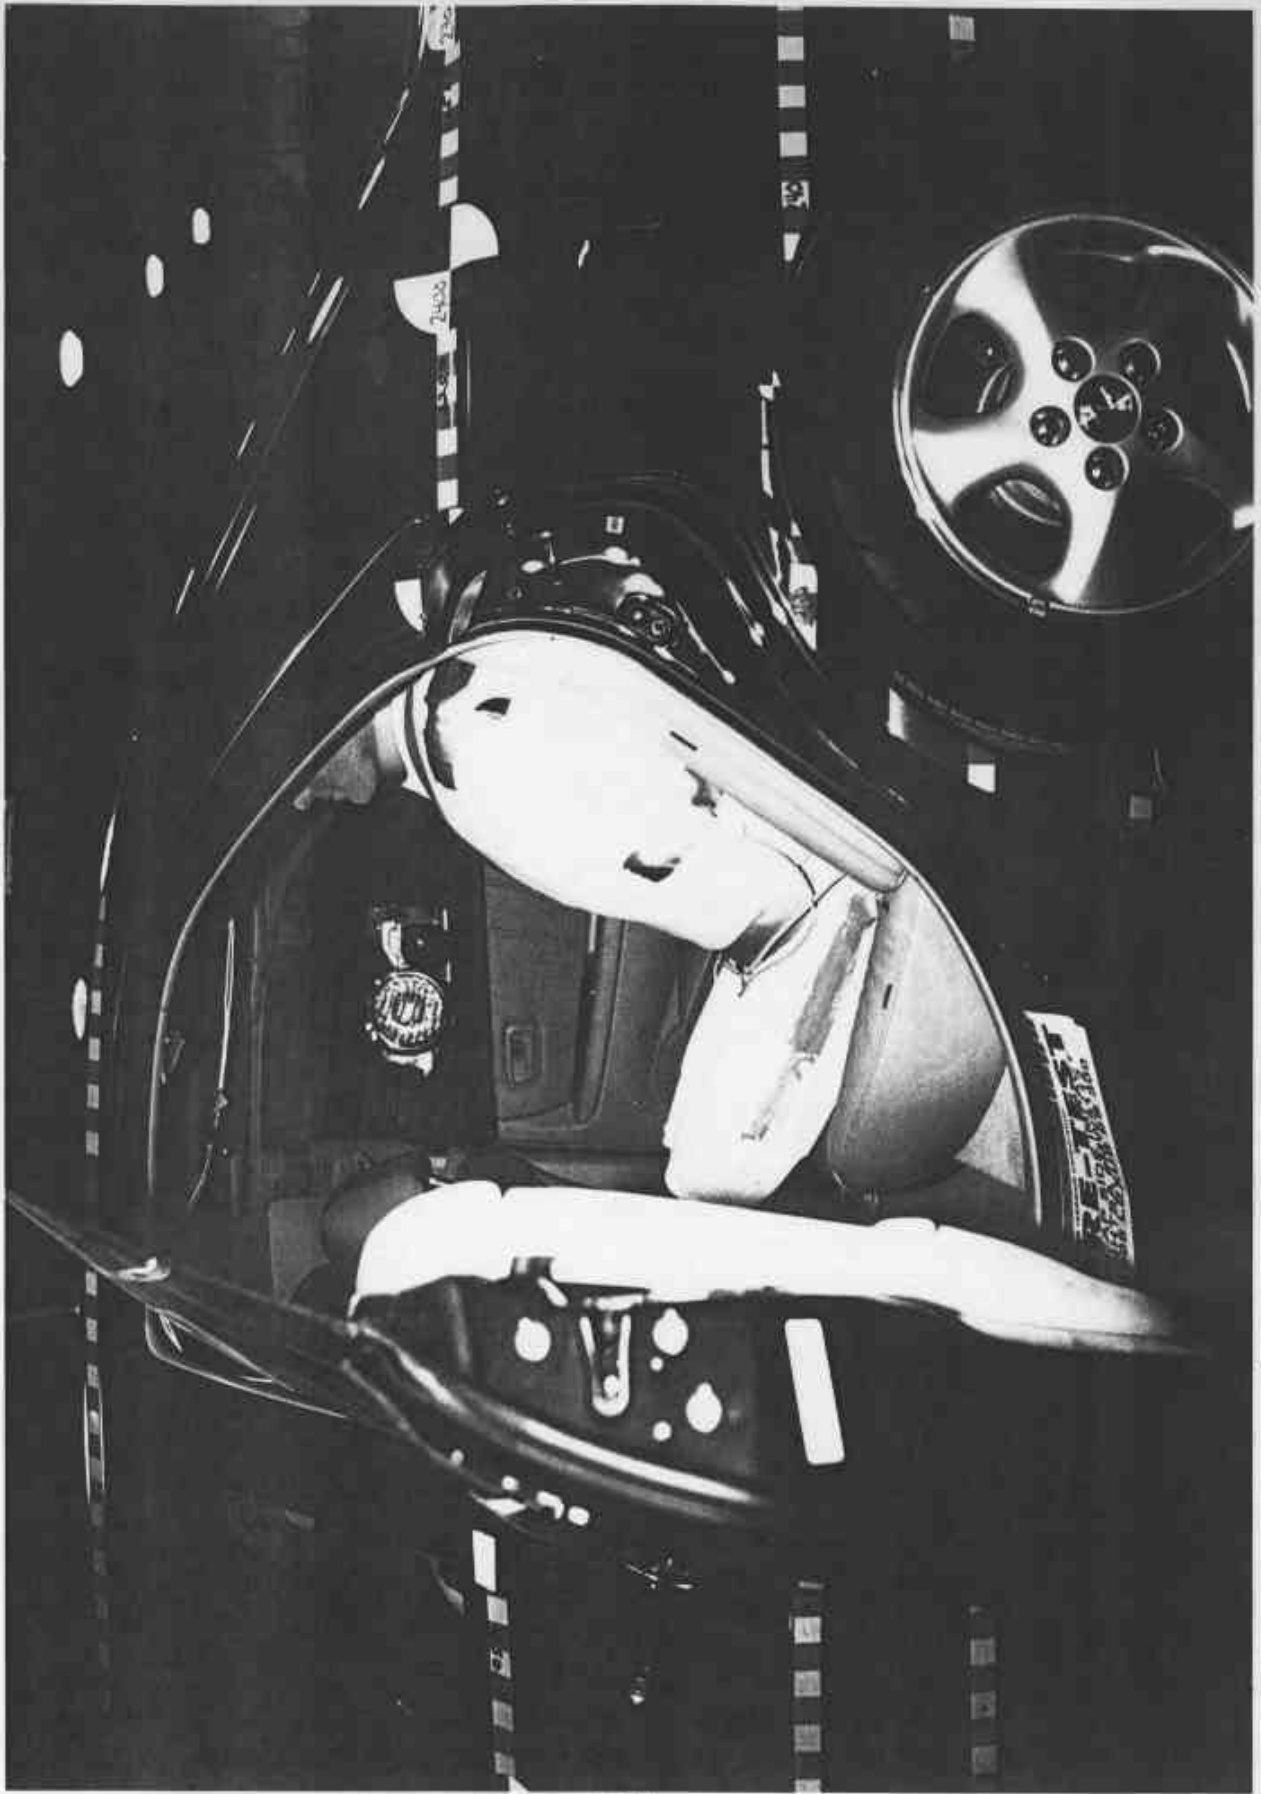
Photo No. A-34 - Pre-Test Passenger Dummy Left Side View (Door Open)

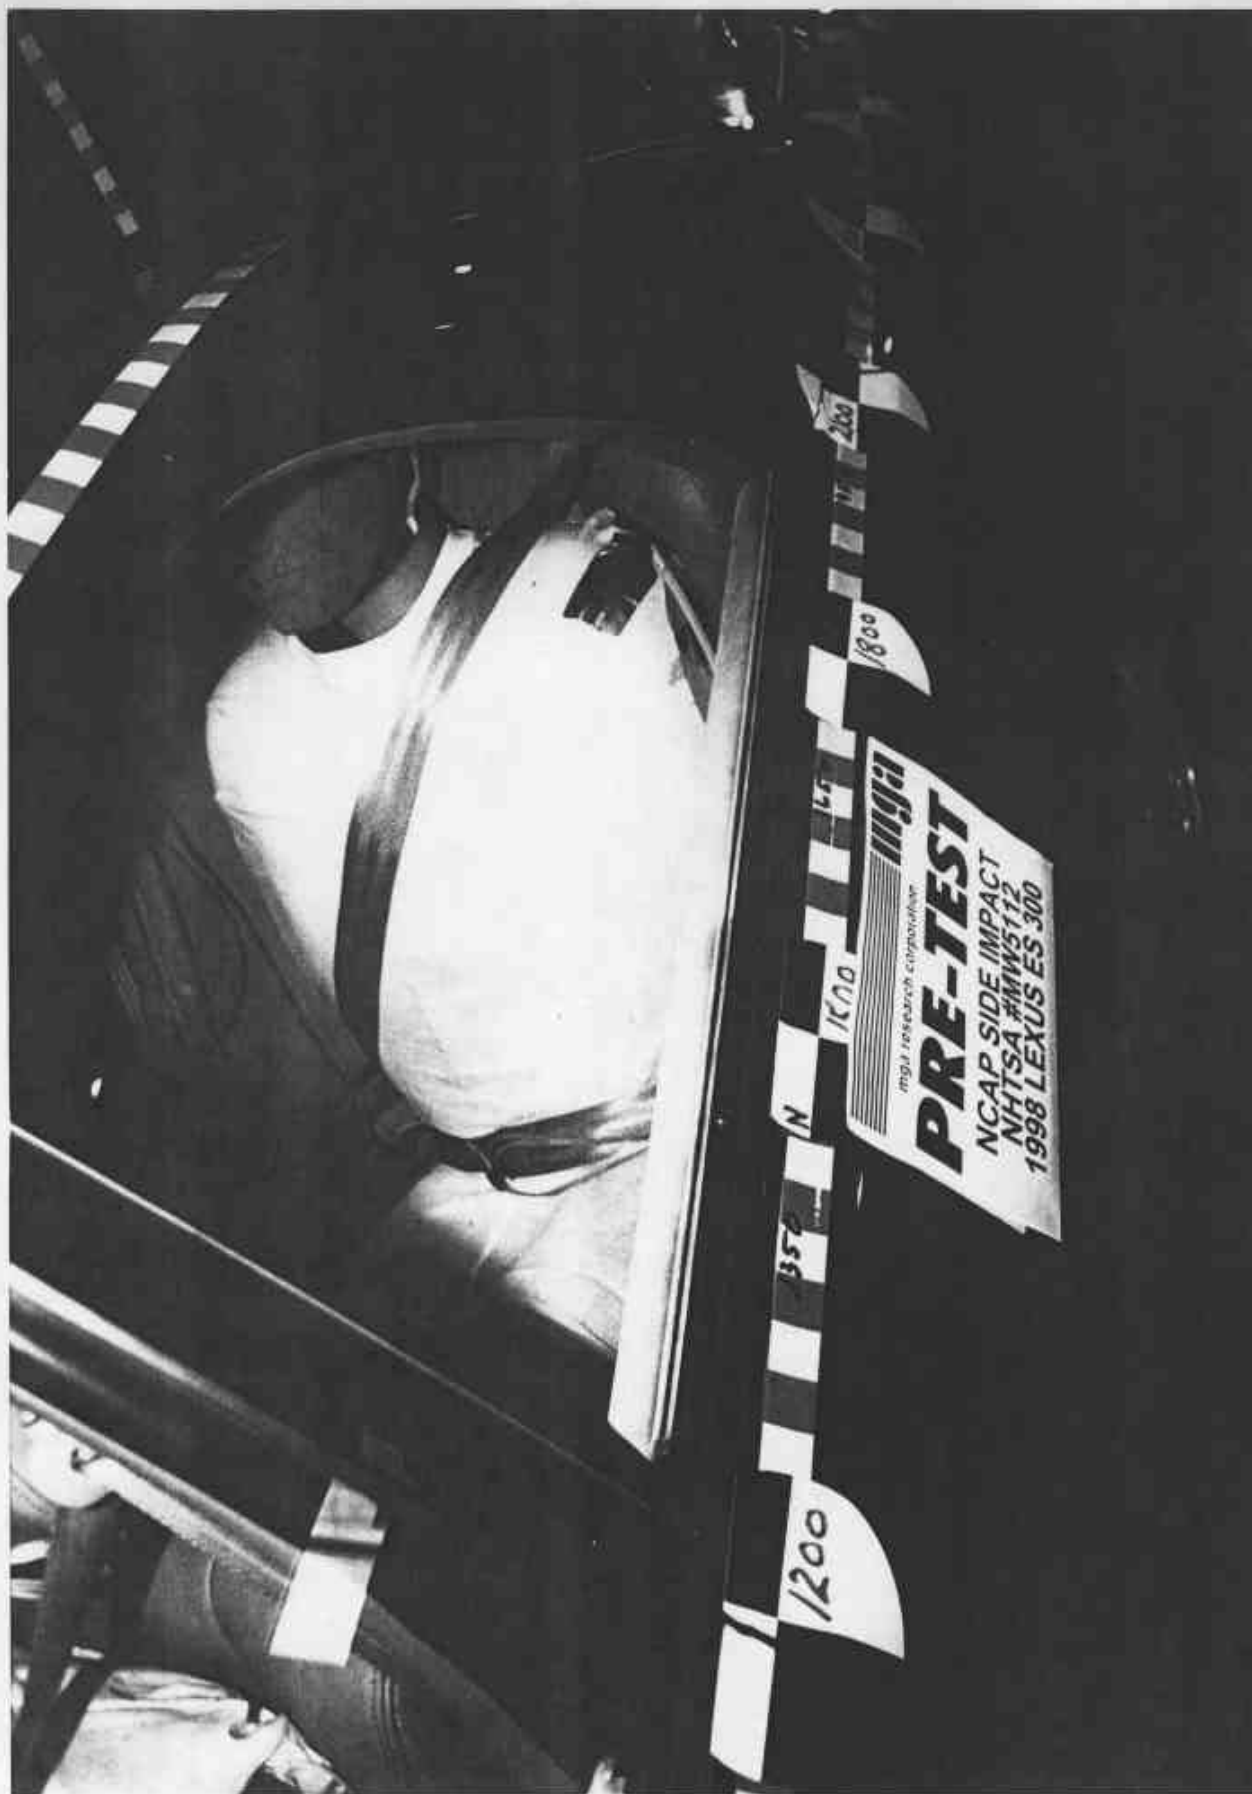
Photo No. A-35 - Pre-Test Passenger Dummy Shoulder and Door Top View

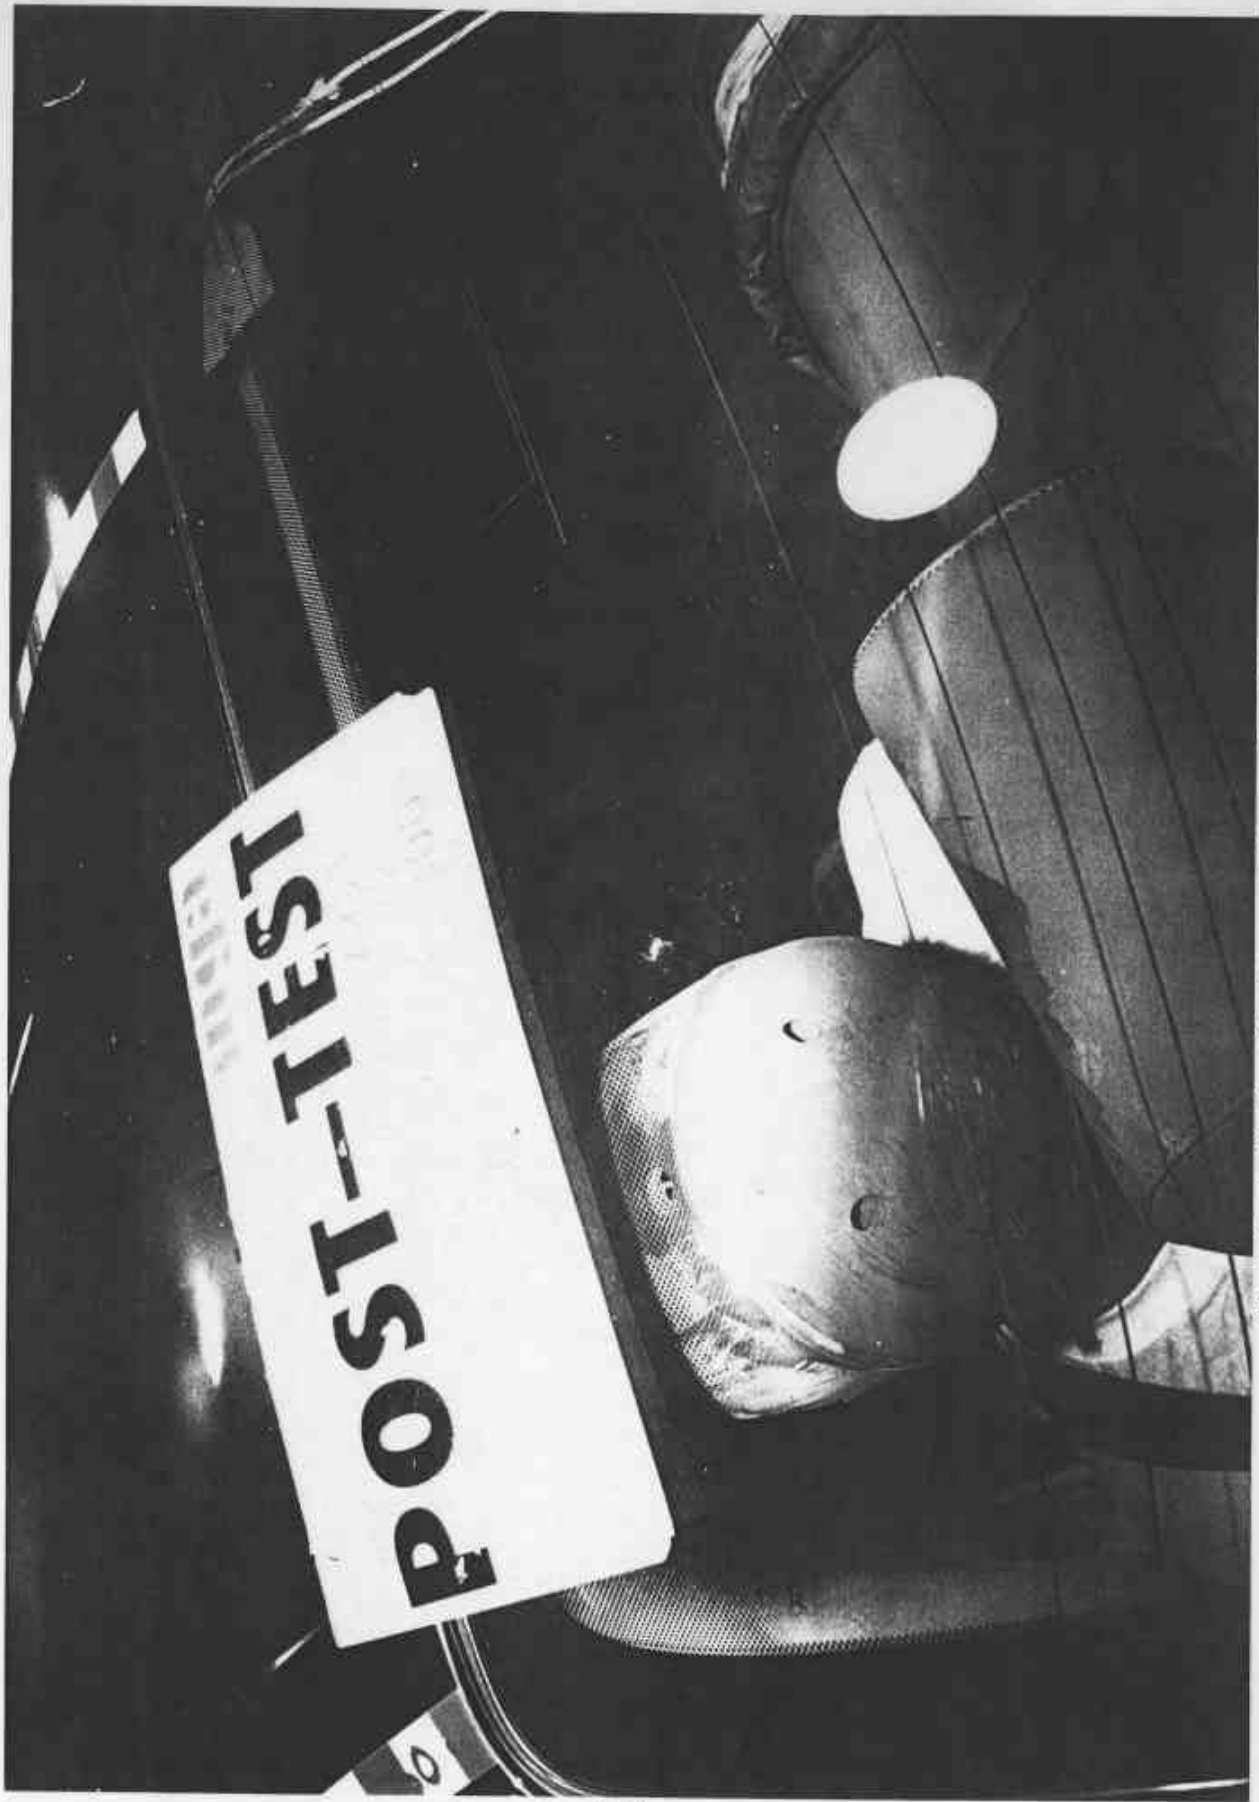
Photo No. A-39 - Post-Test Passenger Dummy Head Contact

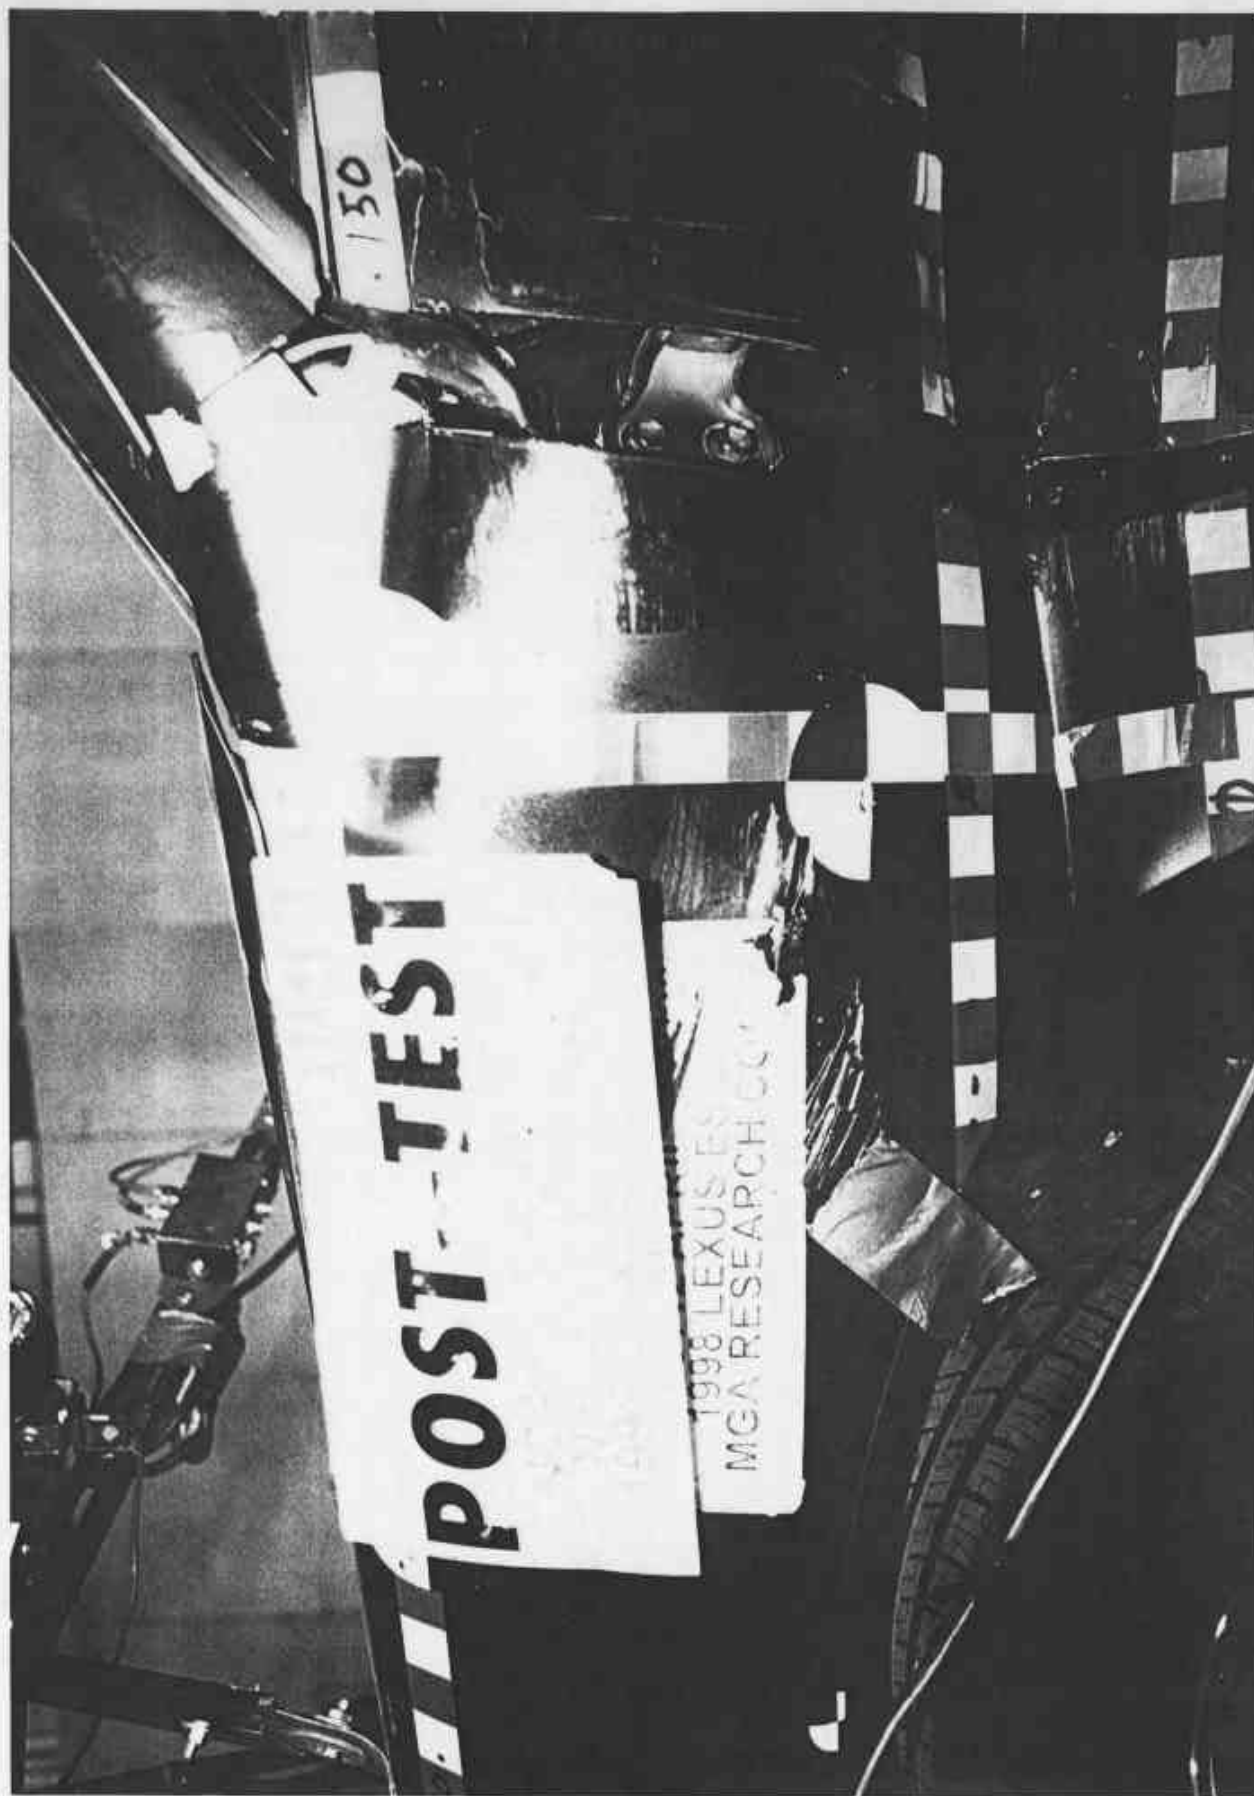
Photo No. A-41 - Post-Test Left Front Impact Point on Vehicle

MDB DISTANCE FROM TARGET IMPACT POINT:

Horizontal: 10 mm forward      Vertical: 3 mm high
