NEW CAR ASSESSMENT PROGRAM  
SIDE IMPACT TESTING  
PASSENGER CARS

1998 MITSUBISHI ECLIPSE  
3 -DOOR HATCHBACK  
NHTSA NO: MW5601

FINAL REPORT

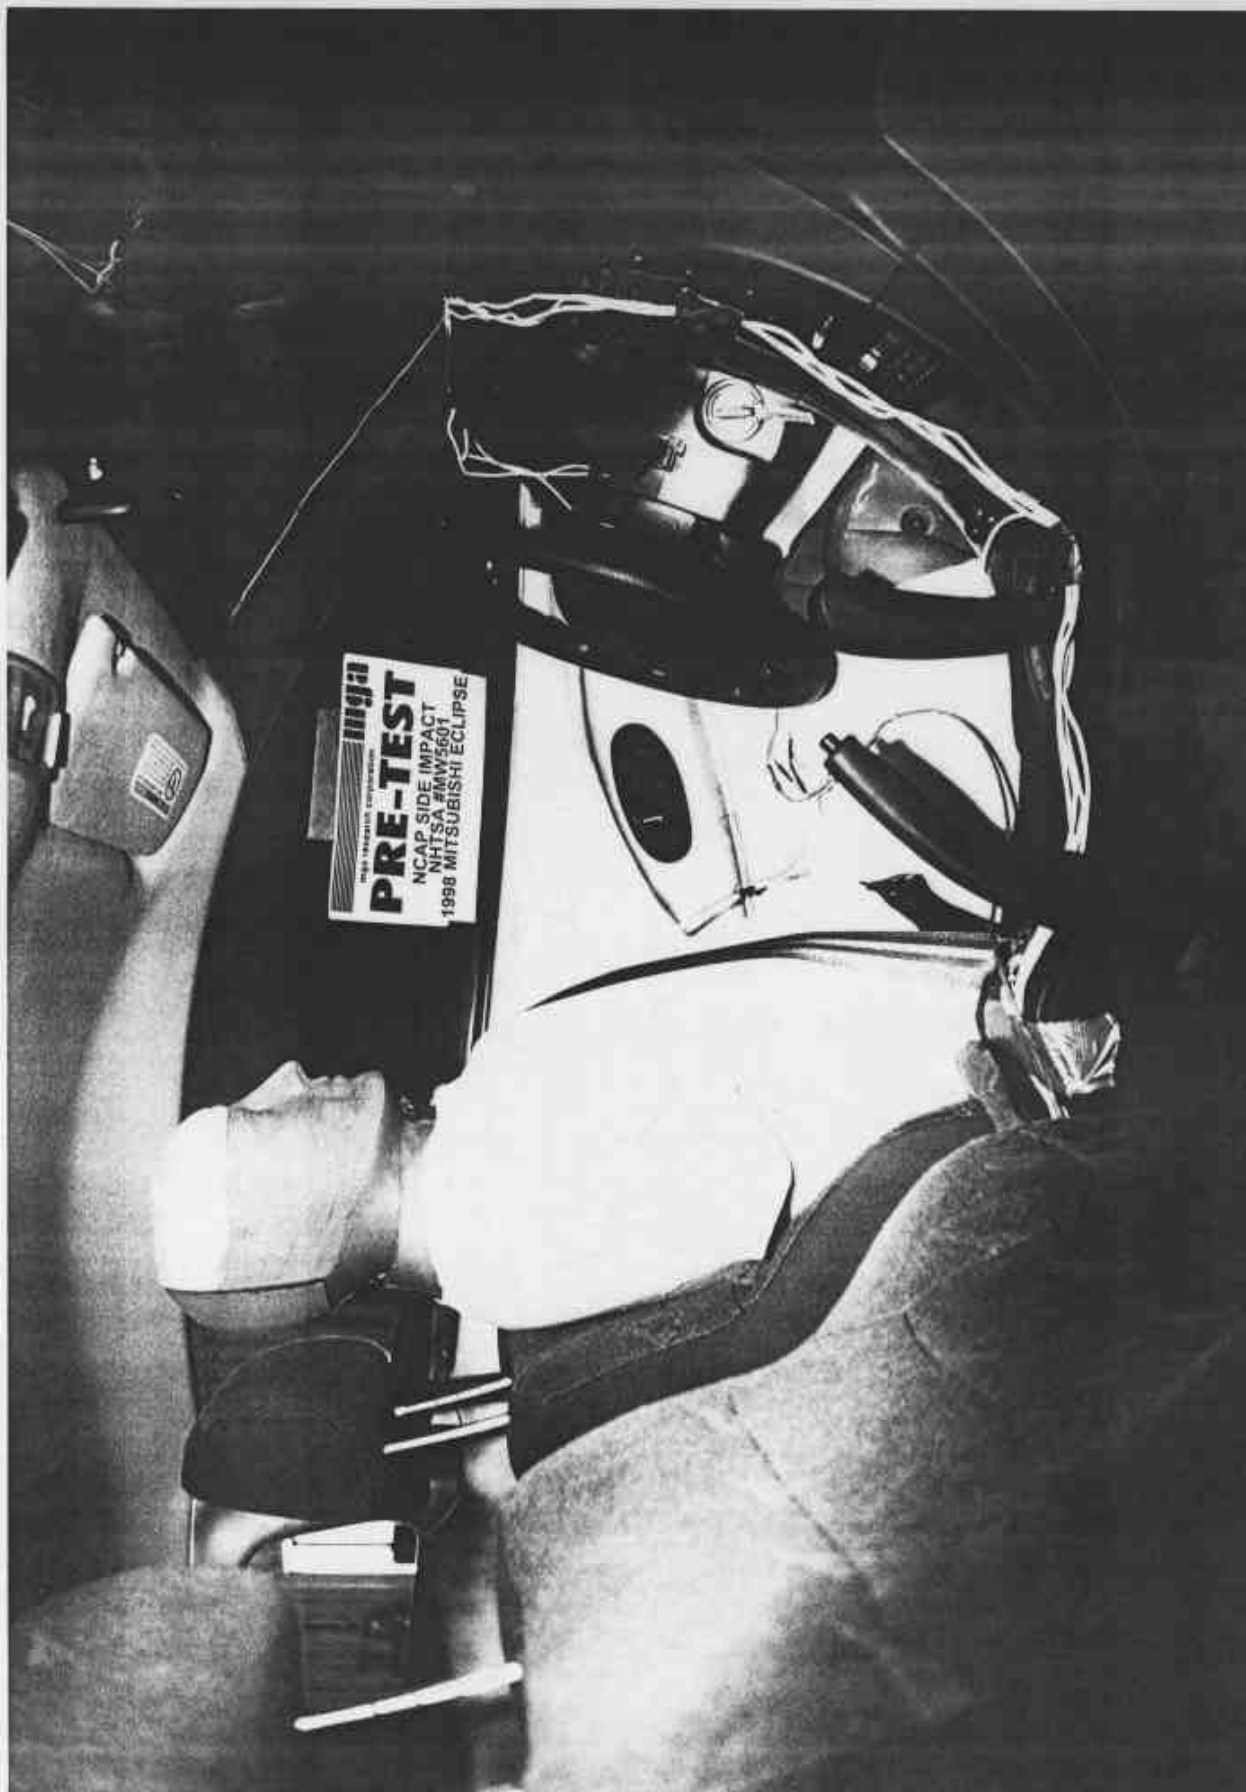
Photo No. A-21 - Pre-Test Driver Dummy Right Side View

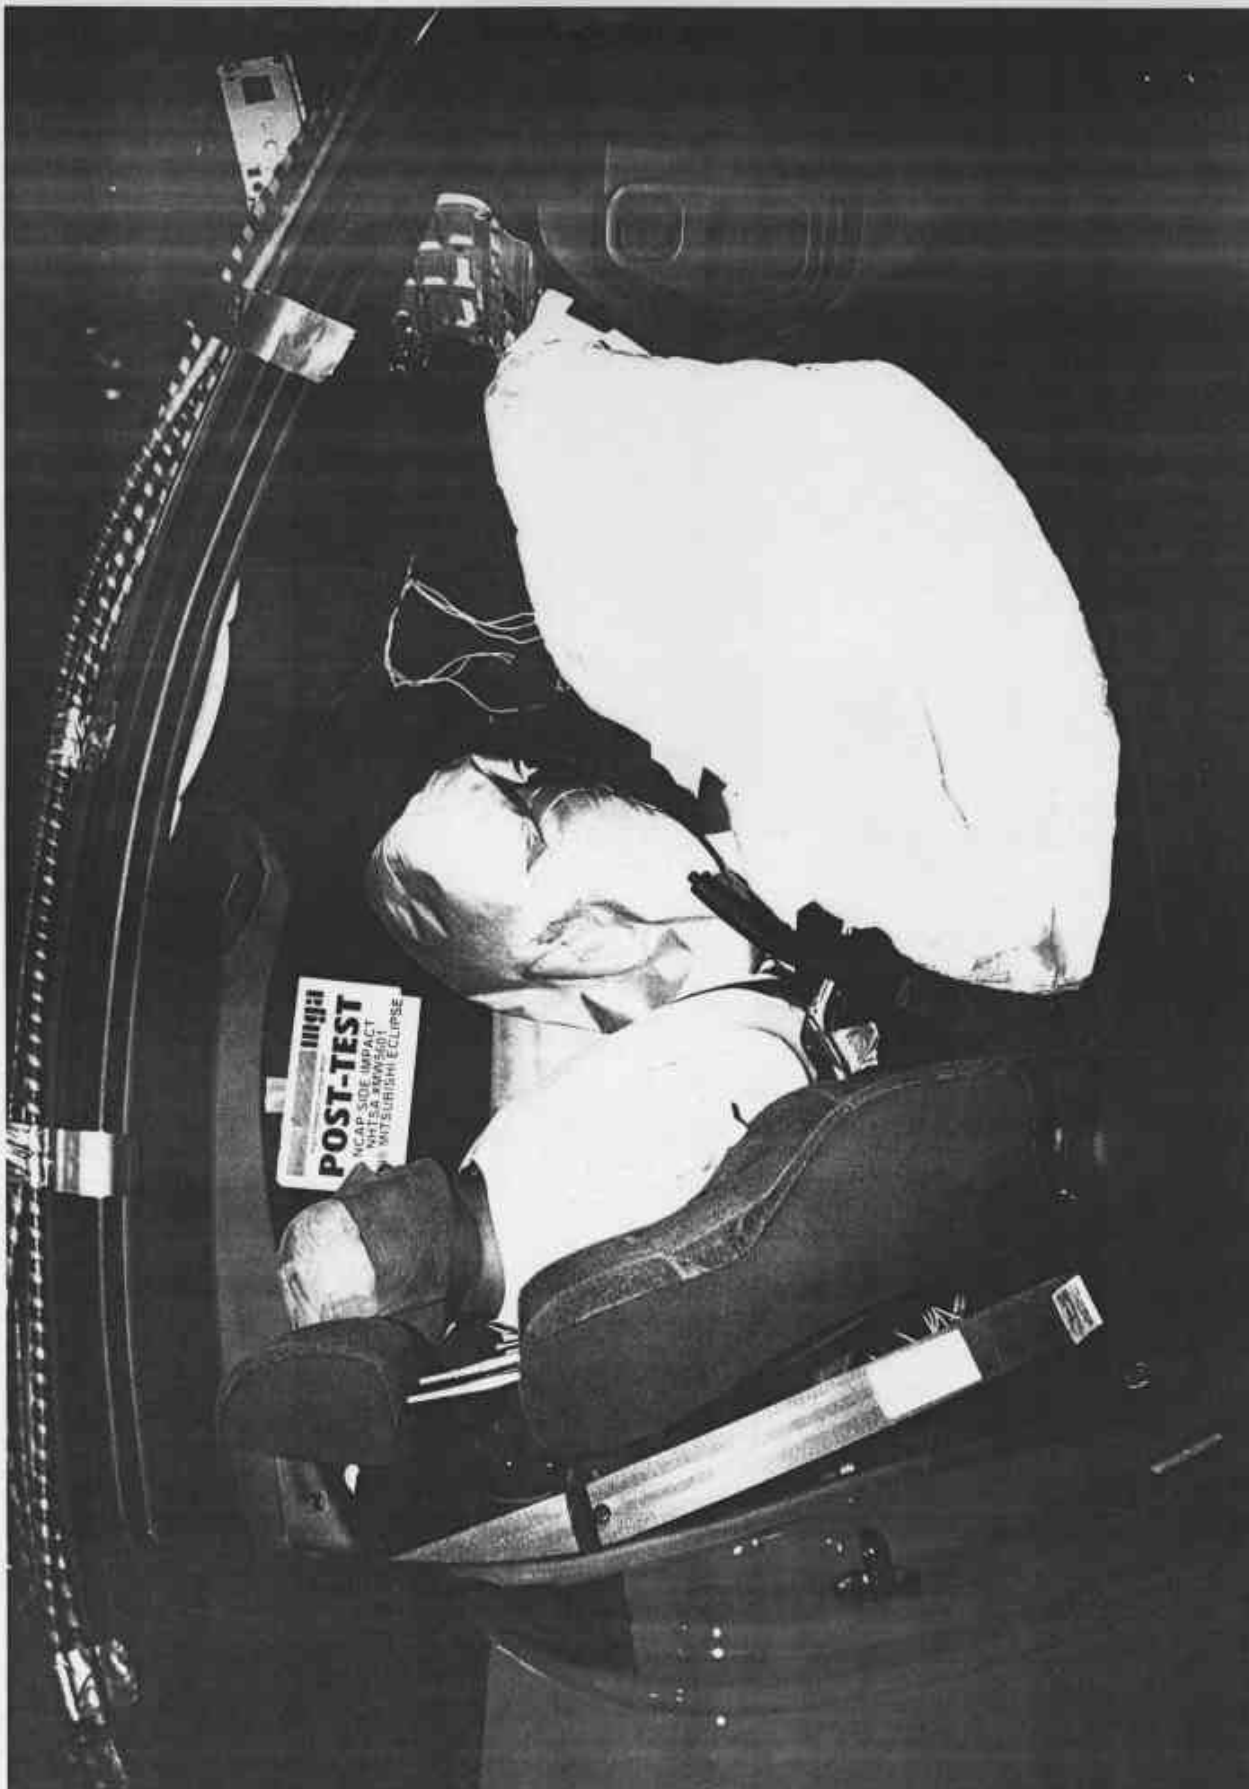
Photo No. A-22 - Post-Test Driver Dummy Right Side View

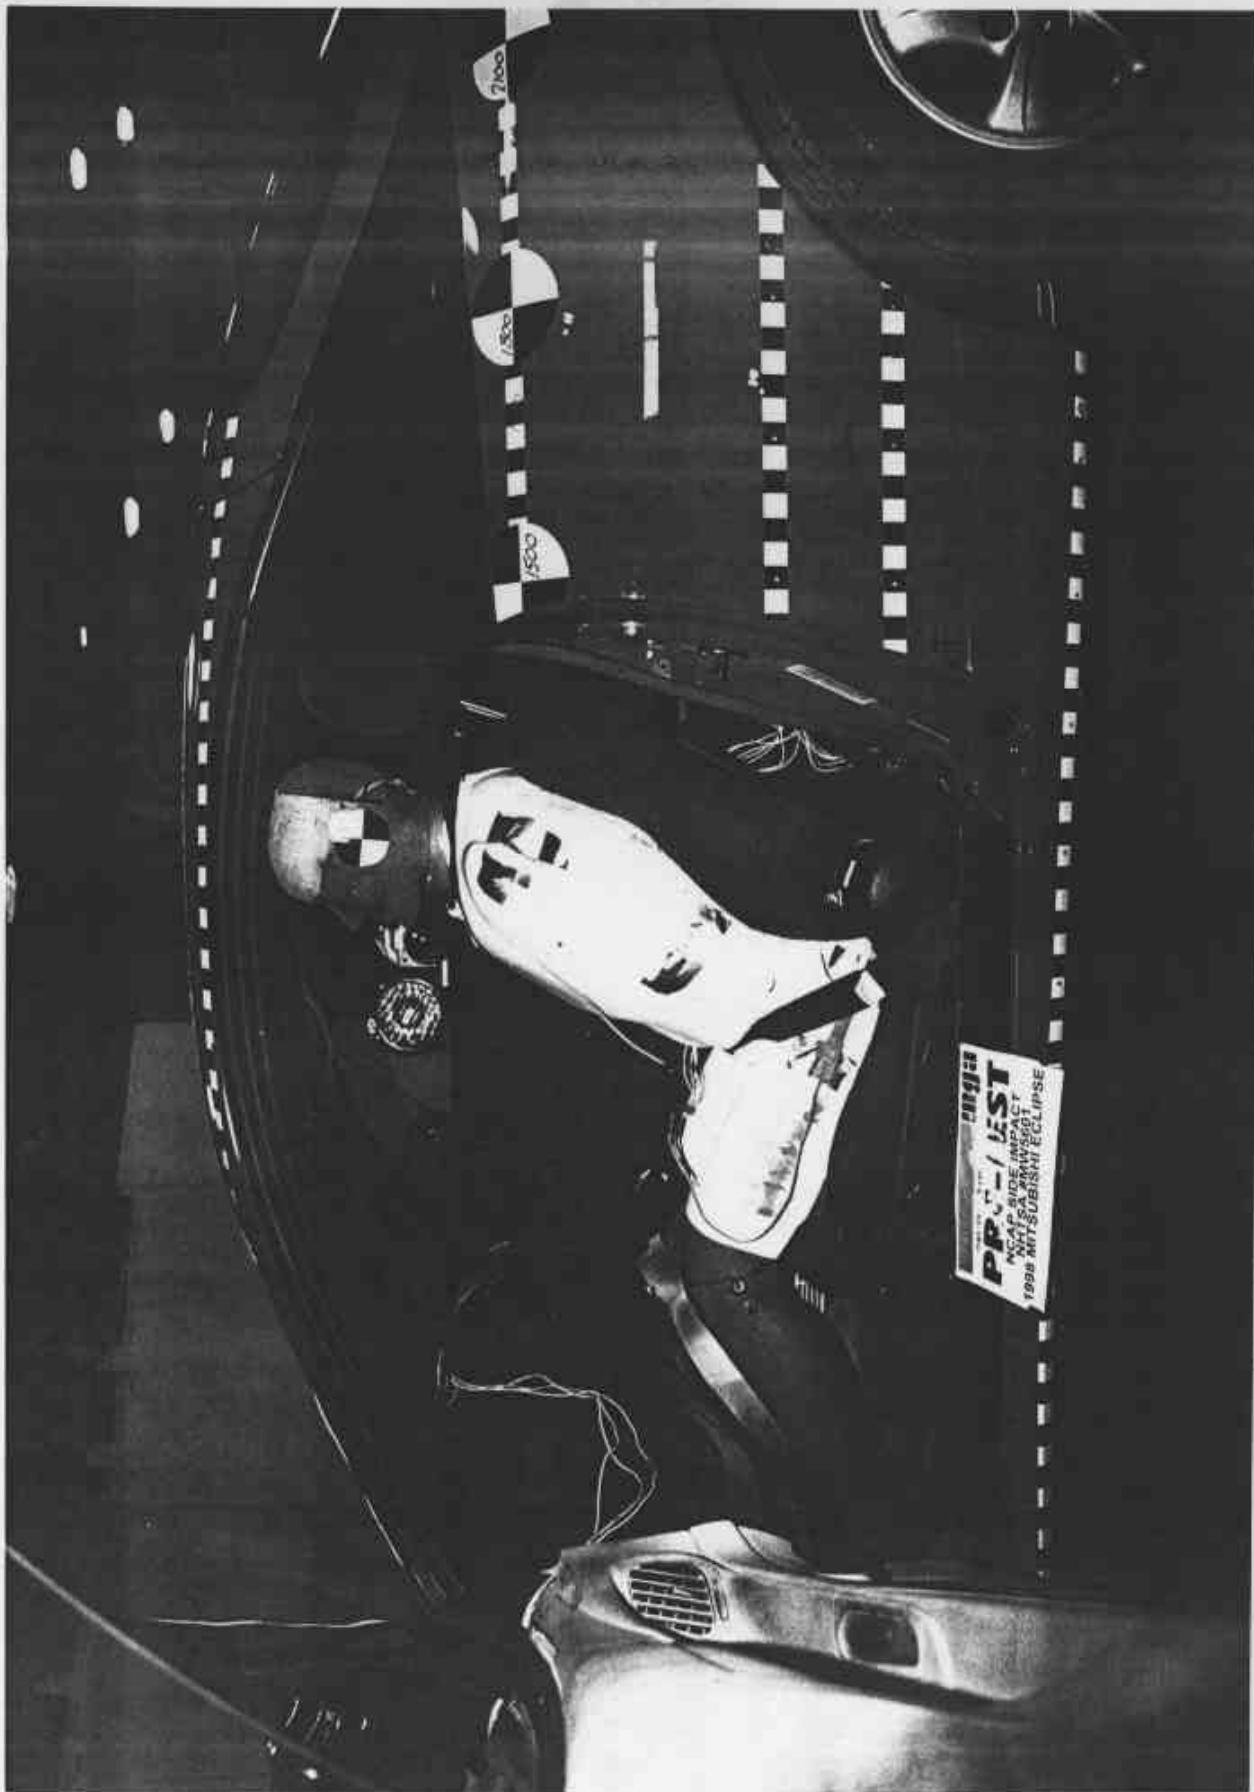
Photo No. A-25 - Pre-Test Driver Dummy Left Side View (Door Open)

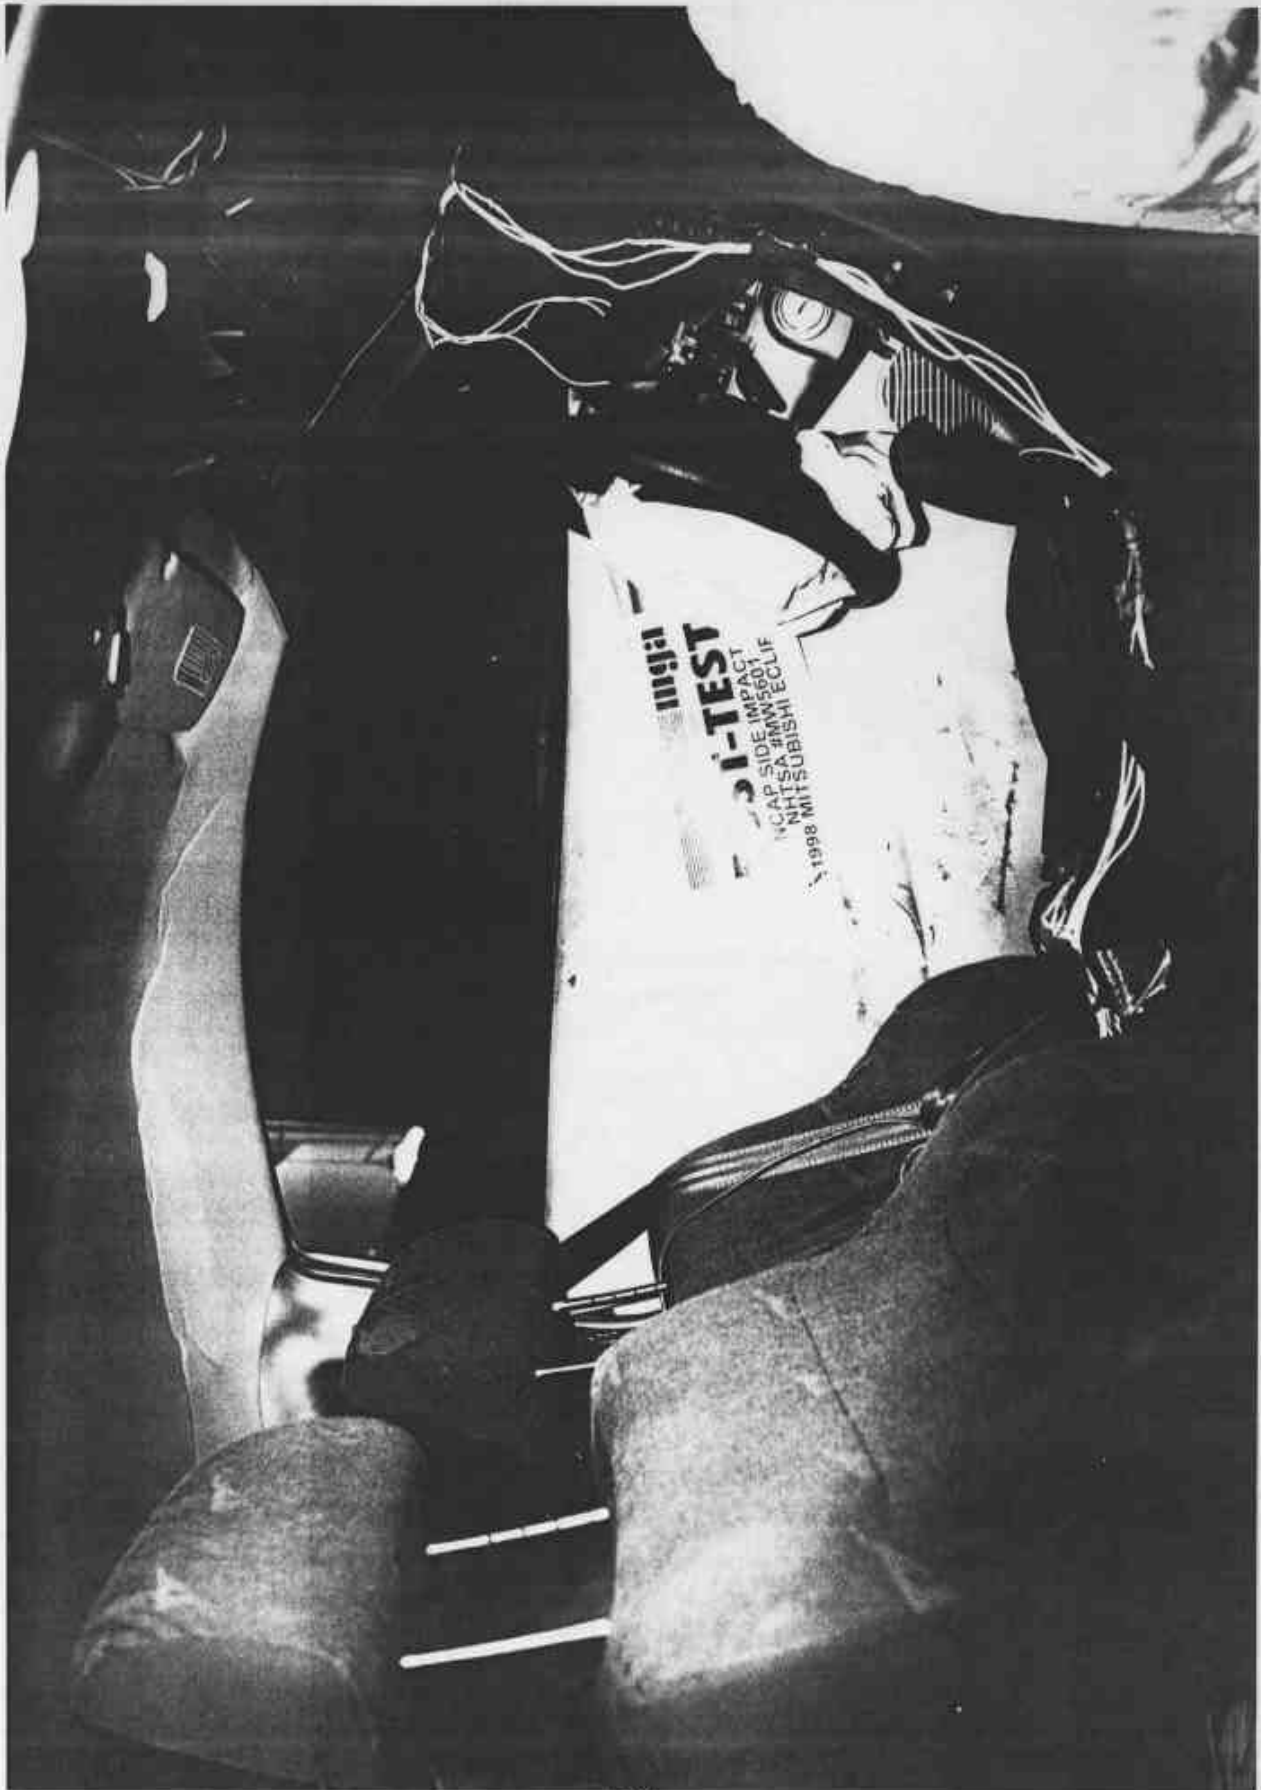
Photo No. A-28 - Post-Test Driver Dummy Contact

VISIBLE DUMMY CONTACT POINTS:

| | <u>LEFT FRONT SIDE</u> |
| Head | <u>window sill</u> |
| Arm | <u>door and armrest</u> |
| Pelvis | <u>armrest</u> |
| Left Knee | <u>front mid door panel</u> |

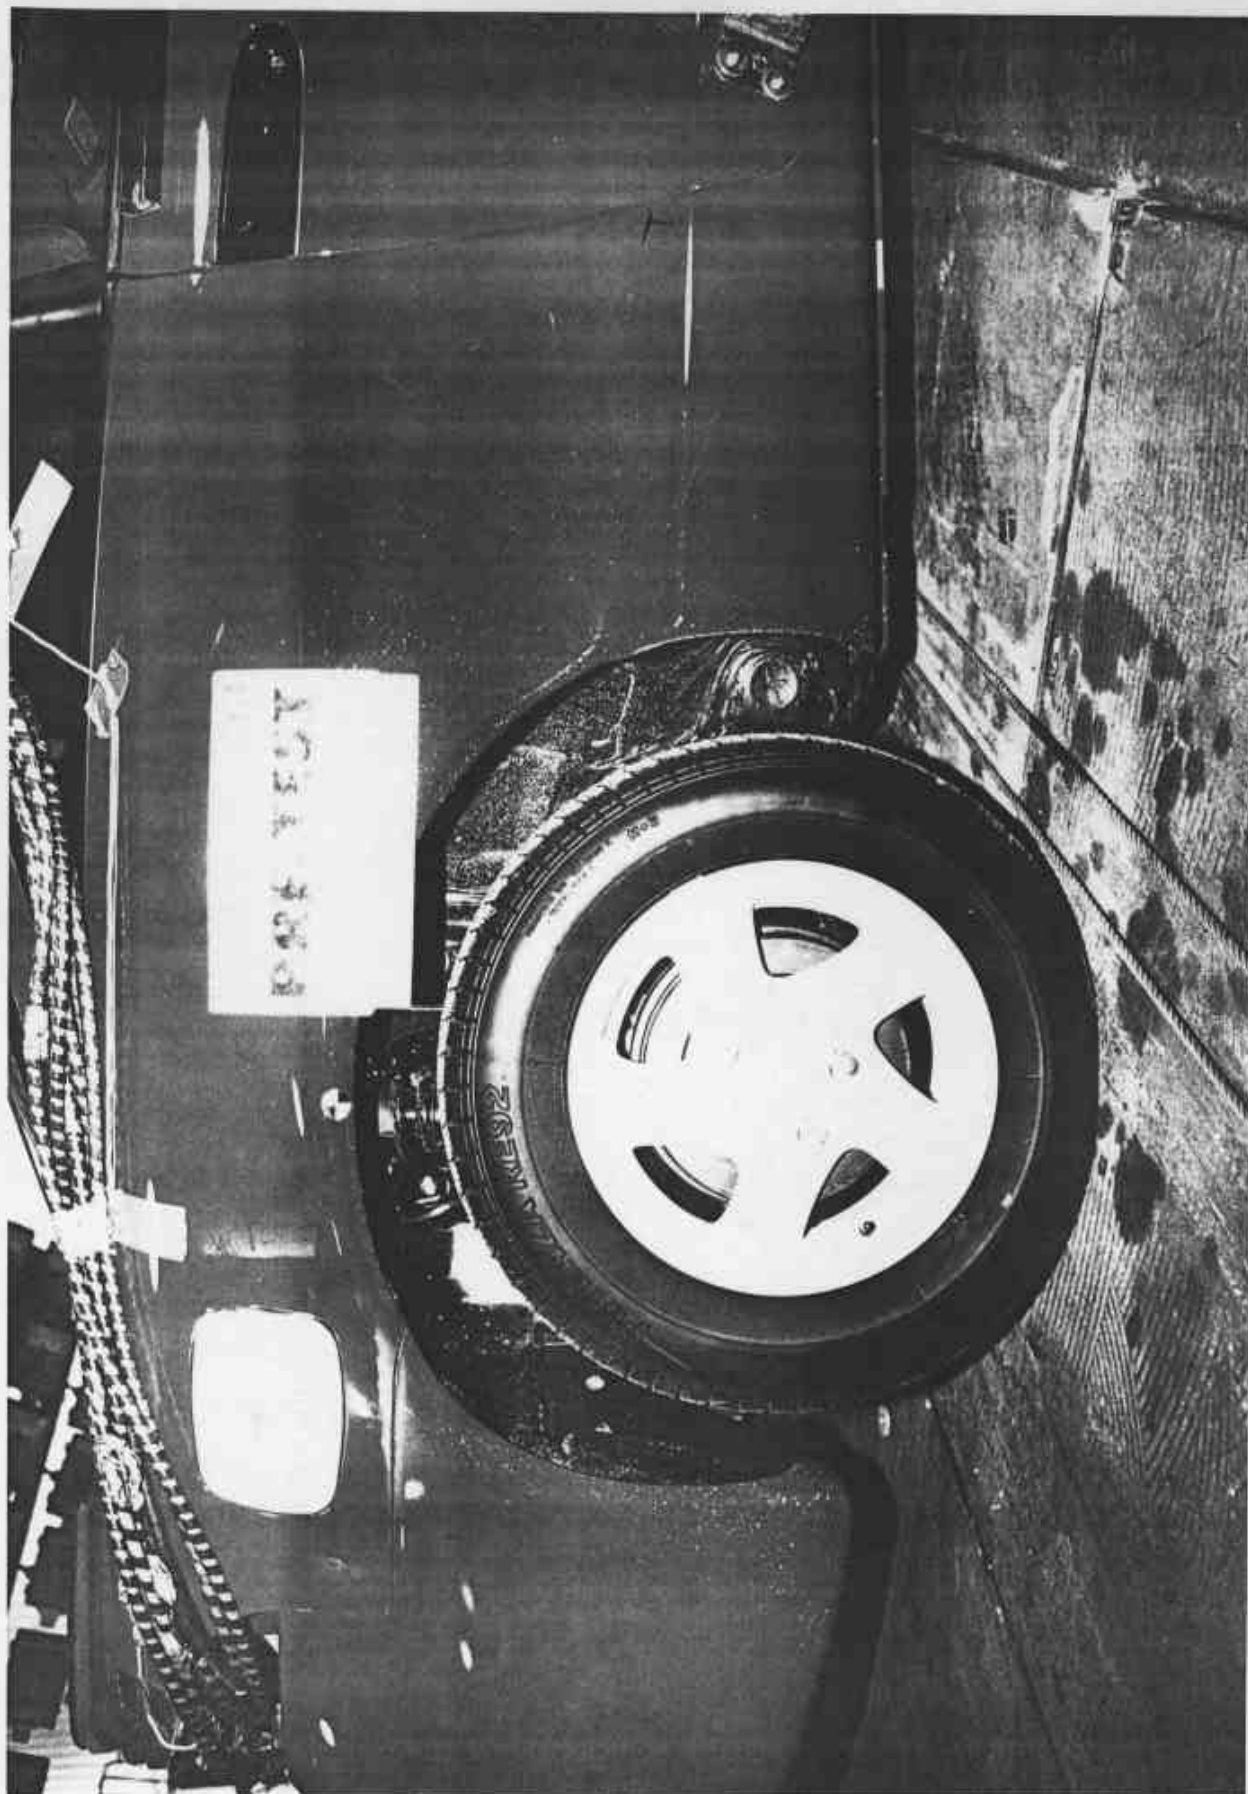
Photo No. A-41 - Right Rear Attitude Point
