REPORT NO. KAR-98-6

NATIONAL HIGHWAY TRAFFIC SAFETY ADMINISTRATION  
NEW CAR ASSESSMENT PROGRAM  
FRONTAL BARRIER IMPACT TEST

GENERAL MOTORS CORPORATION  
1998 ISUZU RODEO SPORT UTILITY VEHICLE  
4-DOOR  
NHTSA NO. MW5701

PREPARED BY:  
KARCO ENGINEERING  
9270 HOLLY ROAD  
ADELANTO, CALIFORNIA 92301

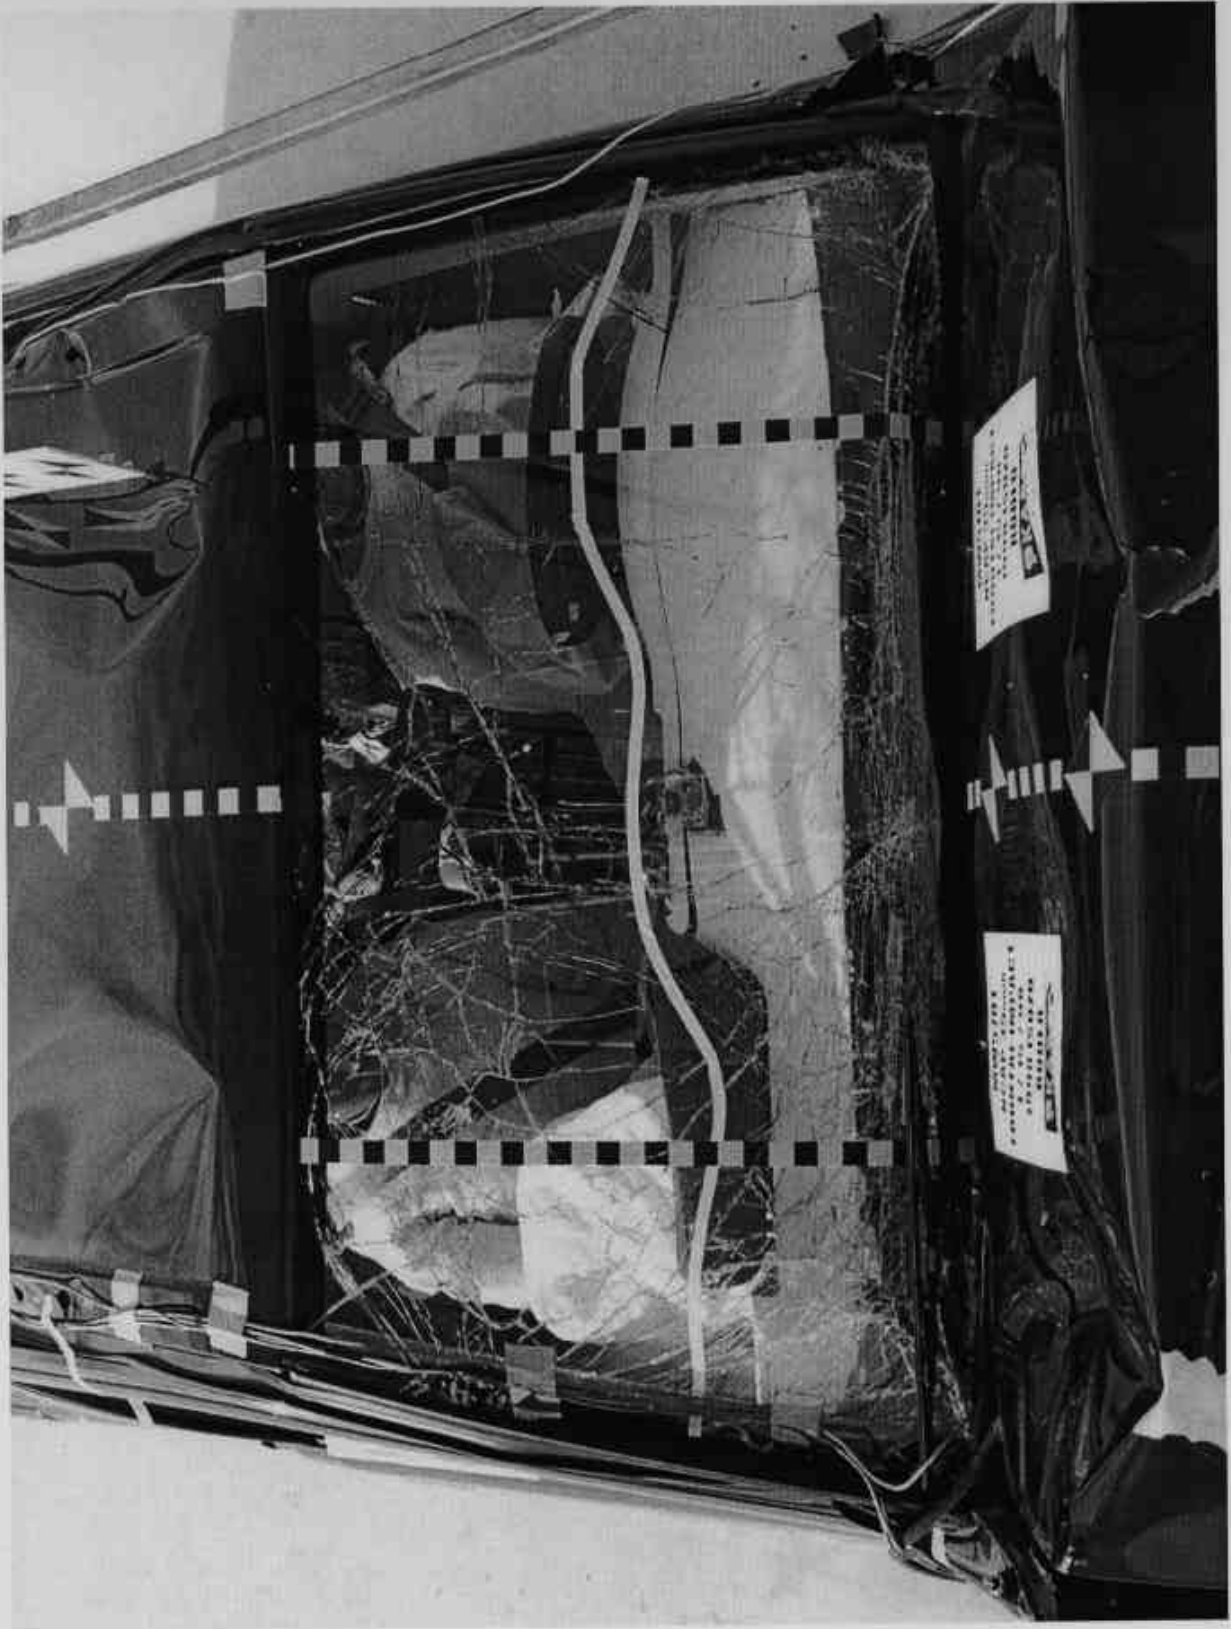
FIGURE A-16. POST TEST WINDSHIELD

There was 100 percent windshield retention (minimum 50 percent required for passive restraint systems), no intrusion into the protected or unprotected zone of the windshield, and no Stoddard solvent leakage occurred after impact or during any phase of the rollover.

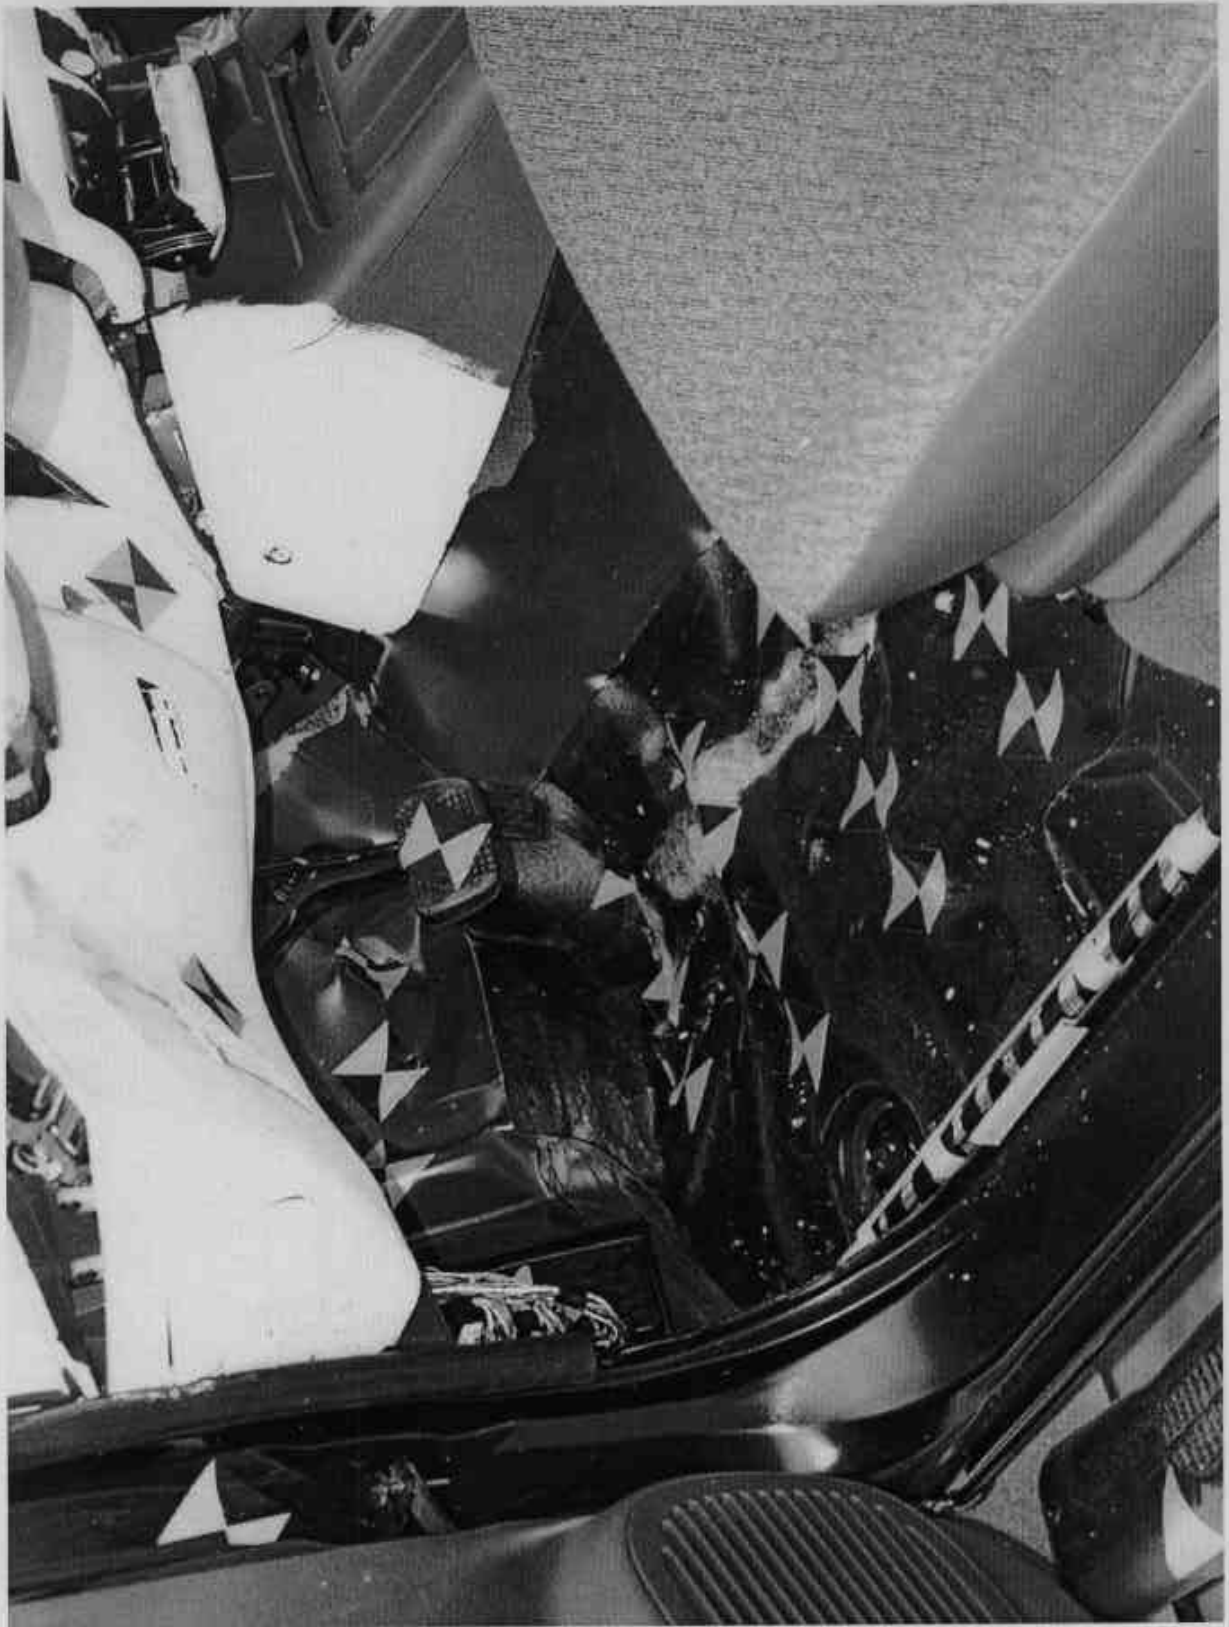
FIGURE A-26. POST TEST DRIVER FLOOR PAN

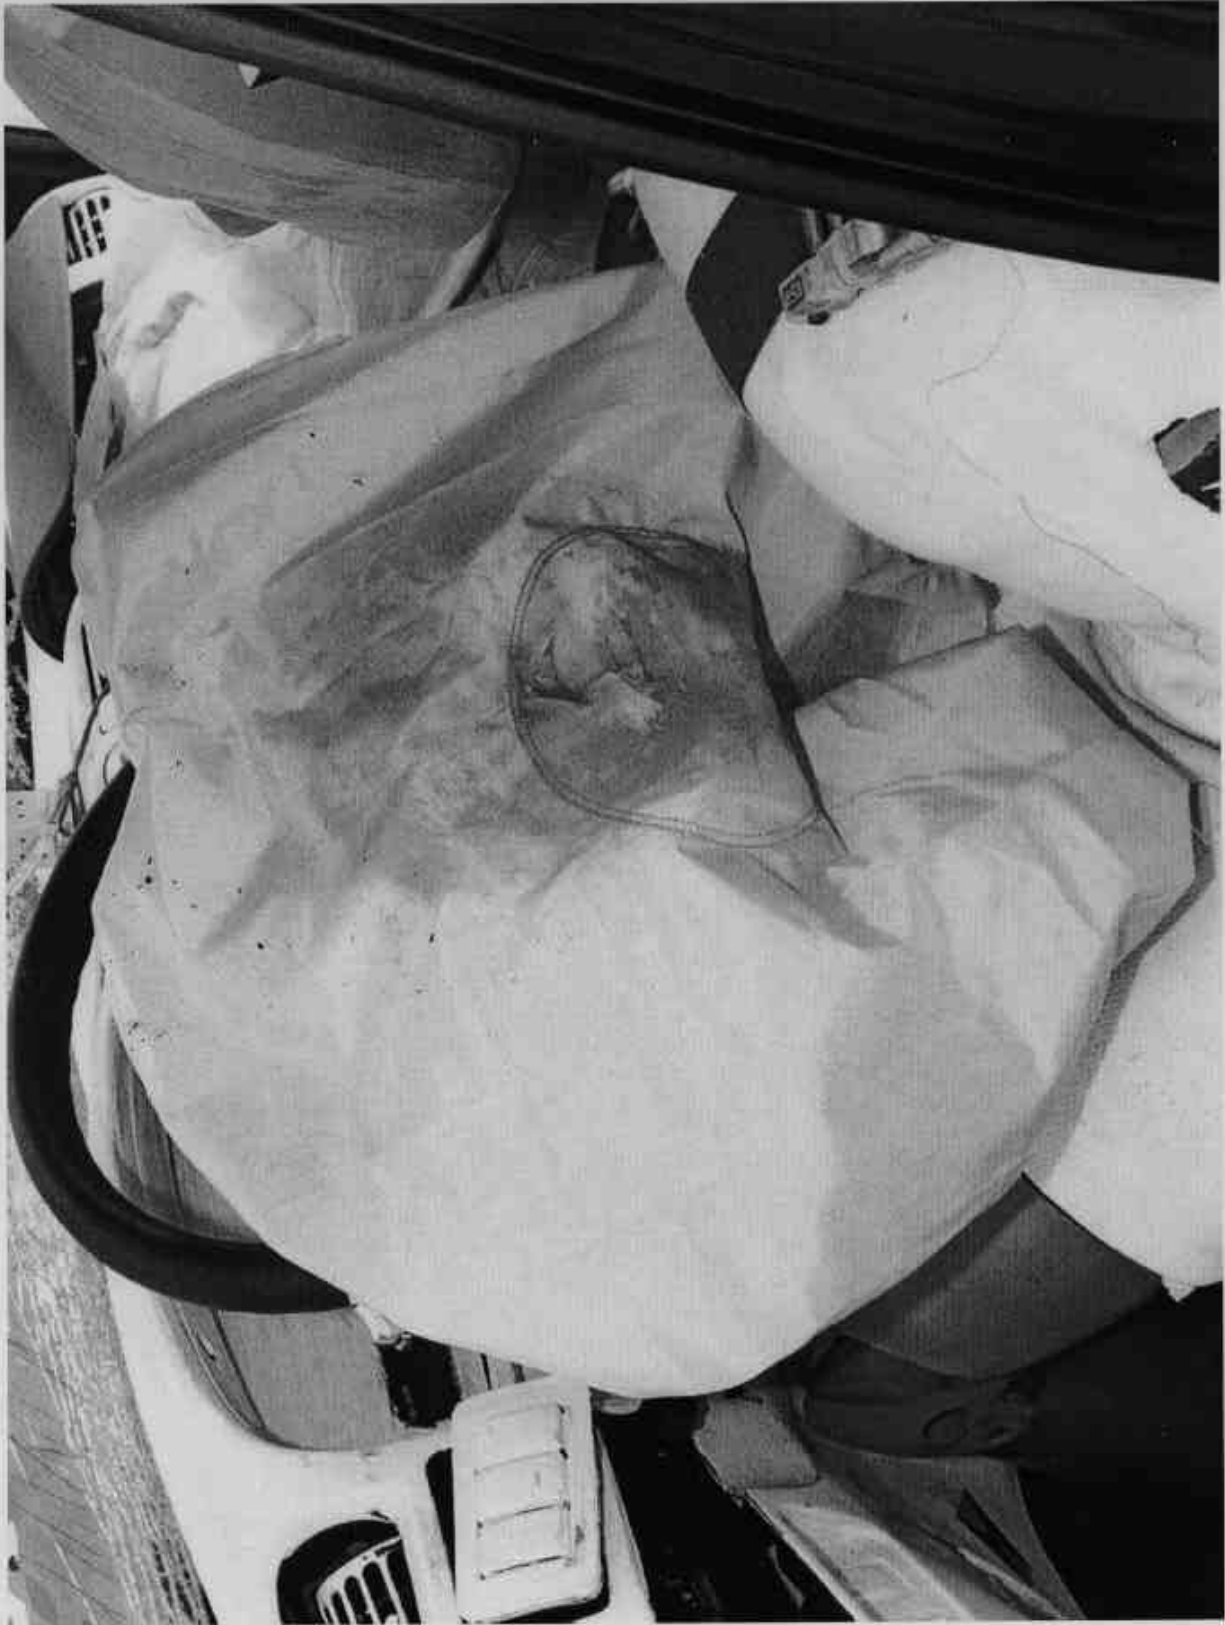
FIGURE A-36. POST TEST DRIVER DUMMY CONTACT POINT

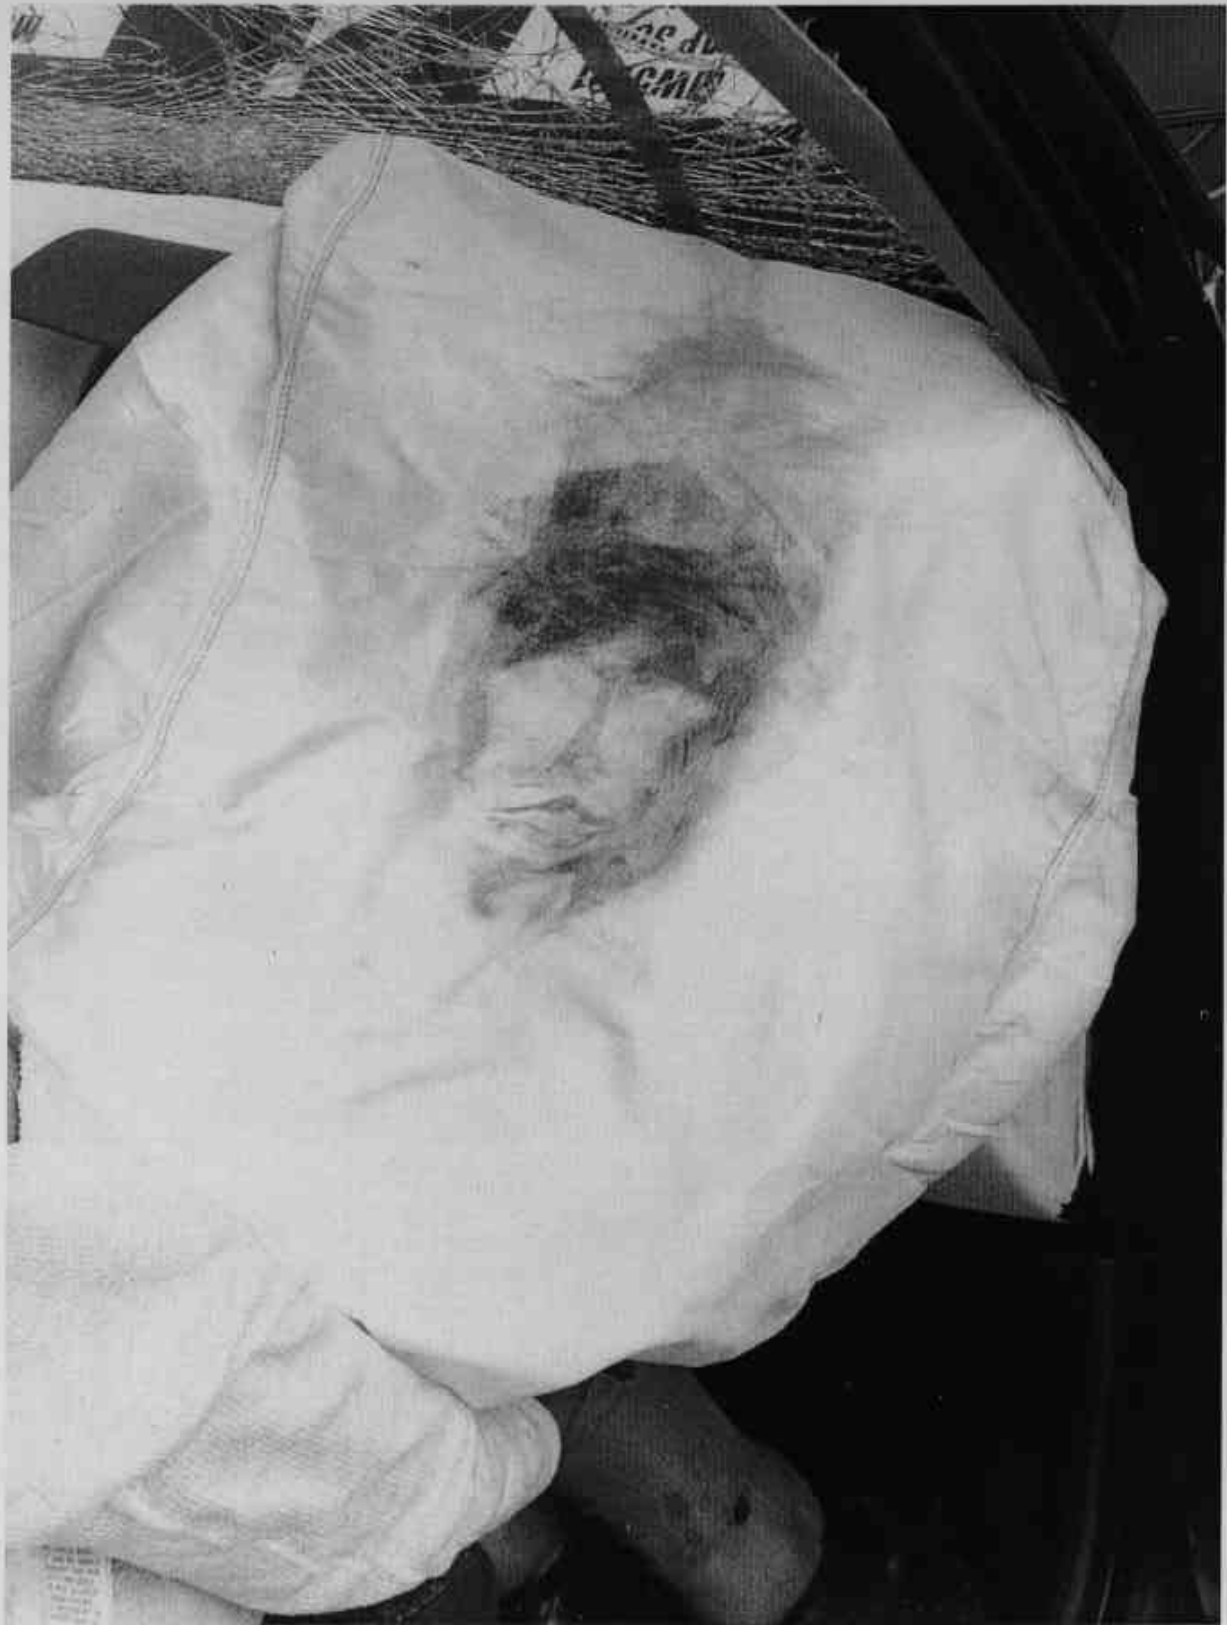
FIGURE A-49. POST TEST PASSENGER DUMMY CONTACT POINT
