REPORT NO.: 214-MGA-98-08  
SAFETY COMPLIANCE TESTING FOR FMVSS NO. 214  
"SIDE IMPACT PROTECTION -  
PASSENGER CARS"

VOLKSWAGEN UNITED STATES, INC.  
1998 VOLKSWAGEN JETTA GL  
NHTSA NO: CW5801

MGA PROVING GROUNDS  
5000 WARREN ROAD  
BURLINGTON, WI 53105

FINAL REPORT

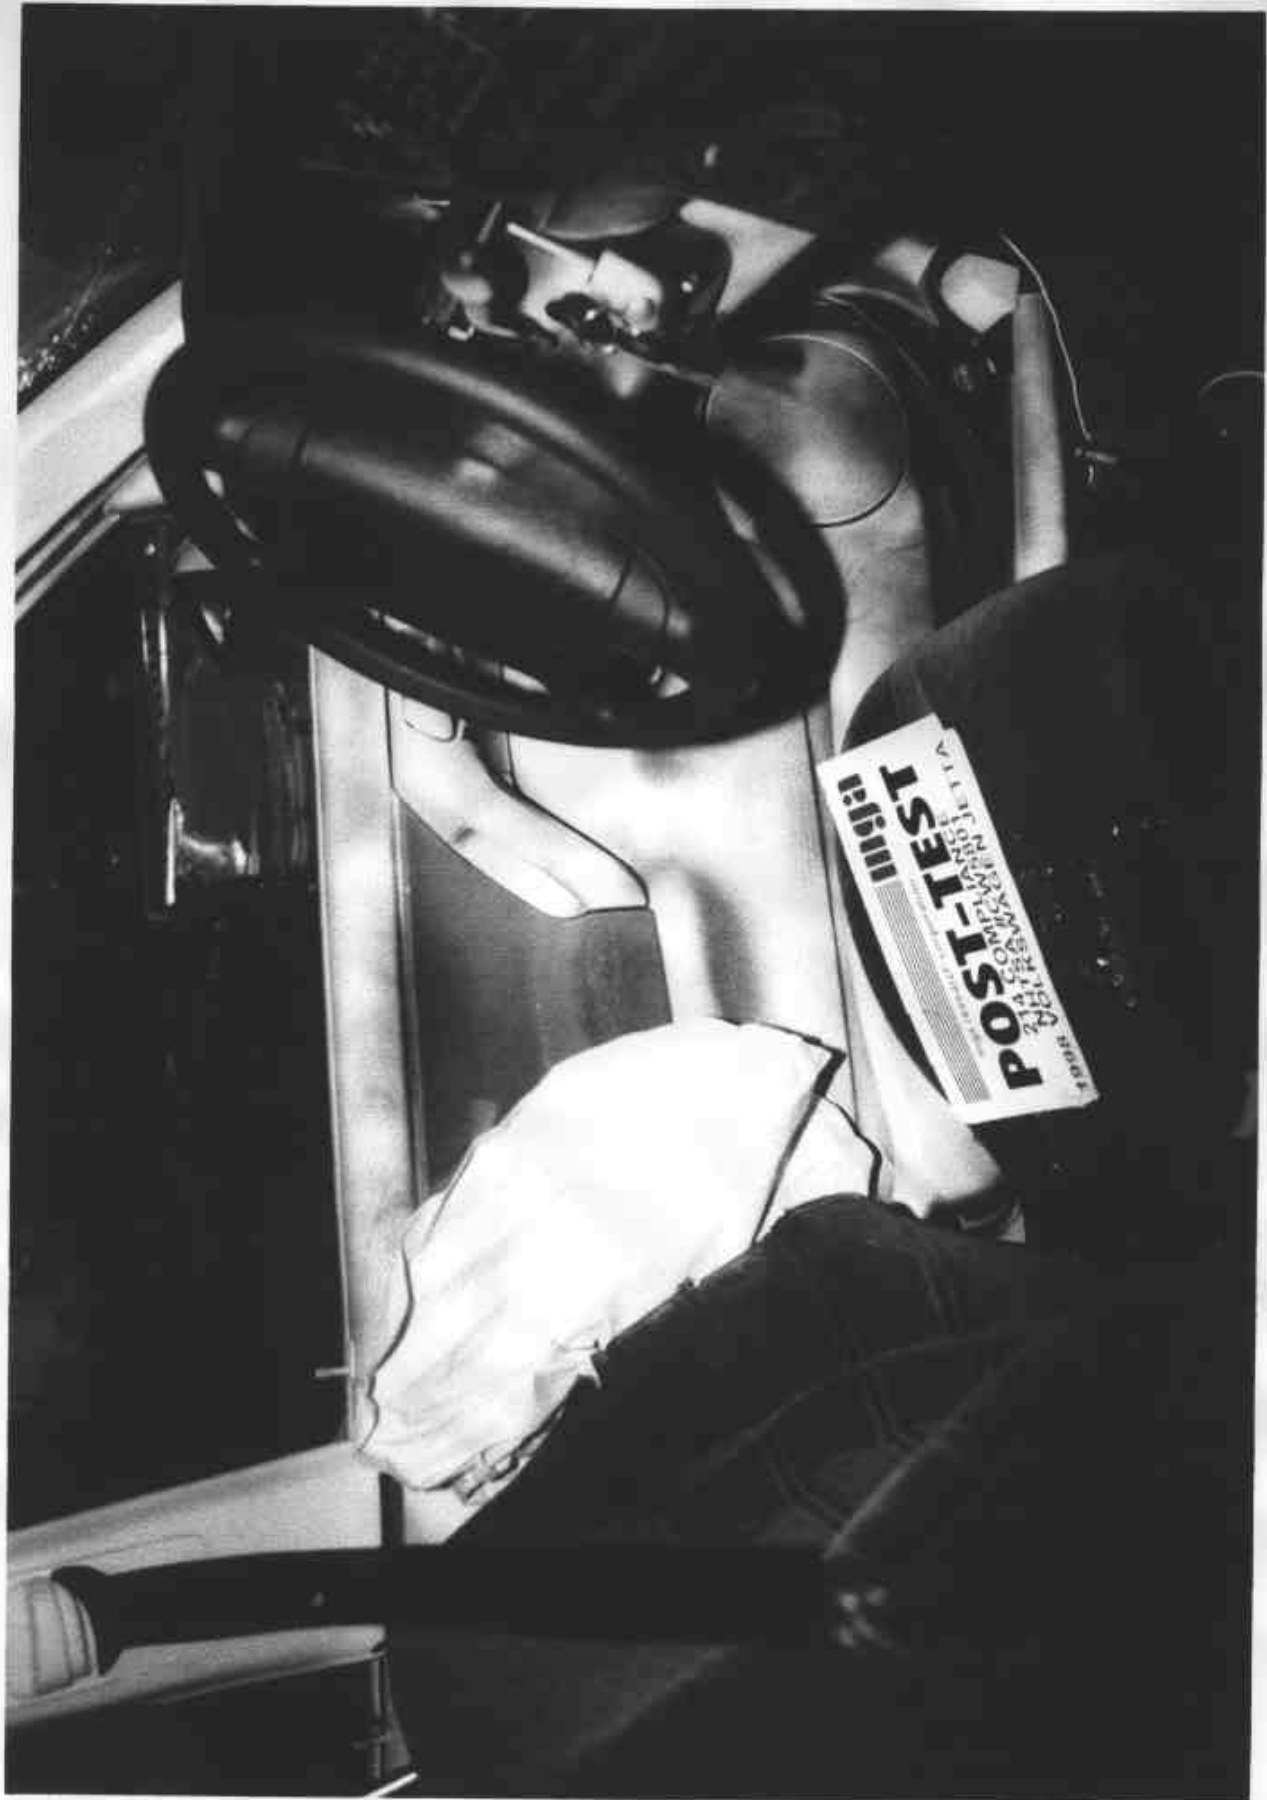
Photo No. A-28 - Post-Test Driver Dummy Contact

| | <u>LEFT FRONT SID</u> | <u>LEFT REAR SID</u> |
|---|---|---|
| Arm | <u>to airbag, B-Post and door panel</u> | <u>to door panel</u> |
| Pelvis | <u>to airbag</u> | <u>to armrest</u> |
| Left Knee | <u>to door panel</u> | <u>to door panel</u> |

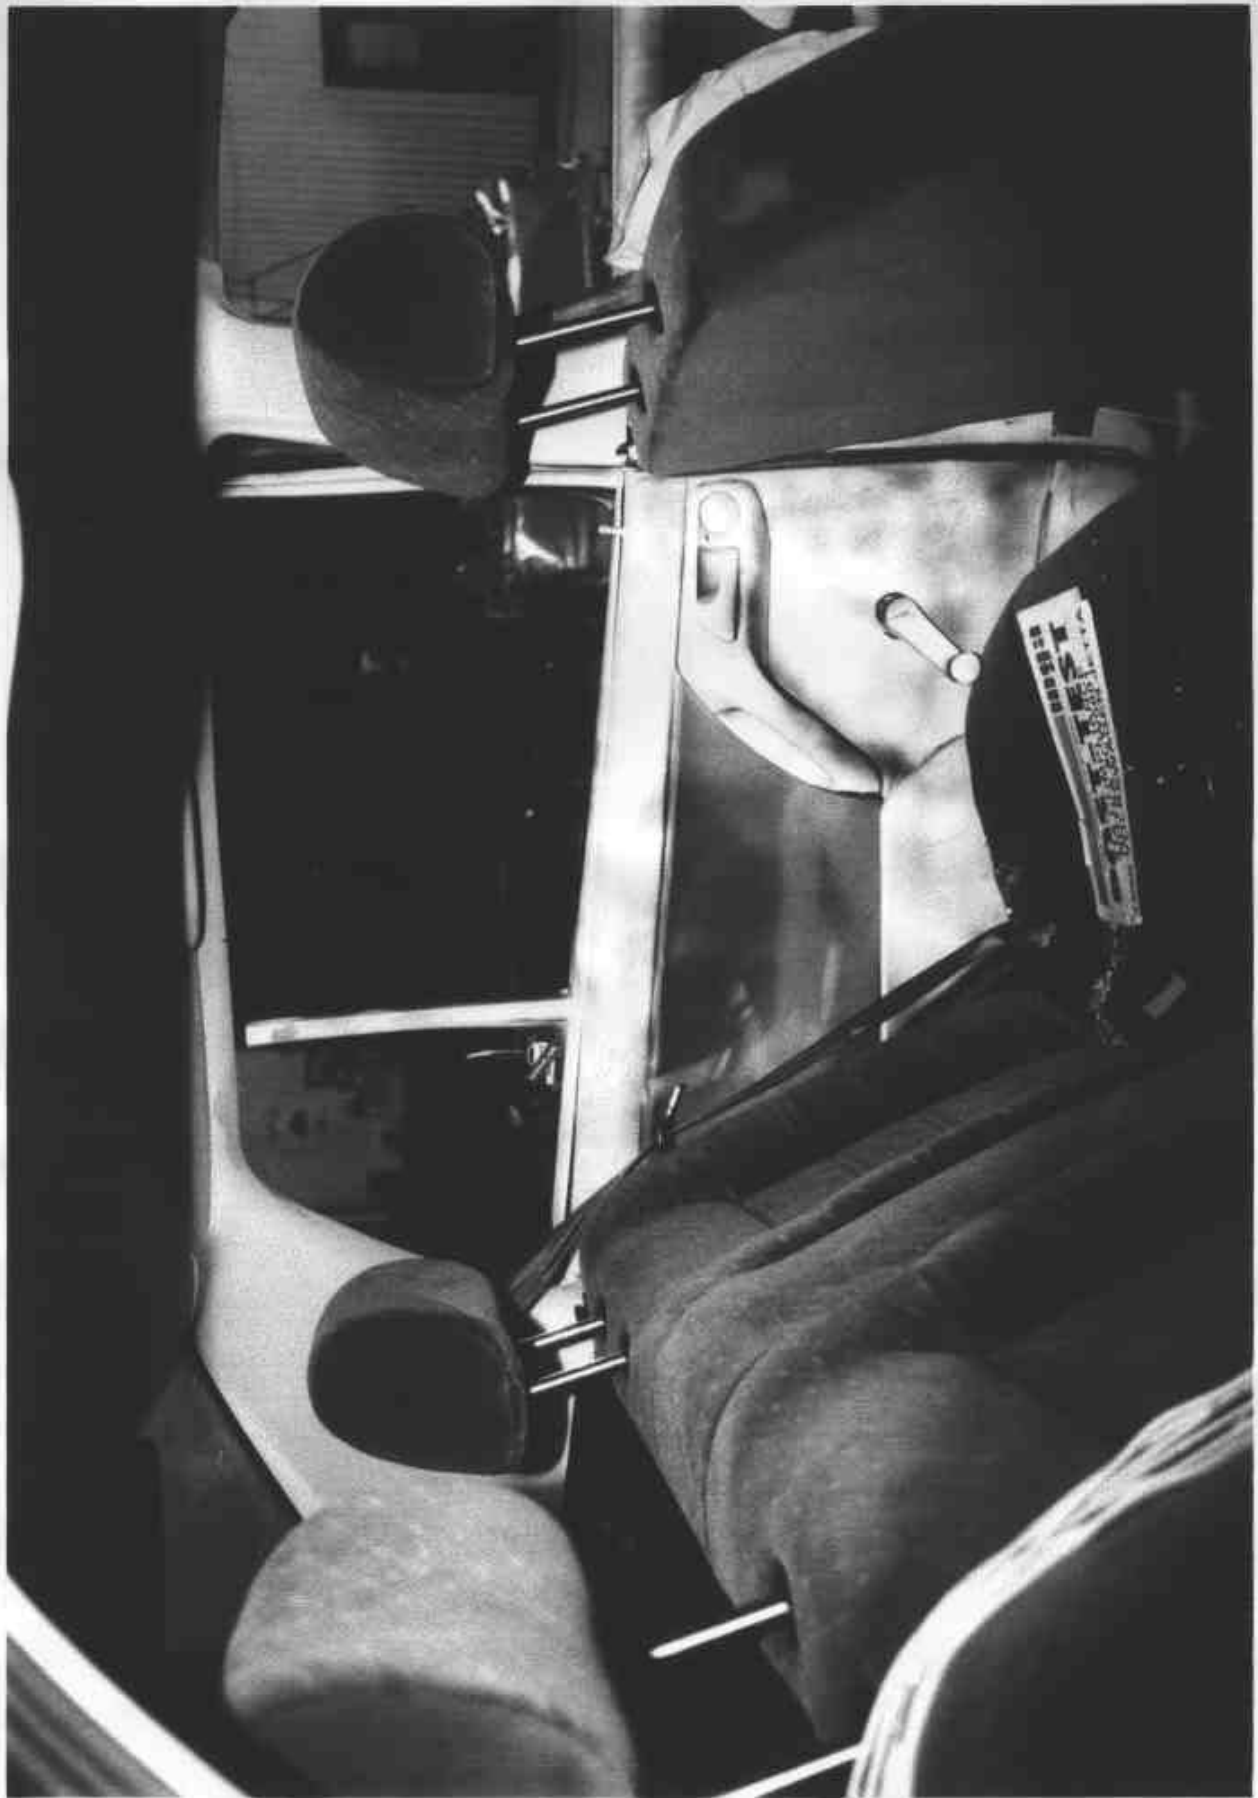
Photo No. A-37 - Post-Test Rear Passenger Dummy Contact

| | <u>LEFT FRONT SID</u> | <u>LEFT REAR SID</u> |
|---|---|---|
| Head | <u>none</u> | <u>to C-Post and widow frame</u> |

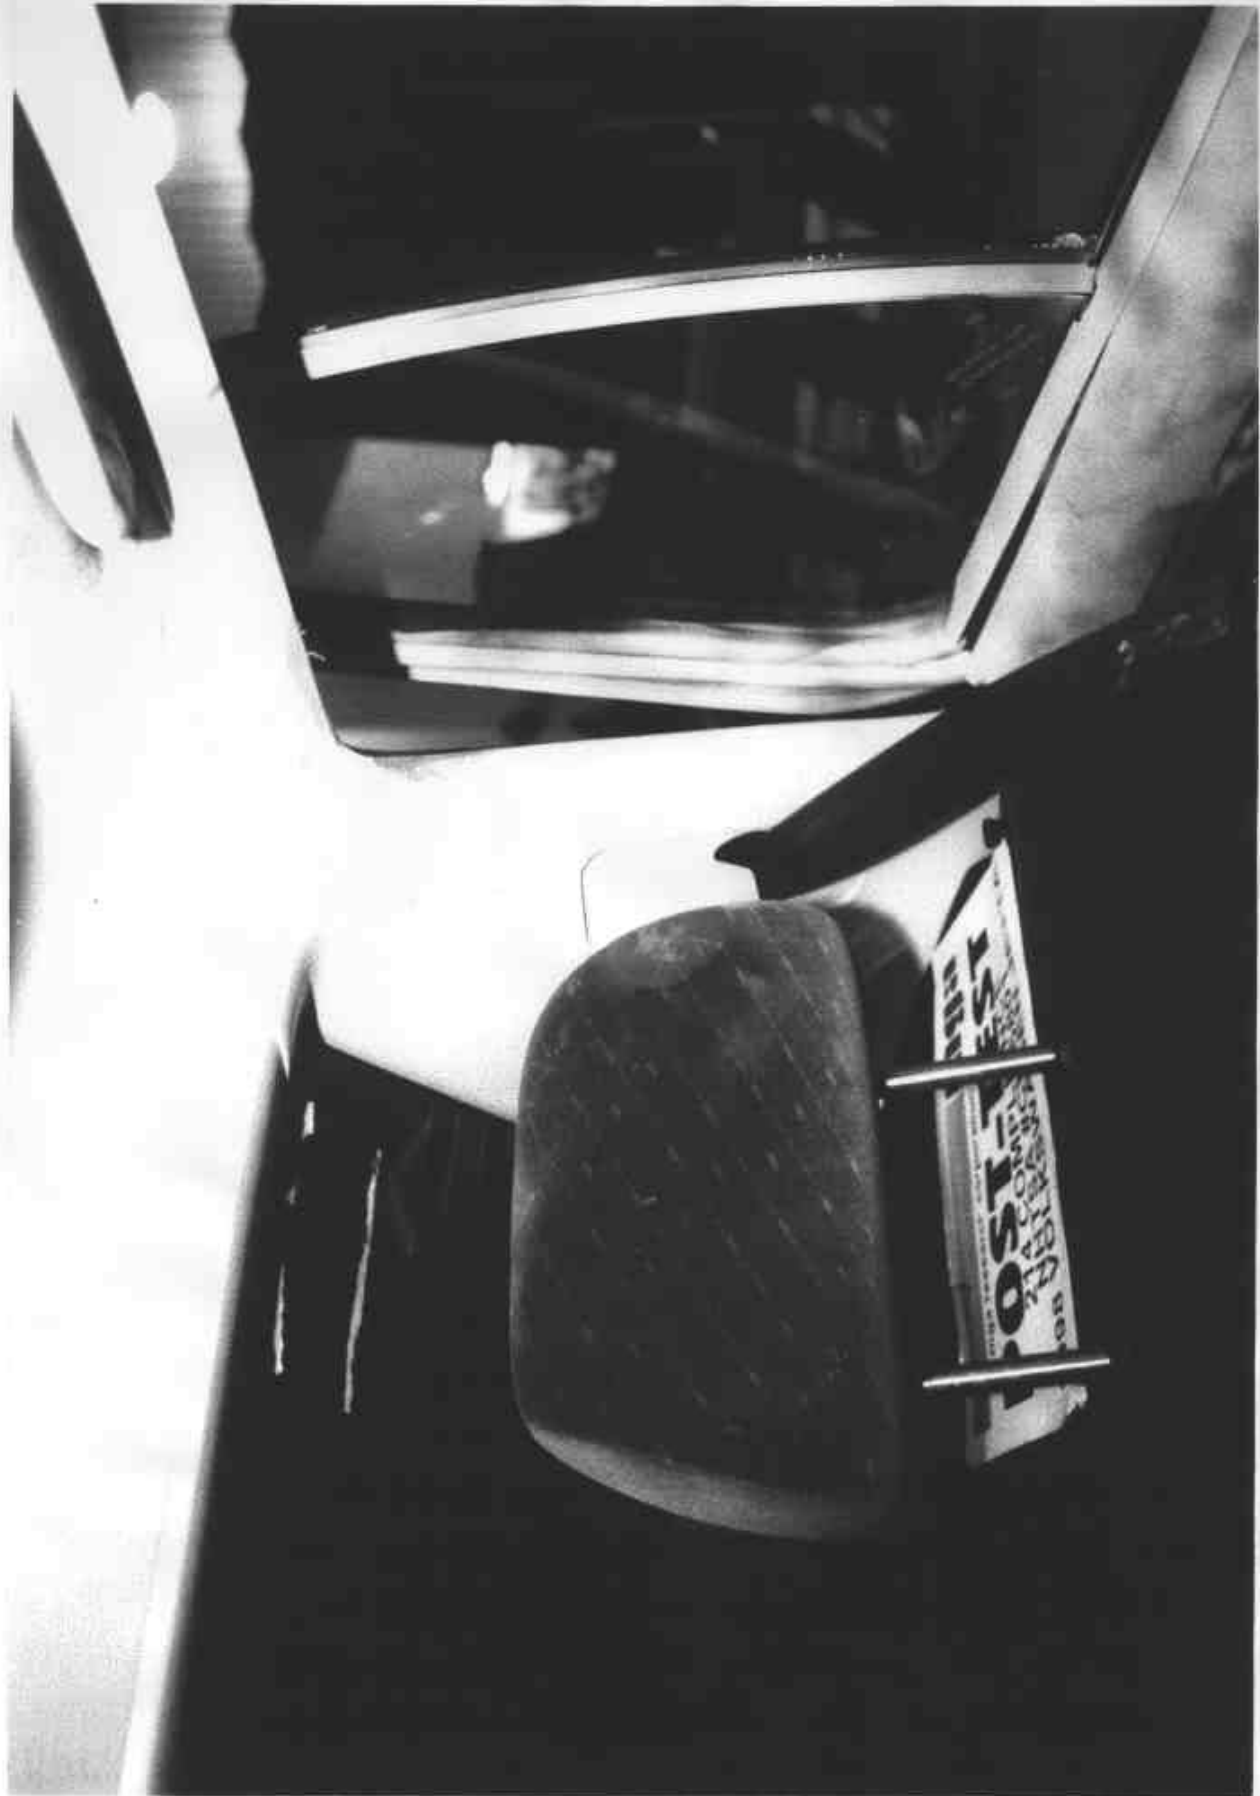
Photo No. A-38 - Post-Test Rear Passenger Dummy Head Contact
