CALSPAN REPORT NUMBER: 8404-5

**VEHICLE-TO-VEHICLE
90° SIDE IMPACT OF A
1995 FORD ESCORT 2-DOOR HATCHBACK TRAVELING 45 kph
INTO THE LEFT FRONT QUARTER OF A
1994 OLDSMOBILE CUTLASS SUPREME 4-DOOR SEDAN TRAVELING 22.5 kph**

CALSPAN TEST NUMBER: A109-5-1716

FINAL REPORT

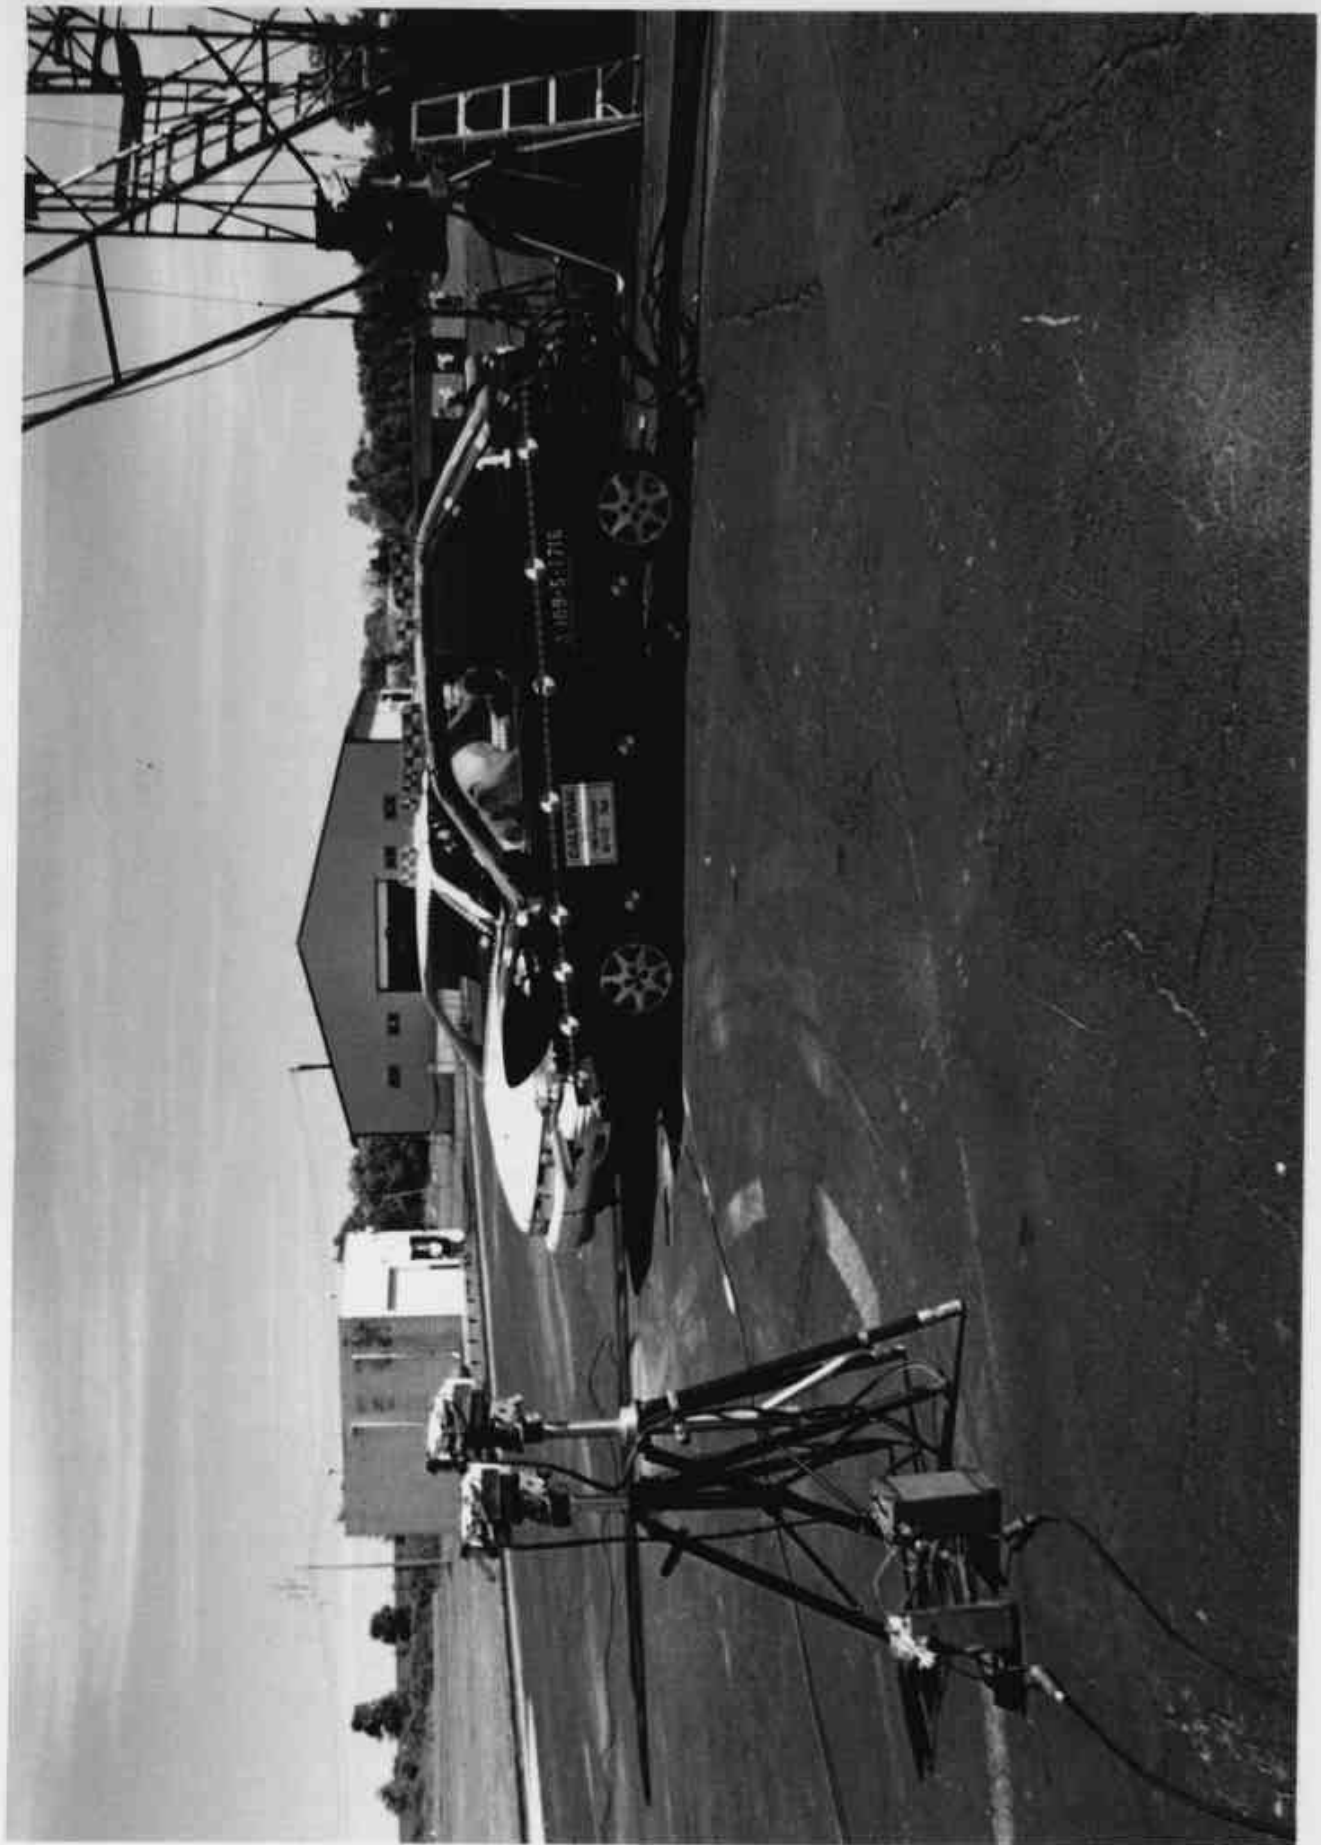
Figure A-7 IMPACT PHOTO #1

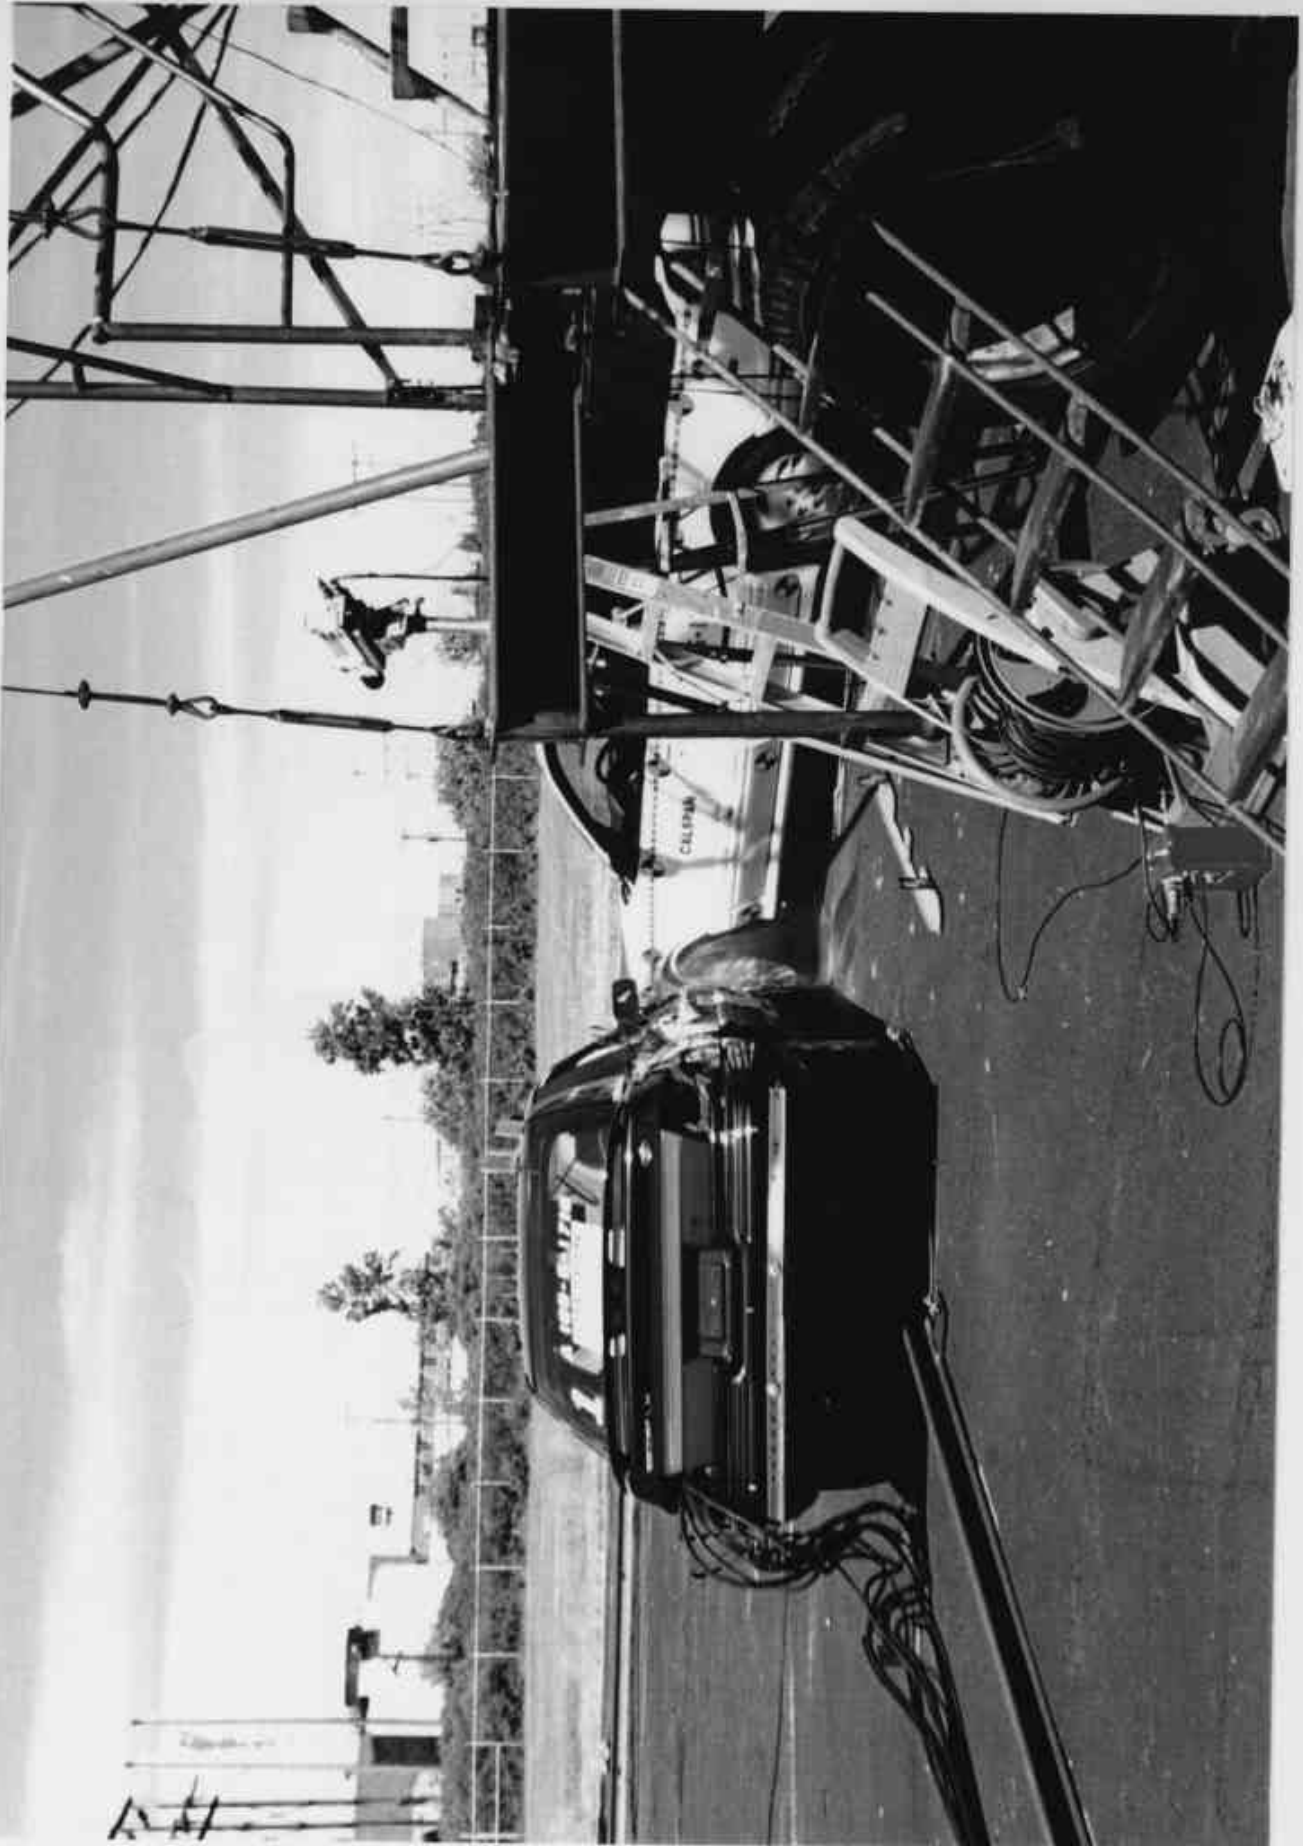
Figure A-8 IMPACT PHOTO #2

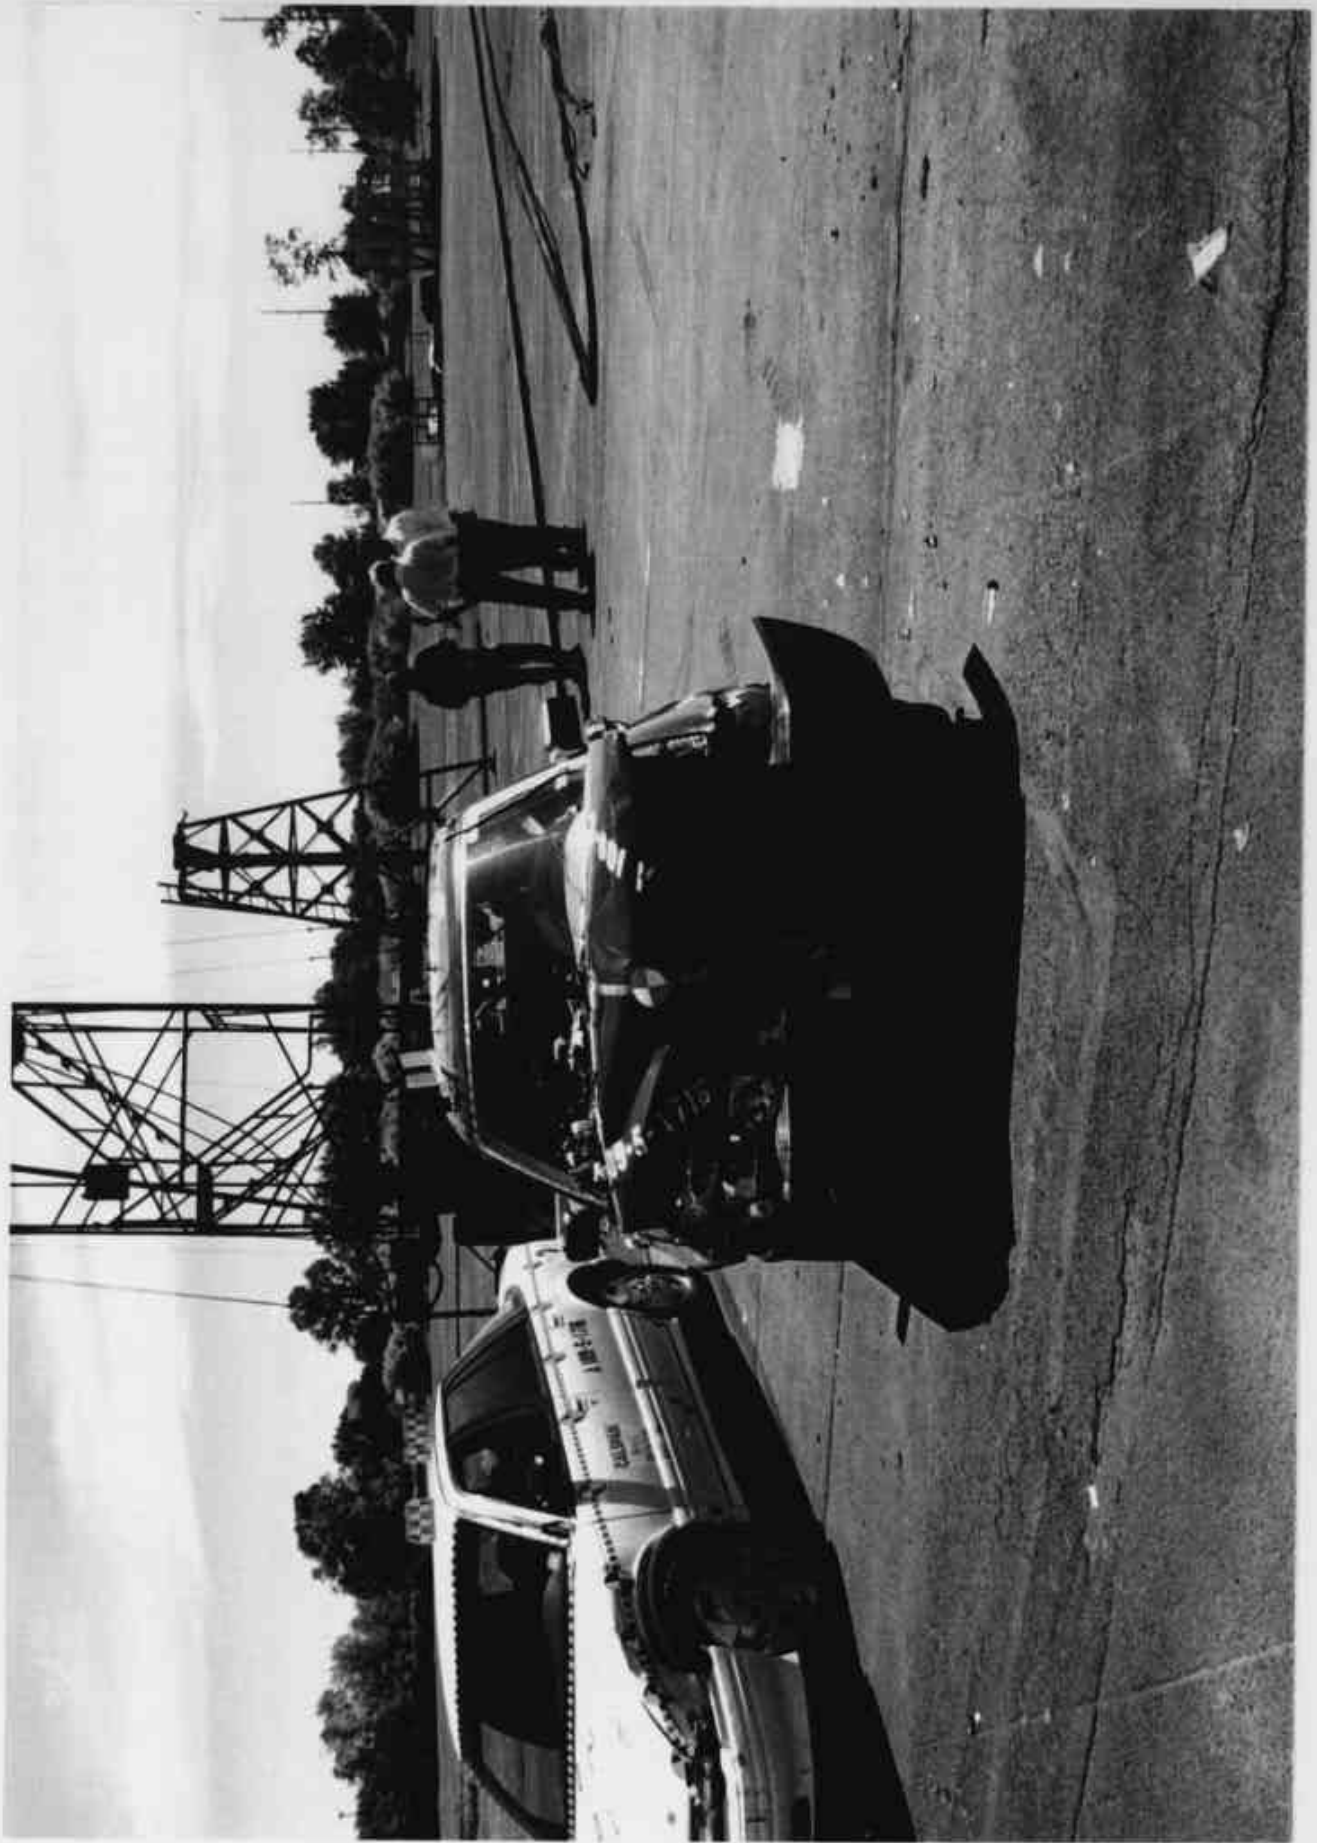
Figure B-2 POST-TEST FRONT VIEW

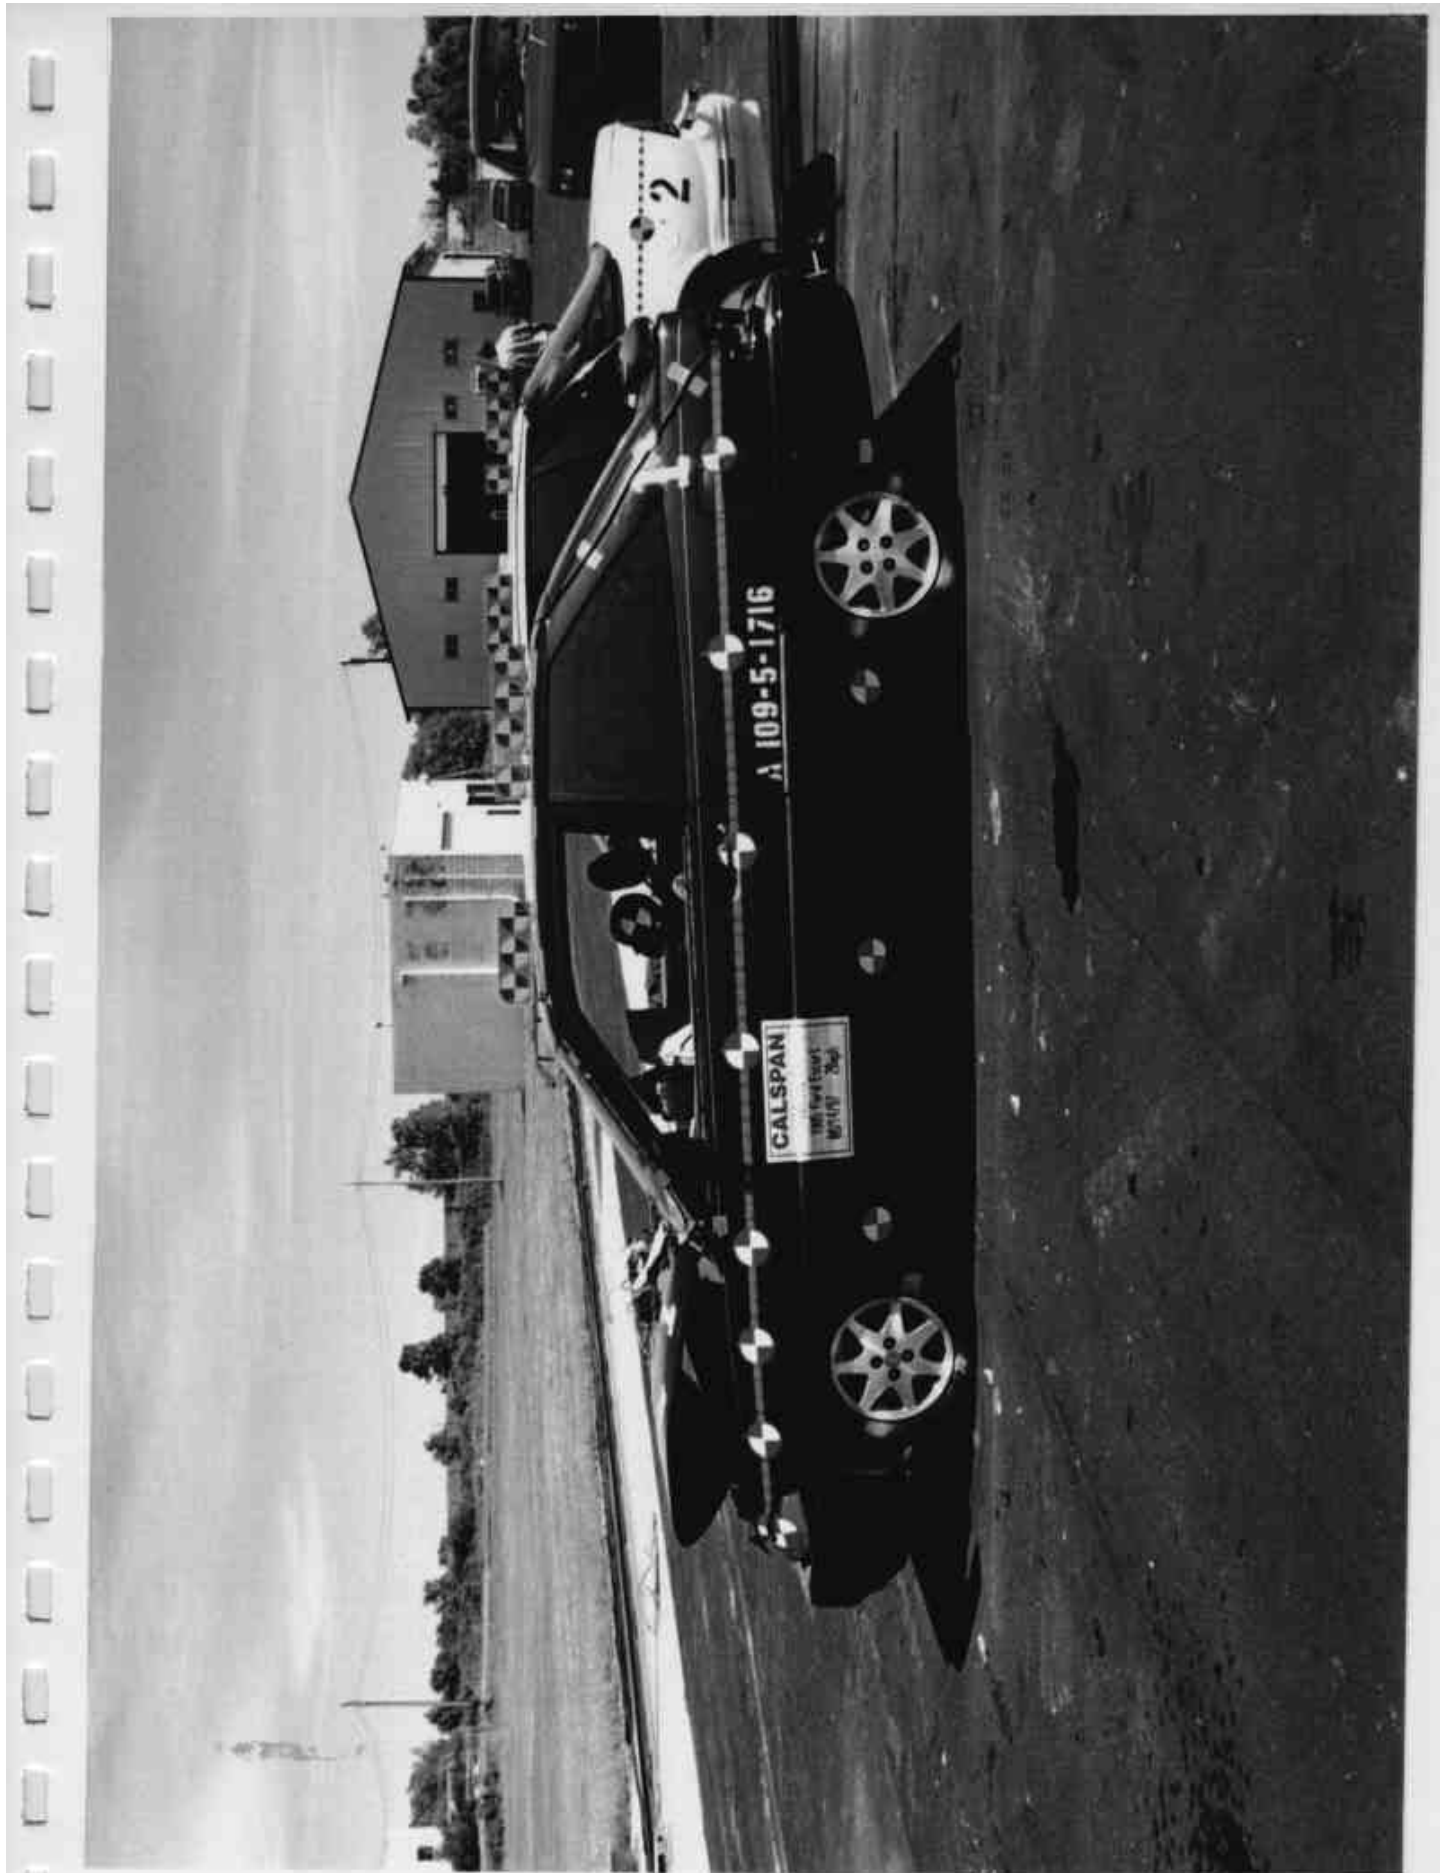
Figure B-14 POST-TEST LEFT SIDE VIEW

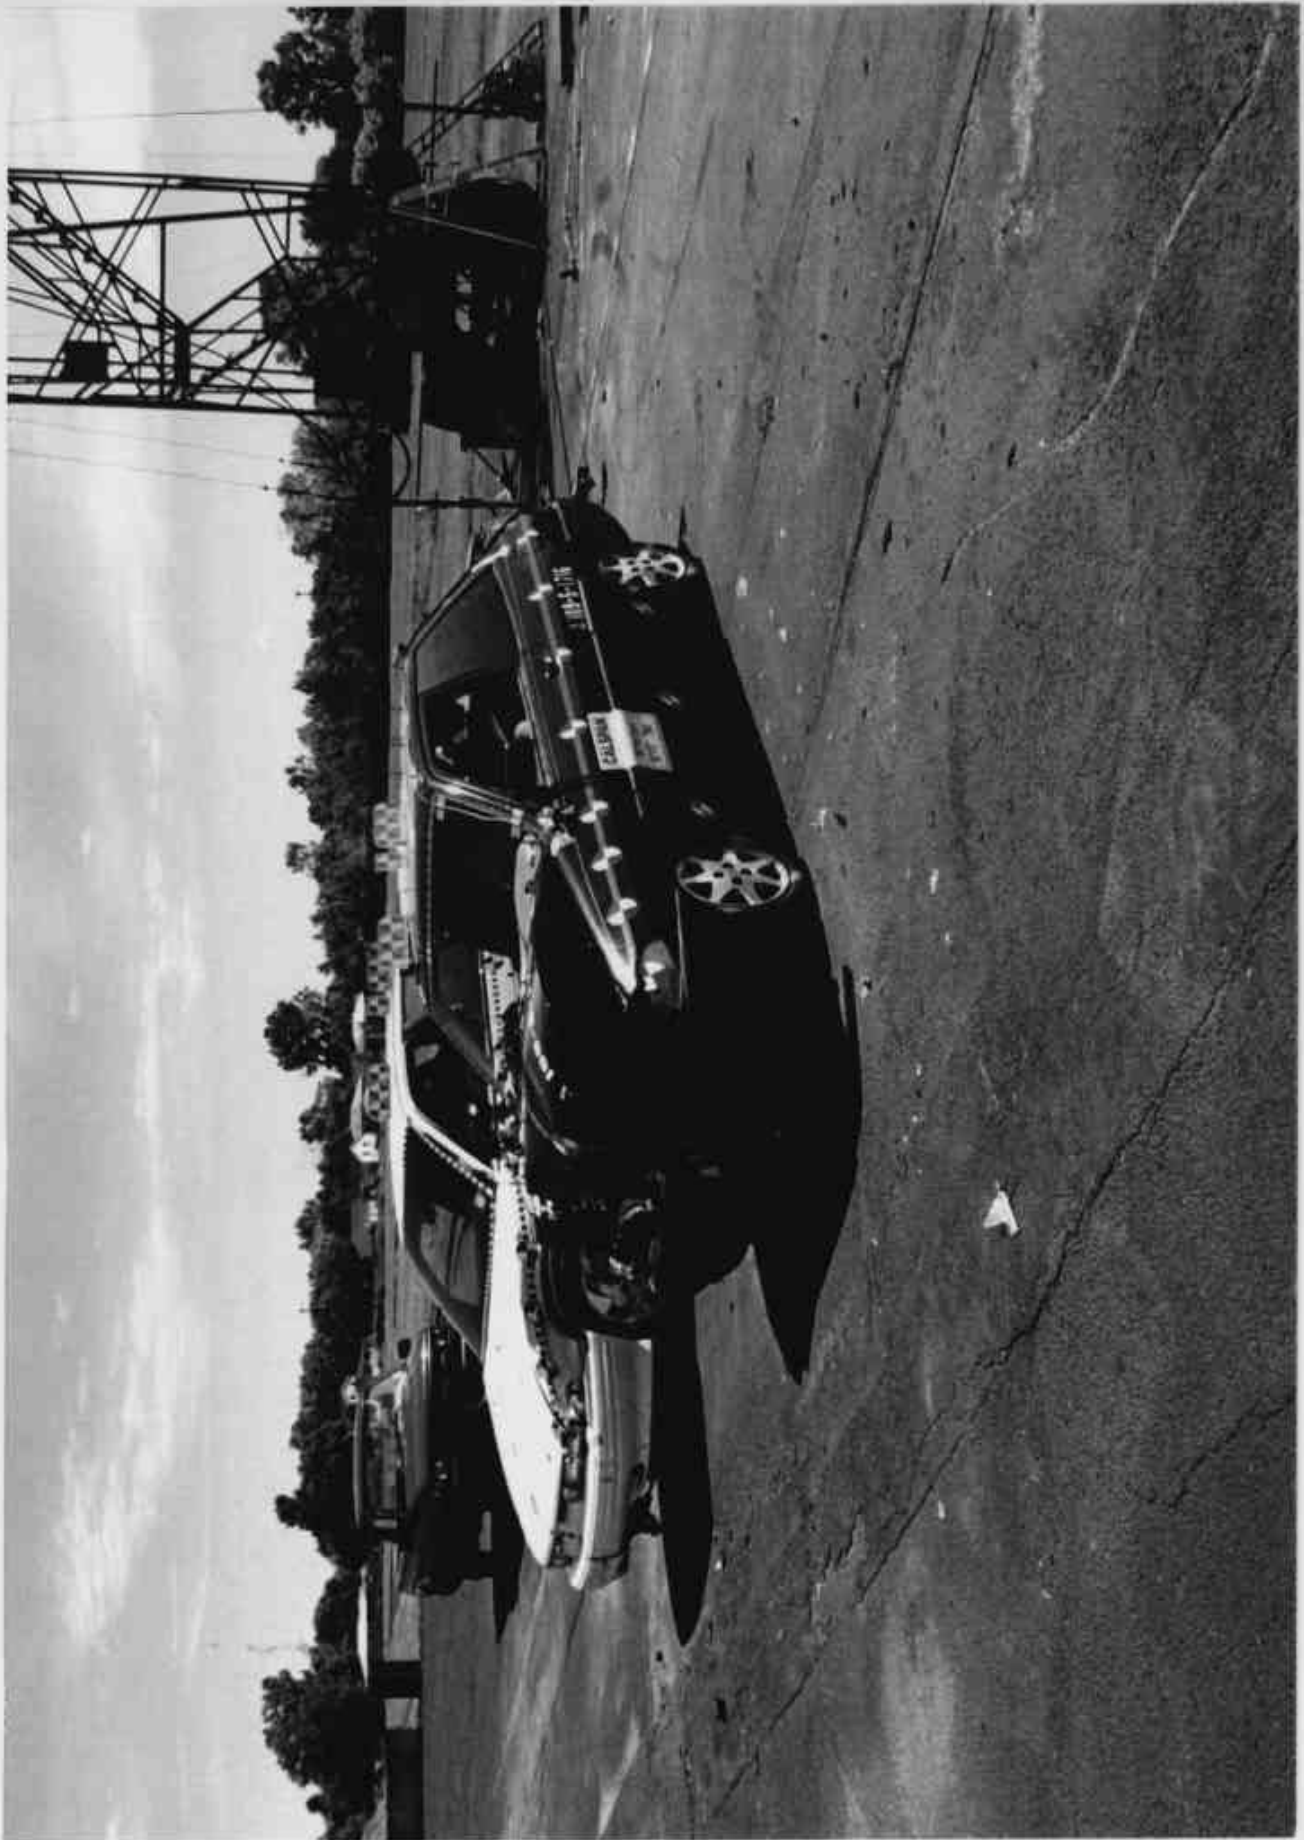
Figure B-16 POST-TEST FRONT LEFT THREE QUARTER VIEW

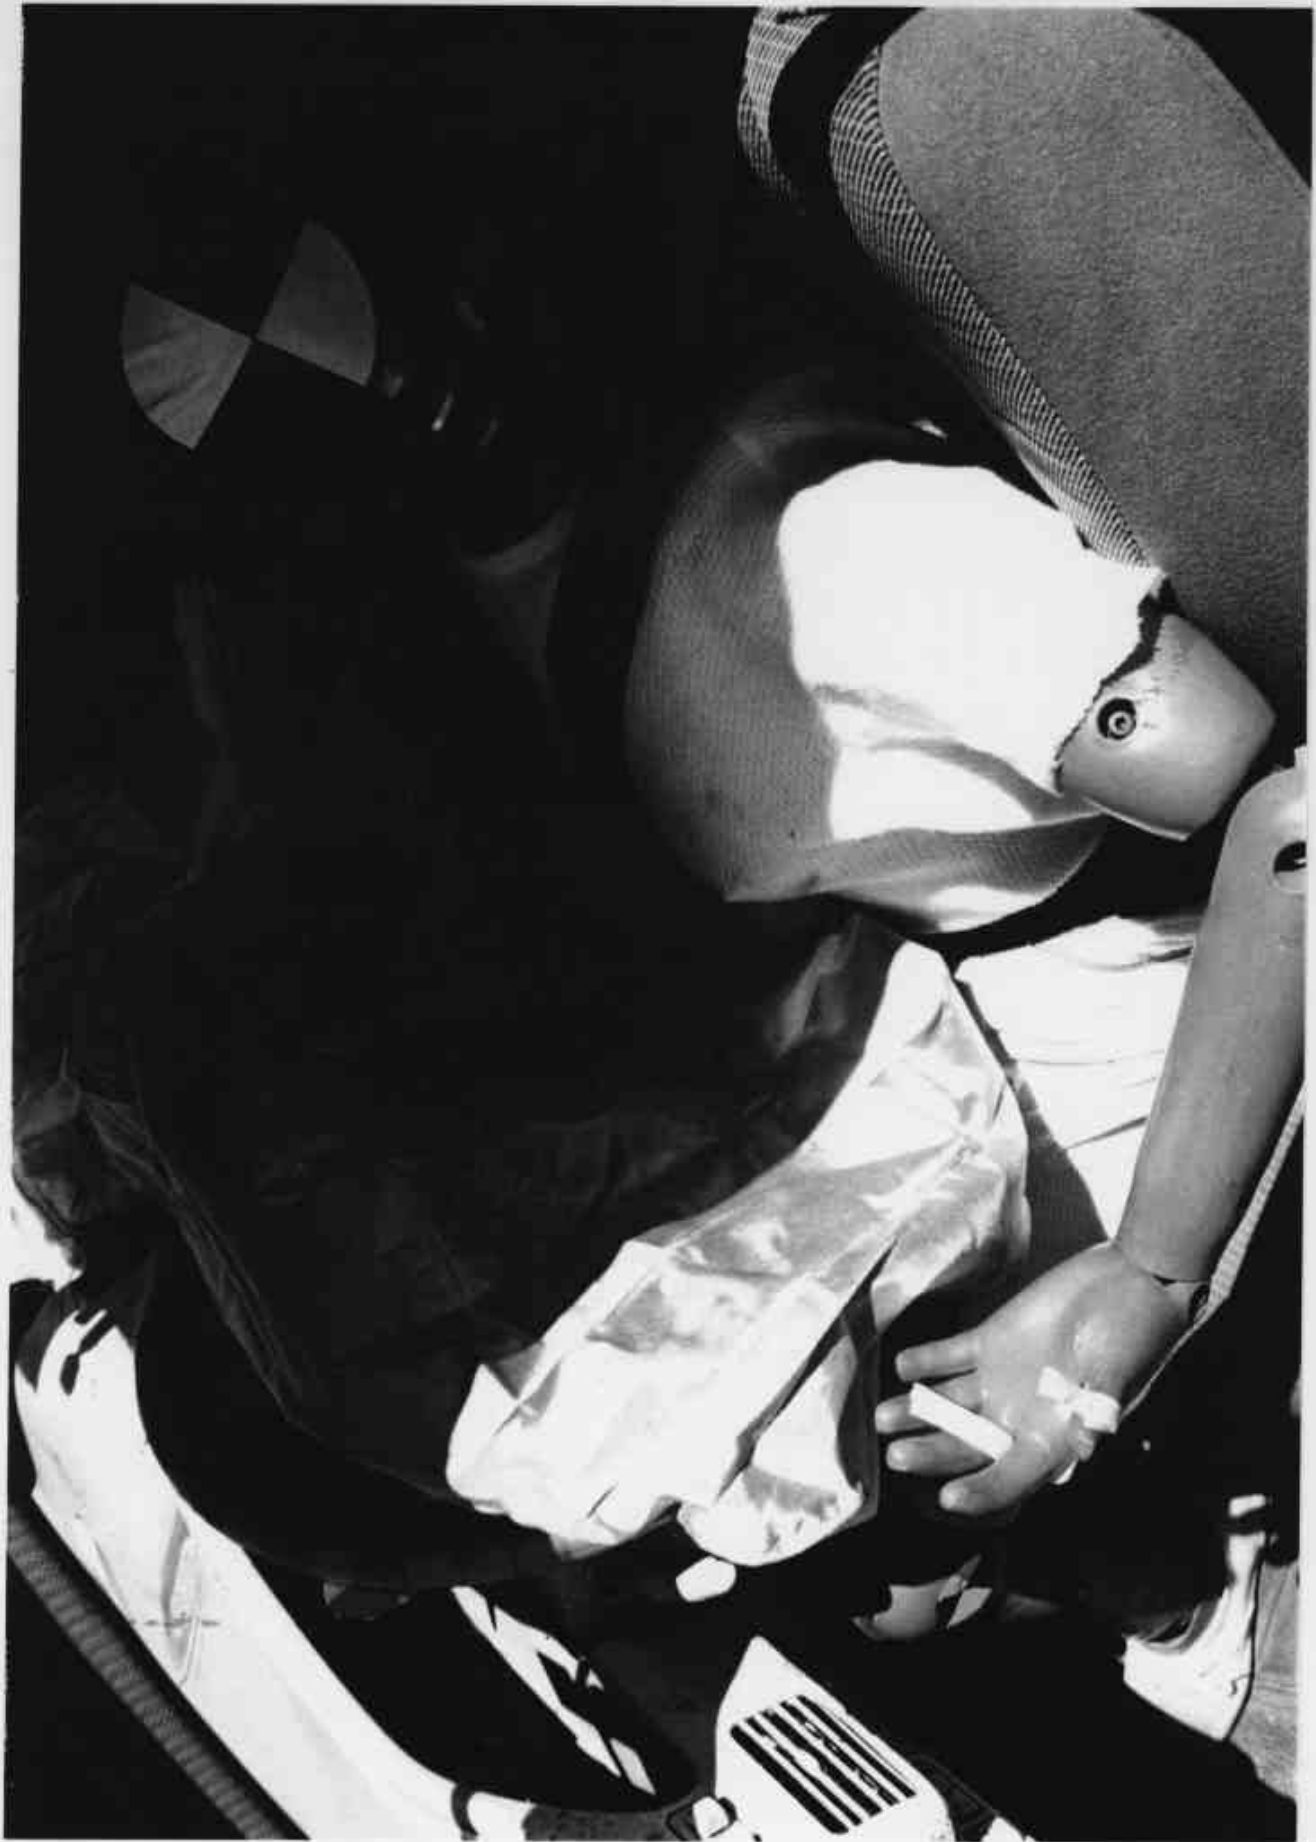
Figure B-31 POST-TEST DRIVER FACE/CHEST CONTACT POINT

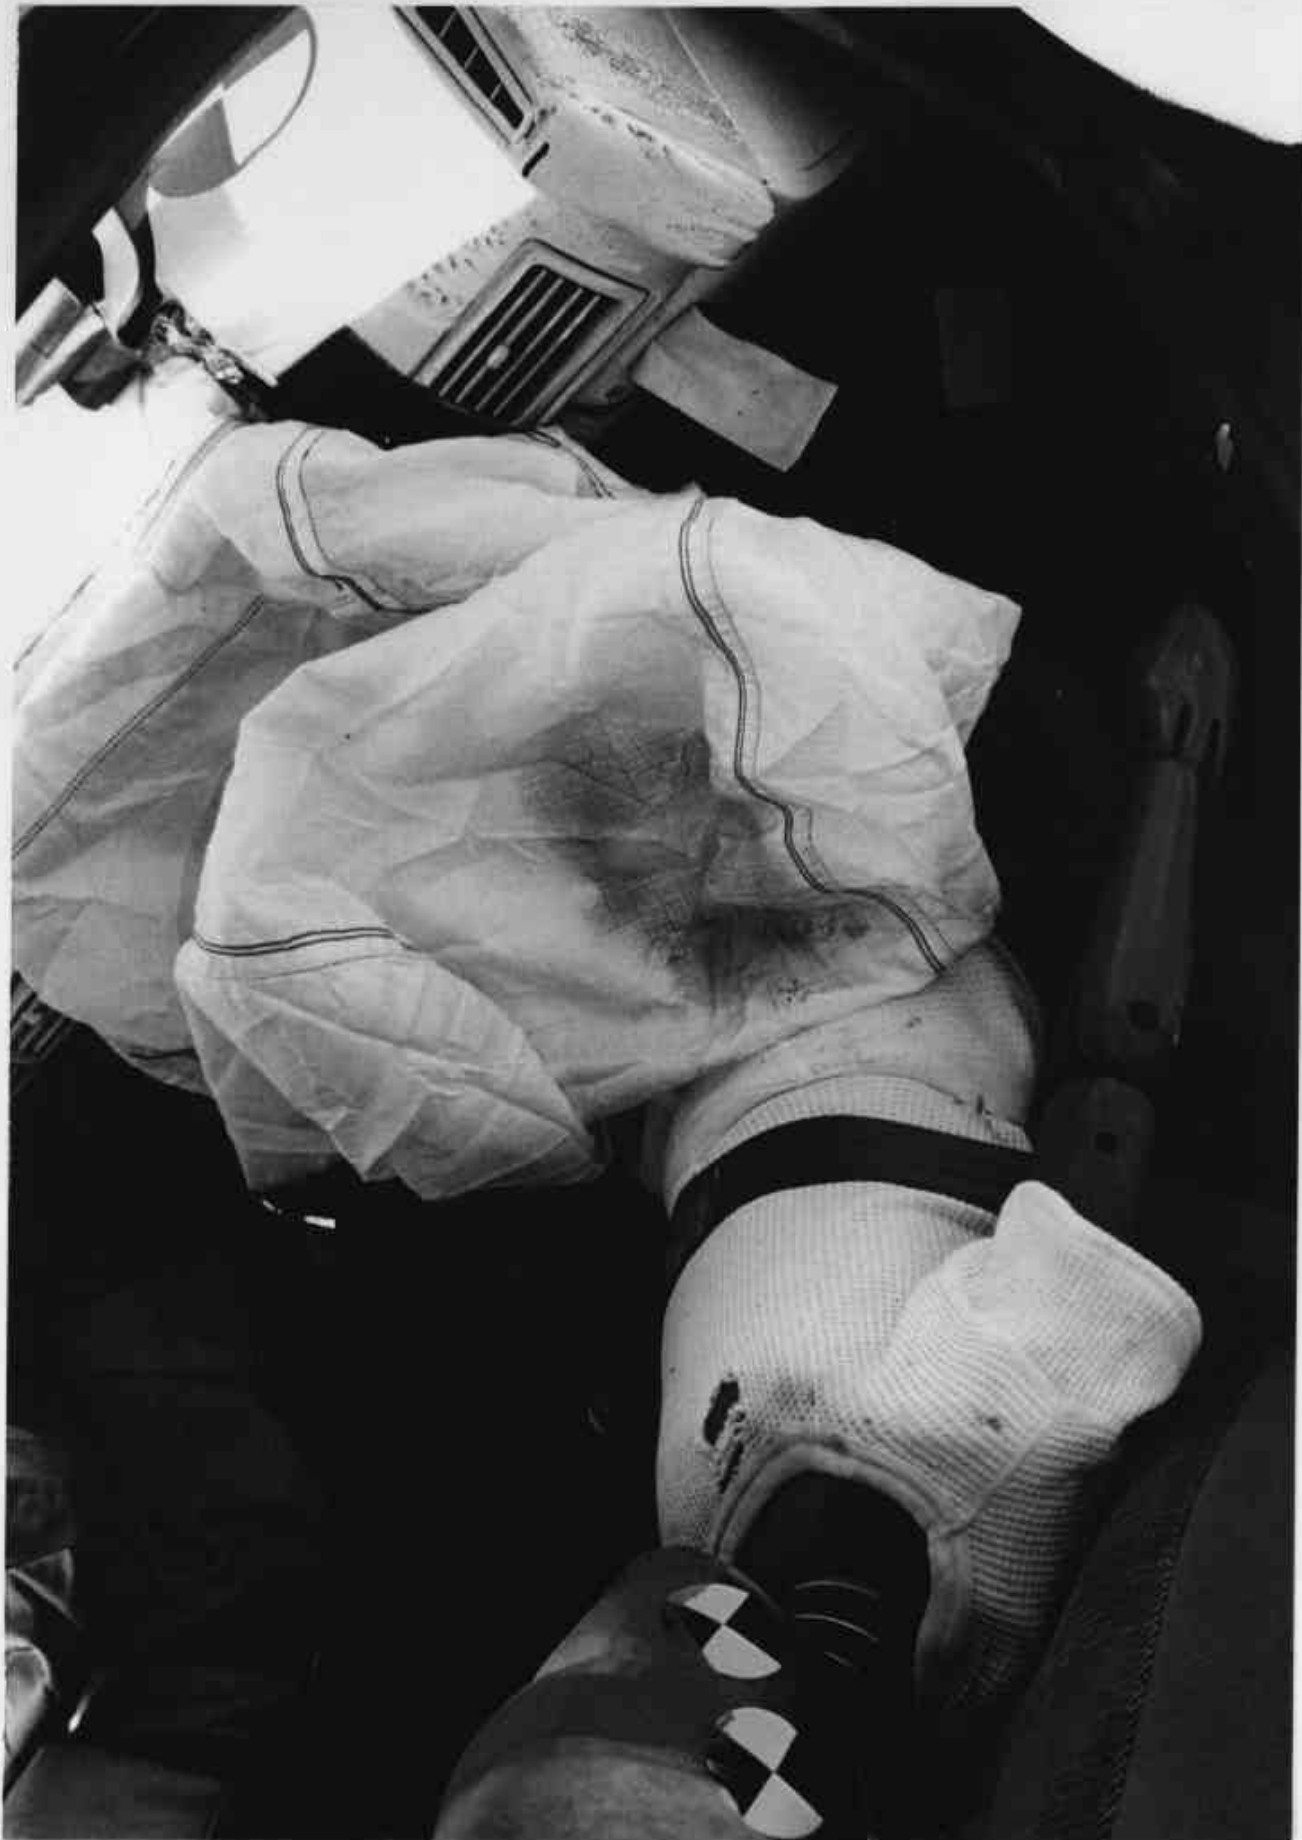
Figure B-32 POST-TEST PASSENGER FACE/CHEST CONTACT POINT

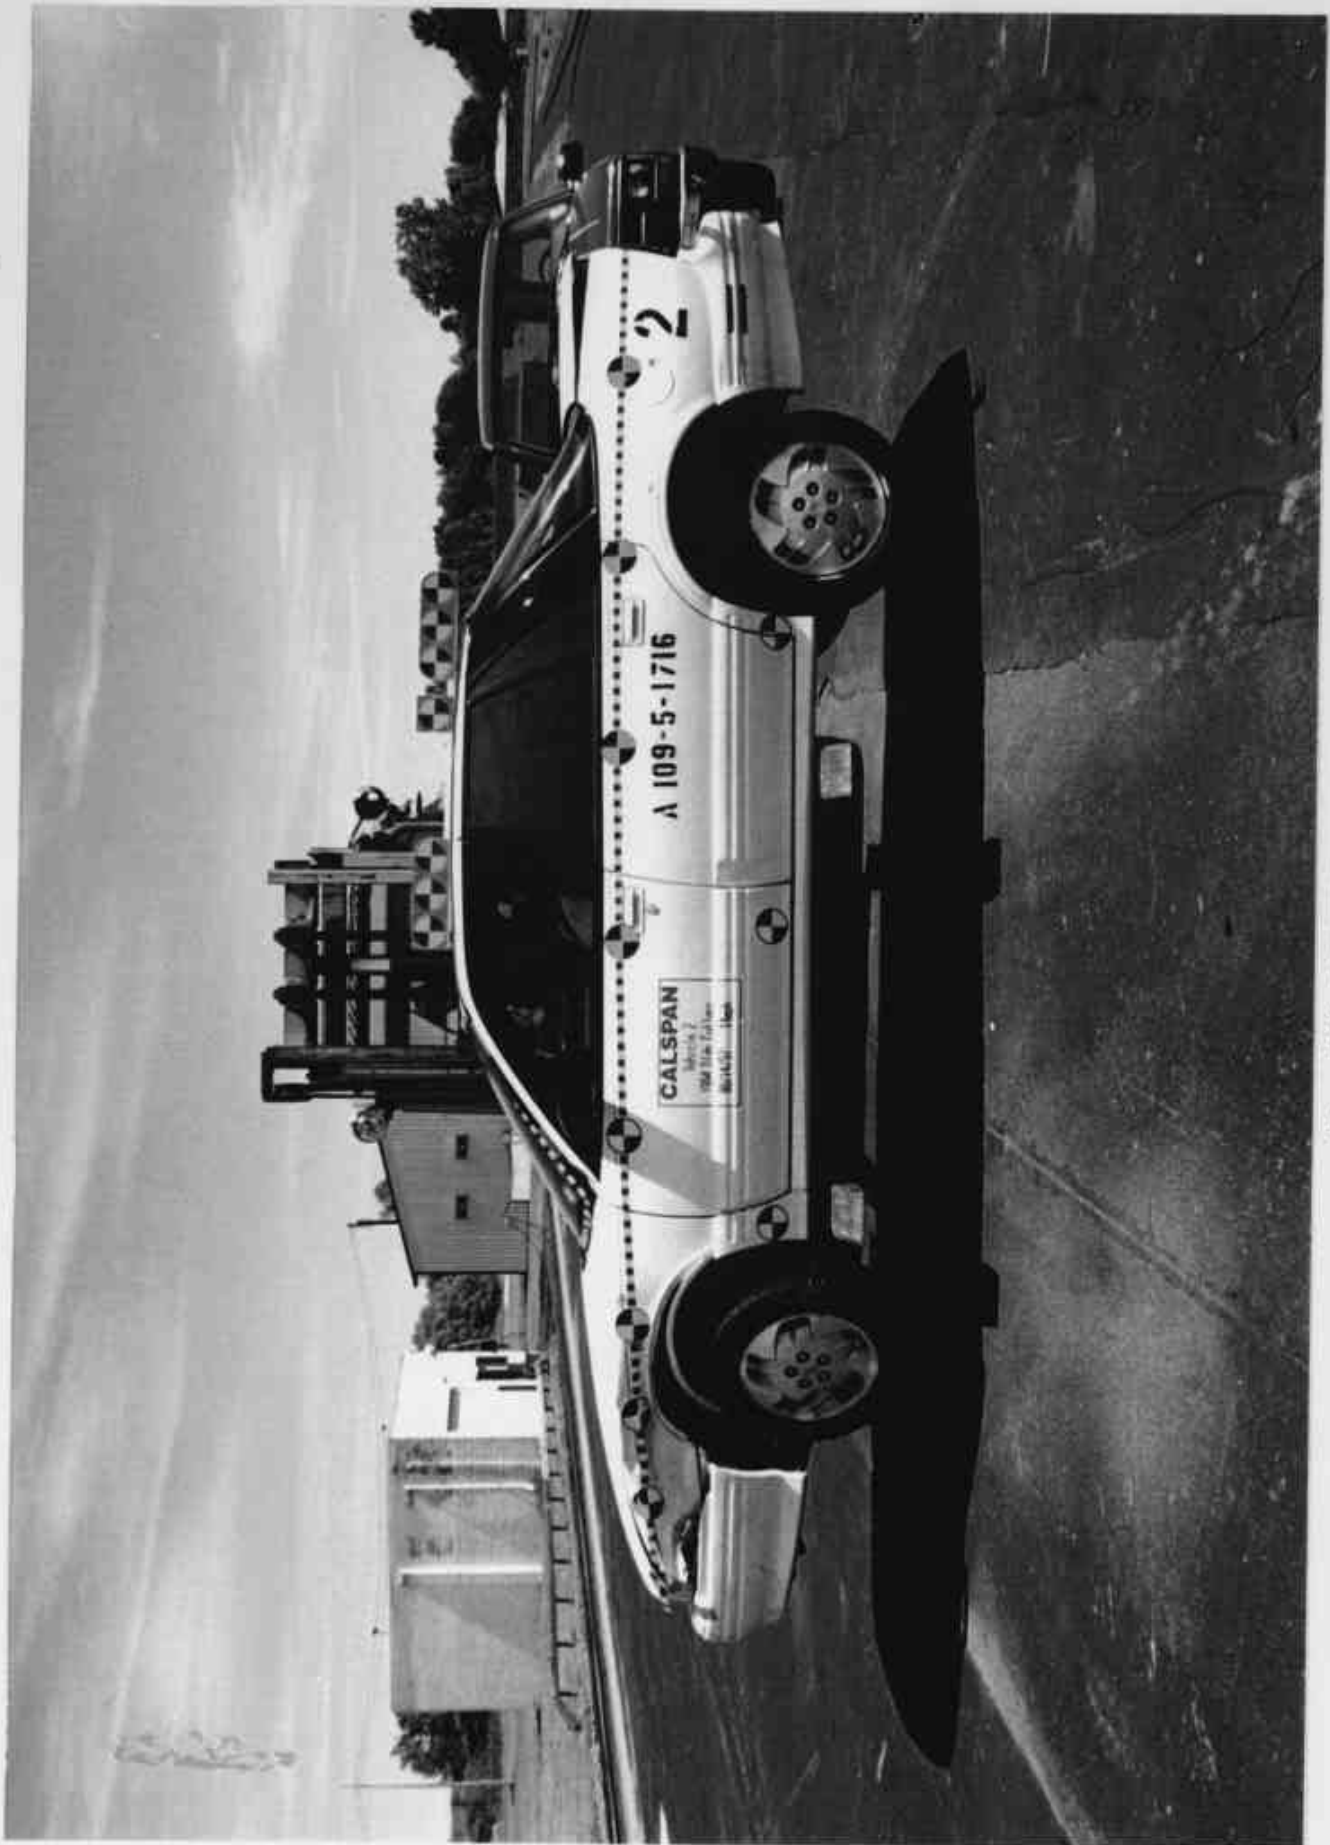
Figure C-14 POST-TEST LEFT SIDE VIEW

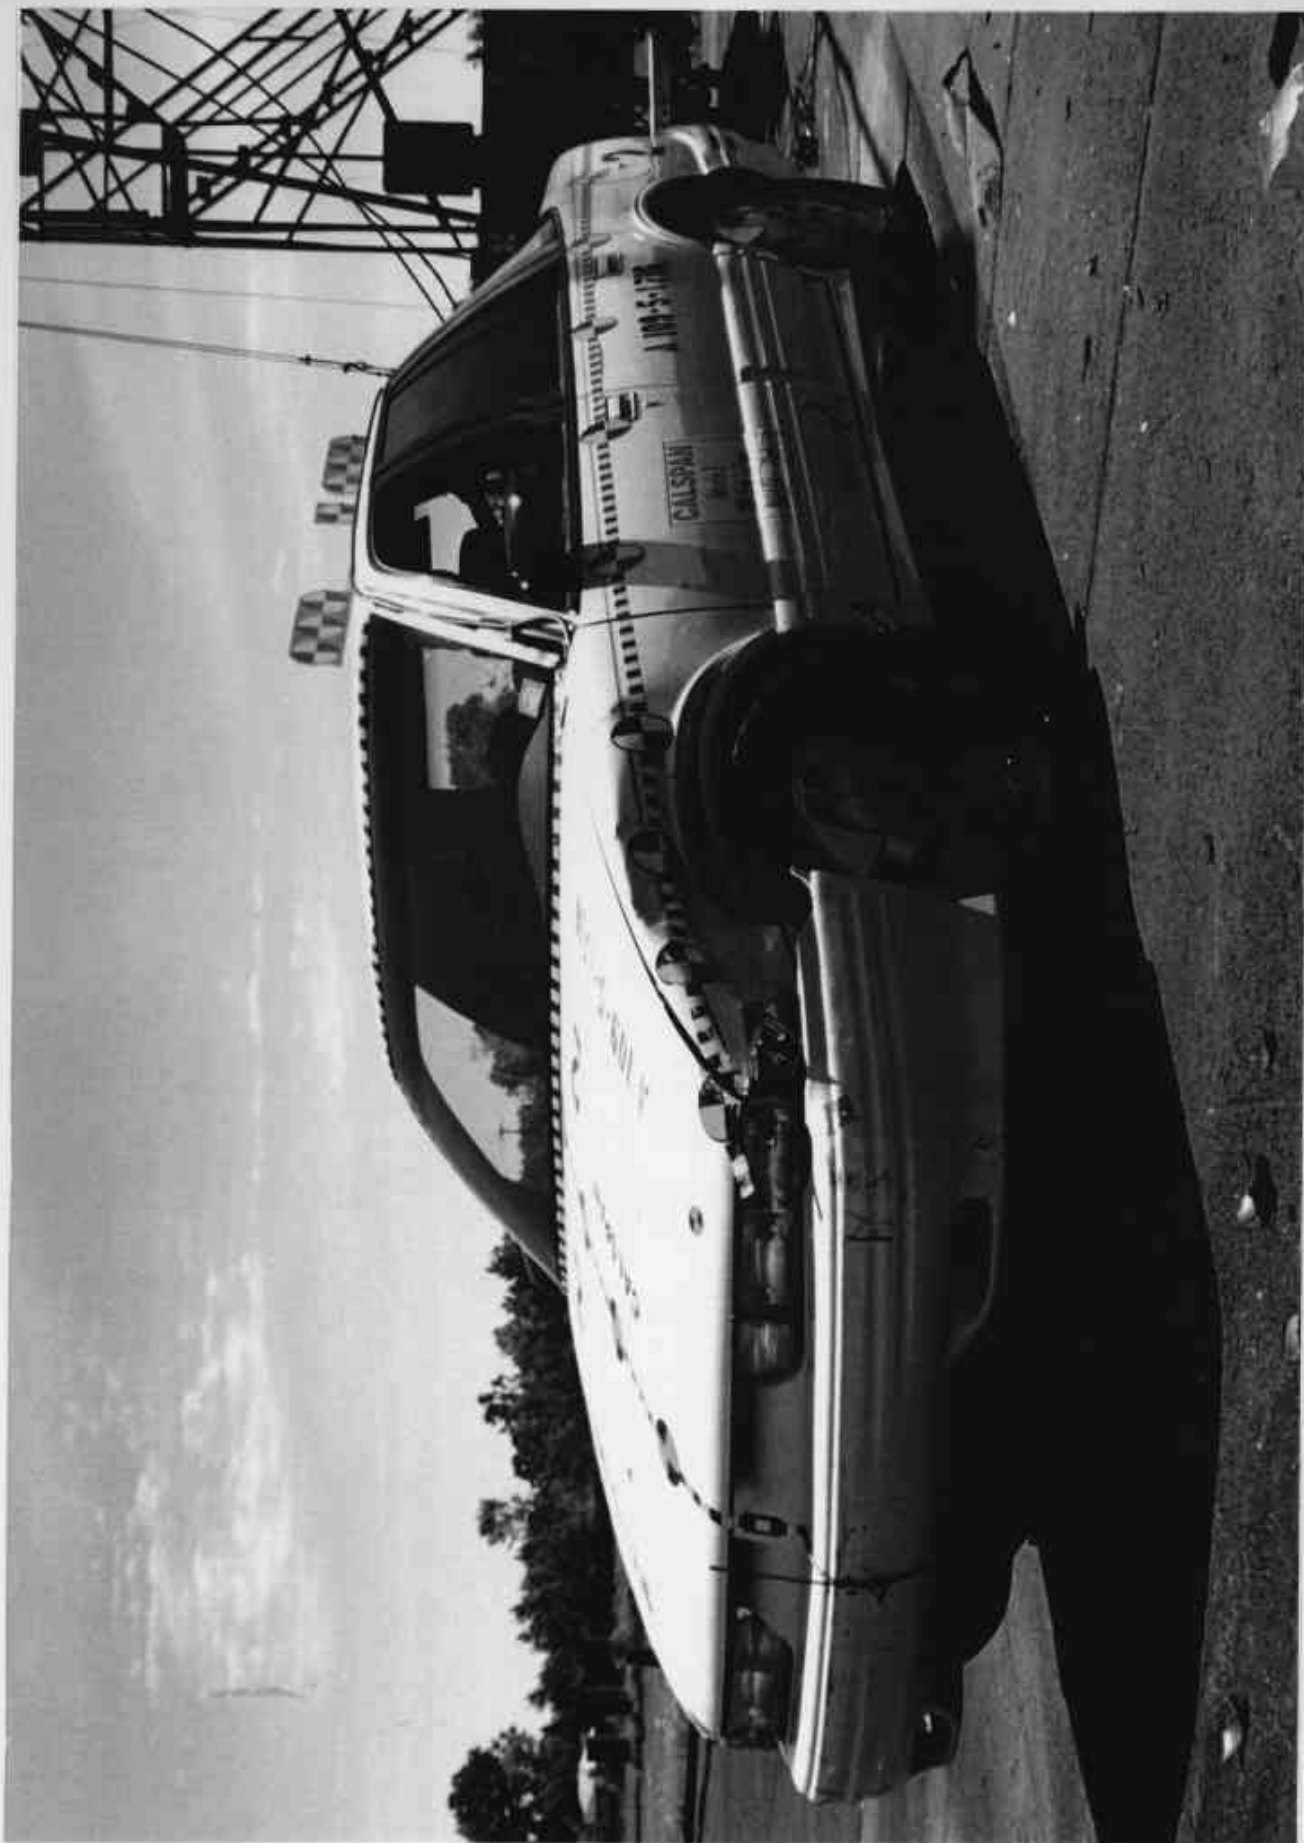
Figure C-16 POST-TEST FRONT LEFT THREE QUARTER VIEW
