CALSPAN REPORT NUMBER: 8404-5

**VEHICLE-TO-VEHICLE
90° SIDE IMPACT OF A
1995 FORD ESCORT 2-DOOR HATCHBACK TRAVELING 45 kph
INTO THE LEFT FRONT QUARTER OF A
1994 OLDSMOBILE CUTLASS SUPREME 4-DOOR SEDAN TRAVELING 22.5 kph**

CALSPAN TEST NUMBER: A109-5-1716

FINAL REPORT

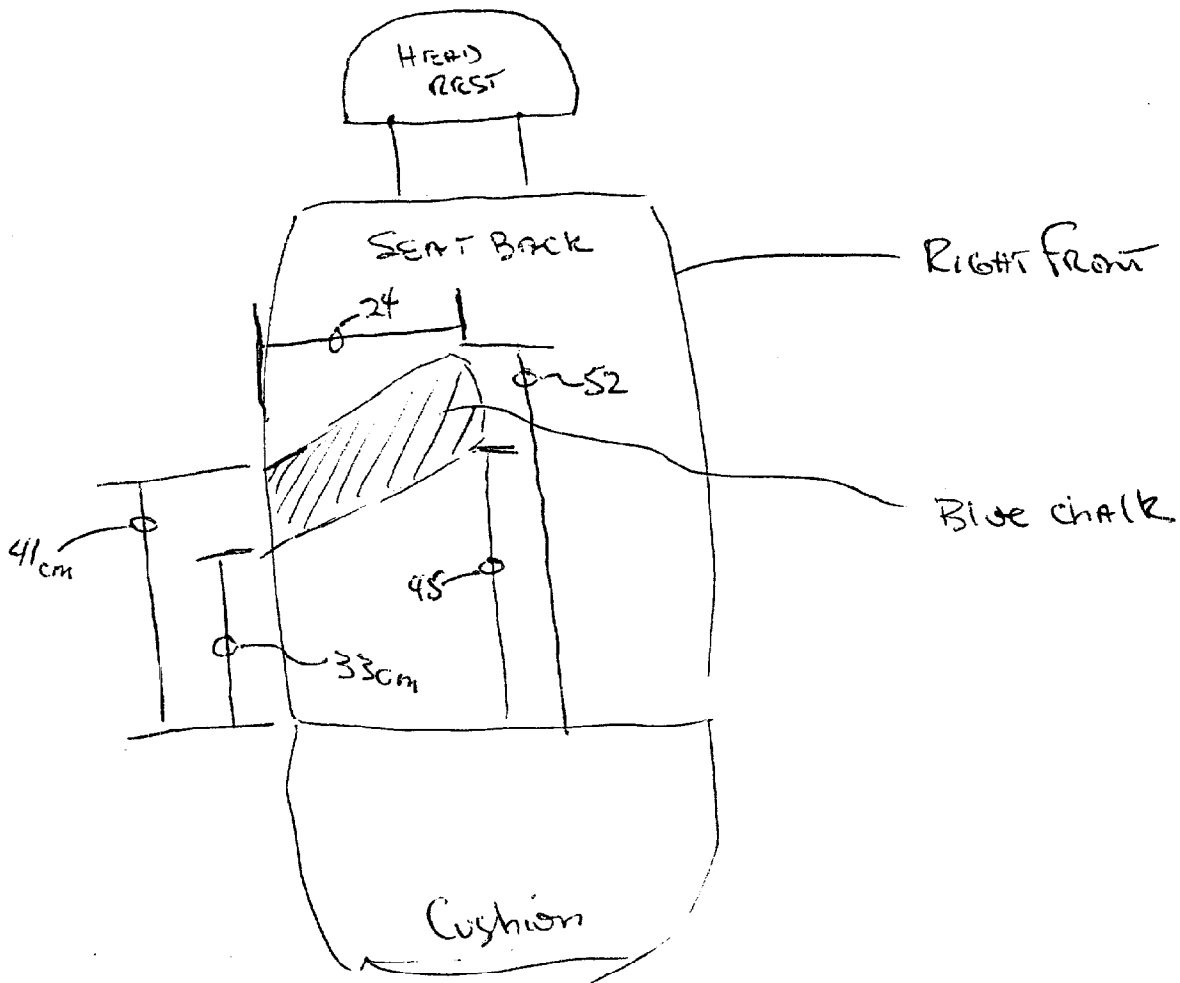
VEHICLE INTERIOR SKETCHES

- A 8cm long, 38cm above floor, 25 - 33 cm \odot of E
- B 2.5 long \times 1.5 tall, 44cm above floor, 26.5 - 29 cm \odot of E
- C 1.5cm tall (Red) line, 45cm above floor, 18cm \odot of E
- D 2cm \times 2cm, 40cm above floor, 13.5 cm \odot of E
- E 10cm \times 9cm on upper R corner of seat back, 0 - 10cm \odot of Right edge of seat.
- F 6cm \times 4cm on lower R corner Head Rest, 3 - 9cm \odot of Right edge
- G See sketch below
- H 1.5 \times 1.5cm, 47cm above floor, 25.5cm \odot of Right edge of IP
- I 1.5 \times 1.5cm, 47cm above floor, 20.5 cm \odot of Right edge of IP
- J 2 \times 5.5cm, 40 - 44cm above floor, 21.5 - 23.5 cm \odot of R edge of IP
