REPORT NO. KAR-98-11

NATIONAL HIGHWAY TRAFFIC SAFETY ADMINISTRATION  
NEW CAR ASSESSMENT PROGRAM  
FRONTAL BARRIER IMPACT TEST

NISSAN MOTOR COMPANY  
1998 NISSAN MAXIMA 4-DOOR SEDAN  
NHTSA NO. MW5203

PREPARED BY:  
KARCO ENGINEERING  
9270 HOLLY ROAD  
ADELANTO, CALIFORNIA 92301

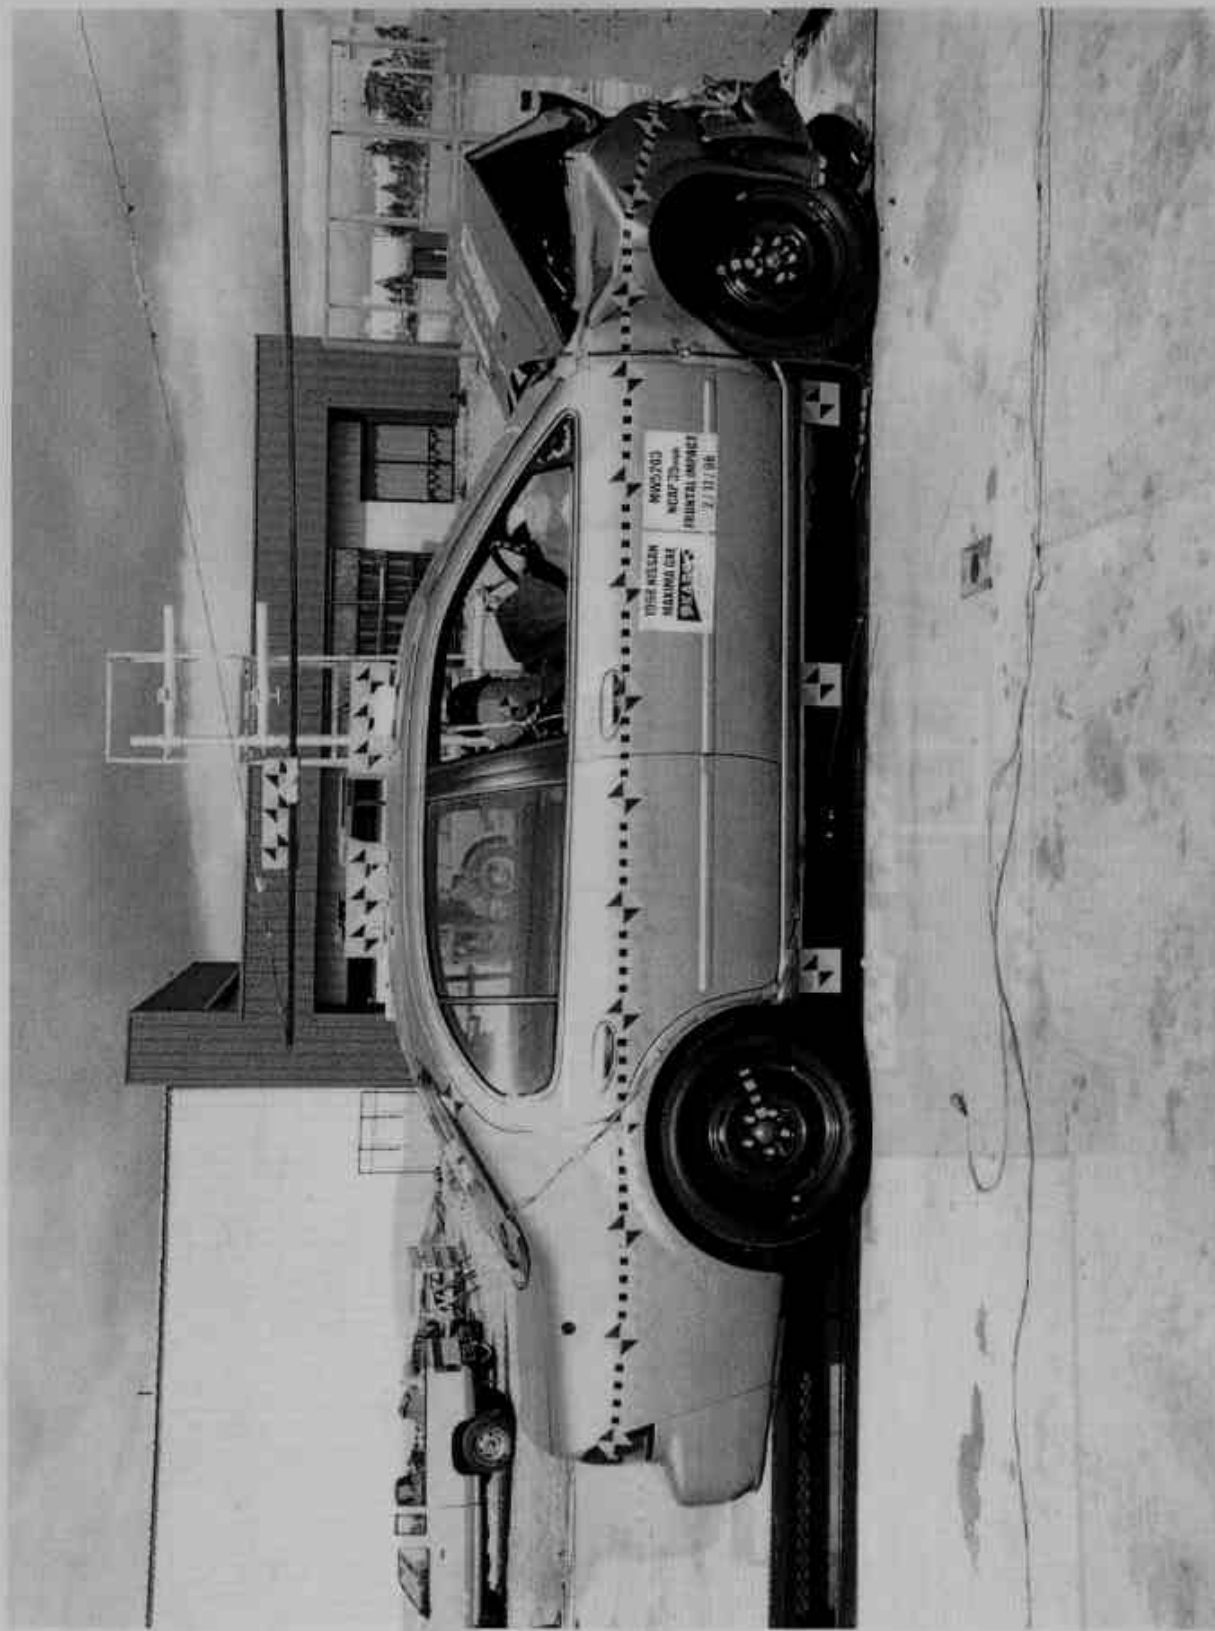
FIGURE A-10. POST TEST RIGHT SIDE VIEW

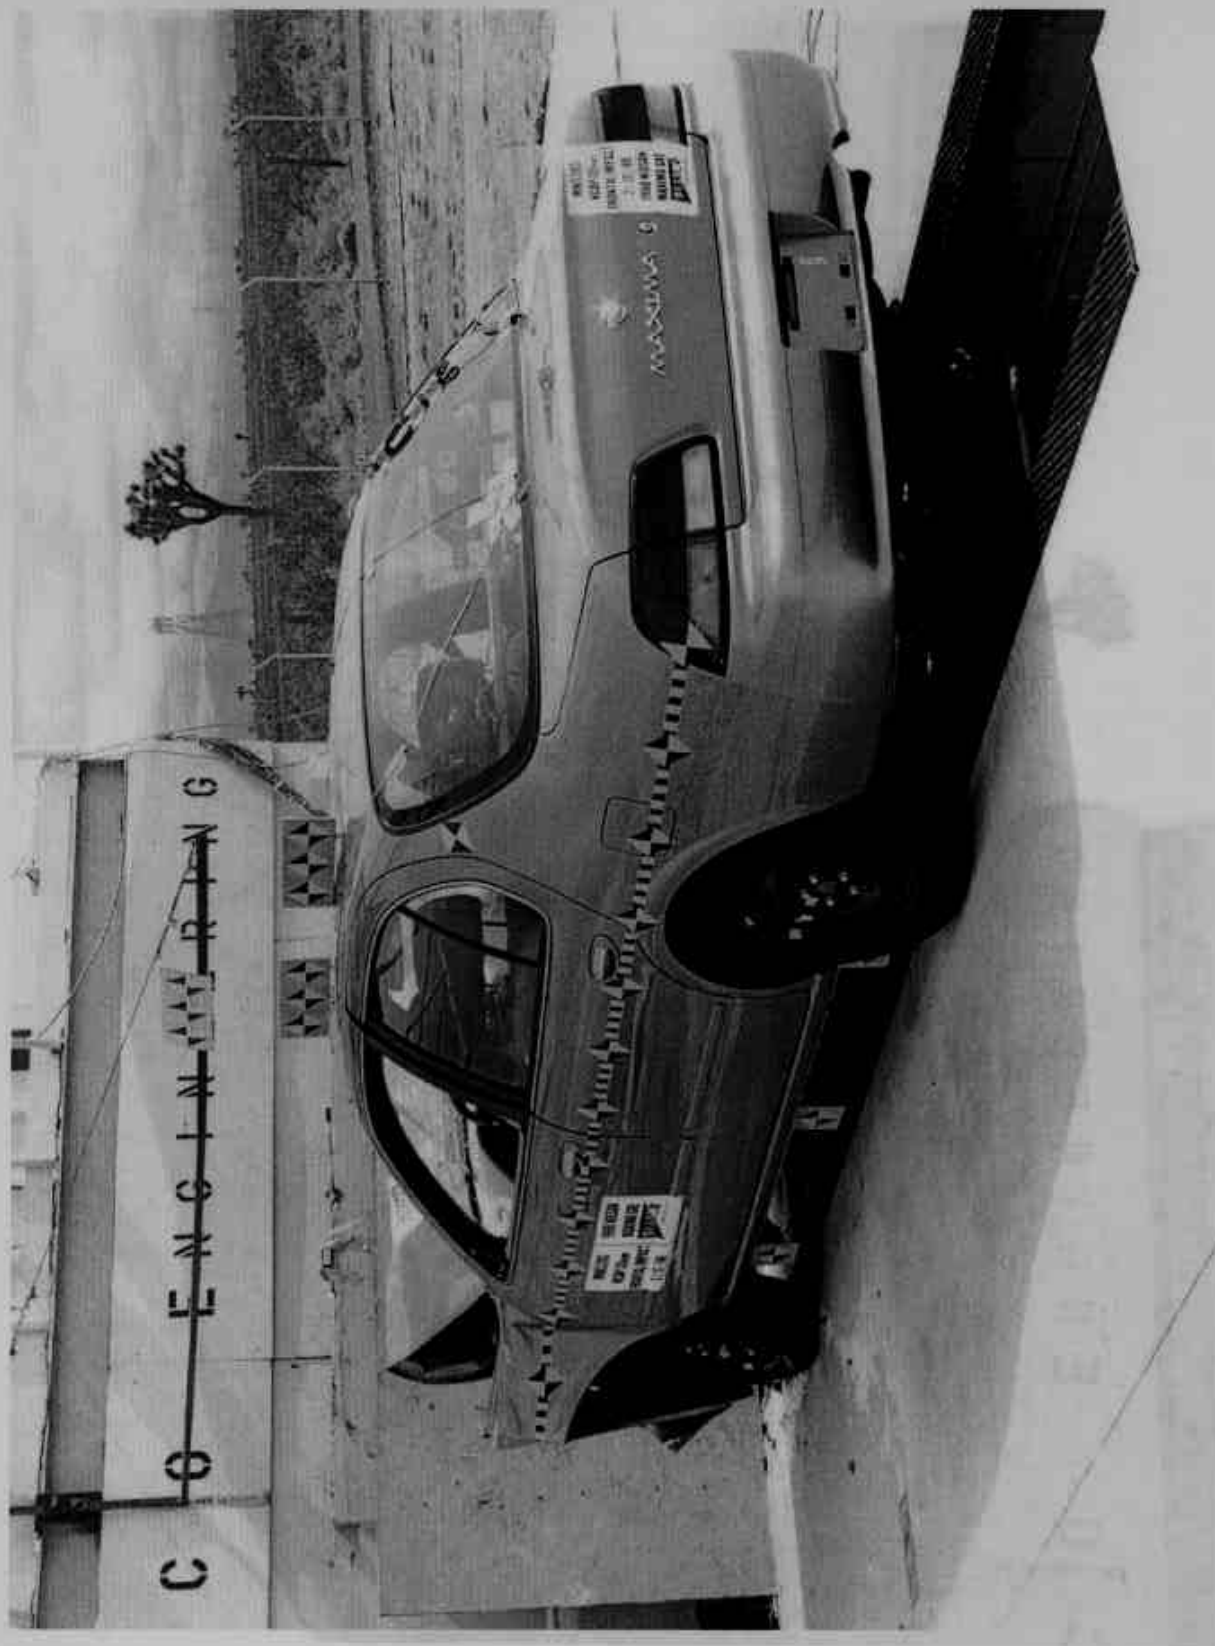
FIGURE A-14. POST TEST LEFT REAR VIEW

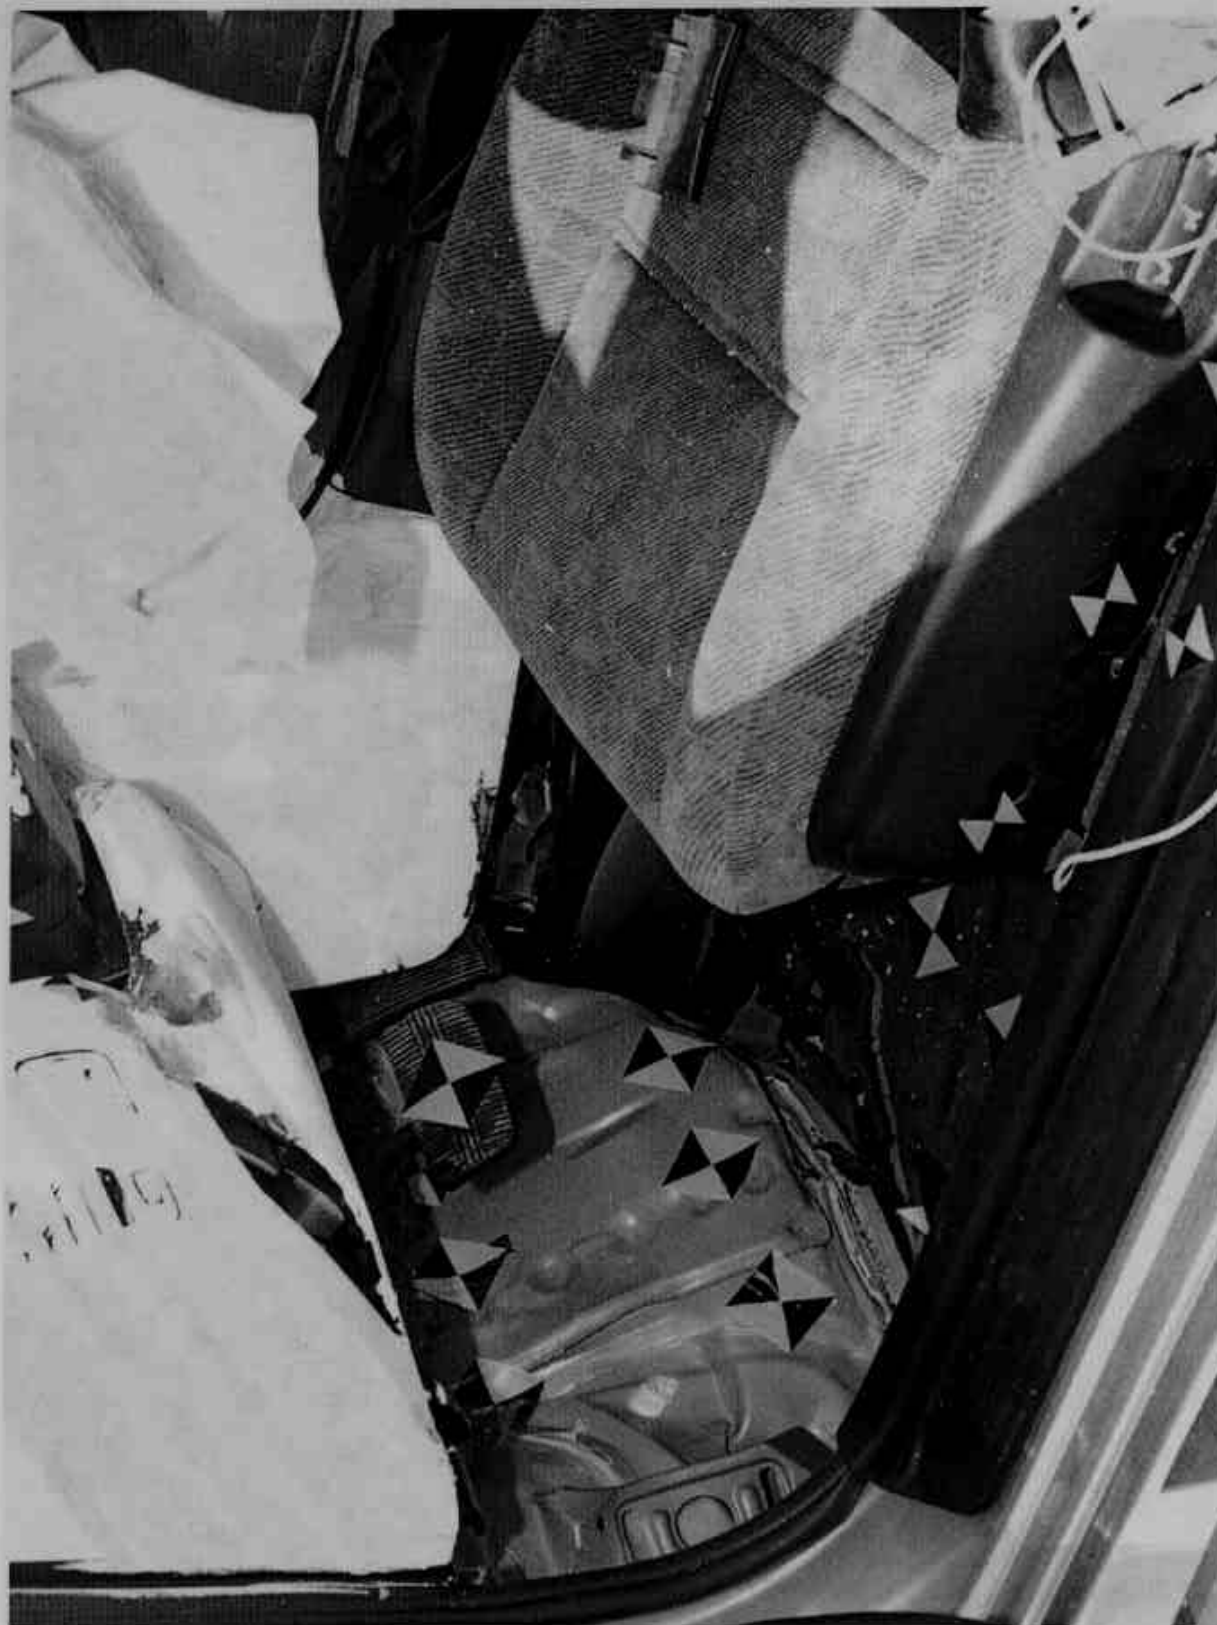
FIGURE A-26. POST TEST DRIVER FLOOR PAN

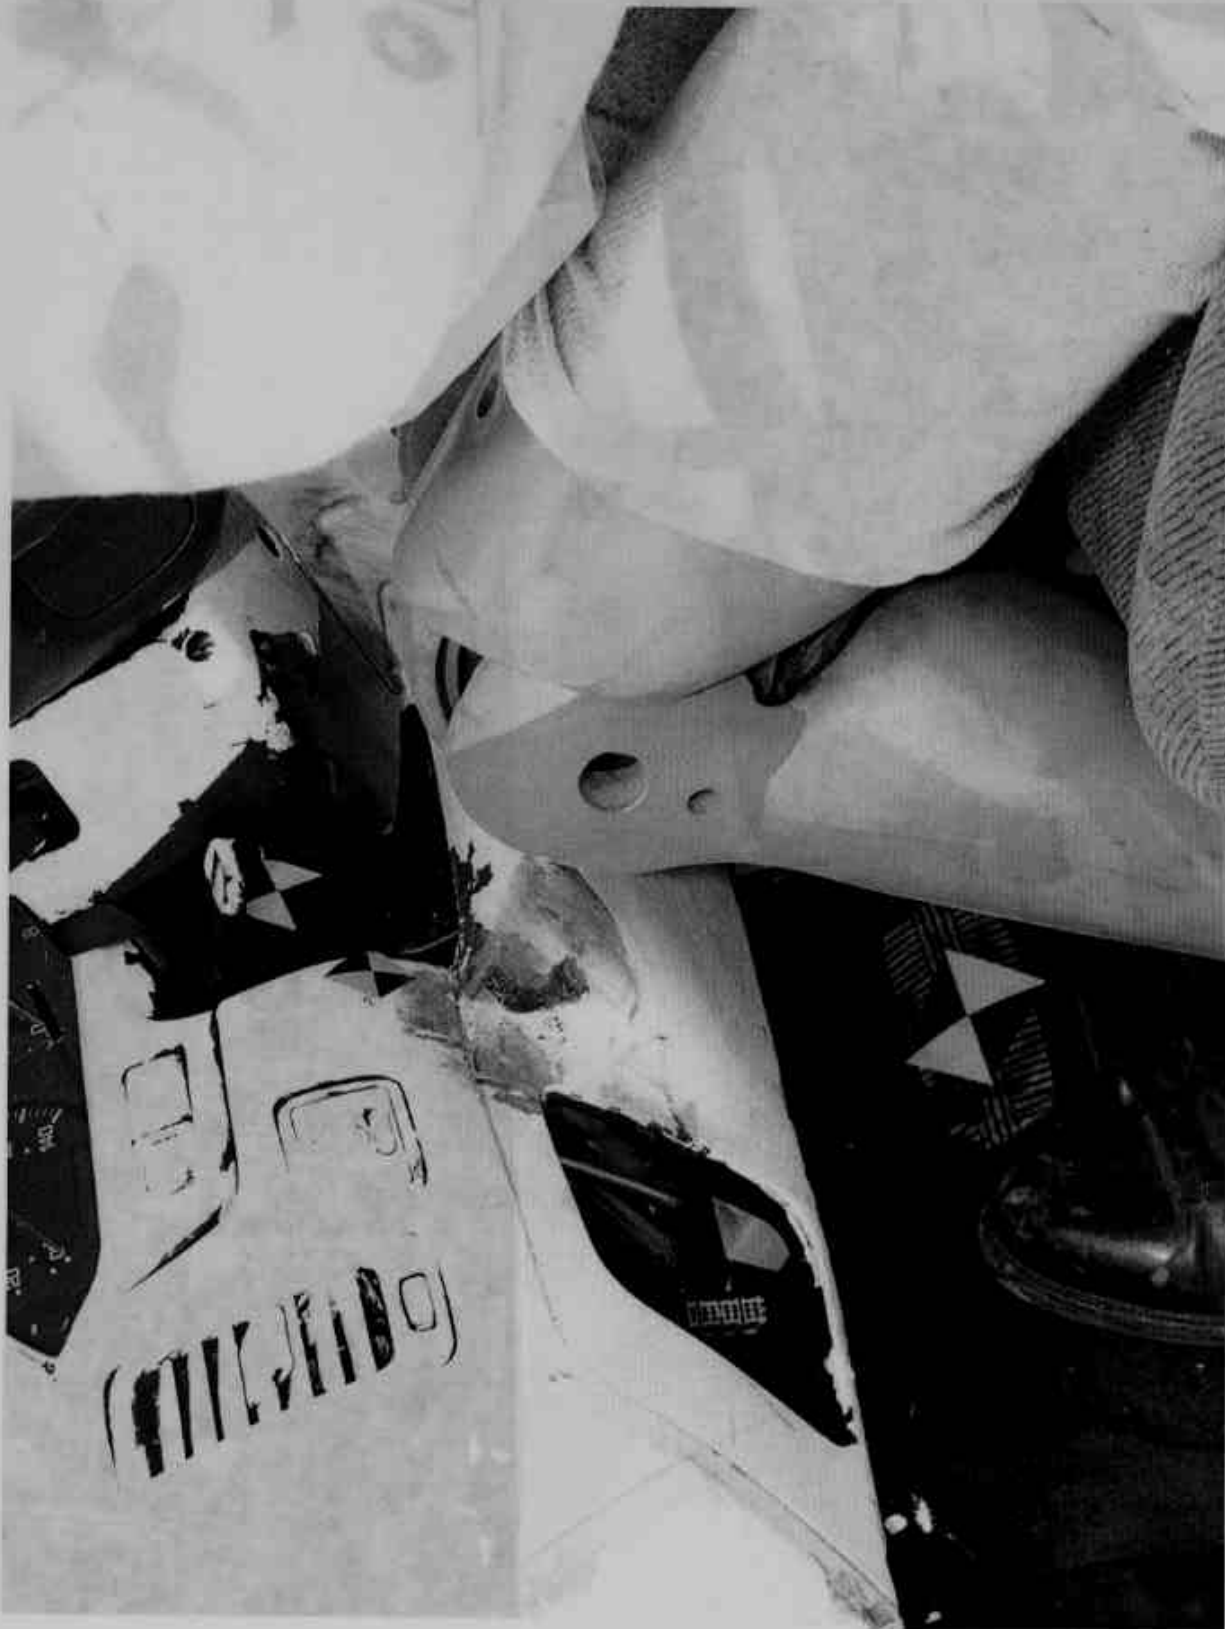
FIGURE A-37. POST TEST DRIVER DUMMY CONTACT POINT

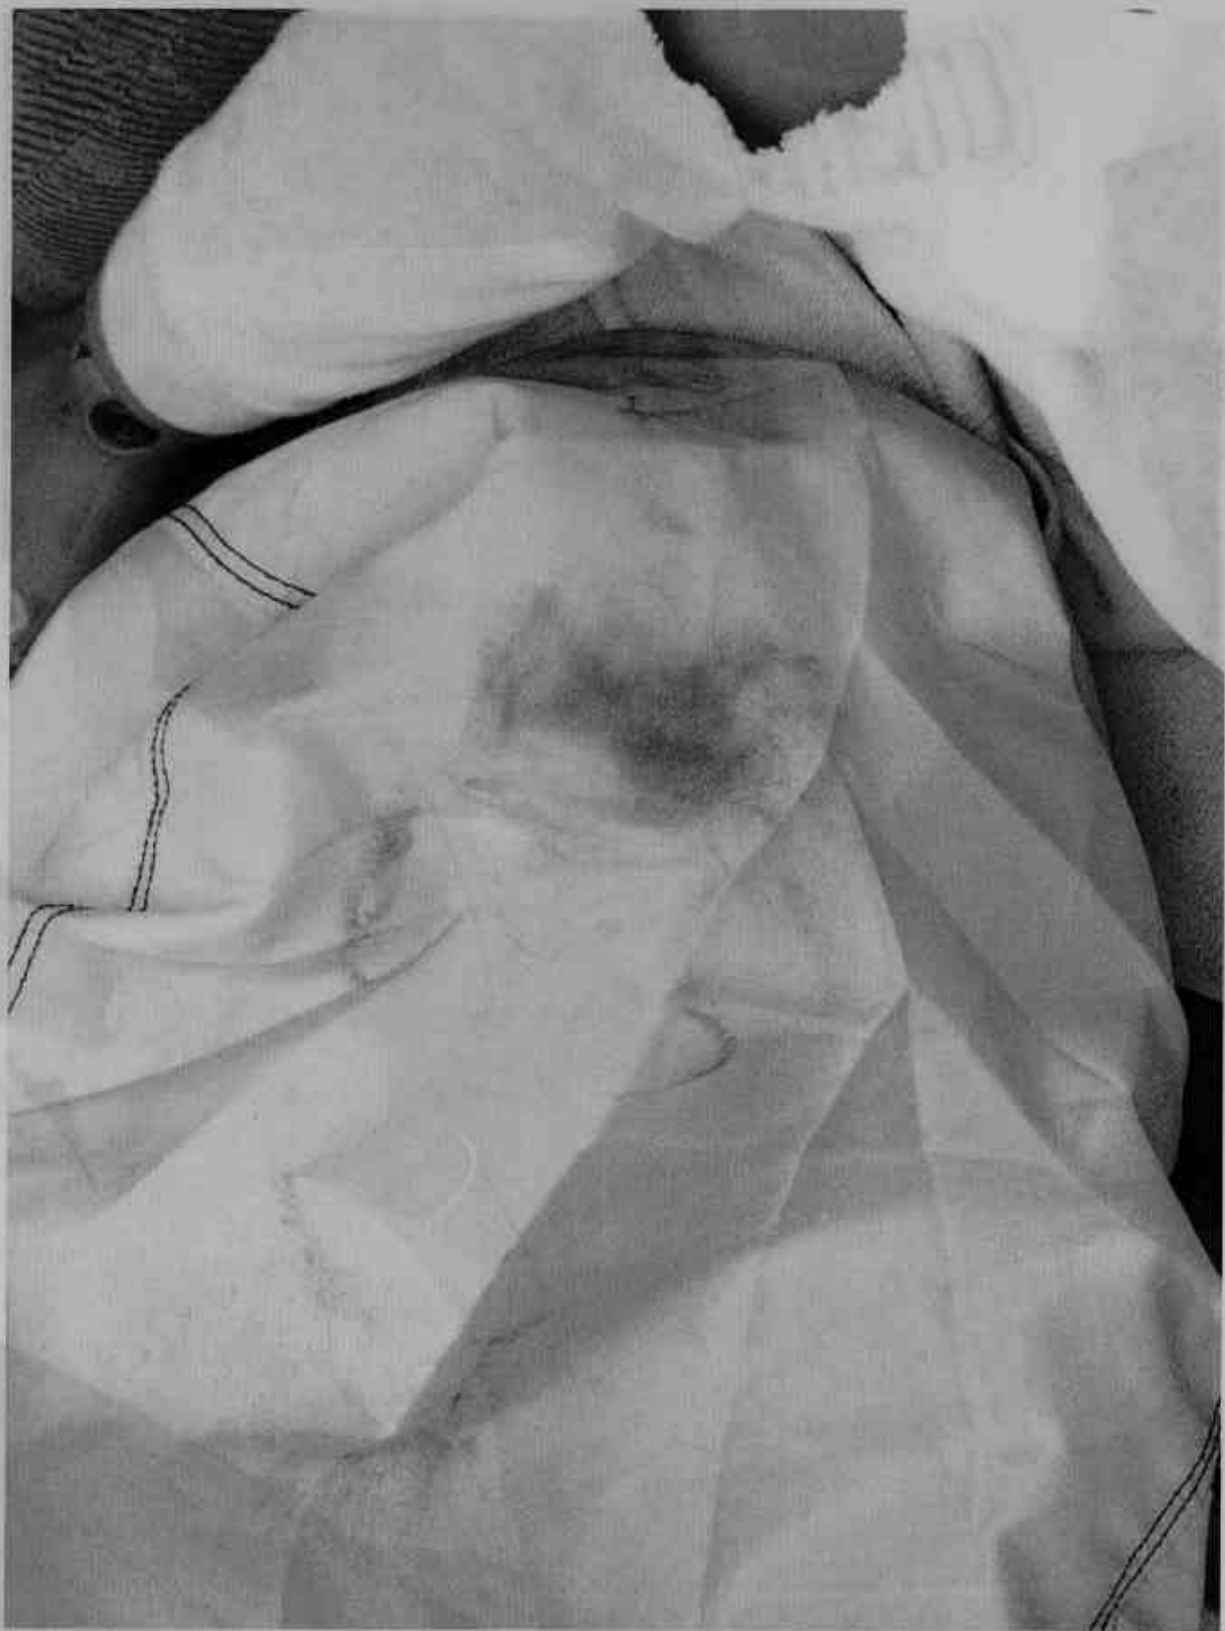
FIGURE A-50. POST TEST PASSENGER DUMMY CONTACT POINT

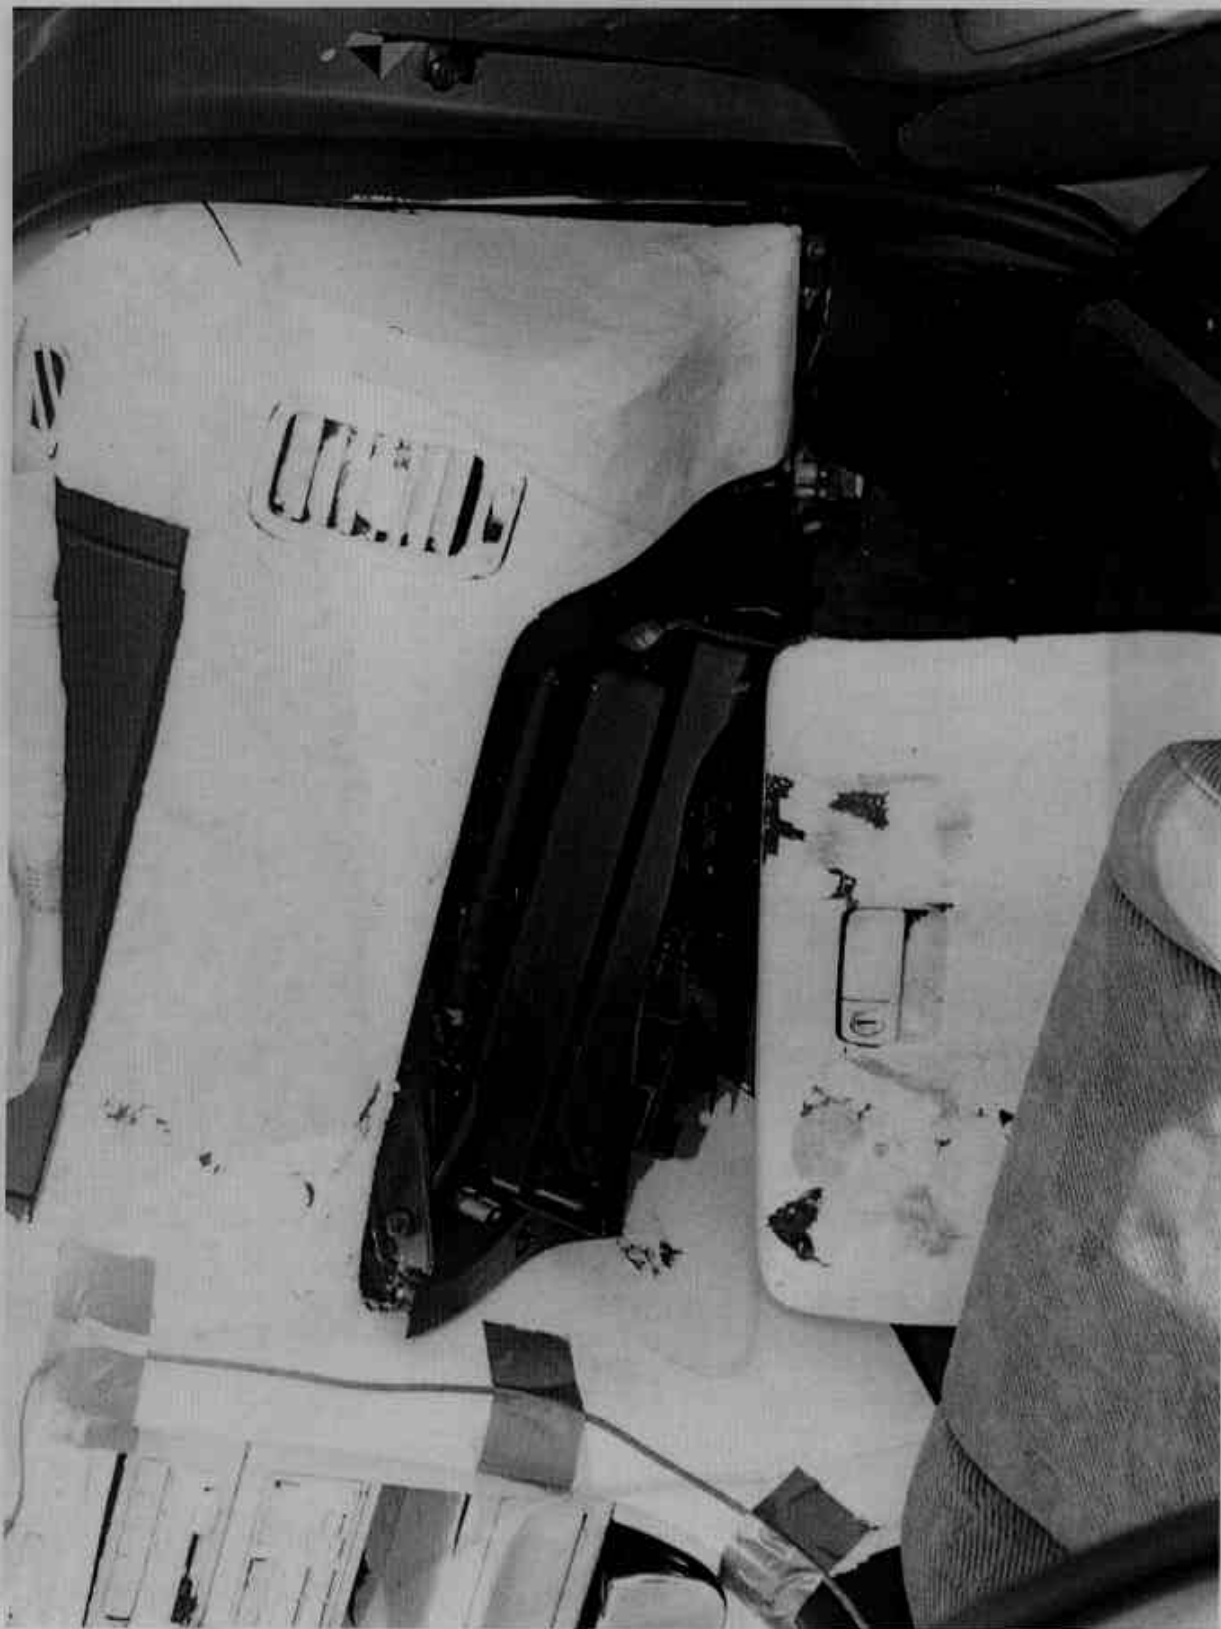
FIGURE A-52. POST TEST PASSENGER SIDE KNEE BOLSTER
