**REPORT NUMBER: 214-TRC-98-004**

**SAFETY COMPLIANCE TESTING FOR FMVSS 214  
SIDE IMPACT PROTECTION - PASSENGER CARS**

**1998 HYUNDAI TIBURON  
2-DOOR COUPE**

**NHTSA NUMBER: CW0501**

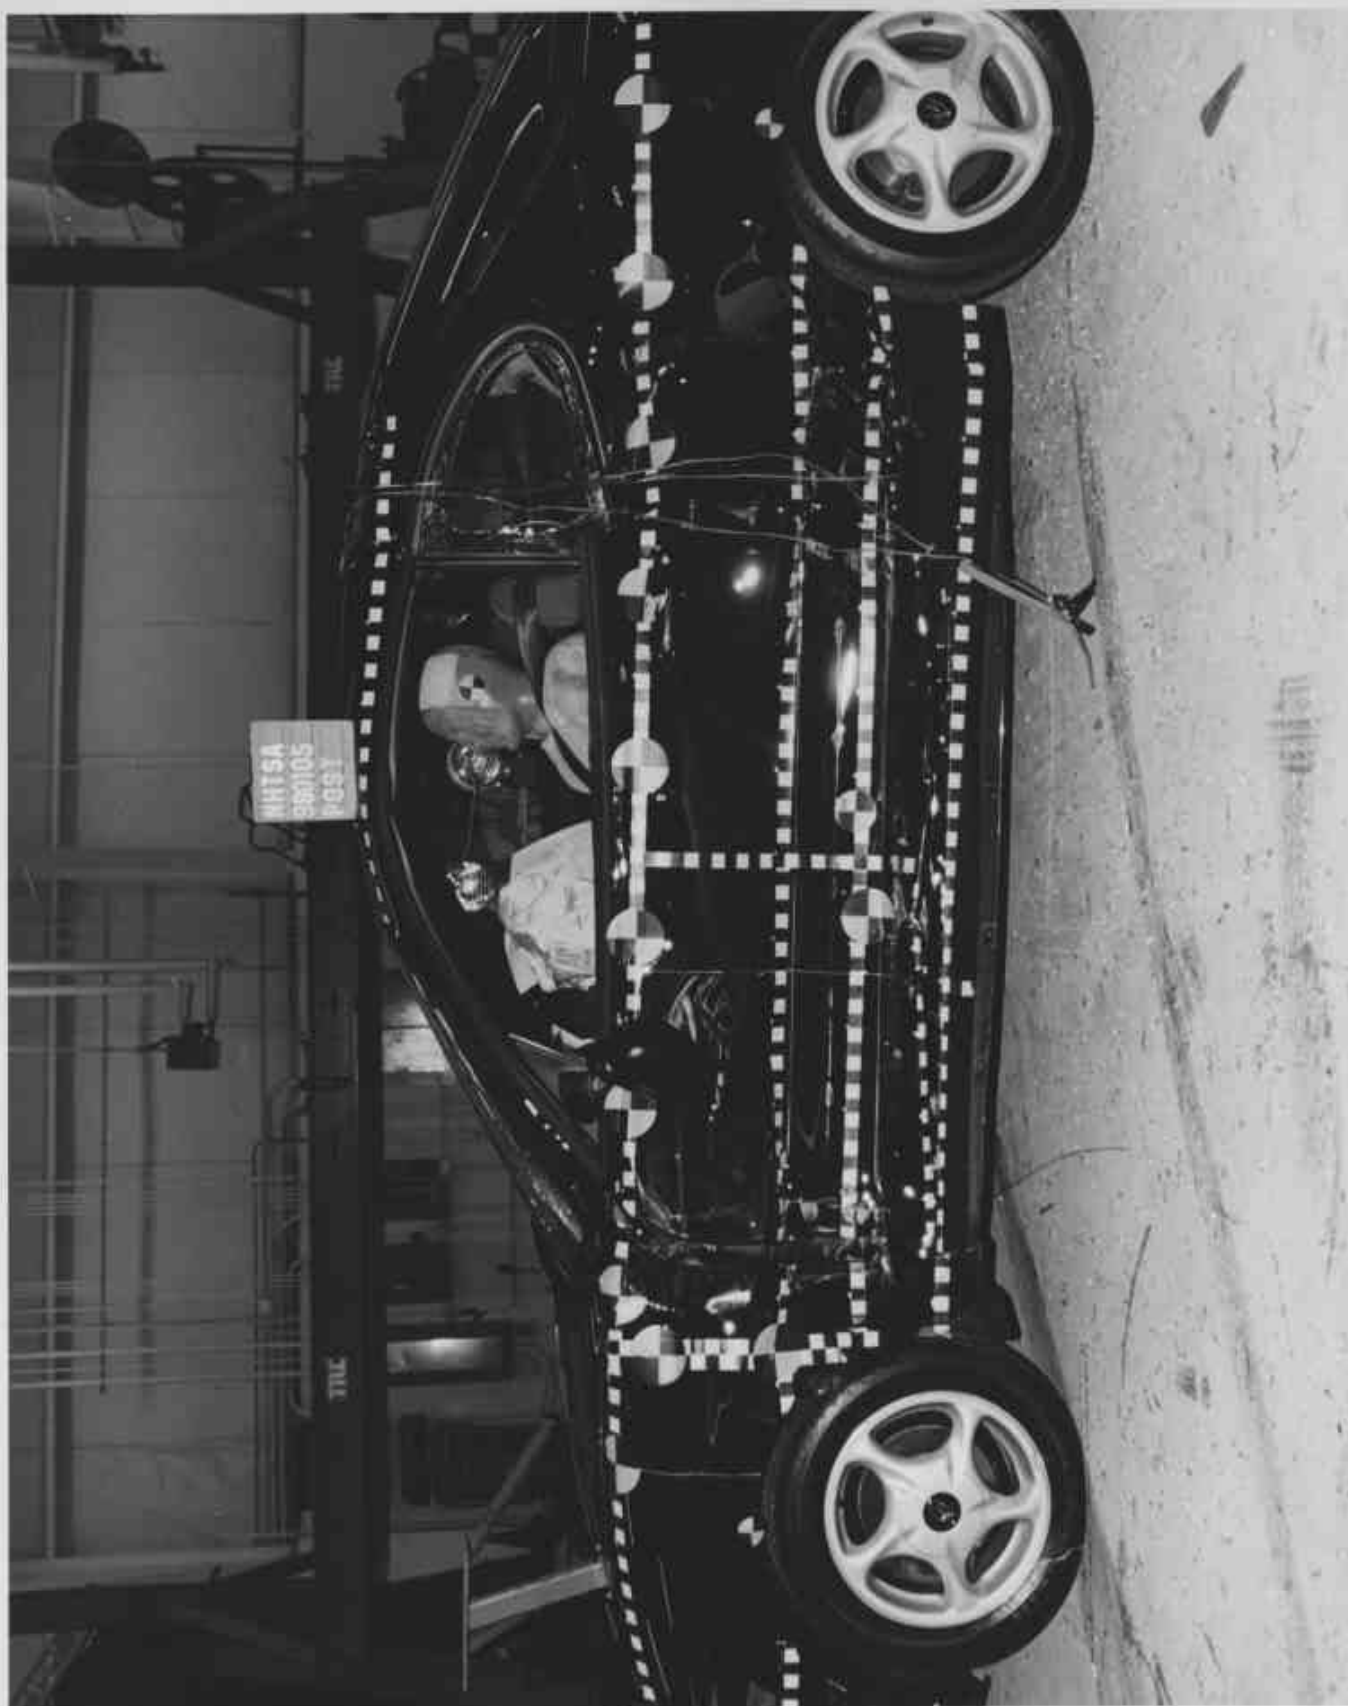
Figure A-6 Post-Test Impacted Side View of Test Vehicle - View 1

Windshield: Left edge of windshield cracked  
Window: Left driver window and left rear passenger window shattered at impact

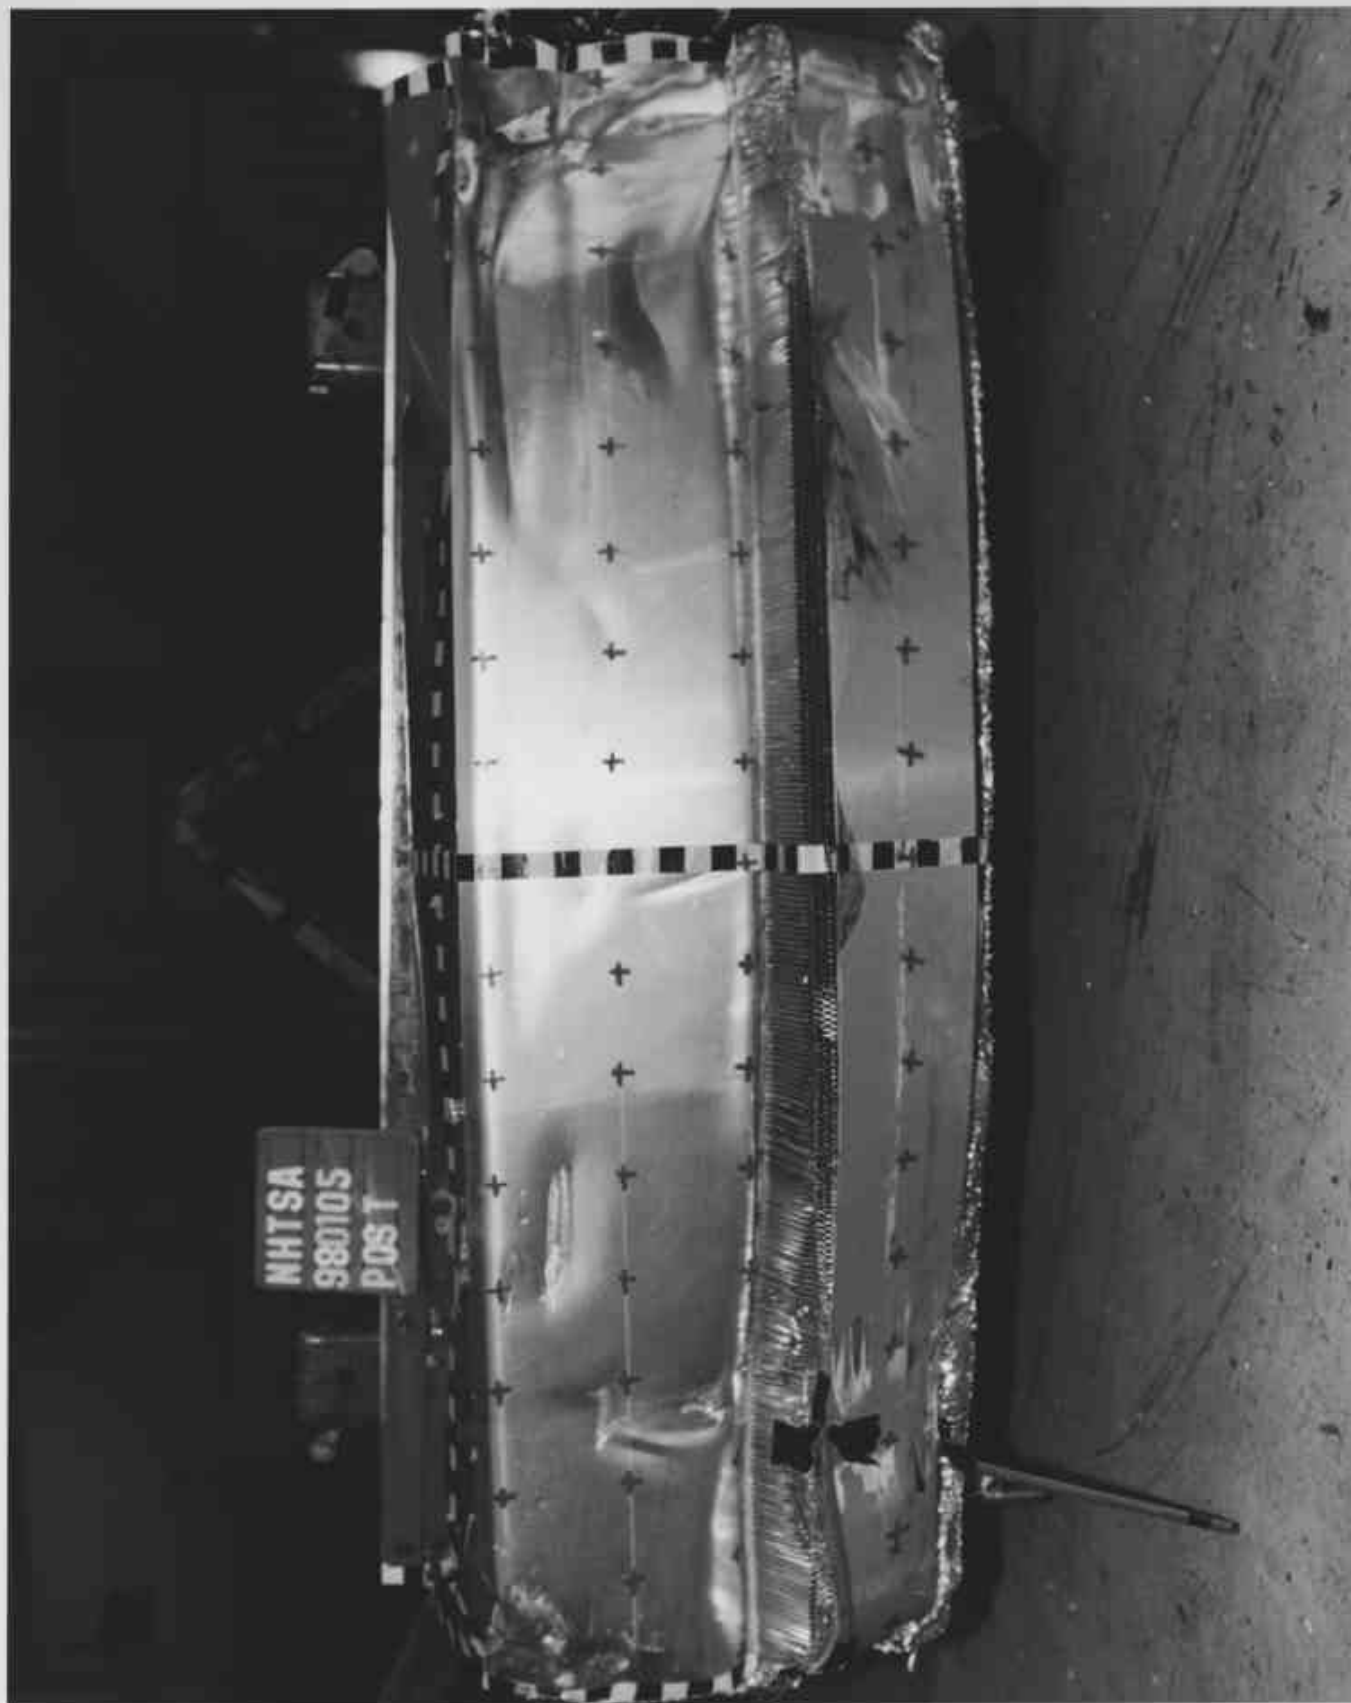
Figure A-9 Post-Test Frontal View of Impactor Face  
A-11

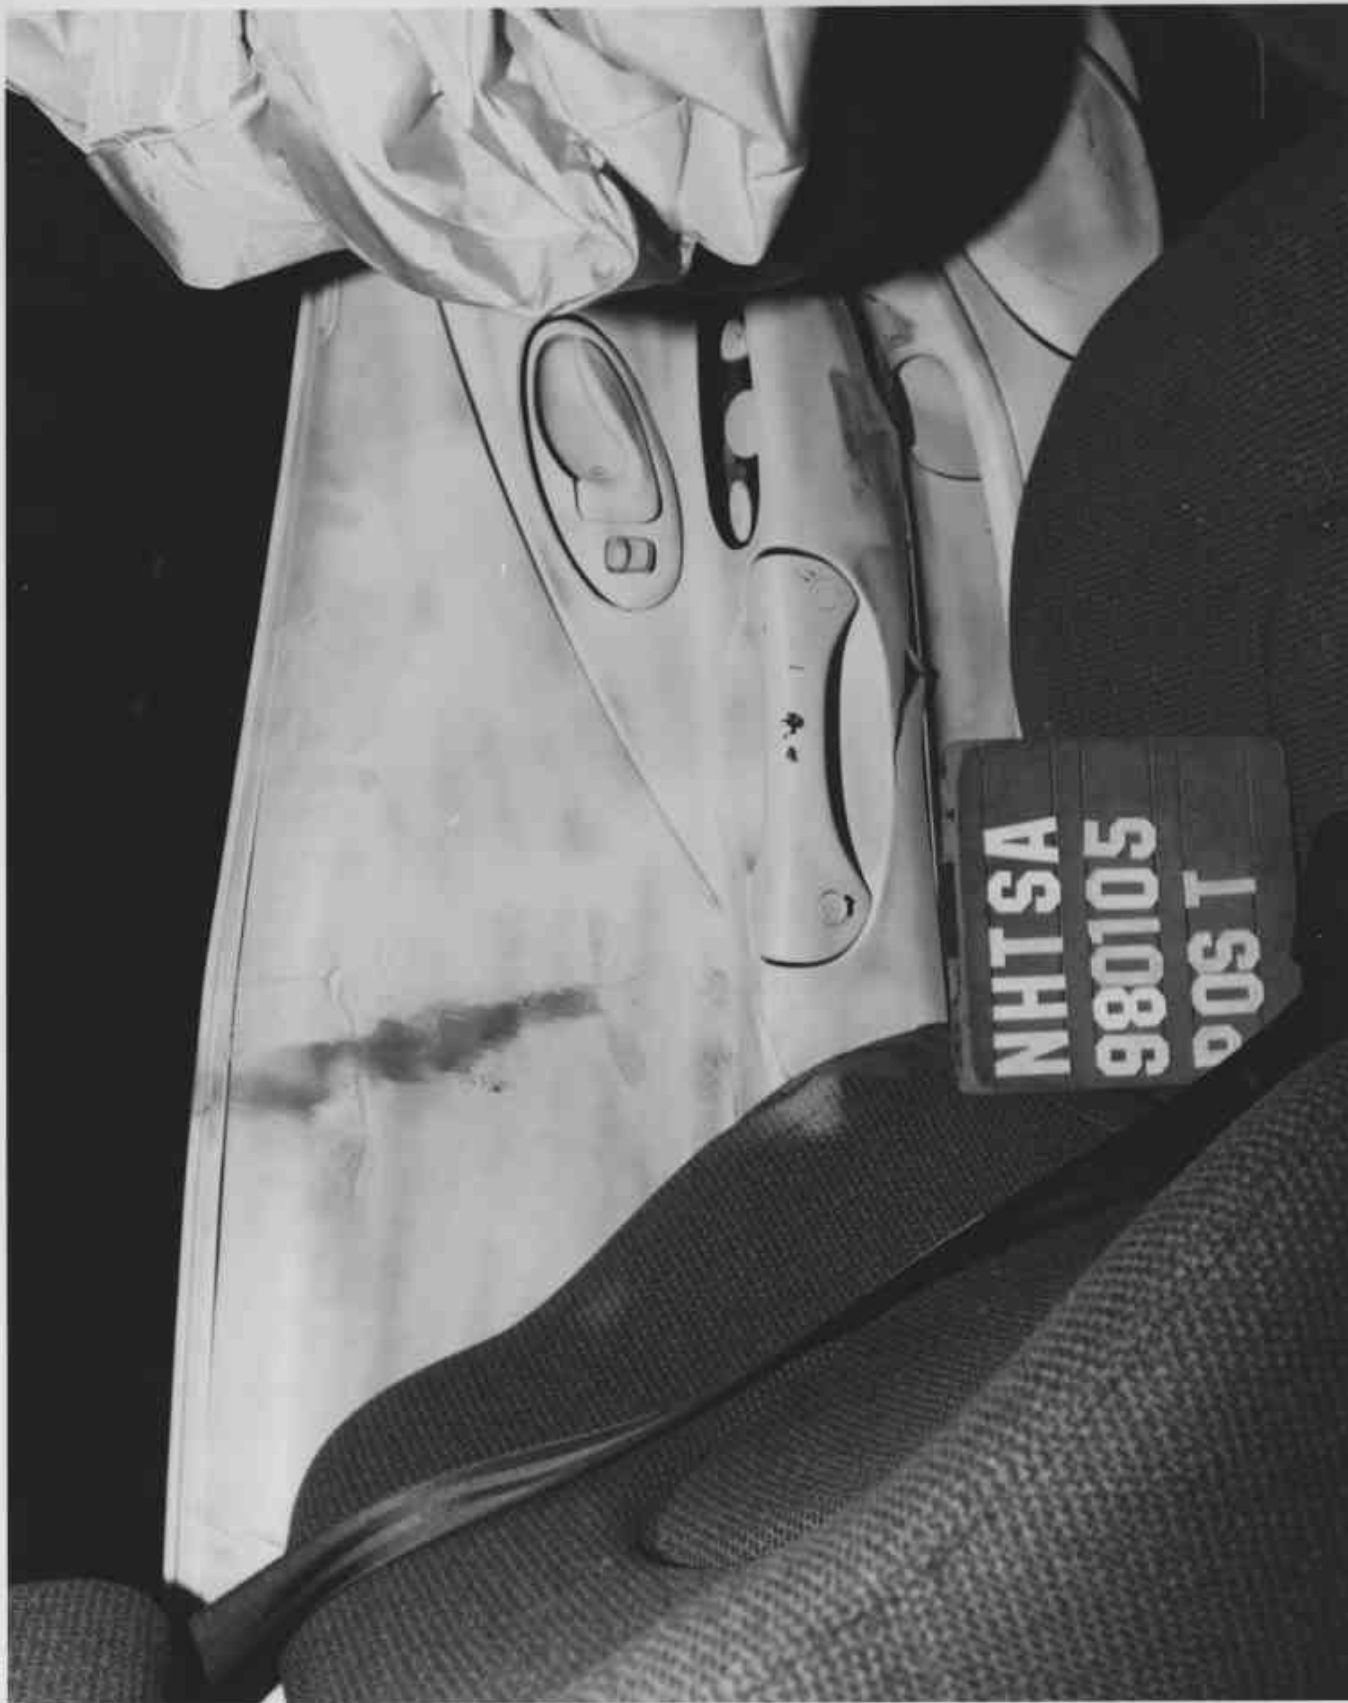
Figure A-27 Post-Test Interior of Front Door Showing SID Impact Locations  
A-29 980105

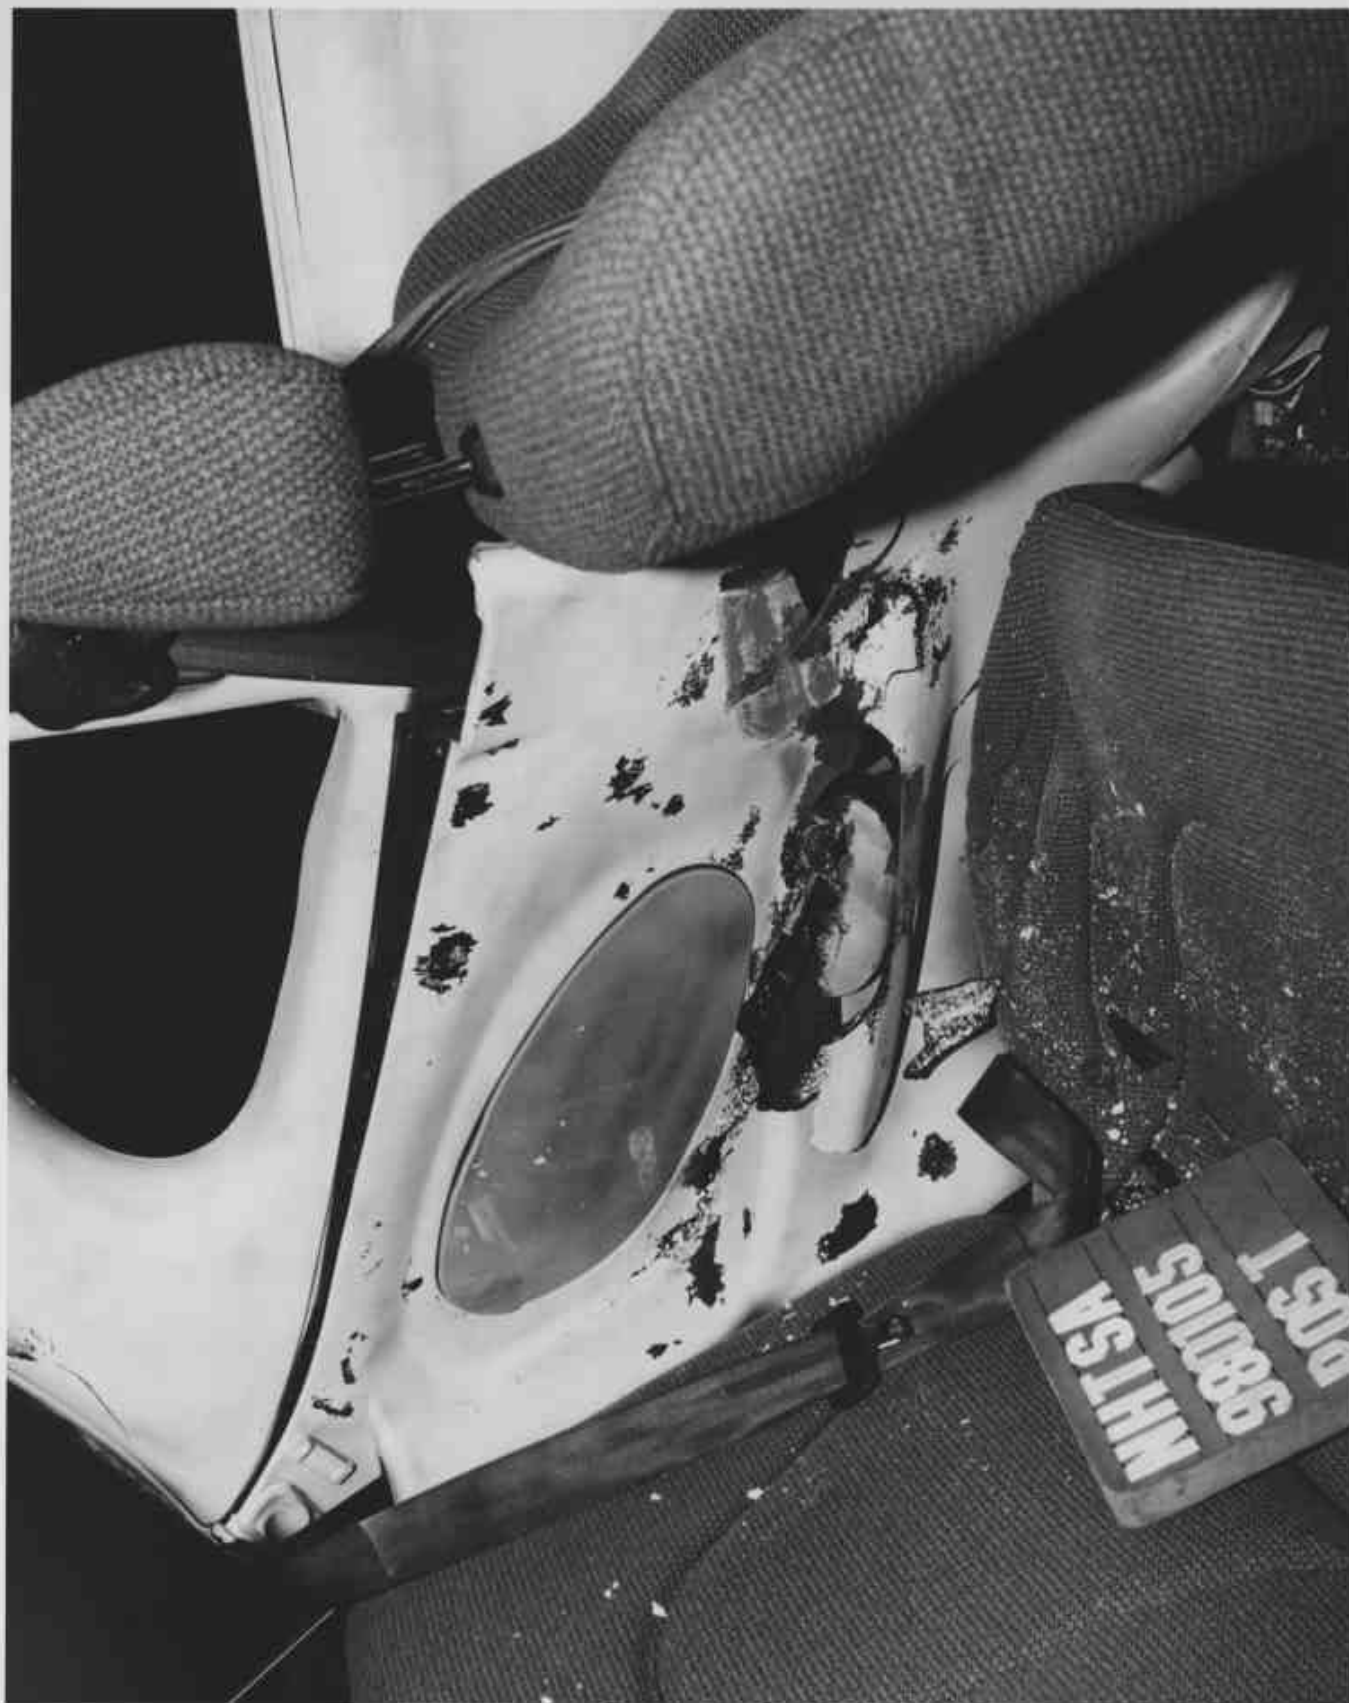
Figure A-28 Post-Test Interior Of Rear Panel Showing SID Impact Locations  
A-30 980105
