Insurance Institute for Highway Safety Crashworthiness Evaluation

Crash Test Report 1997 Ford Escort (CF97016)

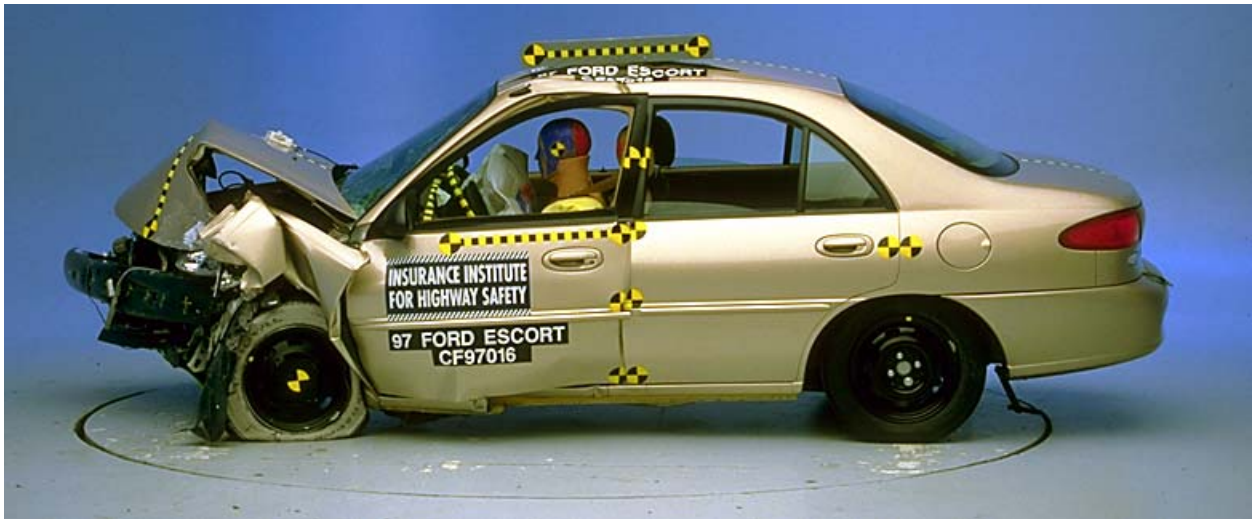
Post-crash — 1997 Ford Escort

All doors remained closed during the crash. The driver door aperture shortened 6 cm as measured at the lower edge of the window. The driver door was driven rearward and shingled slightly beneath the left rear door. As a result, the door was jammed shut and required additional effort to open after the crash. The left rear door opened with ease after the crash, but interference with the driver door prevented it from opening fully until the driver door was pulled out of the way. The right front and right rear doors opened with ease after the crash.

There was extensive tearing of the welded seam between the driver door sill and adjacent floorpan.

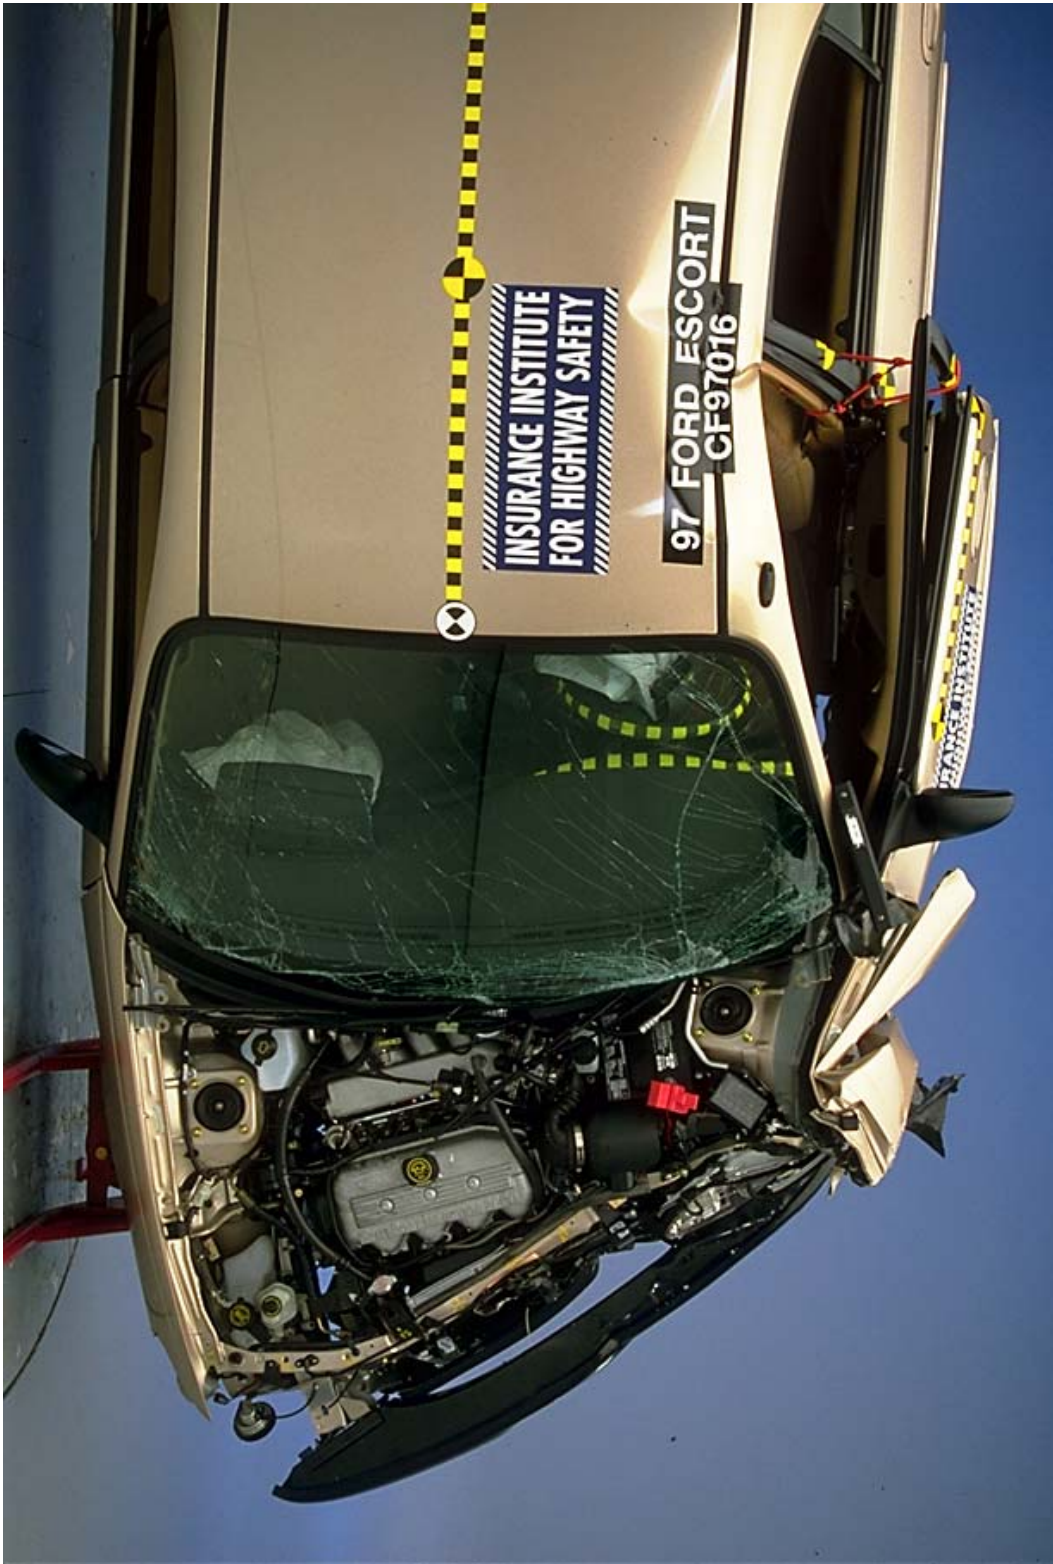
Figure 1
Overhead View of Crash Deformation — 1997 Ford Escort

Figure 1 shows the overhead view of the crash deformation. Figure 2A illustrates the precrash and postcrash contour measures of the front bumper cover profile and the resulting permanent crush. Figure 2B illustrates the corresponding measures of both the front bumper reinforcement bar and the upper crossmember of the radiator support. Figure 3 shows the precrash and postcrash views from below. Figure 4 illustrates the deformation of the frame rails, door sills, floorpan stiffeners, and longitudinal and transverse members beneath the engine, which are visible in Figure 3.
