# Insurance Institute for Highway Safety Crashworthiness Evaluation

## Crash Test Report 1997 Honda Civic (CF97009)

**Vehicle identification number:** 2HGEJ6673VH542157  
**Body style:** Four-door sedan  
**Engine/transmission:** Transverse 1.6-liter 4-cylinder, 4-speed automatic,  
front-wheel drive

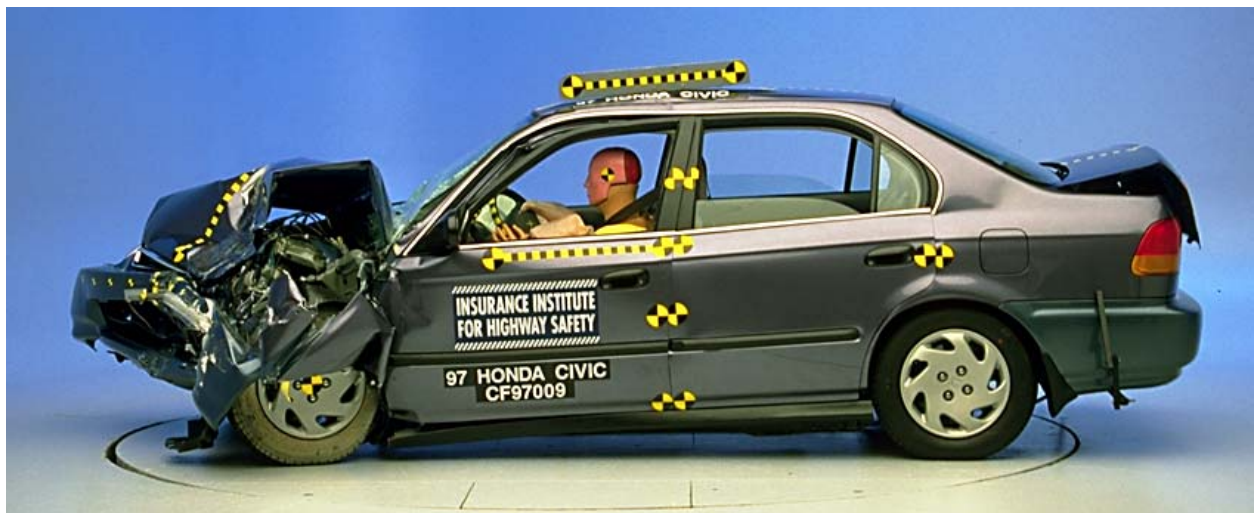
**Postcrash — 1997 Honda Civic**

All doors remained closed during the crash. The driver door aperture shortened 5 cm as measured at the lower edge of the window. The driver and left rear doors required tools to open, but the right front and right rear doors opened with ease after the crash.

The windshield along the left A-pillar separated from the car structure.

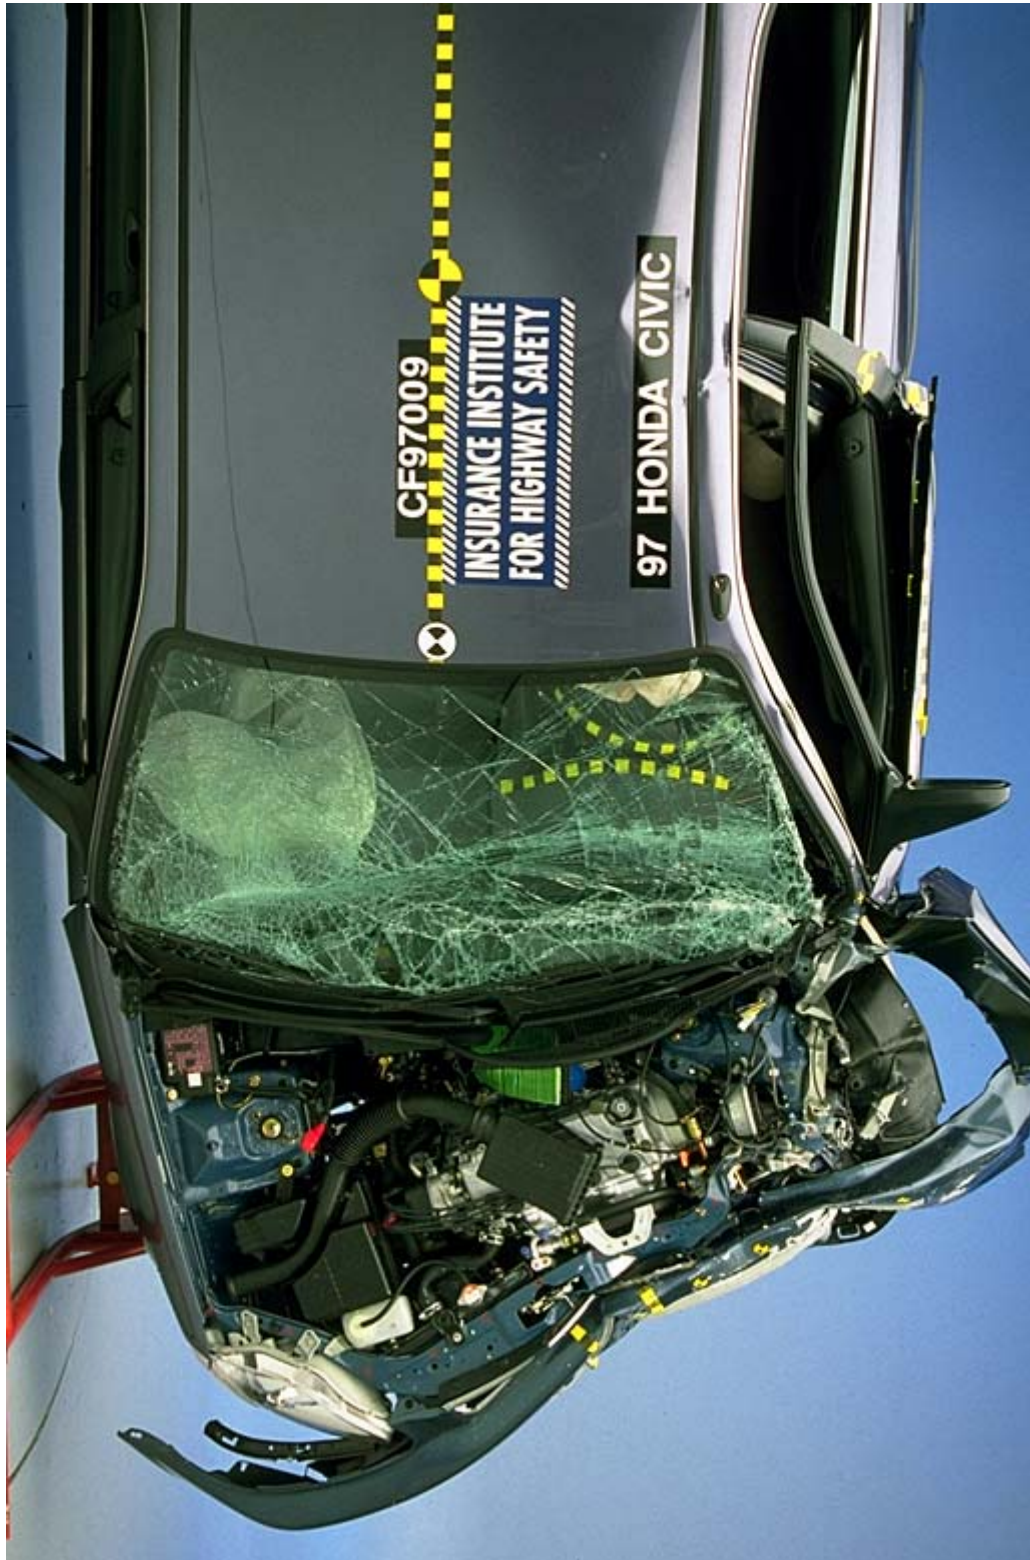
**Figure 1**  
**Overhead View of Crash Deformation — 1997 Honda Civic**

Figure 1 shows the overhead view of the crash deformation. Figure 2A illustrates the precrash and postcrash contour measures of the front bumper cover profile and the resulting permanent crush. Figure 2B illustrates the corresponding measures of both the front bumper reinforcement bar and the upper crossmember of the radiator support. Figure 3 shows the precrash and postcrash views from below. Figure 4 illustrates the deformation of the side rails, floor rails, and crossmember, which are visible in Figure 3.
