# Insurance Institute for Highway Safety Crashworthiness Evaluation

## Crash Test Report 1997 Kia Sephia (CF97013)

**Vehicle identification number:** KNAFA1254V5275108  
**Body style:** Four-door sedan  
**Engine/transmission:** Transverse 1.8-liter 4-cylinder, 4-speed automatic,  
front-wheel drive

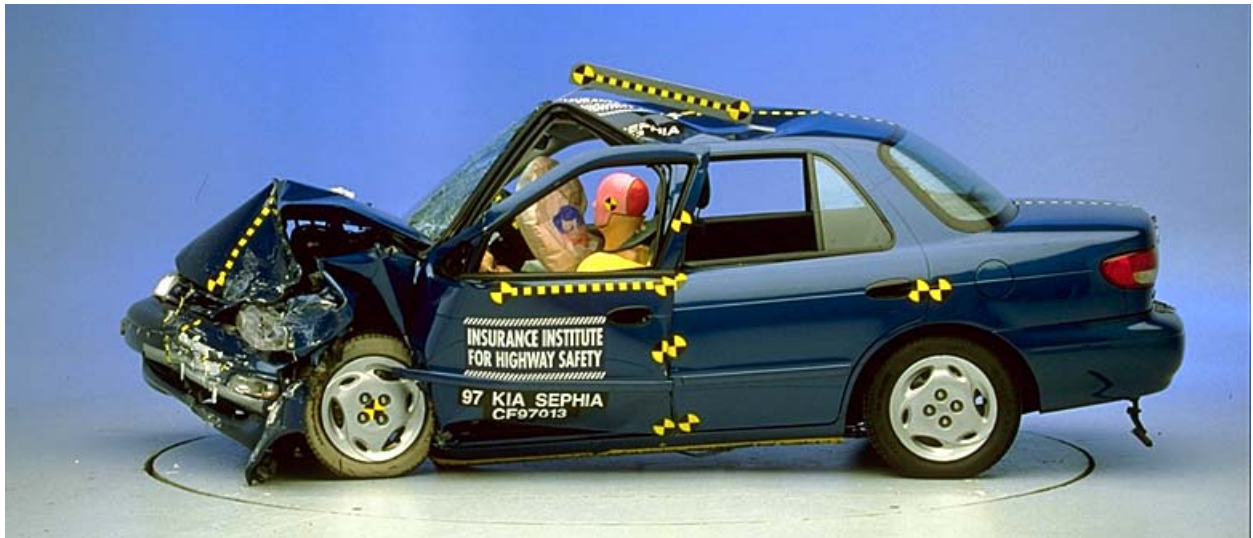
**Postcrash — 1997 Kia Sephia**

Measures of intrusion taken after the crash indicated the lower instrument panel in front of the dummy moved rearward 9-12 cm. A thin metal sheet underlying the left lower instrument panel was compressed forward 11 cm and contacted a steel pipe 4 cm in diameter and 0.64 cm thick. Resultant intrusion in the driver footwell measured 29 cm in the area where a footrest typically would be located and 28-35 cm at other places on the toepan. The upper end of the steering column moved upward 15 cm and rearward 5 cm. All doors remained closed during the crash. The driver door required tools to open after the crash. The right rear door required additional effort to open. The right front and left rear doors opened with ease after the crash.

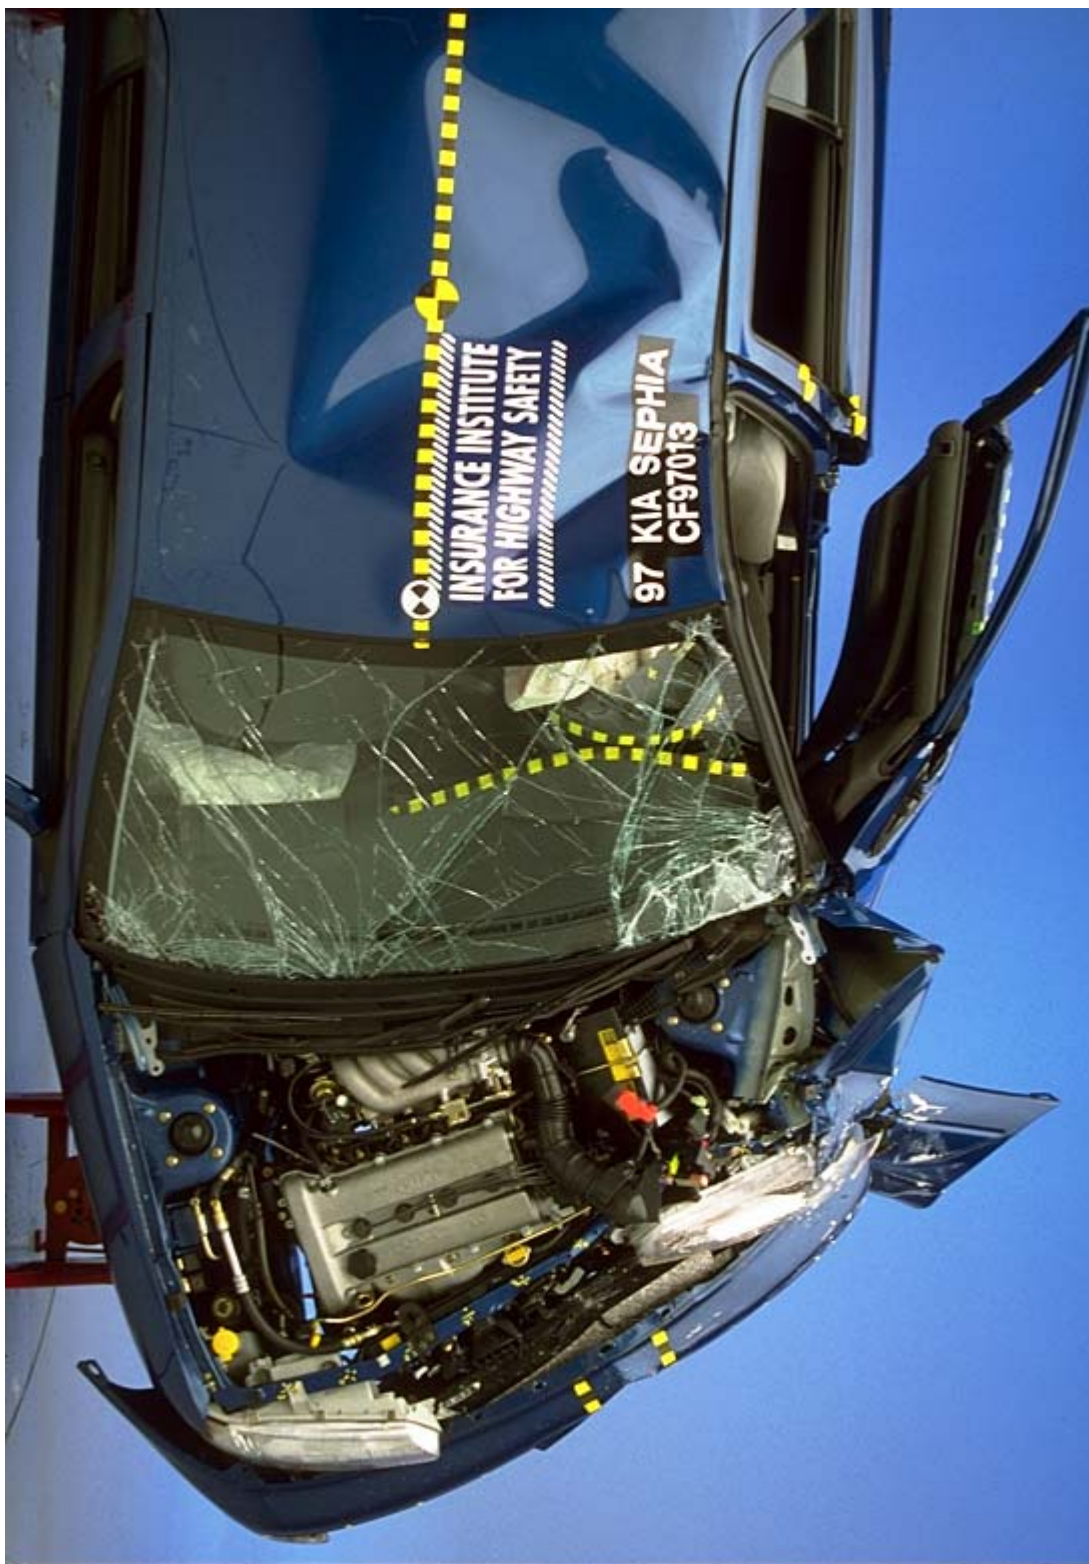
**Figure 1**  
**Overhead View of Crash Deformation — 1997 Kia Sephia**

Figure 1 shows the overhead view of the crash deformation. Figure 2A illustrates the precrash and postcrash contour measures of the front bumper cover profile and the resulting permanent crush. Figure 2B illustrates the corresponding measures of both the front bumper reinforcement bar and the upper crossmember of the radiator support. Figure 3 shows the precrash and postcrash views from below. Figure 4 illustrates the deformation of the side rails, floor rails, lower radiator support, and crossmembers, which are visible in Figure 3.

All doors remained closed during the crash. The driver door aperture shortened 18 cm as measured at the lower edge of the window. The driver door required tools to open after the crash. The right rear door required additional effort to open. The right front and left rear doors opened with ease after the crash.

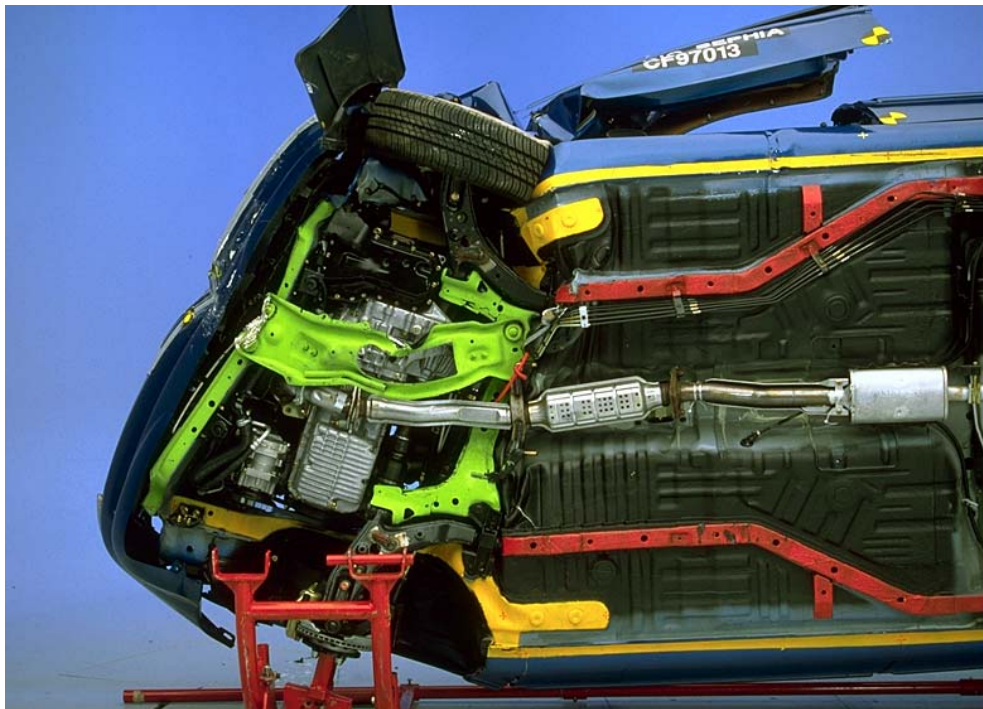
**Figure 3**  
**Preocrash View from Below — 1997 Kia Sephia**

**Postcrash View from Below — 1997 Kia Sephia**
