# Insurance Institute for Highway Safety Crashworthiness Evaluation

## Crash Test Report 1998 Nissan Maxima (CF97024)

**Vehicle identification number:** JN1CA21D8WM905856  
**Body style:** Four-door sedan  
**Engine/transmission:** Transverse 3.0-liter V6, 4-speed automatic,  
front-wheel drive

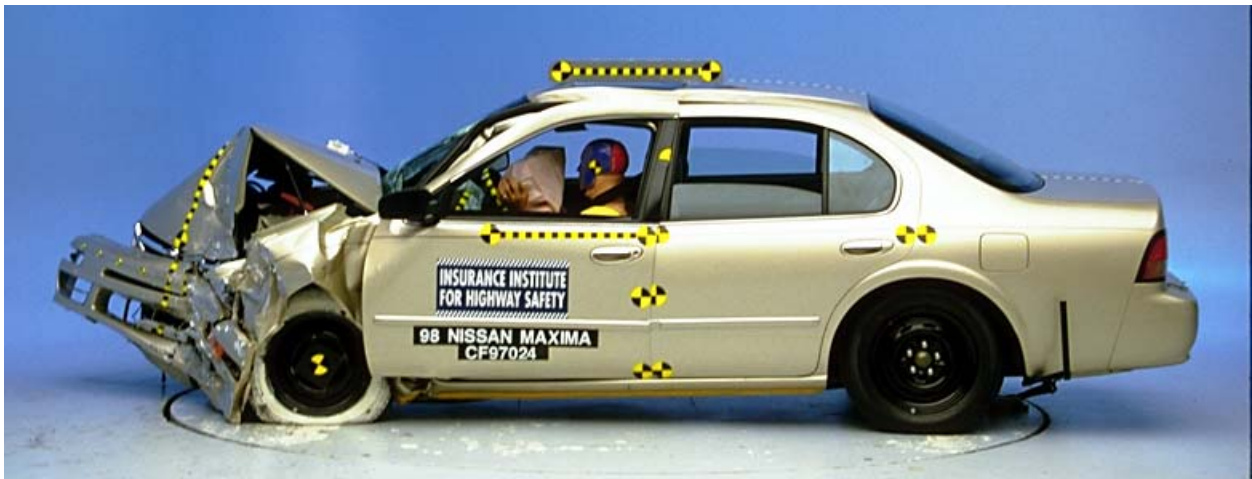
**Post-crash — 1998 Nissan Maxima**

Measures of intrusion taken after the crash indicate the lower instrument panel in front of the dummy moved rearward 7-10 cm. Resultant intrusion in the driver footwell measured 22 cm at the footrest and 21-30 cm at other places on the toepan. The upper end of the steering column moved upward 10 cm and rearward 7 cm. All doors remained closed during the crash. The right front, right rear, and left rear doors opened with ease after the crash, but the driver door required additional effort to open.

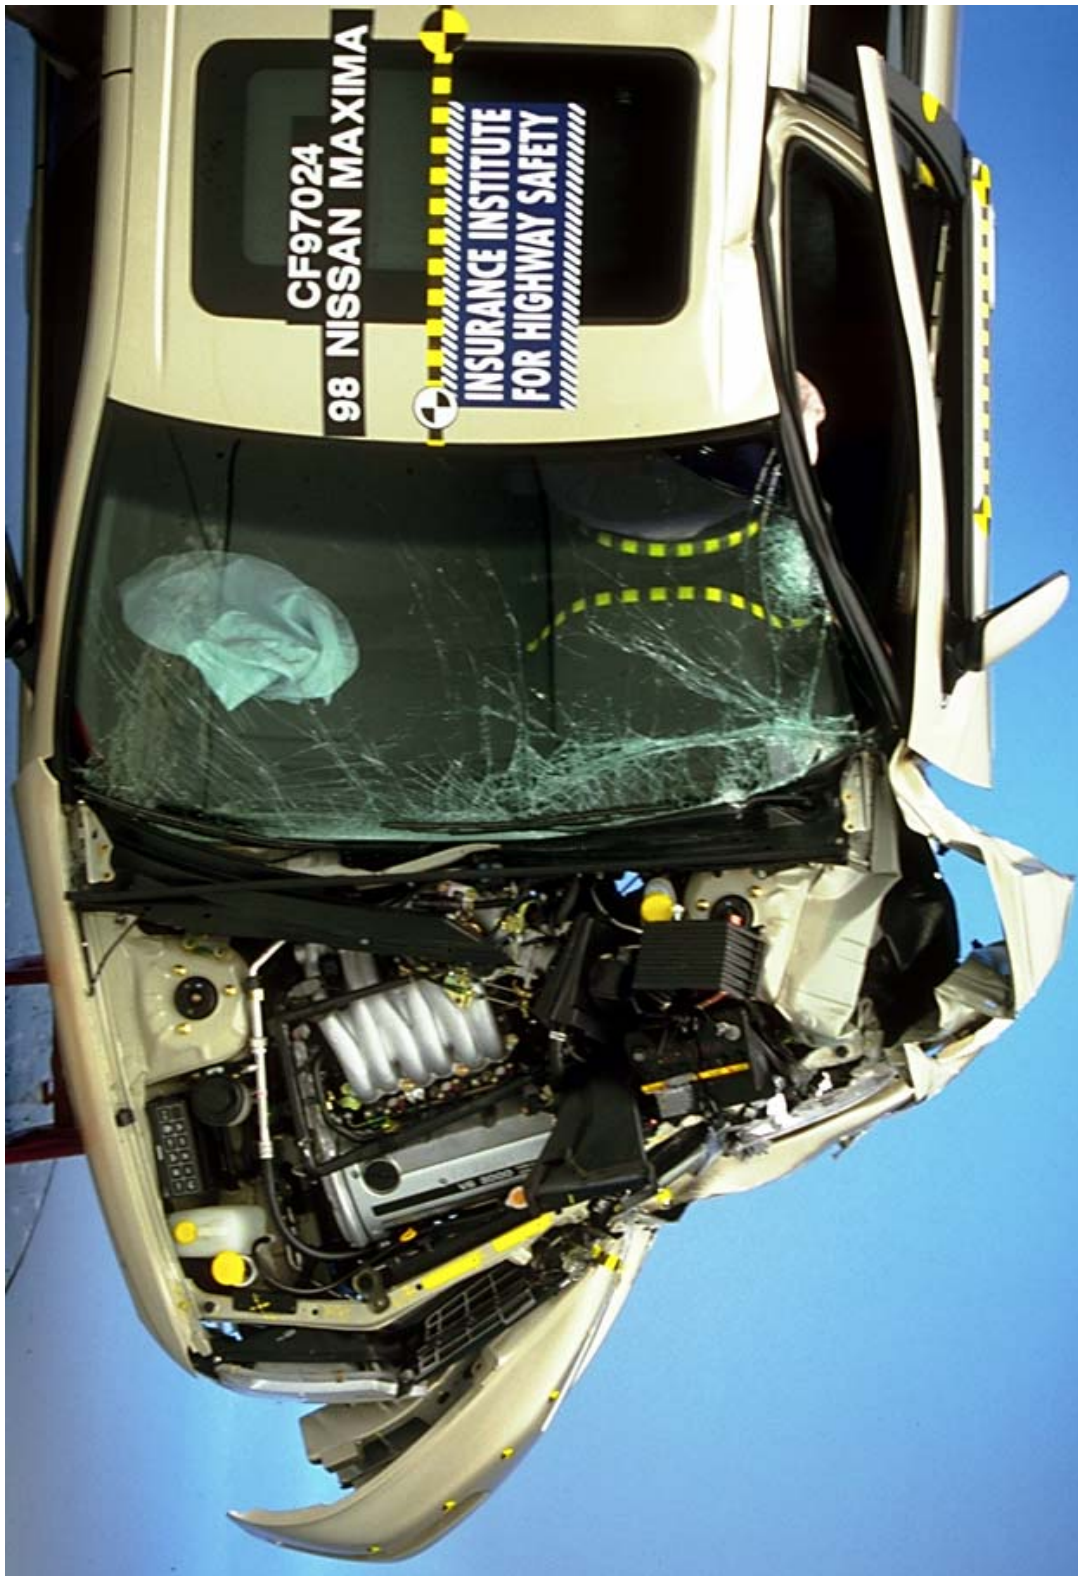
**Figure 1**  
**Overhead View of Crash Deformation — 1998 Nissan Maxima**

Figure 1 shows the overhead view of the crash deformation. Figure 2A illustrates the precrash and postcrash contour measures of the front bumper cover profile and the resulting permanent crush. Figure 2B illustrates the corresponding measures of both the front bumper reinforcement bar and the upper crossmember of the radiator support. Figure 3 shows the precrash and postcrash views from below. Figure 4 illustrates the deformation of the side rails, floor rails, and engine support members, which are visible in Figure 3.
