# Insurance Institute for Highway Safety Crashworthiness Evaluation

## Crash Test Report 1997 Dodge Neon (CF97019)

**Vehicle identification number:** 3B3ES47C0VT517690  
**Body style:** Four-door sedan  
**Engine/transmission:** Transverse 2.0-liter 4-cylinder, 3-speed automatic,  
front-wheel drive

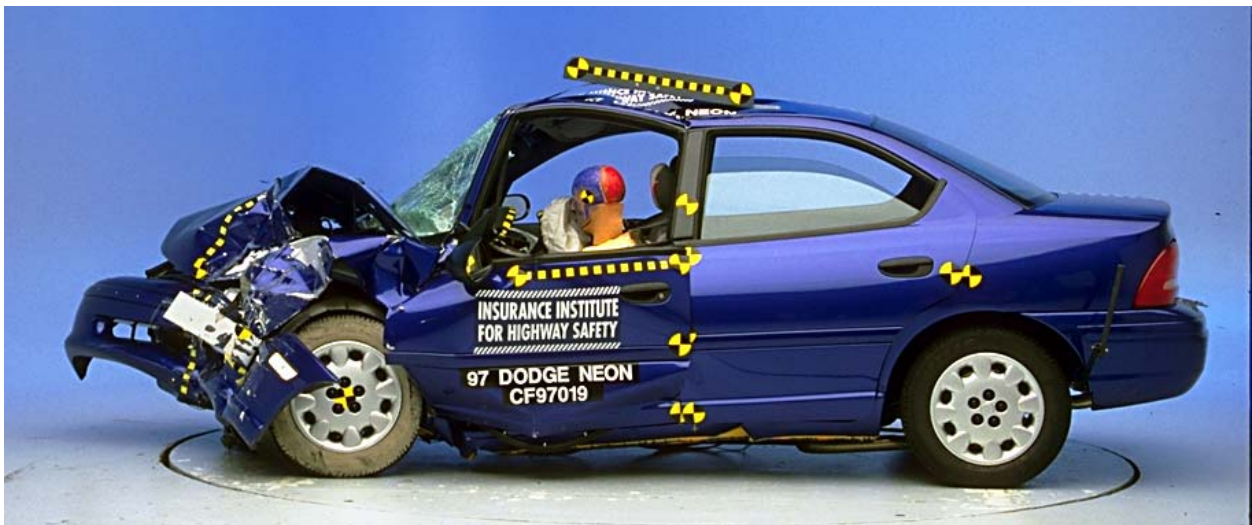
**Postcrash — 1997 Dodge Neon**

All doors remained closed during the crash. The driver door aperture shortened 24 cm as measured near the lower edge of the window. The rear of the driver door was pushed under the front edge of the left rear door after the crash. The driver door latch opened the door after the crash, but the shingled metal prevented the door from opening. The driver and left rear doors could not be opened without the use of tools. The right front and right rear doors opened with ease after the crash.

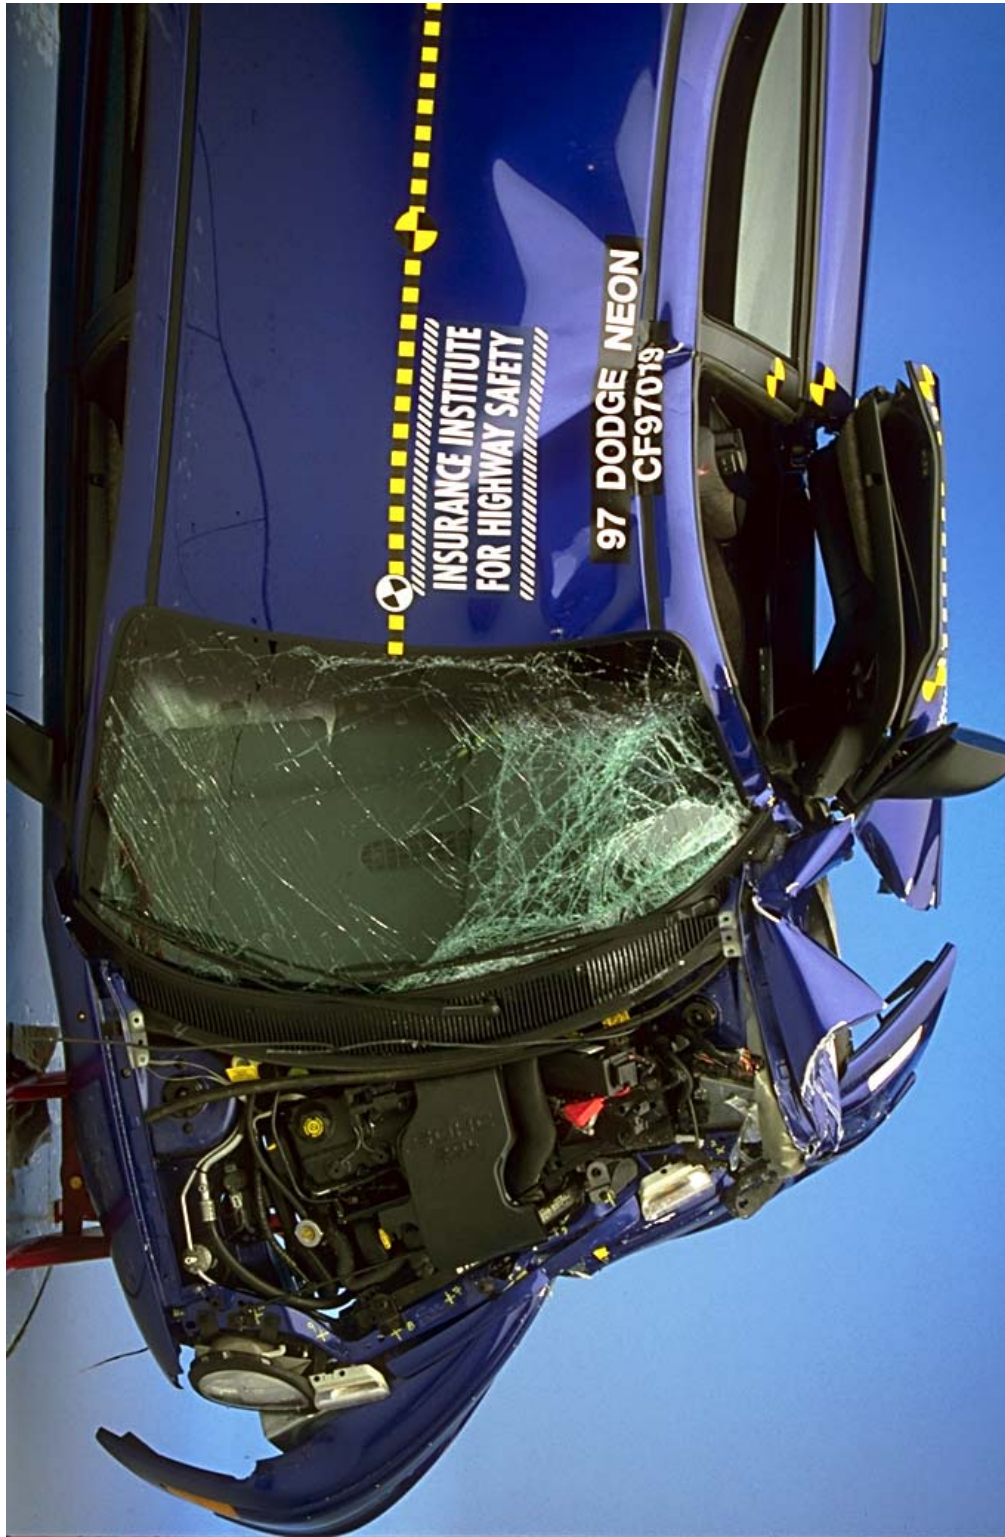
**Figure 1**  
**Overhead View of Crash Deformation — 1997 Dodge Neon**

Figure 1 shows the overhead view of the crash deformation. Figure 2A illustrates the precrash and postcrash contour measures of the front bumper cover profile and the resulting permanent crush. Figure 2B illustrates the corresponding measures of both the front bumper reinforcement bar and the upper crossmember of the radiator support. Figure 3 shows the precrash and postcrash views from below. Figure 4 illustrates the deformation of the side rails, floor rails, and crossmembers, which are visible in Figure 3.
