REPORT NO. KAR-99-03

NATIONAL HIGHWAY TRAFFIC SAFETY ADMINISTRATION  
NEW CAR ASSESSMENT PROGRAM  
FRONTAL BARRIER IMPACT TEST

HONDA MOTOR CORP.  
1999 HONDA CIVIC DX 4-DOOR  
NHTSA NO. MX5300

PREPARED BY:  
KARCO ENGINEERING  
9270 HOLLY ROAD  
ADELANTO, CALIFORNIA 92301

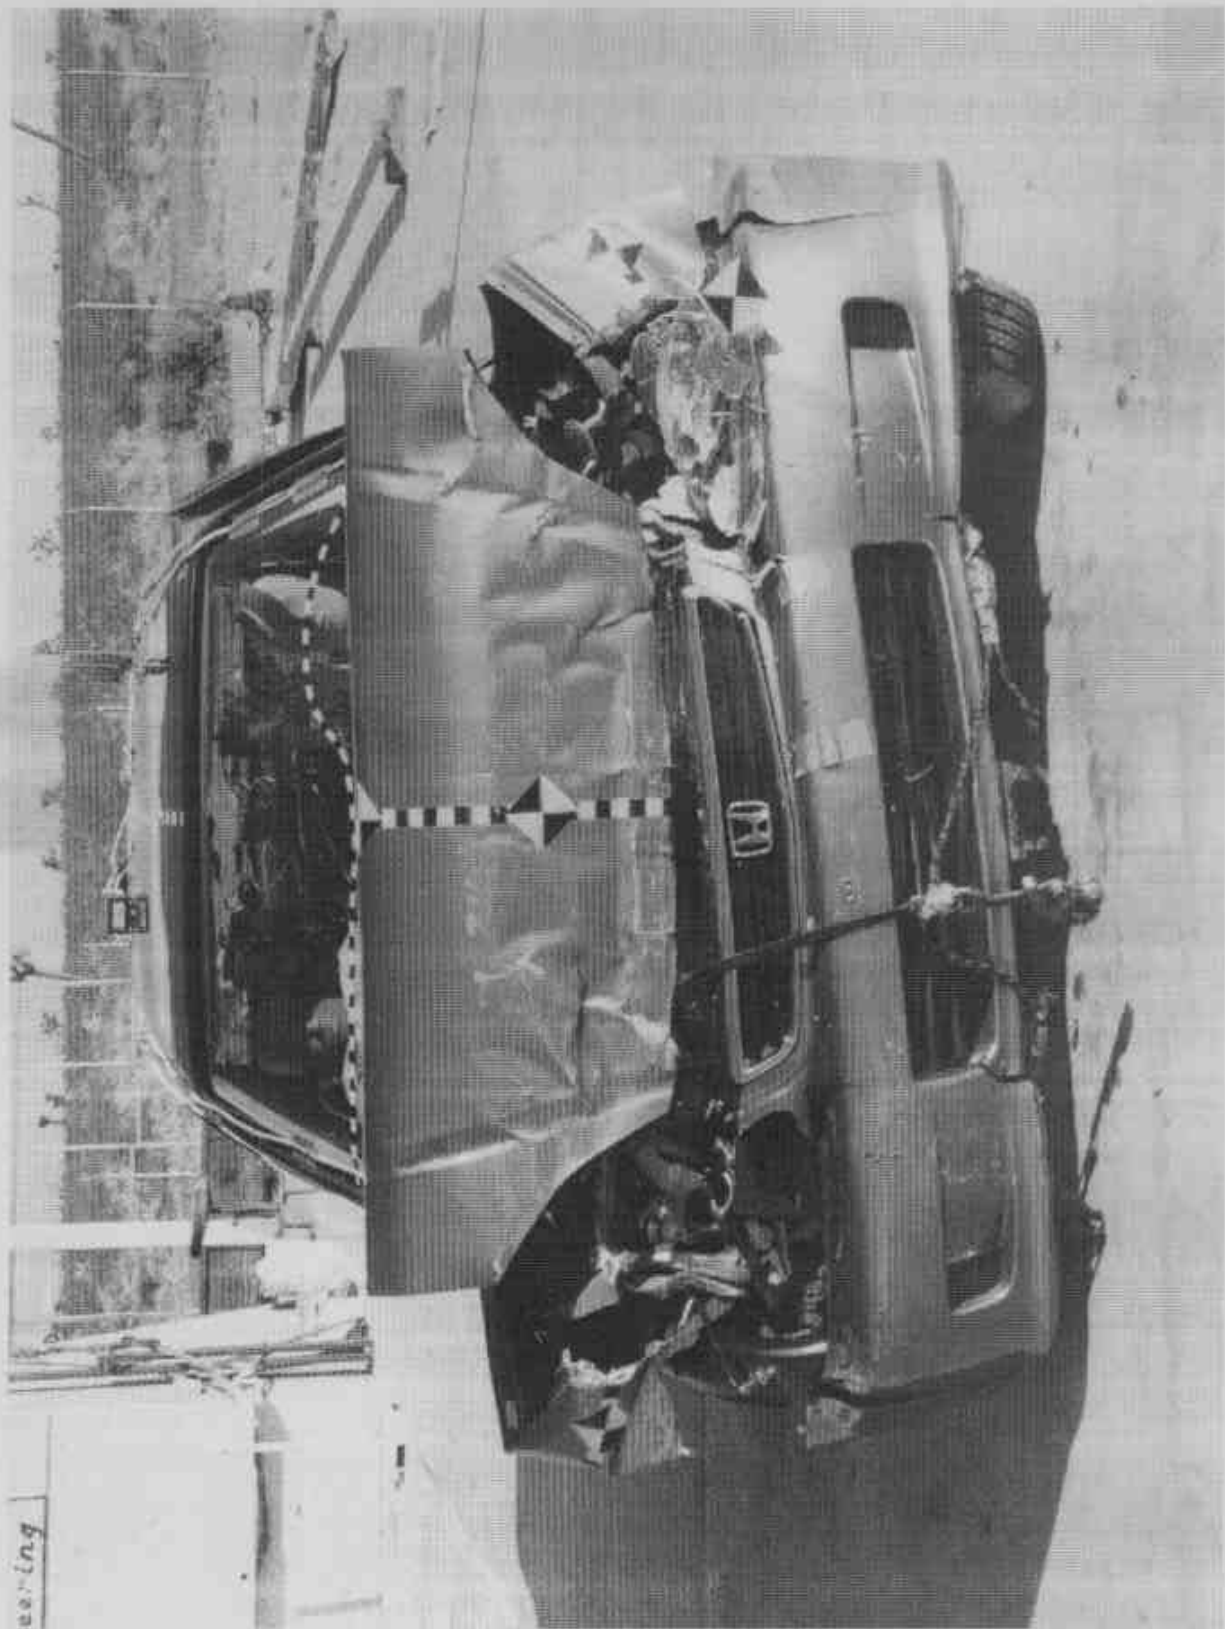
FIGURE A-6. POST TEST FRONT VIEW

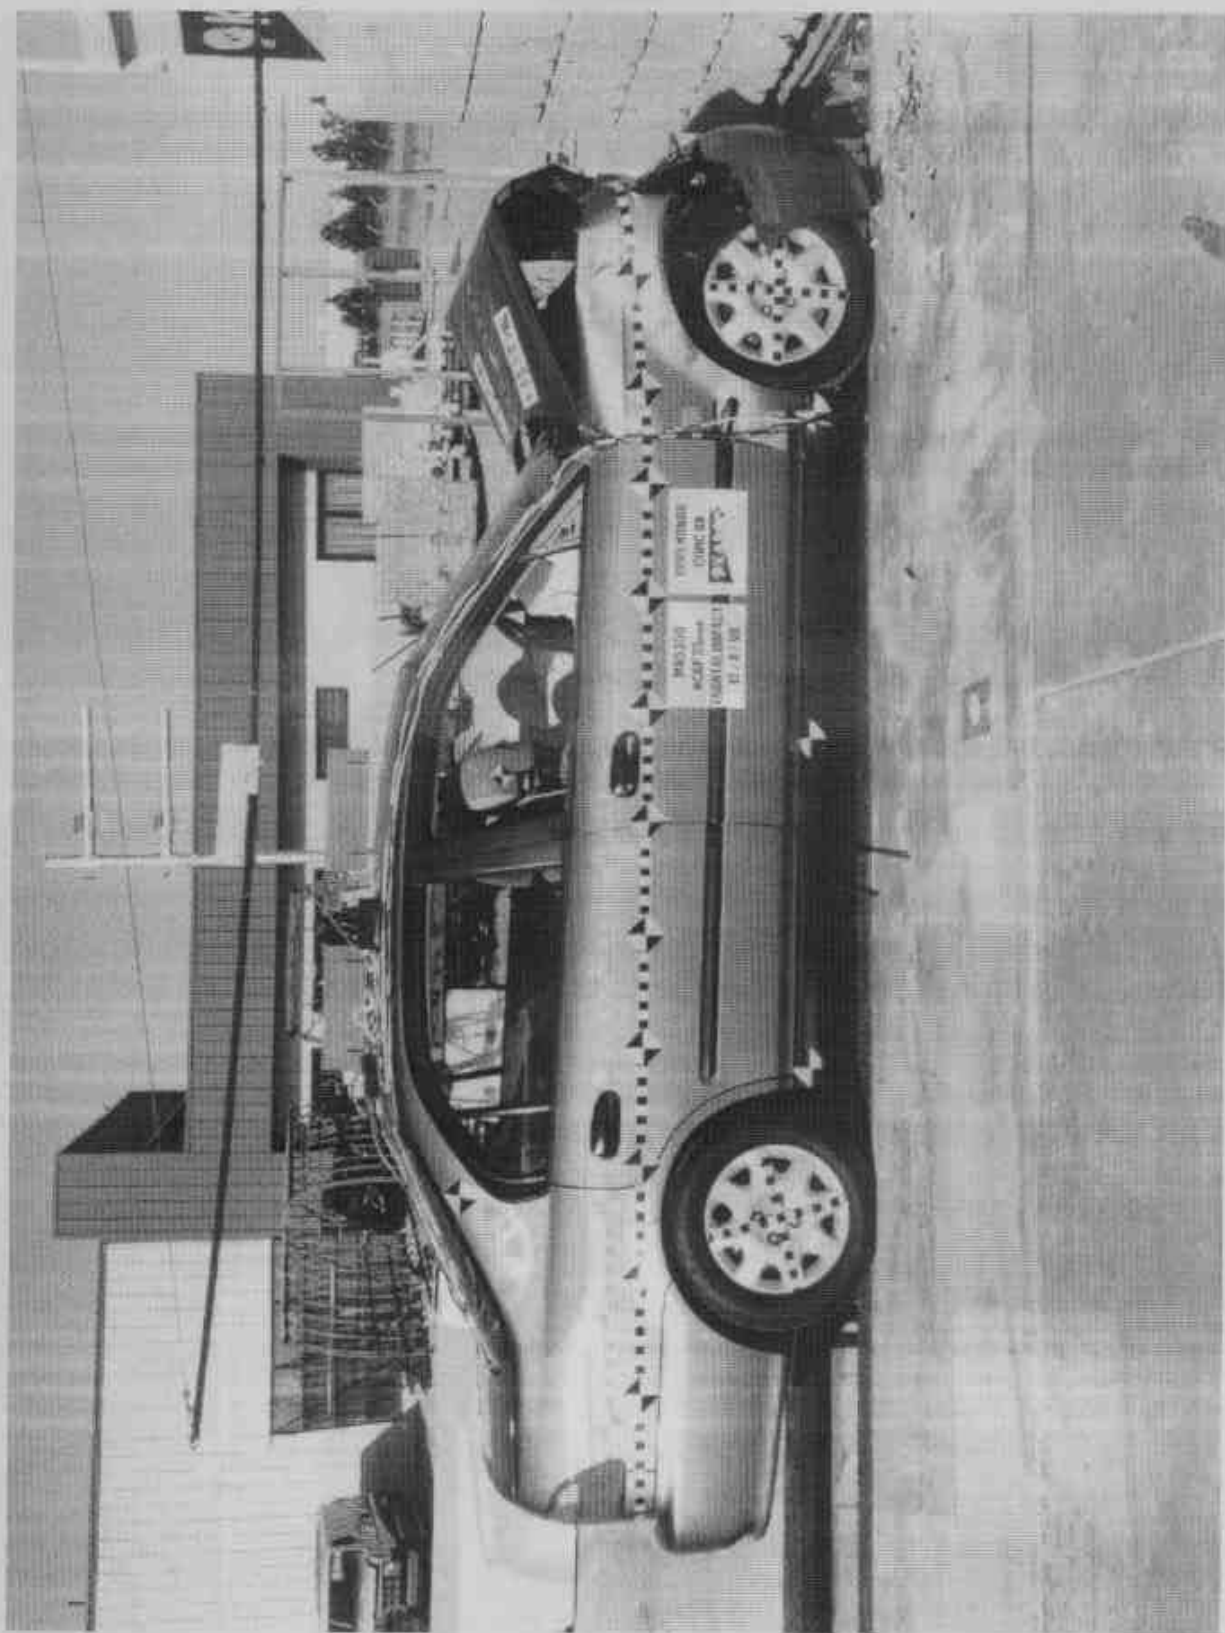
FIGURE A-10. POST TEST RIGHT SIDE VIEW

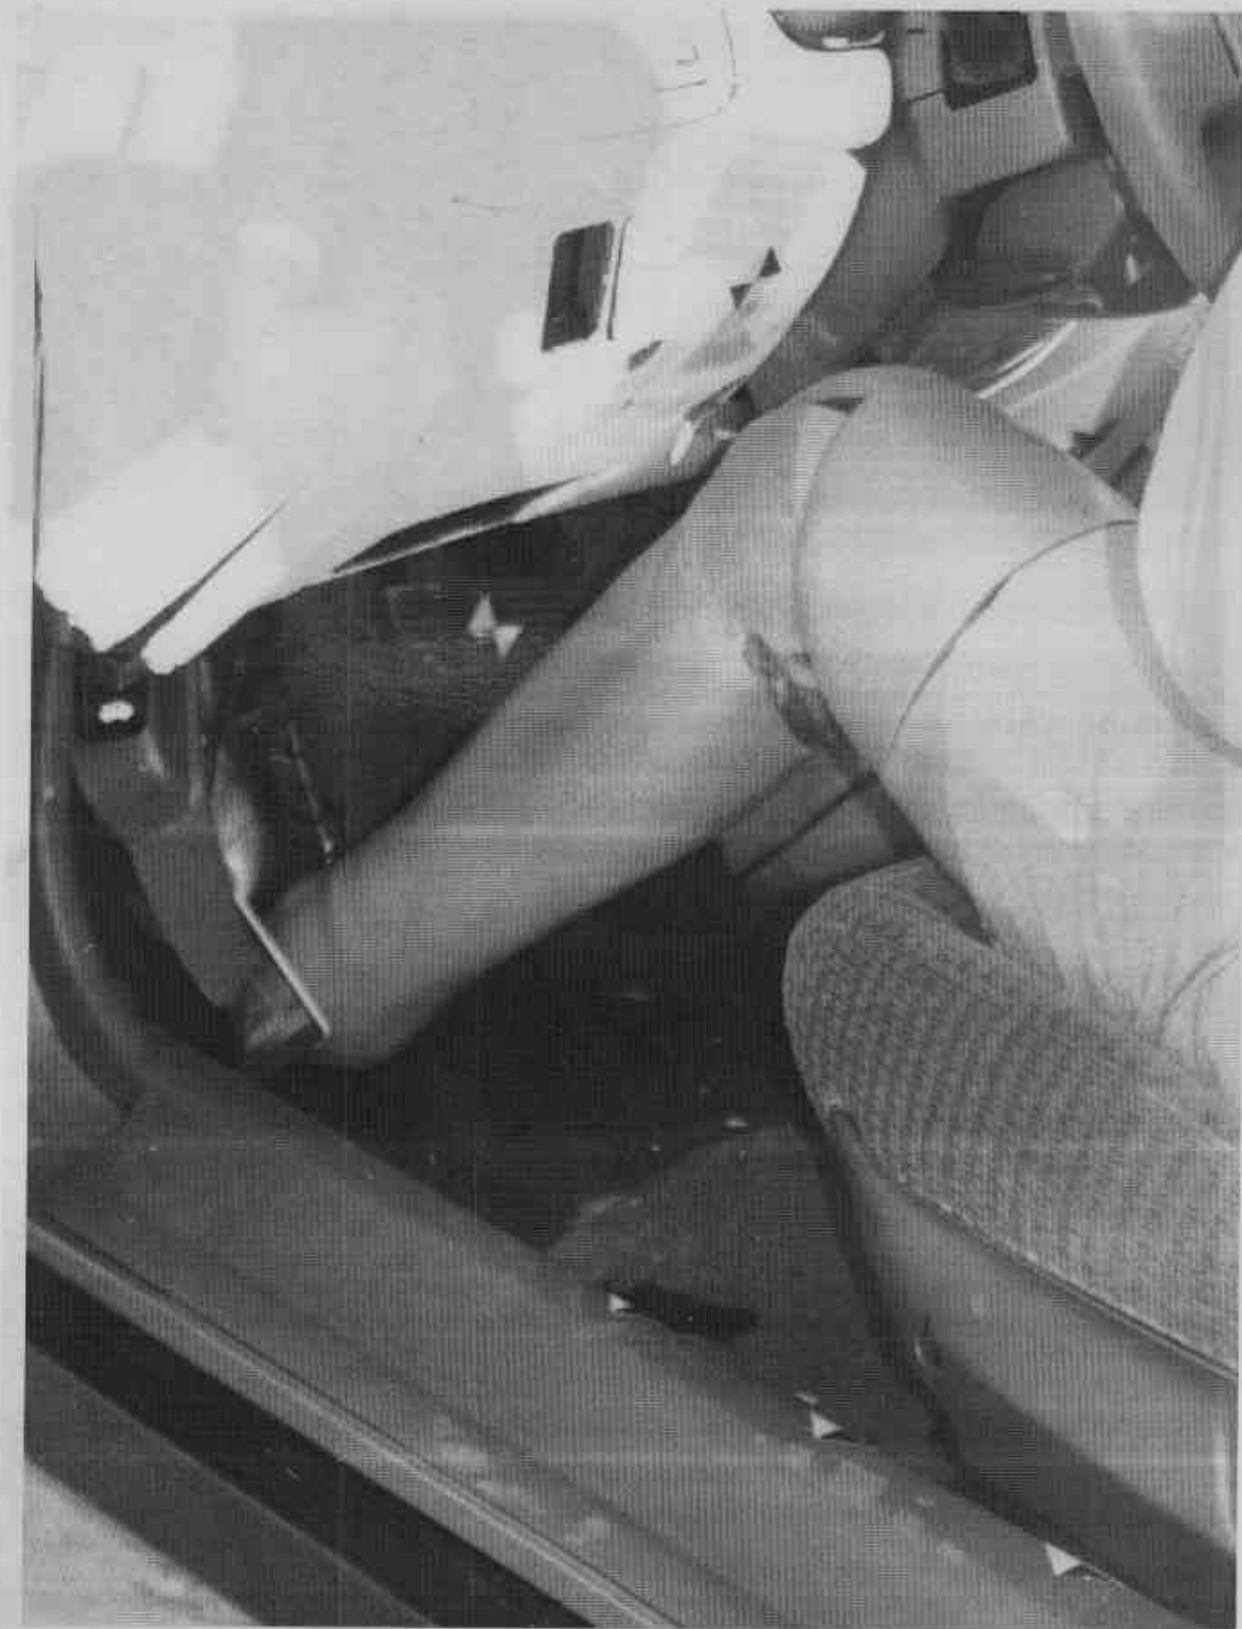
FIGURE A-34. POST TEST DRIVER DUMMY FEET AND KNEE CONTACT

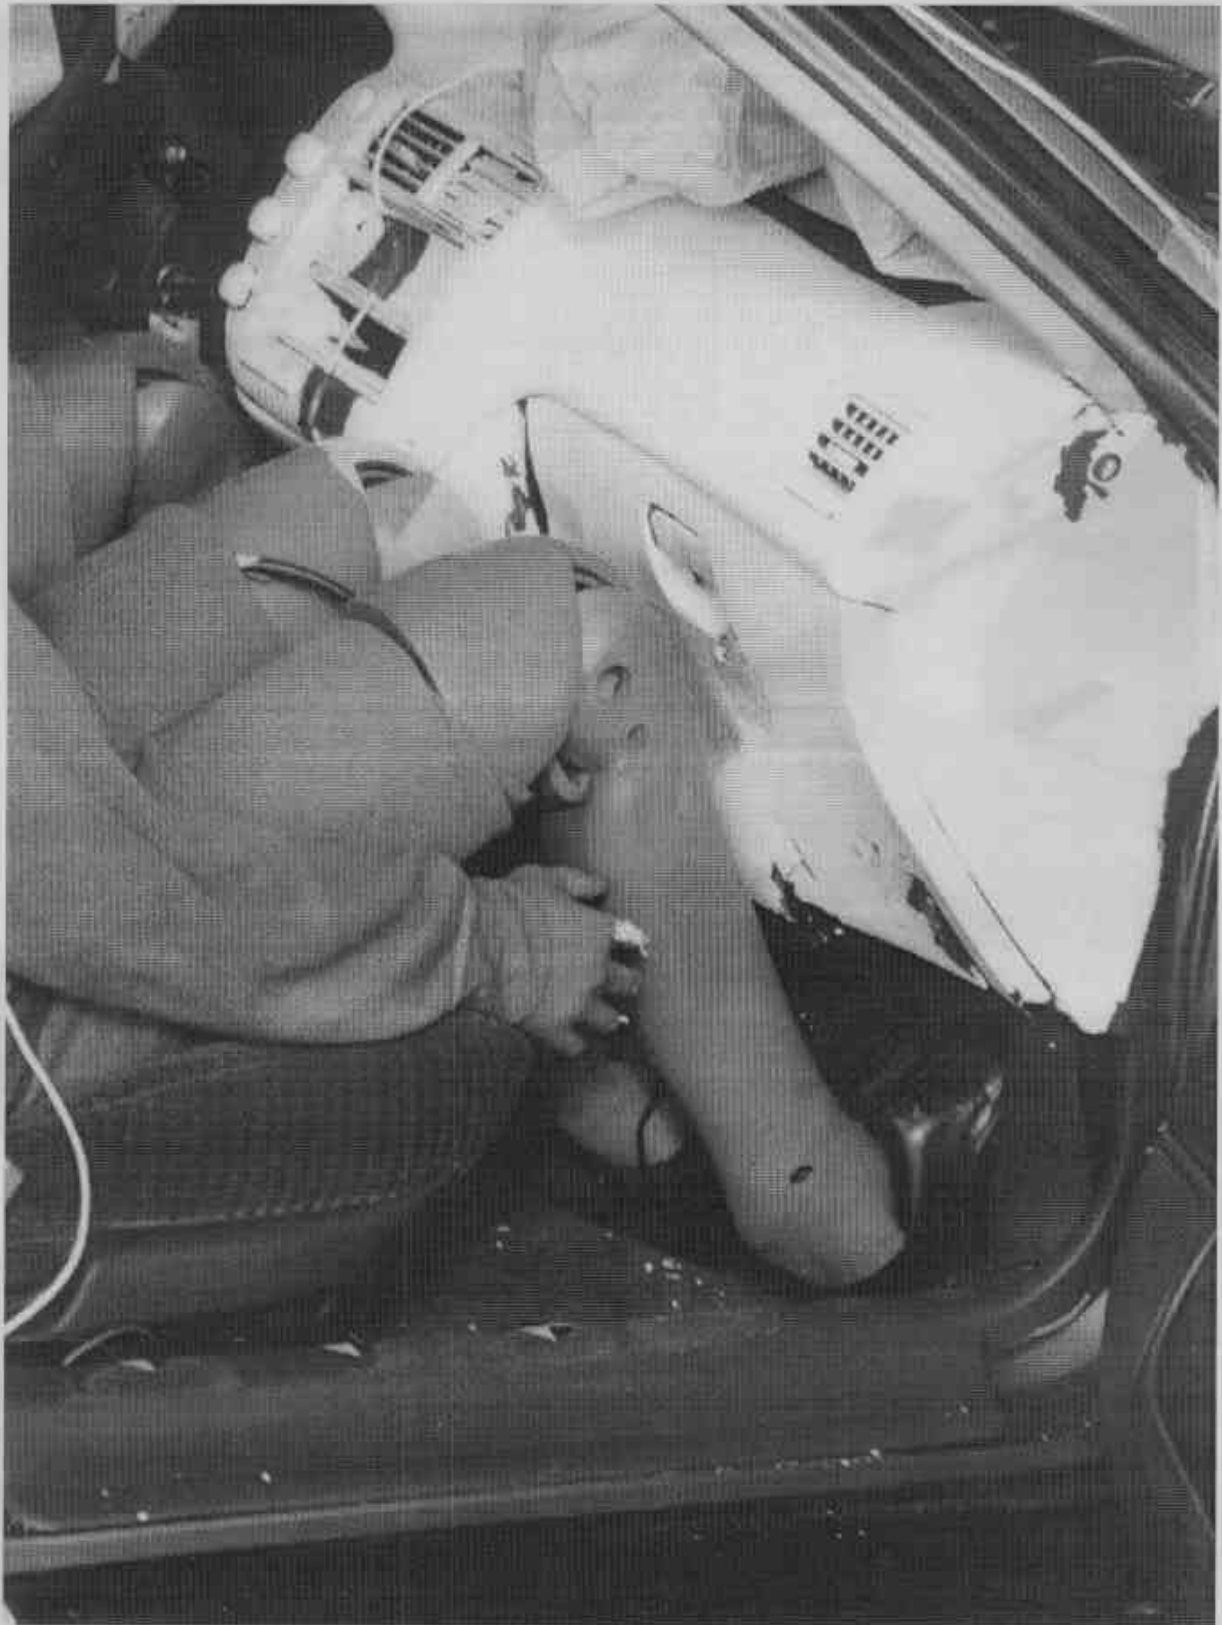
FIGURE A-50. POST TEST PASSENGER DUMMY FEET AND CONTACT POINT

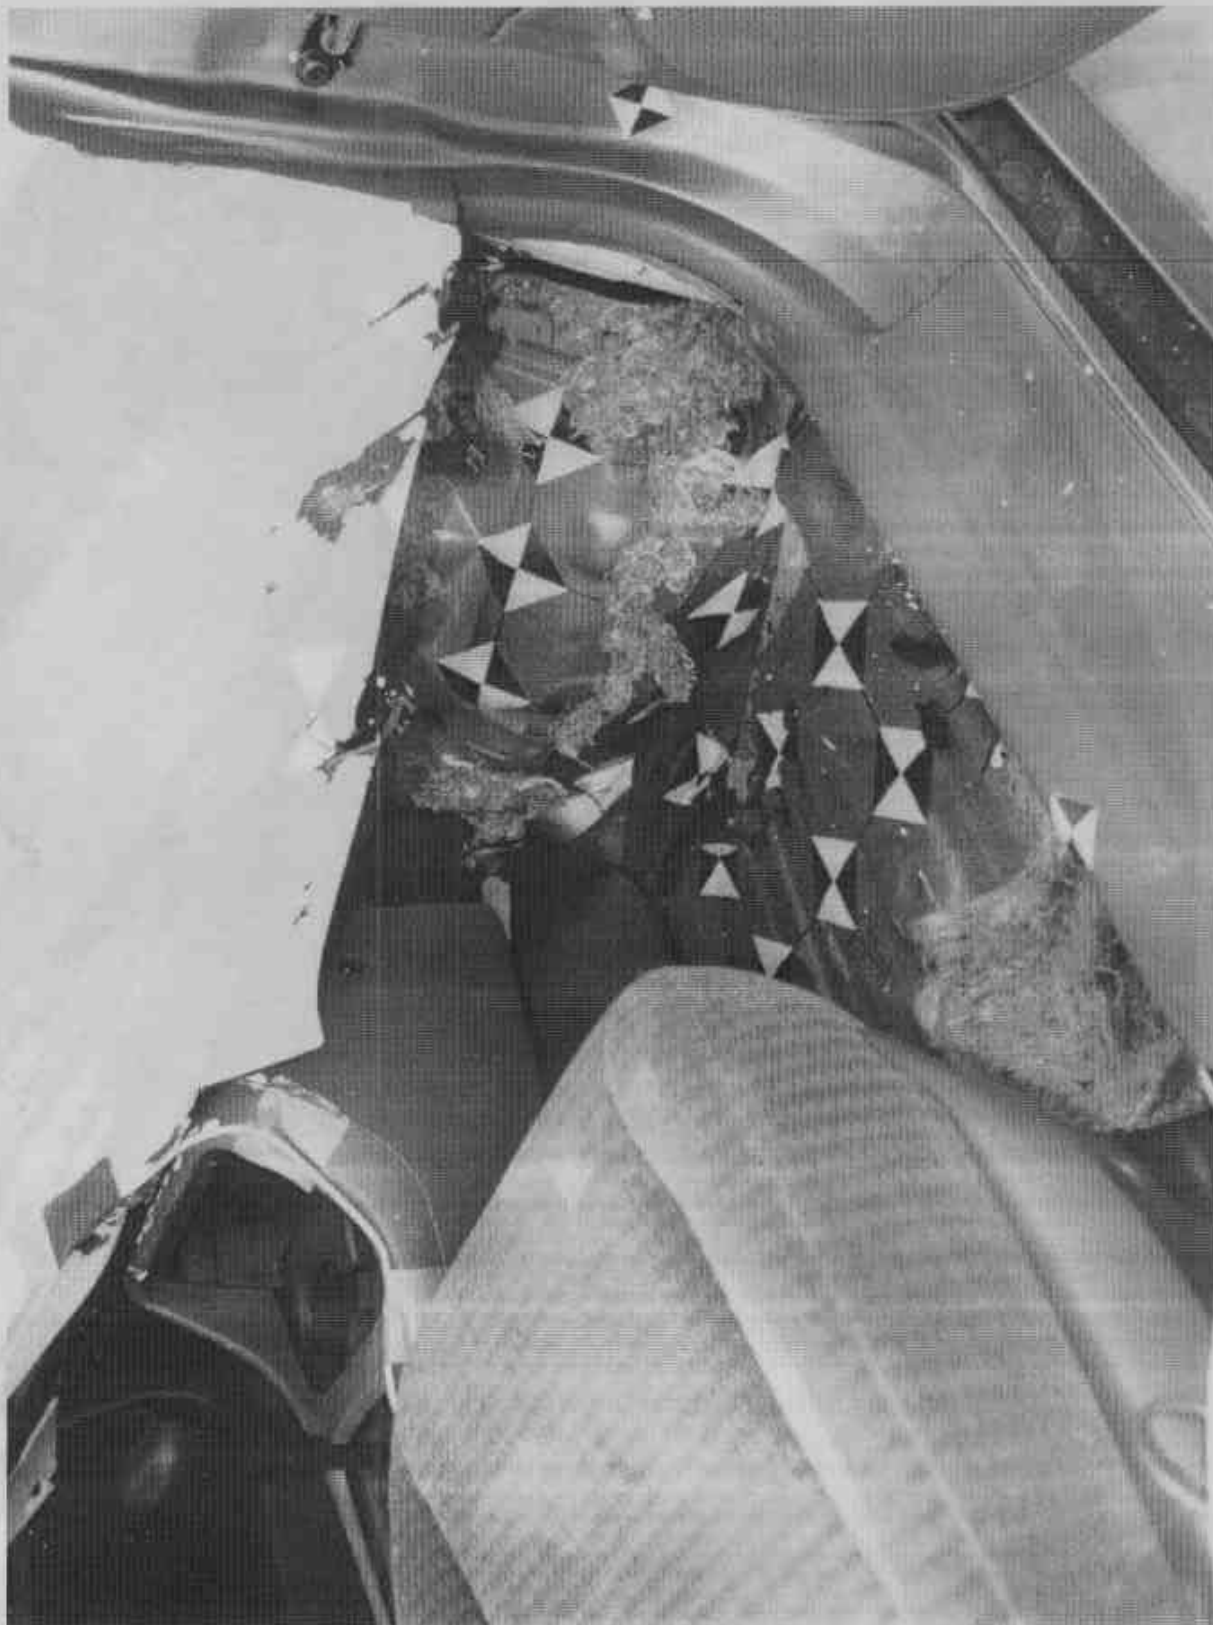
FIGURE A-52. POST TEST PASSENGER SIDE FLOOR PAN

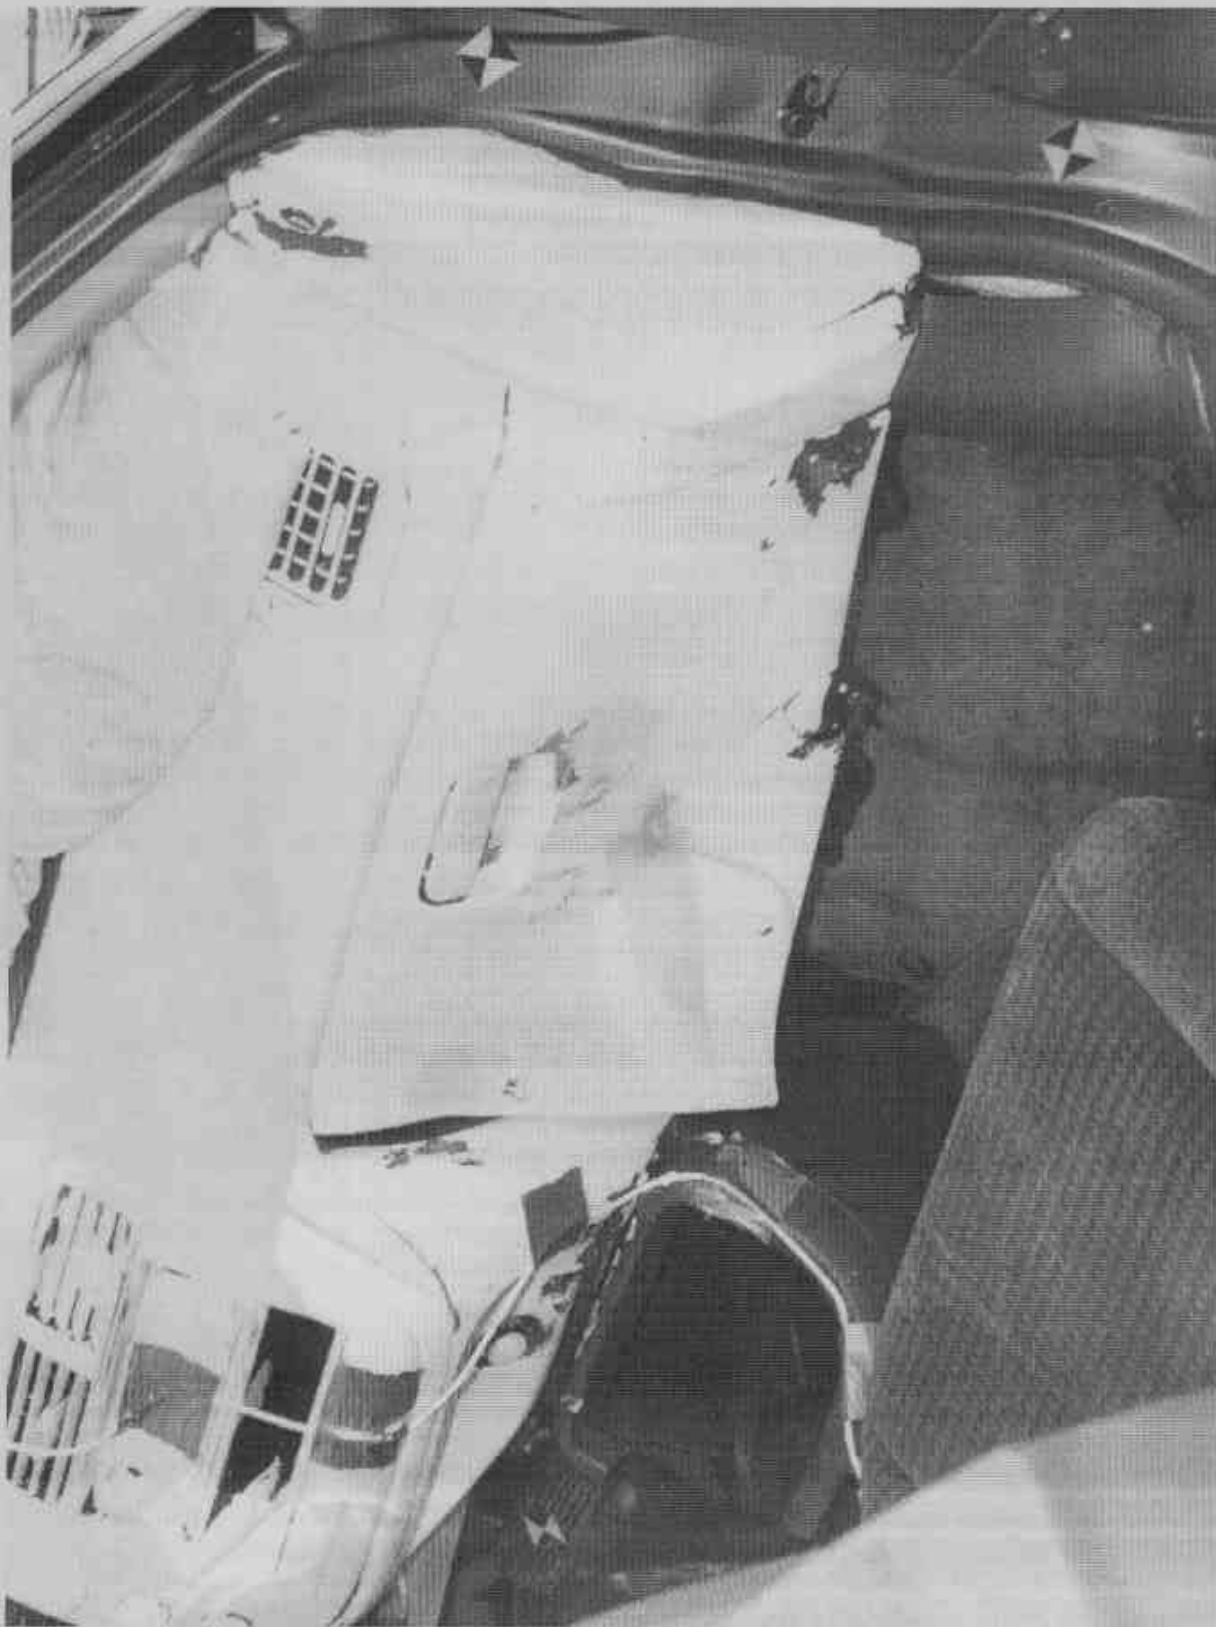
FIGURE A-54. POST TEST PASSENGER SIDE KNEE BOLSTER AND DUMMY CONTACT
