NEW CAR ASSESSMENT PROGRAM  
SIDE IMPACT TESTING  
PASSENGER CARS

1998 HONDA CR-V EX

NHTSA NO: MW5310

FINAL REPORT

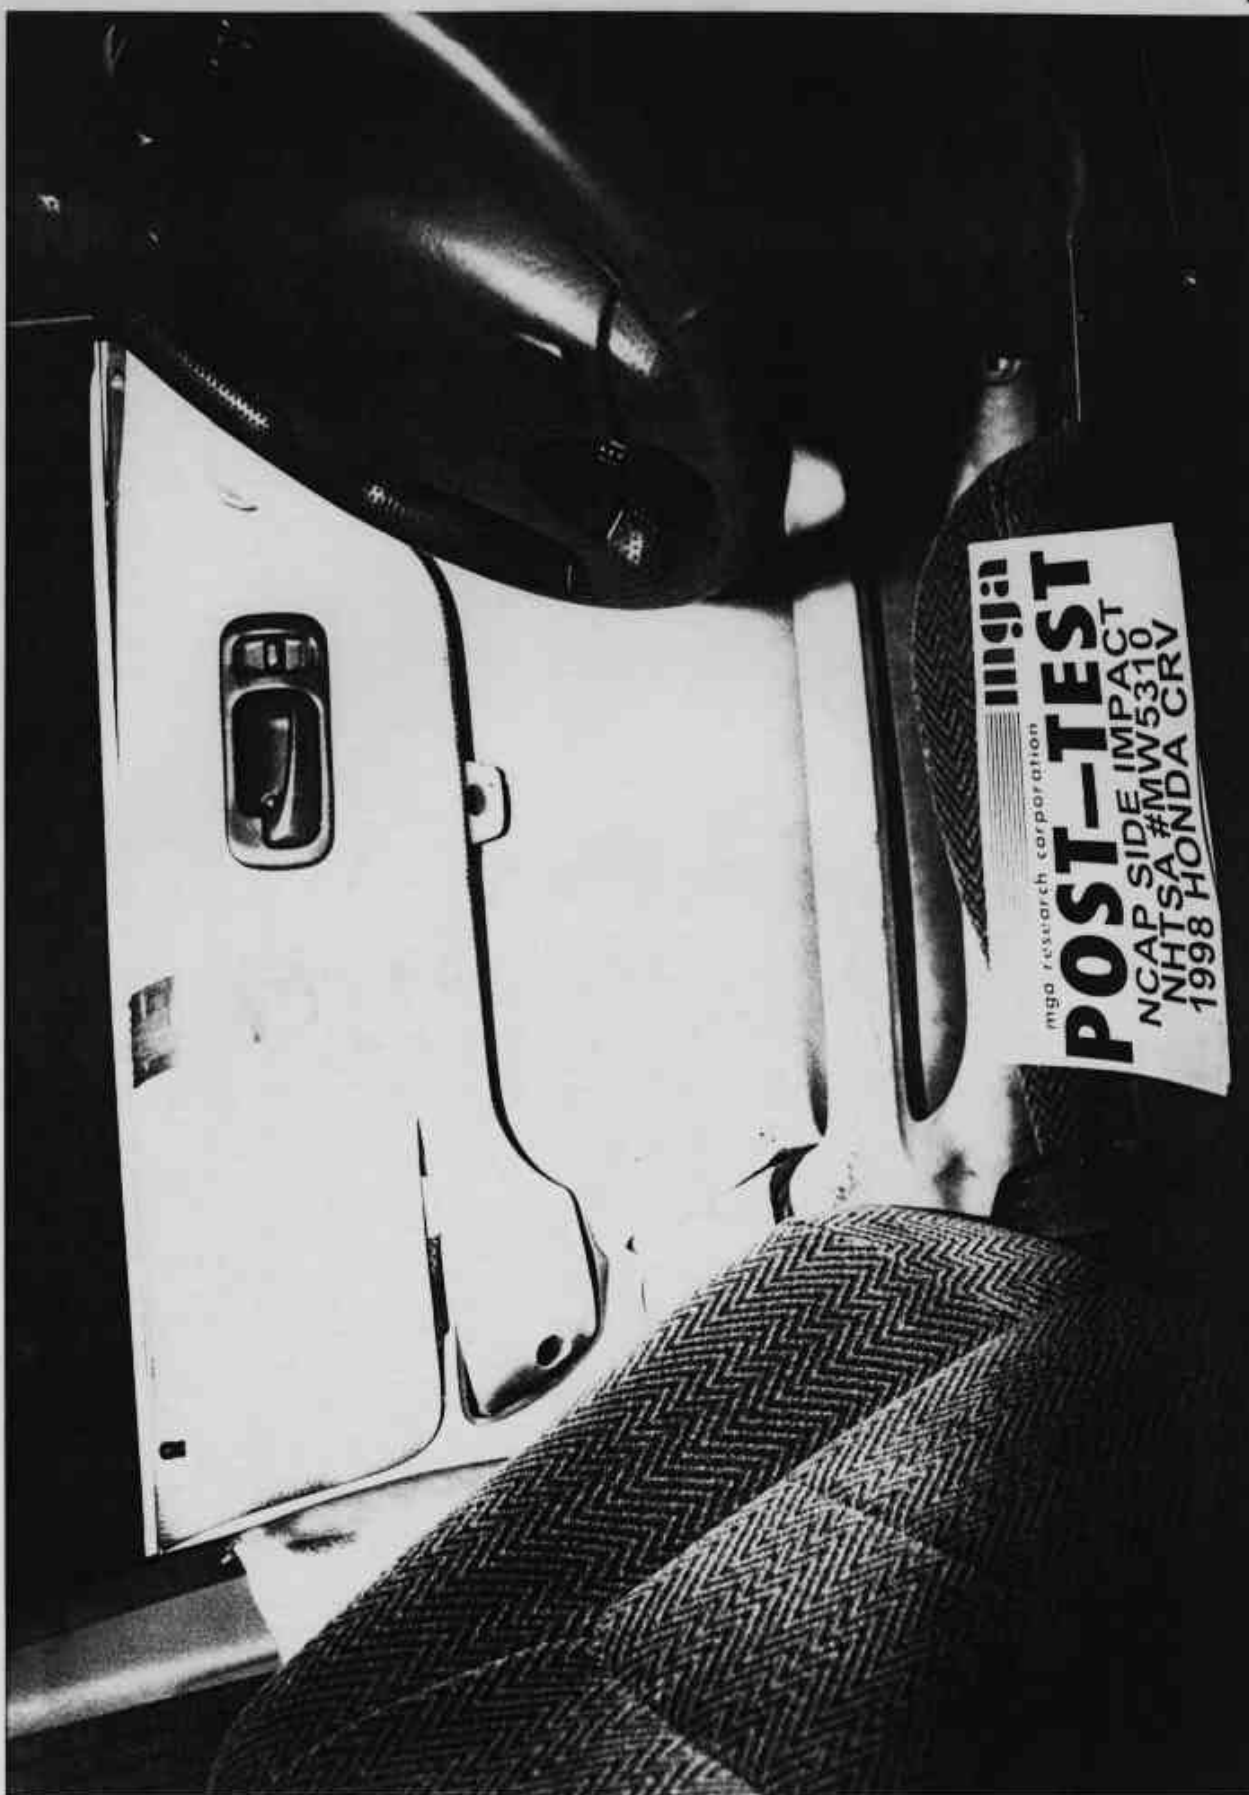
Photo No. A-30 - Post-Test Driver Dummy Contact

VISIBLE DUMMY CONTACT POINTS:

| | <u>LEFT FRONT SID</u> | <u>LEFT REAR SID</u> |
|---|---|---|
| Head | <u>Headrest/shoulder</u> | <u>C-post/headrest</u> |
| Arm | <u>Armrest/rear of door above</u><br><u>armrest</u> | <u>Rear of door above</u><br><u>armrest</u> |
| Pelvis | <u>Armrest</u> | <u>Armrest</u> |
| Left Knee | <u>Mid-door below armrest</u> | <u>Mid-door below armrest</u> |

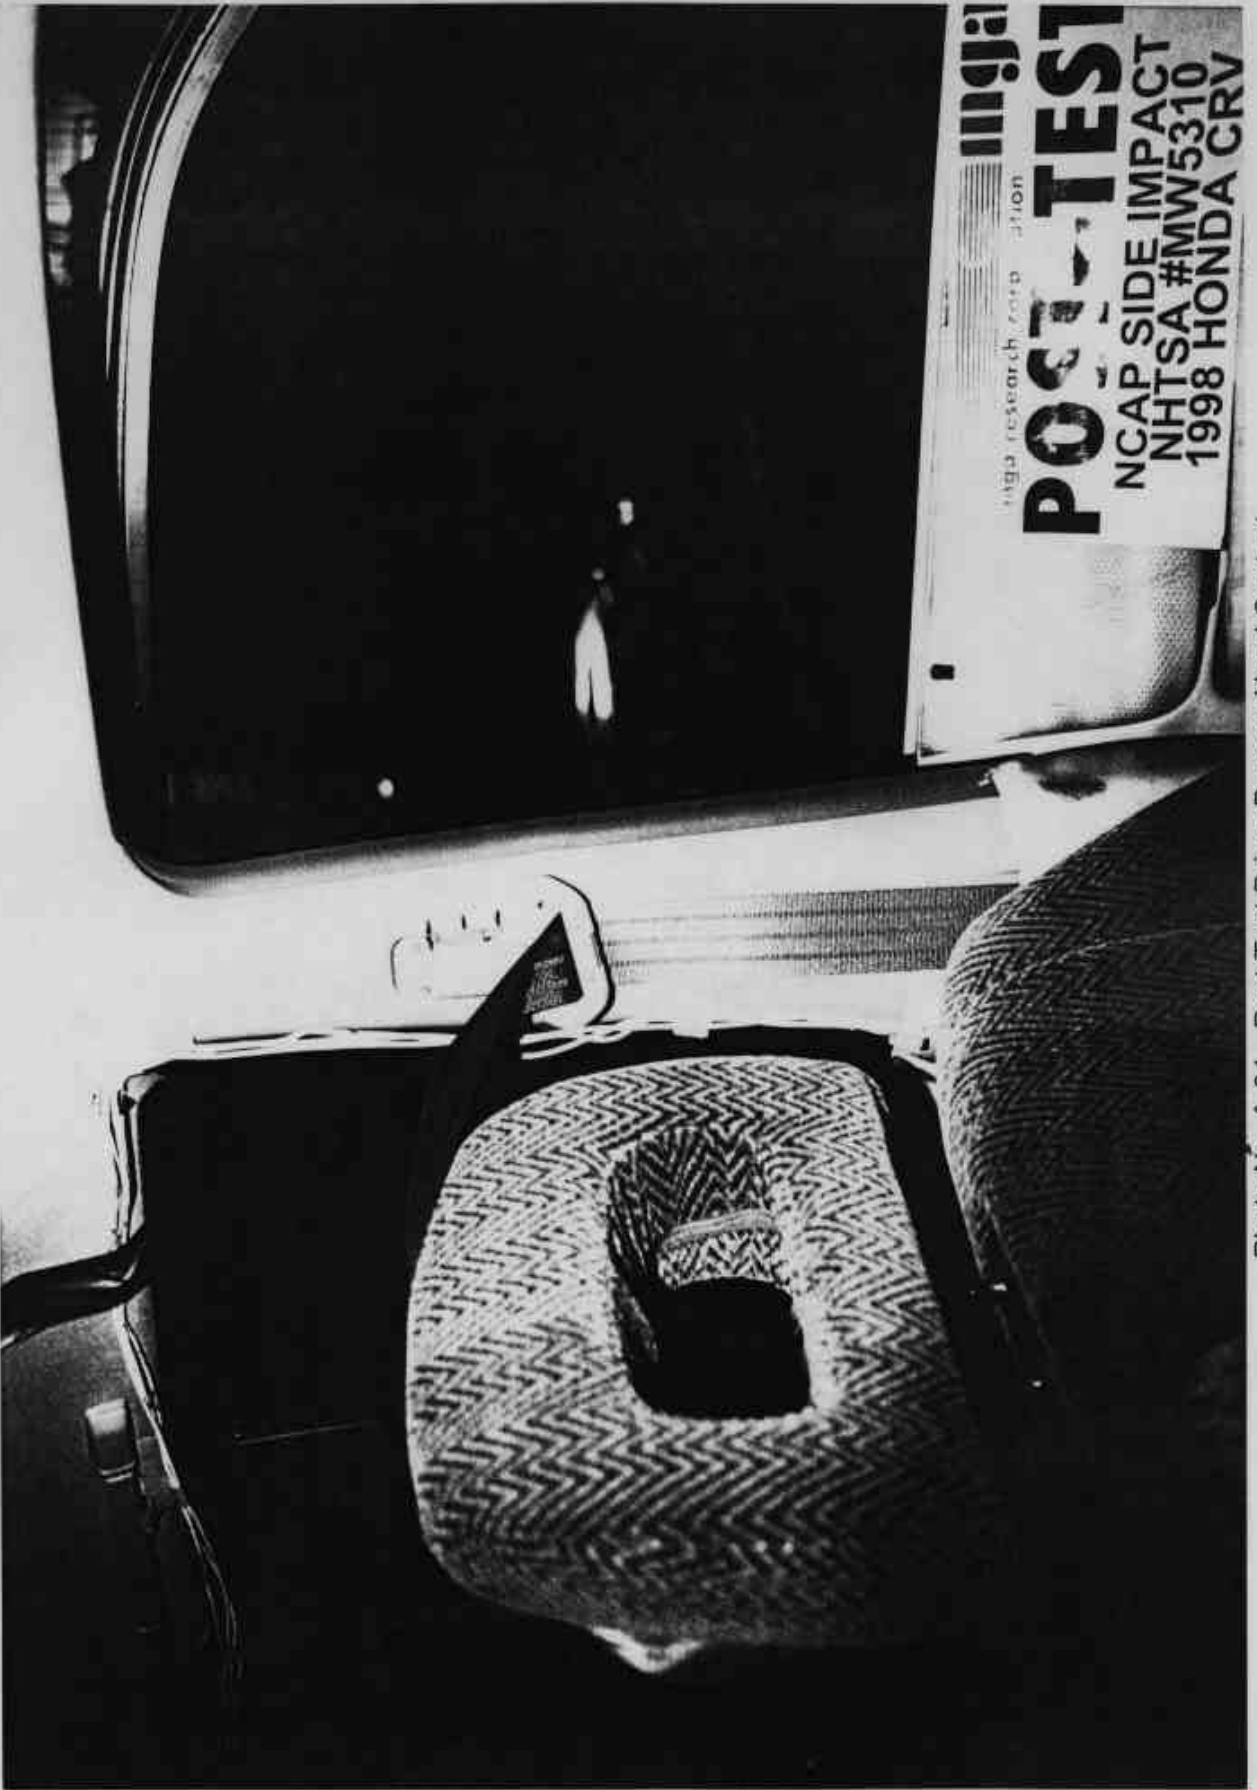
Photo No. A-31 - Post-Test Driver Dummy Head Contact

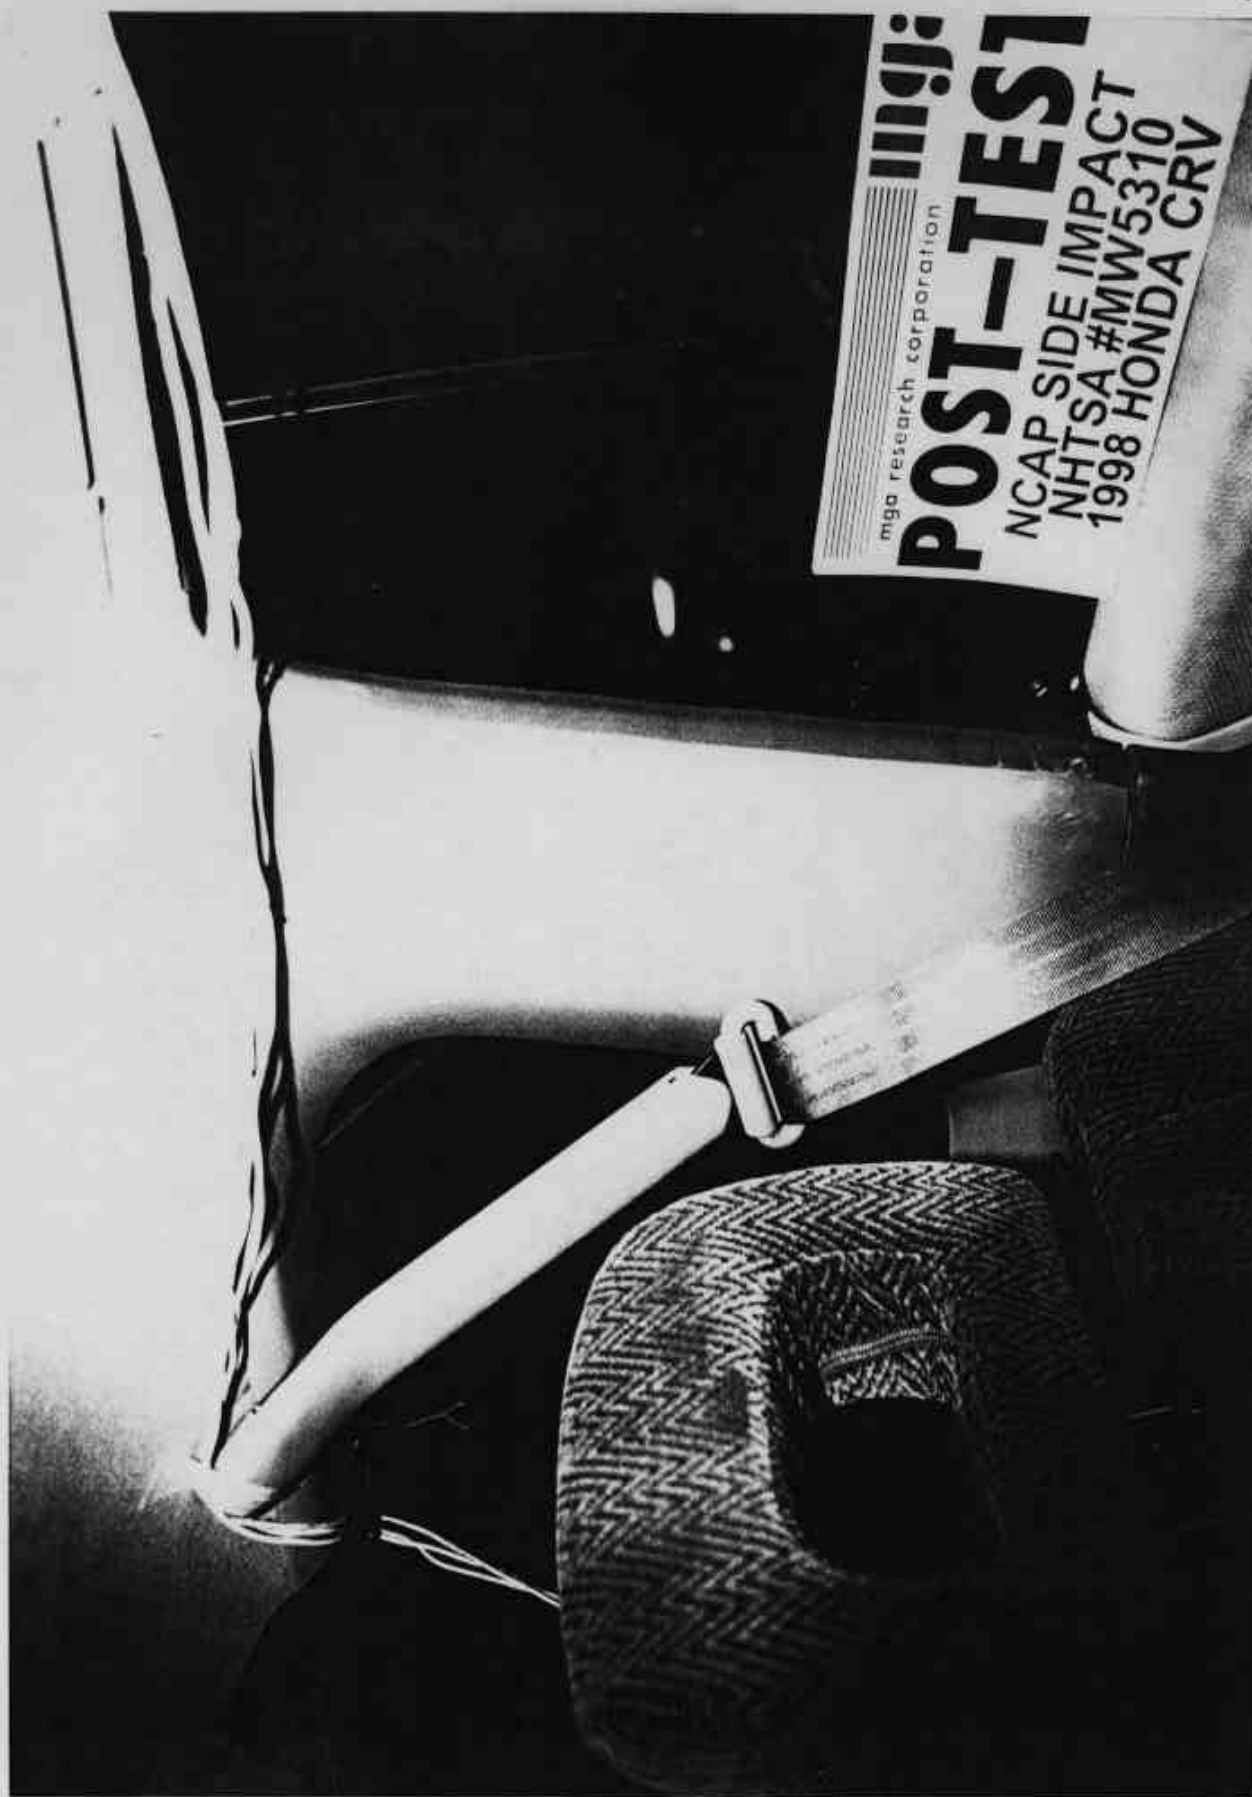
Photo No. A-40 - Post-Test Passenger Dummy Head Contact
