**FUEL SYSTEM INTEGRITY**

**70 PERCENT OVERLAP, 81.1 KPH IMPACT  
OF A MOVING DEFORMABLE BARRIER  
INTO THE REAR OF A STATIONARY  
1998 CHEVROLET CAVALIER 4-DOOR SEDAN**

NHTSA NUMBER: RW0122

CALSPAN TEST NUMBER: A266-1-1790

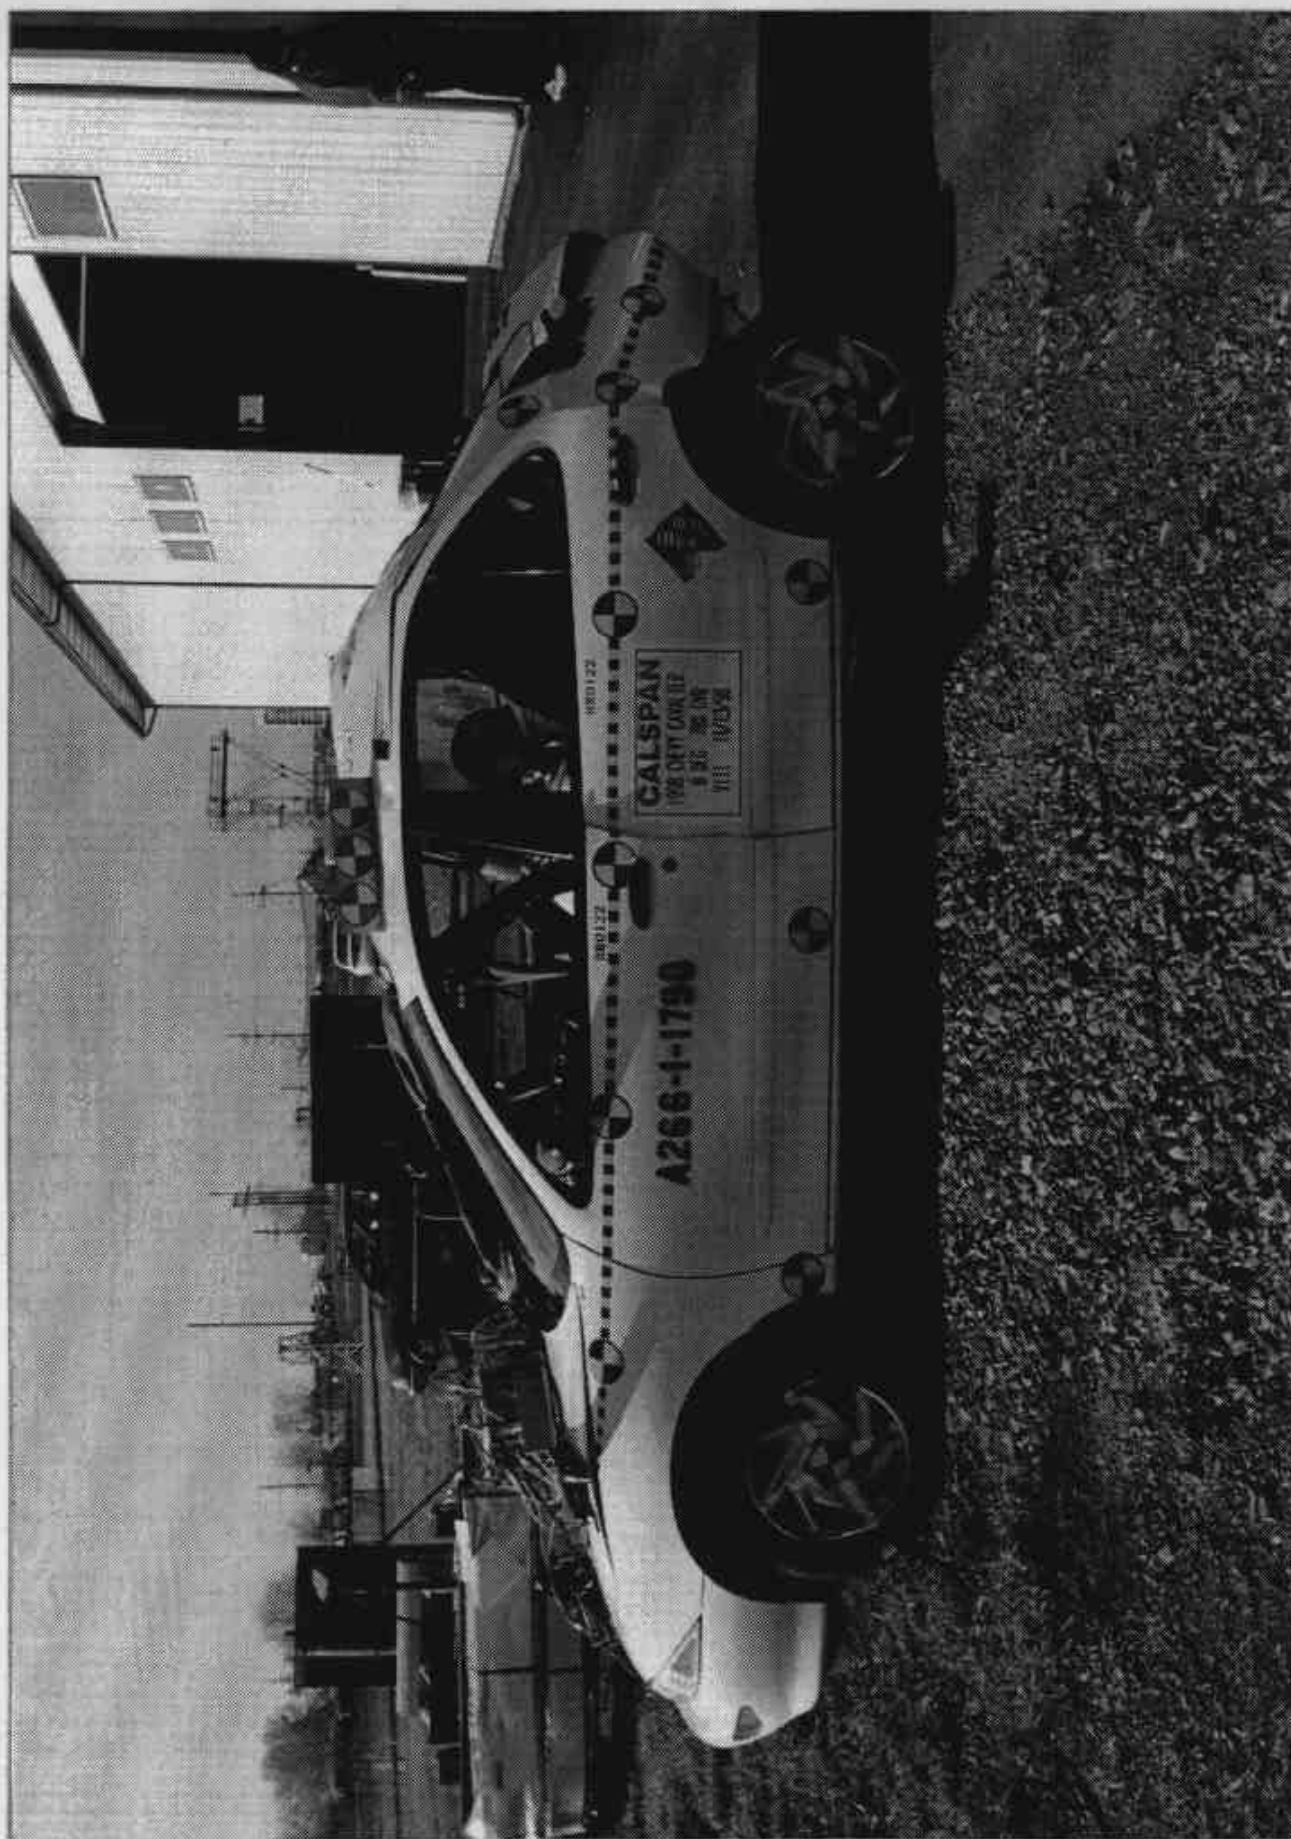
Figure B-4 POST-TEST LEFT SIDE VIEW

From film analysis, it was determined that the vehicles struck 0.25 inches off the nominal target point as to create slightly less overlap. Structural damage to the 1998 Chevrolet Cavalier consisted of severe deformation of the right rear quarter of the vehicle. The right rear portion of the fuel tank was punctured and deformed forward of the rear suspension cross member. Fuel filler cap and tube were detached from rear quarter panel but intact.

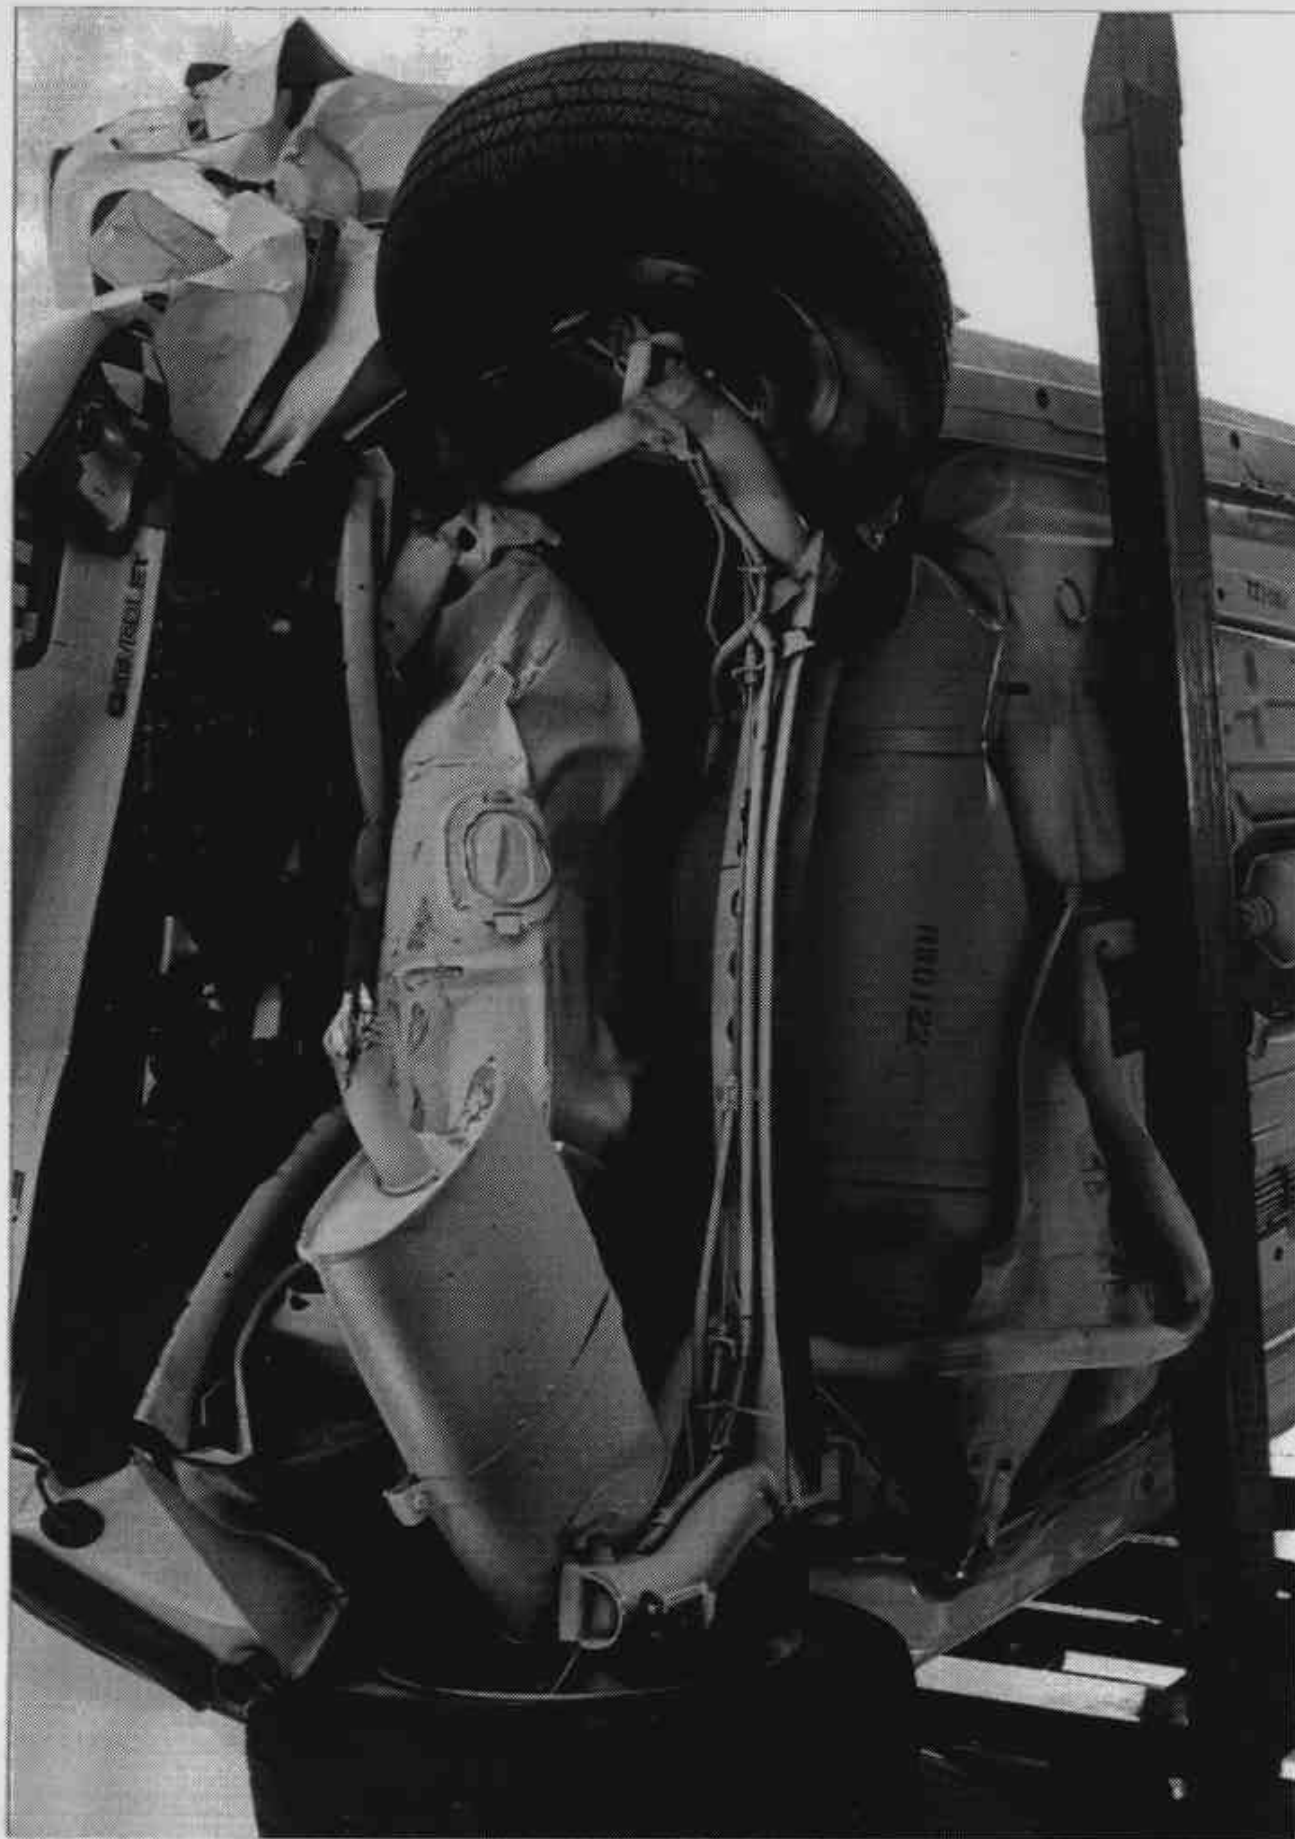
Figure B-12 POST-TEST REAR UNDERBODY VIEW

Fluid leakage started before vehicle came to a full stop. Stoddard solvent leaked from a puncture located on the rear right portion on the fuel tank. Rollover not required when fluid leakage occurring during impact event exceeds maximum allowed fuel spillage.
