Enclosed is the Final Report prepared by Jack L. Jensen and Jeffrey Santrock of General Motors Corporation entitled "Evaluation of Motor Vehicle Fire Initiation and Propagation Part 2: Crash Tests on a Passenger Van."

# **Evaluation of Motor Vehicle Fire Initiation and Propagation**

## **Part 2: Crash Tests on a Passenger Van**

Jack L. Jensen, Jeffrey Santrock  
General Motors Corporation

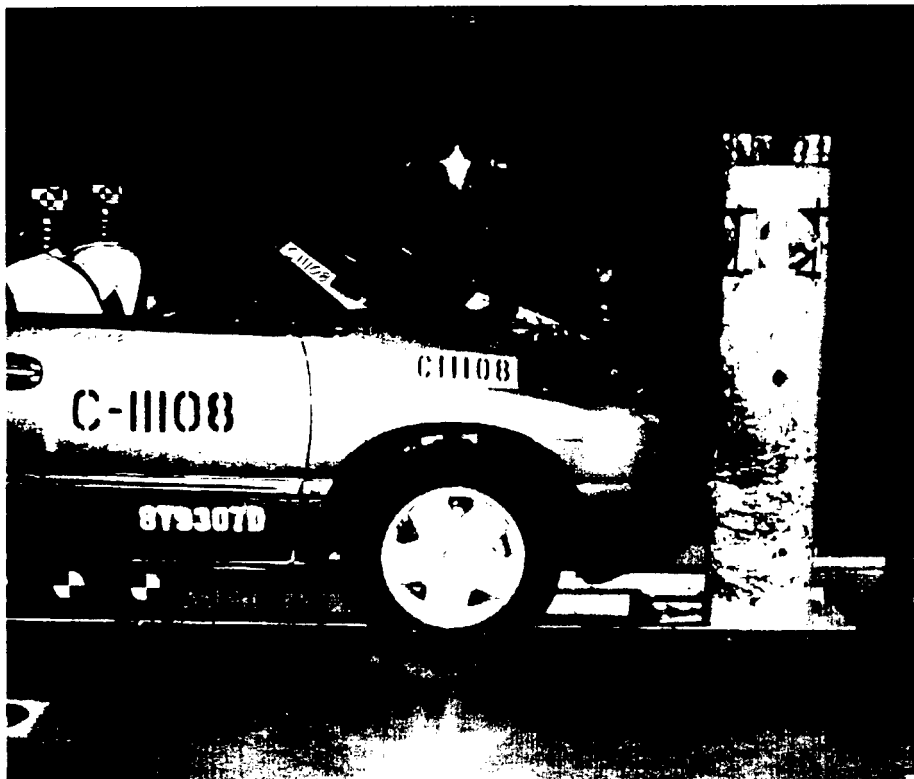
Figure 2.  
Pre-Test Photograph of Test CI 1108

This test was an offset pole frontal impact as depicted in Figures 1 and 2. The test vehicle was towed into a 355 mm (14 inch) diameter steel pole. The lateral offset between the vehicle longitudinal centerline and the pole was 305 mm (12 inches), with the impact occurring on the right side of the vehicle centerline (U.S. passenger's side). The impact velocity, measured with radar, was 55.2 km/h (34.3 mph).

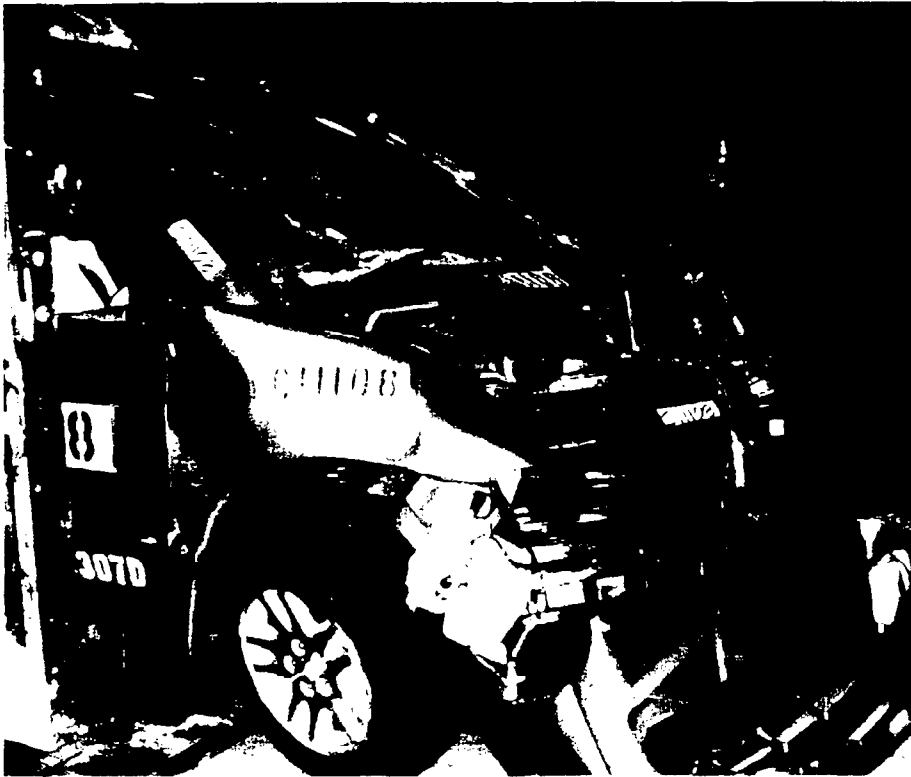
**Figure 4.**  
Post-Test Photograph of Test CI 1108, Front – Right View

Post-test photographs of the vehicle are shown in Figures 3 and 4.

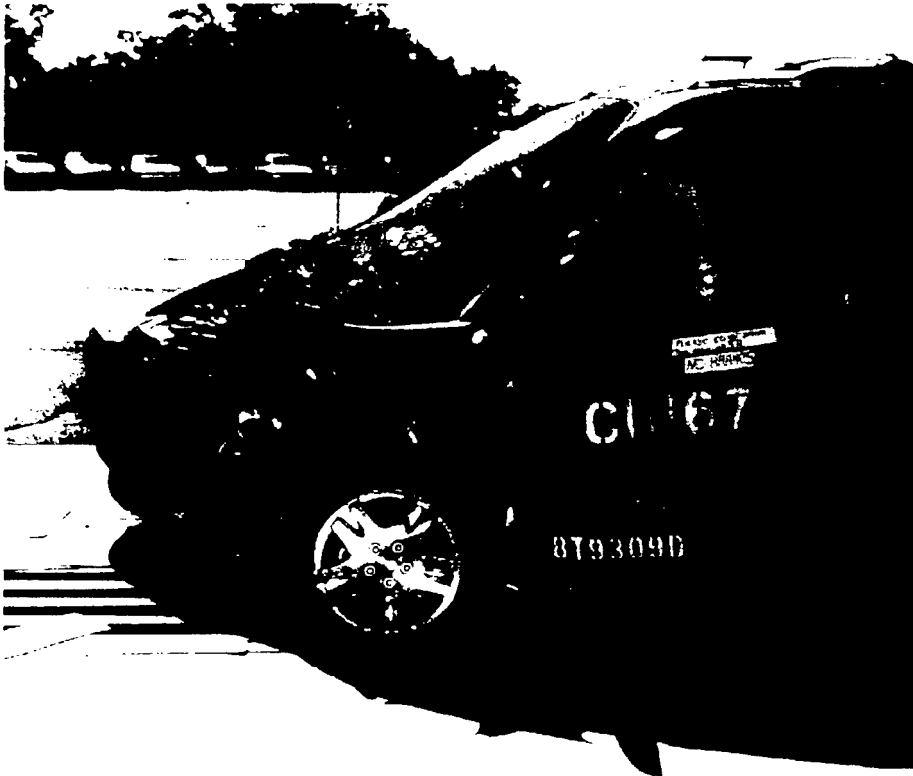
Figure 13.

Post-Test Photograph of Test CI 1167, Left Side

Post-test photographs of the vehicle are shown in Figures 13 and 14.

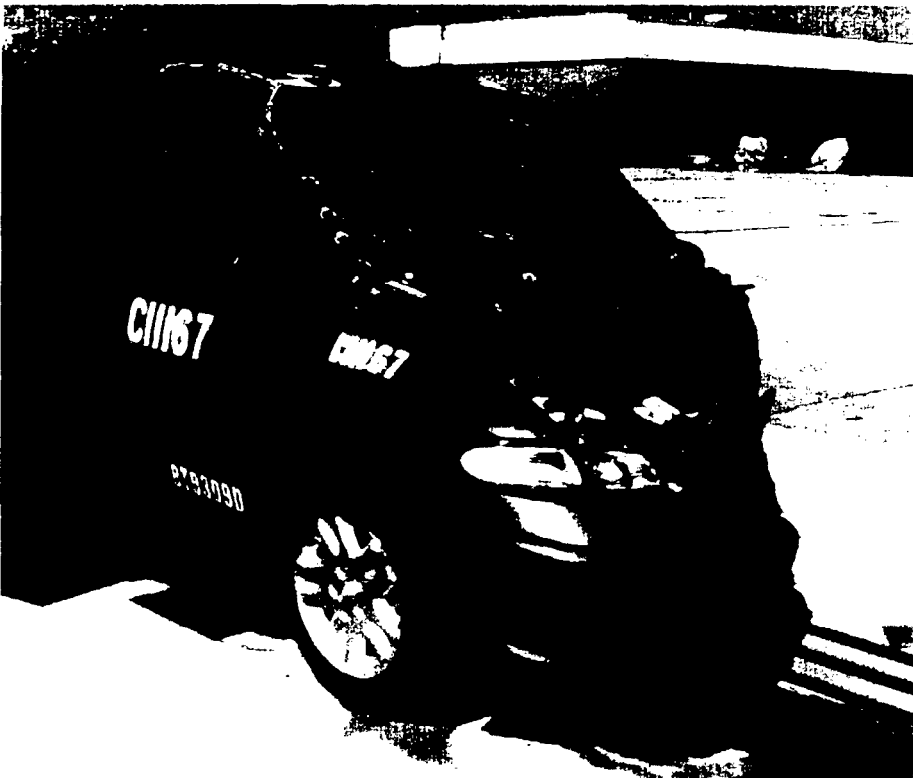
Figure 14.

Post-Test Photograph of Test CI 1167, Front - Right View

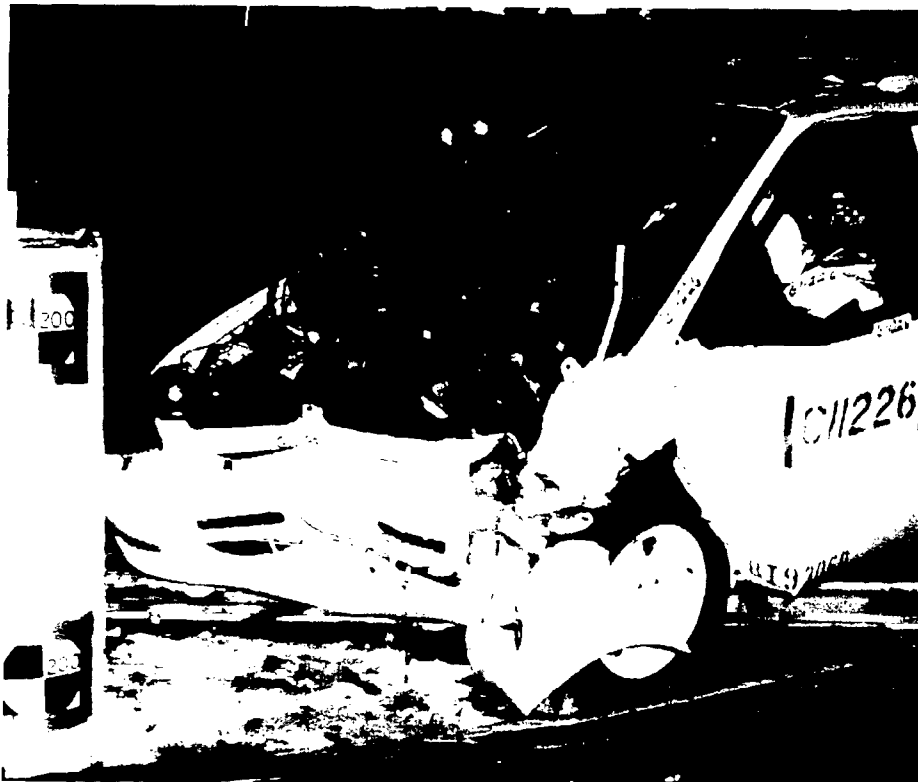
**Figure 33.**

Post-Test Photograph of Test CI 1226, Front – Left View

Post-test photographs of the vehicle are shown in Figures 32 and 33.

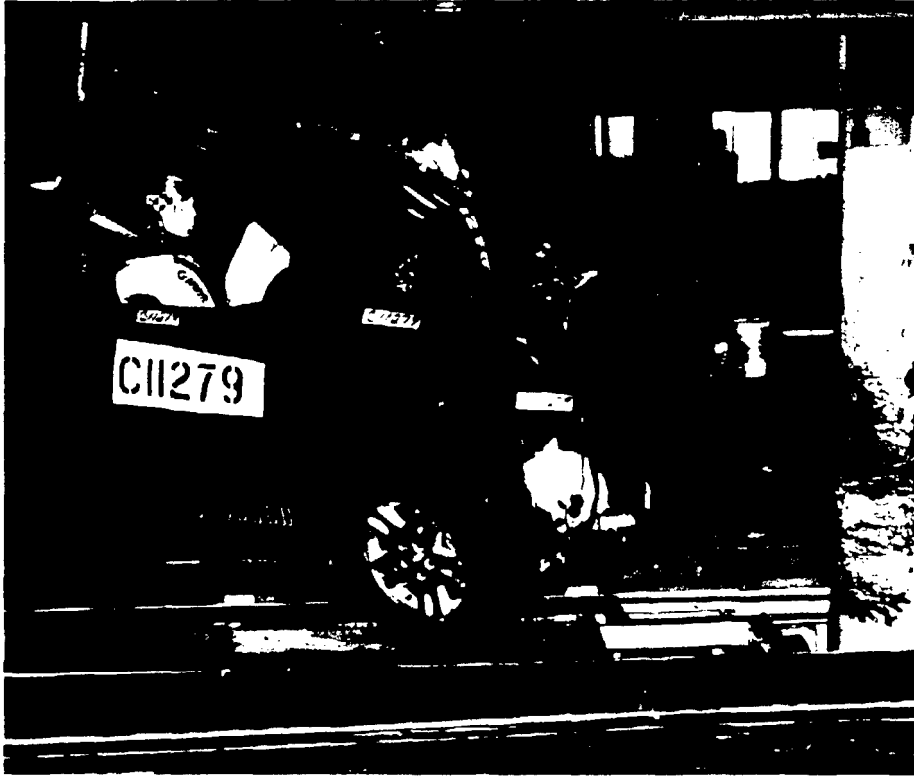
Figure 41.

Post-Test Photograph of Test CI 1279, Front-Right View

Post-test photographs of the vehicle are shown in Figures 41 and 42.
