REPORT NUMBER: 214-CAL-99-01

**SAFETY COMPLIANCE TESTING FOR FMVSS 214  
SIDE IMPACT PROTECTION**

GENERAL MOTORS CORPORATION  
1999 OLDSMOBILE Alero  
4-DOOR SEDAN

NHTSA NUMBER: CX0100

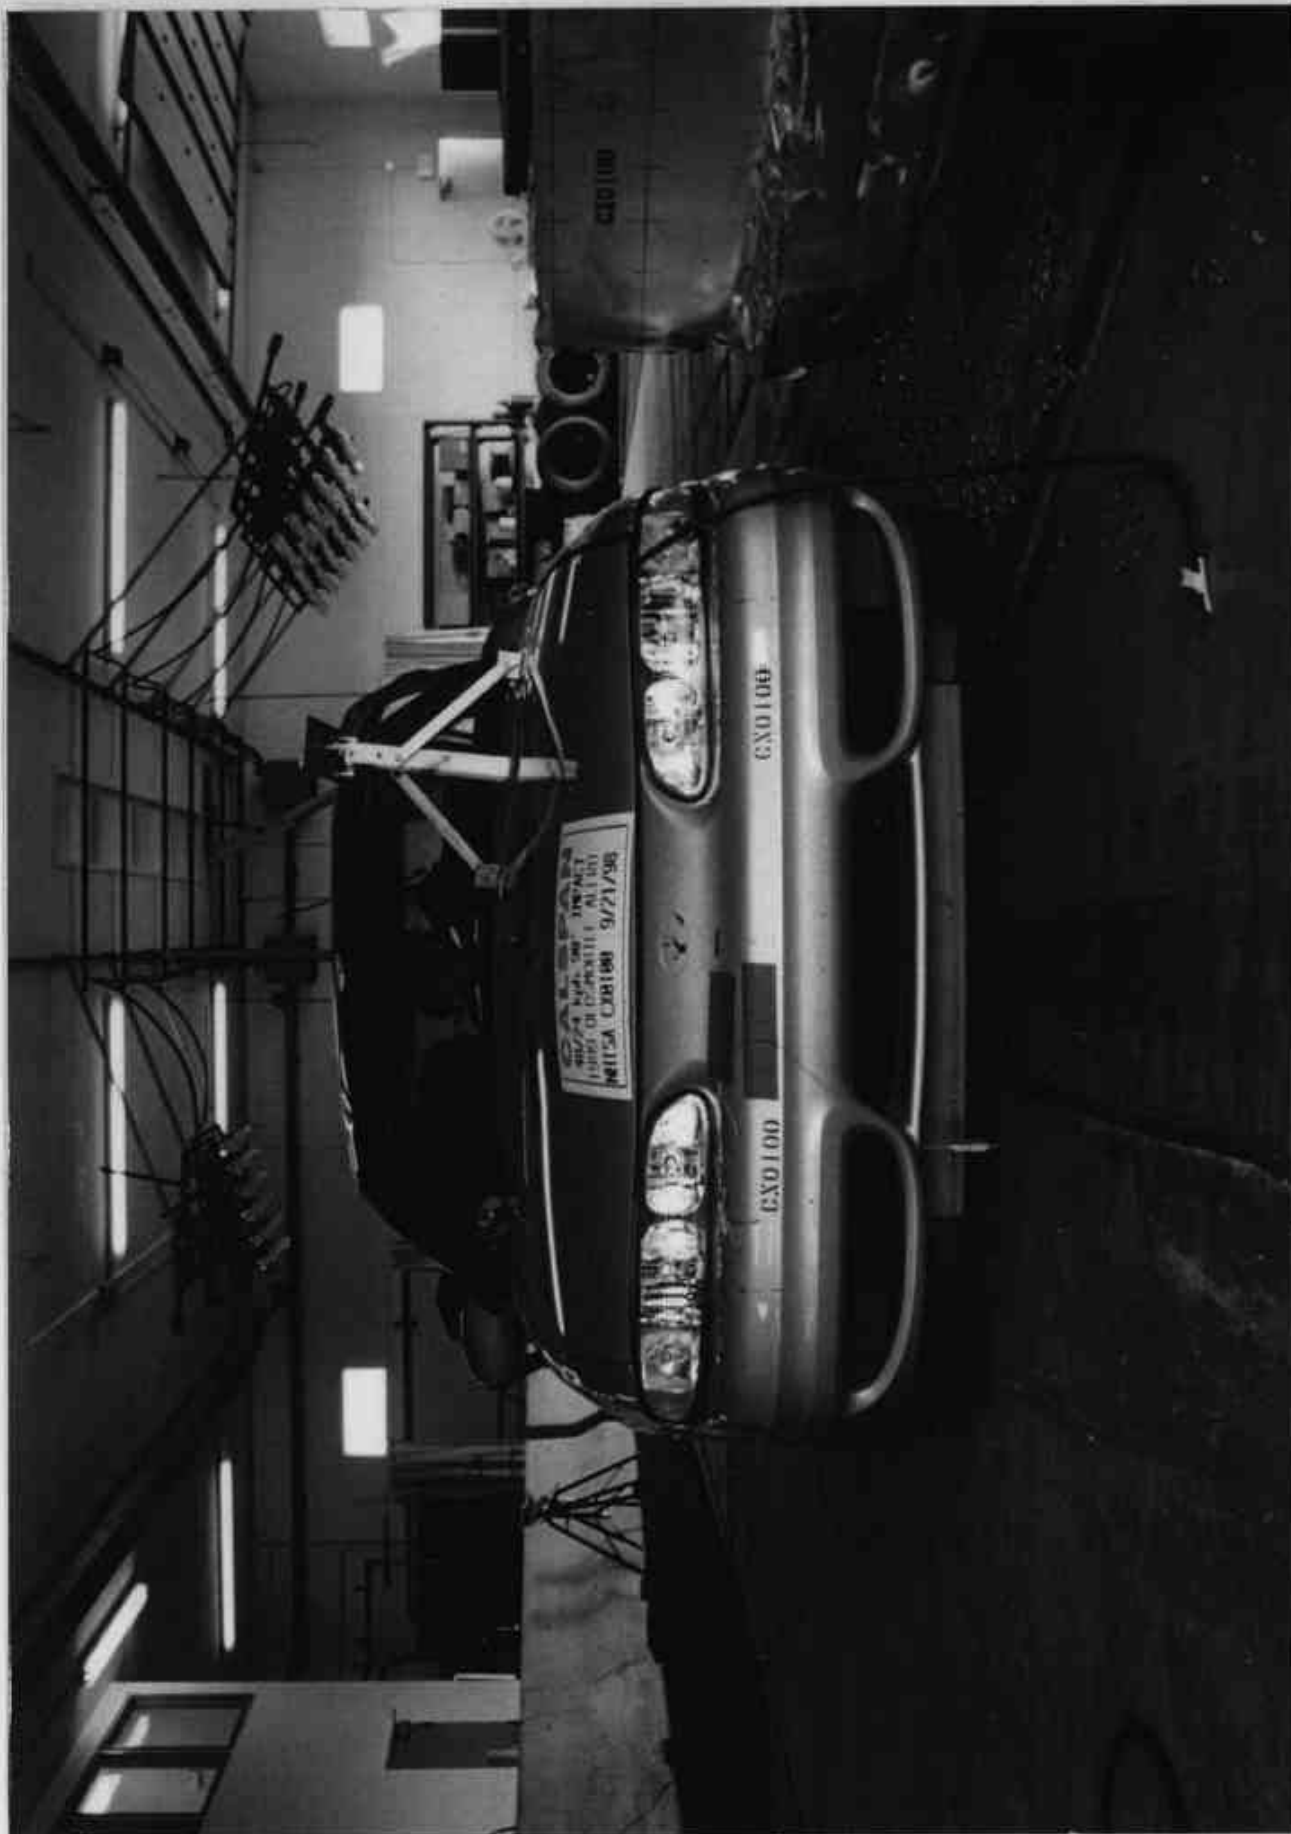
Figure A-2 POST-TEST FRONTAL VIEW OF TEST VEHICLE

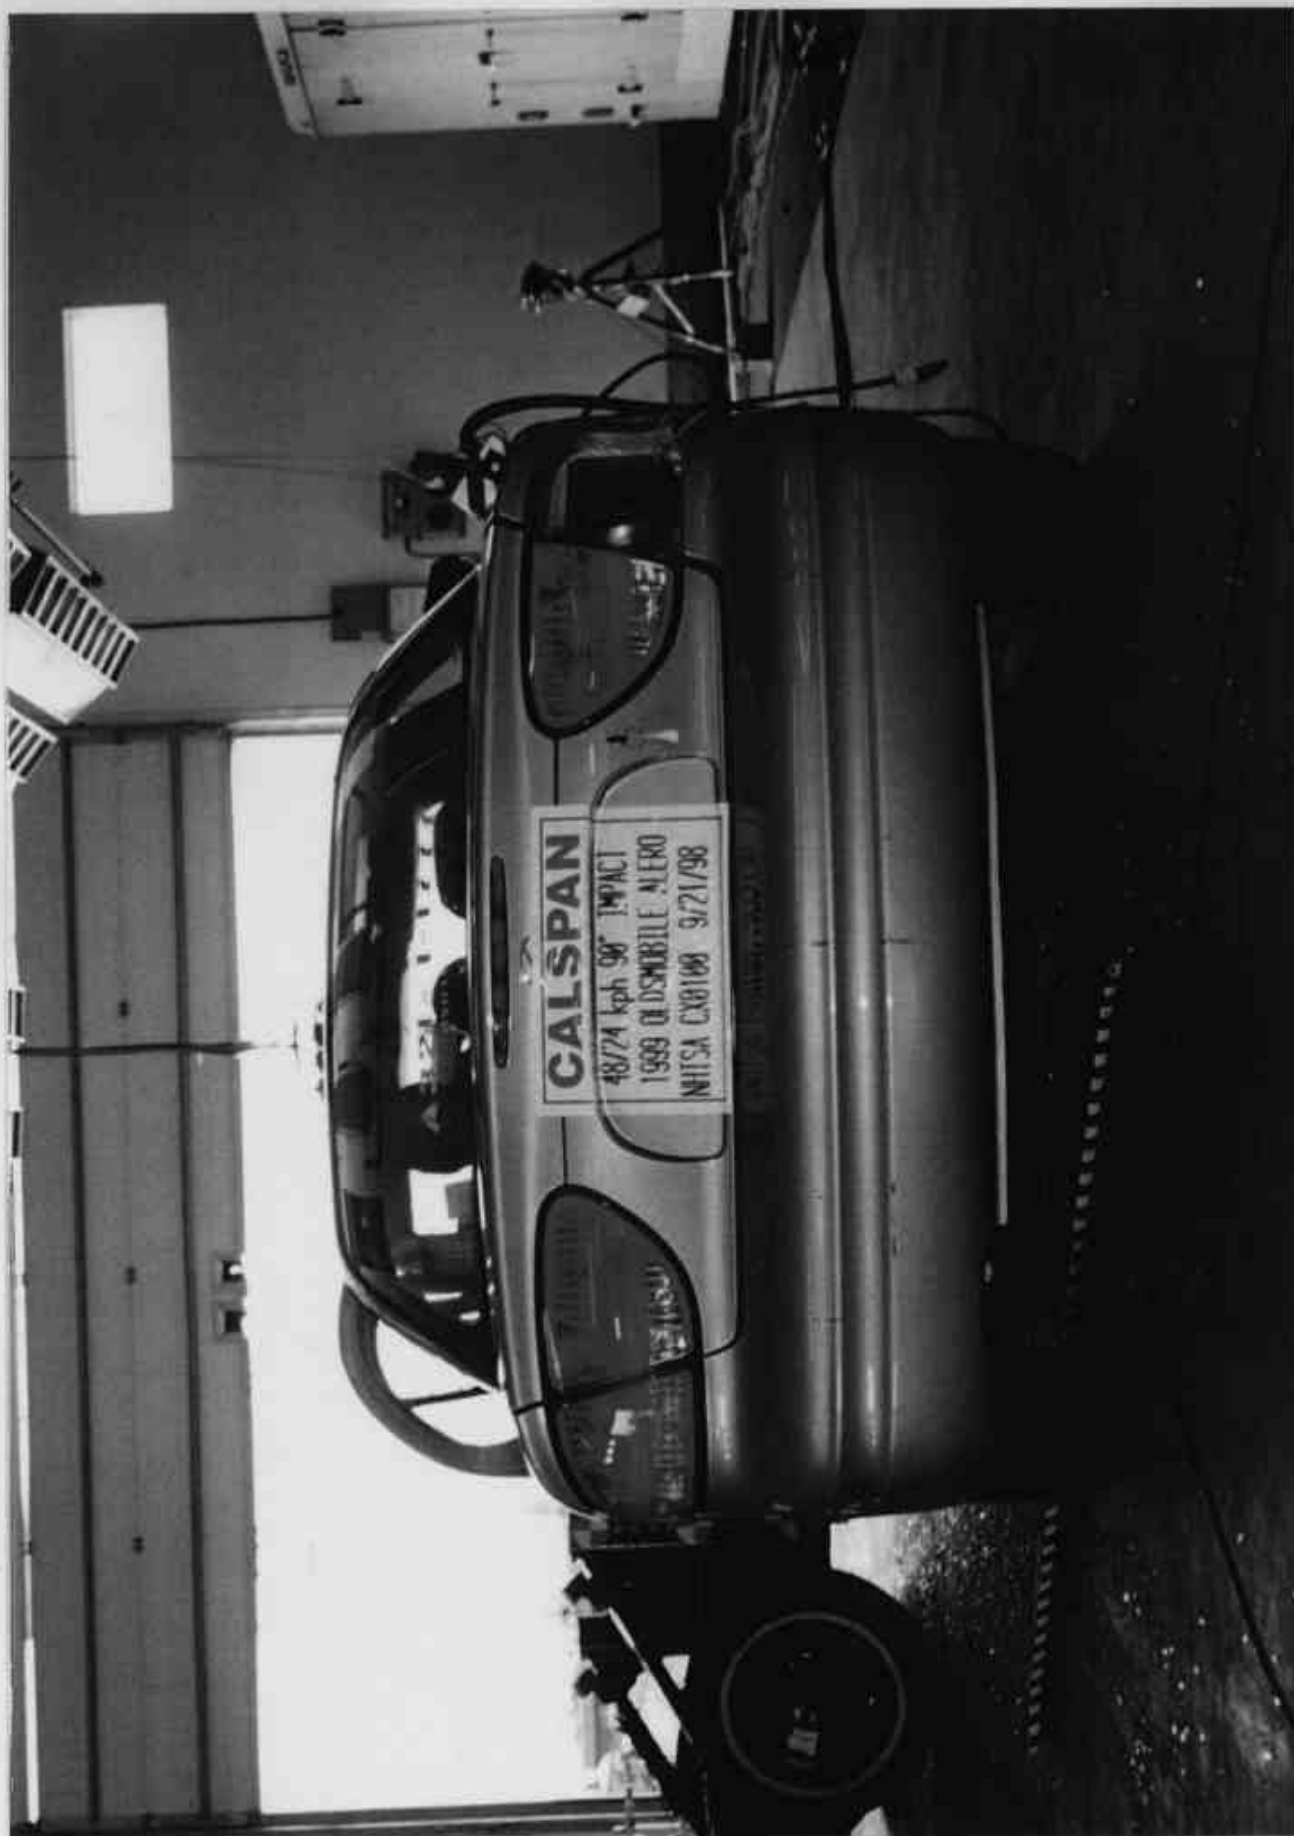
Figure A-4 POST-TEST REAR VIEW OF TEST VEHICLE

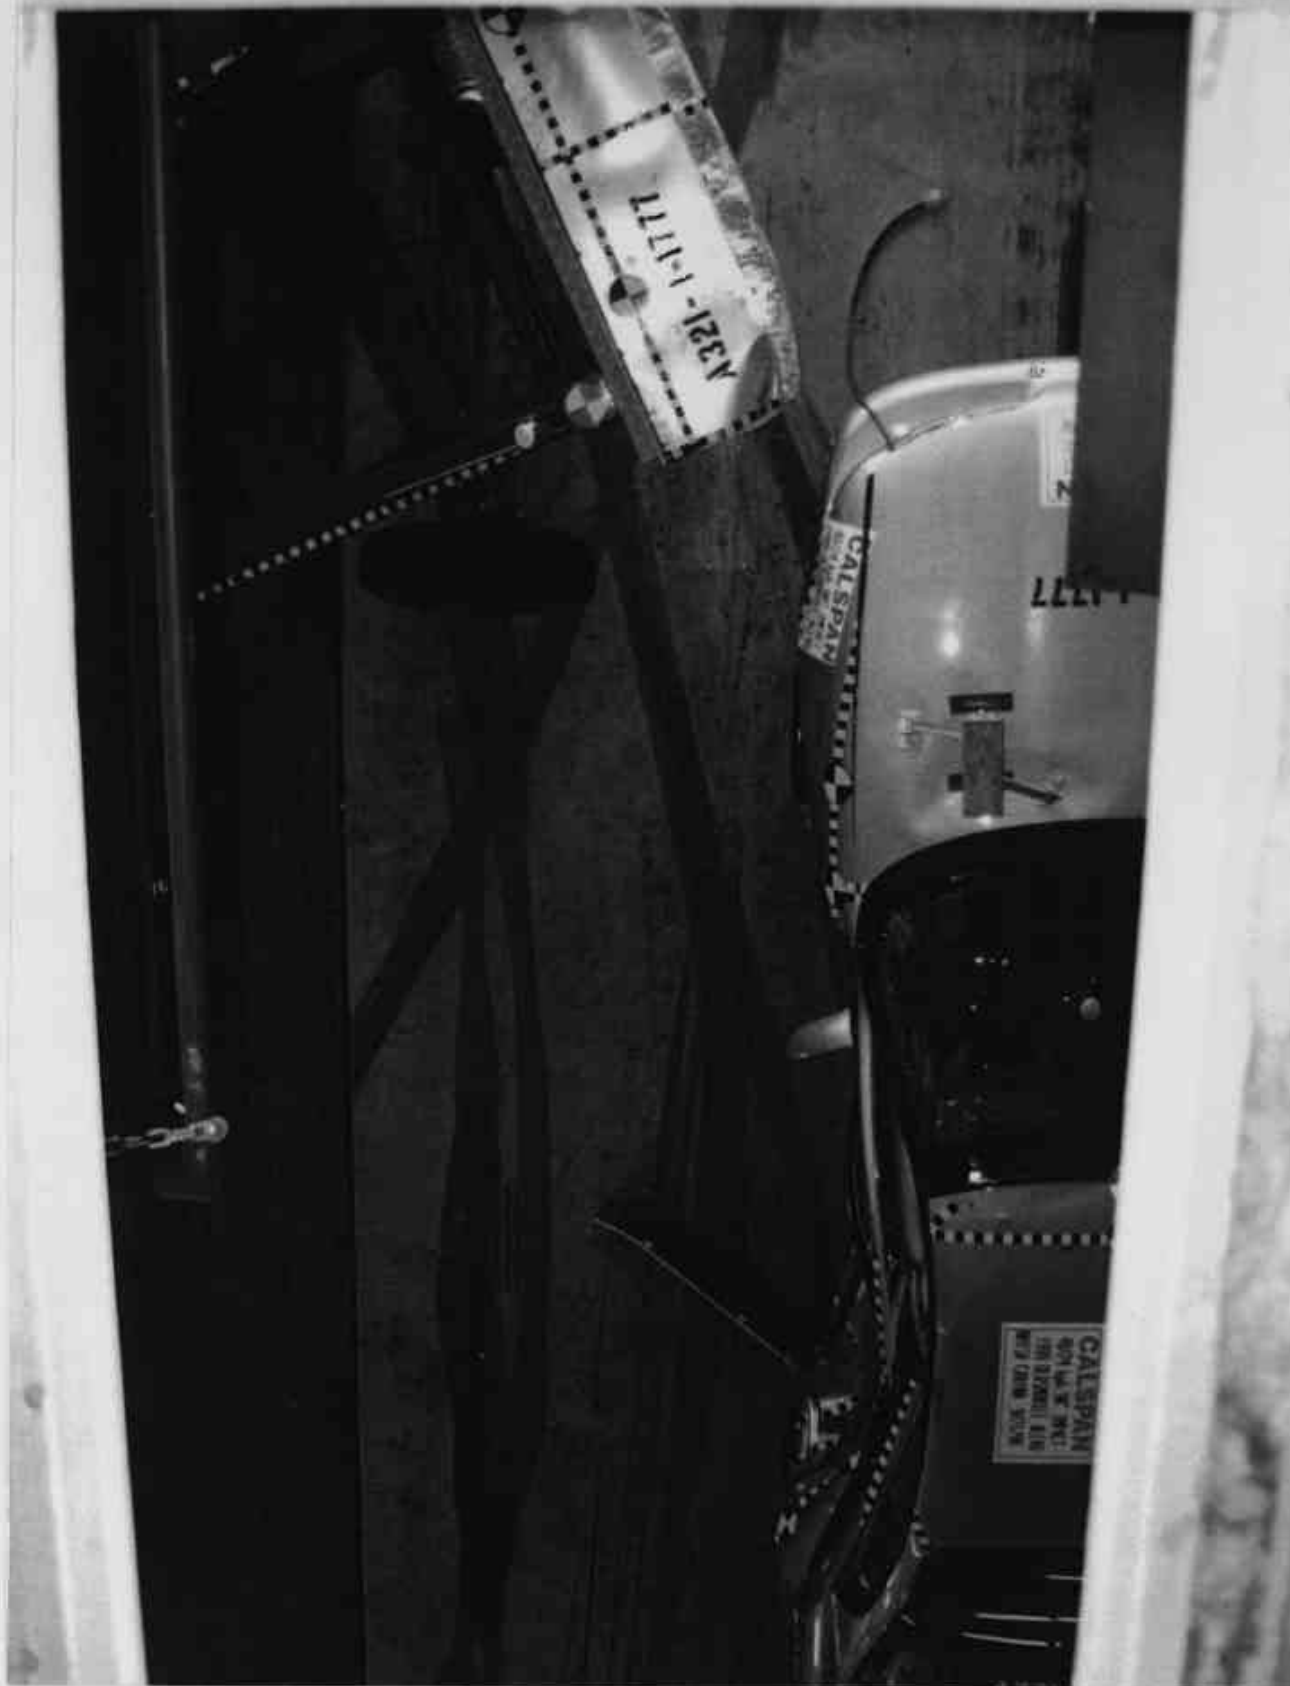
Figure A-16 POST-TEST OVERHEAD VIEW OF MDB AND VEHICLE

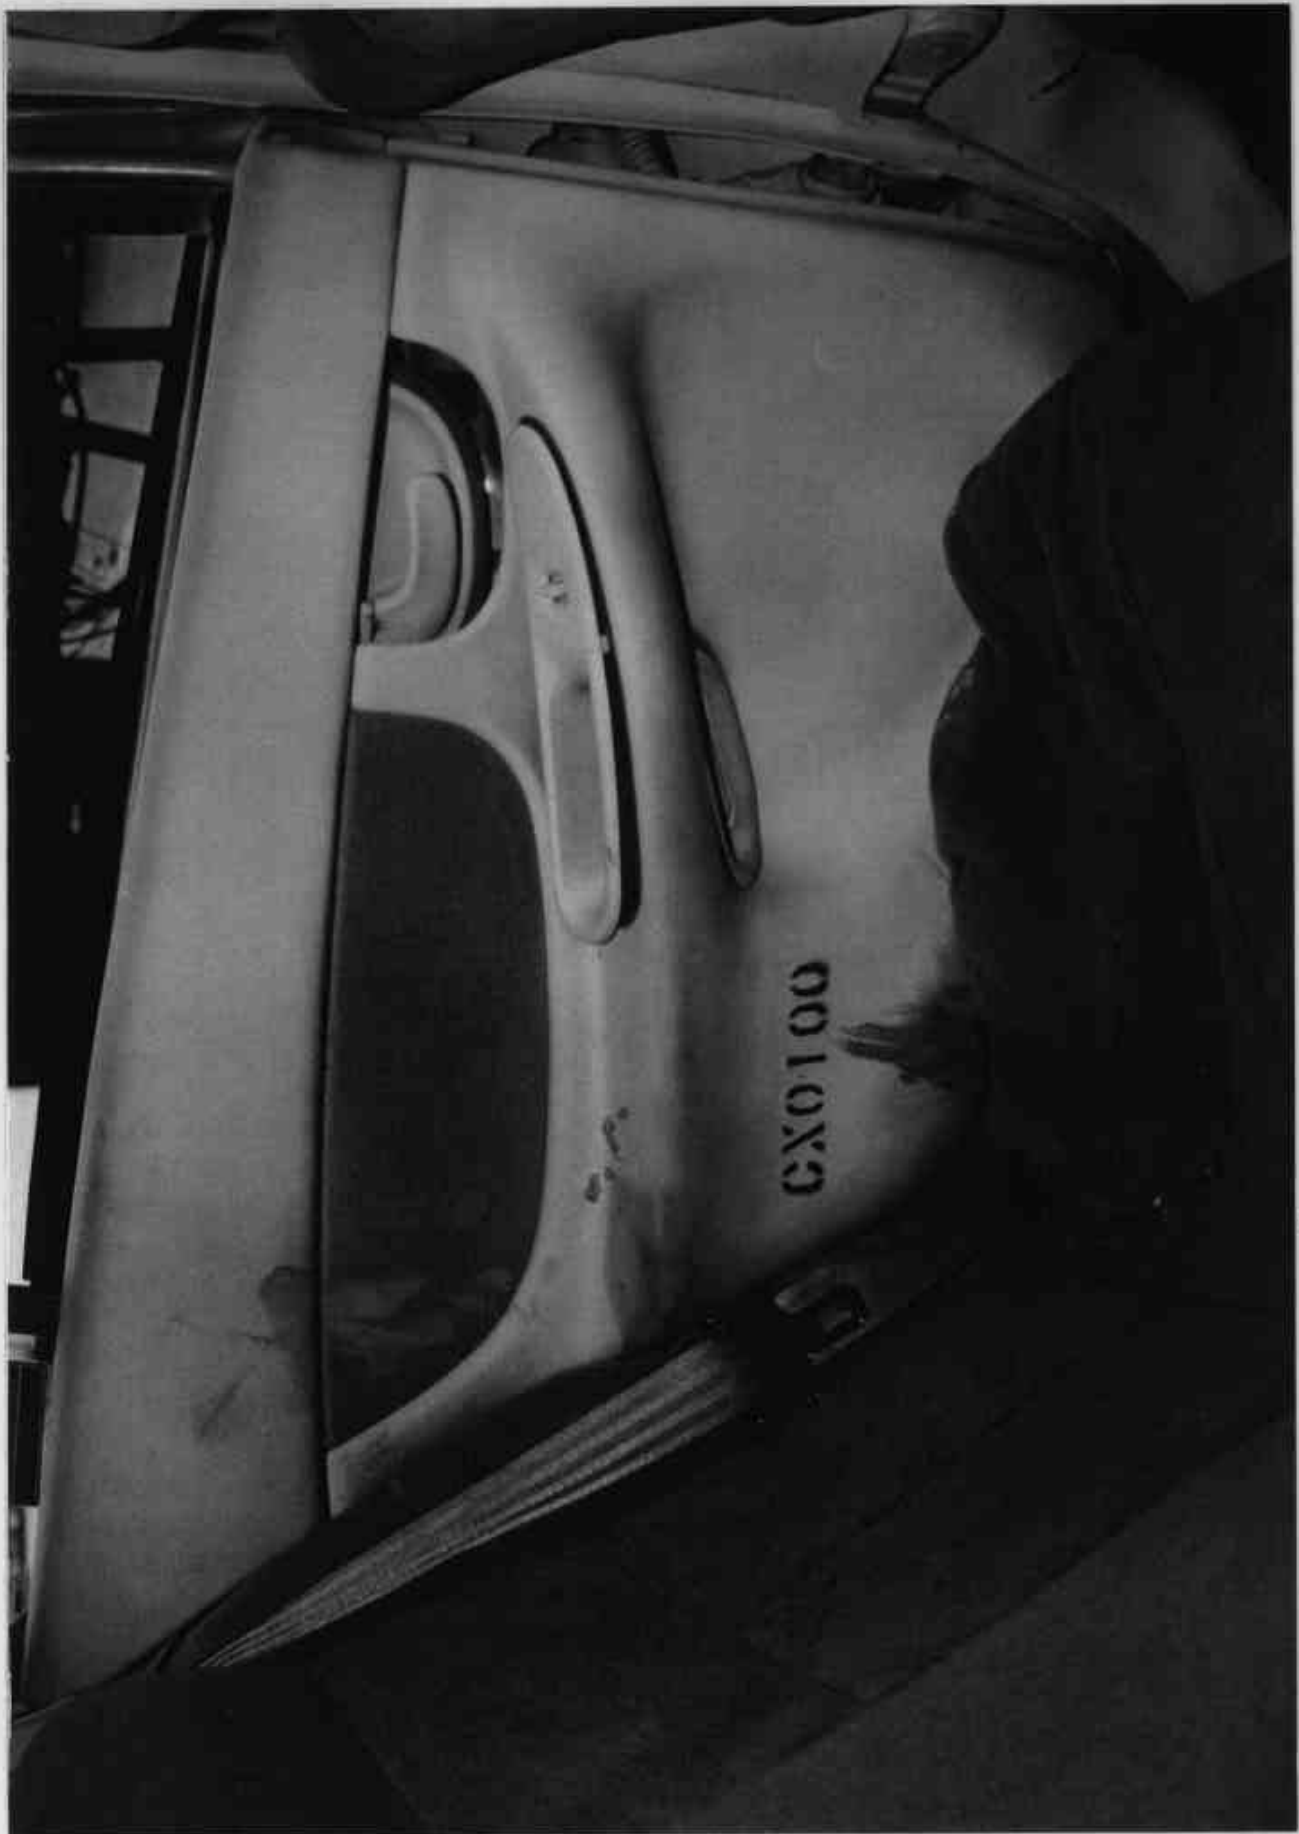
Figure A-28 POST-TEST INTERIOR OF REAR DOOR SHOWING SID IMPACT LOCATIONS
