REPORT NUMBER: 214-CAL-99-03

**SAFETY COMPLIANCE TESTING FOR FMVSS 214  
SIDE IMPACT PROTECTION**

SAAB AUTOMOBILE AB  
1999 SAAB 9-5  
4-DOOR SEDAN

NHTSA NUMBER: CX0500

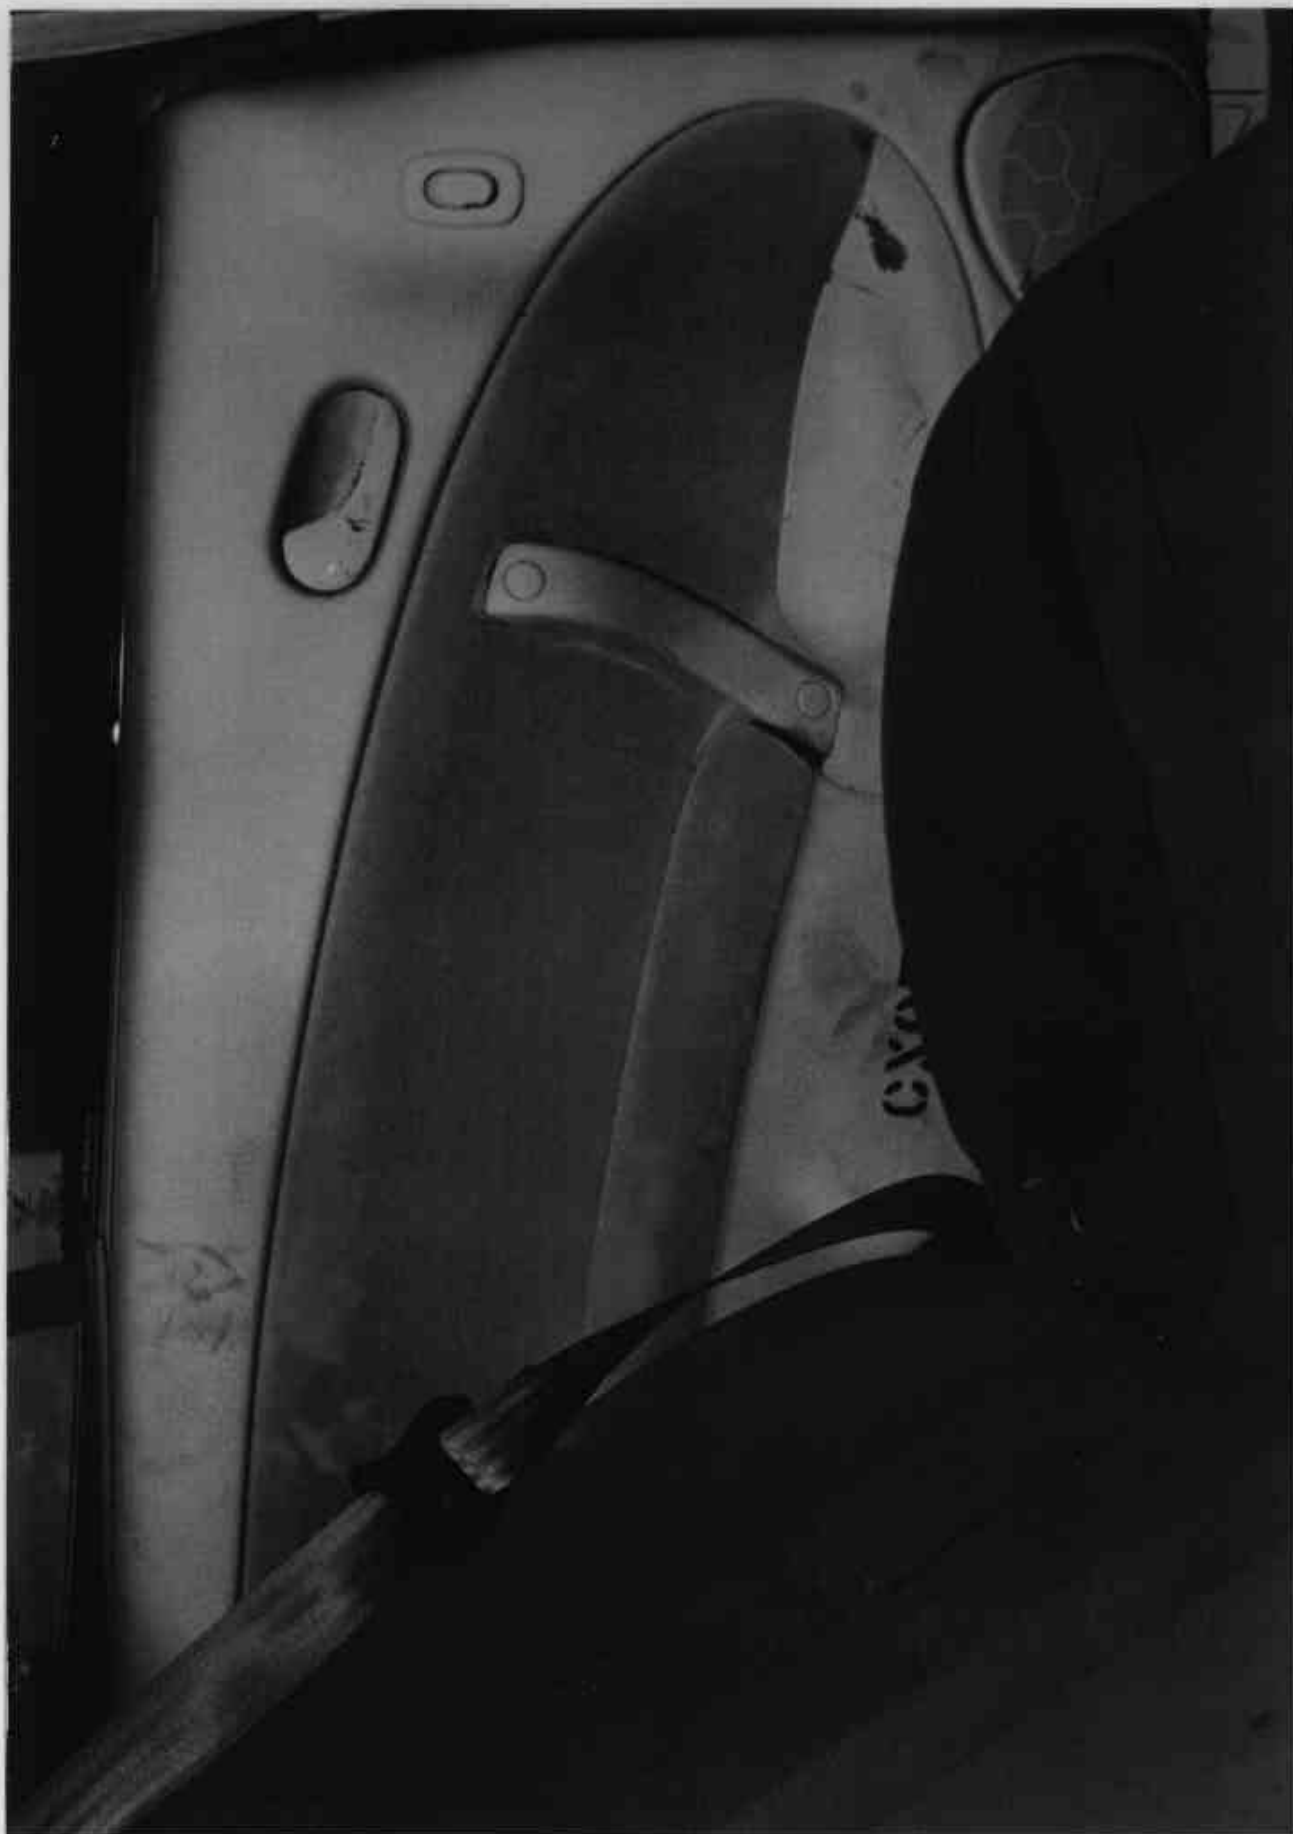
Figure A-28 POST-TEST INTERIOR OF REAR DOOR SHOWING SID IMPACT LOCATIONS
