REPORT NO. KAR-99-05

NATIONAL HIGHWAY TRAFFIC SAFETY ADMINISTRATION  
NEW CAR ASSESSMENT PROGRAM  
FRONTAL BARRIER IMPACT TEST

HONDA MOTOR CORPORATION OF AMERICA  
1999 HONDA CIVIC DX 2-DOOR  
NHTSA NO. MX5301

PREPARED BY:  
KARCO ENGINEERING  
9270 HOLLY ROAD  
ADELANTO, CALIFORNIA 92301

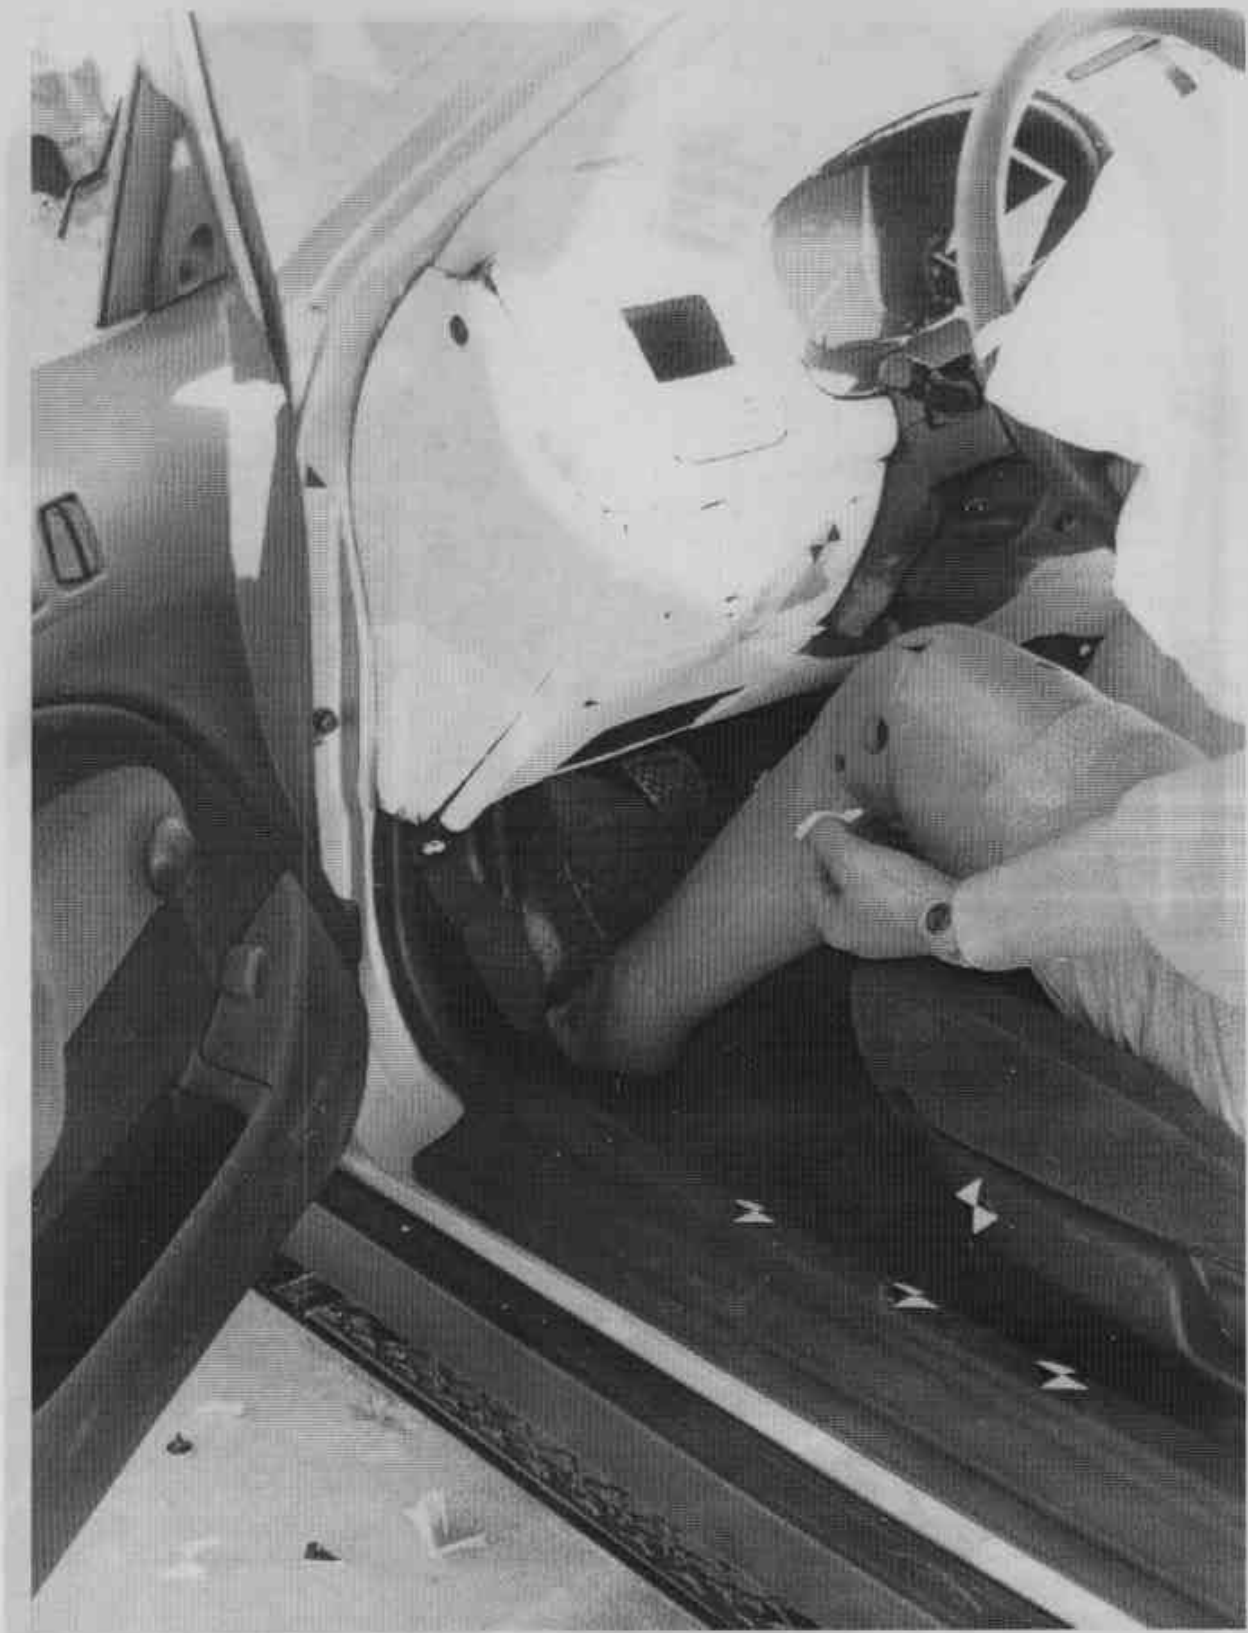
FIGURE A-34. POST TEST DRIVER DUMMY FEET AND KNEE CONTACT

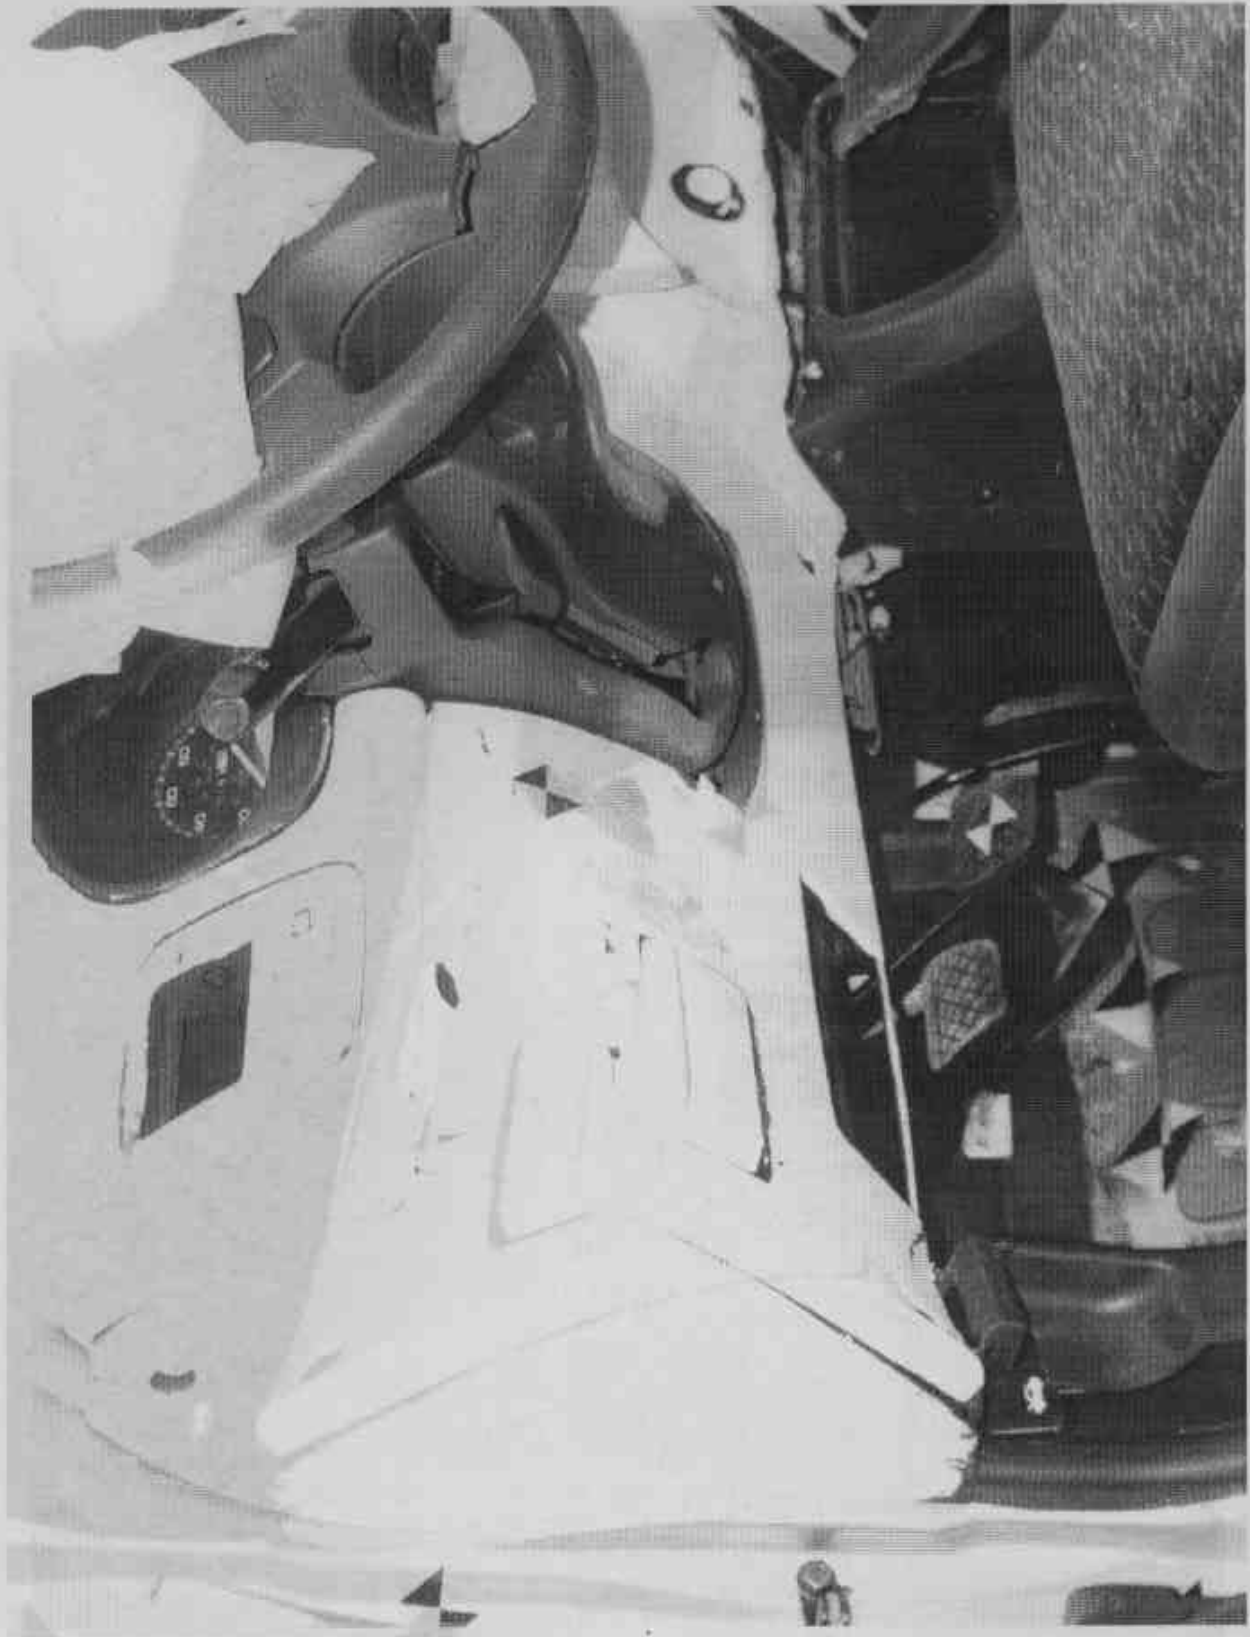
FIGURE A-36. POST TEST DRIVER KNEE BOLSTER

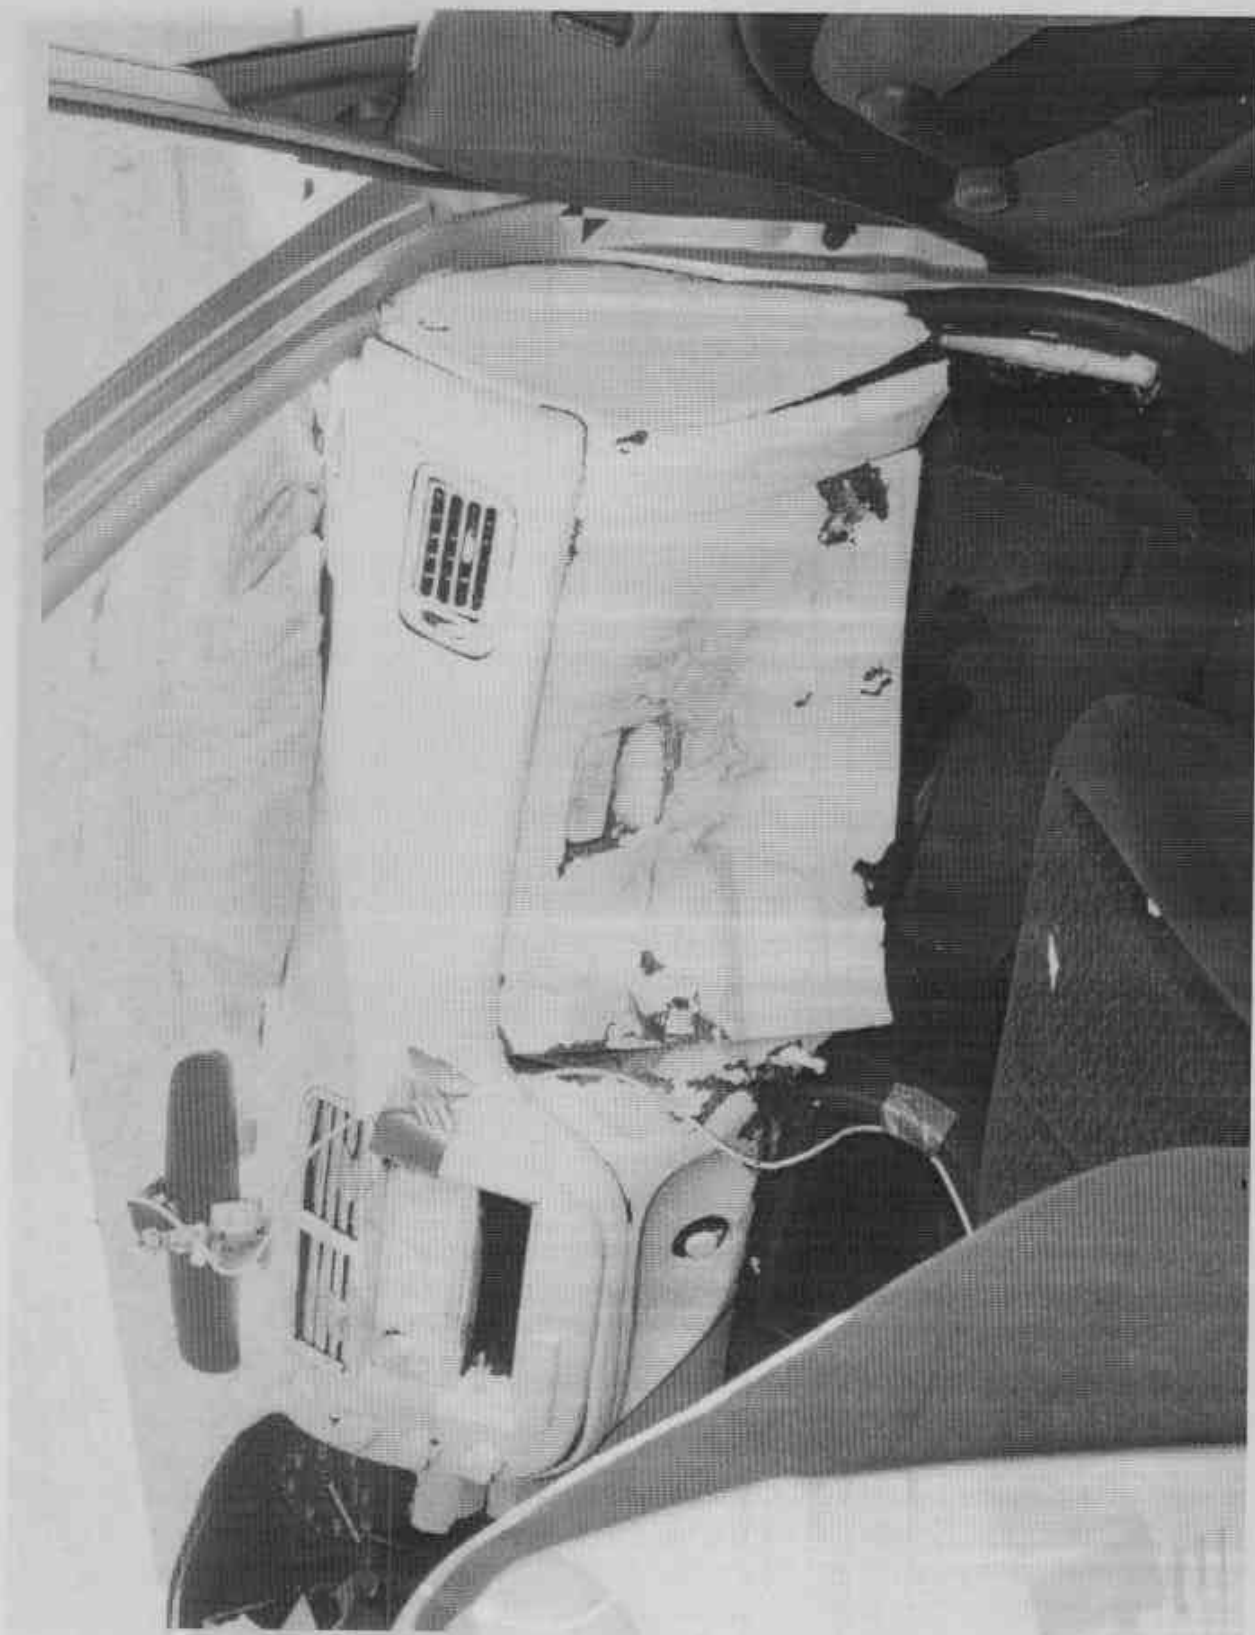
FIGURE A-54. POST TEST PASSENGER SIDE KNEE BOLSTER AND DUMMY CONTACT
