REPORT NUMBER: SNCAP-CAL-99-01

**NEW CAR ASSESSMENT PROGRAM  
SIDE IMPACT TEST**

CHRYSLER CORPORATION  
1999 DODGE DAKOTA CLUB CAB  
TRUCK

NHTSA NUMBER: MX0302

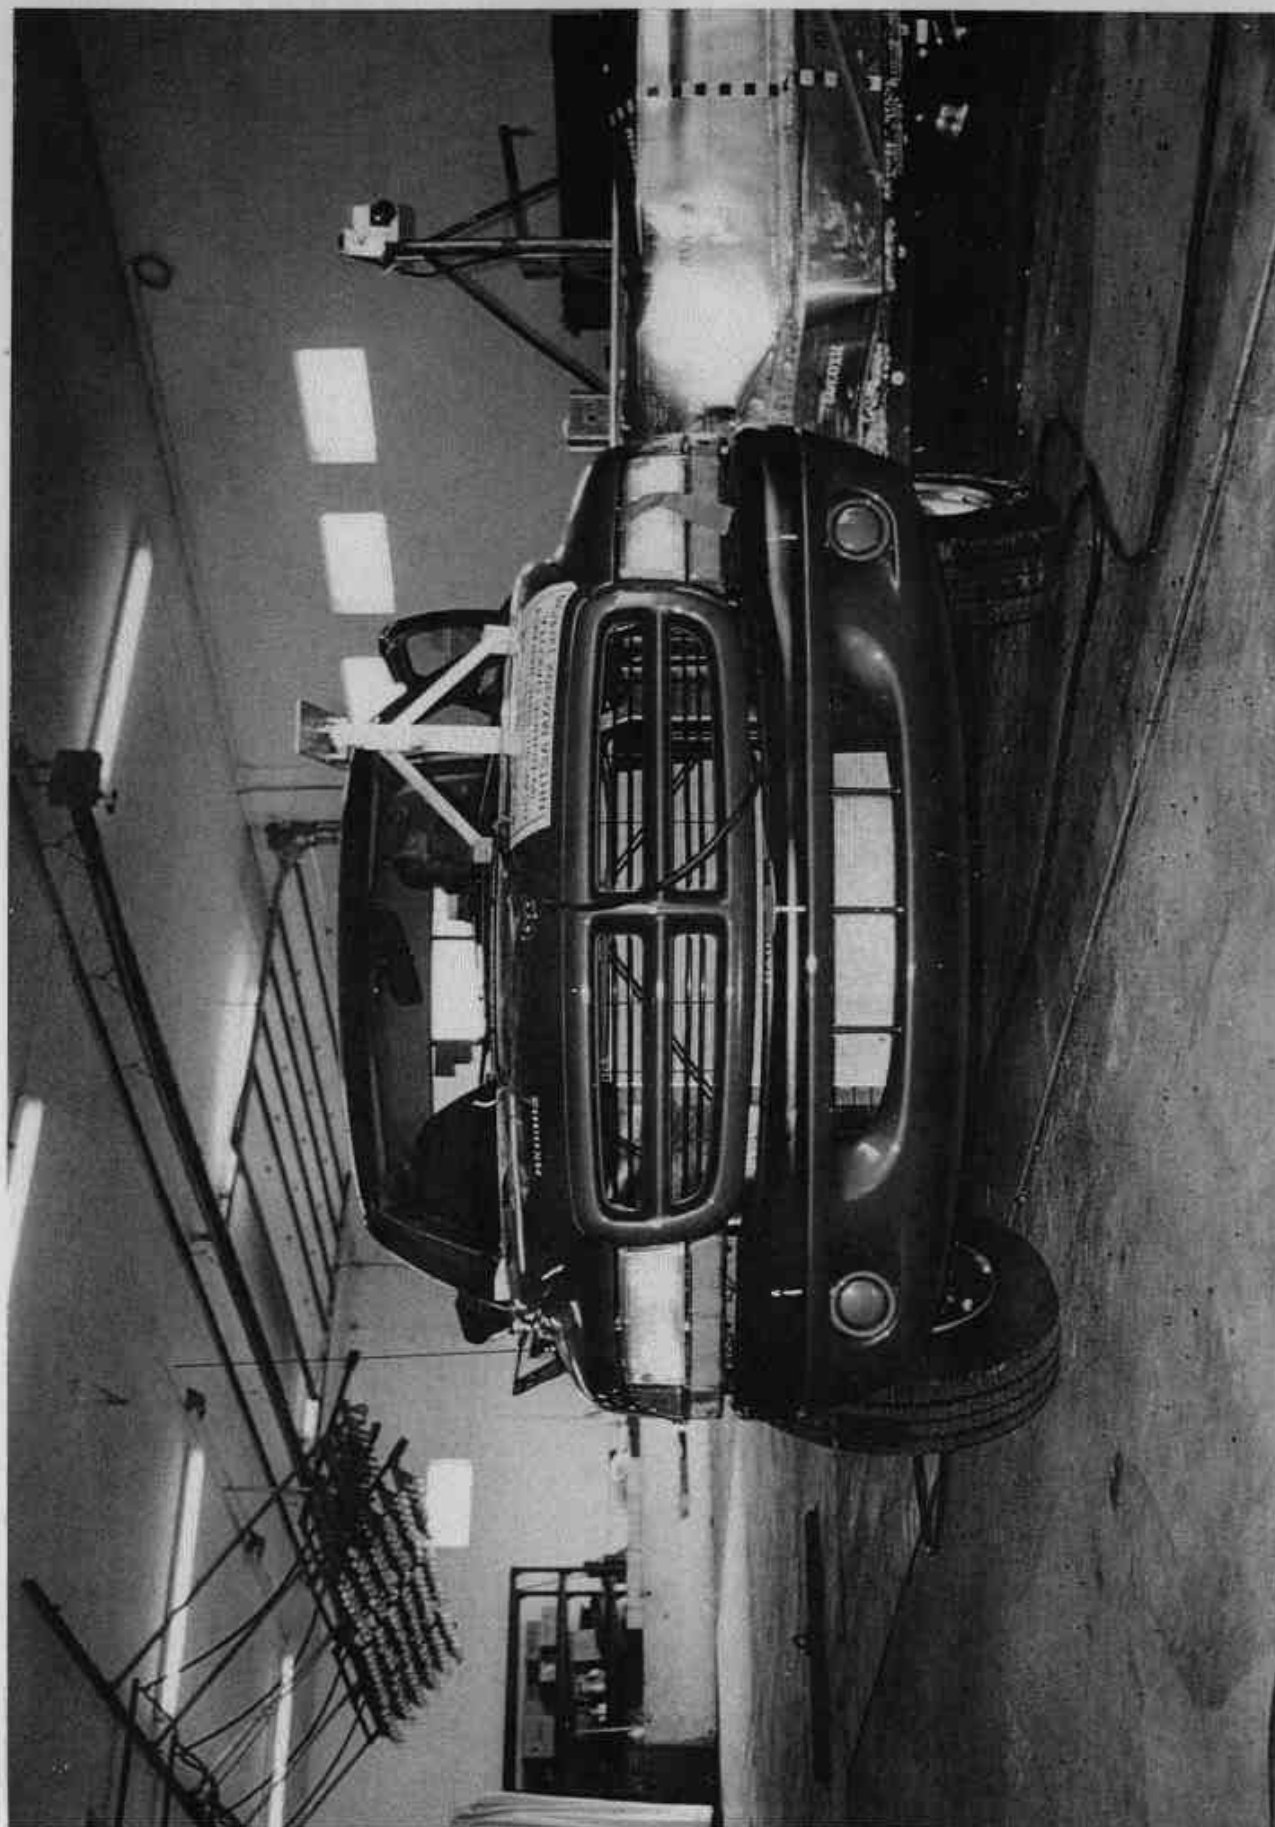
Figure A-2 POST-TEST FRONTAL VIEW OF TEST VEHICLE

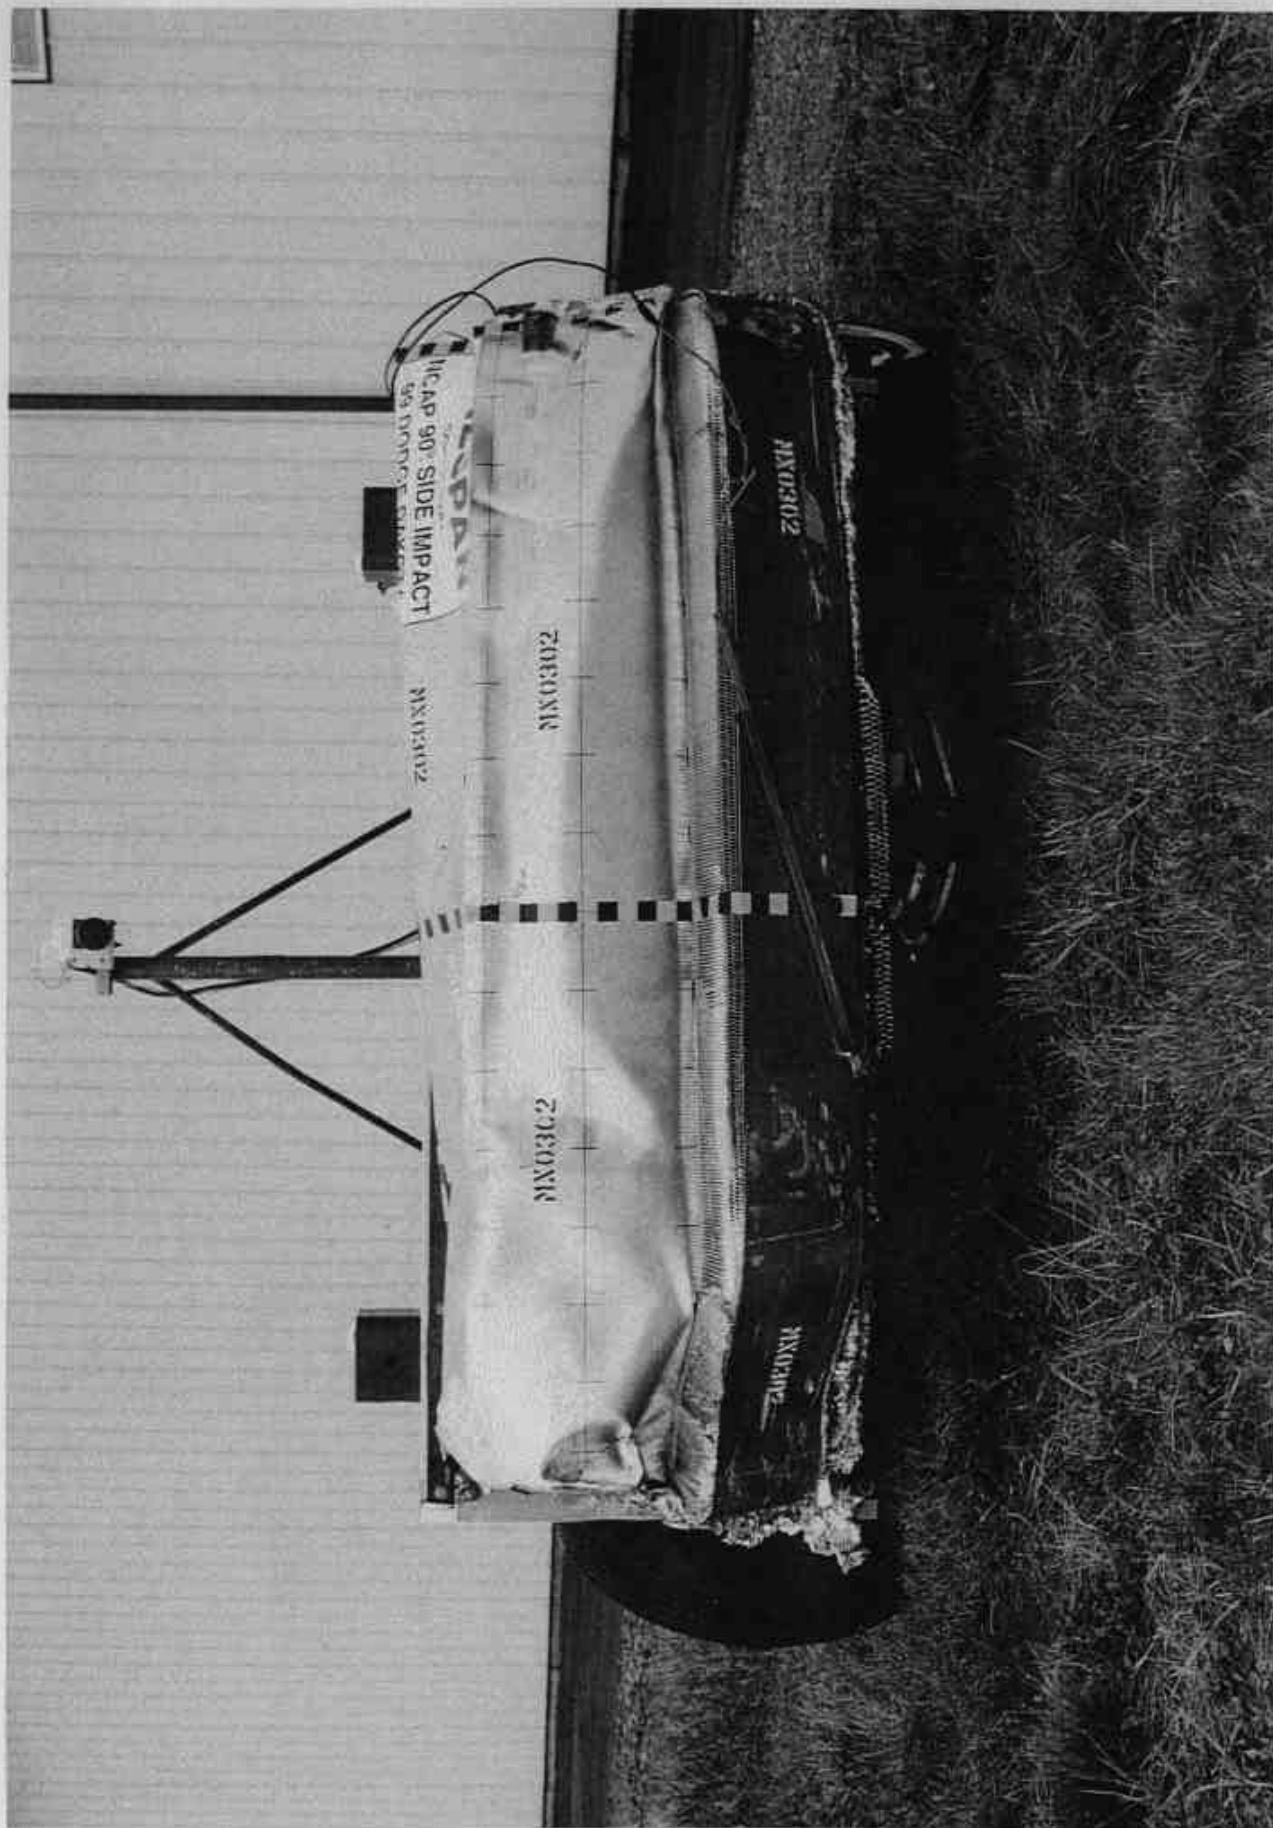
Figure A-8 POST-TEST FRONTAL VIEW OF IMPACTOR FACE

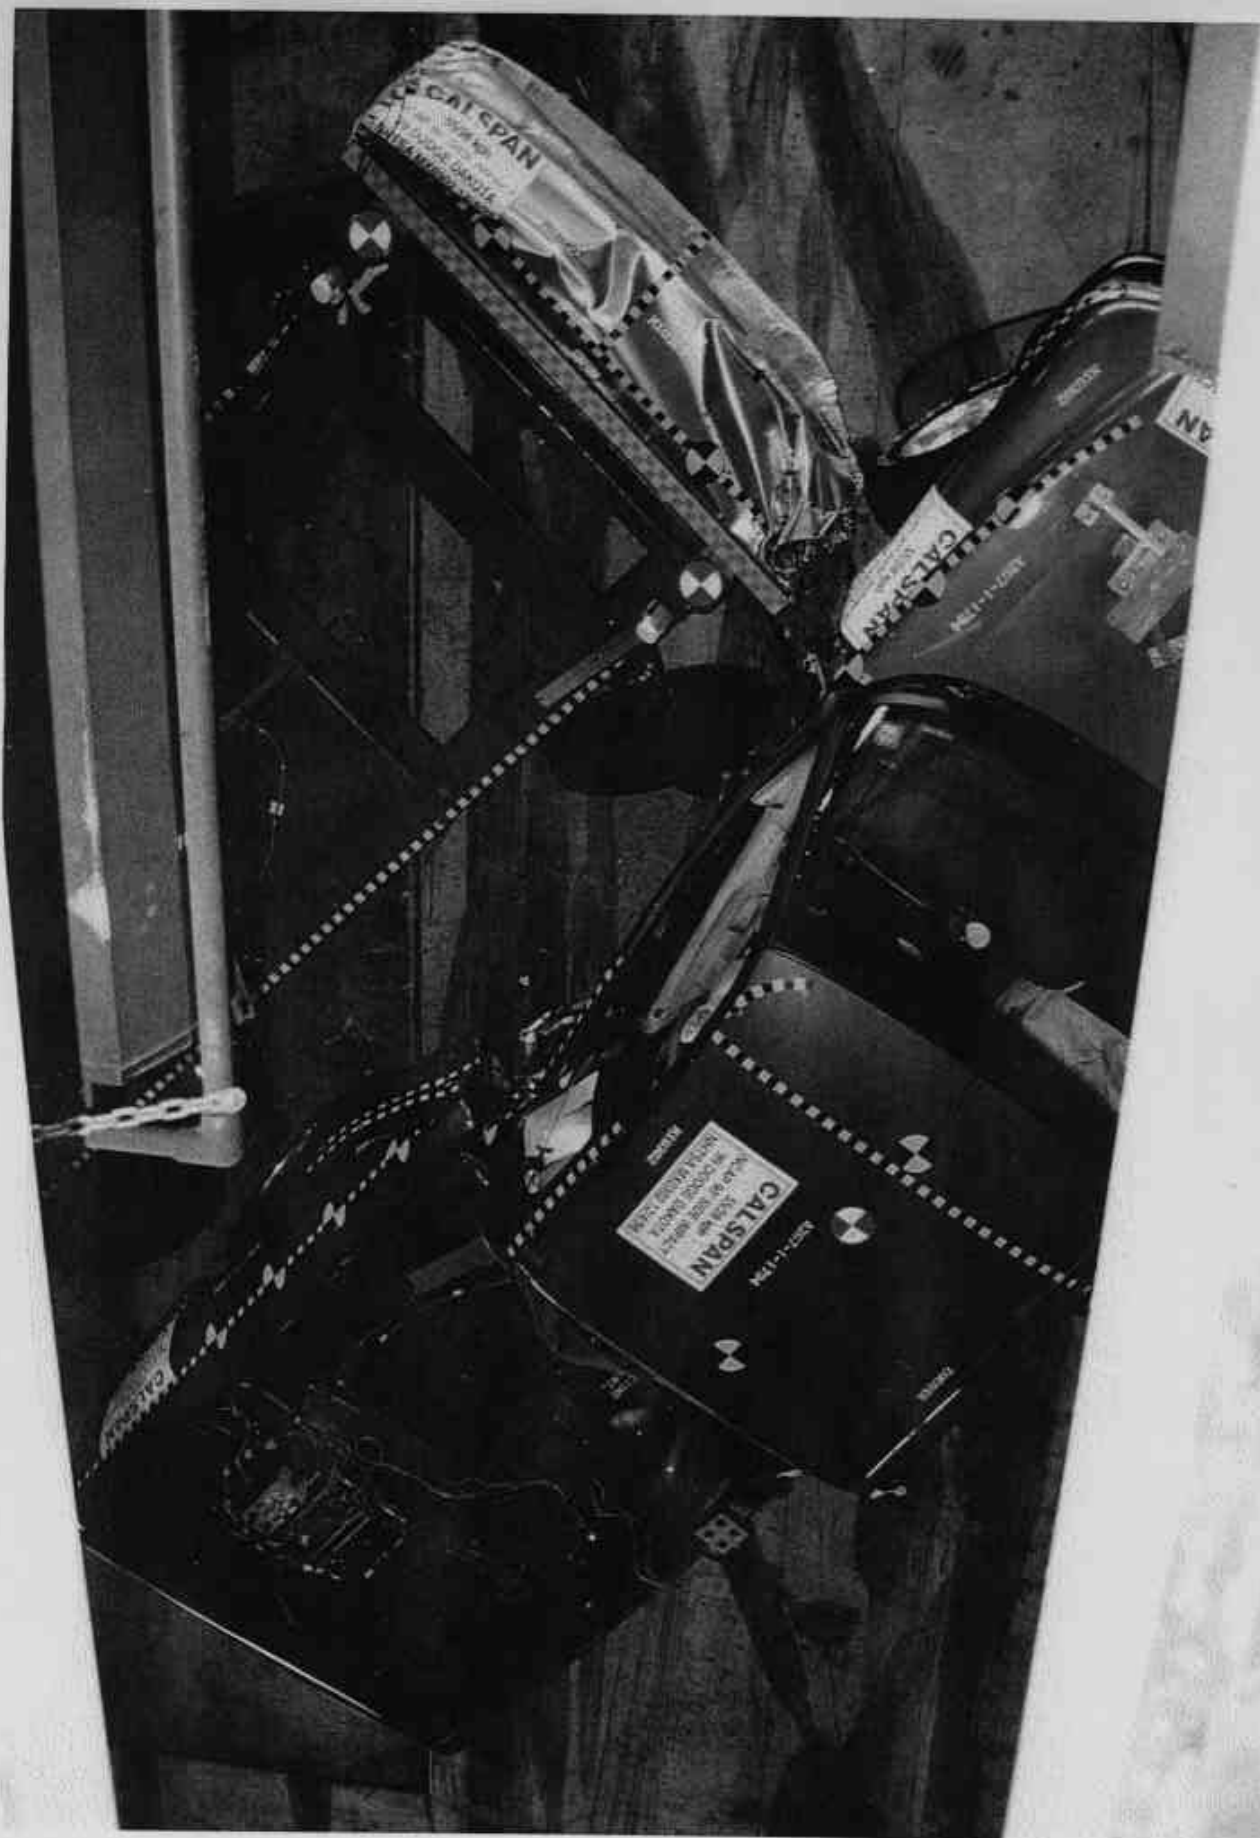
Figure A-16 POST-TEST OVERHEAD VIEW OF MDB AND VEHICLE

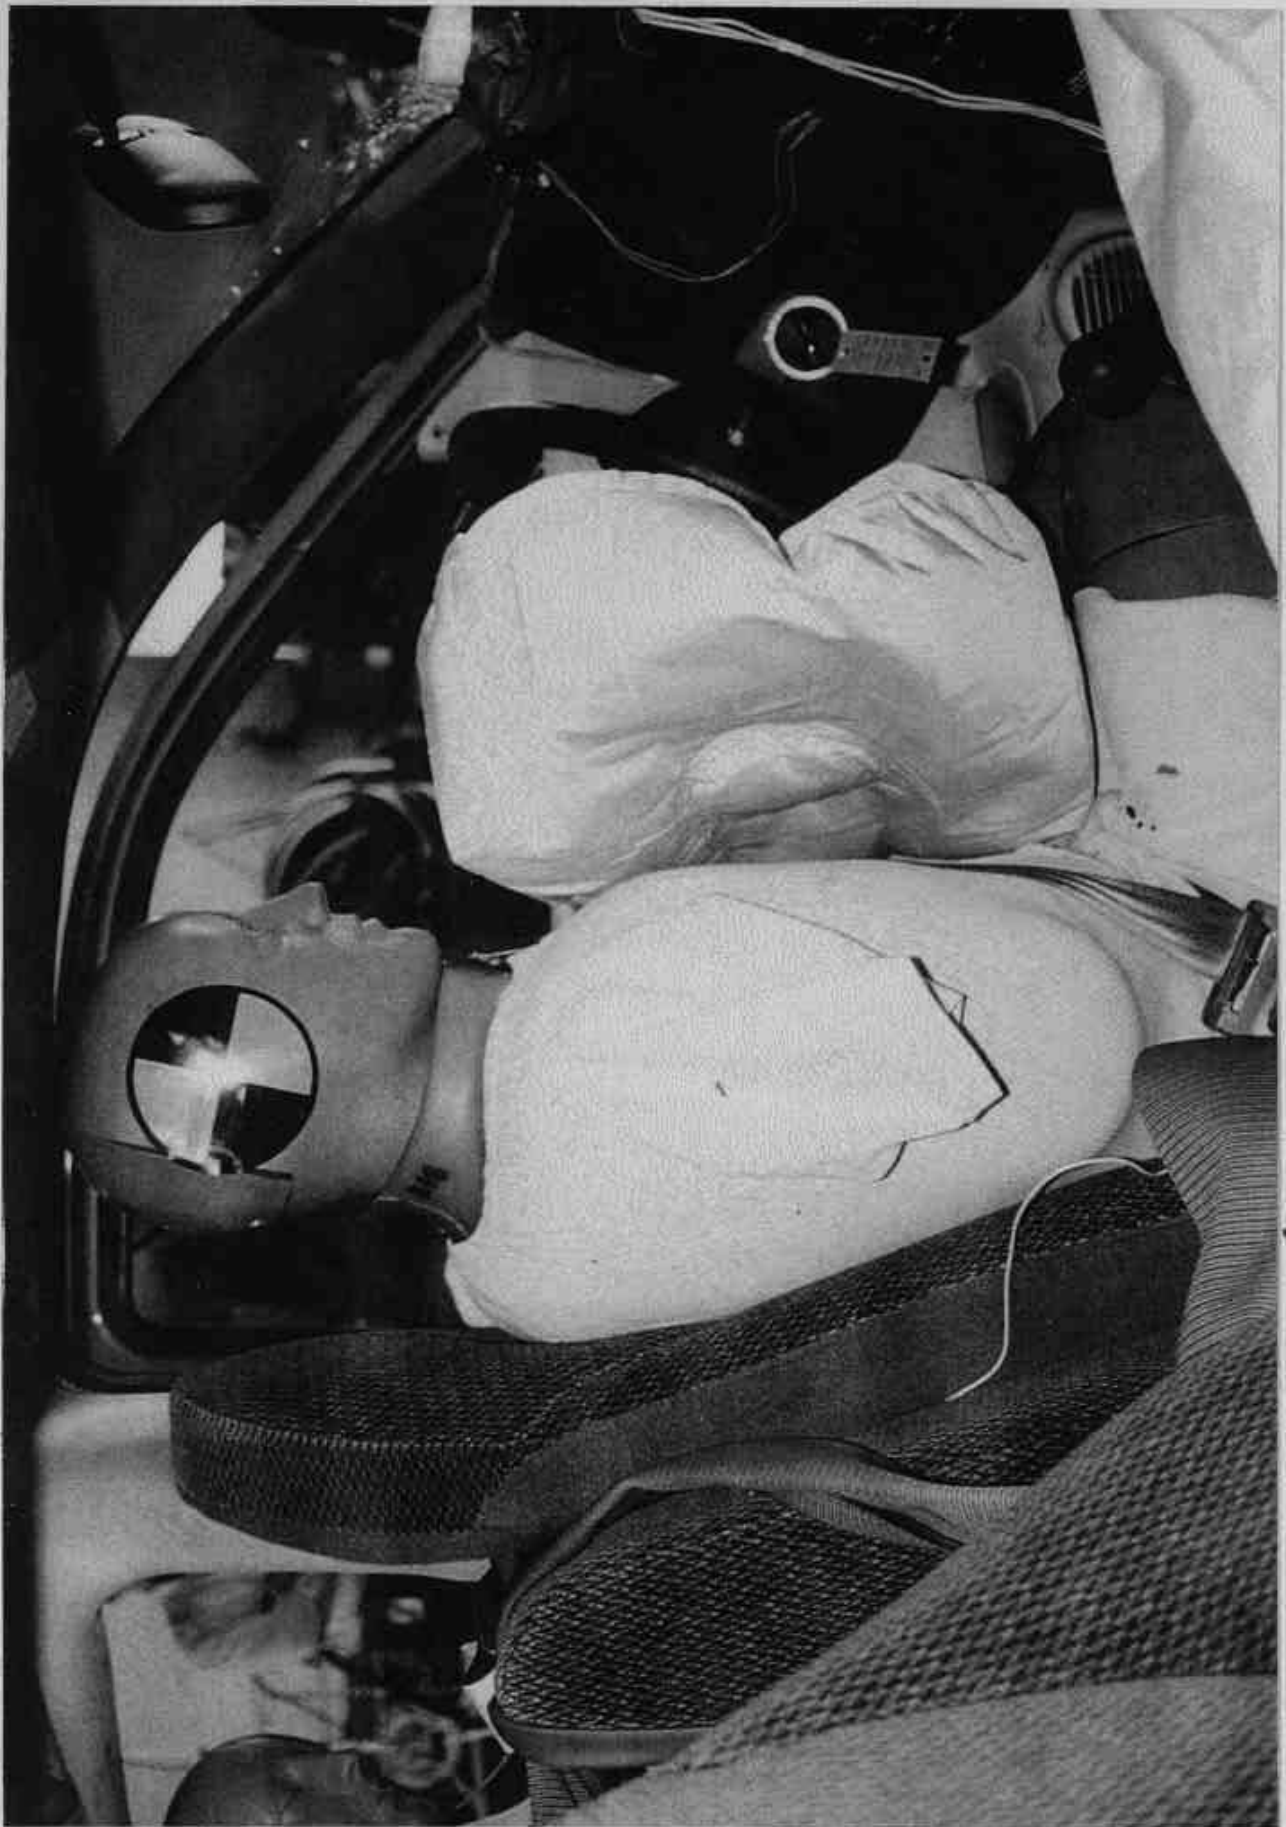
Figure A-18 POST-TEST RIGHT OCCUPANT COMPARTMENT VIEW OF FRONT SID

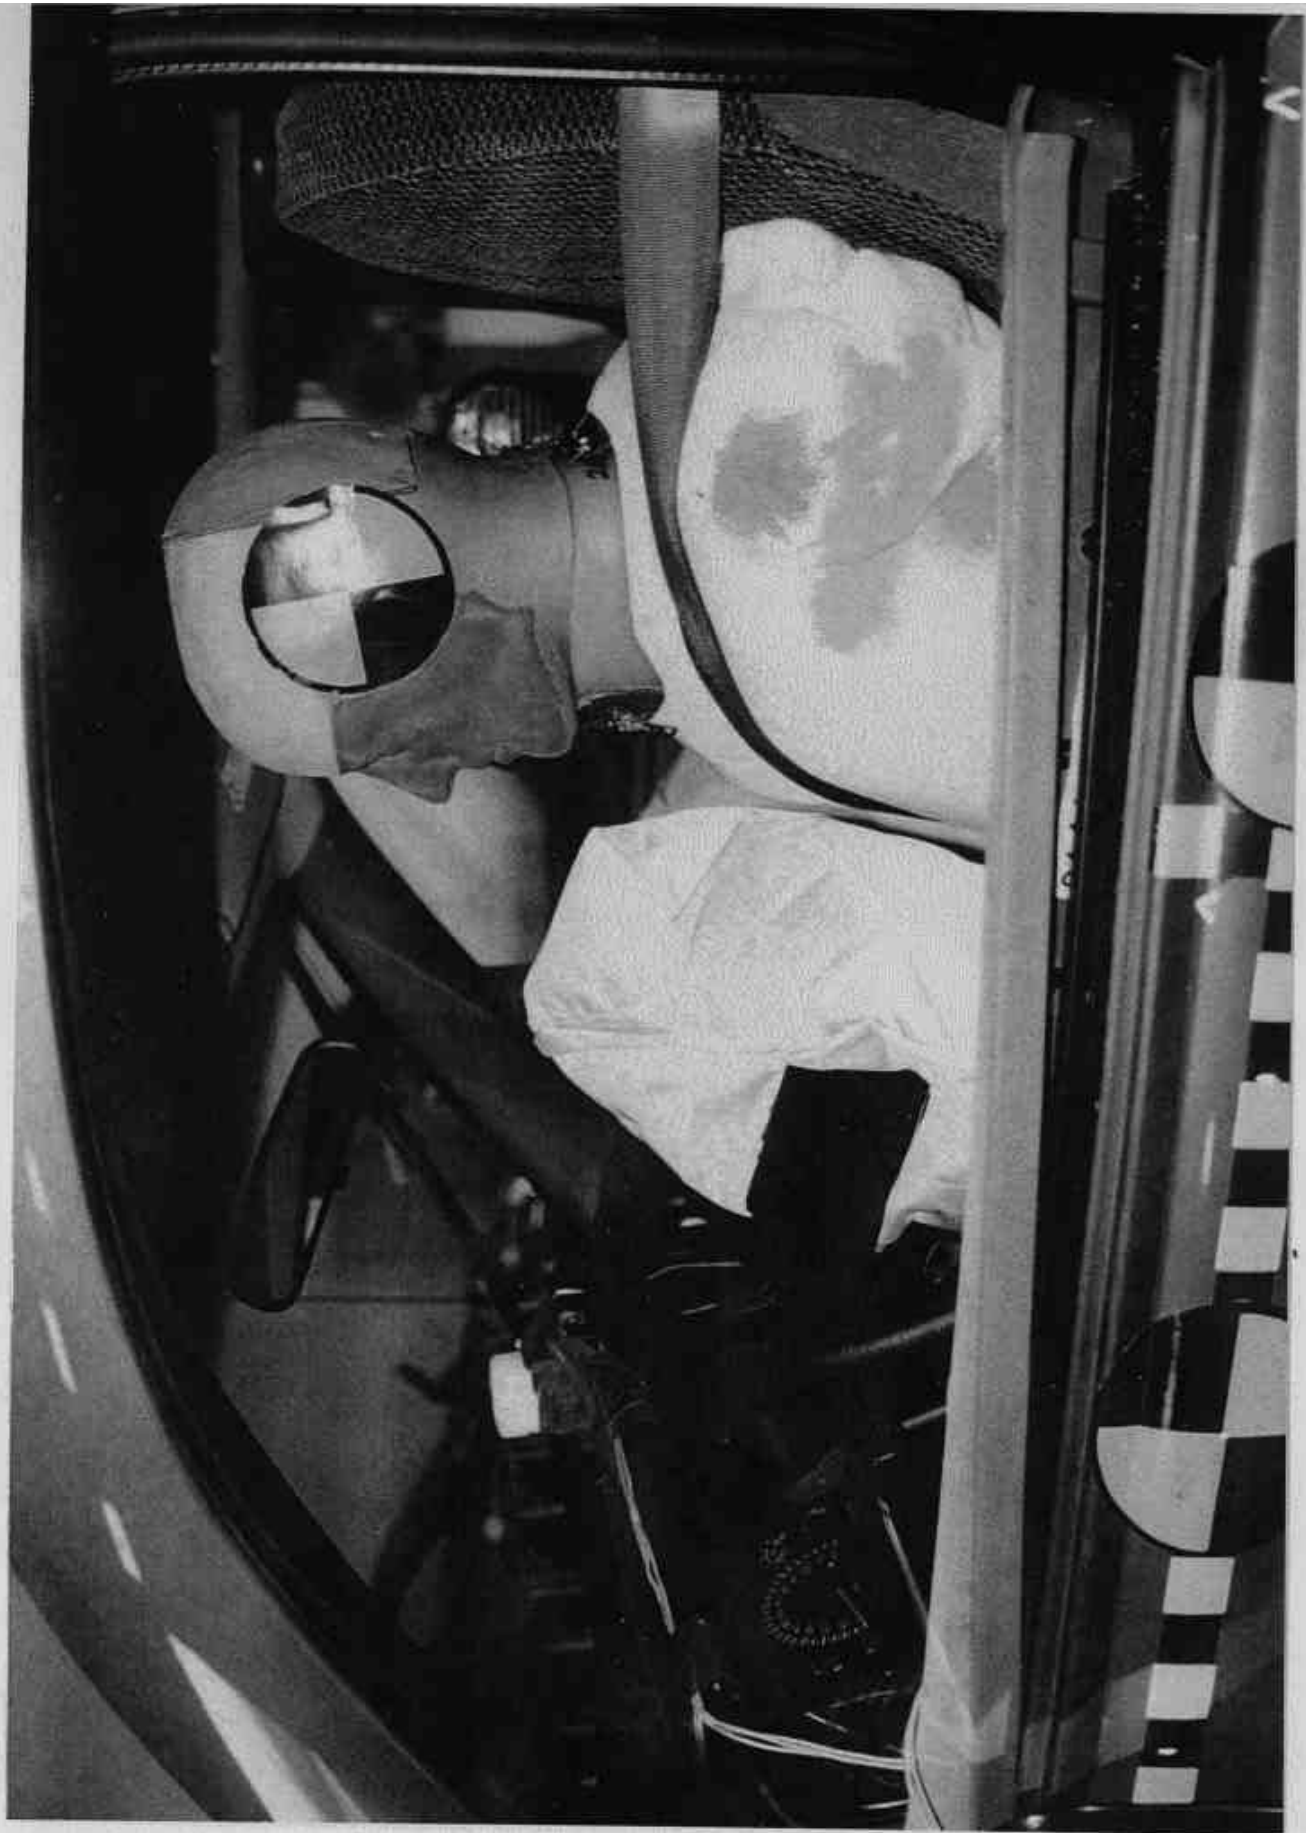
Figure A-22 POST-TEST LEFT OCCUPANT COMPARTMENT VIEW OF FRONT SID

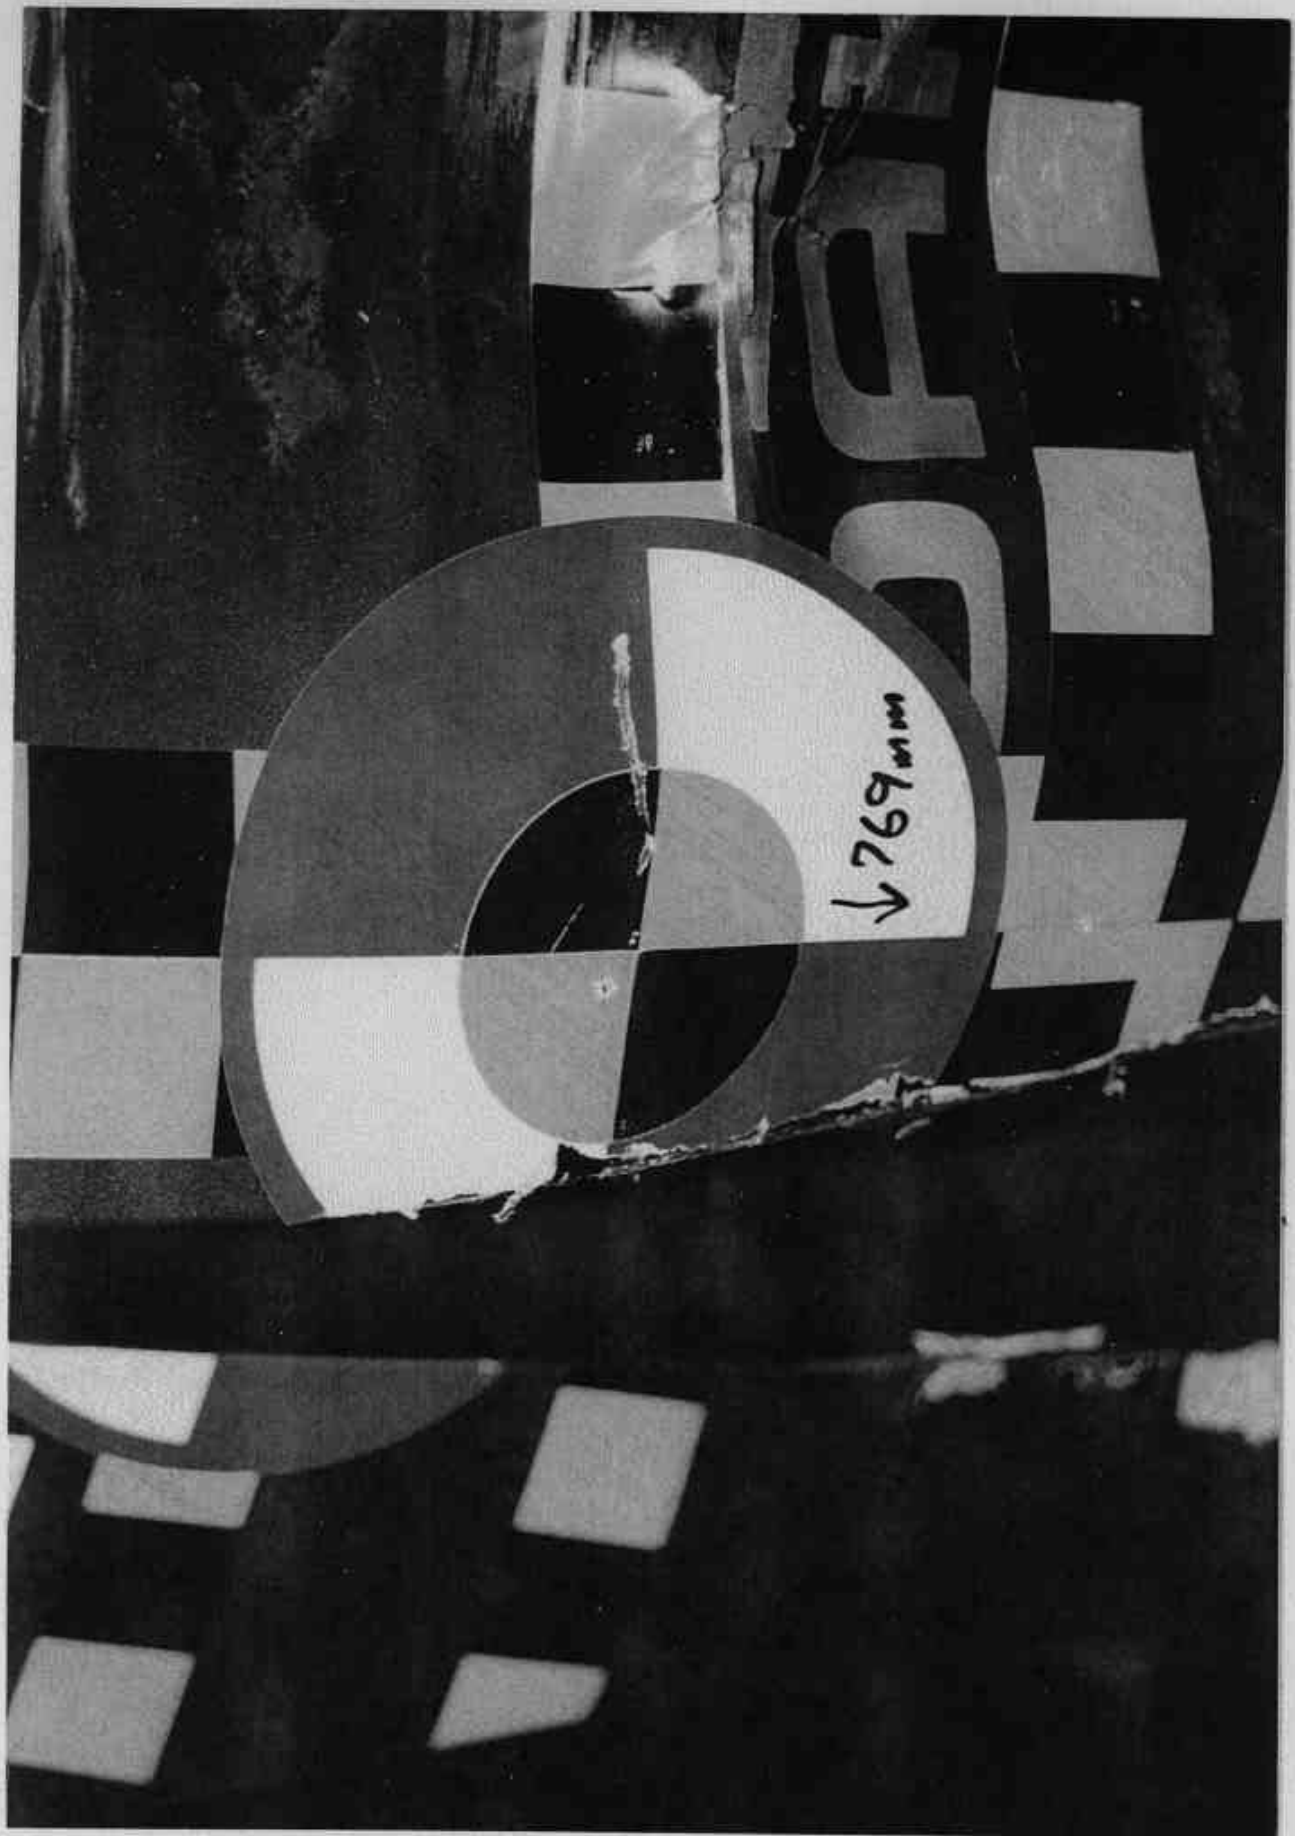
Figure A-31 POST-TEST CLOSE-UP VIEW OF IMPACT POINT TARGET

Actual Impact Point is 5 mm forward of nominal impact ref. line (Lateral)

Actual Impact Point is 4 mm above nominal impact point (Vertical)
