REPORT NO. KAR-99-08

NATIONAL HIGHWAY TRAFFIC SAFETY ADMINISTRATION  
NEW CAR ASSESSMENT PROGRAM  
FRONTAL BARRIER IMPACT TEST

MAZDA CORPORATION  
1999 MAZDA PROTEGE DX 4-DOOR SEDAN  
NHTSA NO. MX5401

PREPARED BY:  
KARCO ENGINEERING  
9270 HOLLY ROAD  
ADELANTO, CALIFORNIA 92301

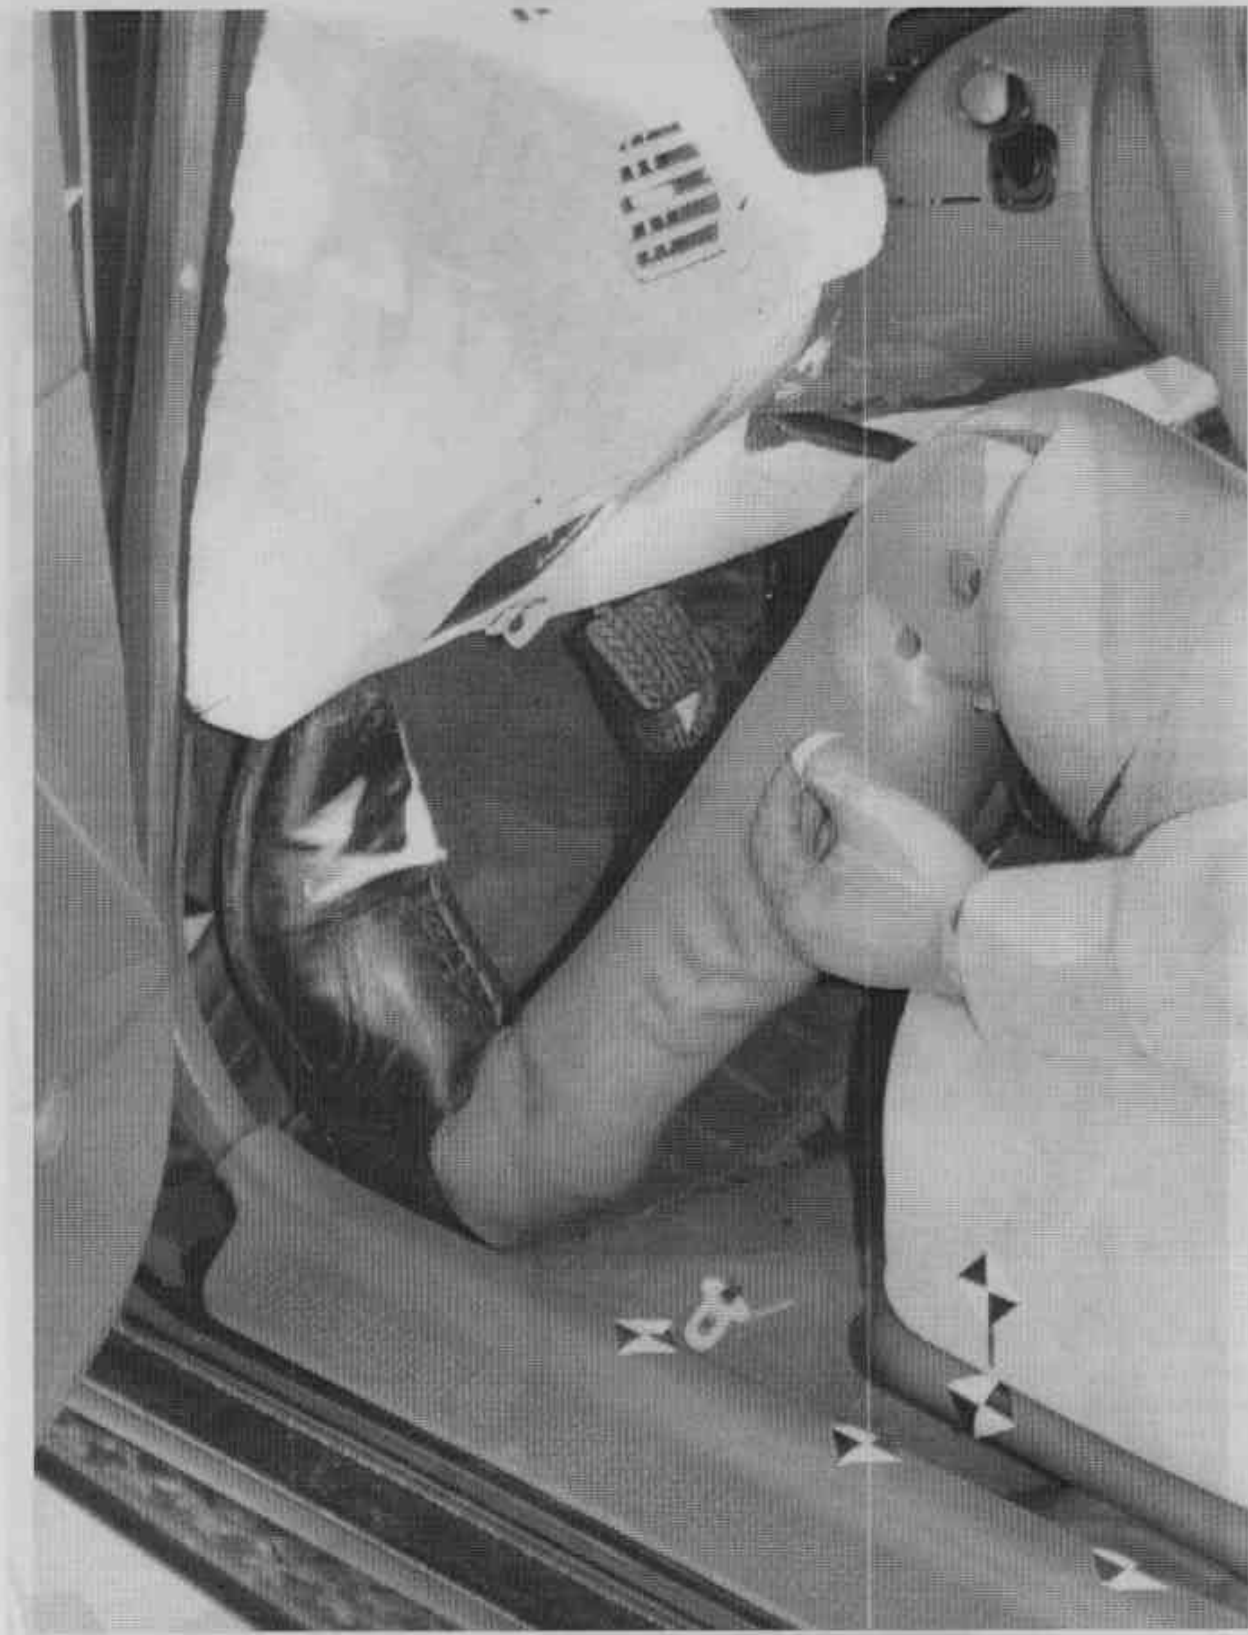
FIGURE A-34. POST TEST DRIVER DUMMY FEET AND KNEE CONTACT

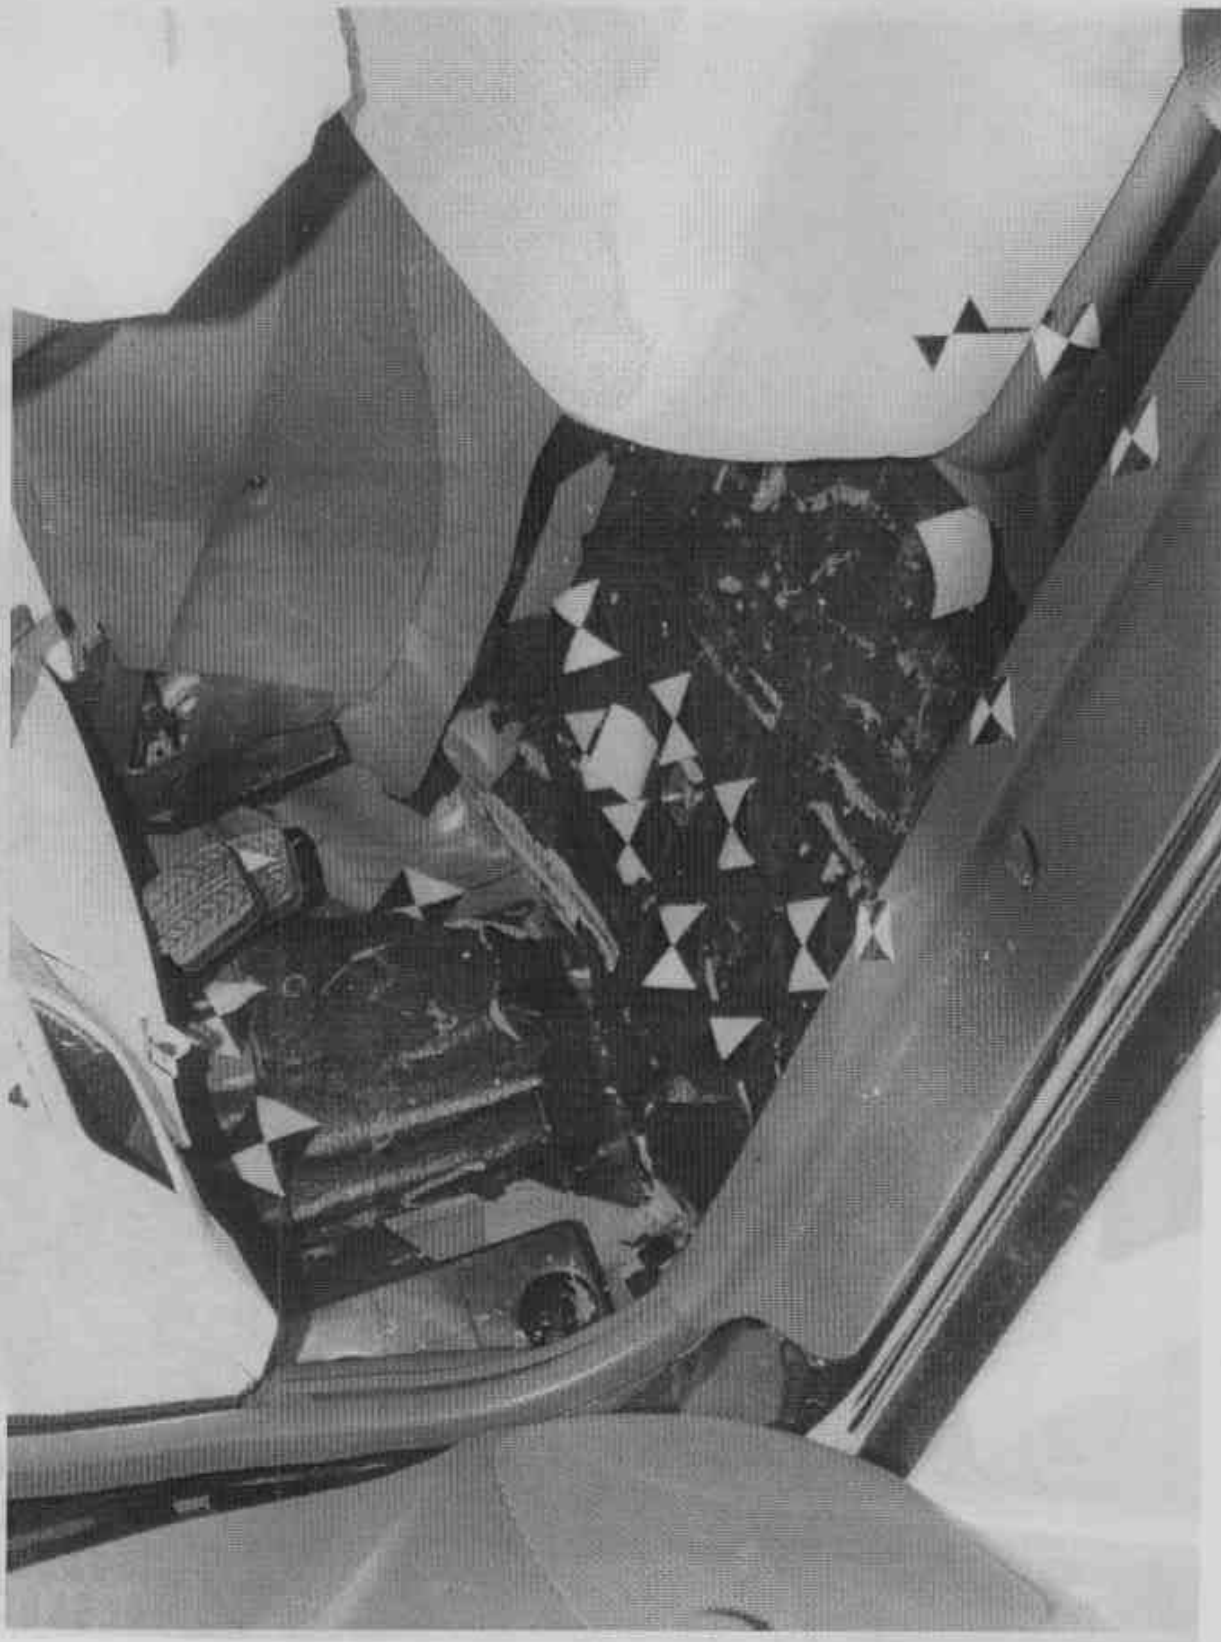
FIGURE A-38. POST TEST DRIVER SIDE FLOOR PAN
