REPORT NO. KAR-99-09

**NATIONAL HIGHWAY TRAFFIC SAFETY ADMINISTRATION**  
**NEW CAR ASSESSMENT PROGRAM**  
**FRONTAL BARRIER IMPACT TEST**

**MAZDA CORPORATION**  
**1999 MAZDA 626 LX 4-DOOR SEDAN**  
**NHTSA NO. MX5400**

**JANUARY 26, 1999**  
**FINAL REPORT**

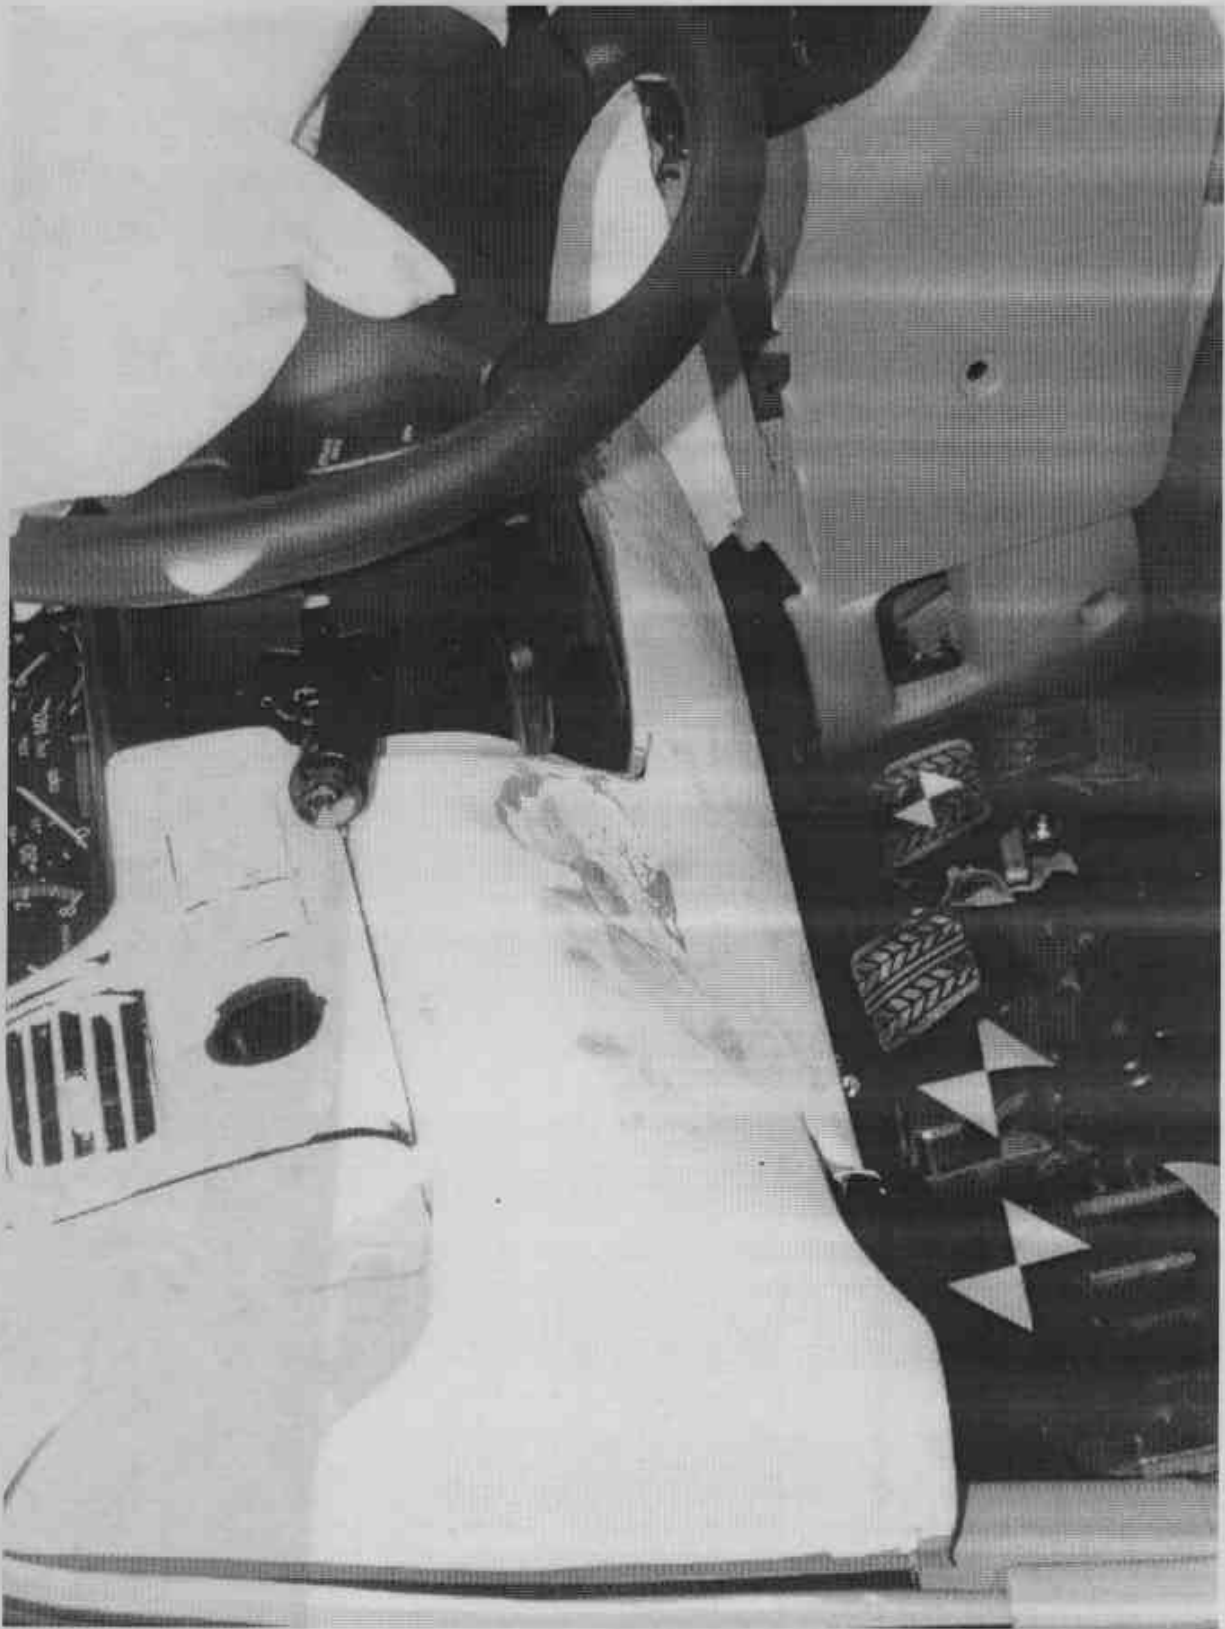
FIGURE A-36. POST TEST DRIVER KNEE BOLSTER
