REPORT NO.: 214D-MGA-99-16

NEW CAR ASSESSMENT PROGRAM  
SIDE IMPACT TESTING  
PASSENGER CARS

1999 TOYOTA SIENNA CE MINI-VAN

FINAL REPORT

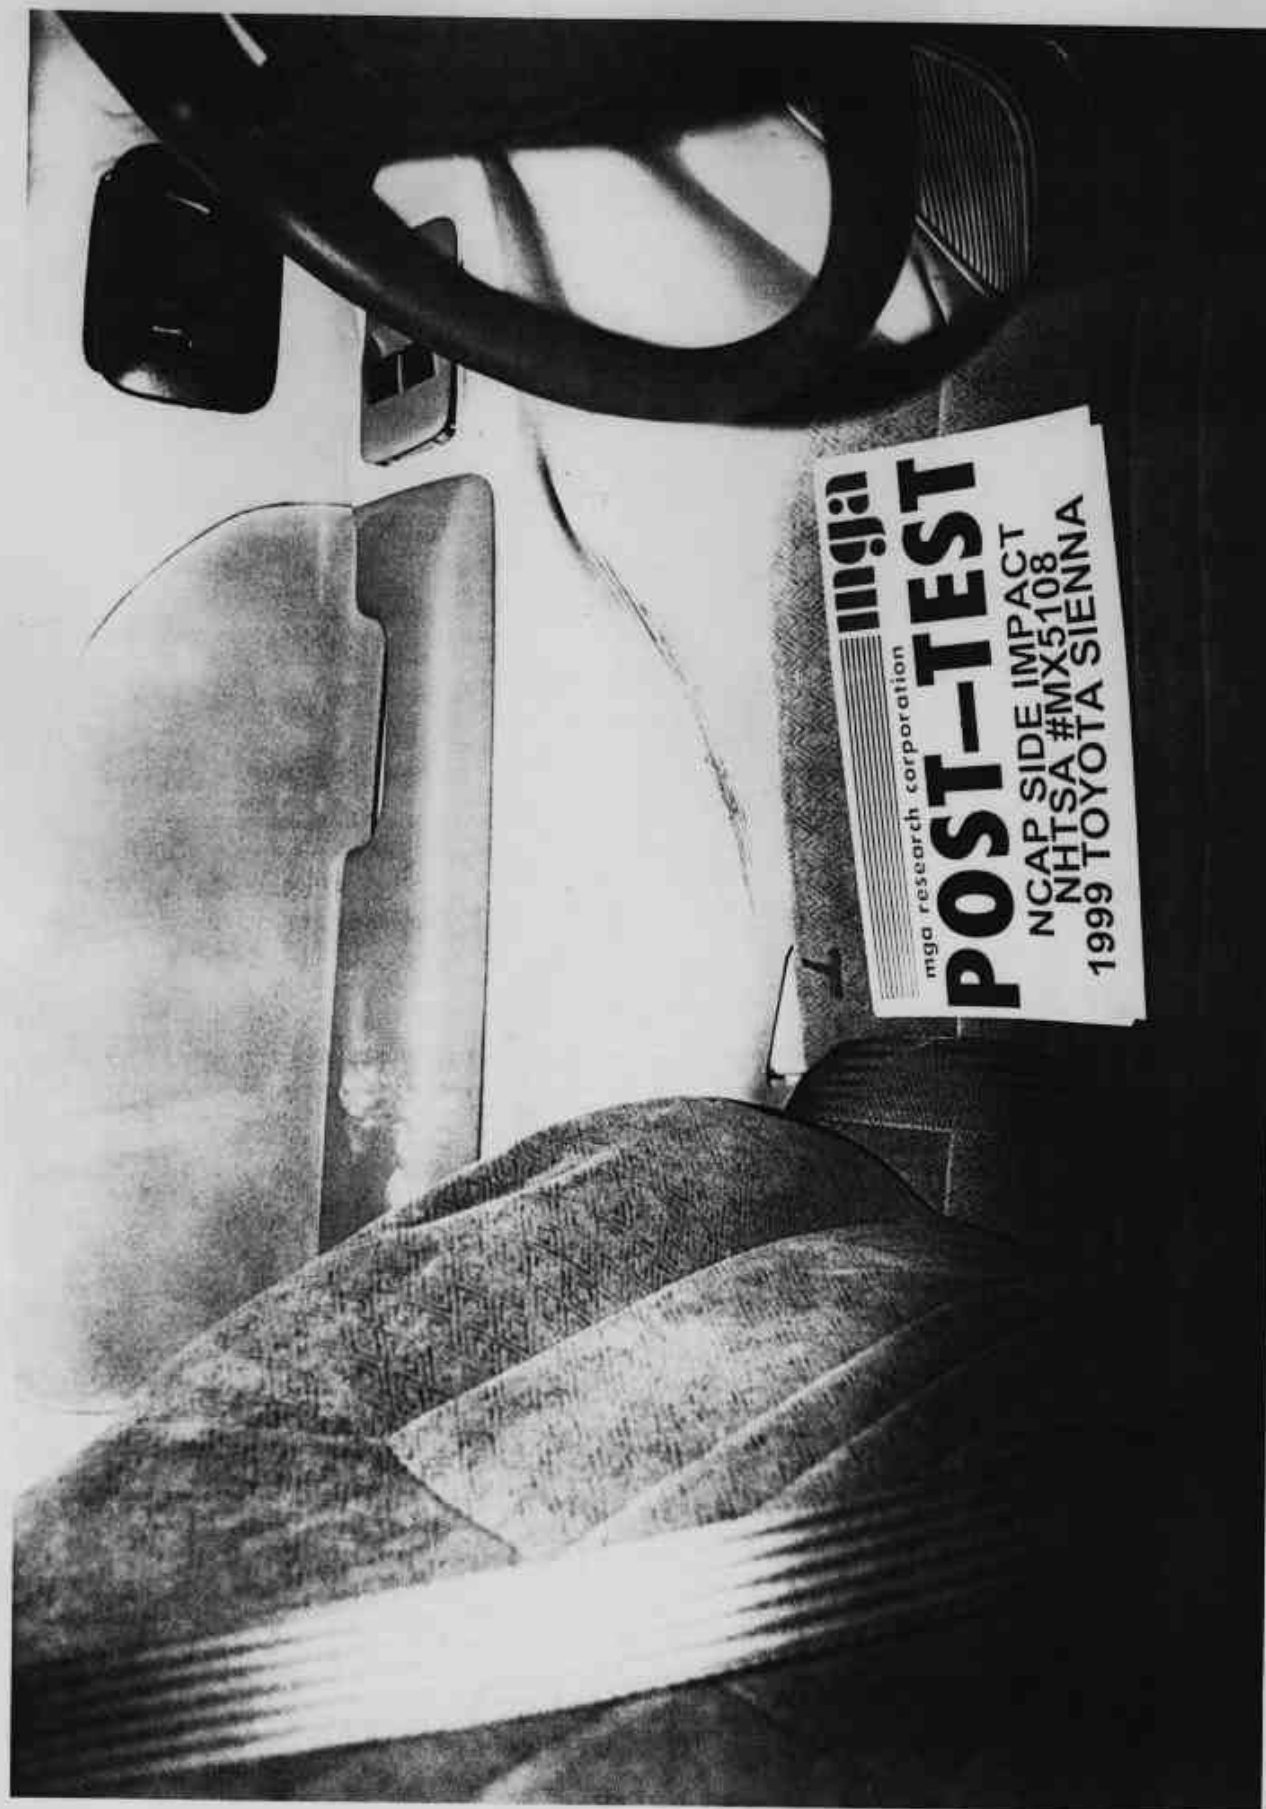
Photo No. A-28 - Post-Test Driver Dummy Contact

| | <u>LEFT FRONT SID</u> | <u>LEFT REAR SID</u> |
|---|---|---|
| Head | <u>Headrest/shoulder/seatbelt</u> | <u>Headrest/shoulder/</u><br><u>window sill</u> |
| Arm | <u>Upper-rear of door</u> | <u>Middle of side panel</u> |
| Pelvis | <u>Mid-rear of door/armrest</u> | <u>Lower side panel</u> |
| Left Knee | <u>Front center of door</u> | <u>Side panel rear B-post</u> |
