REPORT NUMBER: CAL-99-02

**NEW CAR ASSESSMENT PROGRAM (NCAP)  
FRONTAL BARRIER IMPACT TEST**

**CHRYSLER CORPORATION  
1999 DODGE DURANGO  
4 X 4 SLT**

NHTSA NUMBER: MX0300

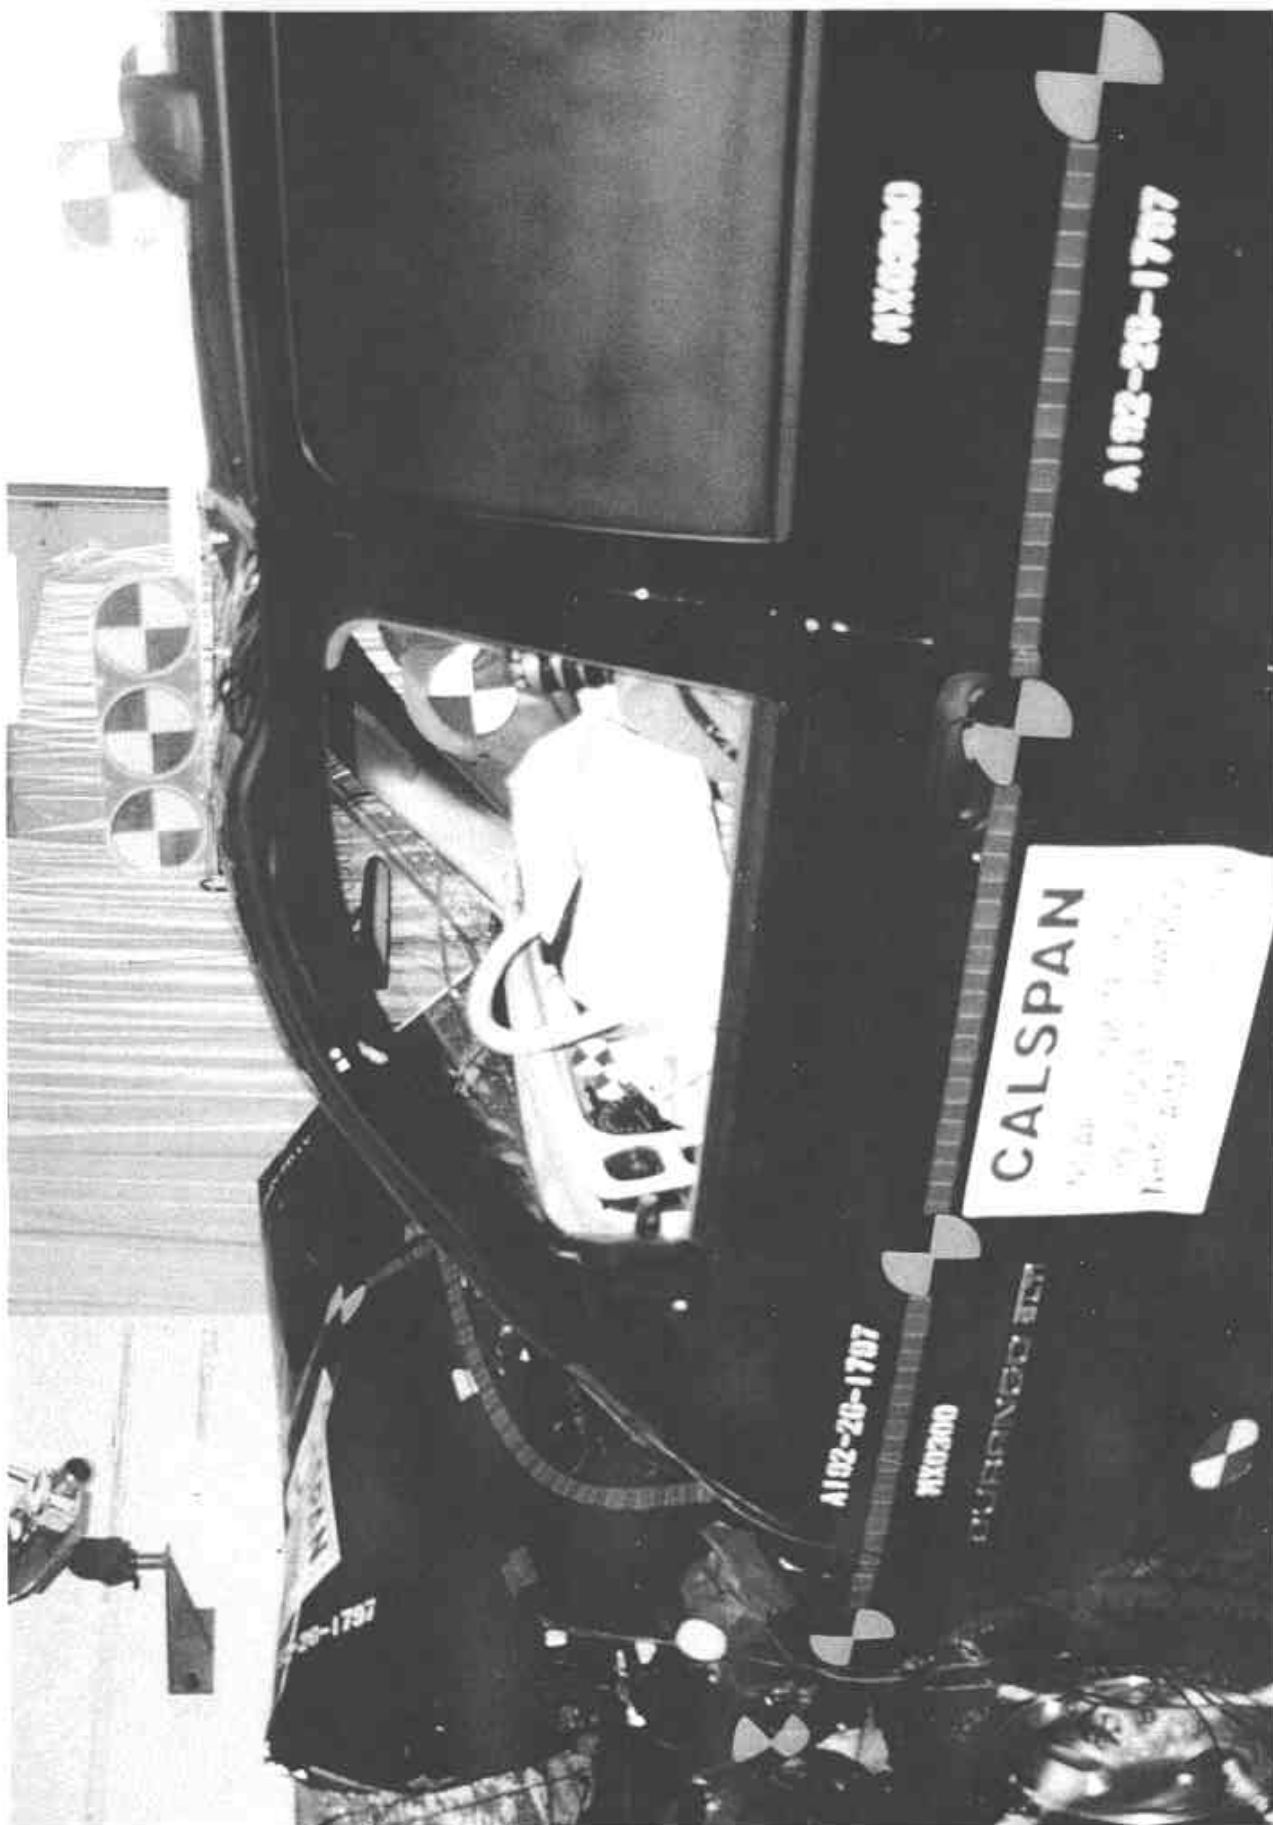
Figure A-23 POST-TEST DRIVER POSITION VIEW

| <u>VISIBLE DUMMY CONTACT POINTS :</u> | <u>DRIVER</u> | <u>PASSENGER</u> |
|---|---|---|
| Head : | <u>Head to airbag/ Back of head to headrest</u> | <u>Head to airbag/ Forehead to visor/ Back of head to headrest</u> |
| Chest | <u>Airbag</u> | <u>Airbag</u> |
| Knees | <u>Knee Bolster</u> | <u>Knee Bolster</u> |
