REPORT NUMBER: 214-CAL-99-04

**SAFETY COMPLIANCE TESTING FOR FMVSS 214  
SIDE IMPACT PROTECTION**

TOYOTA MOTOR MANUFACTURING KENTUCKY INC.  
1999 TOYOTA SIENNA CE MINIVAN

**FINAL REPORT**

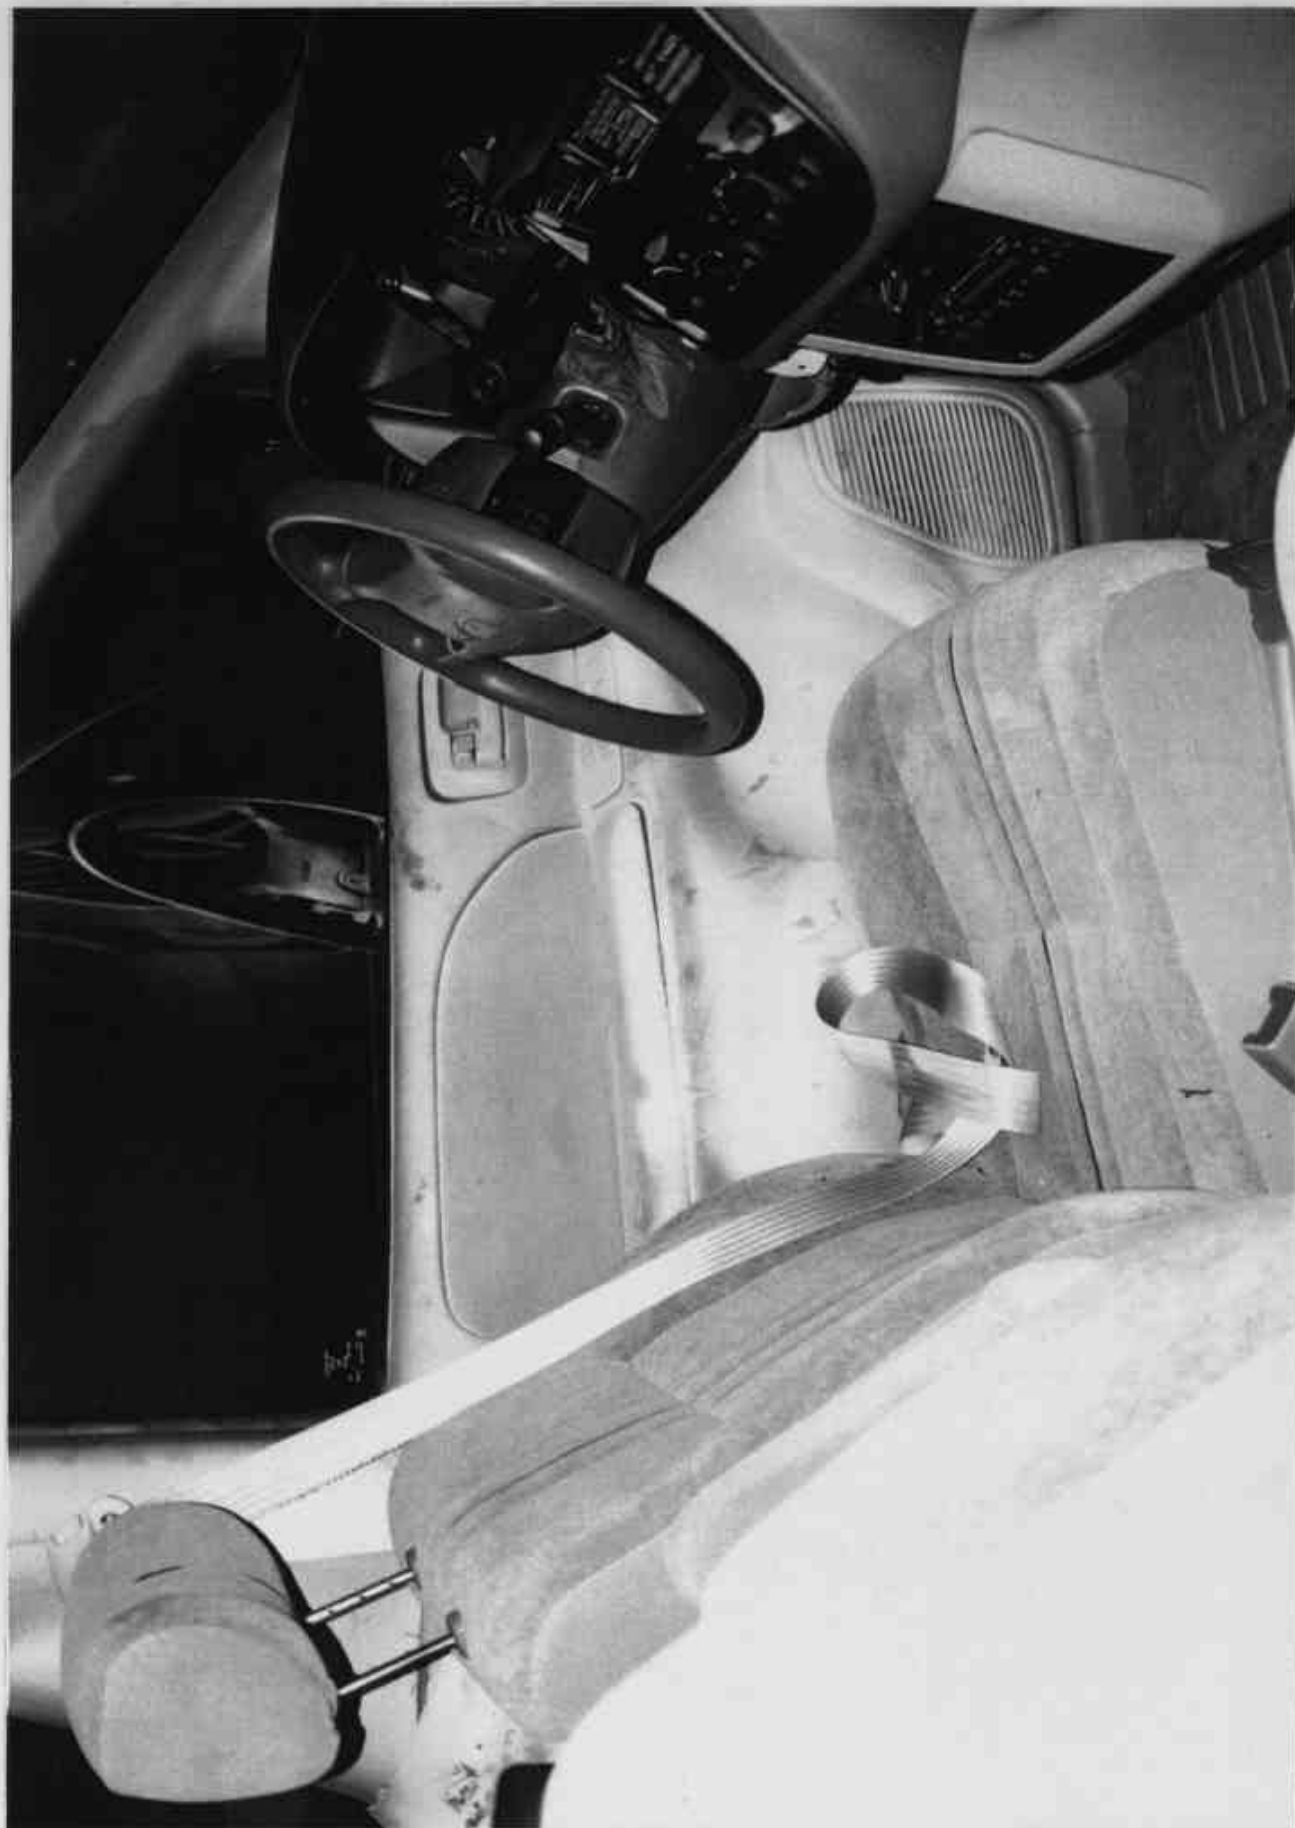
Figure A-26 POST-TEST INTERIOR OF FRONT DOOR SHOWING SID IMPACT LOCATIONS
