REPORT NUMBER: 214-CAL-99-8

**SAFETY COMPLIANCE TESTING FOR FMVSS 214  
SIDE IMPACT PROTECTION**

GENERAL MOTORS CORPORATION  
1999 CHEVROLET VENTURE  
EXTENDED 4-DOOR MINIVAN

**FINAL REPORT**

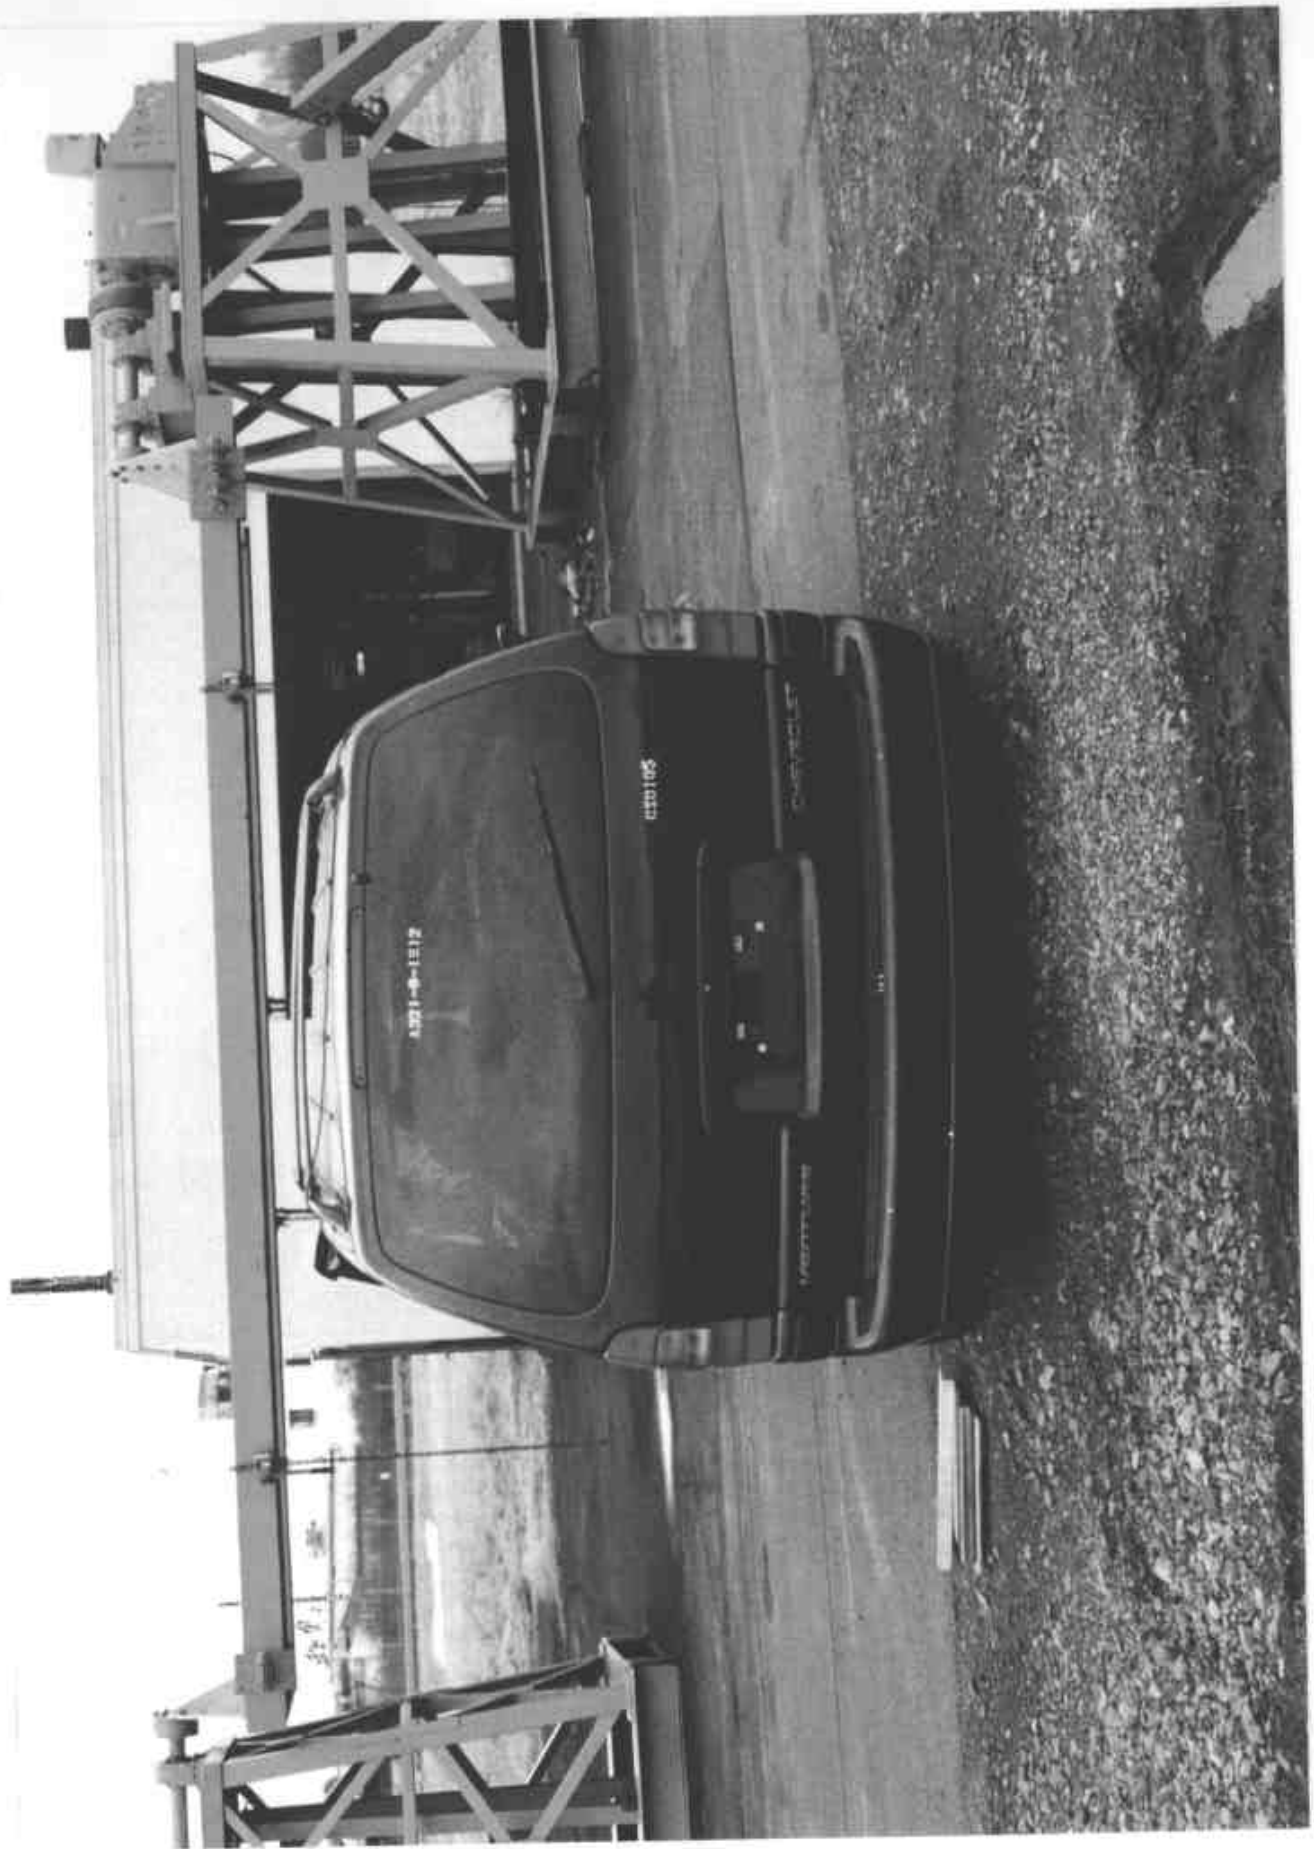
Figure A-4 POST-TEST REAR VIEW OF TEST VEHICLE

The rear hatch opened during the impact event. All vehicle doors were checked prior to the event. A post-test inspection of the rear latch mechanism by the COTR could not confirm whether or not the rear hatch was properly latched prior to the test.
