**REPORT NUMBER: NCAP-TRC-98-003**

**NEW CAR ASSESSMENT PROGRAM  
"SIDE IMPACT TESTING"**

**1999 ISUZU RODEO  
4-DOOR SPORT UTILITY**

**NHTSA NUMBER: MX5700**

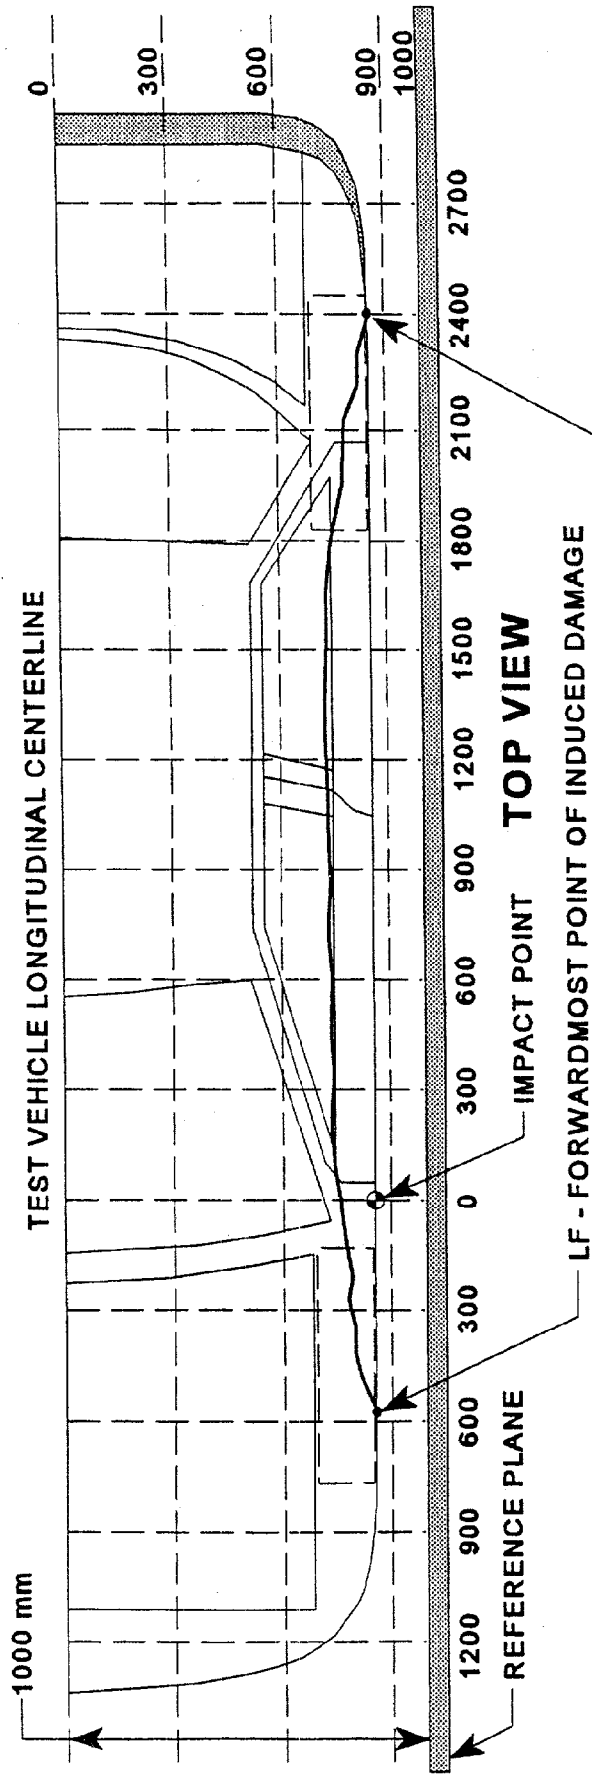
DATA SHEET 11

VEHICLE DAMAGE PROFILE DISTANCES

**MEASUREMENT CONVENTIONS:** LR - REARWARDMOST POINT OF INDUCED DAMAGE  
 Forward of the impact point (towards front of vehicle) is considered negative (-).  
 Rearward of the impact point (toward rearend of vehicle) is considered positive (+).

DPD Measurements	Post-Test (mm)	Pre-Test (mm)	Static Crush (mm)
1 (LF = -900 mm)	415	405	10
2 -330	379	340	39
3 240	614	366	248
4 810	699	366	333
5 1380	732	364	368
6 (LR = 1950 mm)	501	333	168

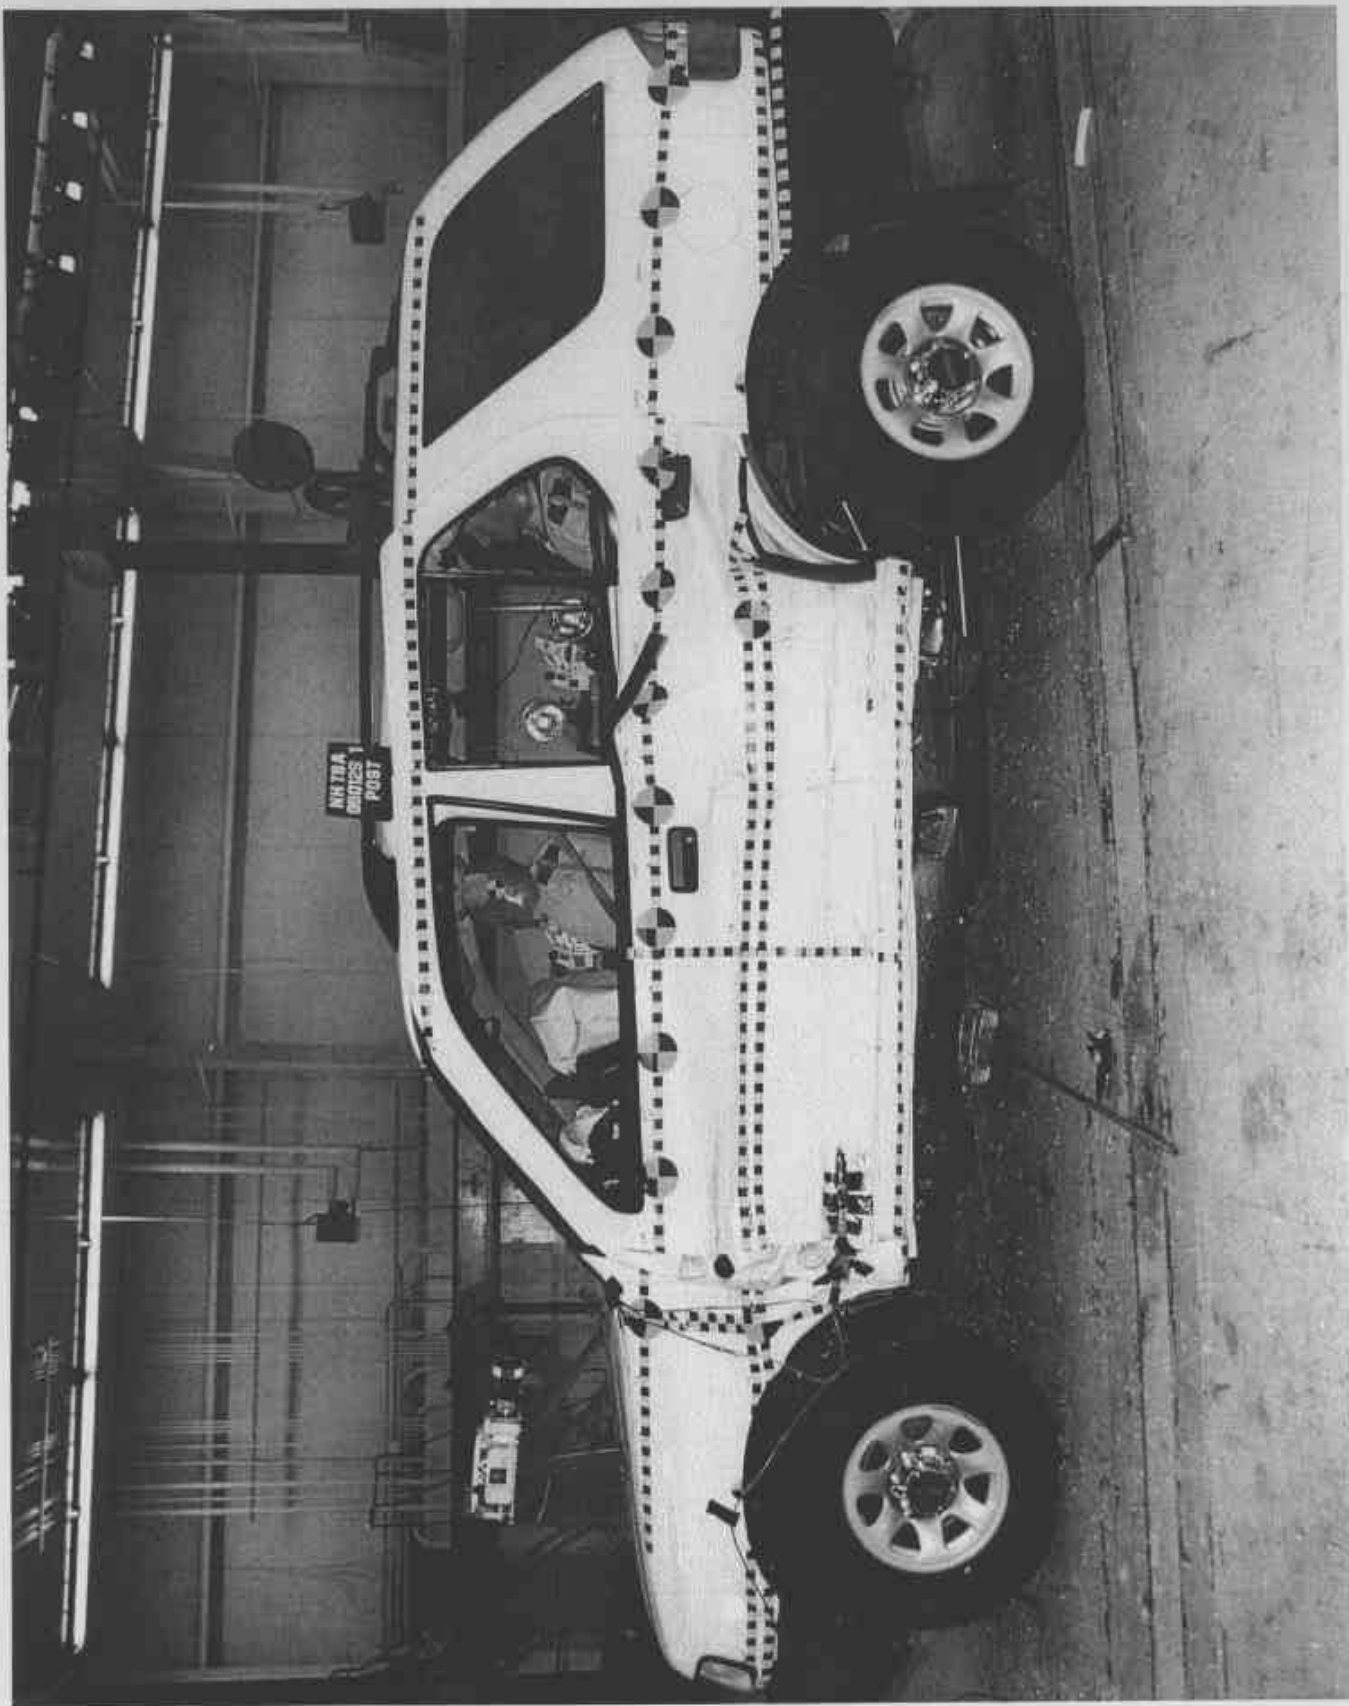
Figure A-9 Post-Test Impacted Side View of Test Vehicle - View 2

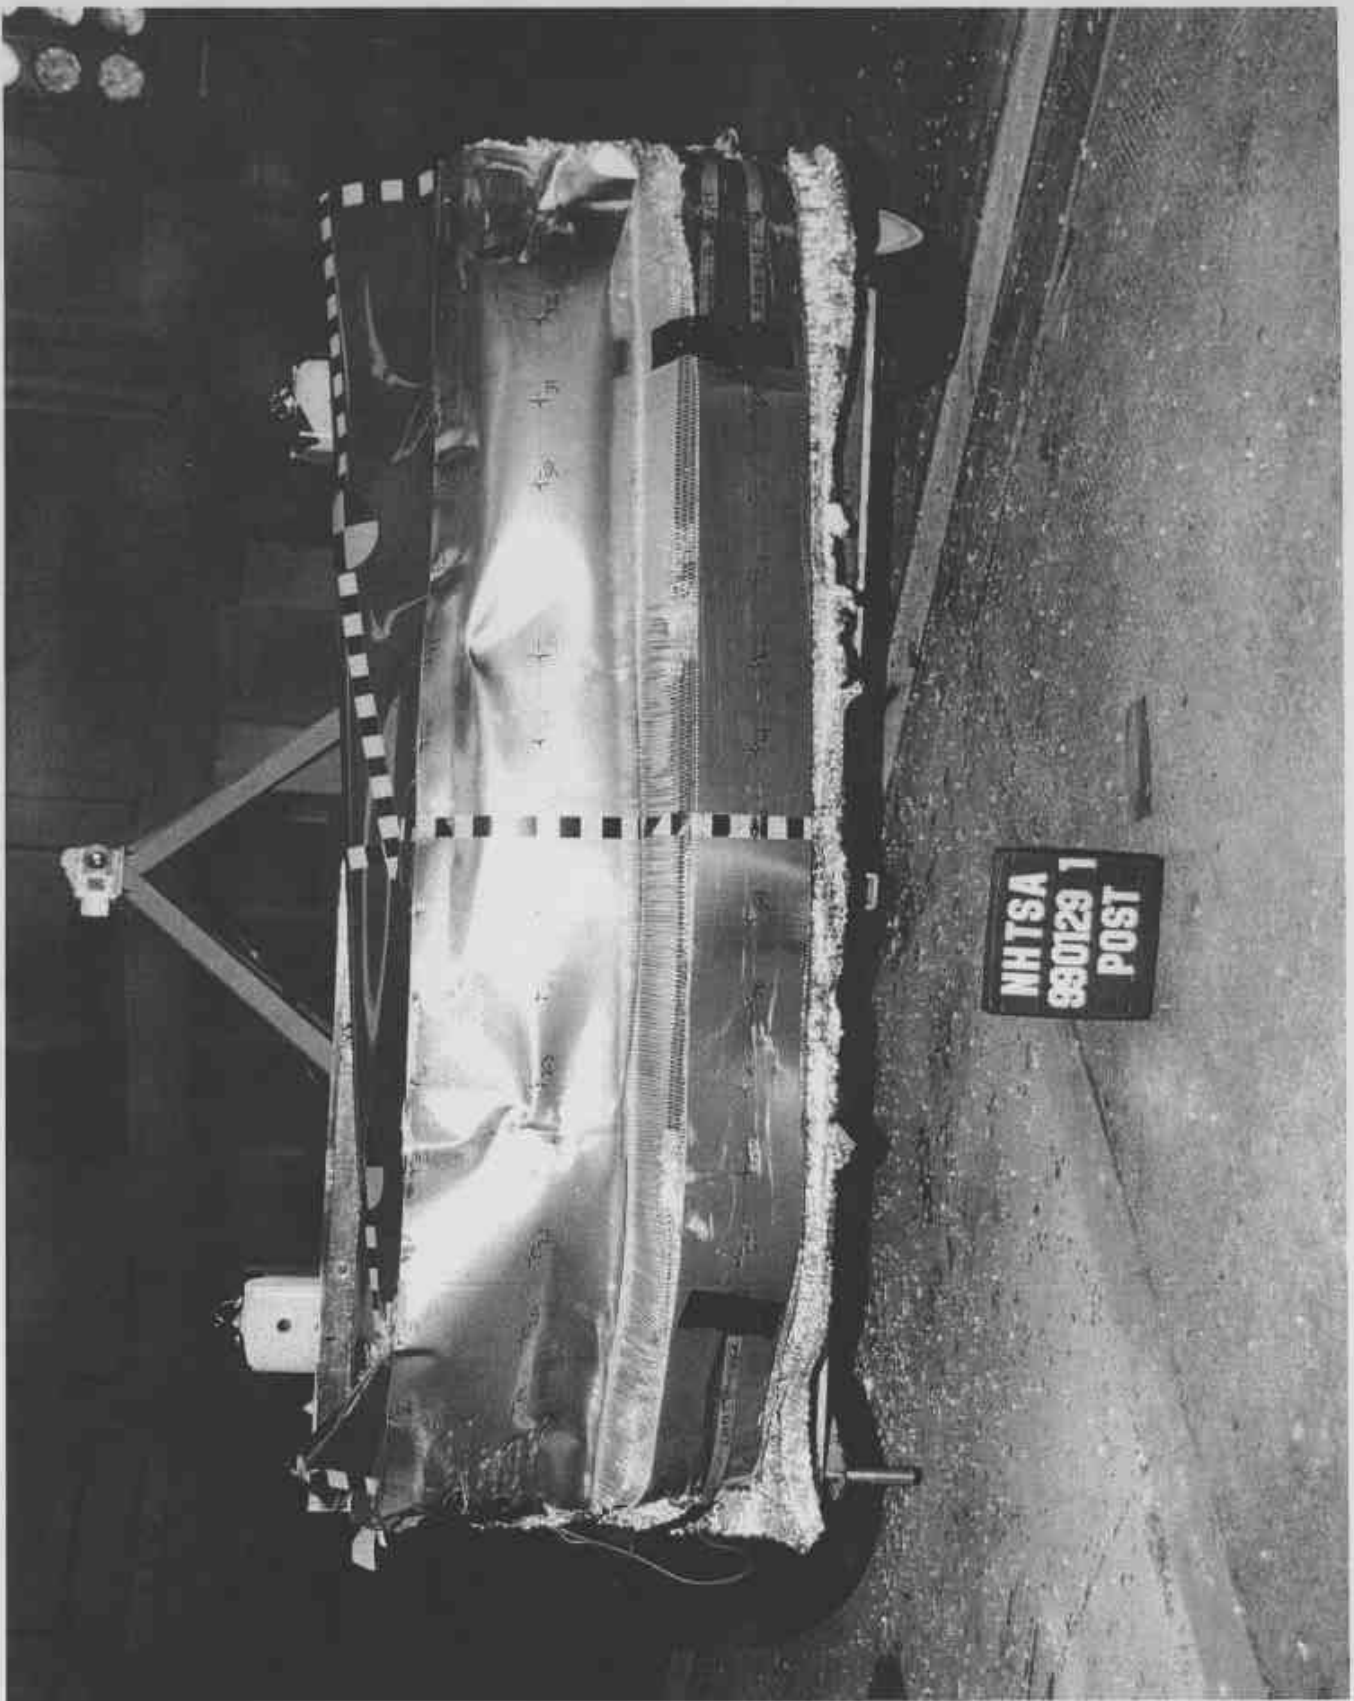
Figure A-14 Post-Test Frontal View of Impactor Face  
A-17

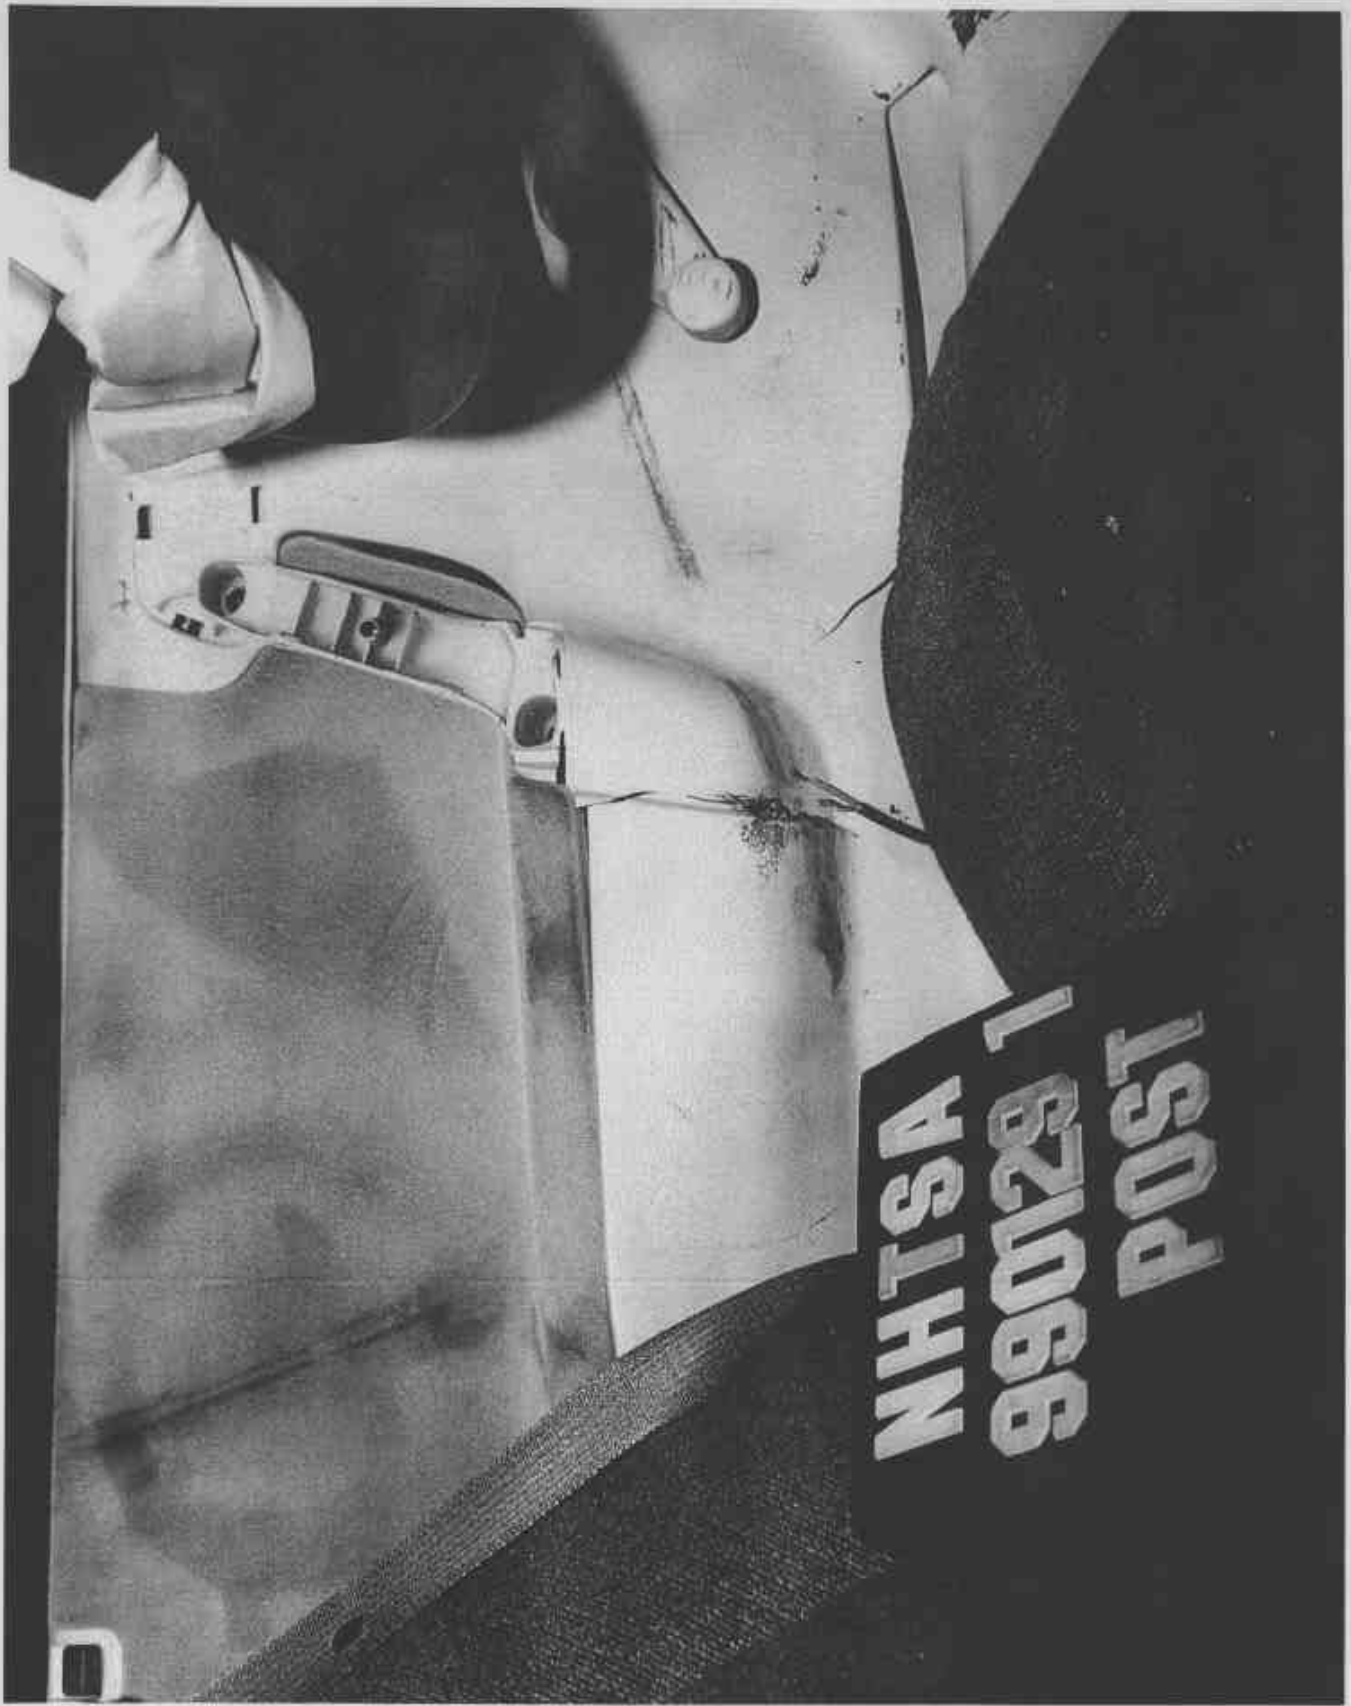
Figure A-31 Post-Test Interior of Front Door Showing SID Impact Locations

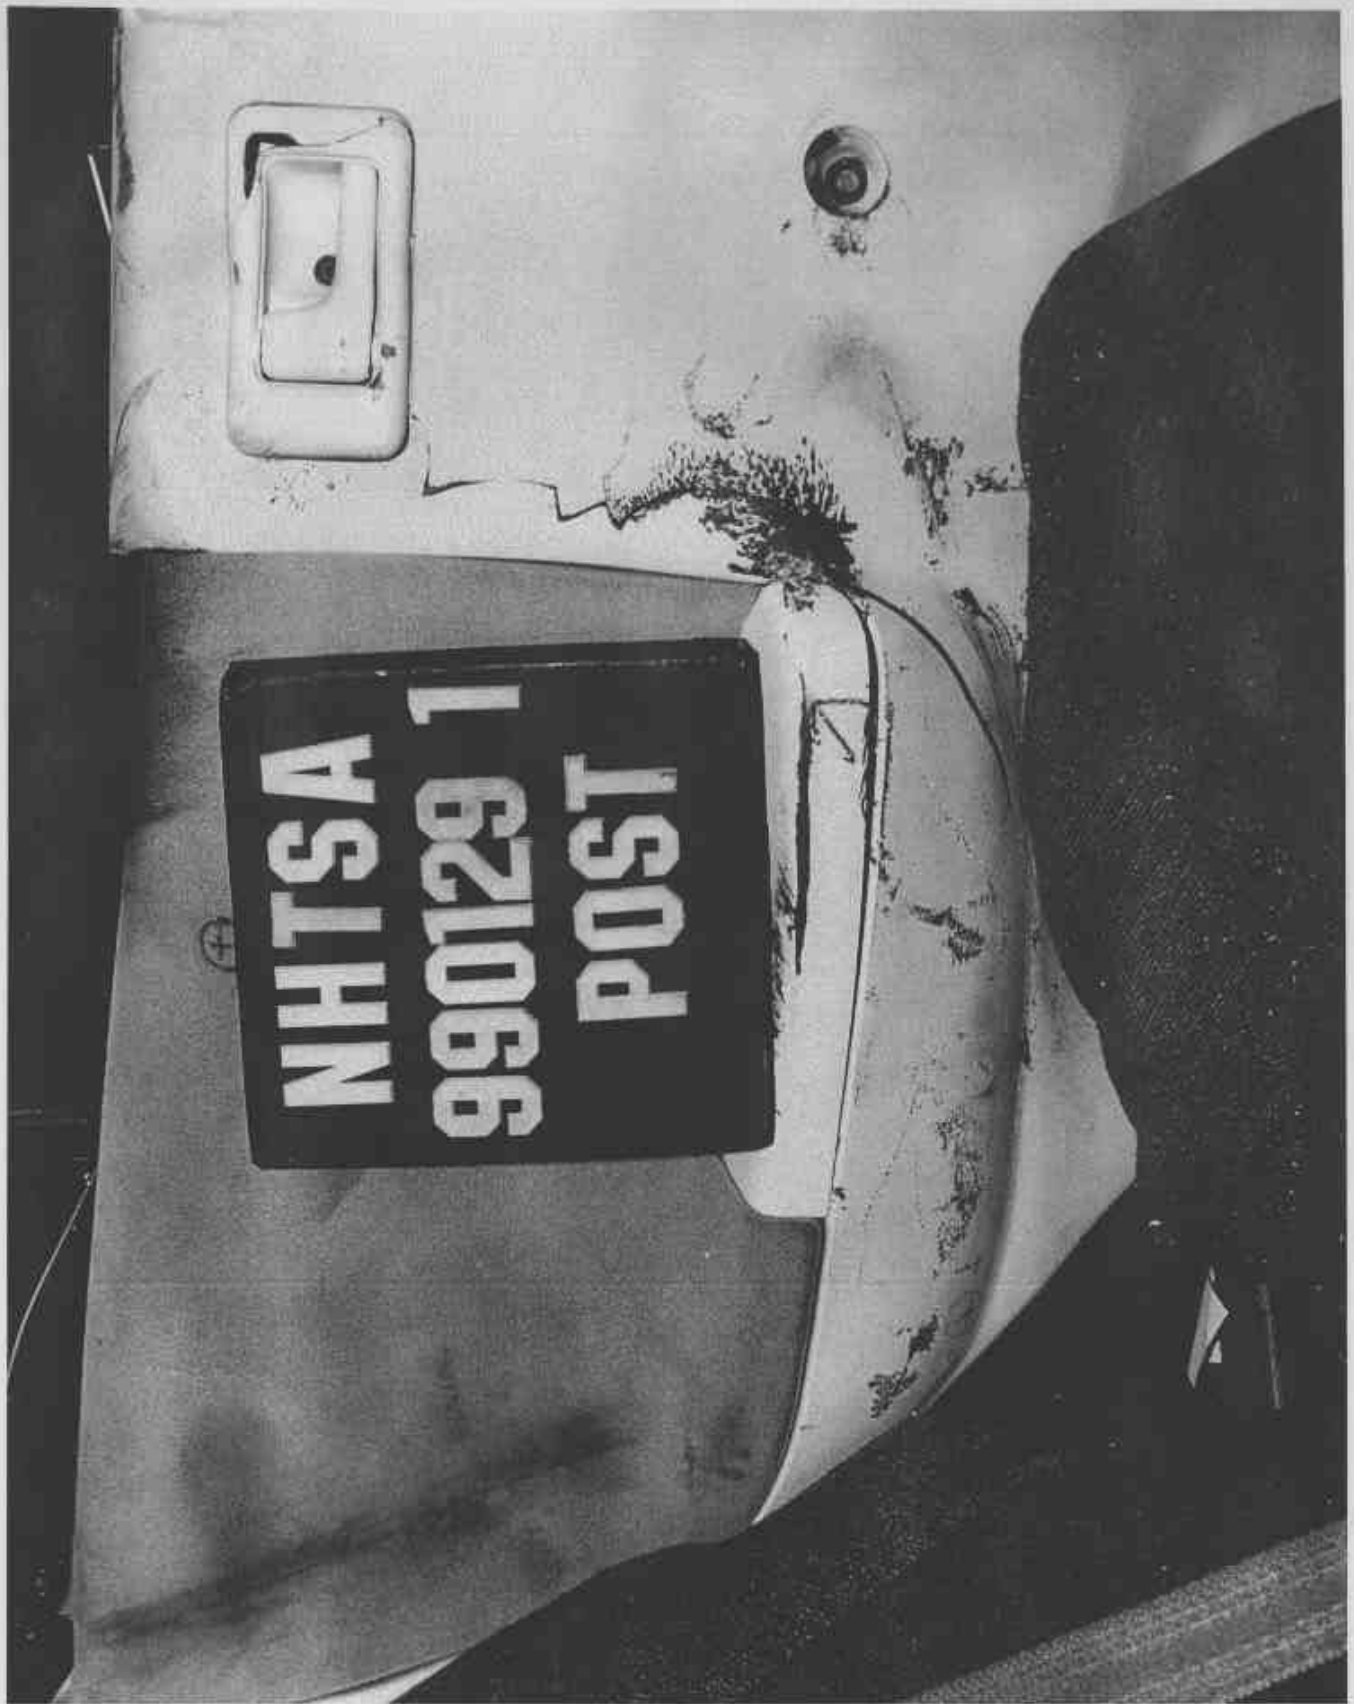
Figure A-33 Post-Test Interior of Rear Door Showing SID Impact Locations

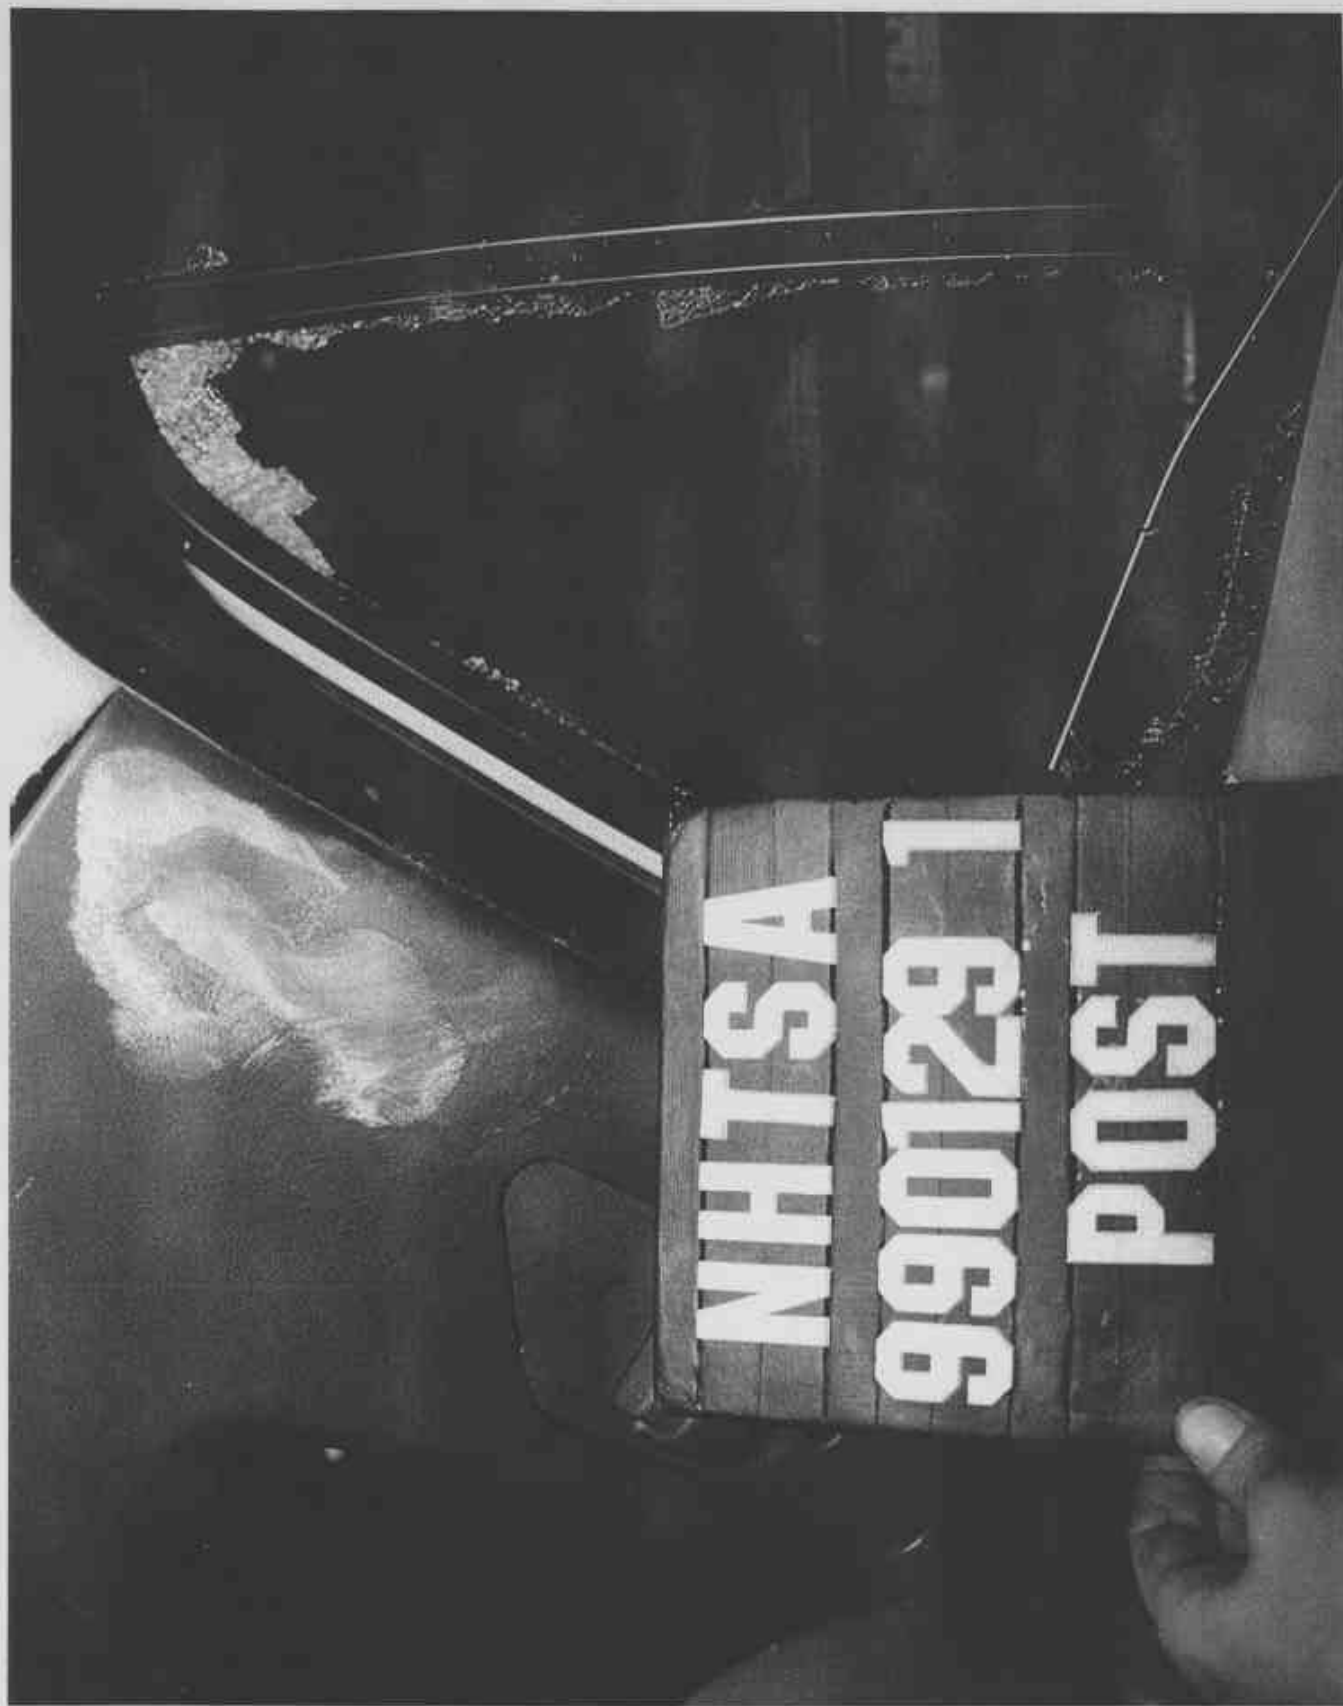
Figure A-34 Post-Test Rear SID Impact Location  
A-37

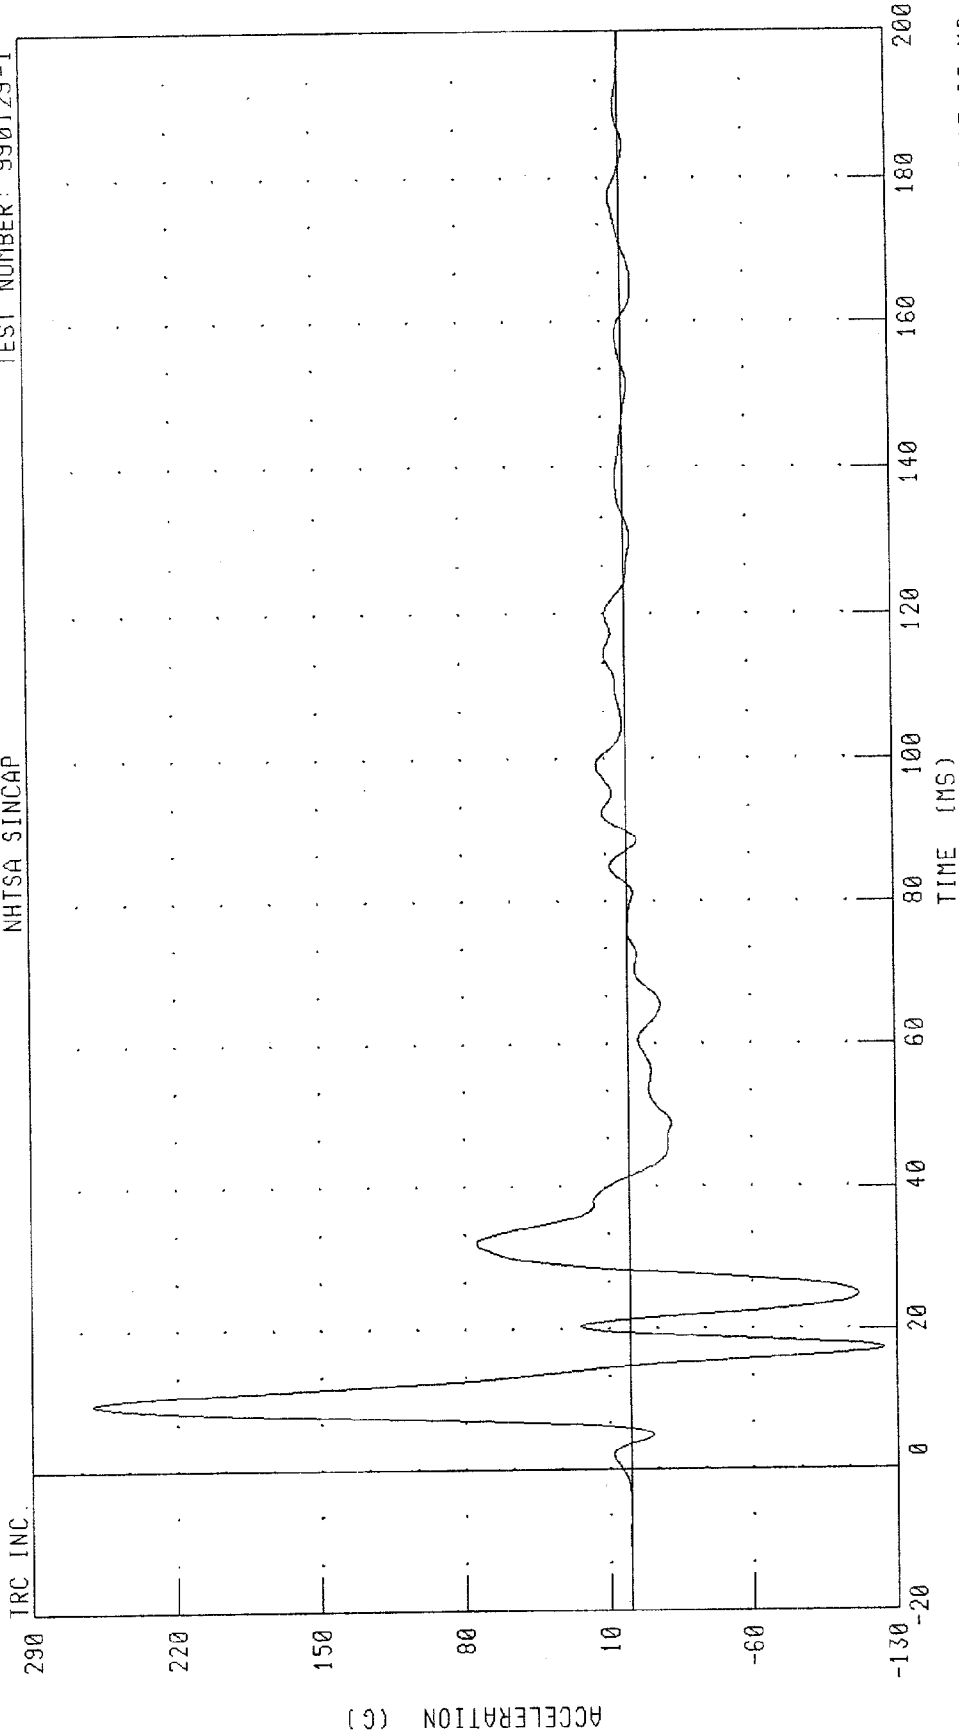
MOVING DEFORMABLE BARRIER INTO LEFT SIDE OF 1999 ISUZU RODEO  
LEFT FRONT DOOR ON CENTERLINE Y-AXIS ACCELERATION  
NHTSA SINCAP

CHANNEL: LFCYG1 FILTER: CH. CLASS 60

PEAK DATA: 260.88 G @ 9.68 MS, -123.72 G @ 17.28 MS

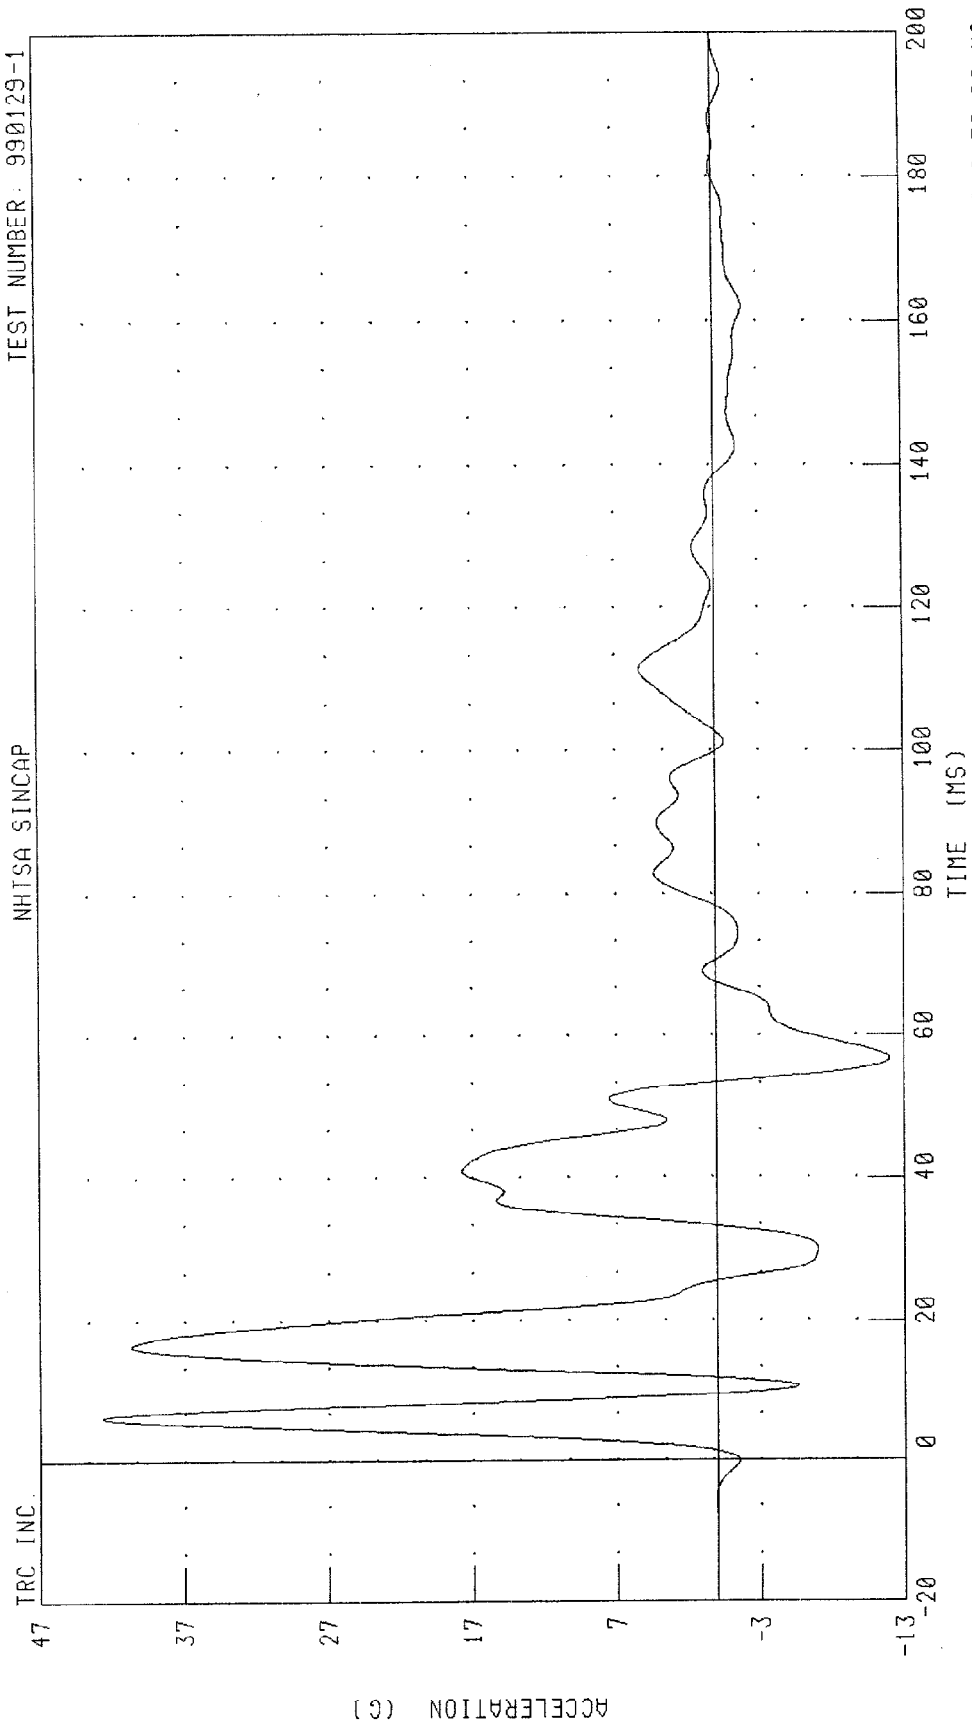
MOVING DEFORMABLE BARRIER INTO LEFT SIDE OF 1999 ISUZU RODEO  
VEHICLE CENTER OF GRAVITY Y-AXIS ACCELERATION  
NHTSA SINCAP

PEAK DATA: 42.69 G @ 6.16 MS; -12.03 G @ 56.80 MS

CHANNEL: VCCYG1 FILTER: CH CLASS 60

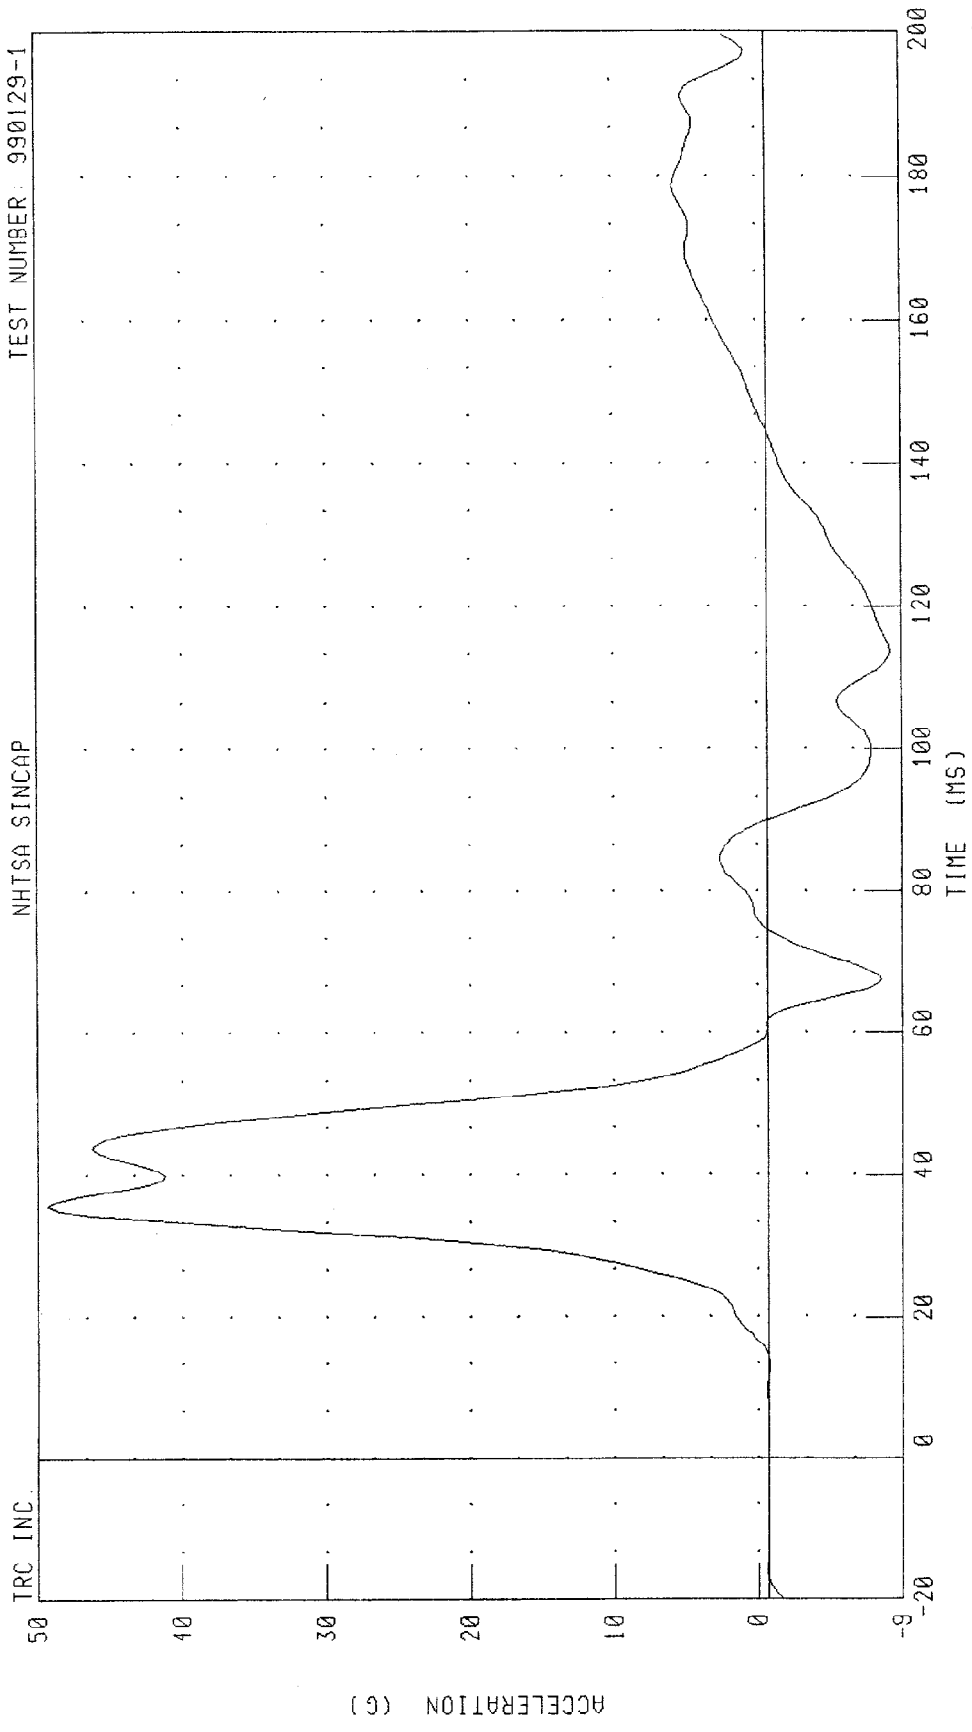
MOVING DEFORMABLE BARRIER INTO LEFT SIDE OF 1999 ISUZU RODEO  
DRIVER LOWER SPINE Y-AXIS ACCELERATION  
NHTSA SINCAP

CHANNEL: T12YG1 FILTER: FIR 100 PEAK DATA: 50.02 G @ 35.63 MS; -8.51 G @ 113.75 MS

<table><tr> <th style="width: 50%;"></th> <th style="width: 20%; text-align: center;"><u>Front SID</u></th> <th style="width: 10%;"></th> <th style="width: 20%; text-align: center;"><u>Rear SID</u></th> <th style="width: 10%;"></th> </tr><tr> <td>Lower Spine Acceleration:</td> <td style="text-align: center;">50</td> <td style="text-align: center;">g's</td> <td style="text-align: center;">32</td> <td style="text-align: center;">g's</td> </tr></table>

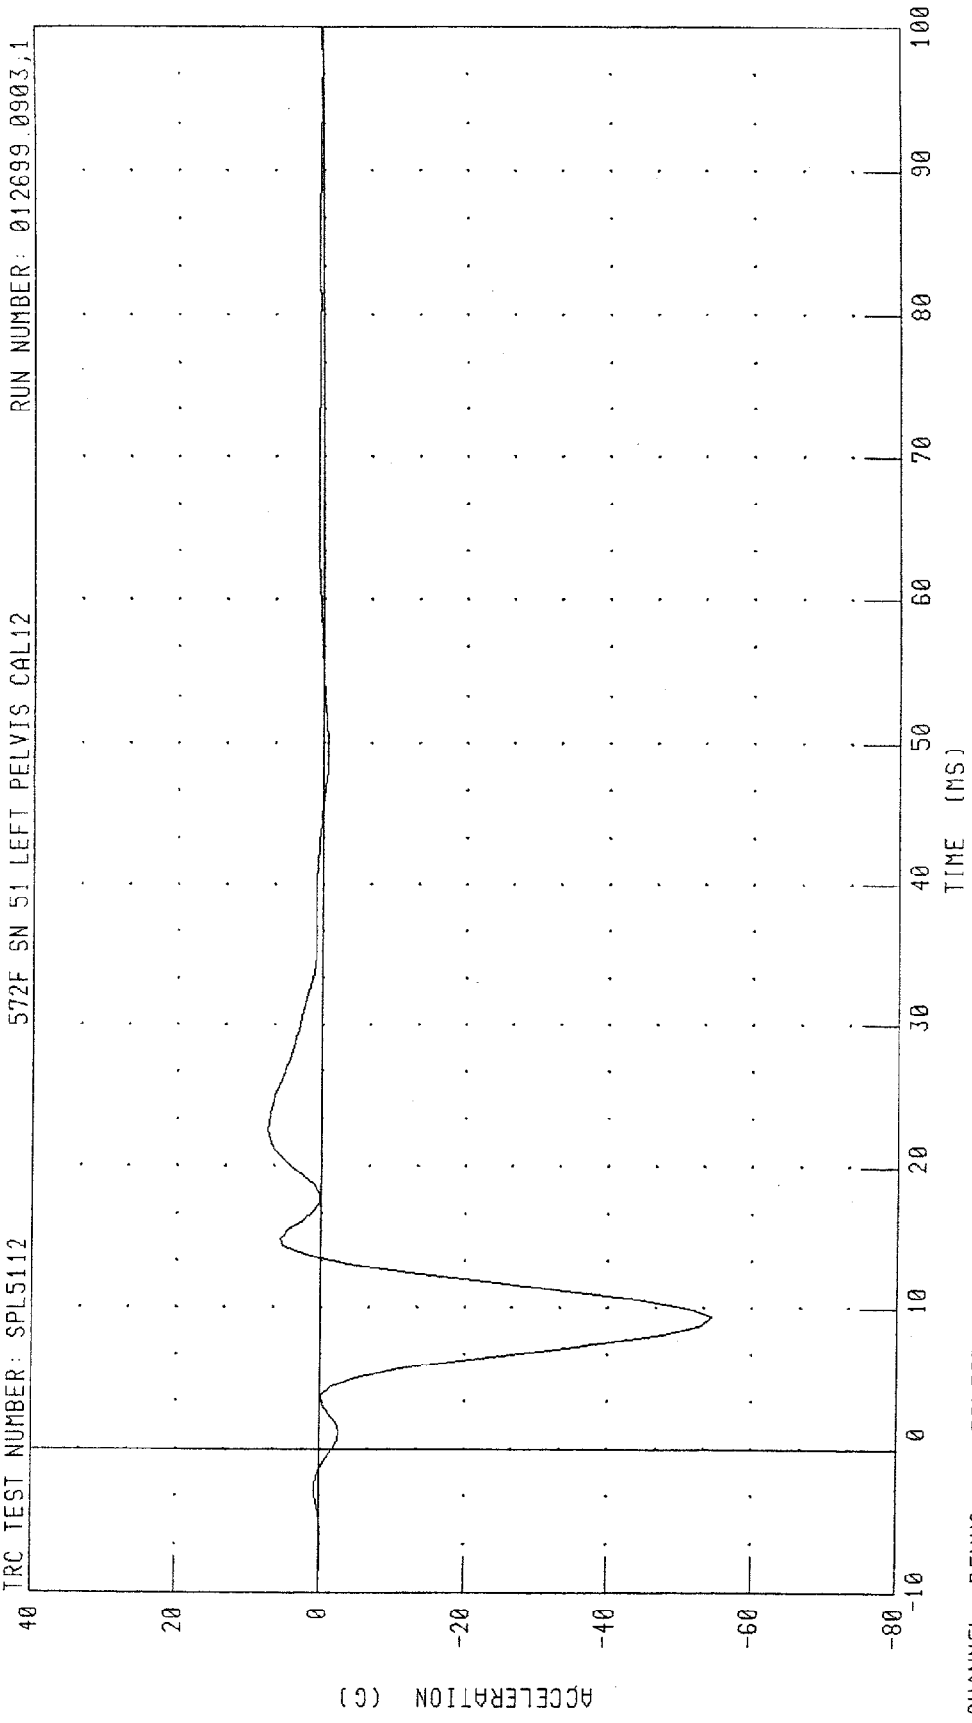
572F SN 51 LEFT PELVIS CAL12

CHANNEL: PEVYG FILTER: FIR 100

PEAK DATA: 7.46 G @ 22.50 MS; -54.40 G @ 9.37 MS

TEST PARAMETER	SPECIFICATION (ABSOLUTE VALUE)	TEST RESULTS
TEMPERATURE	18.9 - 25.5 C	21.1 DEG. C
RELATIVE HUMIDITY	10 - 70 %	20.0 %
PENDULUM VELOCITY	4.27 - 4.33 M/S	4.29 M/S
PEAK PELVIC ACCELERATION	40 - 60 G	-54.4 G
TIME ABOVE 20 G LEVEL	3 - 7 MS	5.8 MS
IS ACCELERATION CURVE UNIMODAL?	YES	YES

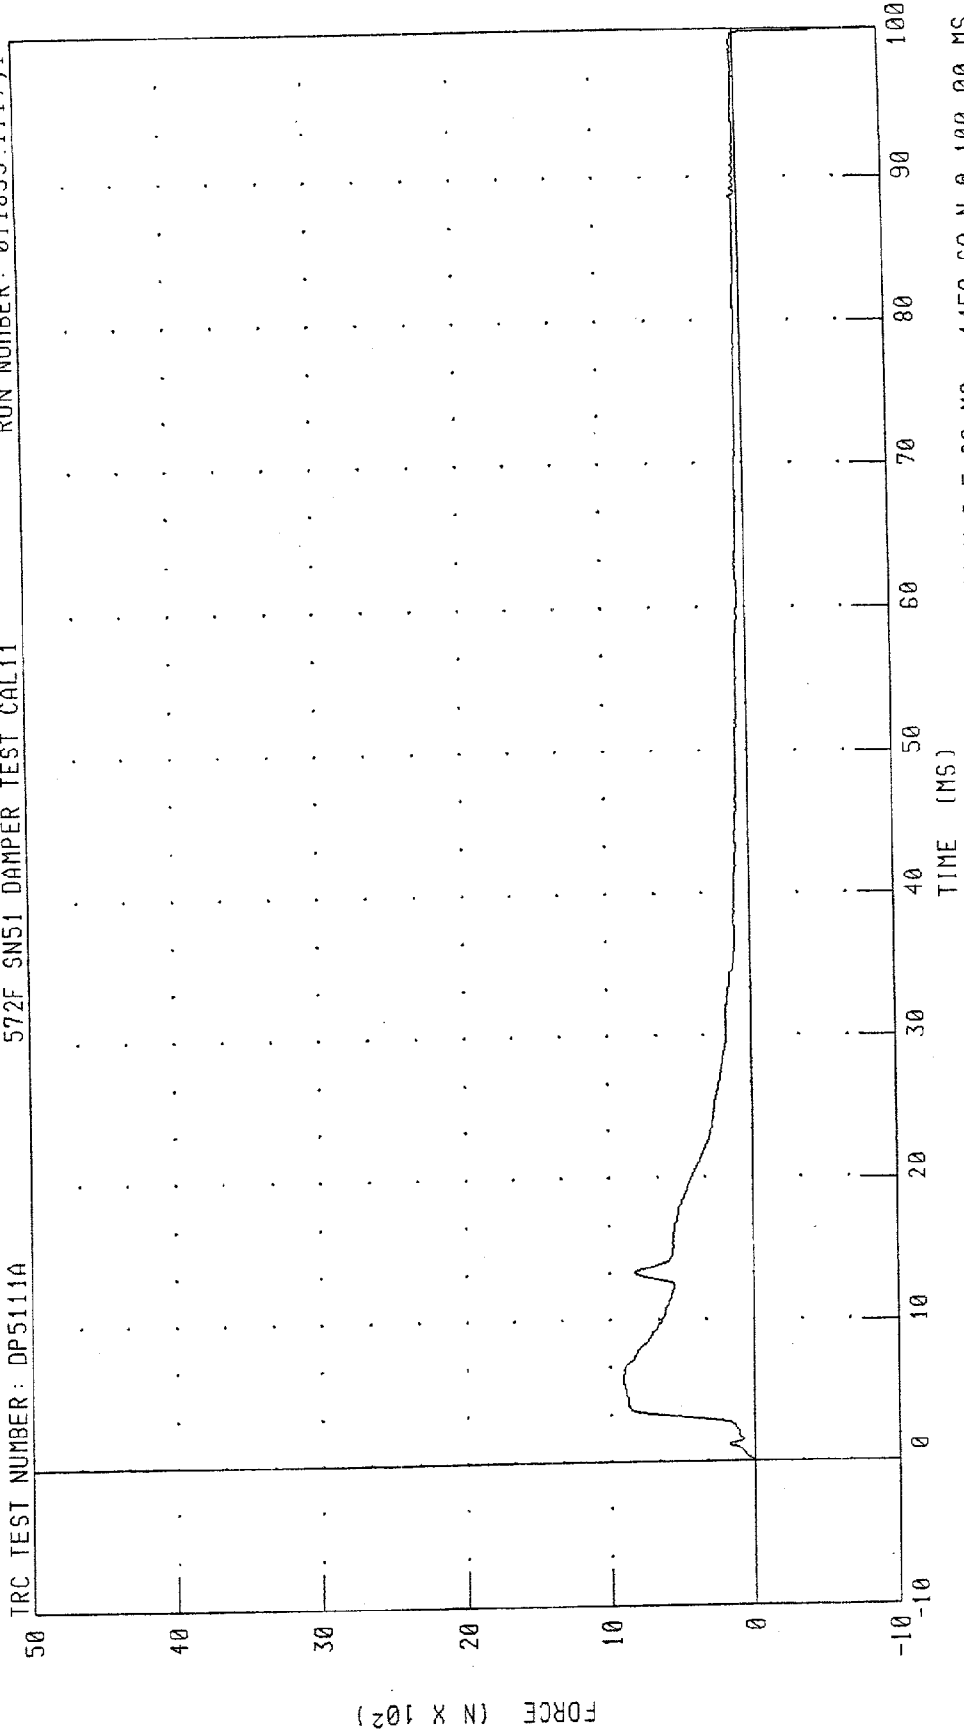
572F\_SNS1\_DAMPER\_TEST\_CAL11

CHANNEL: DAMPF FILTER: CH. CLASS 1000 PEAK DATA: 916.34 N @ 5.68 MS; -1458.68 N @ 100.00 MS

PART 572-F S.I.D. THORACIC SHOCK ABSORBER CALIBRATION (3.0 M/SEC)

TEST PARAMETER		SPECIFICATION	TEST RESULTS
TEMPERATURE		18.9 - 25.5 C	21.1 DEG. C
RELATIVE HUMIDITY		10 - 70 %	20.0 %
VELOCITY	FORCE	838 - 1125 N	916 N
3.06 M/S	DISPLACEMENT	30.2 - 35.2 MM	31.6 MM
VELOCITY	FORCE	1733 - 2100 N	1833 N
4.27 M/S	DISPLACEMENT	31.6 - 37.2 MM	34.8 MM
VELOCITY	FORCE	3784 - 4495 N	4149 N
6.12 M/S	DISPLACEMENT	33.3 - 39.6 MM	37.7 MM
