**REPORT NUMBER: 214-TRC-99-003**

**SAFETY COMPLIANCE TESTING FOR FMVSS 214  
SIDE IMPACT PROTECTION**

**1999 SUZUKI VITARA  
MULTI-PURPOSE VEHICLE**

**NHTSA NUMBER: CX0506**

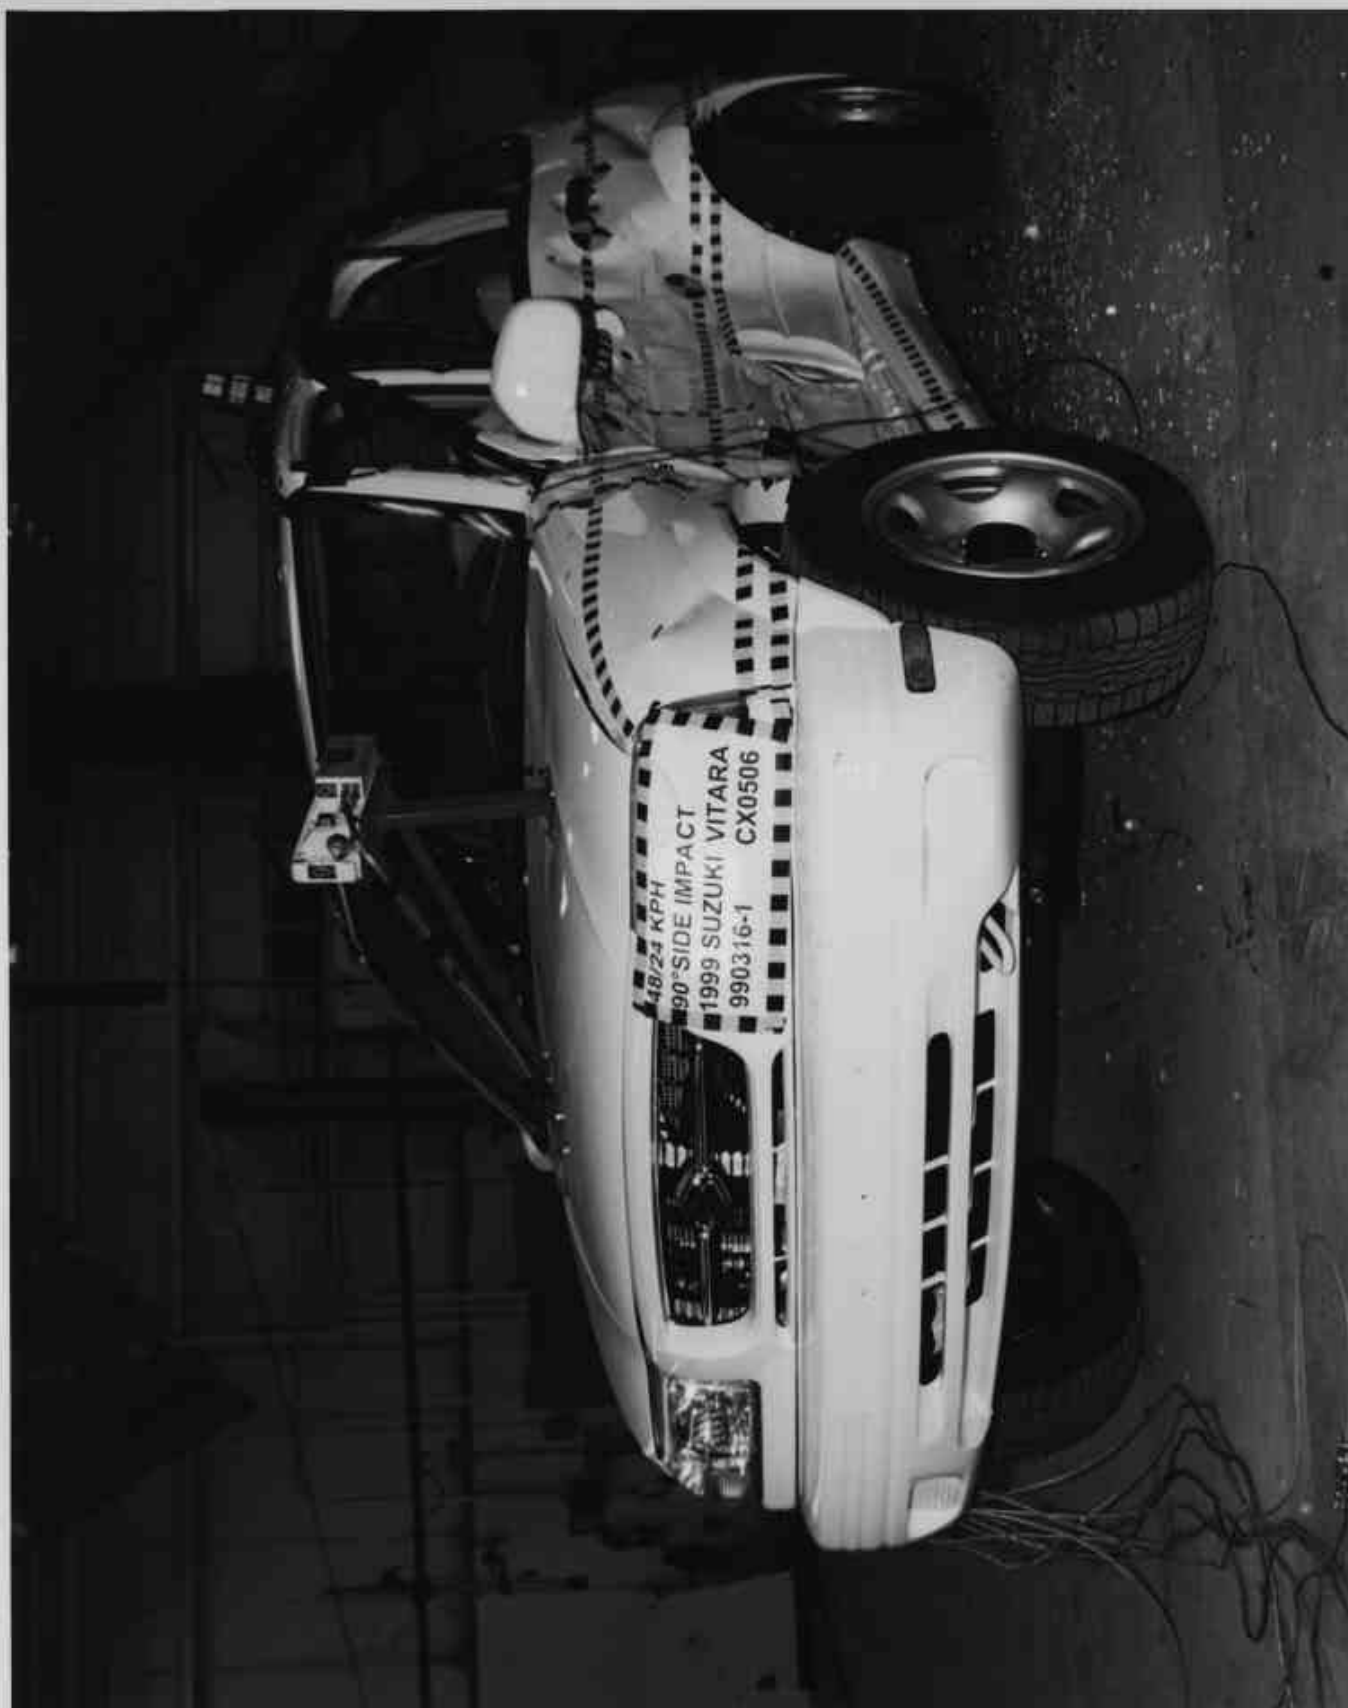
Figure A-4 Post-Test Front Three Quarter View of Test Vehicle  
A-7

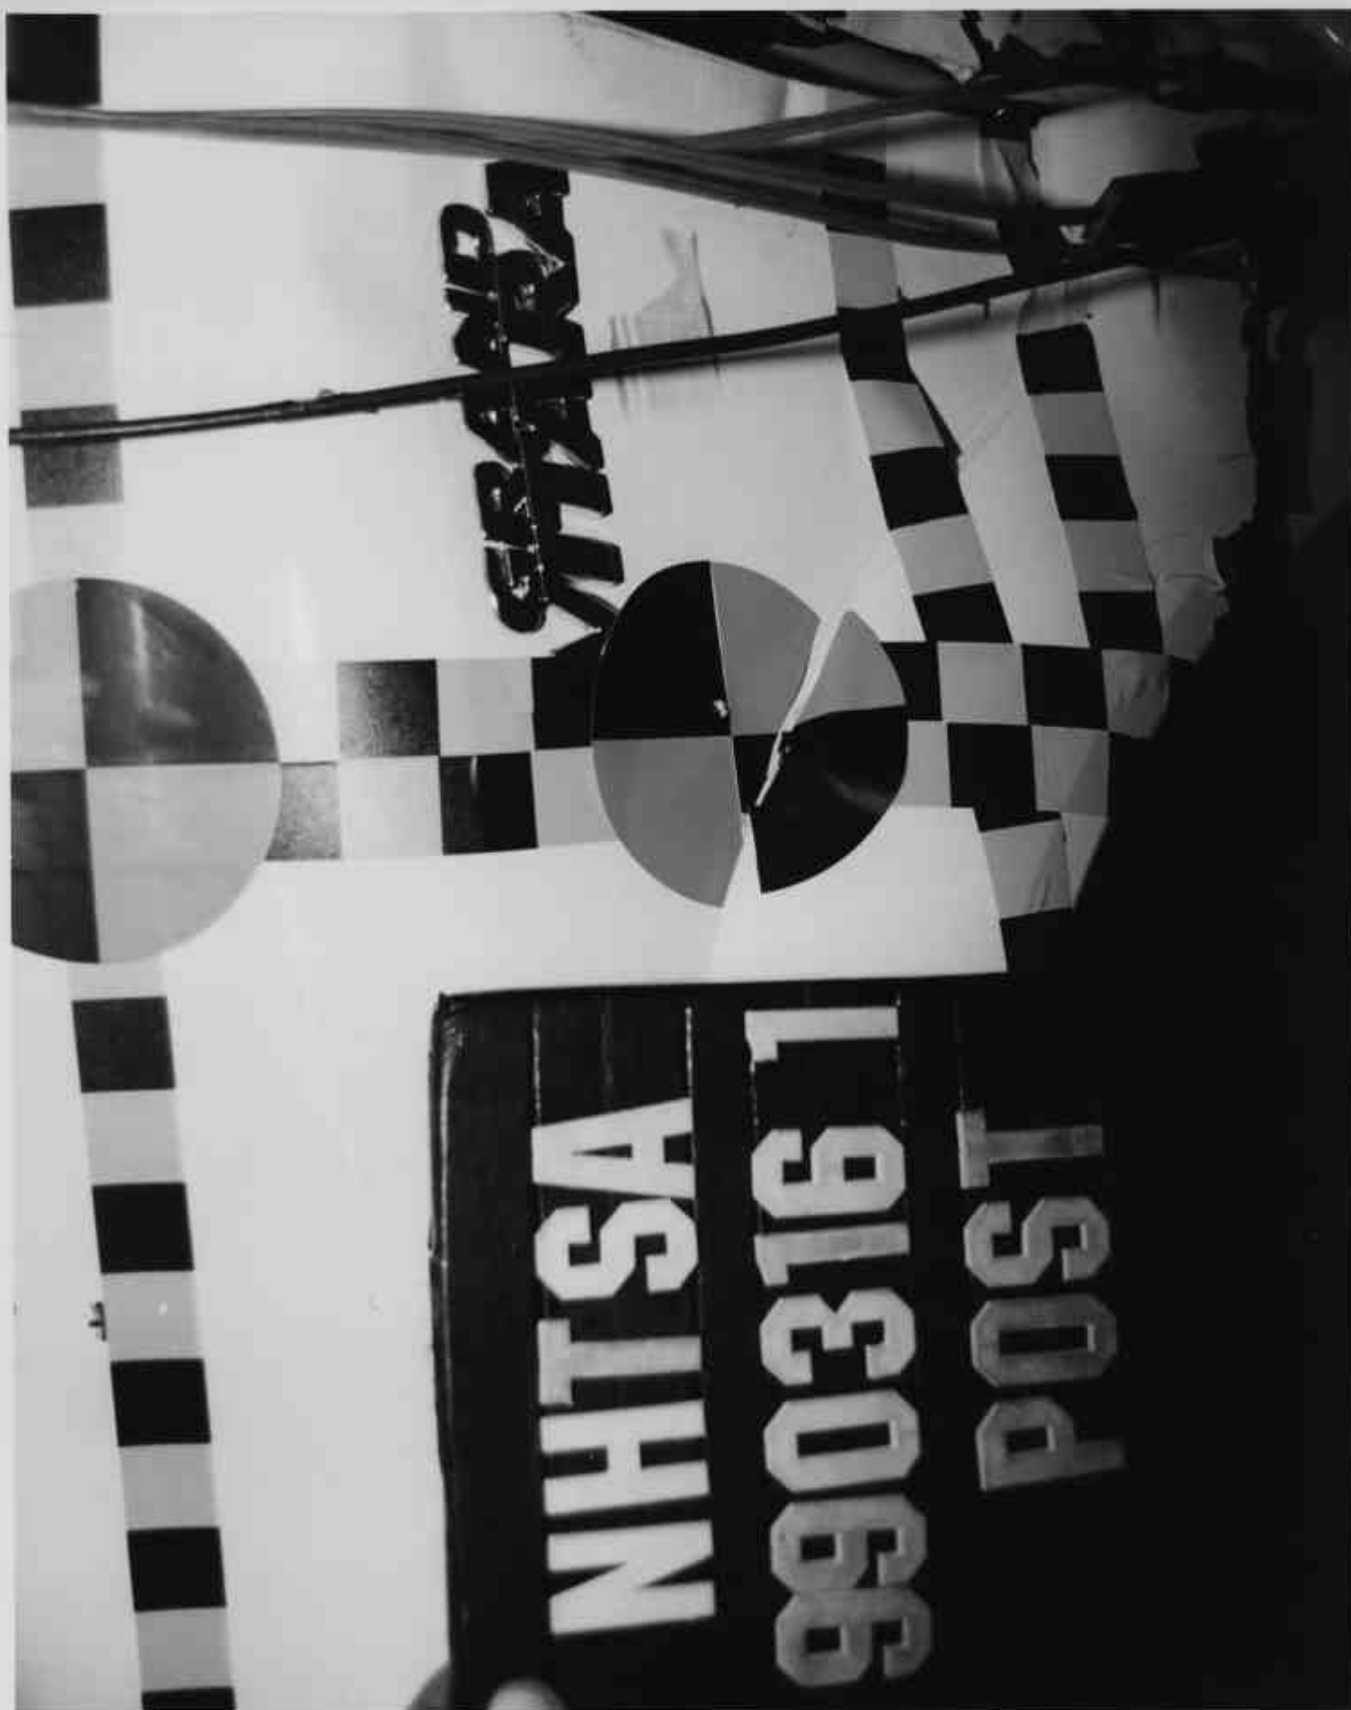
Figure A-25 Post-Test Primary Impact Point View  
A-28

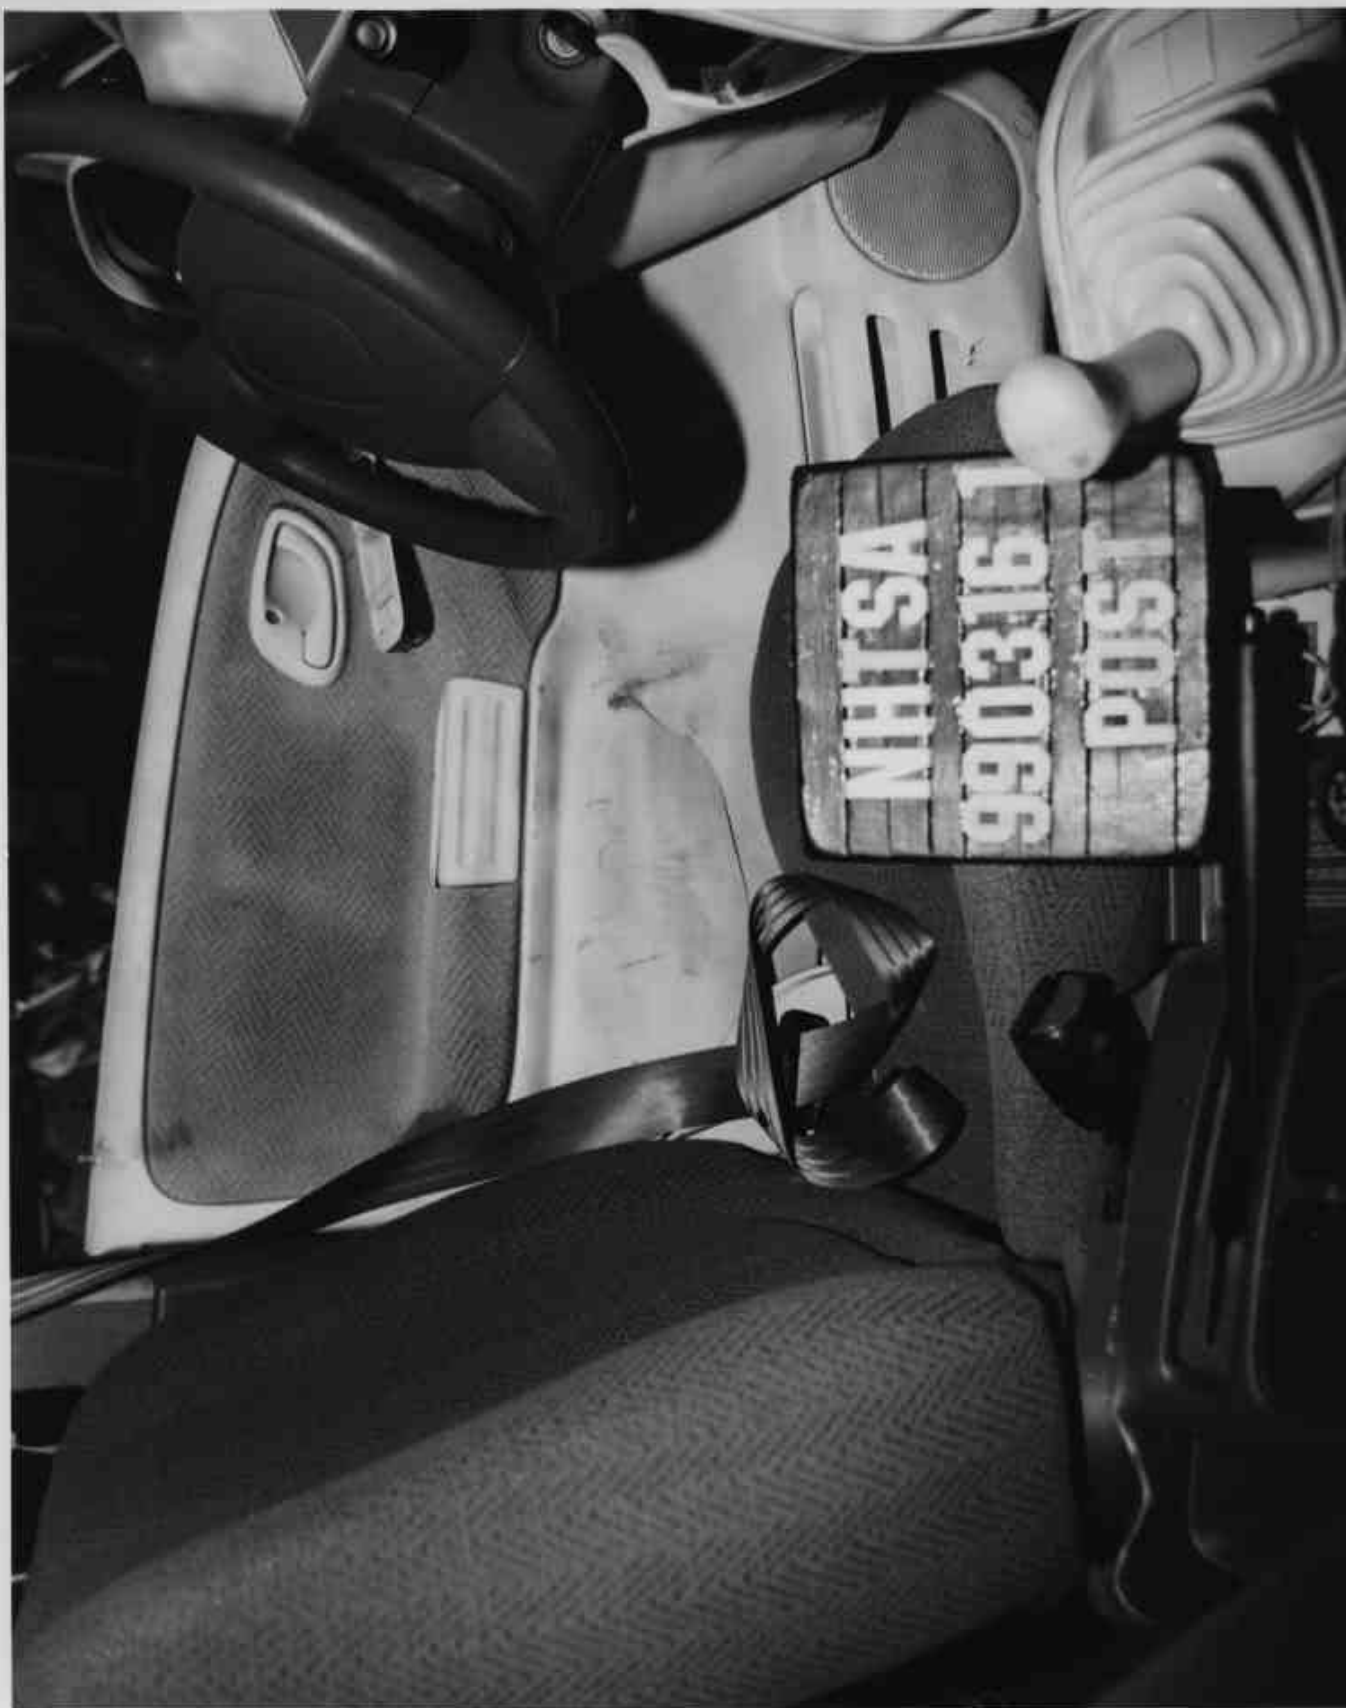
Figure A-43 Post-Test Interior of Front Door Showing SID Impact Locations  
A-46 990316

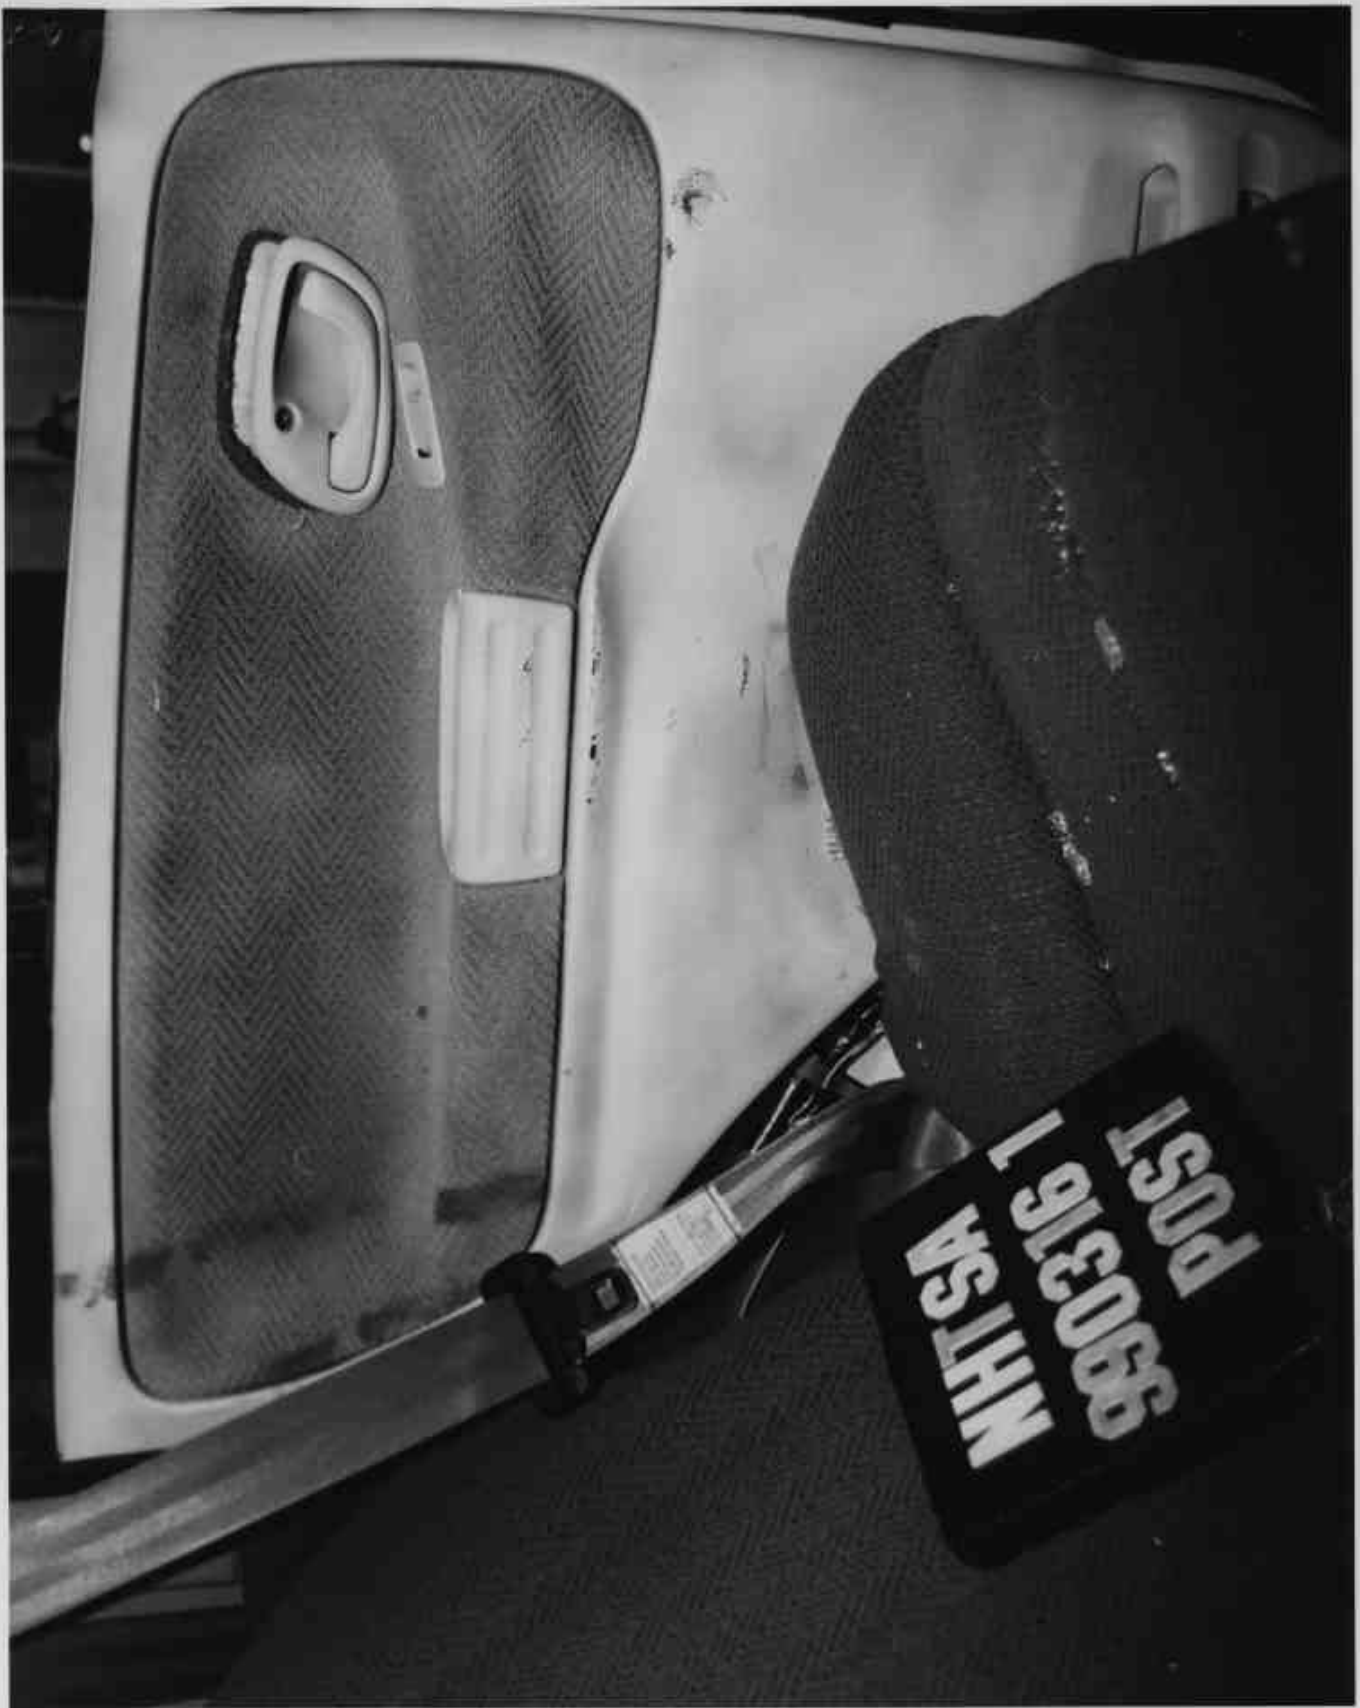
Figure A-45 Post-Test Interior of Rear Panel Showing SID Impact Locations  
A-48 990316
