REPORT NUMBER: SNCAP-CAL-99-6

**NEW CAR ASSESSMENT PROGRAM  
SIDE IMPACT TEST**

**VOLVO GOTHENBURG SWEDEN  
1999 VOLVO S80  
4-DOOR SEDAN**

**FINAL REPORT**

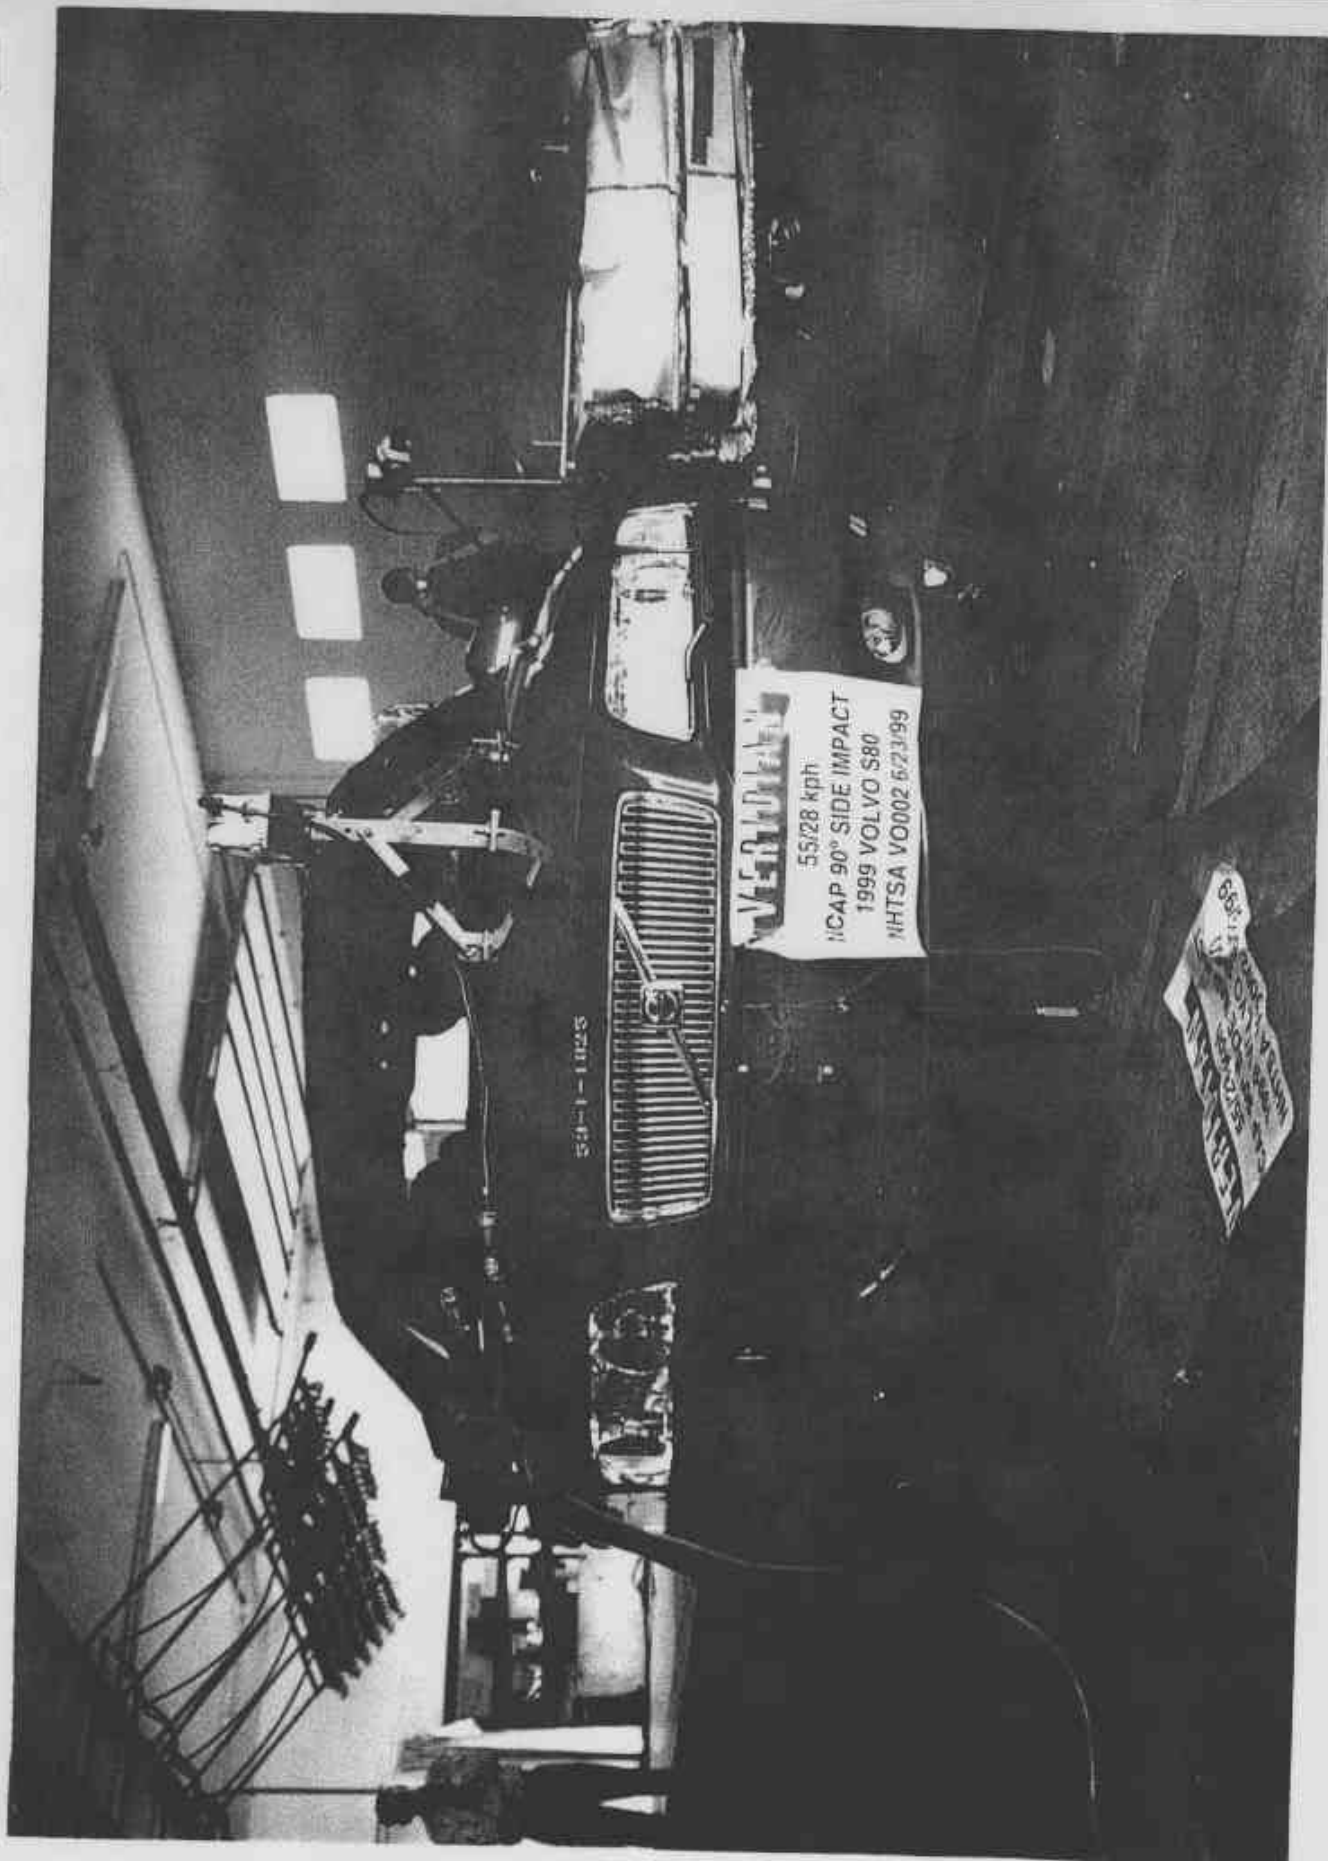
Figure A-2 POST-TEST FRONTAL VIEW OF TEST VEHICLE

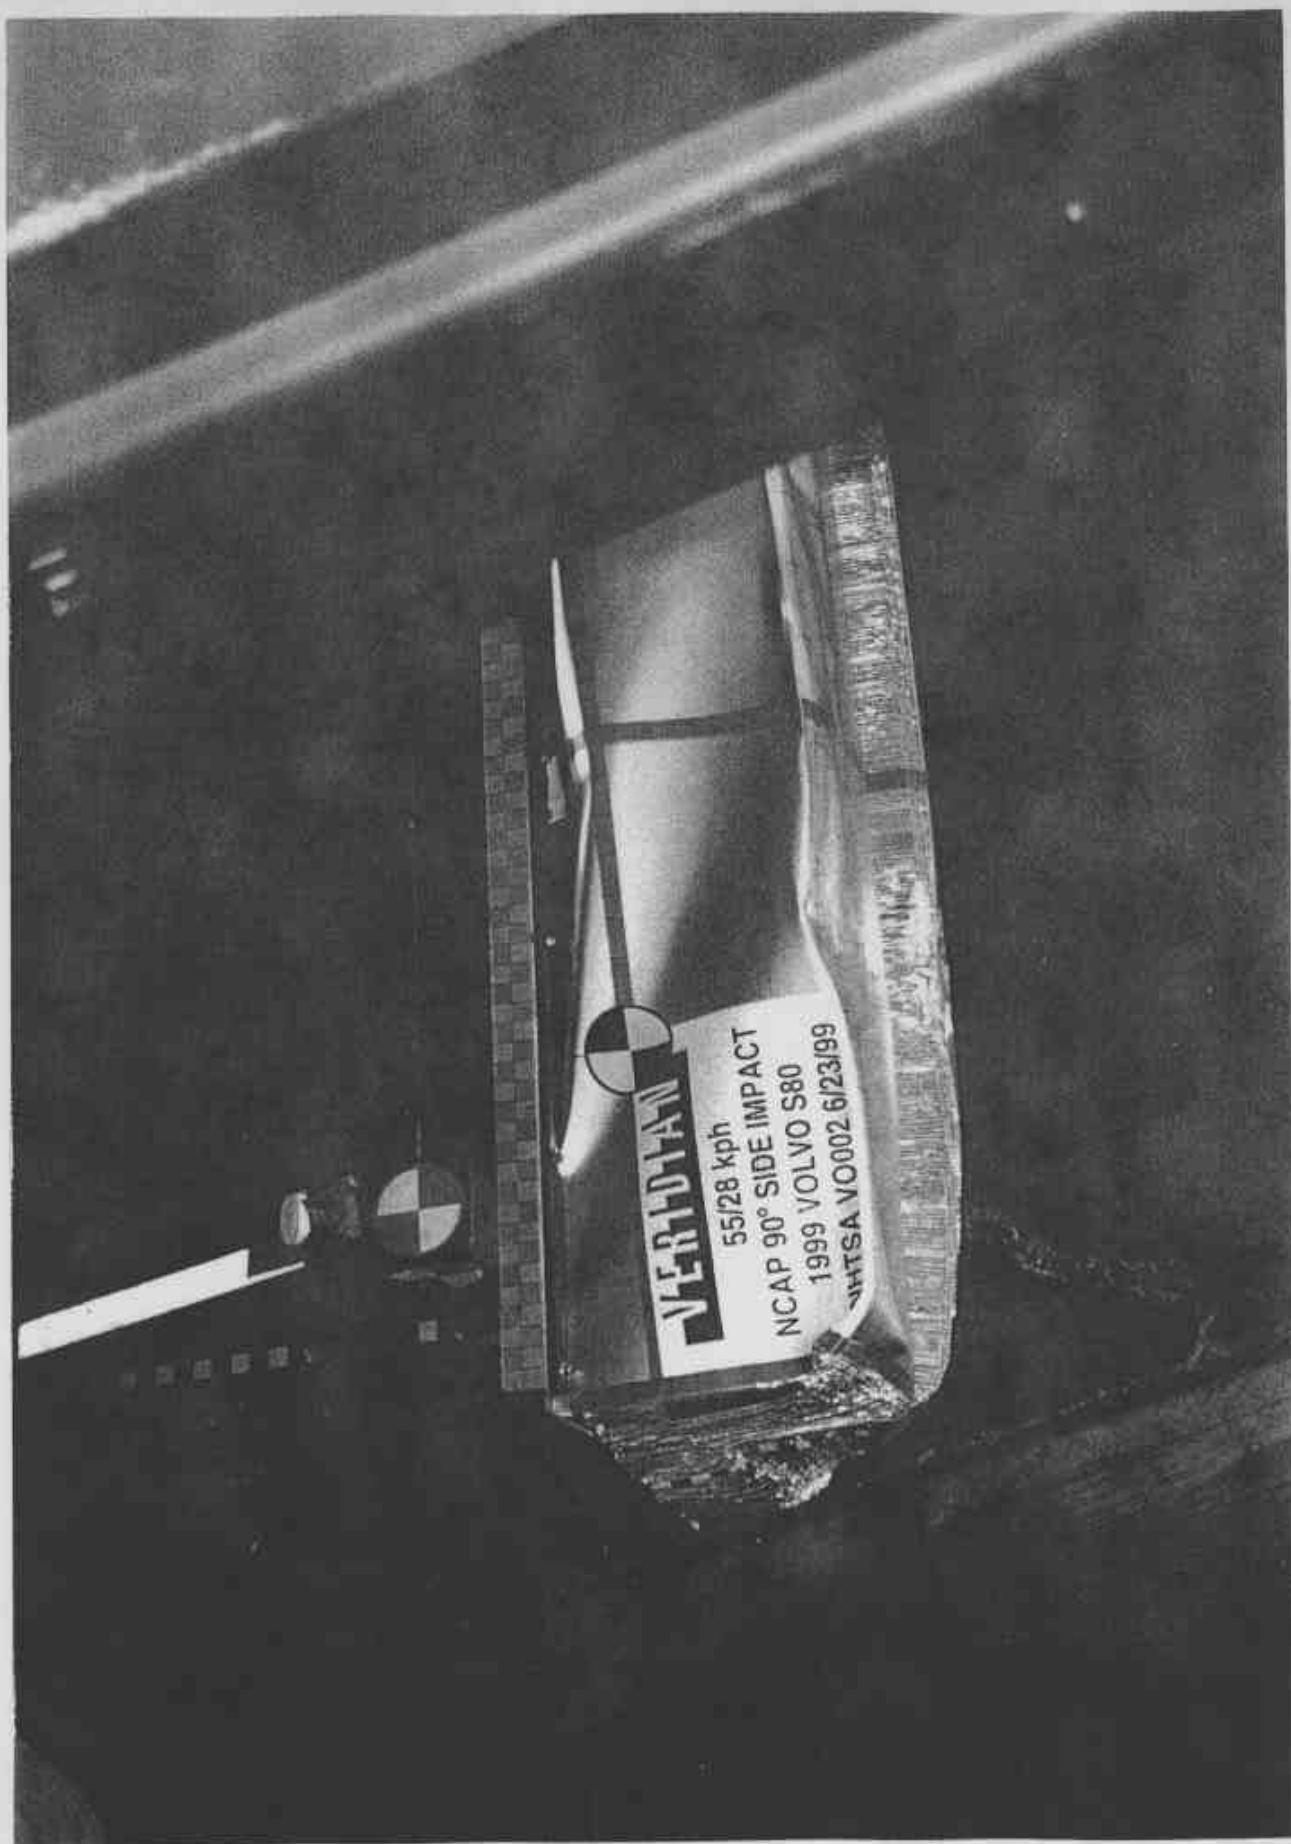
Figure A-14 POST-TEST TOP VIEW OF IMPACTOR FACE

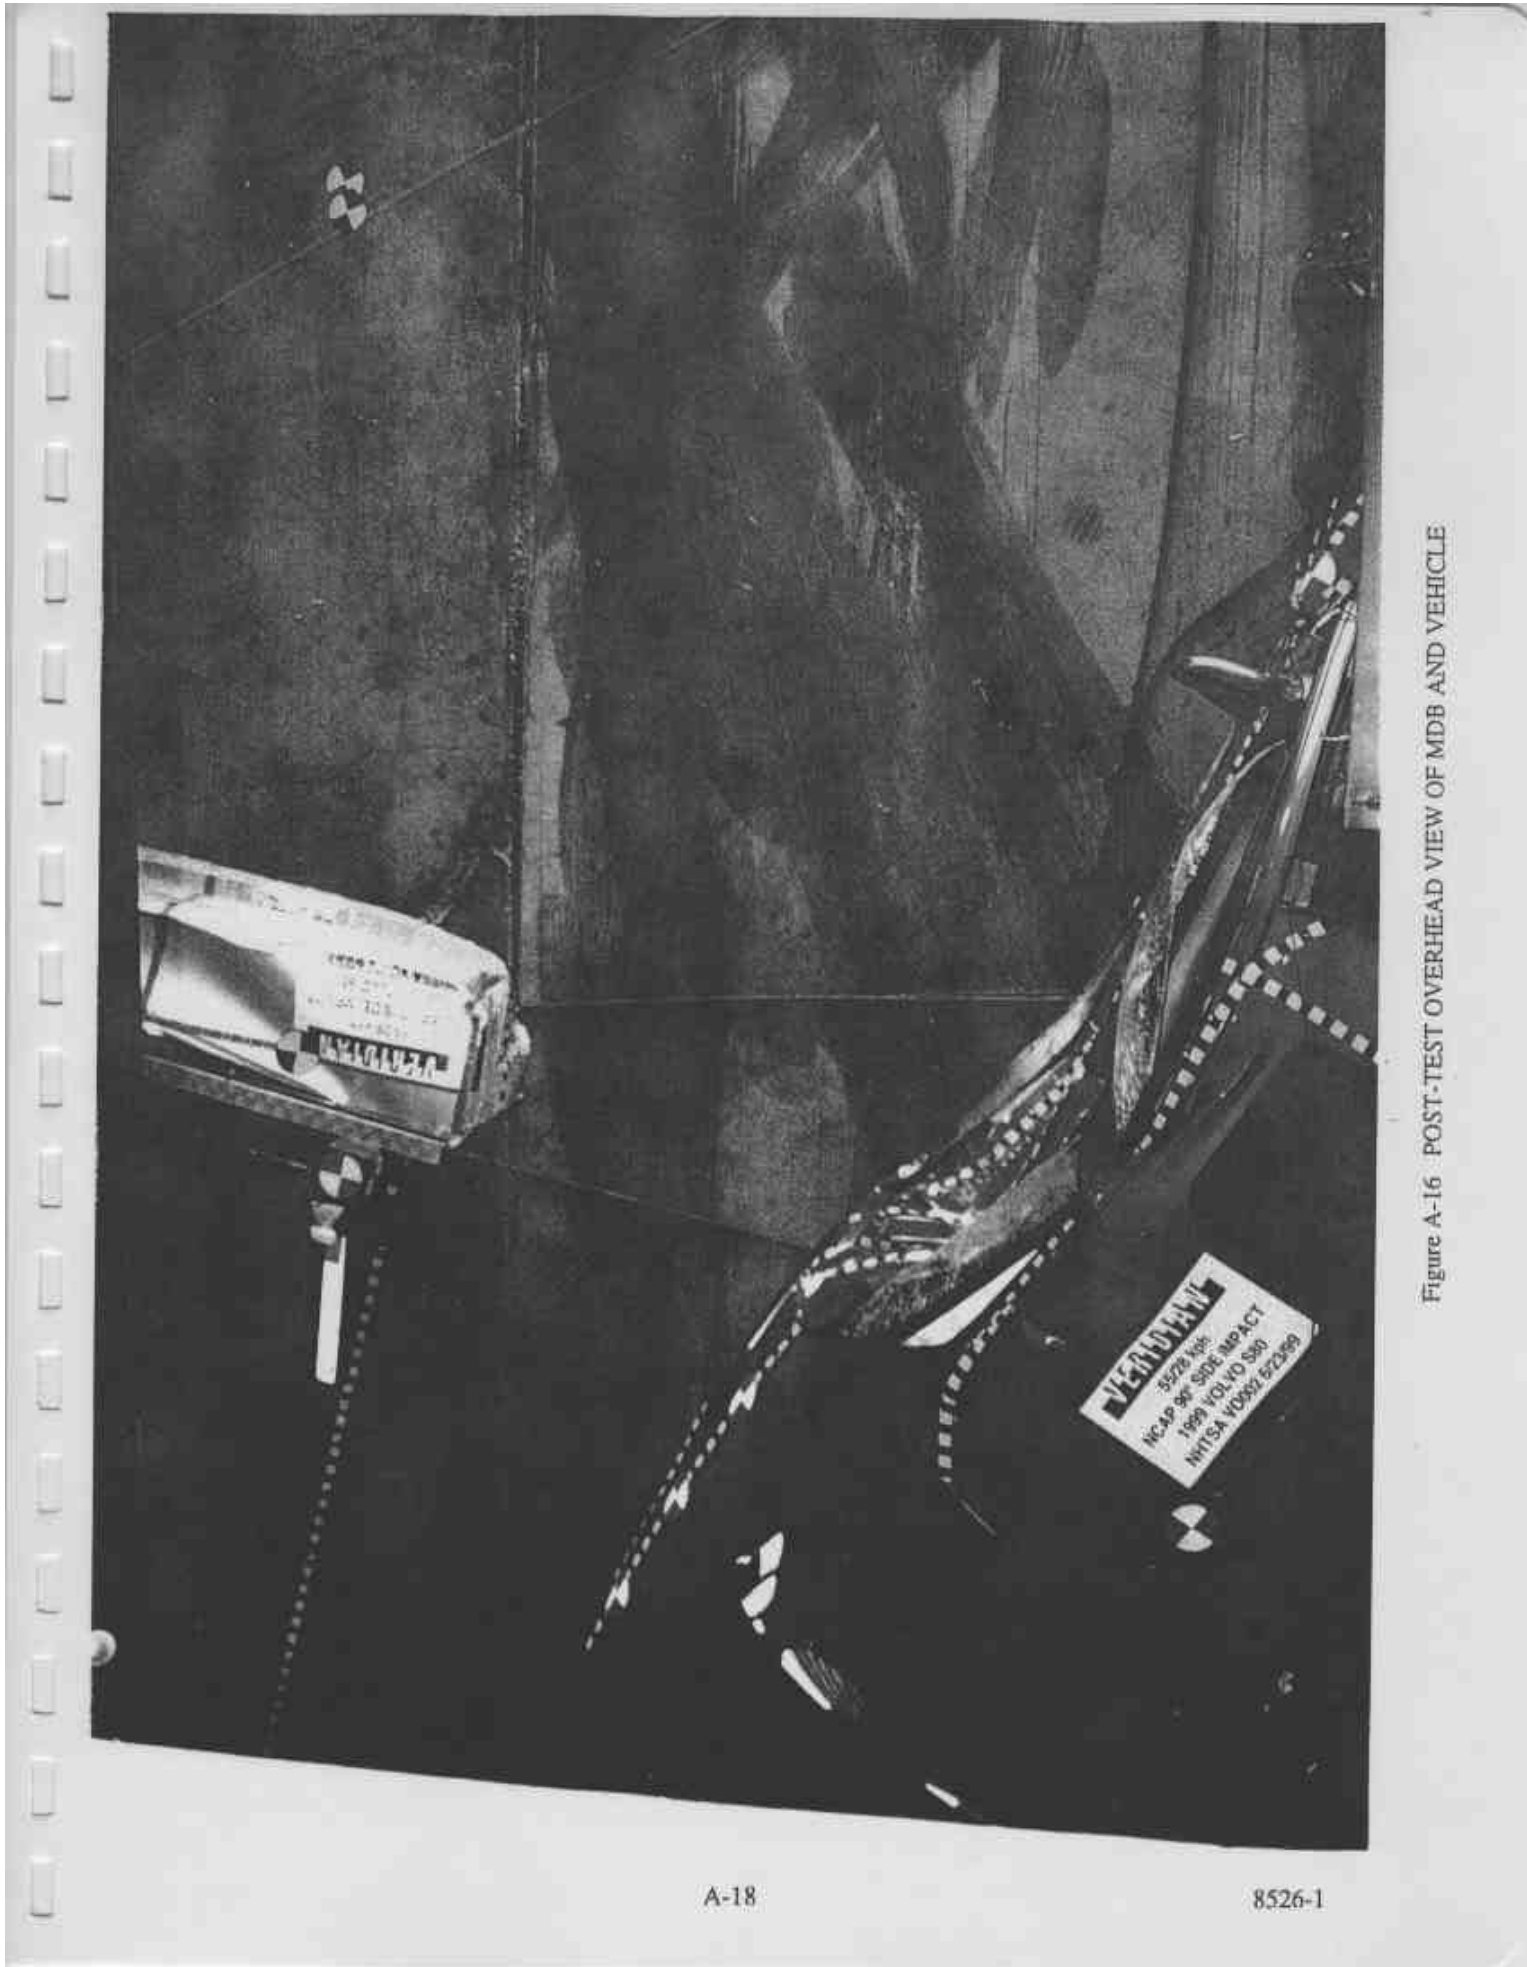
Figure A-16 POST-TEST OVERHEAD VIEW OF MDB AND VEHICLE

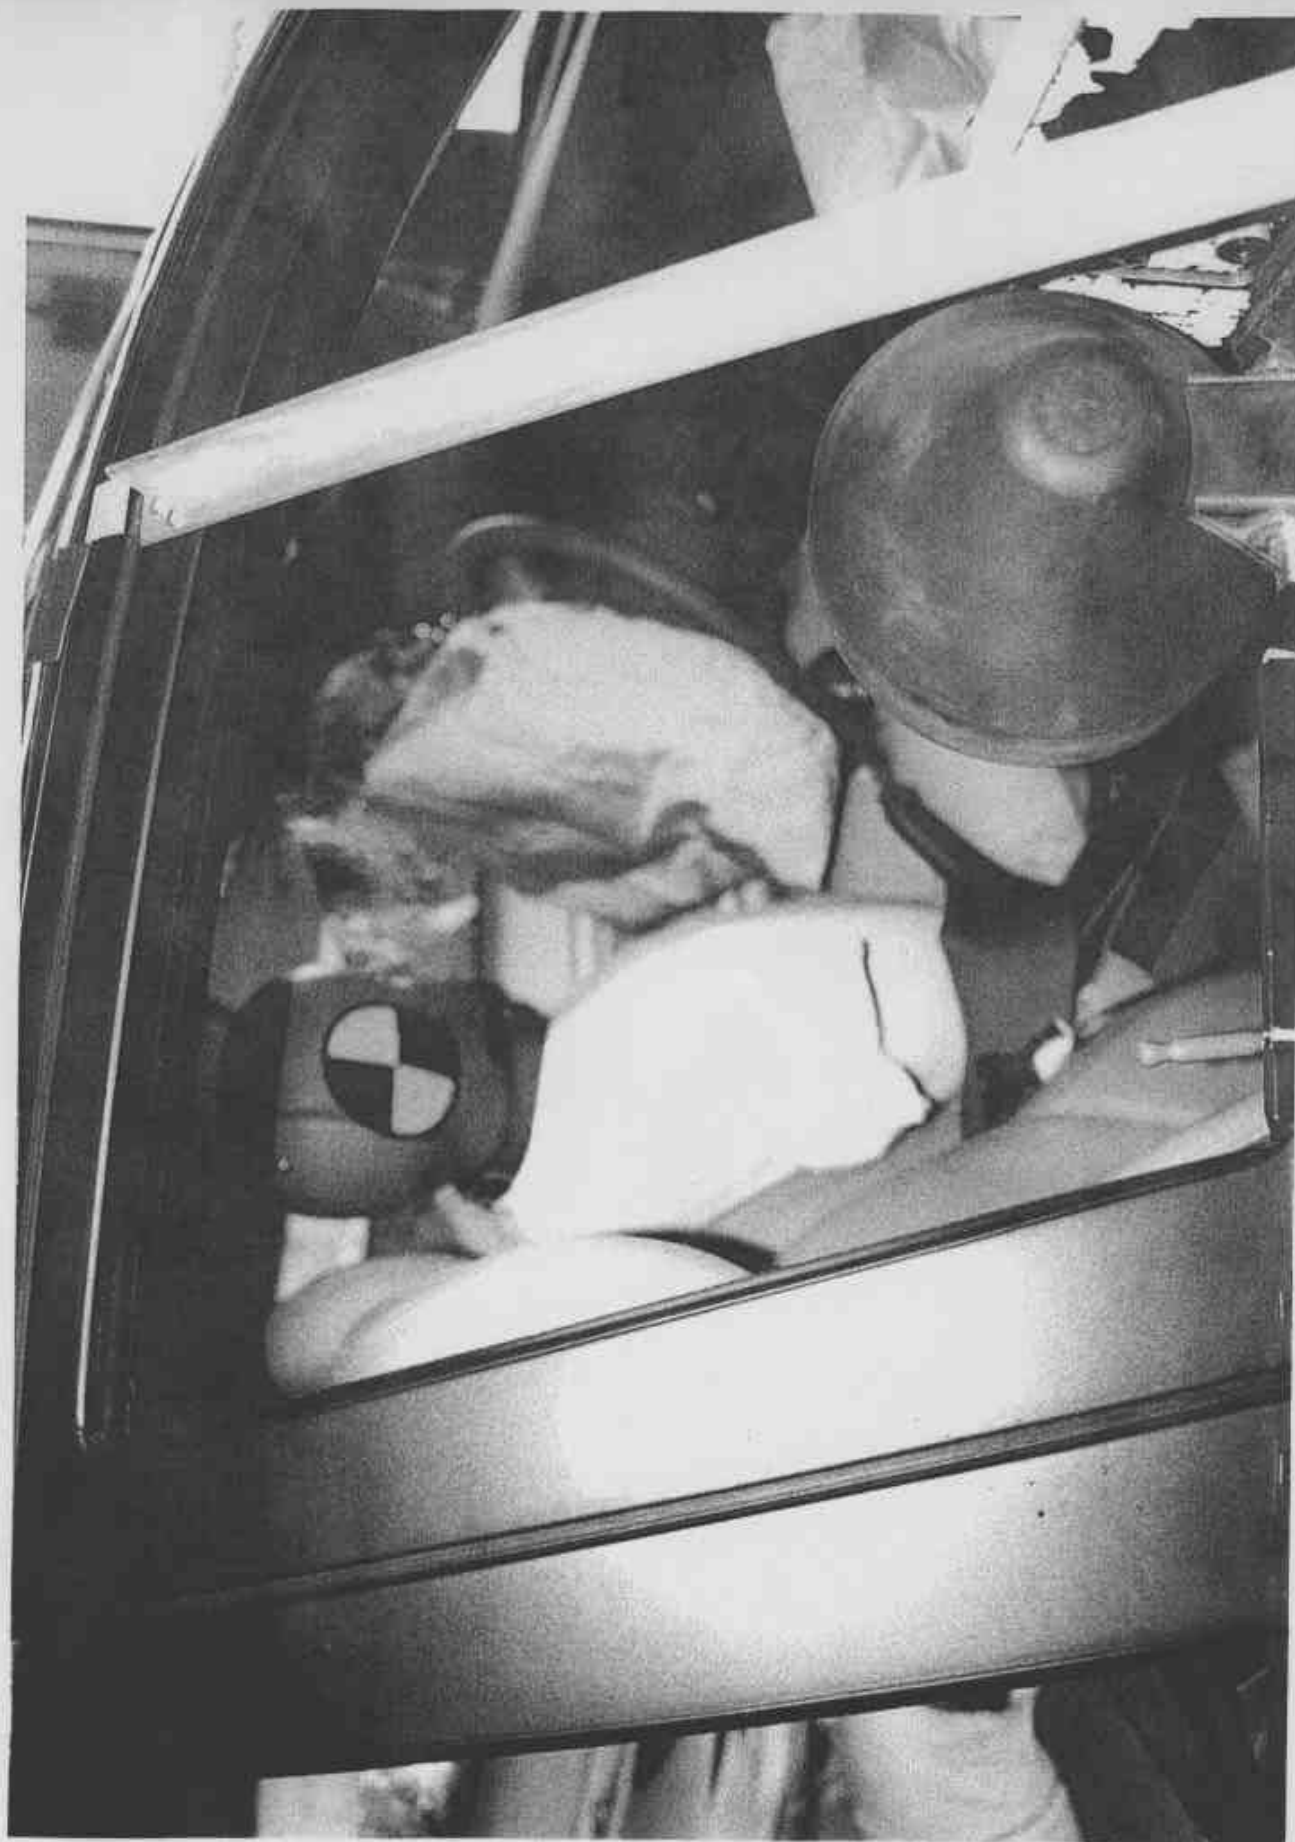
Figure A-18 POST-TEST RIGHT OCCUPANT COMPARTMENT VIEW OF FRONT SID

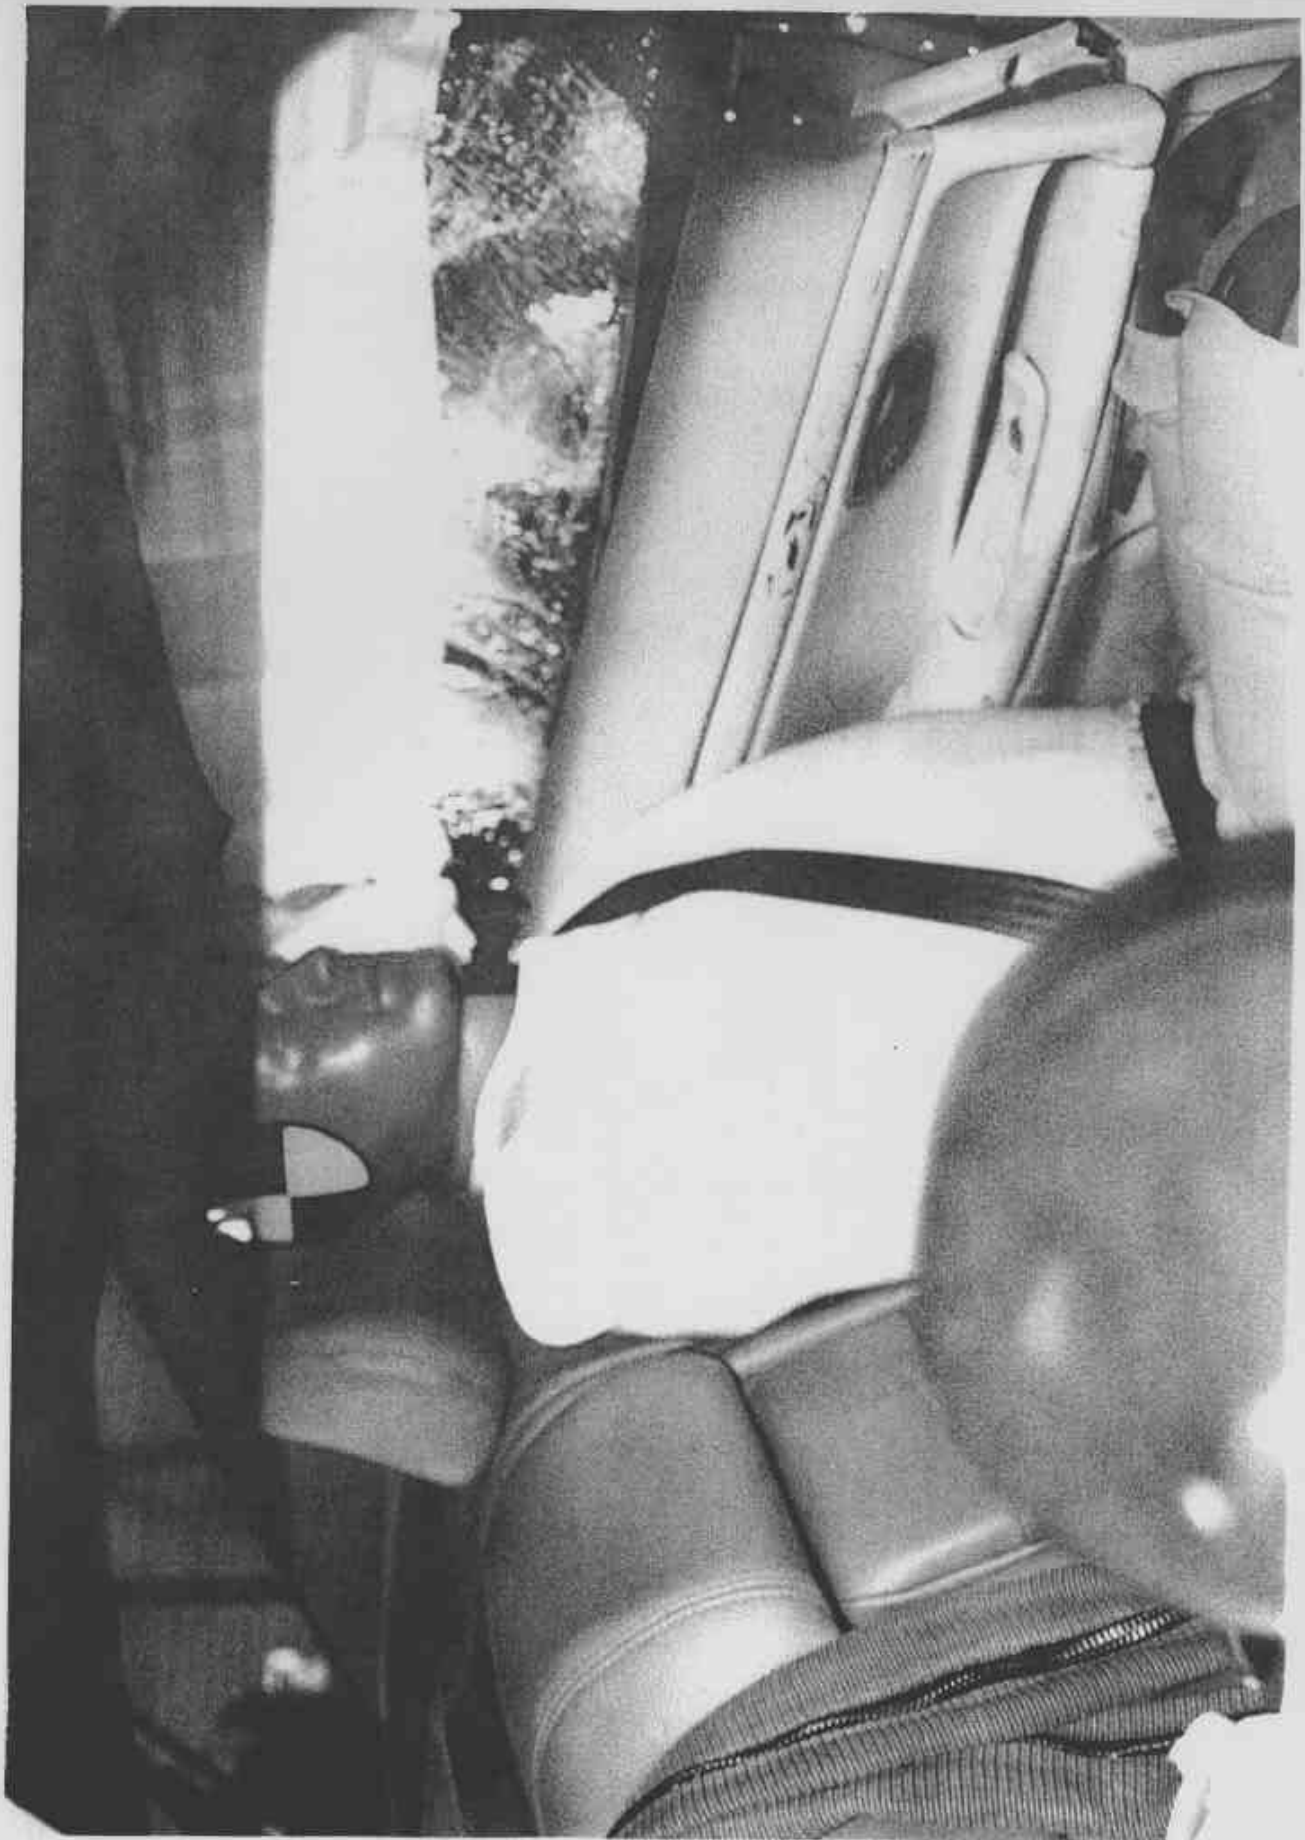
Figure A-20 POST-TEST RIGHT OCCUPANT COMPARTMENT VIEW OF REAR SID

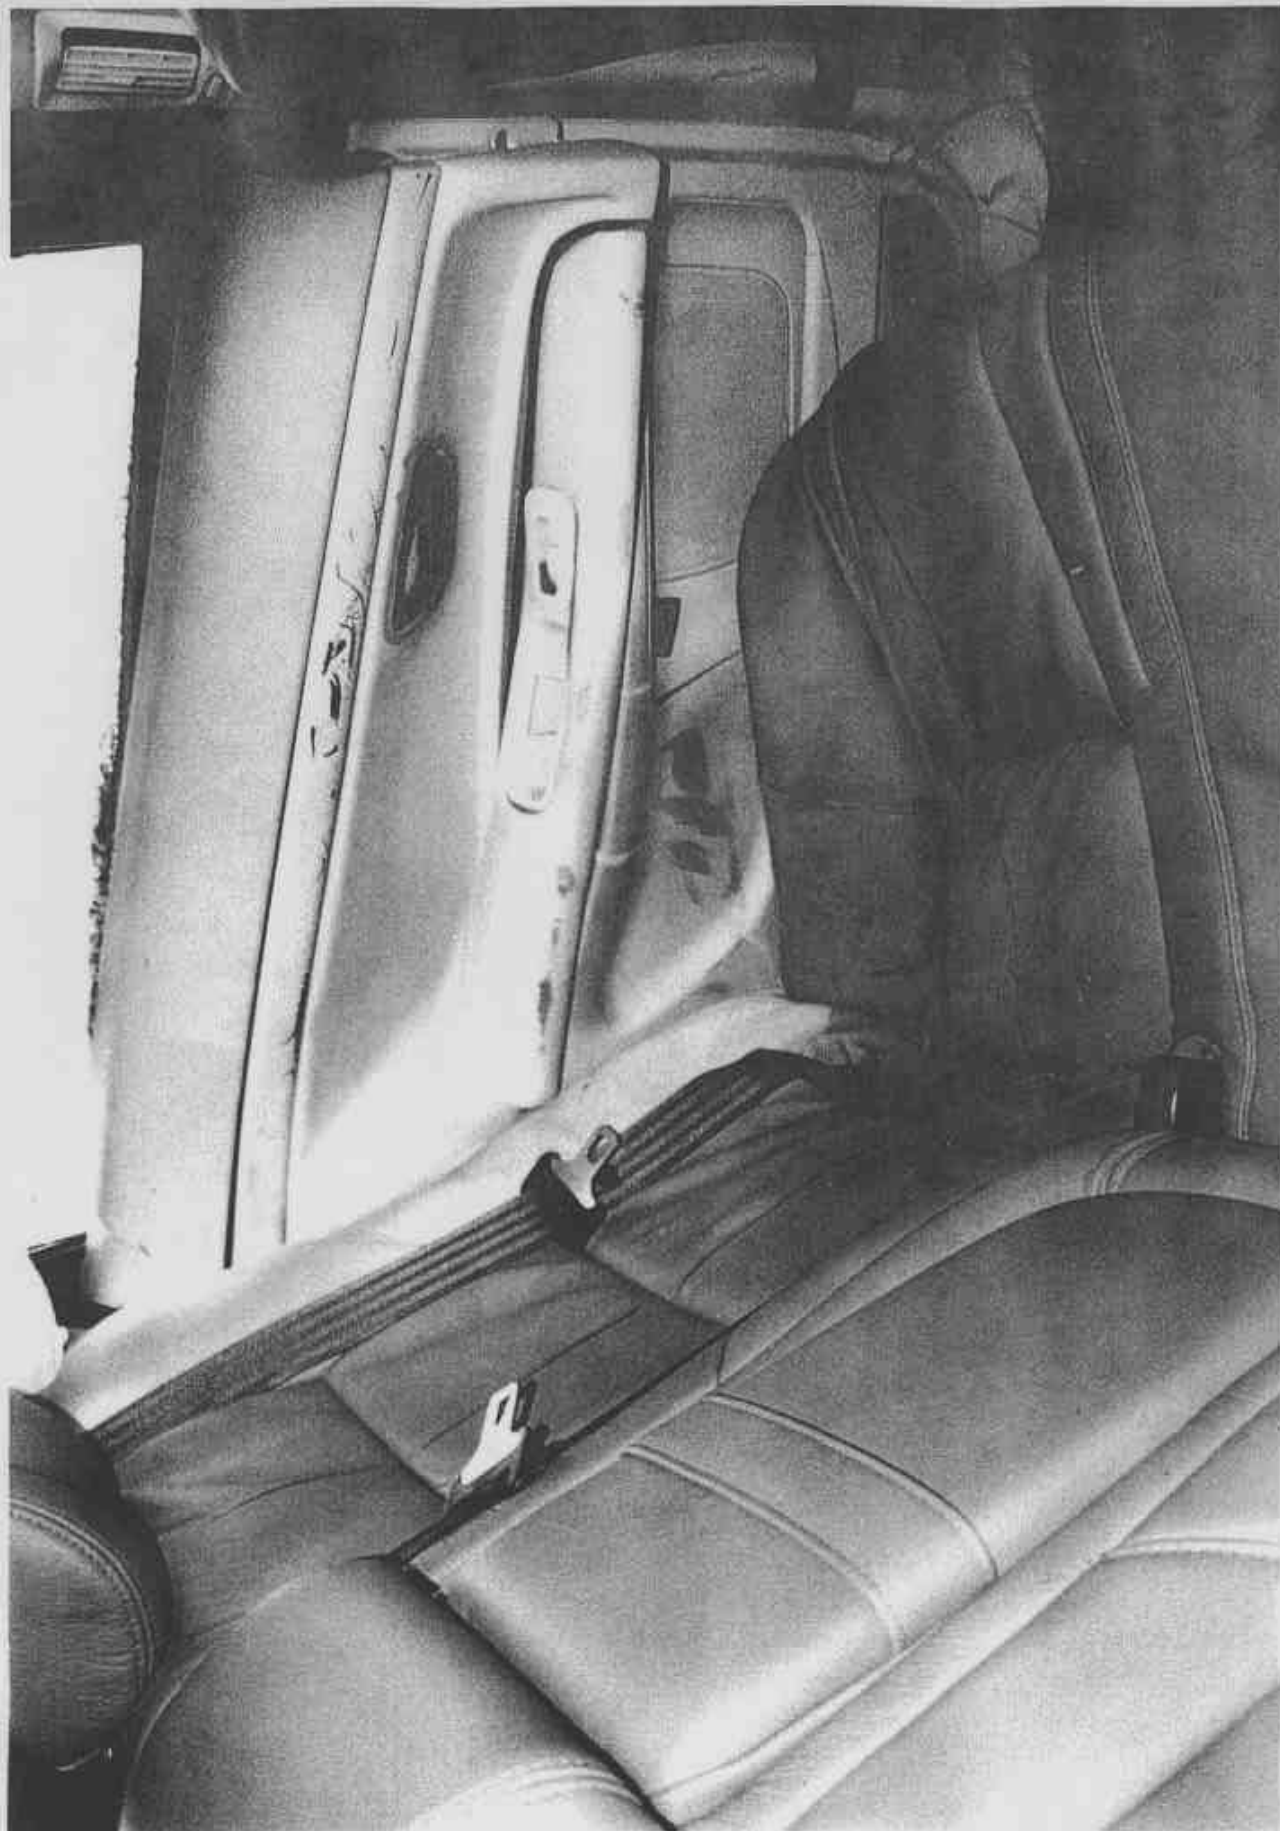
Figure A-28 POST-TEST INTERIOR OF REAR DOOR SHOWING SID IMPACT LOCATIONS

| | <u>LEFT FRONT SID</u> | <u>LEFT REAR SID</u> |
|---|---|---|
| Head: | <u>Side of head to side curtain airbag</u> | <u>Side and top of head to side curtain airbag</u> |
| Upper Torso: | <u>Seat bolster mounted airbag</u> | <u>Interior door trim panel</u> |
| Lower Torso: | <u>Seat bolster mounted airbag</u> | <u>Interior door trim panel</u> |
| Left Knee: | <u>None</u> | <u>Interior door trim panel</u> |
